## On-site assessment of timber structures

*Master's Thesis in the Master's programme Structural Engineering and Building Performance Design*

SVEN LÖWENMARK

Department of Civil and Environmental Engineering  
*Division of Structural Engineering*  
*Timber Structures*  
CHALMERS UNIVERSITY OF TECHNOLOGY  
Göteborg, Sweden 2009  
Master's Thesis 2009:91

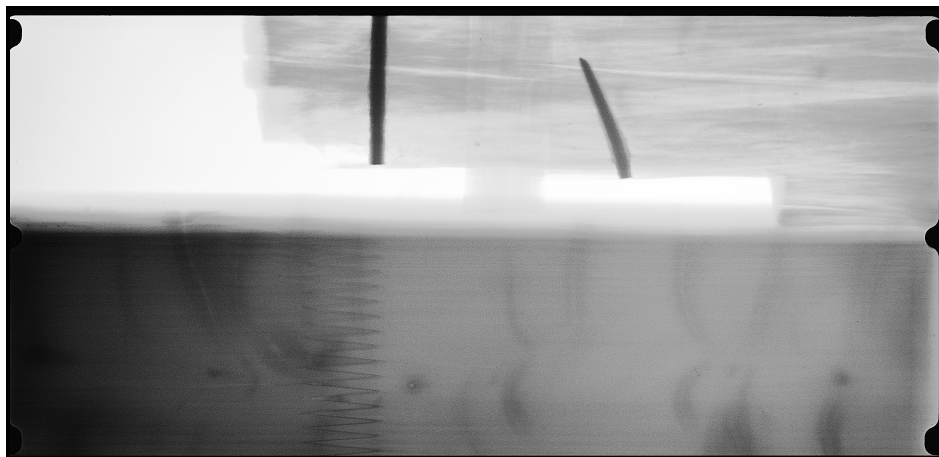
In Figure 5.4, a difference can also be observed in the structure between the materials. In the gluelam beam it is possible to glimpse the annual rings. What else can be clearly seen is the finger joint. The darker area at the left side of the gluelam beam is a result of that it is underexposed. In the log, compared to the gluelam beam, it is not possible to distinctly see the annual rings. Some type of structure can be seen, but it can clearly be seen that the original structure is deteriorated.

*Figure 5.4 Radiograph of material 2 lay upon material 3*

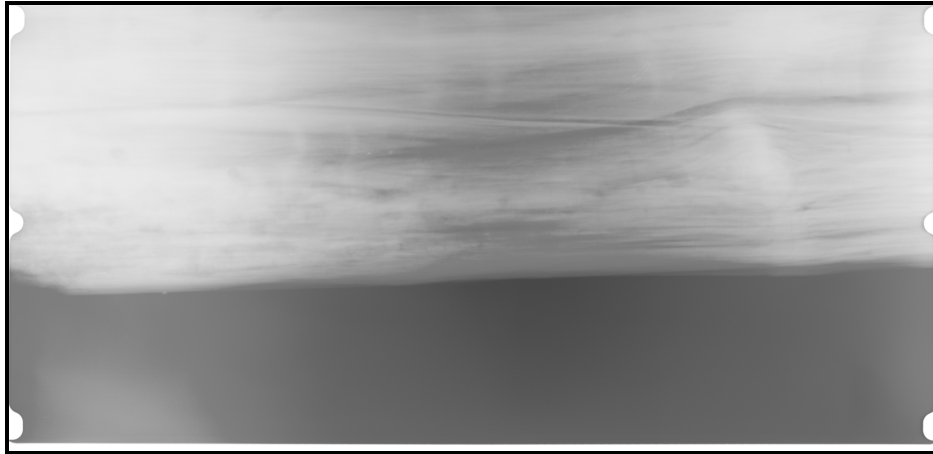
When inspecting other parts of material 2, it is clear that the log is decayed by looking at the grain structure, see Figure 5.6. As in Figure 5.5(a), only some grain structure is visible with a mottled appearance and no annual rings.

*Figure 5.6 Radiograph of material 1*

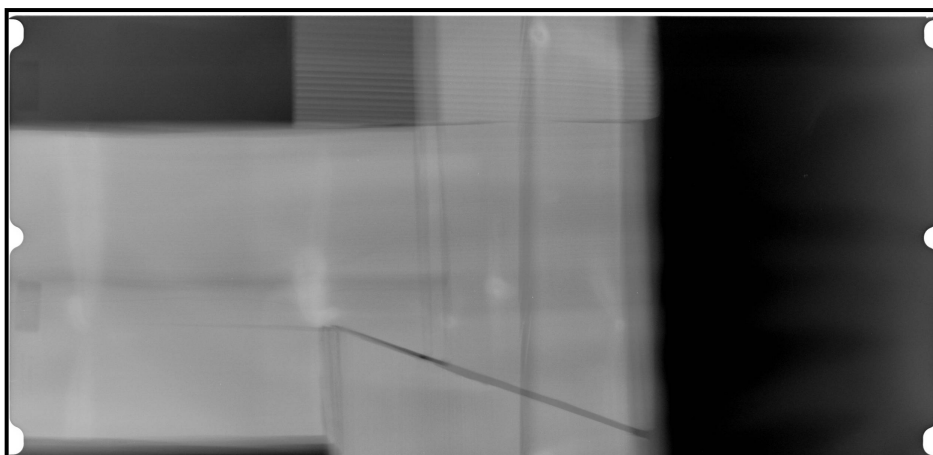
When studying the radiograph of the joint shown in Figure 5.3, it can be stated that distinction between different components in the joint is possible with x-ray equipment, see Figure 5.7. The scarf between the mortice and tenon can be seen in the lower part and looks like inclined splitting. The lock can be seen above the connection and it may be stated from the radiograph that the lock and the member inserted in have different thickness, as the structure of the lock is more transparent. The splitting in the vertical member can be seen as a darker line, and so also the splitting in the horizontal member, even if more unclear. It is possible to distinguish between the horizontal and vertical member where the tenon is inserted in the mortice due to the darker vertical lines, more easily seen above the horizontal member in the lock. In the horizontal member two inner knots are also visible as lighter spots with centre in the middle of the member and then directed toward the edges. Close to the vertical splitting another smaller knot is also visible. As the light from this is directed in the same direction as it is in the knots in the horizontal member, this knot has to be a part of this member as well. In the upper region a smaller knot is visible also but not any special direction of the lighter area and as a result it is not possible to be convinced if it belongs to the lock or the vertical member.

*Figure 5.7 Radiograph of the joint (laterally reversed)*

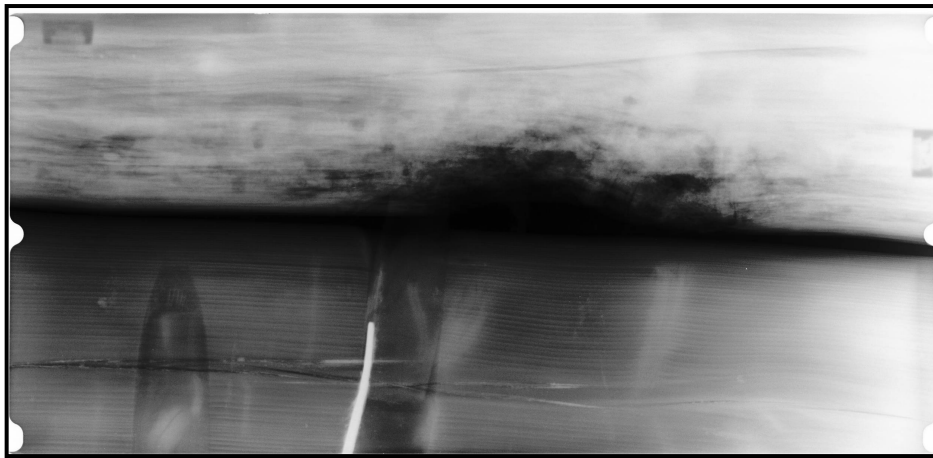
In the next radiograph, material 1 is laid below material 2, see Figure 5.11. When visually observed from outside, material 2 seemed decayed, but with this image the annual rings can clearly be seen which means it is sound. In the middle of the image there is a dark area which exhibits an even more decayed part of material 1. Furthermore, two dowels are seen in material 2, crossing the grain structure, with a nail at the side of one of those.

*Figure 5.11 Radiograph of material 1 lay upon material 2*

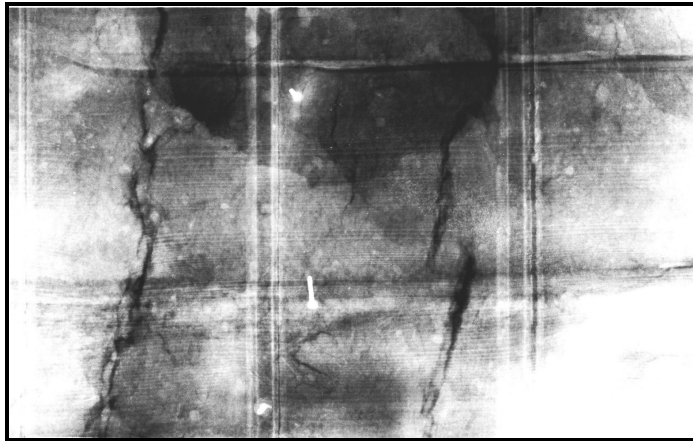
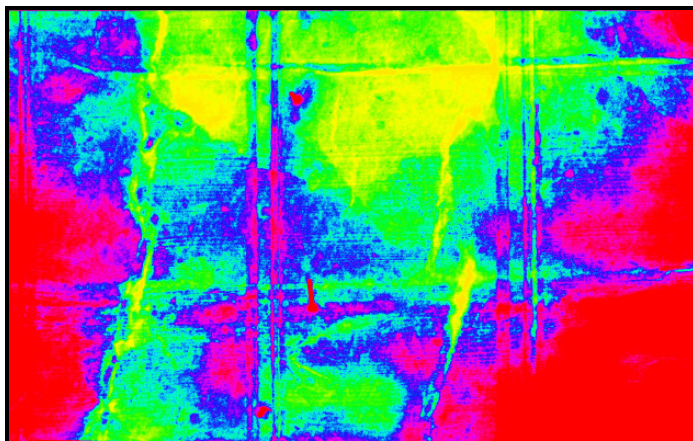
In the radiograph, shown in Figure 6.4(a), some vertical fissures can be seen, but also an upper region where the grain structure disappears into a dark area, which is expected to be rot. To extend the analysis, it is also possible to colourize respectively emboss the image, see Figure 6.4(b) and 6.5. In the embossed image it can be seen that the grain structure at some places disappears, which visualize the rot even more.

*Figure 6.4 Radiograph and colourized radiograph of the outer wall*

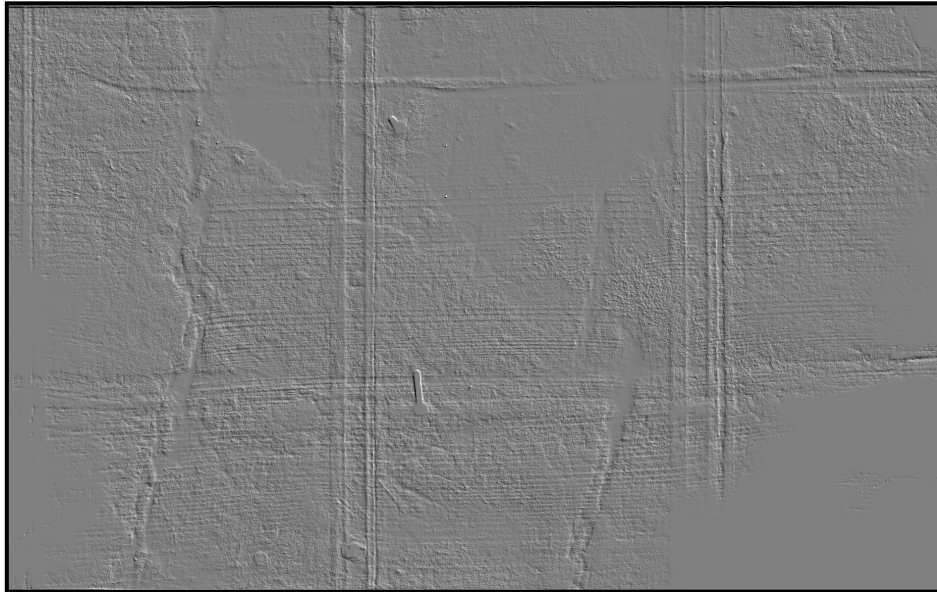
*Figure 6.5 Embossed radiograph of the outer wall*

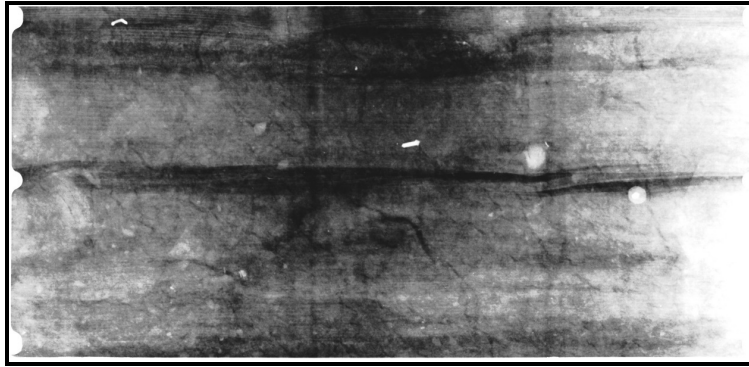
In the image, and perhaps more easier in the enhanced images in Figure 6.6(b) and 6.7, the rot can be seen both in the middle, as a strip and in the middle at the upper part as a more concentrated spot. In the colourized image this is where the colour is orange first of all. The smaller lighter spots at some places in the radiograph, indicate smaller nails, see also Figure 6.7 where the contour of those are clearer. Similar images were obtained from other parts of the wall as well. It was not possible to take any radiograph on the upper face of the members, in order to determine whether the rot were continuous through the width of the logs or not.

*Figure 6.6 Radiograph and colourized radiograph of wall on the central part of the house*

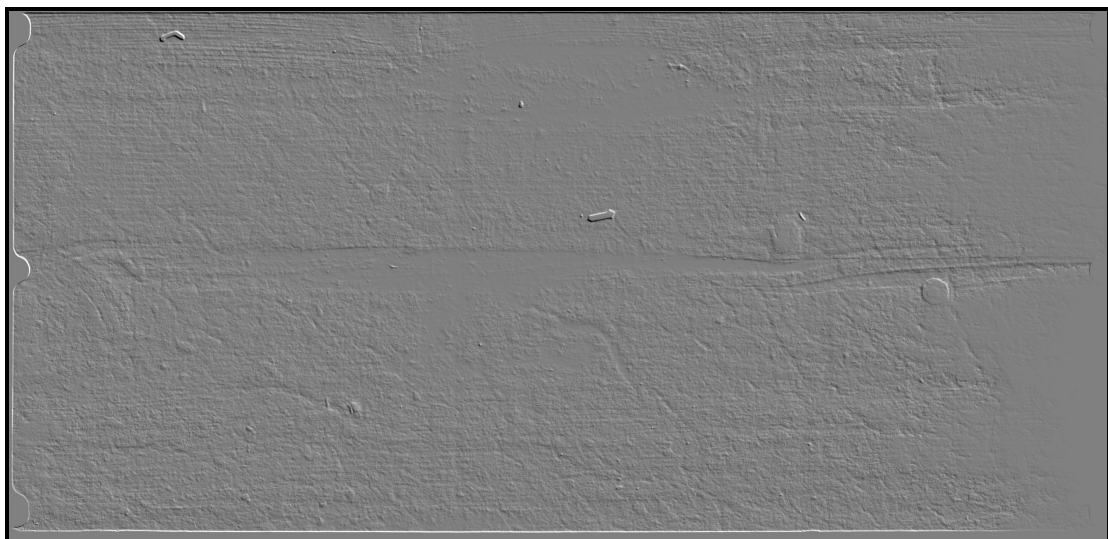
*Figure 6.7 Embossed radiograph of wall on the central part*

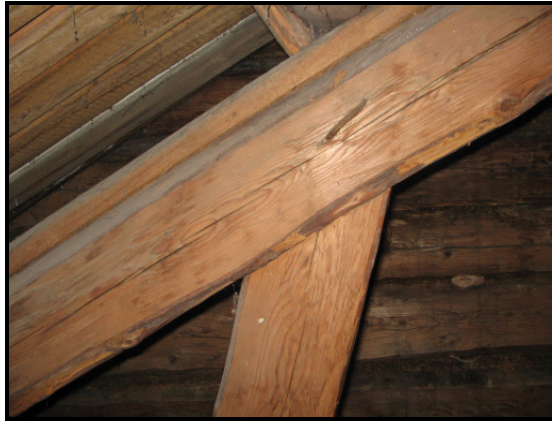
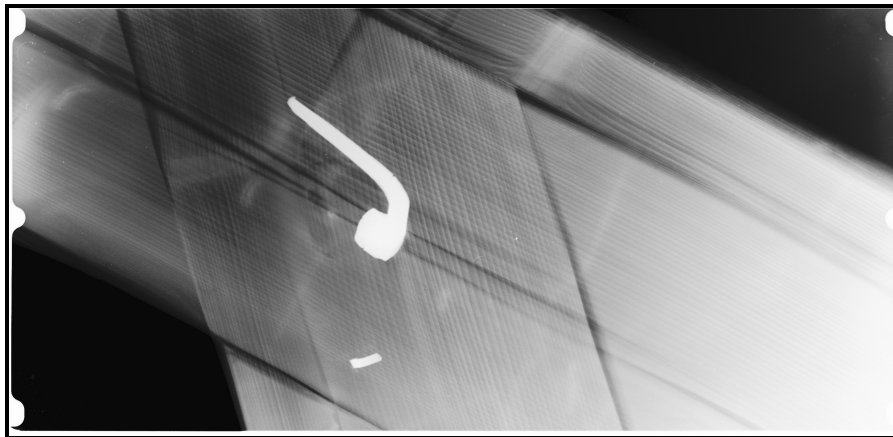
In addition to the walls, a joint in the roof structure was inspected, see Figure 6.8(a), and was expected to be sound. This was also what the radiographs exhibited; see Figures 6.8(b) and 6.9(b). In the images it is also possible to see how the joint is mounted. In the area where the members are joined, the annual rings in two directions can be seen in Figure 6.8(b), which verify that there really are two members joined to each other. In the rafter, a line with the same width as the nails is visualized in the middle of the member. This indicates splitting, probably caused by stresses from the nailed connection. Where the more or less vertical post is fasted to the top chord, a slot can be seen, see Figure 6.9(b). It can be seen that the nail in this space has a reduced cross section, which mean it has been corroded. The bowed shape of the nail in Figure 6.8(b) is a result of a too long nail struck against the timber. In Figure 6.9(c) a drawing visualize the design of the joint from the front.

*Figure 6.8 Radiograph and photo from the side of the joint inspected*

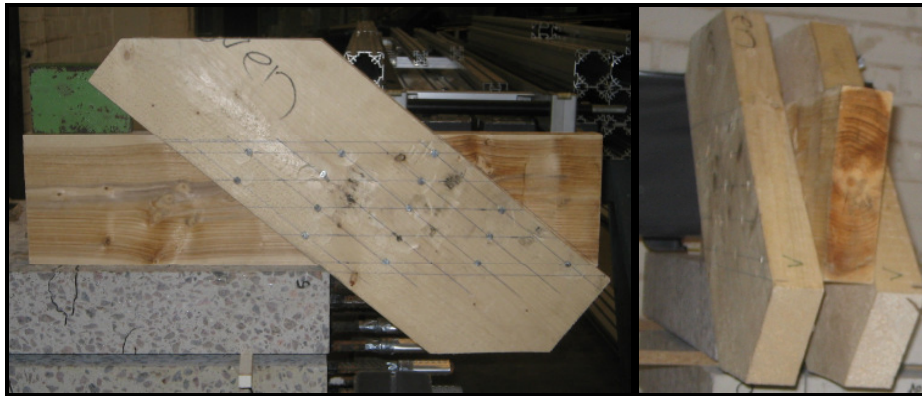
The timber joint was thereafter constructed by the author in the laboratory of the Division Structural Engineering. One may notice the difference in colour between the tie beam and the rafter, where the tie beam is darker, see Figure 7.5. This indicates the fact that the tie beam is decayed and the rafters are sound.

Figure 7.5 Joint from roof truss inspected
