Surface analysis of polyethylene pipes and failure characterization of electrofusion joints

Master of Science Thesis in the Master Degree Programme, Materials and Nanotechnology

LUKAS BOGE
EMIL HJÄRTFORS

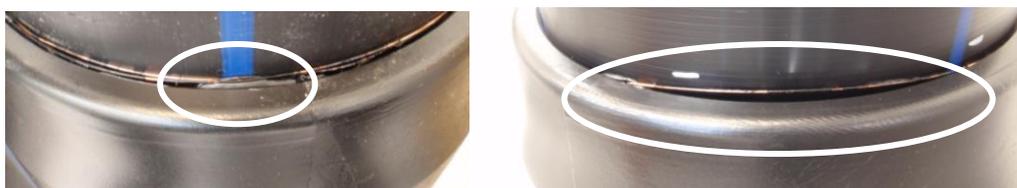
Figure 17. Pictures showing defects such as melt flow and exposed heating wires. These defects might suggest something is wrong with the joints.

In some joints the weld indicators did not protrude at all, implying not enough melt pressure was obtained in the fusion zone. According to Nordiska Plaströrgruppen (2009) these kinds of defects would indicate that there might be something wrong with the joints. Despite the leaked out melt flow and exposed heating wires the joints can still be approved after evaluation with peel decohesion test.

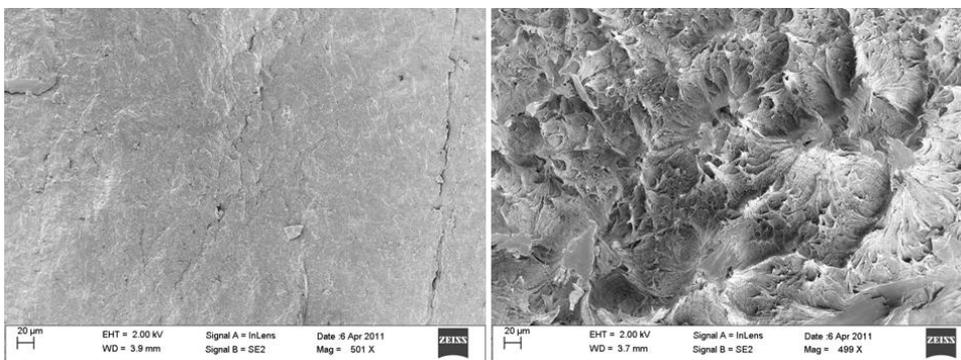
In order to reveal if there is any difference in topography of the two kinds of brittle failures present at peel testing pieces of electrofused joint, dark black surface and gray surface, SEM imaging were carried out. The result can be seen in Figure 25. The image to the left shows a dark black brittle fracture surface with no signs of plastic deformation present. Plastic deformation can easily be seen in the right hand side image of a gray brittle fracture.

Figure 25. SEM images of the two kinds of brittle fractures, dark black to the left at and gray to the right. The magnification is close to 500 x. Notice the difference in plastic deformation.

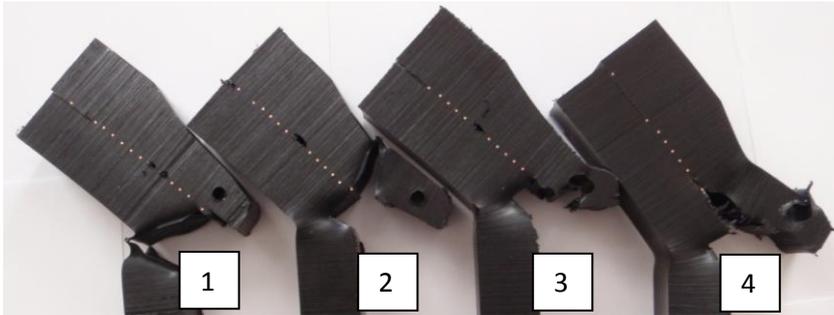
In Figure 28 four peel decohesion test samples are shown. The first sample has failed in the pipe while the second failed in the coupler. The third sample failed in both pipe and coupler while the last sample failed in pipe, joint interface and finally in the coupler. These samples are classified as ductile since the joint is stronger than the pipe and/or coupler.

Figure 28. Peel decohesion samples with different failing modes in pipe/coupler/joint interface.

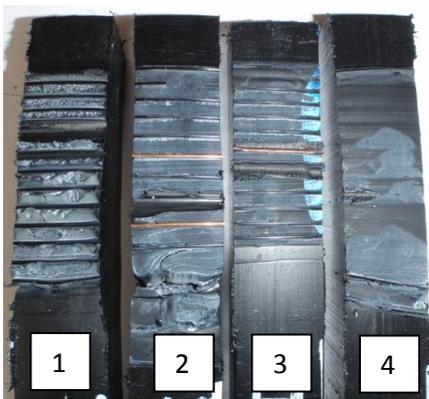
In Figure 29 typical peel decohesion tested samples are shown. First sample is characterized 0 % brittle, the second one as 70 % brittle and the last two ones 100 % brittle. Almost no wire imprints are present at sample 4, indicating extremely low strength at the fusion interface.

Figure 29. Typical failures in fusion interface with increasing brittleness from left to right.

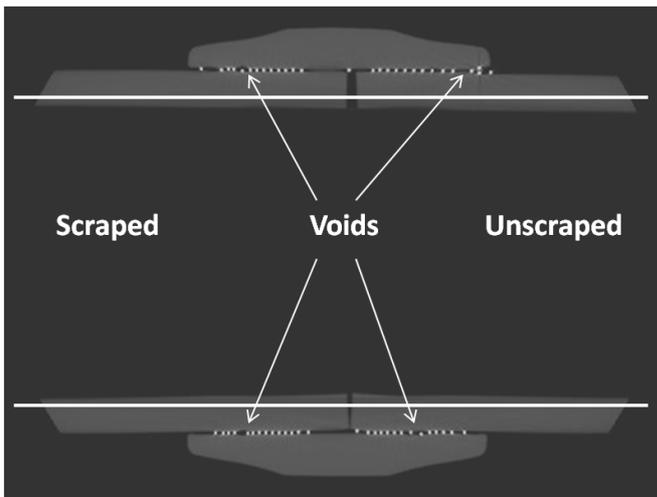
Figure 34. X-ray computed tomography image taken parallel to pipe axis.

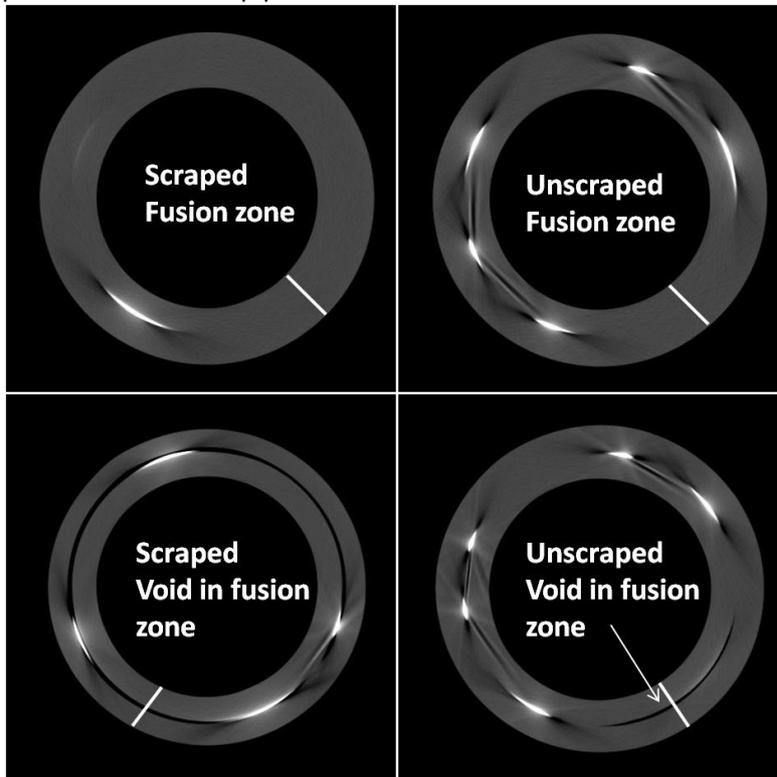
Figure 35 shows images from the CT-scans perpendicular to the pipe axis. Again, voids were present at both the pipe ends.

Figure 35. X-ray computed tomography images taken perpendicular to pipe axis.

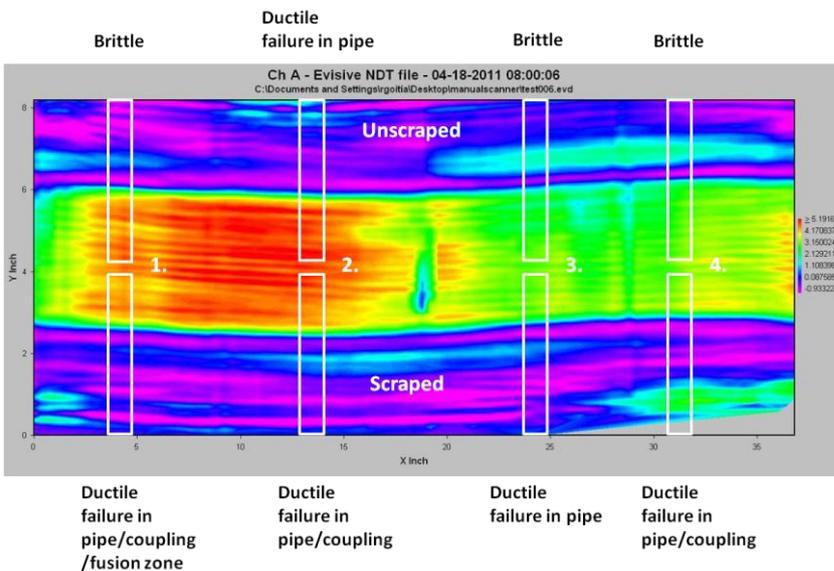
Figure 38. Results from peel tested samples, cut at marked positions, around the coupling.
