## Fatigue-Prone Details in Steel Bridges

Reza Haghani \*, Mohammad Al-Emrani and Mohsen Heshmati

**Abstract:** This paper reviews the results of a comprehensive investigation including more than 100 fatigue damage cases, reported for steel and composite bridges. The damage cases are categorized according to types of detail. The mechanisms behind fatigue damage in each category are identified and studied. It was found that more than 90% of all reported damage cases are of deformation-induced type and generated by some kind of unintentional or otherwise overlooked interaction between different load-carrying members or systems in the bridge. Poor detailing, with unstiffened gaps and abrupt changes in stiffness at the connections between different members were also found to contribute to fatigue cracking in many details.

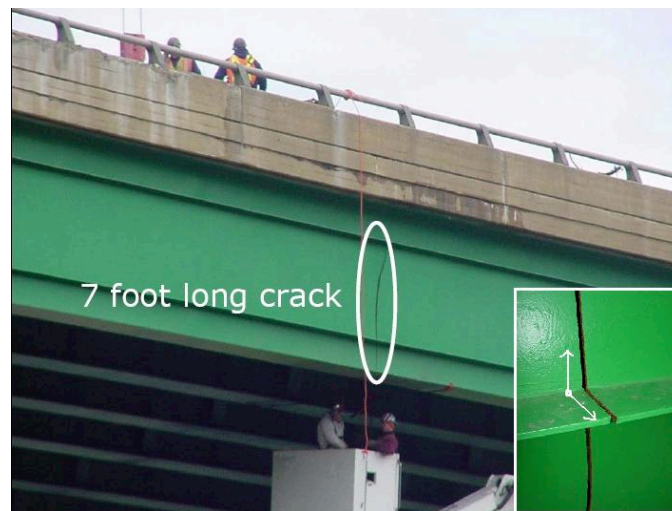
In very few cases, weld defects have caused fatigue damage in steel bridge details, under the action of primary load effects. These cases are found either in fairly old bridges, built before quality control methods and non-destructive testing techniques were well developed, or in details which were regarded as “secondary” for the load-carrying capacity of the bridge and therefore were not included in quality control of this kind. One example of the latter case is the fatigue cracking in bridge girders with welded longitudinal stiffeners. Several bridges in the United States have experienced this type of cracking [3,4]. The cracks started from weld defects at the intersection between the fillet welds connecting the longitudinal stiffeners to the girder web and the butt welds made for transverse splices in the longitudinal stiffeners, see Figure 2. The detail was considered to be of secondary importance and no inspection of the weld intersection was made. The weld intersection also provided a path for the crack to grow from the stiffener into the girder web, resulting in brittle failure in some cases.

**Figure 2.** Fatigue cracking in a bridge girder starting from weld defects at a weld intersection point (after [3]).

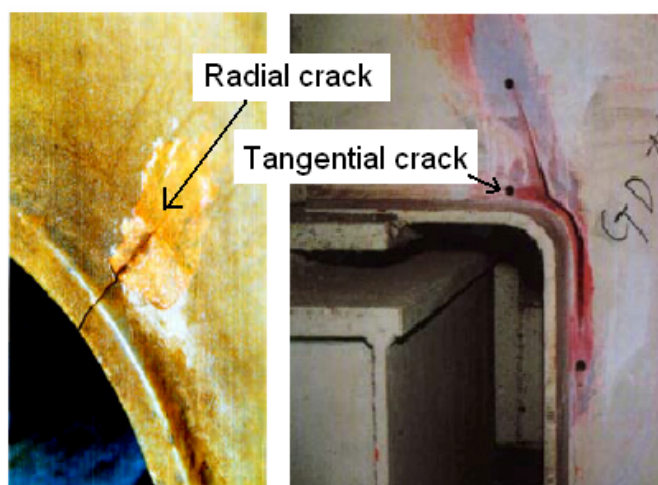
Damage cases involving fatigue cracking in the web of the girder, as well as in the flange-to-web welds, have been reported. In the latter case, the connection between the flange and web was made by means of fillet welds. The cracks in the girder web can grow either in a direction tangential to the flange curvature (caused by the radial stress component) or in a radial direction (generated by the tangential stress component), see Figure 5.

**Figure 5.** Examples of radial and tangential cracks [5].

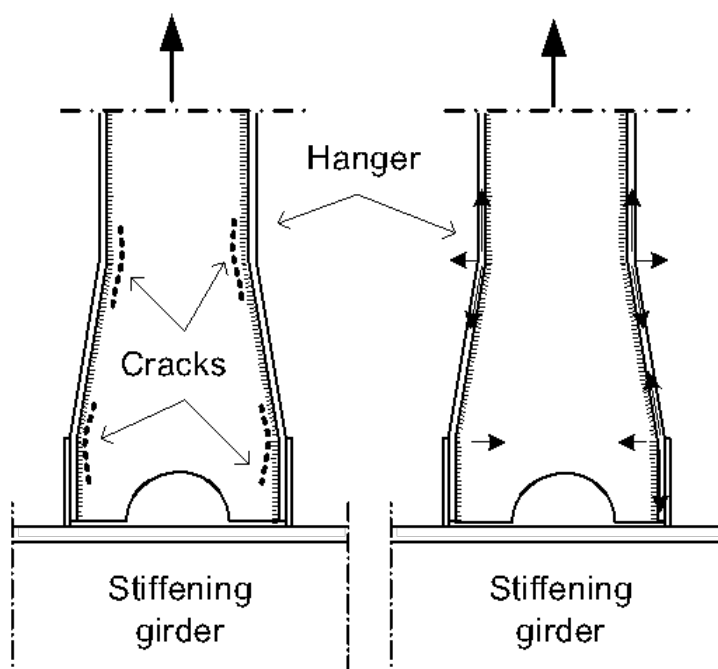
Figure 6 shows another case in which a change in the cross-section of a hanger in an arch bridge resulted in additional stress components that were not taken into account in the design of this member. In this detail, not only the axial stresses in the I-shaped hanger are magnified by the change in

cross-section, but also transverse stresses (in the plane of the web) are generated locally at locations where these axial force in the flanges change direction. Fatigue cracks were observed in the web plate in these locations. The crack grew along the fillet weld parallel to the direction of normal axial stresses in the hanger, indicating that they were generated by a stress component perpendicular to the welds.

**Figure 6.** Fatigue cracking in a vertical hanger with a change in cross-section near its connection to the stiffening girder in an arch bridge.

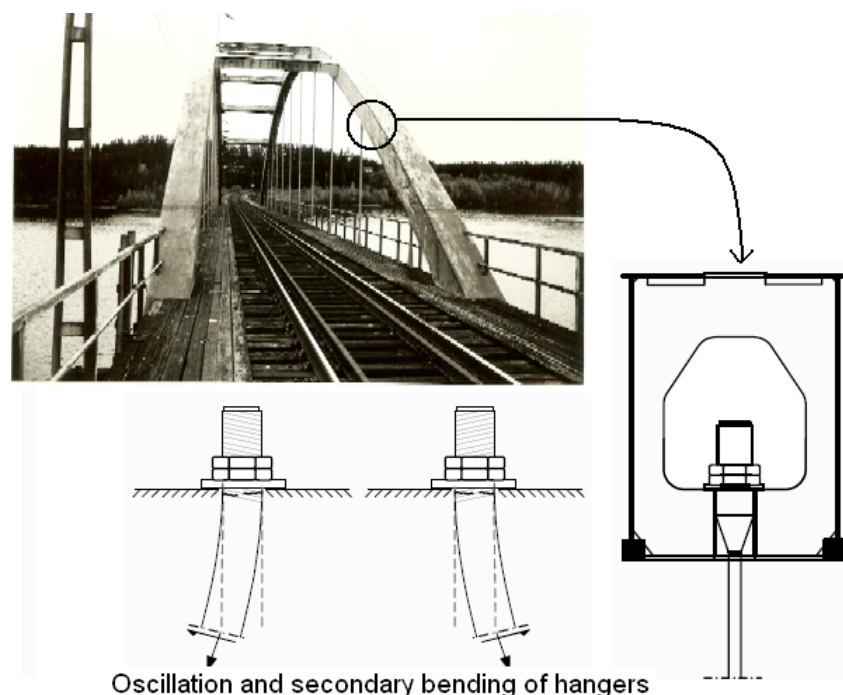
Figure 7 shows an example of an arch bridge in which the hangers have developed fatigue cracks at their connections to the steel arch. This railway bridge, which was built in 1943, has a span of 61 m and comprises a steel arch with two ties (stiffening girders) connected by floor beams. The hangers were made of steel cables with a diameter of 79 mm. A detail of the hanger connection to the steel arch is also shown in Figure 7. The fatigue damage was detected in the early 1980s; some hangers had cracked and totally separated from their connections to the arch. The cracking which took place at the threaded part of the hanger was attributed to a combination of oscillation and secondary bending of the hangers at their connection to the steel arch [7].

**Figure 7.** Fatigue cracking of the hangers in the bridge over Skellefte River in Sweden [7].

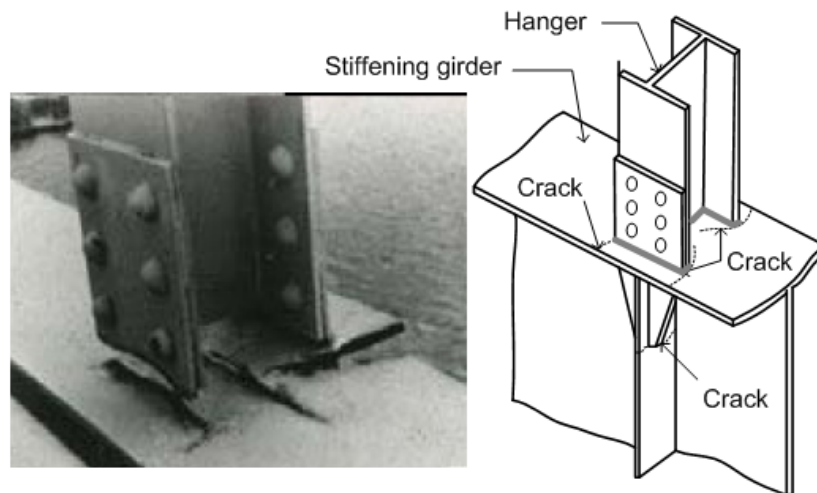
The same mechanisms—often combined with poor detailing of the hanger connection—have led to similar fatigue damage in steel arch bridges in Japan [5]. An example is shown in Figure 8.

**Figure 8.** Fatigue cracking in the hangers of the Mashita Bridge in Japan [5].

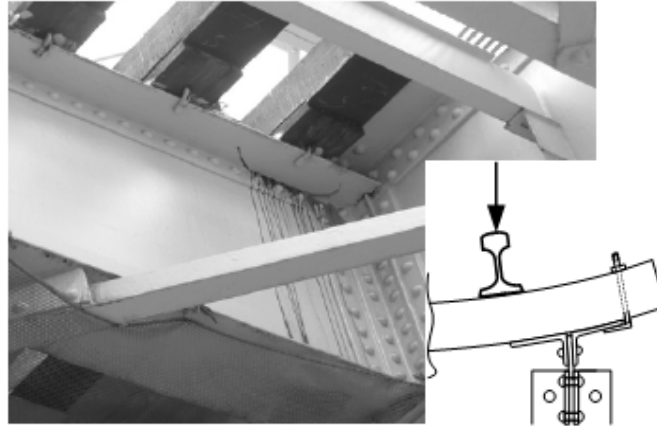
In many old railway bridges, traffic loads on the bridge are transferred to the longitudinal load-carrying members (bridge girders or stringers) via timber ties resting on these members and connected to them by means of hooks or bolts. Several fatigue damage cases in which the stringers exhibited fatigue cracking at locations beneath the timber ties have been reported [8,9]. In welded girders, the cracks often grow along the toe of the welds connecting the girder web to the upper flange. In older riveted girders, the cracks were found along the fillet of one of the L-profiles forming the upper flange of the girder, see Figure 9.

**Figure 9.** Example of fatigue cracking in stringers at timber tie connections [8].

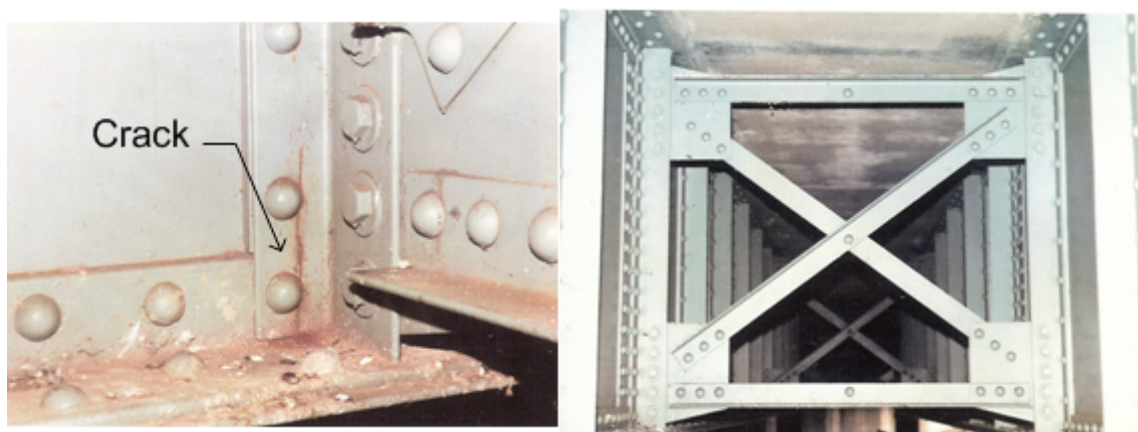
Furthermore, riveted connections of the type discussed here have also been shown to be prone to fatigue cracking [10]. In this case, the fatigue damage is found either in the outstand leg of the connection angle or in the rivets connecting the angle to the girder web, see Figure 13.

**Figure 13.** Fatigue cracking in the riveted connection of cross-bracing elements [11].

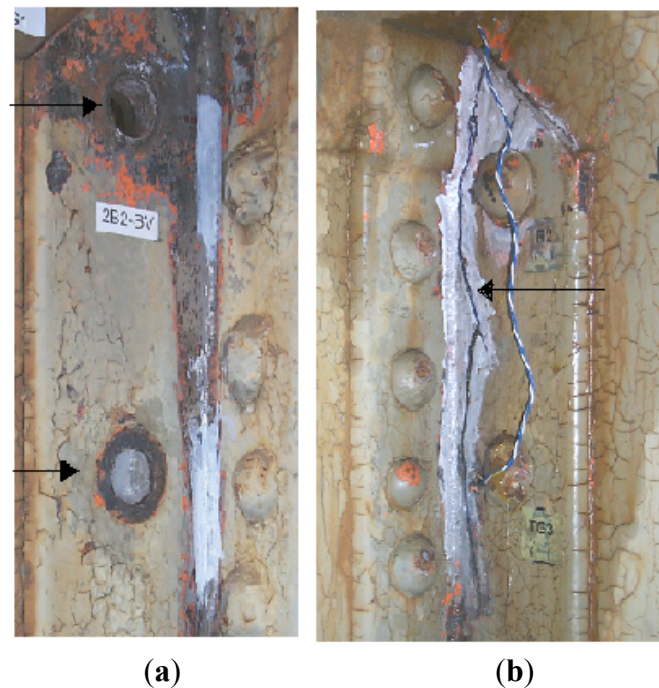
Connections of this type have displayed high vulnerability to fatigue cracking. A large number of damage cases in which fatigue cracks were detected in the connection angles have been reported [12,13]. The cracks usually start at the outstand leg of the connection angle and grow along the fillet of the angle. Figure 14b shows an example of this kind of fatigue cracking.

**Figure 14.** Example of fatigue damage in stringer-to-floor-beam connections [12]: (a) at the junction between the rivet head and shank; (b) at the external leg of the connection angle.

In old riveted connections, rivet failures are also very common. Here, cracking starts in the junction between the rivet head and shank (caused by prying and rivet bending) and finally results in the total separation of the rivet head, see Figure 14a. Fatigue damage of this kind is generally located at the top of the connection, but cases of damage with fatigue cracking and/or rivet failure at the bottom of the connection have also been reported [12].

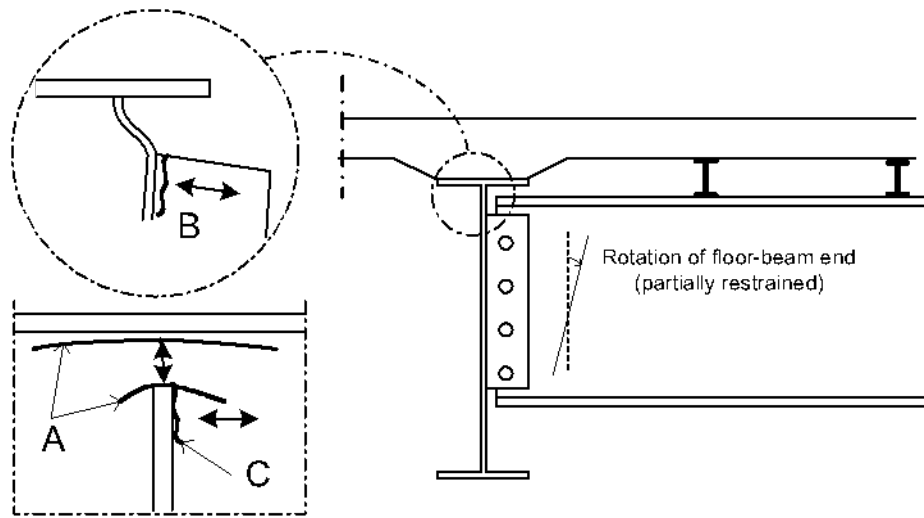
Figures 17 and 18 show two examples of fatigue cracking caused by the restrained rotation of floor-beam ends. In mechanically fastened connections, the fatigue damage is generally found in the connection angles or the rivets (or bolts) connecting the angles to the main load-carrying element [5,14], see also Figure 15. In welded details, where the floor beam is connected to a welded transverse plate, cracking has been reported in the main girder web (types A and C in Figure 18) or in the connection plate along its fillet weld to the main girder web (type C) [4,5,10].

**Figure 18.** Fatigue cracking in a floor beam welded to the main girder connection.

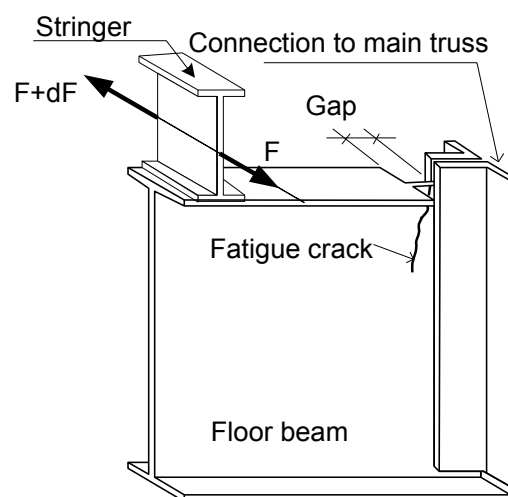
The second type of interaction (transverse bending of the floor beams) has also resulted in fatigue damage in many steel bridge types. One example is shown in Figure 19. In this case, the upper flange of the floor beam is cut short near the floor beam to main truss connection, leaving a small—locally flexible—gap in the floor-beam web where the deformation is concentrated. In such a case, after crack initiation, further propagation of the fatigue crack is derived by the secondary bending stress in the floor beam near the connection. The same kind of fatigue cracking has been reported for highway girder bridges [4,10], truss bridges [5] and arch bridges [14,15].

**Figure 19.** Fatigue cracking in the floor-beam web caused by the transverse bending deformation generated by the interaction between the floor system and the main trusses in the bridge.

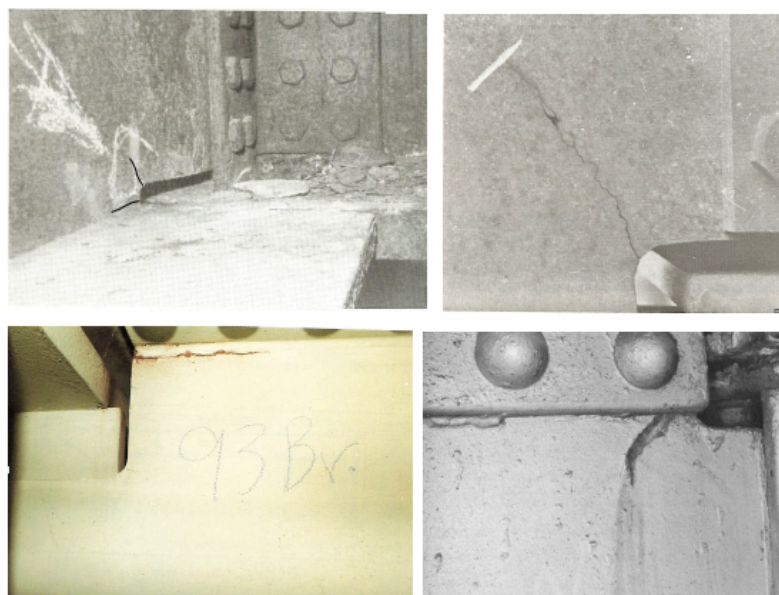
Figure 21 shows some examples of fatigue cracking in various elements with coped ends or cut-short flanges at their connections to other elements.

**Figure 21.** Examples of fatigue cracking in various bridge elements with coped ends or cut-short flanges (after [4,5]).

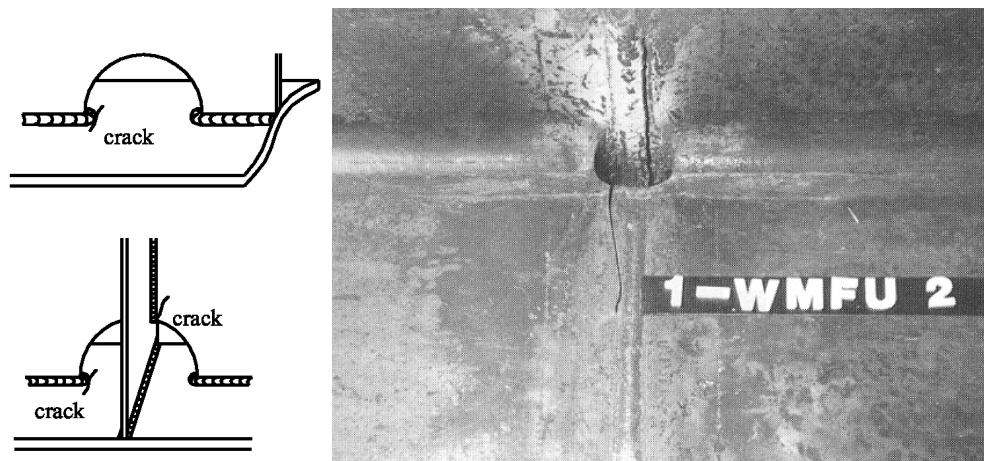
In many long-span bridges, the steel girders are usually fabricated in several segments due to transportation limitations and sectional changes. Consequently, the assembly of steel girder segments is carried out on-site through welded or riveted connections. When welded connections are used, cut-outs in the girder's web are introduced at its intersections with the flanges to facilitate for transversal butt welds and avoid weld crossing. The web cut-outs, also known as cope-holes, have shown to be susceptible to fatigue cracking in several studies [11,17,18]. The fatigue crack initiation site is often reported to be at the fillet weld toes of the cope-hole; where it can grow either in the web or across the flange, see Figure 22.

**Figure 22.** Examples of fatigue cracking in bridge girders with cope-holes at severe stress concentration locations [11].

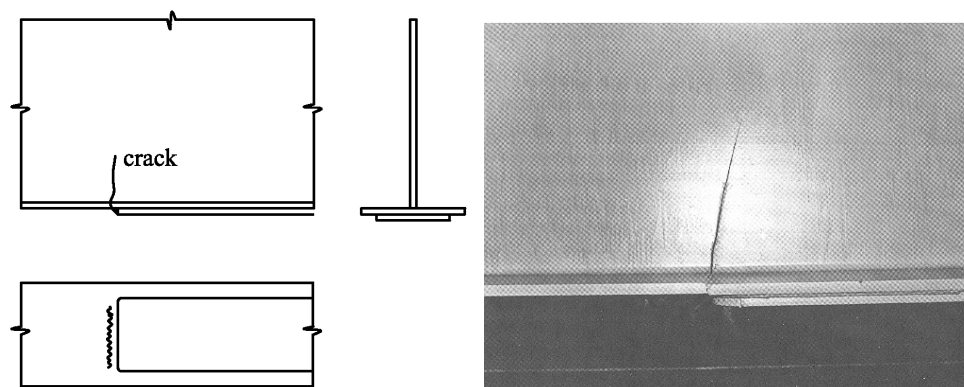
Fatigue cracks of this kind initiate at the weld toe of cover-plate transverse end weld and begin to develop in the web, once propagated through the entire flange width, see Figure 24. The main cause of such low behavior of cover-plate ends is associated with the expeditious change of sectional stiffness before and after the welded cover-plate, which causes severe stress concentration at the cover-plate end. In addition to that, the inevitably formed micro-cracks at the weld toe, as a consequence of welding process, accelerate the fatigue failure. Furthermore, it is reported that when the transverse end weld is omitted, the fatigue strength does not improve [22]. Besides, in such cases, other degradation mechanisms such as corrosion caused by trapped water between the cover-plate and flange have been observed in several cases [11].

**Figure 24.** Fatigue cracking of cover-plate ends [11].
