THESIS FOR THE DEGREE OF LICENTIATE OF ENGINEERING

Damage and thermally induced defects in railway materials

Casey Jessop

CHALMERS UNIVERSITY OF TECHNOLOGY

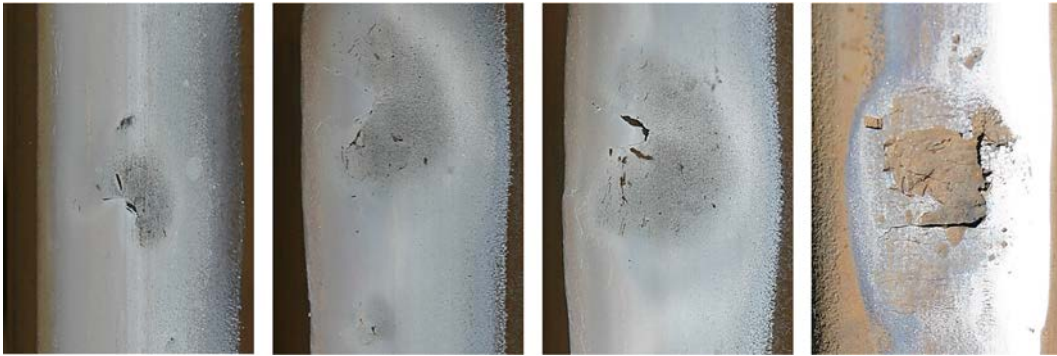
Figure 2. Examples of squats of different severity in field, as well as an example of spalling (far right).

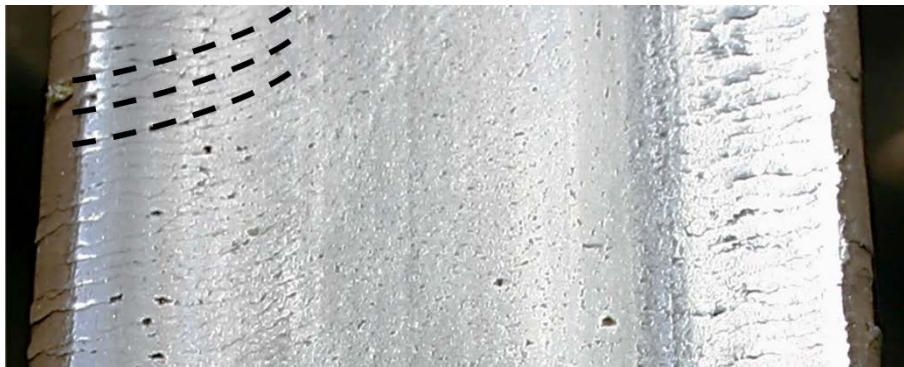
Figure 3. Commonly occurring RCF defects on the gauge corner of rails. Dashed lines highlight the curvature of the head checks from the gauge corner into the running band.

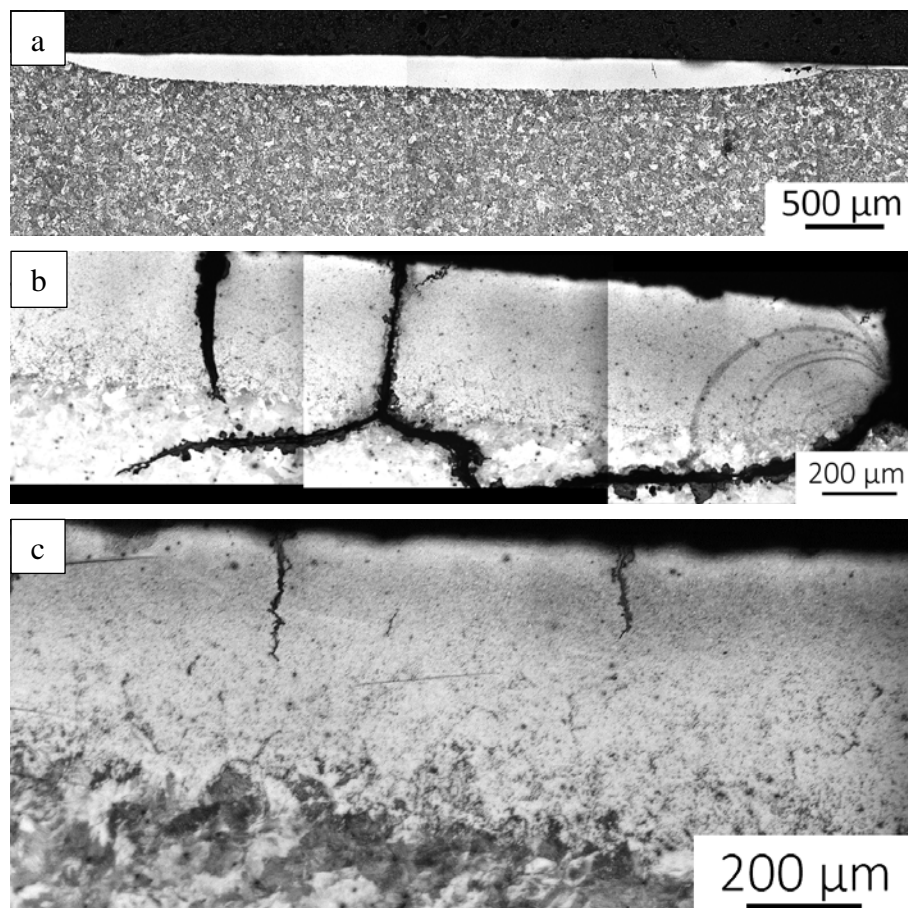
Figure 5. Examples of WELs taken from the field: (a) overview of WEL on rail surface, (b) close-up of cracks growing at interface of WEL and bulk surface, and (c) through WEL.

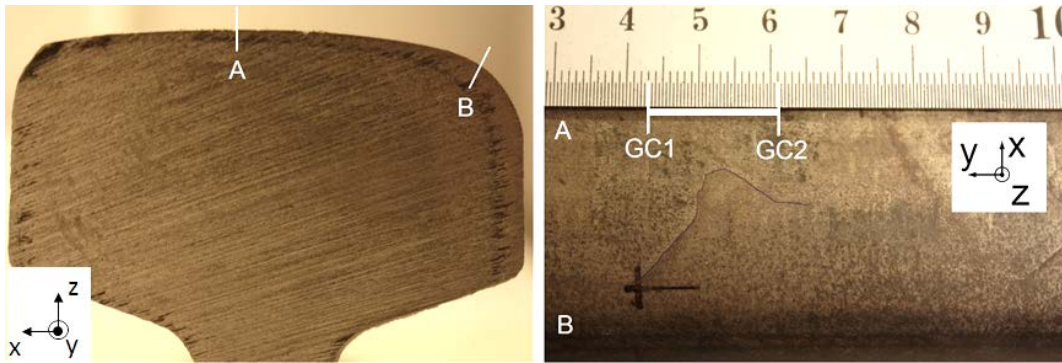
Figure 10. Squat with gold cross marks (GC1, GC2) and scale (the V-shaped surface-breaking crack has been traced to make it more visible).

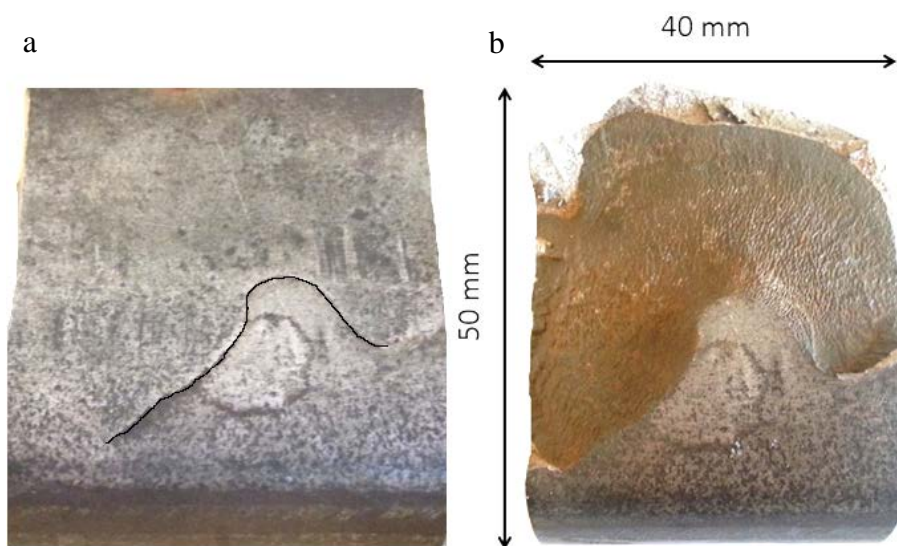
Figure 12. Surface of rail with squat before (a) and after (b) being opened for topography measurements.

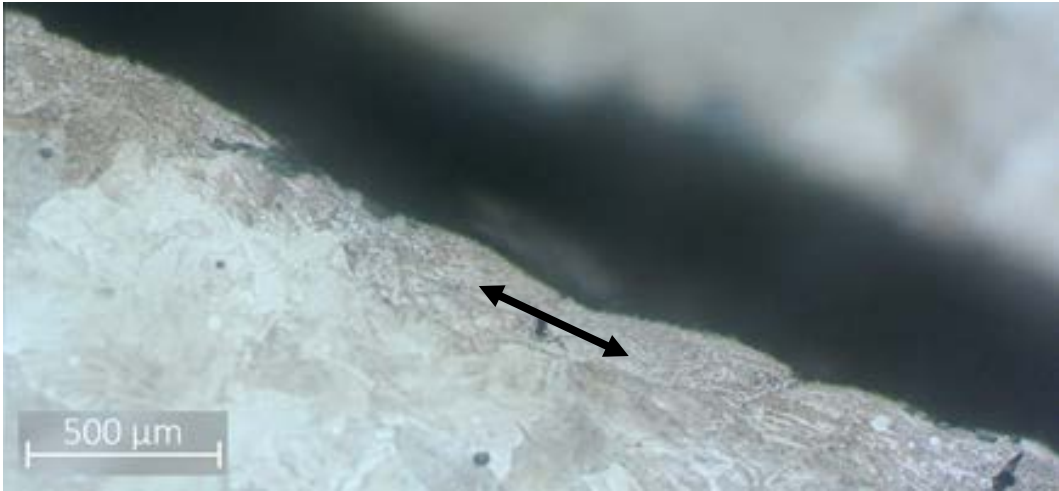
Figure 16. OM image of pearlite colonies deformed along the crack face.

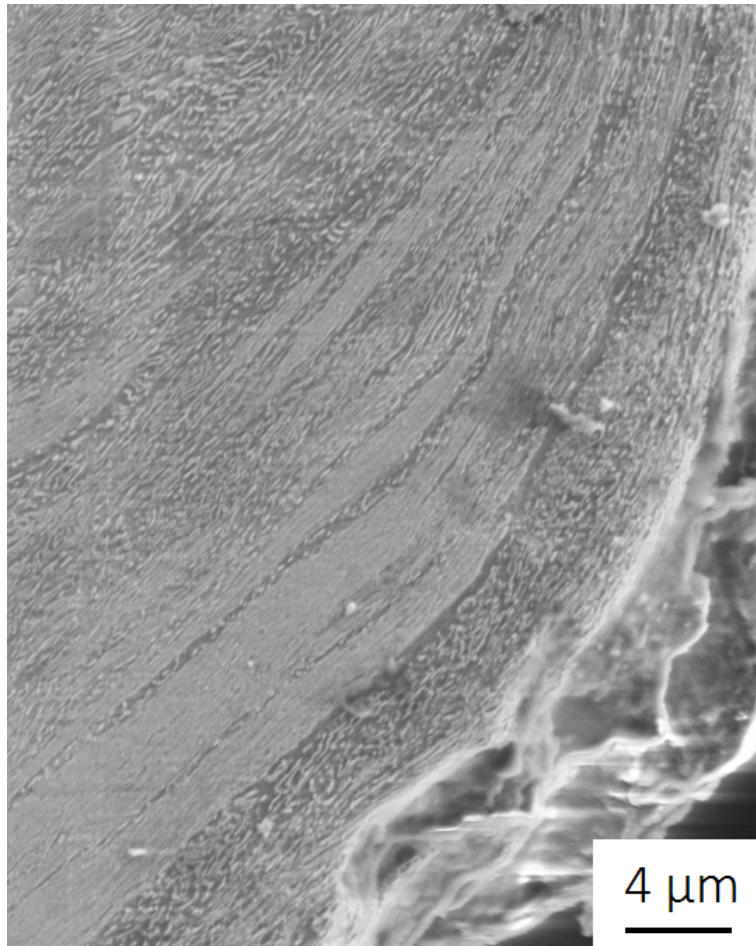
Figure 17. Deformation of pearlite colonies along the edge of the crack opening.

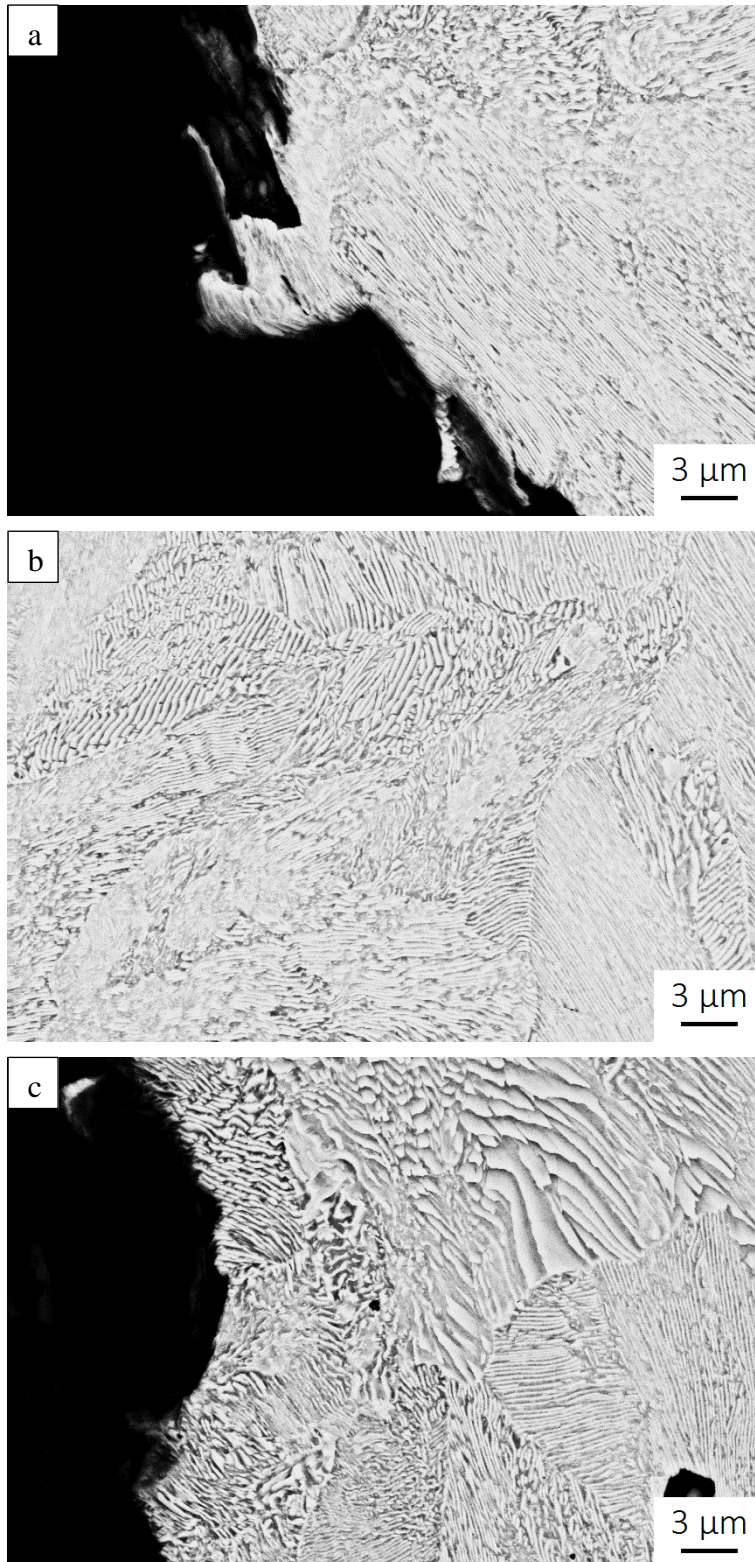
Figure 18. Backscattered electron (BSE) SEM micrographs showing plastic deformation and realignment of pearlite along the crack in (a), compared to the bulk material (b). Randomly oriented pearlite grains can be seen in (c).

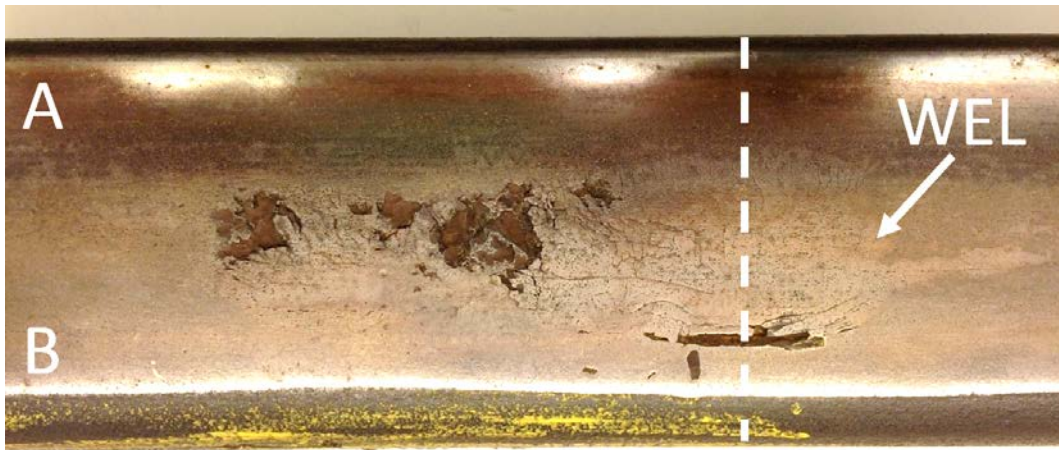
Thermal damage is often found on railheads, and initial inspection of a rail section taken from the field showed quite severe spalling occurring on the surface, in addition to a large thermally damaged strip, the origination of which cannot be determined (Figure 19). The surface was cleaned and etched using Nital in order to reveal the presence of a white etching layer (WEL). The WEL suggests there was some thermal damage that transformed a thin layer of the pearlitic/ferritic material into martensite. Many small cracks are seen within this layer, which highlights the brittle nature of the martensite.

Figure 19. Rail surface after Nital etching: spalling off of large sections is observed in the running band. Section location is shown with a dashed line.

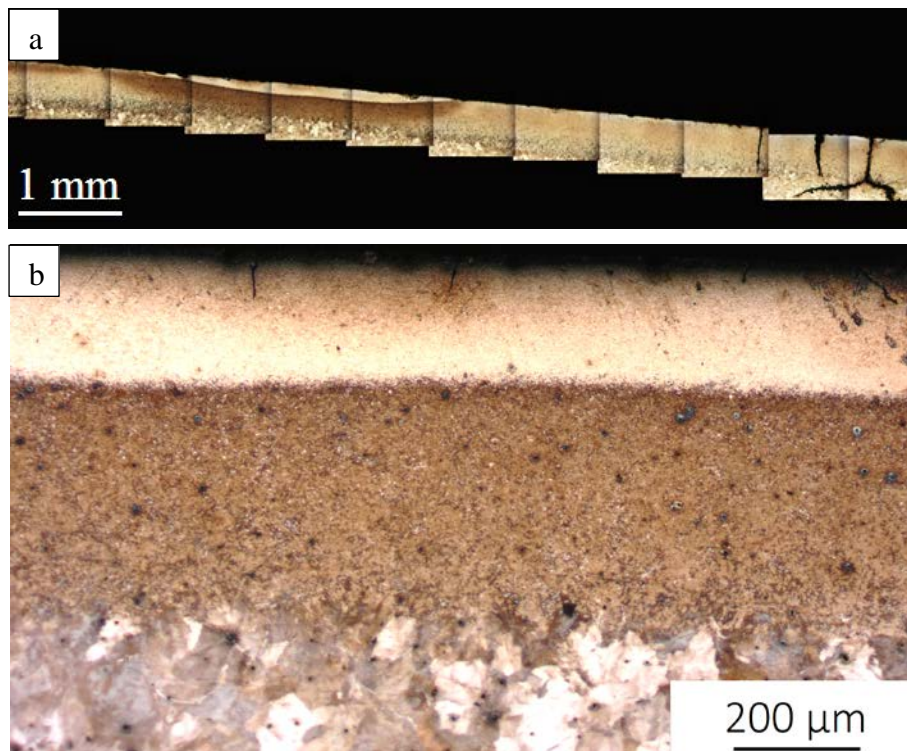
Upon sectioning as shown in Figure 19, the depth of the damage can be more closely examined, including crack patterns and crack depths in the different parts. Sections were prepared for inspection using optical and stereomicroscopy. Thermal damage can be observed in Figure 20. Some cracks in the cross-section reach more than 1 mm in depth, while smaller cracks (150 and 200  $\mu\text{m}$ ) are found close to the field side. A closer look at the WEL (Figure 20b) shows that there are in fact two different WELs present: a thin ( $\sim 200\text{-}\mu\text{m}$ ) layer appears above a thicker ( $\sim 550\text{-}\mu\text{m}$ ) layer on the surface. The presence of two layers should be the result of multiple occurrences of thermal damage (e.g. wheel burns) on the same place. The primary layer exhibits a heat-affected zone, appearing darker just below the secondary layer,

which suggests some tempering of the martensite accompanying a second heating event [33]. Furthermore, near the bottom-right corner of Figure 20a deep cracks are present, traveling through the WEL and along the transition between the WEL and bulk material. This could be due to the rolling contact loading occurring between the wheel and rail, affecting the harder and more brittle material within the WEL as well as causing localized strain concentrations beneath the harder layer. The same crack is shown in Figure 5.

Figure 20. (a) WEL on cross-section from optical microscopy, and (b) close-up of double WELs.

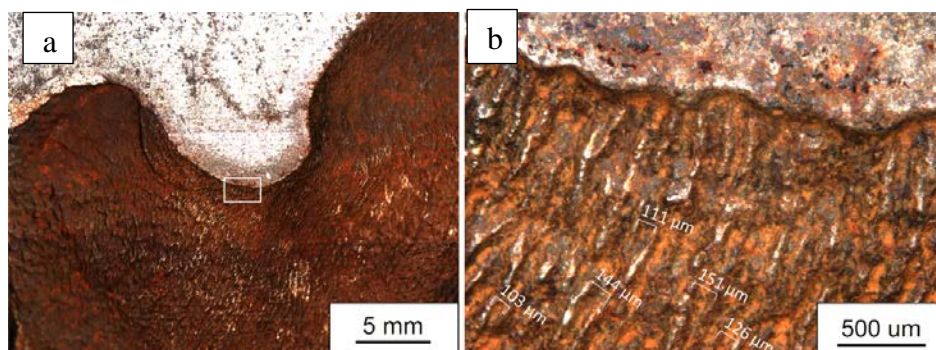
Figure 21. Images from stereomicroscopy of (a) Squat surface, and (b) detail of squat surface close to the tip of the V.

The 3D mapping (Figure 23b) shows a highly textured surface on different scales: some beach marks, ridges, and surface roughness. It can be speculated that the ridges on the fracture surface (Figure 21b) are a result of repeated relative movement of the two crack surfaces in the same direction, while the smoother regions observed near the surface-breaking part of the crack (Figure 21a, top) are a result of rubbing of crack faces in different directions due to an additional shear displacement. This is thought to be a result of the stresses propagating the crack [14]. According to the literature, the fracture surface has both rough and smooth parts, corresponding to tension and shear crack growth, in mode I and mixed mode II/III, respectively [34].

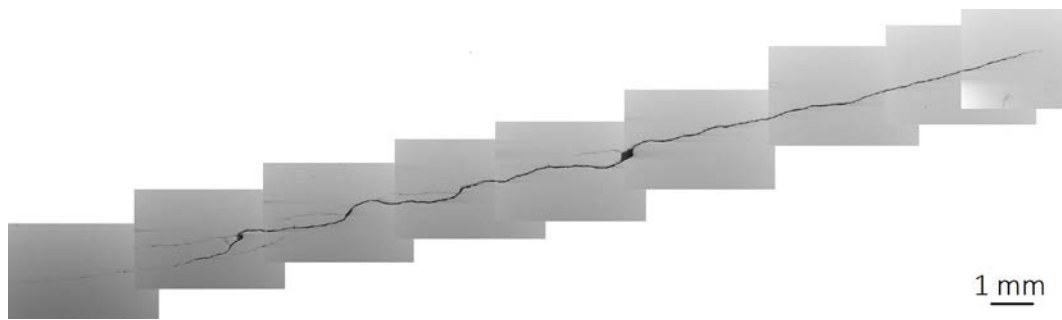
Figure 22. SEM micrographs of sections from squat in Figure 10 showing crack branching in transverse sections, not distinguishable by geometric reconstruction.

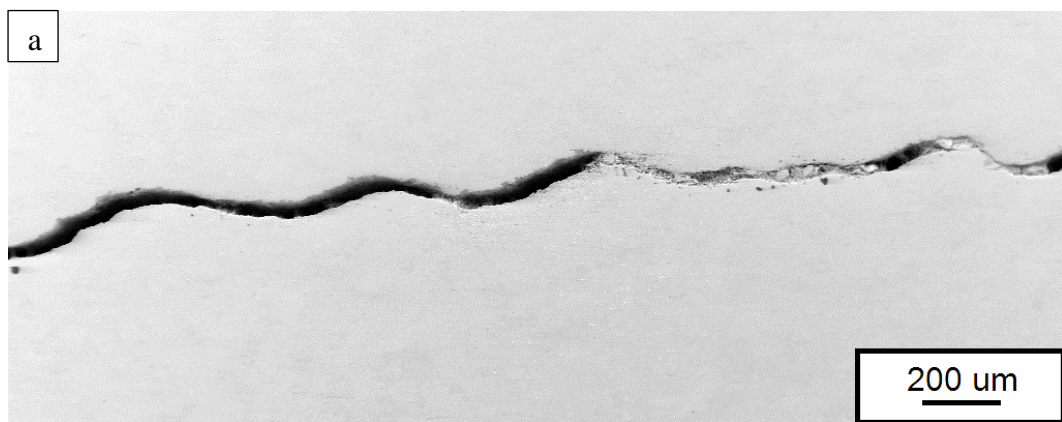
Figure 23. (a) Undulations in longitudinal section of squat network. (b) Mapping from topography showing ridges, 50- $\mu$ m step size.

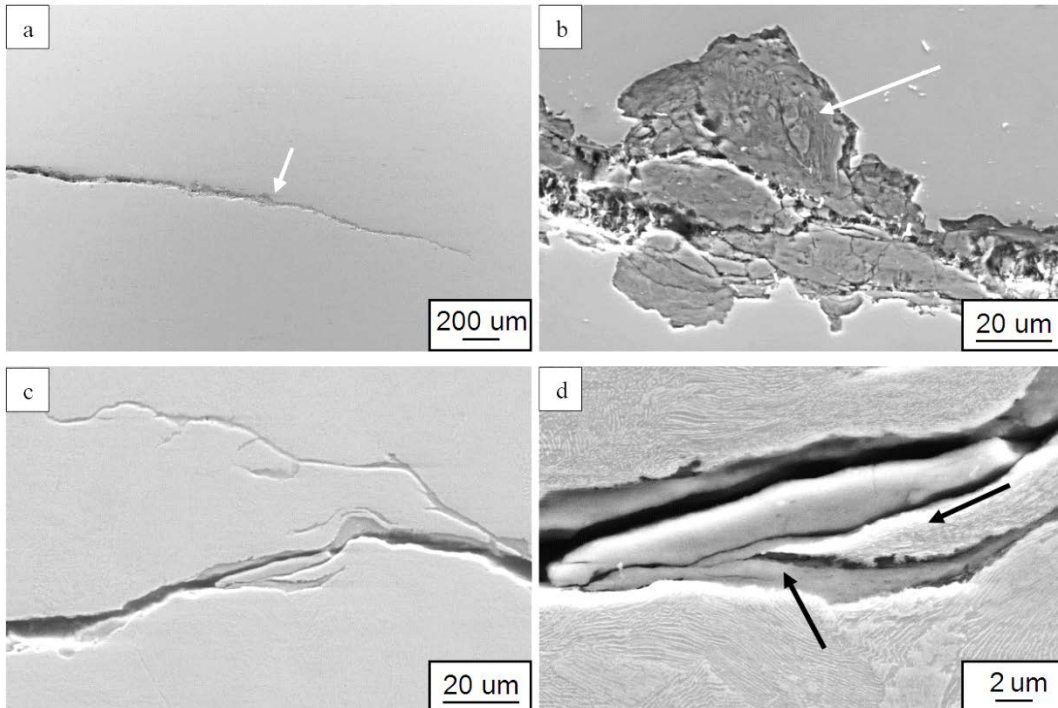
Figure 25. SEM image showing residues in cracks. a) Dark grey material near crack tip are residues, b) close-up showing deformed microstructure within the residues, c) and d) are from a transverse section of the rail.
