Proceedings of the 35th AIVC Conference, 24-25 September, 2014, Poznan, Poland

AIR LEAKAGES IN A RETROFITTED BUILDING FROM 1930: MEASUREMENTS AND NUMERICAL SIMULATIONS

Pär Johansson*¹, Angela Sasic Kalagasidis¹

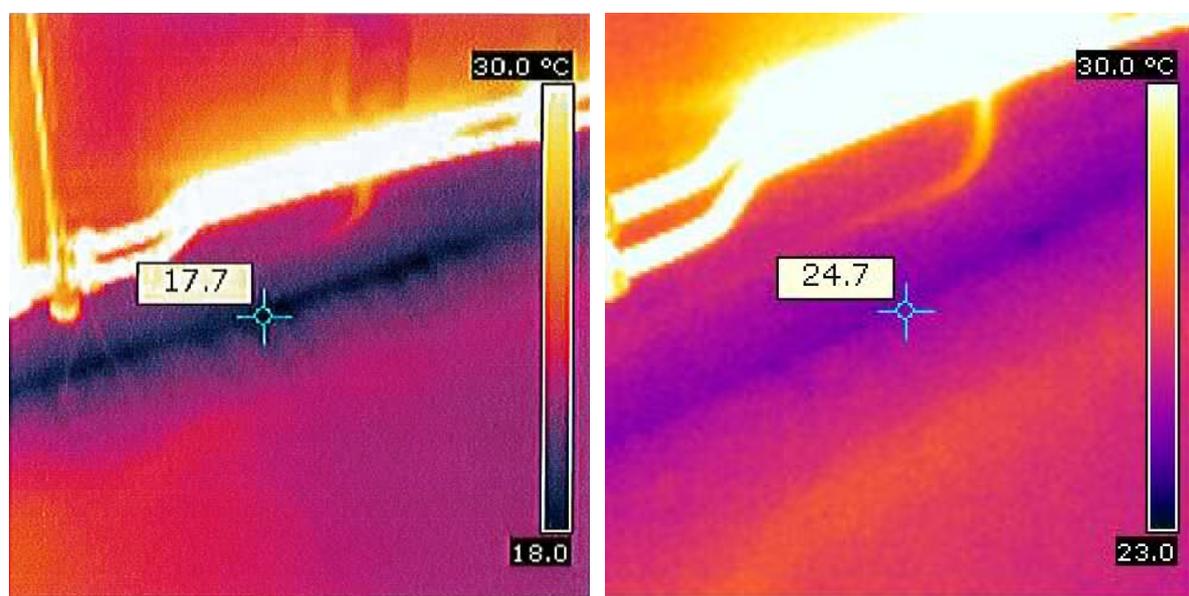
The blower door measurements were performed in single rooms since only one of the façades was equipped with VIPs. The results before and after the retrofitting are presented in Table 1. The air leakage paths were dominated by leakages around the windows, at the connections between the interior and exterior wall and along the floor (see Figure 4). These air leakage paths remained after the retrofitting but from the air temperature we can conclude that it is the indoor air that infiltrates through these leakages. Any further general conclusions of changed air tightness after the retrofitting could not be made based on the blower door measurements performed in single rooms. A better picture would be obtained if the blower door measurements were supplemented with, for example, tracer gas measurements that could separate infiltration of outdoor air from the air leakage paths through interior walls and floors.

Figure 4: Thermograms showing air leakages in an apartment on the 2nd floor along the floor to wall connection before (left) and after (right) the retrofitting. The air leakage is less after the retrofitting (Svensson, 2010, 2011).

At the site visits before and after the retrofitting, the indoor temperature was 21°C and 23°C and the outdoor temperature was 4°C and 6°C, respectively. The temperature of the air passing through the air leakage is around 24°C, which indicates that it is indoor air, possibly from the apartment below.

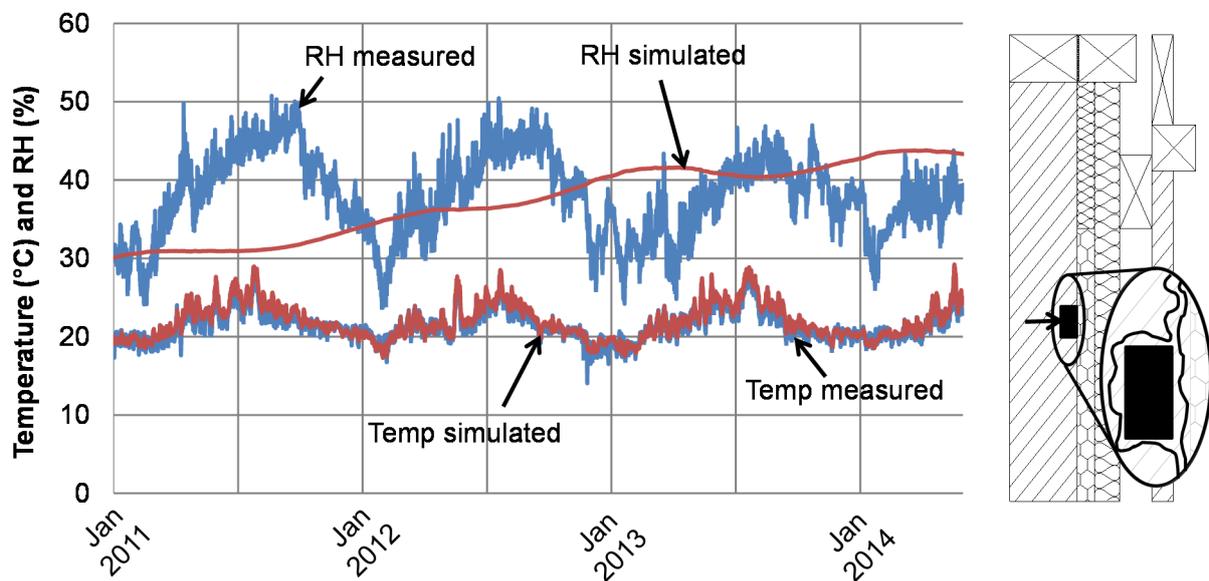
Figure 5: Comparison of the hygrothermal simulations with the measurements of the temperature and relative humidity behind the VIP in the wood wall. The simulation was based on the measured indoor and outdoor climate from January, 2011, to June, 2014. The location of the sensor is marked by the black box with a black arrow pointing from the left.

The average simulated temperature and RH at the sensor position in the wall was 21.9°C and 37.4% while the measurements gave 21.5°C and 37.8% on average during January, 2011, to June, 2014. It was noted that the vapor content was on average 1.3 g/m³ higher in the numerical simulations than in the measurements. This suggested that there was an additional drying process in the wall. The sensor is located in an air filled void in the wall, measuring the temperature and RH of the air closest to the sensor. The high fluctuation in the measured RH indicated a leaky construction with air leakage from the interior or exterior side of the vapor barrier into the construction. It is anticipated that the air could enter e.g. through details around windows and flow along the interior of the vapor barrier to the sensor position. Although measures were taken to make the exterior wall air tight with the polyethylene foil, due to uneven surfaces certain connections have remained loose. Therefore, an air exchange with the outdoor air was added to the model between the vapor barrier and wood. The resulting temperature and RH is presented in Figure 6.

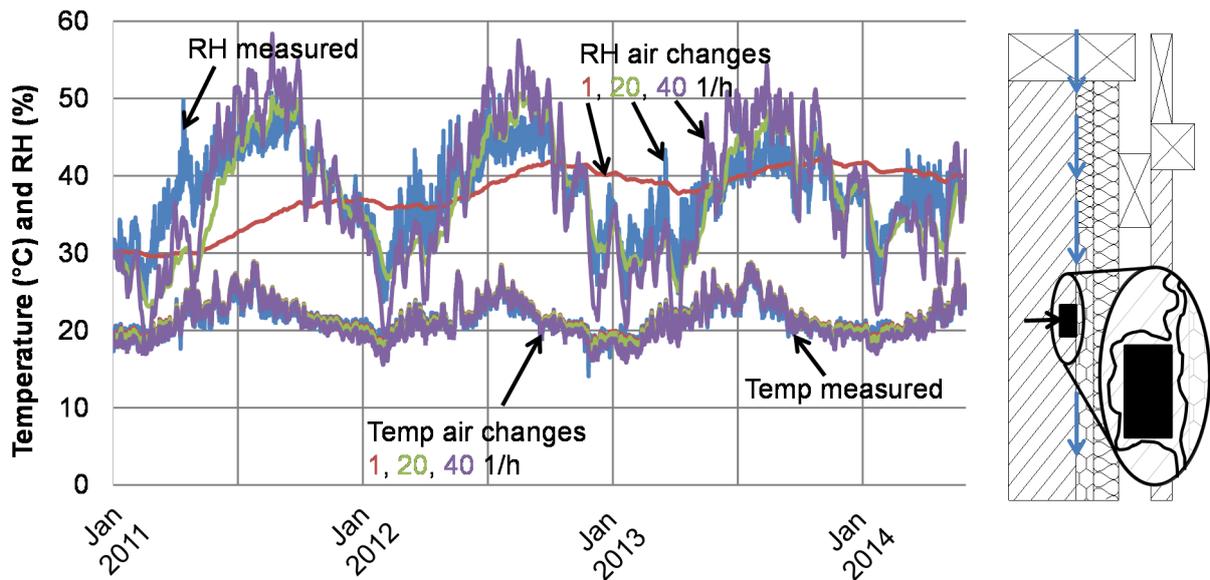
Figure 6: Comparison of the hygrothermal simulations with the measurements of the temperature and relative humidity behind the VIP in the wood wall. The air changes per hour with the outdoor air were varied from 1 1/h to 40 1/h. The location of the sensor is marked by the black box with a black arrow pointing from the left. The material surfaces in the wall are rather uneven which makes air flow through the small voids between them possible.

When an outdoor air exchange rate of 40 1/h was used, the simulated average temperature was 21.2°C. This is close to the measured average temperature 21.5°C. The simulated average RH was 37.6% which is also close to the measured average RH 37.8%. In addition, the simulated variations during the year corresponded well with the measurements. However, one cannot be entirely sure that the air is really coming from the exterior without testing this. Figure 7 presents the temperature and RH in the wall given that the air is coming from the interior.

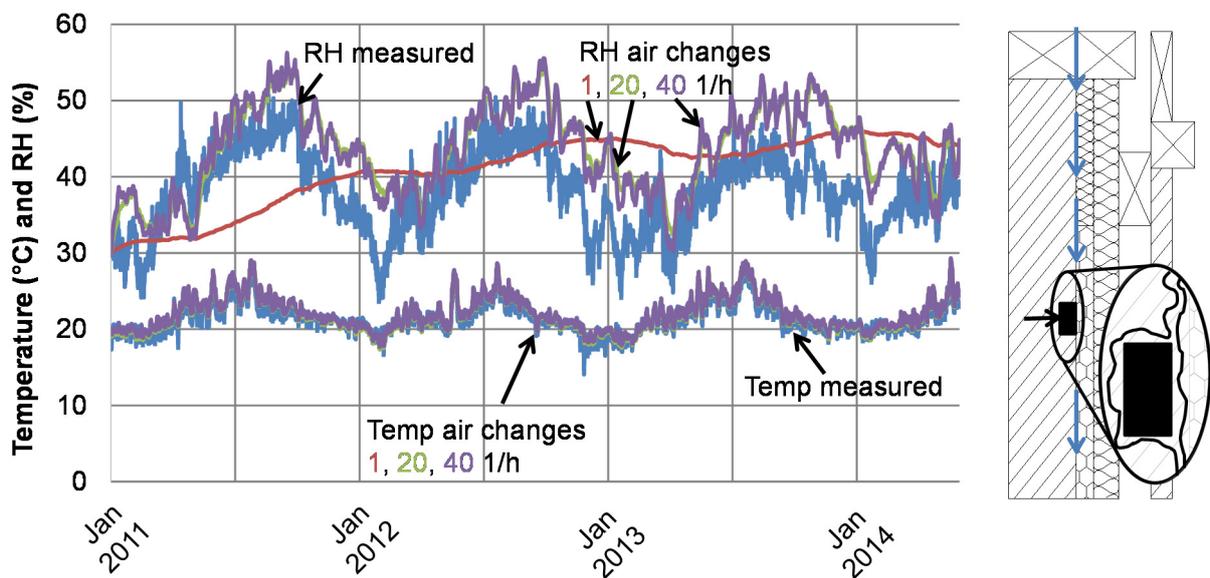
Figure 7: Comparison of the hygrothermal simulations with the measurements of the temperature and relative humidity behind the VIP in the wood wall. The air changes per hour with the indoor air were varied from 1 1/h to 40 1/h. The location of the sensor is marked by the black box with a black arrow pointing from the left. The material surfaces in the wall are rather uneven which makes air flow through the small voids between them possible.

The simulated temperature and RH deviated more when the air was coming from the interior than in the previous case. The simulation gave an average temperature 22.1°C and 43.4% RH for the case with 40 l/h, compared to the measurements that were 21.5°C and 37.8% on average. This shows that the air leaking into the wall is most certainly coming from the exterior.
