6th International Building Physics Conference, IBPC 2015

Long-term field measurements of moisture in wooden walls with different types of facades: Focus on driving rain tightness

Lars Olsson^{a,b,*}

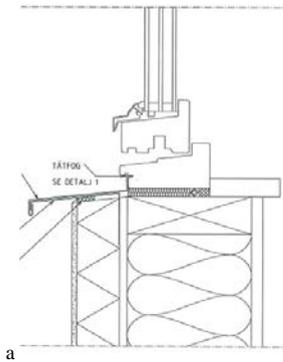
External wall seen from outside
 -8 mm render/plaster
 -50 mm EPS
 -8 mm mineral-based board
 -145x45 mm wooden stud and MW
 -Plastic film
 -13 mm gypsum board

Fig. 1. (a) Vertical cross-section of wooden stud wall with rebuilds ETICS. (b) Position of measurement point 6 (Helsingborg B) in the outer part of the sill, facade facing southeast.

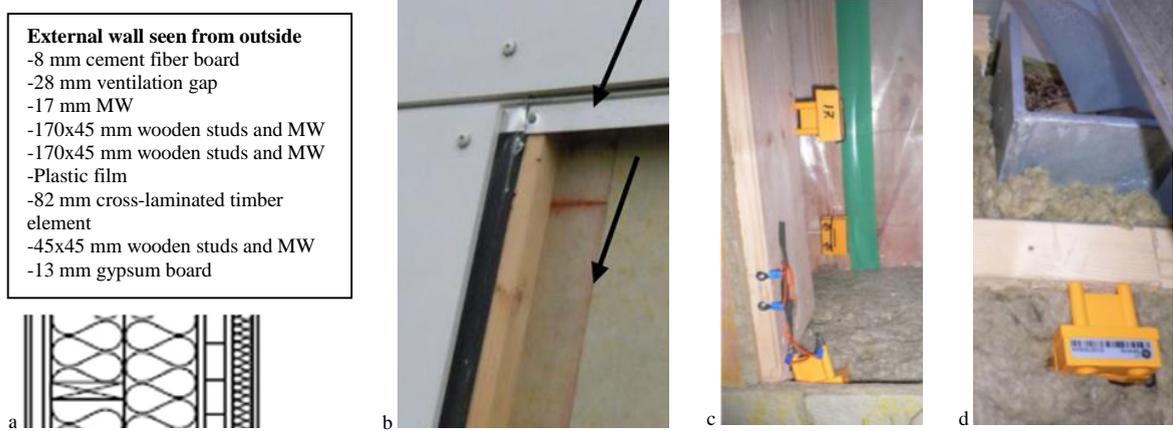
Fig. 2. (a) Cross-section of wooden stud wall with ventilated facade. (b). The facade board is opened up in point 16, arrows show pass way for water flow. (c) Position of measurement point 16 and extension cables for MC bolted onto the outside of the stud.(d) Position of measurement point 8 bolted near the outside of the stud and underneath the fastening of a balcony.

In 2012, the wall was opened up from the outside to investigate the cause, see Fig. 2. Above the measurement point, there is a horizontal joint in the facade board, where water could have penetrated between the board and the joint profile. This could explain the problem, together with the fact that there was a joint in the weather barrier, which consists of stiff mineral wool slab, where water could have penetrated into the wall.

However, we do not know if the inward leakage has worked its way further down or somewhere else in the wall. The wall surface that was opened has reportedly been restored with wind barrier fabric inside the air gap, which could possibly explain why leakage appears to have ceased at this measurement point.

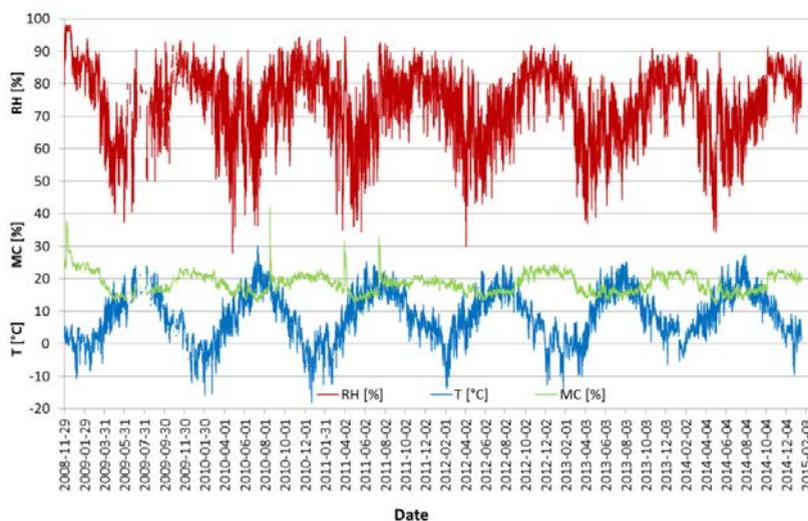
Measurements in point 16 show RH around 80–90% at most, briefly over 90% during the construction phase and thereafter for occasional hours over 90% RH, see Fig. 3. The higher humidity level appears to have occurred in connection with inward leakage, during MC peaks, or during the colder months when outdoor RH is at its highest.

Fig. 3. Measured RH, T and MC for measurement point 16 during the period 2008-11-29 to 2015-01-25. The MC is measured using extended electrodes, for only this point and with a large contact surface, which is why the values are somewhat higher than in reality.

There were sudden increases in MC of over 30% on around 17 August 2010, 31 March 2011 and 14 July 2011, which were probably caused by inward leakage. The MC appears to have dropped over time, despite recurring inward leakage, which means that the humidification that has occurred at the measurement point seems to have been able to dry out within the following weeks. Climate observations show rain at these times and with wind direction from the southeast and east, and the facade is also east-facing.

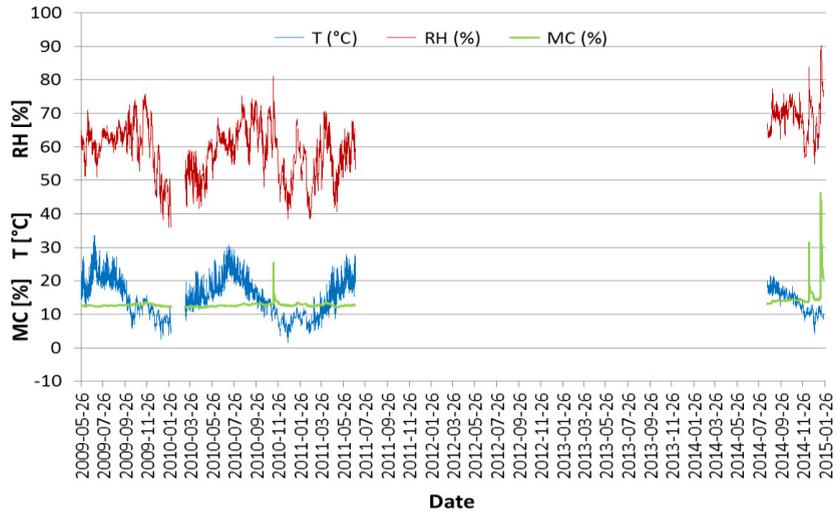
Fig. 4. Measured RH, T and MC for measurement point 6 (Helsingborg B) during the period 2008-11-29 to 2015-01-28. There is no data for 2012–2013.

The measurements in point 6 (Helsingborg B) behind the ETICS in the stud walls show normal values: at most, about 75% RH, i.e. no elevated moisture conditions that could result in moisture damage, see Fig. 4. However, there were some exceptions: the measurements indicating high MC of 25%, or higher, on 12 November 2010, 12 December 2014 and 9 January 2015 when there was particularly heavy rain and wind load on this facade, see Fig. 5. There is no data for 2012 to 2013 due to interruption in measurements. Additionally, there were some additional points where there were minor indications of leakage.

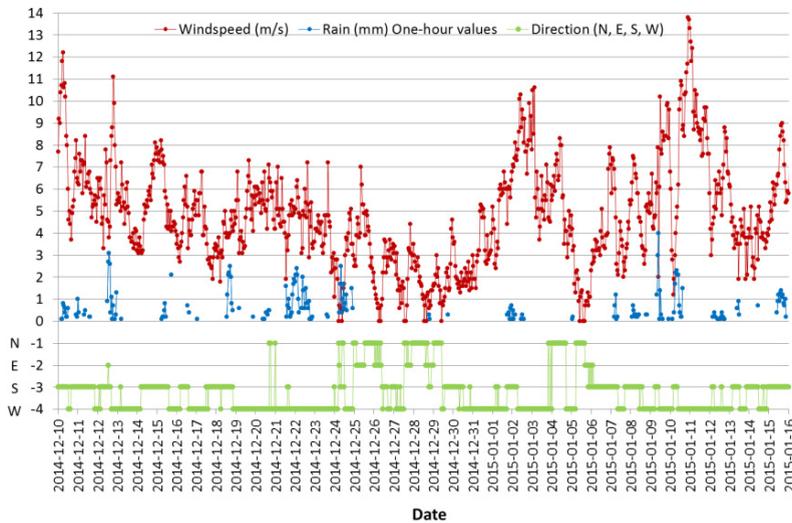
Fig. 5. Each point represents the average value for a period of one hour for precipitation and 10 min average (one time per hour) for wind speed and direction [3].
