SBE16 Tallinn and Helsinki Conference; Build Green and Renovate Deep, 5-7 October 2016,  
Tallinn and Helsinki

## Pending for renovations: Understanding the conditions of the multi-family housing stock from before 1945

Pär Johansson<sup>a\*</sup>, Paula Femenías<sup>b</sup>, Liane Thuvander<sup>b</sup>, Paula Wahlgren<sup>a</sup>

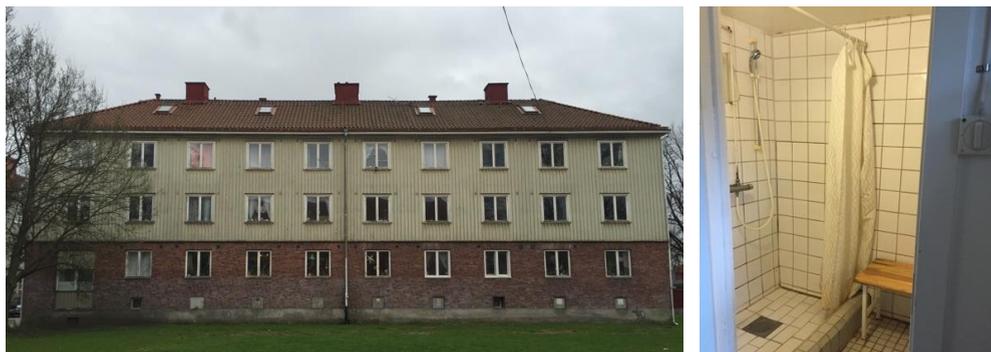
Case 1, Fig. 4, is built in 1929 and has not been renovated apart from smaller repair. The building is not categorized as housing but rented by the city as such. The standard is very low. Only four larger apartments out of approximately 20 have bathrooms, the rest have common showers in basement and shared WC on each level. The tenants profit from very low rents but they have pay high electricity bills as the building is only equipped with electric heating. It was supposed to be demolished to make way for a new plan for the area. The plan is now to renovate the building for continued function as housing. Workshops have been carried out in order to understand the tenants' expectation for an up-coming renovation. Tenants complain about draught, high electricity bills but are otherwise satisfied with the low standard and the high level of social interaction between tenants.

Fig. 4. Case study building 1 is a Landshövdingehus on Banérsgatan 6. Left: façade with brick on ground floor and wooden weather board on the upper two floors. Right: common shower in basement.

There is no energy performance certificate for the building but after an ocular inspection it was concluded that the building is poorly insulated. Some of the tenants' electricity bills have been retrieved which point to a possible energy use of over 200 kWh/m<sup>2</sup>. A number of windows have been exchanged, mainly to units of two panes. However, both newer and old windows are in poor condition and our view is that all windows are in need of renovation. The façade consists of brick and wood, see Fig. 4. The brick is in good condition in most places but the wooden part needs painting. On the interior, some water leakage into the attic was detected. Further investigations need to be performed to determine whether the leakages are old or ongoing. On the first floor, some of the internal brick walls have been severely damaged by water. There seem to be water suction through the basement floor, which also has resulted in biological growth. The common bathroom is in bad condition, with for example cracked tiles. Interior surfaces need to be painted, plastered or replaced.

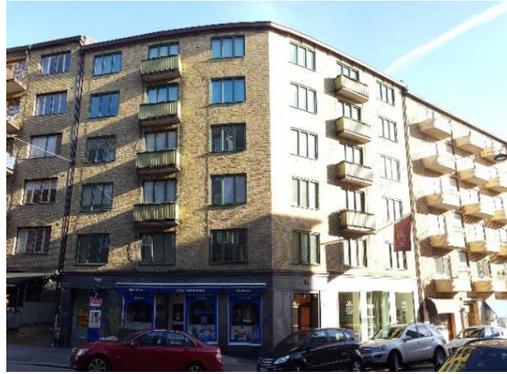
The building built in 1932, see Fig. 5, is located on Geijersgatan in the centre of Gothenburg. The area as a whole is protected and 'represents an excellent example of the late 19<sup>th</sup> century upper-class urban areas and is one of the country's most well-preserved environments of this kind' [13]. The building was and is consisting of dwellings on the upper floors and shops on the ground floor. It is situated in a bend of the block with the façade facing the street pointing at south and south-east. The inner courtyard is facing north, north-west. The façade is a yellow brick, most likely the same brick type is used consistently in the construction. The inspection of the façade indicates large exposure to weather and wind, since exterior damages can be seen on the façade facing the street. The condition of the bricks was better on the façade towards the courtyard than on the other one.

The façade facing the street has an extra window pane added on the inside of the existing windows. The original window frame was kept and with an external cover layer so that the wooden frame is no longer visible, but the original shape of the window remains. The walls are unchanged with the original brick wall with different thickness dependent on the floor level. The façade facing the inner courtyard is not so different from the façade towards the street. There is no added insulation, the window construction is the same as for the other façade. The entrance doors of the building are original from 1932. The foundation is a crawl space underneath the bottom slab due to uneven excavations underneath the building. The roof of the building was replaced due to water leakage. The original structure of the roof was kept and slightly improved with a double layered roofing felt. The roofing tiles are made of slate [11].

Fig. 5. Case study building 2 is a brick building located on Geijersgatan 14.

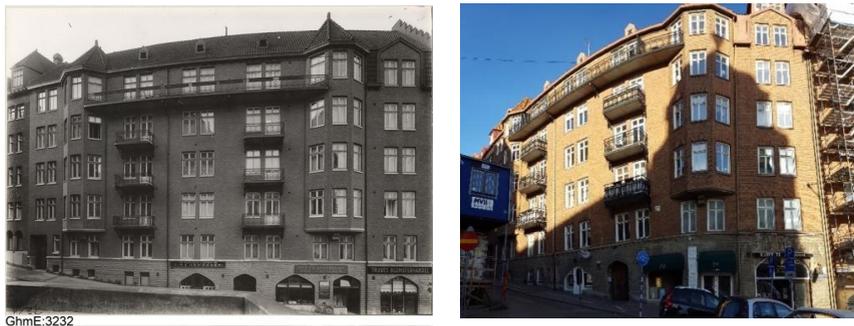
The more renovated building, see Fig. 6, is situated in the inner city of Gothenburg and was built in 1929. The building contains rental apartments. Today the bottom floor consists of two shops and one restaurant. The façade facing the street is original with red bricks and the entrance doors are original. The attic has partly been re-constructed to create additional apartments. The only apparent exterior change is new dorm windows in the new attic seen in the far left in the picture, a change that has been approved by the Museum of Gothenburg. There is still a small unheated attic on top of the apartments, close to the ridge.

The original windows were changed around 1980, but the original windows were kept in the stairwell. The newer windows are chosen with the same design as the original in order to respect the architecture. On the façade facing the courtyard, 100 mm mineral wool was added on the exterior which was plastered. This added insulation unfortunately covers detailing on the eaves. The windows were kept in the same depth in the wall construction after the insulation was added. Many of these kind of houses had stucco on the façades heading to the yard in original. Therefore it is hard to say how far the façade is from its original appearance after the insulation was added. The only interior changes are re-painting and new wall papers [11].

Fig. 6. Case study building 3 is a brick building of National Romantic style located on Föreningsgatan 34. Left: Photos show before (left) and after (right) renovation.
