# Influence of running-in on surface characteristics of efficiency tested ground gears

D. Mallipeddi<sup>a,\*</sup>, M. Norell<sup>a</sup>, M. Sosa<sup>b</sup>, L. Nyborg<sup>a</sup>

## ABSTRACT

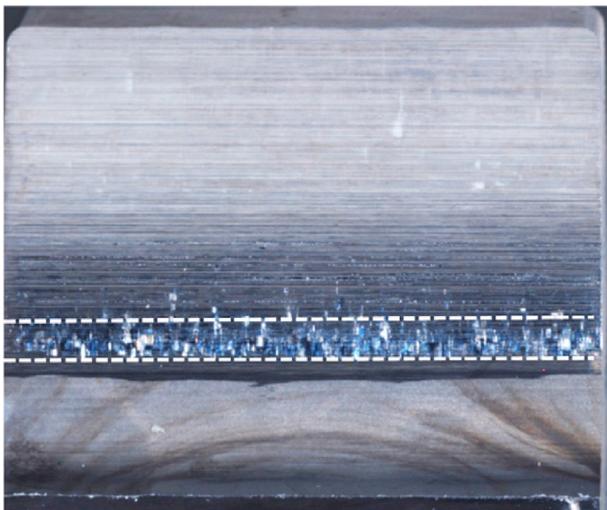
Fig. 5. Macro photo of gear tooth after RI9+E.

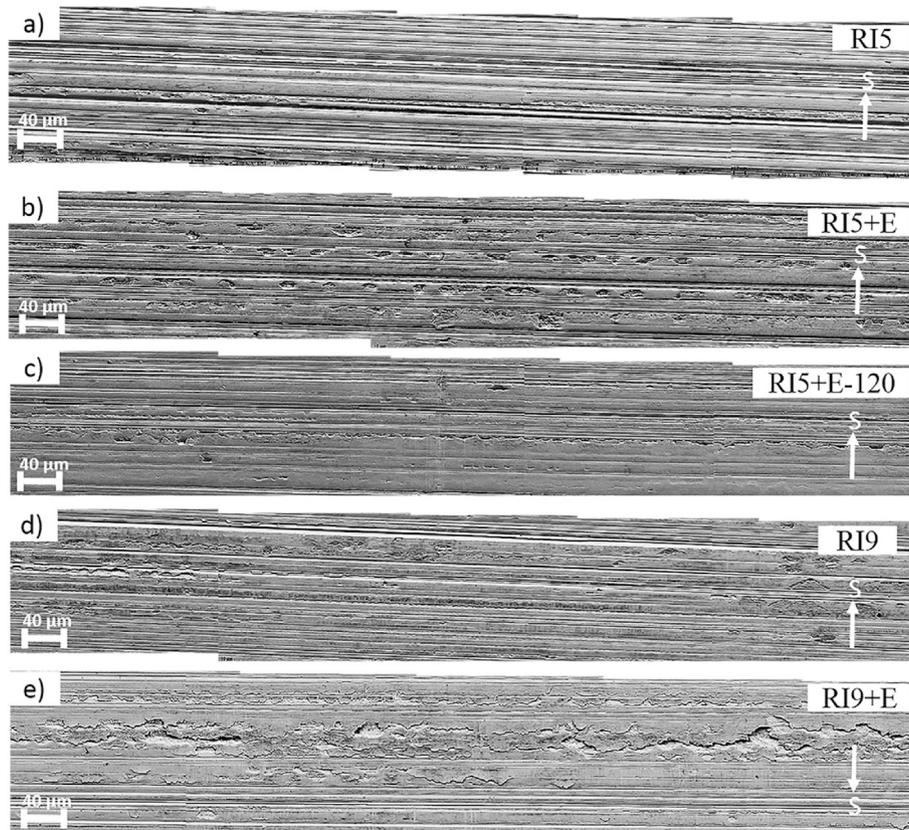
To compare the evolution of surface topography, the dedendum gear surfaces along the EAP for different test conditions are shown in Fig. 6. The stitched SEM micrographs reveal that micropitting occurred readily

after running-in, but the amount of micropits was higher for RI9 compared to RI5. It can also be observed that the degree of micropitting increased after efficiency testing. For test condition RI9+E coalescing micropits had formed close to one another, whereas for RI5+E a multitude of micropits some distance apart can be seen. The efficiency testing at 120 °C resulted in a very smooth surface with less micropits compared to testing at 90 °C. The morphology of micropits at dedendum is

Fig. 6. Surface topography of dedendum surfaces after testing at different conditions a) RI5, b) RI5+E, c) RI5+E-120, d) RI9 and e) RI9+E. “S” in the figure indicates the sliding direction.

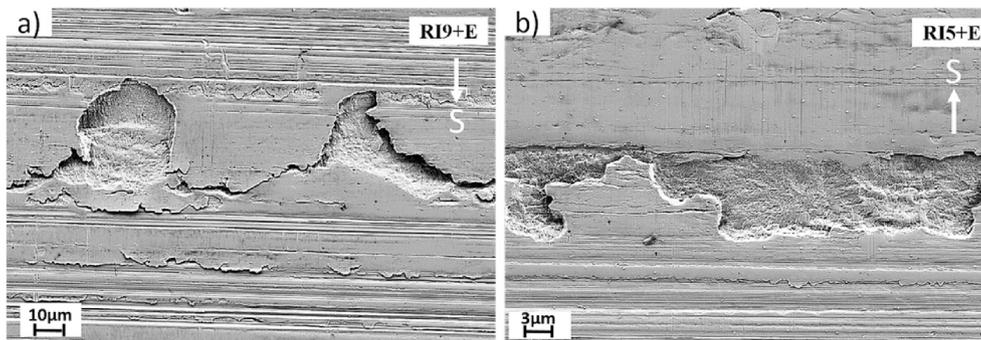
illustrated in Fig. 7. It is seen from the micrographs that the growth of micropits was opposite to the sliding direction, in accordance with ref. [28]. Furthermore, the high asperity peaks appear to be plastically deformed and cover adjacent valleys.

Fig. 7. SEM micrographs showing micropitting at dedendum after efficiency testing a) RI9+E and b) RI5+E. “S” indicates the sliding direction.

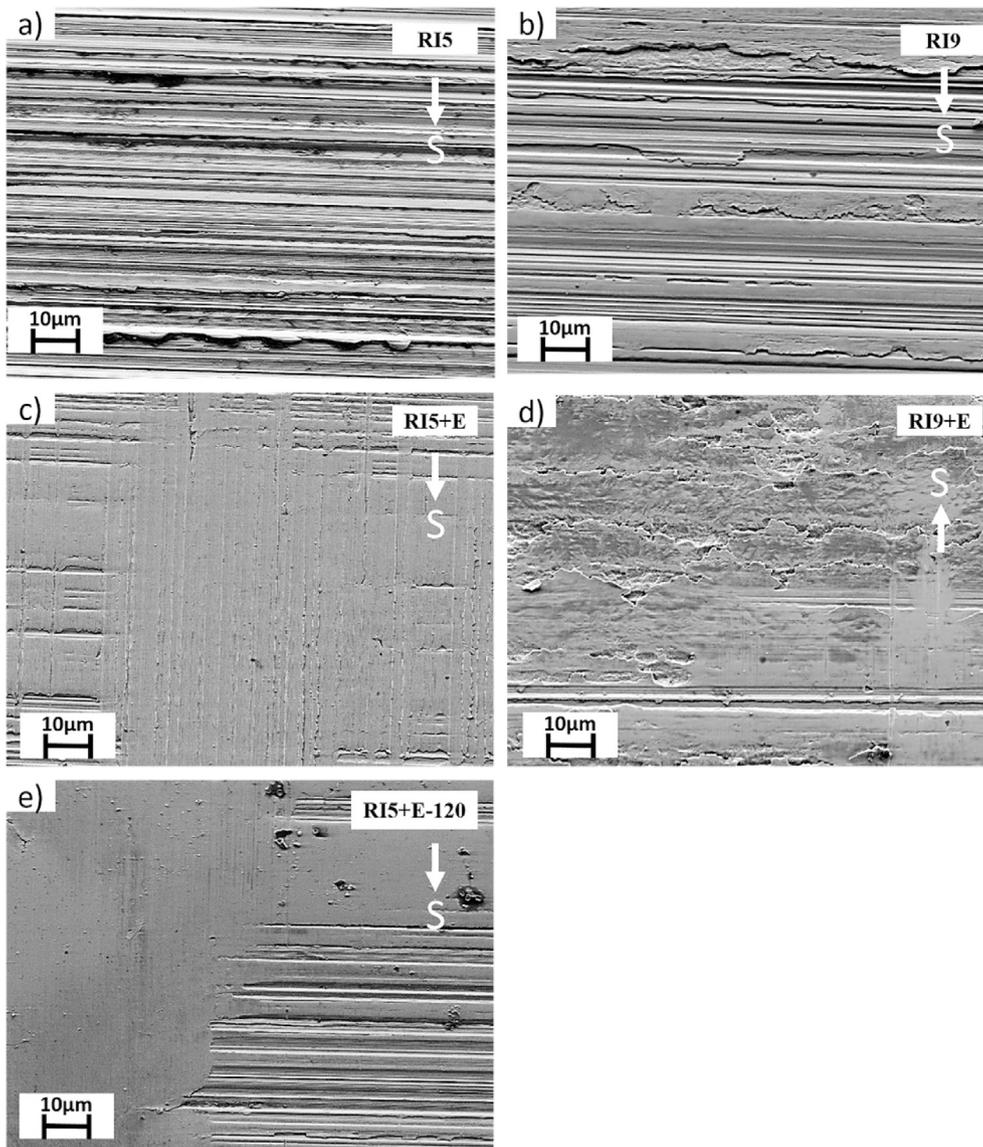
Fig. 8 shows the surface topography at tip surface with one micrograph for each condition. Different deformation patterns can be seen, but at this magnification, the area proportions are not representative. It is interesting to see that after RI5 the topography still resembles the as-ground condition indicating limited plastic deformation. Micropits appeared at the tip surface for RI9. After efficiency test RI5+E the grinding lay cannot be seen in some areas where plastic flow in profile direction have occurred, without any micropitting. A similar appearance though with a smoother surface is visible after RI5+E-120, while RI9+E has more micropits than any other test condition also at the tip.

Fig. 8. Surface topography of tip surfaces after testing at different conditions a) R15, b) R19, c) R15+E, d) R19+E and e) R15+E-120. “S” indicates the sliding direction.

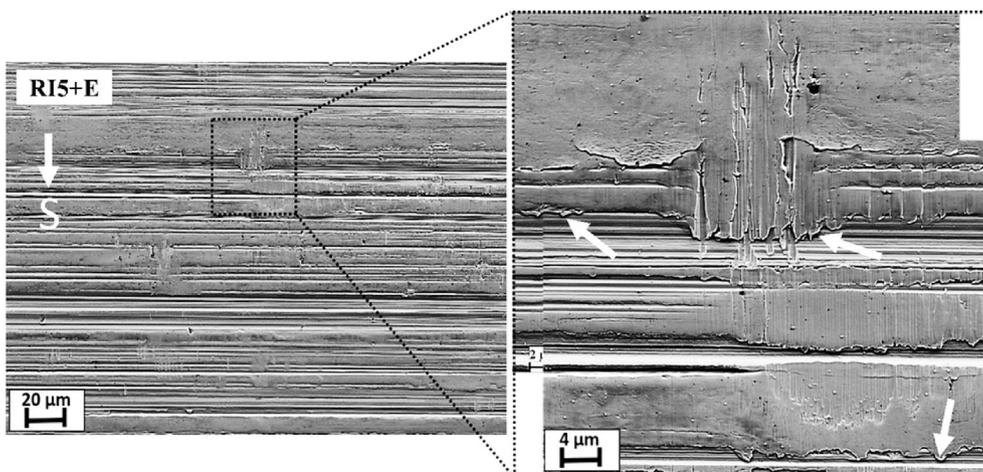
The SEM micrographs close to the pitch line revealed some scattered micropits for all test conditions except for RI5. Otherwise, plastic deformation was seen prominently. As an example, a SEM micrograph from RI5+E is shown in Fig. 9. It can be observed that asperities are plastically deformed downwards in the direction of sliding and appears to cover valleys in the grinding lay. Thus, both the peaks and valleys are smoothed, but the material is strongly deformed.

Fig. 9. SEM micrographs showing plastic deformation at pitch after efficiency testing R15+E. “S” indicates the sliding direction.

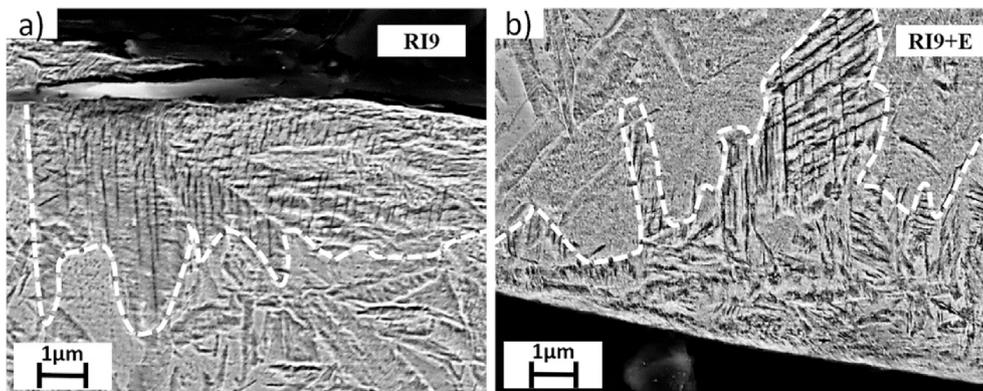
For every test condition except RI5, the metallographic investigations revealed the presence of a distinct structure near the teeth surface that was not present on as ground gears. Fig. 15 shows microstructures near the surface for RI9 and RI9+E, where the distinct features are indicated with dotted lines. Their morphology consists of parallel bands, sometimes intersecting, with sharper contrast and edges than in the plate martensite. They appear very close to the surface and extended to a maximum depth of about 7 μm. Though it is difficult to quantify the small amounts, more of this structure was formed after the efficiency tests and

in particular for RI9+E. The morphology resembles that of deformation induced martensite in stainless steel [30]. Formation of deformation induced martensite from retained austenite has been observed after fatigue testing of case carburized gears [31]. The features observed here are also considered as deformation induced martensite as further discussed below.

Fig. 15. Deformation induced martensite observed after a) RI9 and b) RI9+E test.

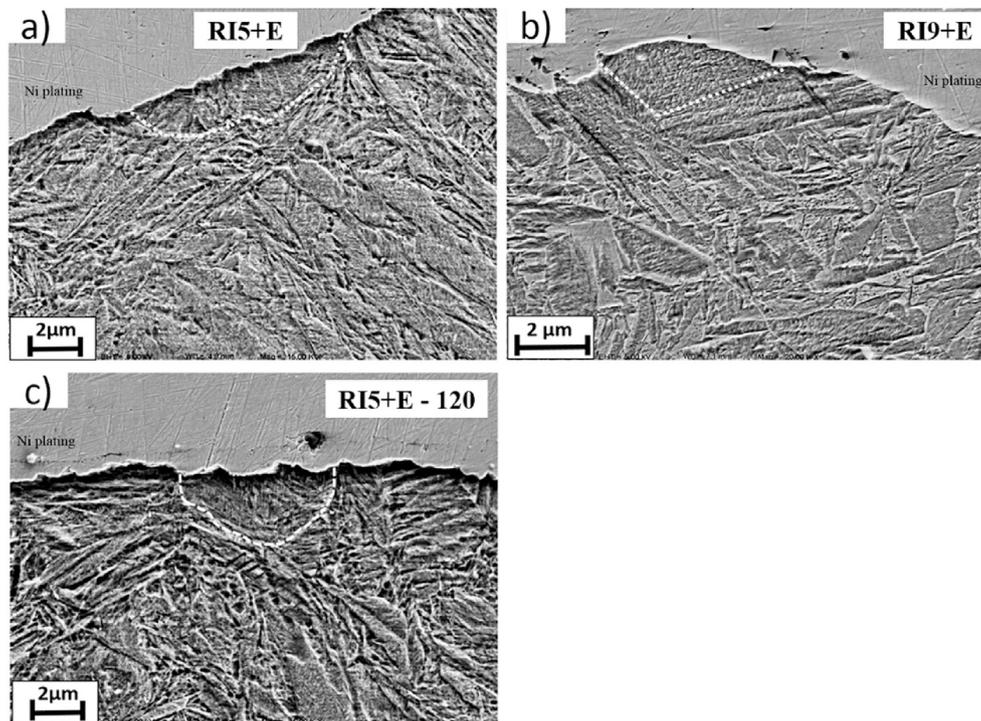
Fig. 16. SEM images with encircled plastic deformation regions at the surfaces for different test conditions a) RI5+E, b) RI9+E and c) RI5+E-120.

In addition to deformation induced martensite, Fig. 16 depicts the formation of plastic deformation regions (PDR) at the surface. These regions were observed only for efficiency test conditions. In this study no dark etching regions have been noted at the edge of the PDR and no initiation of microcracks have been associated with them. Such a mechanism has been suggested by Oila [17] after testing with loads similar to RI9 but for higher number of cycles.

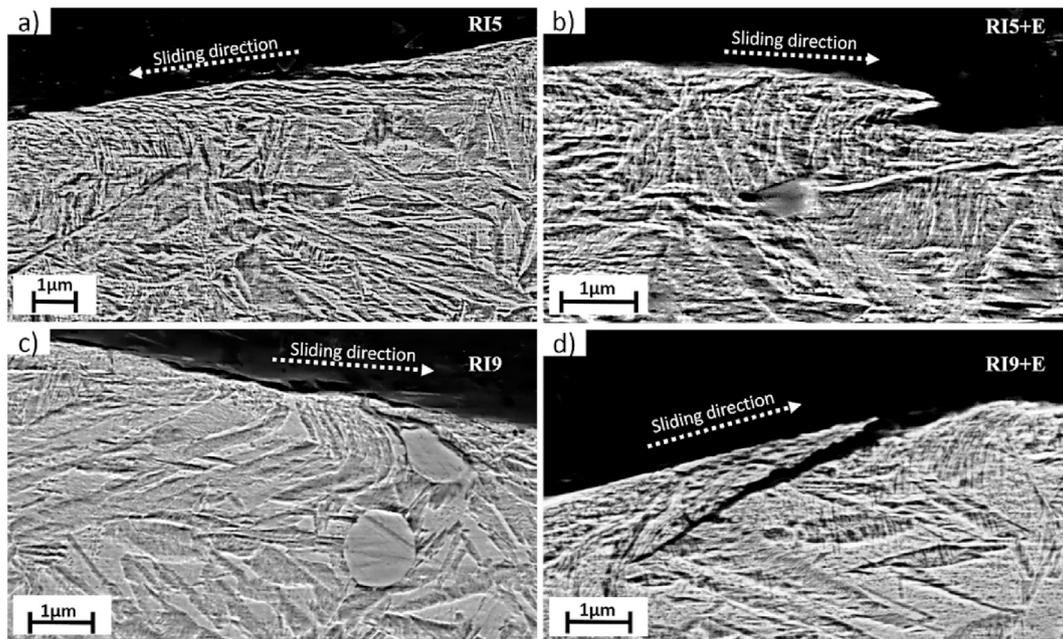
for different test conditions are shown in Fig. 17. The negative sliding in the dedendum caused the surface below the asperities to deform and flow

in the direction of sliding. Wedges that may cause stress concentrations were also seen and sometimes connected with small cracks, most clearly

seen for RI9+E. In the outermost part (less than a micron in depth), martensite plates in the deformed region were distorted in the sliding direction.

Fig. 17. Surface deformation at dedendum after a) RI5, b) RI5+E, c) RI9 and d) RI9+E test.

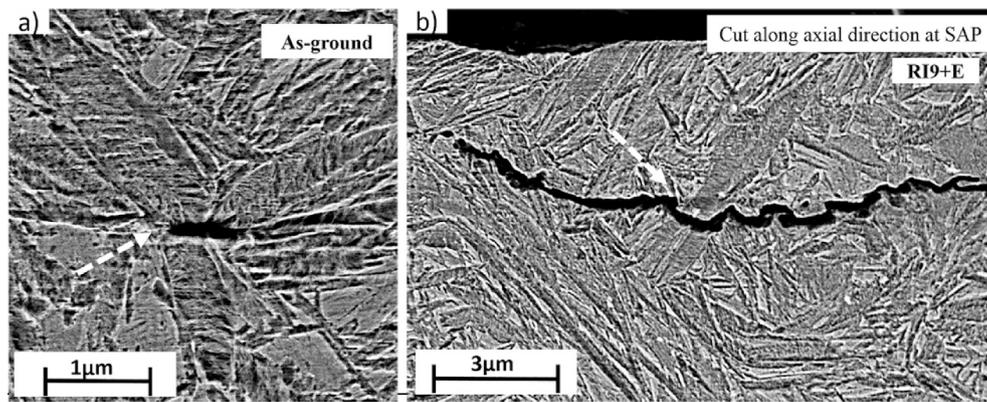
Short microcracks limited to the thickness of martensite plates were observed both on as-ground gear (Fig. 18, left) and for other test conditions.

Fig. 18. Microcrack through a martensite plate a) as-ground condition and b) longer crack going through a martensite plate after RI9+E test.

The metallographic investigations revealed the presence of microcracks in martensite plates on as-ground gears. These cracks are expected to form during the heat treatment and martensite formation. When a secondary plate forms with another variant of habit plane in the same austenite grain, it can lead to cracking of the first at the contact between the plates [35]. This occurs mostly for large plates, just as seen in Fig. 18 with a crack through a larger plate at the contact with a smaller one. Only for RI9+E at dedendum longer sub surface cracks down to a depth of 380  $\mu\text{m}$  were observed. Some of these cracks also went through martensite plates in the same way as the microcracks. It is reasonable to believe that the microcracks have affected the growth of the subsurface cracks as well as the inclusions that were also associated with them.

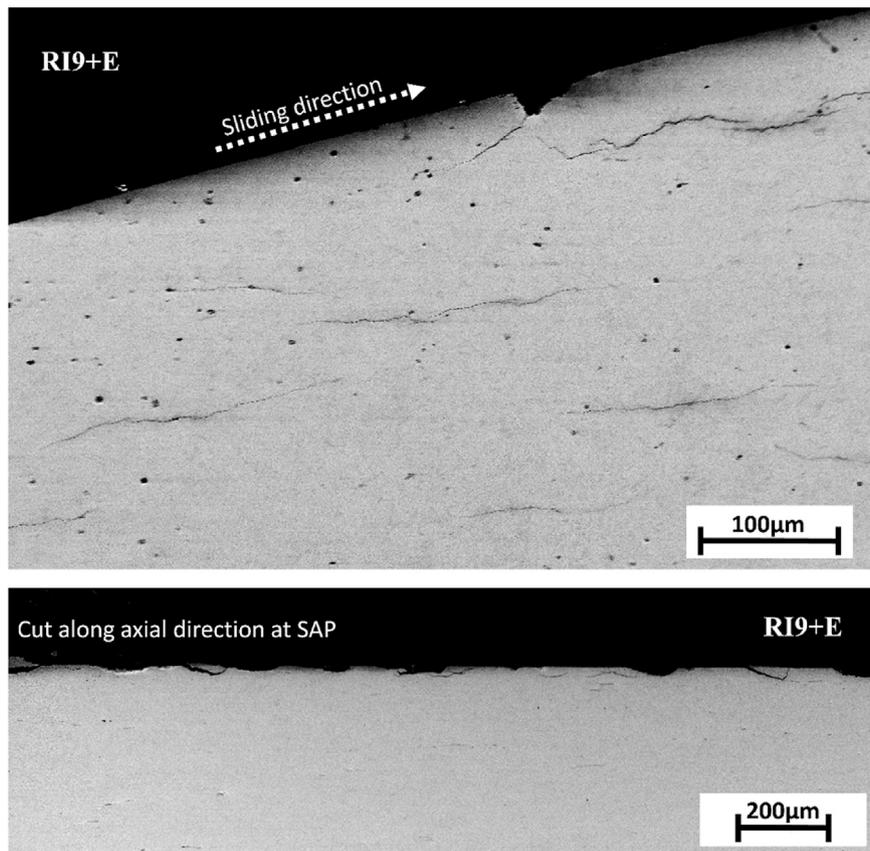
Longer cracks were only observed for RI9+E near dedendum. Fig. 19 shows cross sections both in profile direction and in axial direction close to SAP. In the section cut in axial direction, multiple surface cracks that extend some 10–20 µm into the material can be seen. This is the region where extensive micropitting was seen for the same condition as in Fig. 6.

In sections cut in profile direction large cracks were observed to a depth of approximately 380 µm with minimum length of 250 µm (Fig. 19), still only for RI9+E near dedendum. Similar cracks were observed on some of the multiple sections of this kind from different teeth. Etching on these sections (not shown) revealed that some long cracks passed through martensite plates in the same manner as the short cracks (Fig. 18). Inclusions were also found along the cracks, see Fig. 20.

Fig. 19. Surface and subsurface cracks at dedendum after RI9+E test.

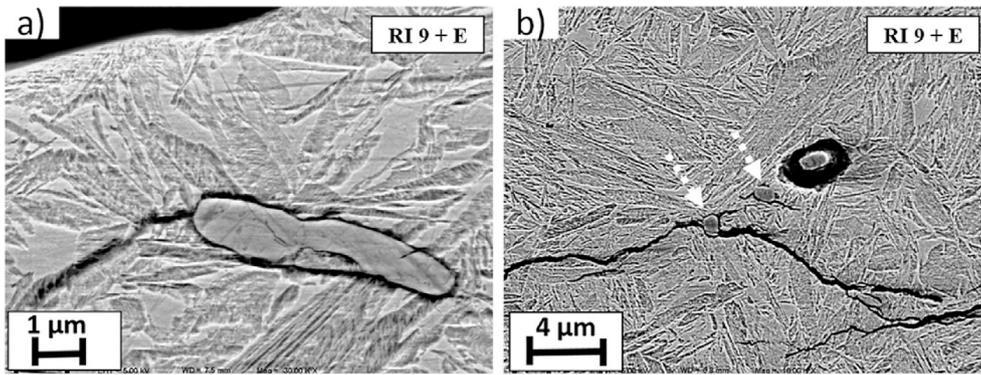
Fig. 20. Cracks connected to inclusions in RI9+E test a) short crack connected to inclusion b) both short and long cracks connected to two different close by inclusions.
