In situ Measurements of Façade Retrofitted with Vacuum Insulation Panels

P. Johansson¹

Abstract

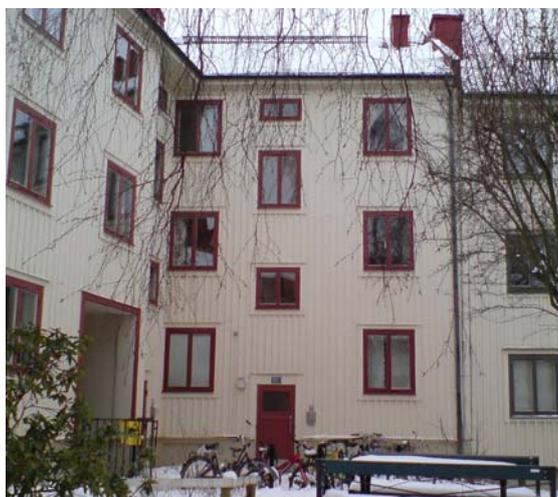
Figure 1. The 1930s multi-family building in Gothenburg, retrofitted with VIP.

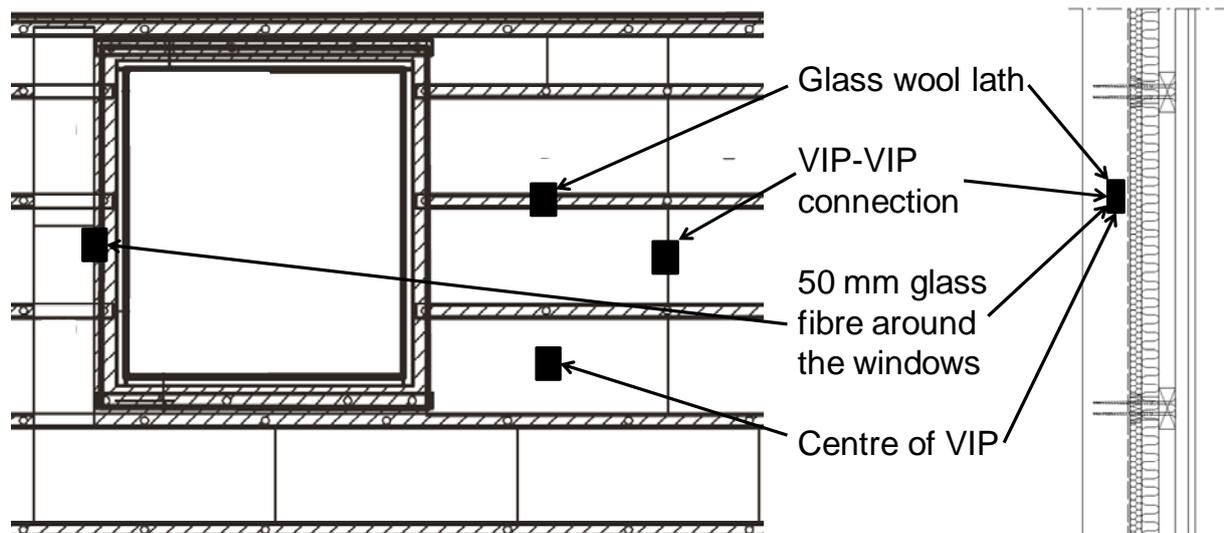
Figure 3. Locations of sensors in the retrofitted wall. All sensors are placed in the existing wall, on the interior of the polyethylene foil and VIP.

The hygrothermal conditions on different locations in the wall, see Figure 3, can be studied. One sensor in the brick wall was mounted on the wrong location, which means that two sensors are located behind the glass wool laths and none behind the VIP-VIP connection. The temperatures at the different locations are presented in Figure 6.

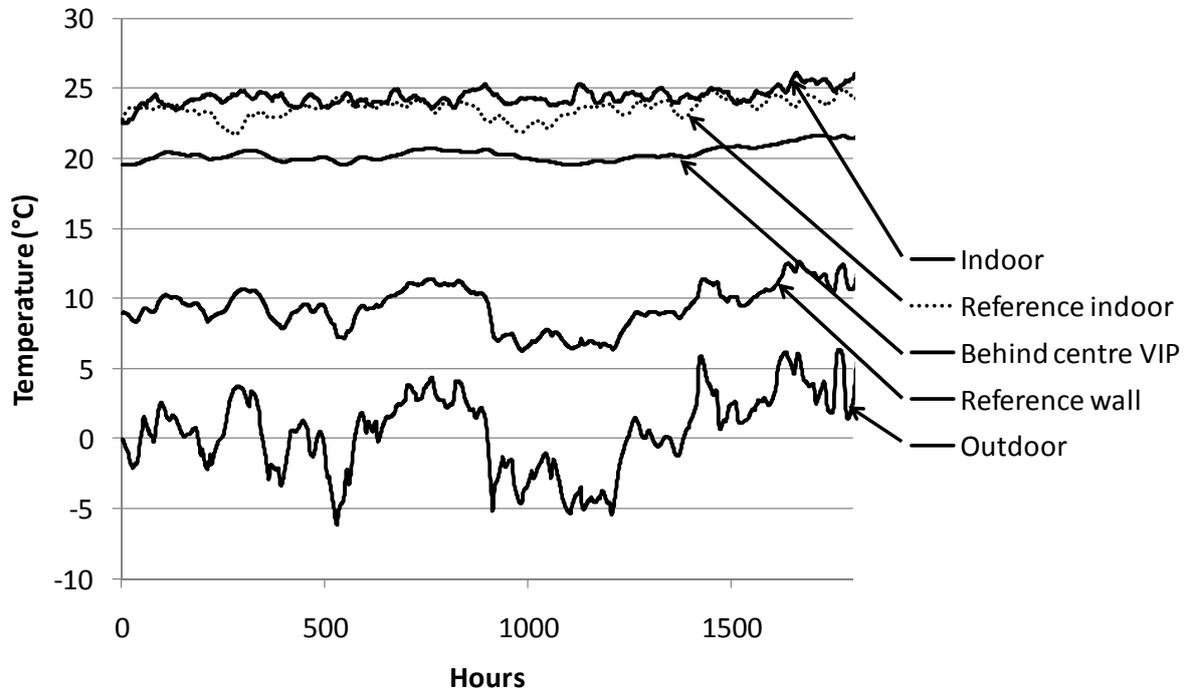
Figure 4. Daily averaged temperature behind the centre of the VIP and indoors, compared to the reference wall, indoor and outdoor. The measurement period is January 5 to March 22, 2011.

Indoor temperature is measured in the kitchen of the apartment closest to the location of the sensors in the wall. During the period, the temperature was on average 0.8°C higher in the kitchen with the retrofitted wall than in the reference kitchen. The higher temperature was caused by an unbalanced heating system in the building which caused the occupants to have their windows open very often, also during the cold season, and many technical appliances generating heat. However, with this fact taken in consideration, the temperature was on average 10°C higher in the retrofitted wall than in the reference wall. The corresponding vapor content is shown in Figure 5.

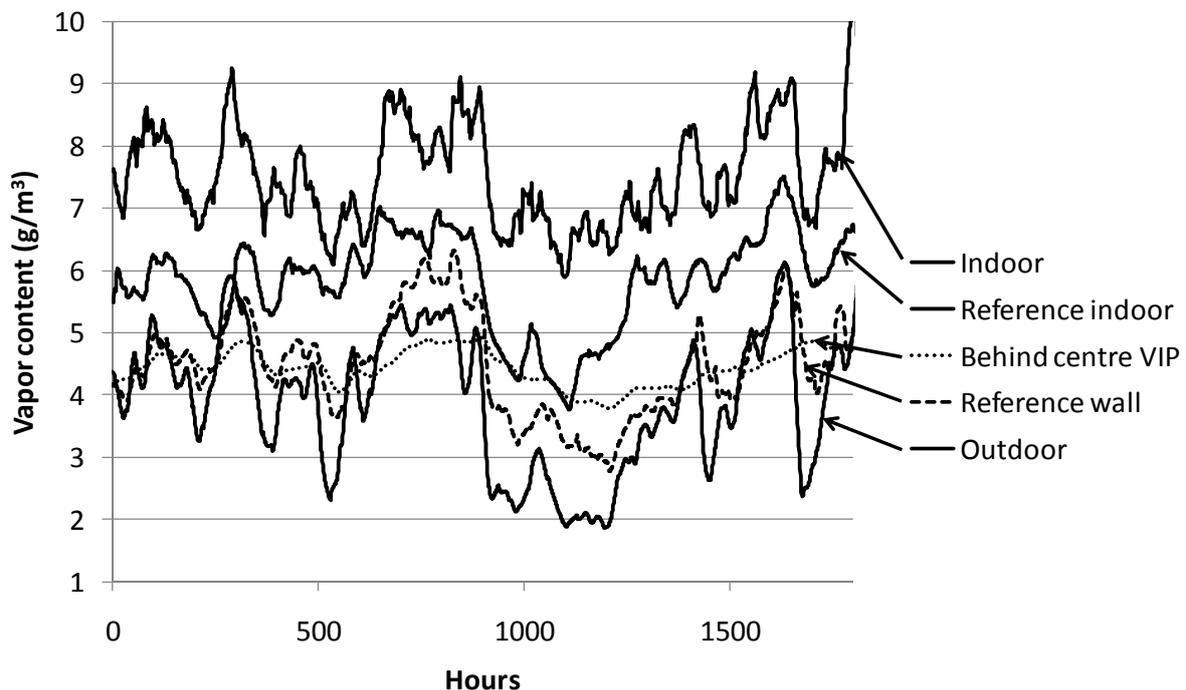
Figure 5. Daily averaged vapor content behind the centre of the VIP and indoors, compared to the reference wall, indoor and outdoor. The measurement period is January 5 to March 22, 2011.

The vapor contents in the air in the kitchens and in the reference wall were following the changes in the outdoor air closely. Behind the VIP, the vapor content was more stable with a slower response. The moisture supplies in the kitchens were 3.6 and 1.9 g/m³, respectively in the retrofitted part and the reference part, which means that the retrofitted wall was exposed to a heavier moisture flux than the reference wall. The brick behind the VIP and in the reference wall had a similar moisture supply, on average 0.5 g/m³. However, the temperature influence gave an average relative humidity of 22-27% with an average of 25% in the retrofitted wall, and 37-62% with an average of 50% in the reference wall.

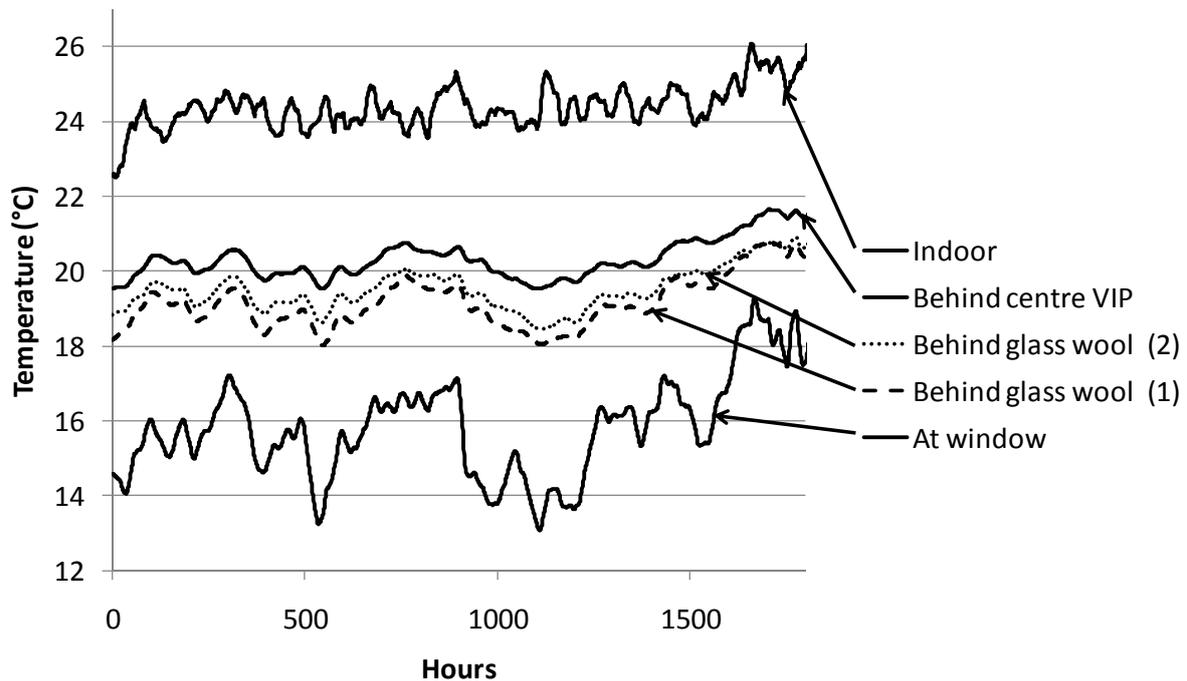
Figure 6. Daily averaged temperatures in the brick wall at different locations behind the VIP. The measurement period is January 5 to March 22, 2011.

All the temperatures measured during the period were following the same pattern, influenced mainly by the outdoor temperature. The temperature next to the window was lowest which was expected since there was least insulation around that location. The influence by the glass wool laths on the temperature was on average 1°C, compared to behind the centre of the VIP. There was a difference between the two measurements behind the glass wool of 0.4°C. The measured vapor contents are shown in Figure 7.

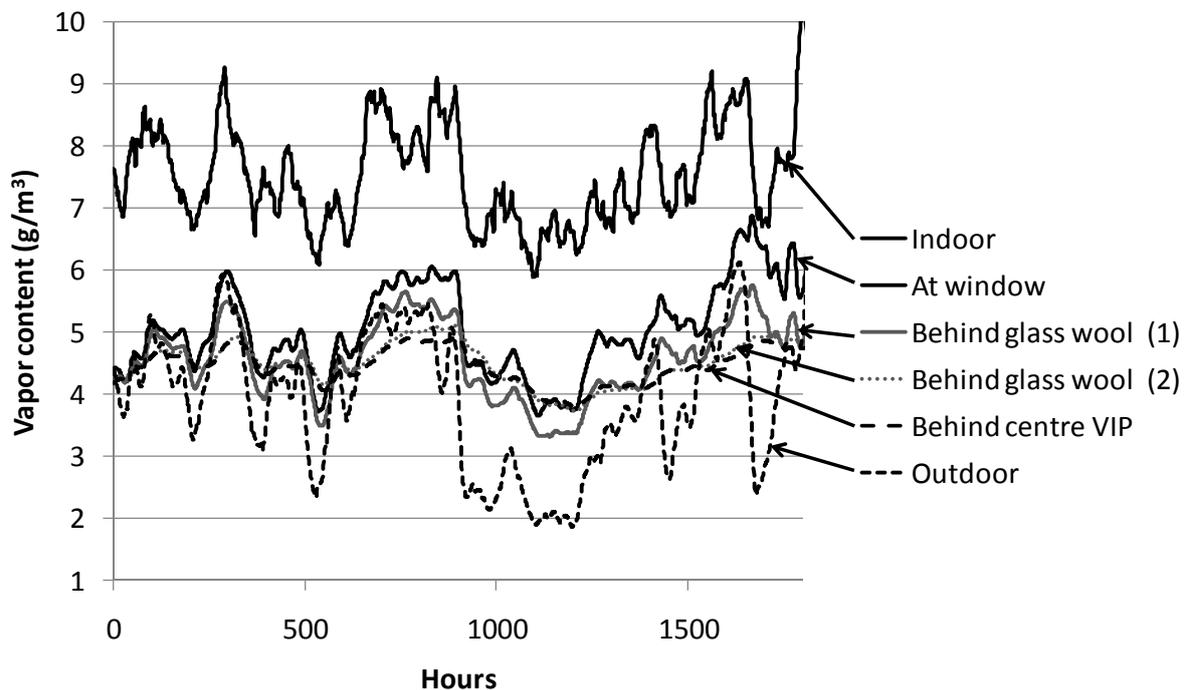
Figure 7. Daily averaged vapor contents in the brick wall at different locations behind the VIP. The measurement period is January 5 to March 22, 2011.

The vapor contents in the wall were higher than outdoors for most of the measured period. Indoors, at the window and at one of the locations behind the glass wool laths, the vapor content was following the changes in the outdoor air faster than in the two other locations. Behind the VIP and at one of the glass wool laths, the response to changing vapor content was slower. The reason for the difference could be a crack in the wall where an air flow is induced. Figure 8 shows the relative humidity at the different locations in the wall.

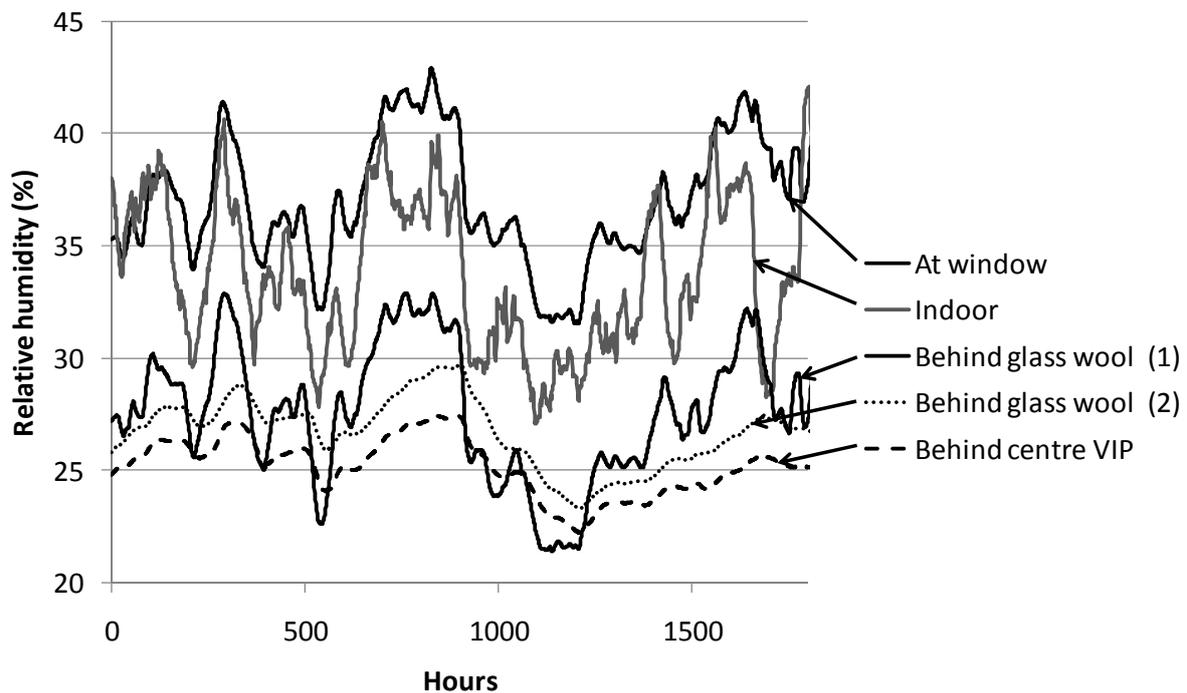
Figure 8. Daily averaged relative humidity in the brick wall at different locations behind the VIP. The measurement period is January 5 to March 22, 2011.

The relative humidity was low at all measured locations of the wall. At the window, the relative humidity is highest, varying between 32-43% with an average value of 37%. There was a difference between the two glass wool lath measurements; one case vary between 21-33% and the other case between 23-27%. However, the difference on the average relative humidity was only 1%.
