INFLUENCE OF DESIGN AND MATERIALS WITH CONSIDERATION TO THE ANNUAL MAINTENANCE WORKS IN RECOVERY BOILERS

Diploma work No. 48/2011

at the Department of Materials and Manufacturing Technology CHALMERS UNIVERSITY OF TECHNOLOGY Gothenburg, Sweden

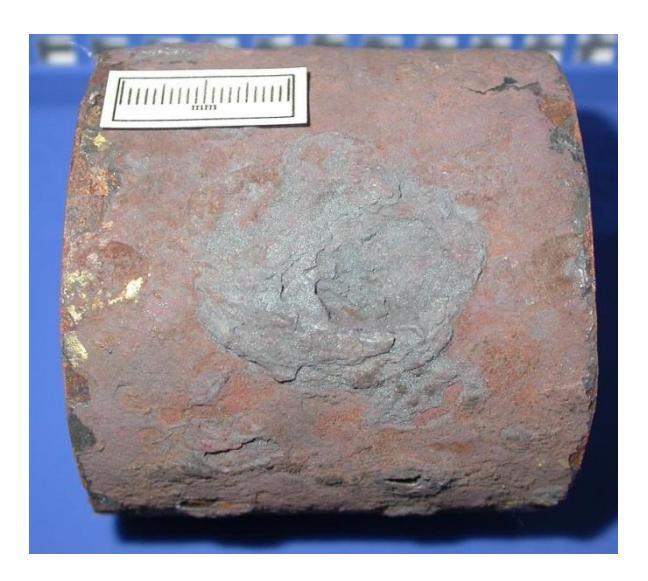
The ocular inspection revealed areas with material loss and a thick deposit on the gas-side of the tubes. The deposits had a red-brown and dark grey appearance as seen on the tube sample is shown in Figure 16.

Figure 16 – Tube sample from Nueva Aldea with the deposit clearly visible in gray/blue

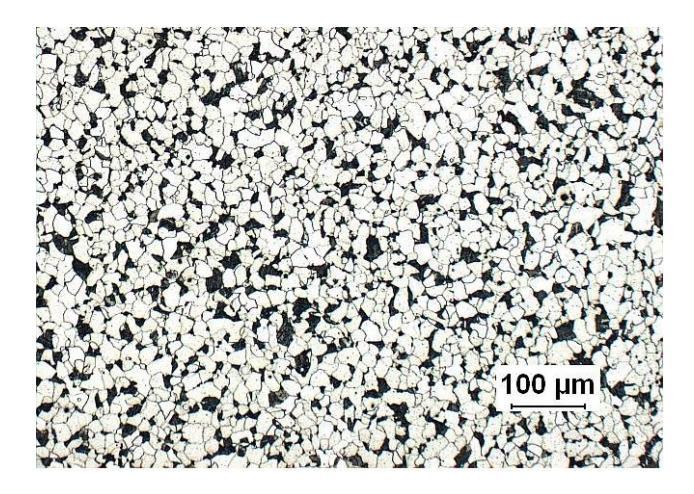
Gas-side tube surface revealed intergranular corrosion, but no changes to base material structure which consisted of ferrite and pearlite.

Figure 17 – Microstructure in tube sample from Nueva Aldea

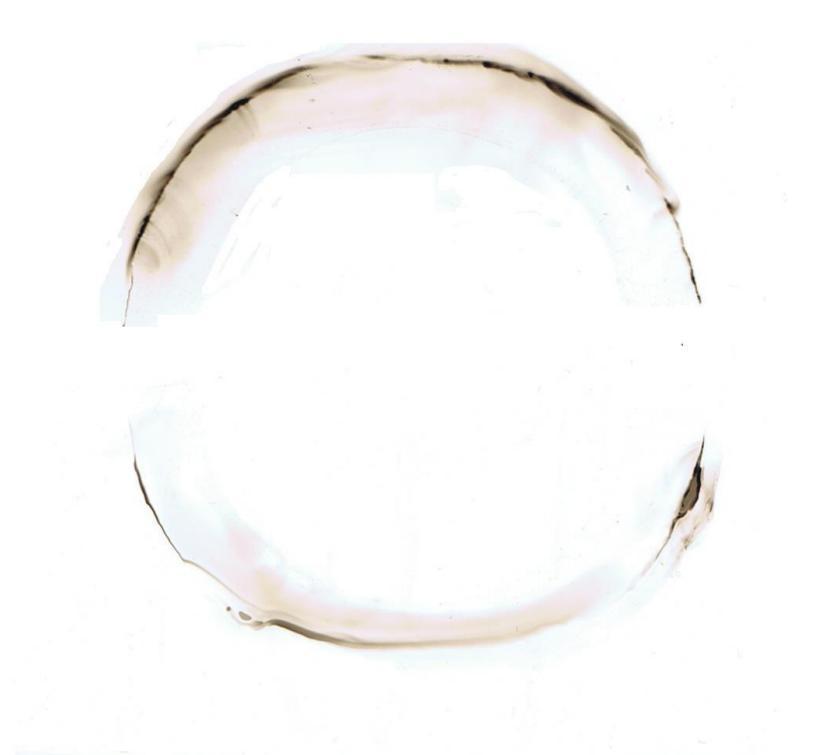
As seen in the print presented in Figure 23, the Baumann test revealed what looks like high concentrations of sulphur in some parts of the tube. Please note that the tube was cut in half before the test was made and that is why there appears to be sulphur-free areas in the middle of the tube.

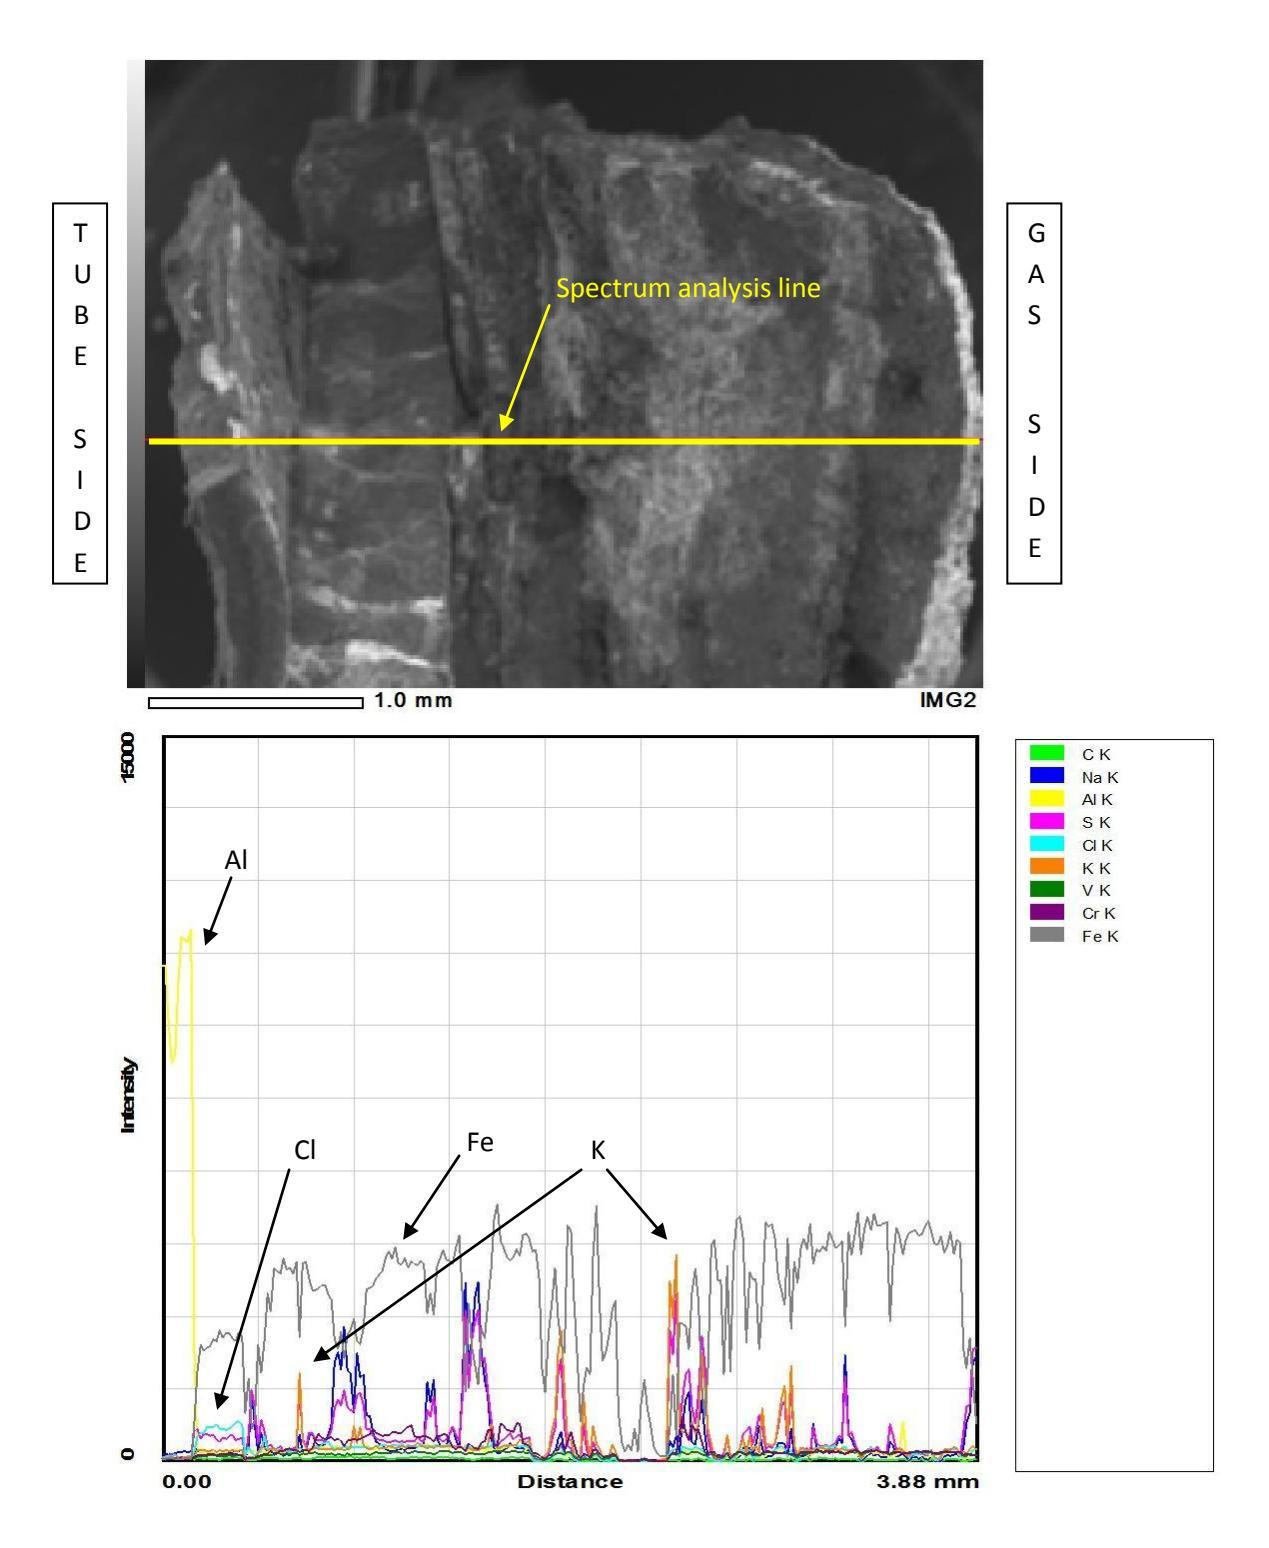
Scanning electron microscope (SEM) analyses of a thick scale from the tube sample revealed layers with high contents of sulphur, sodium and potassium as well as high contents of chlorine closest to the tube surface. Notable was that the sulphur and sodium layers follow each other tightly. The result of a line analysis is showed in Figure 25 below.

Figure 25 – Line analysis of the corrosion layer. The aluminium comes from the sample holder. High chlorine is observed closest to the tube surface.

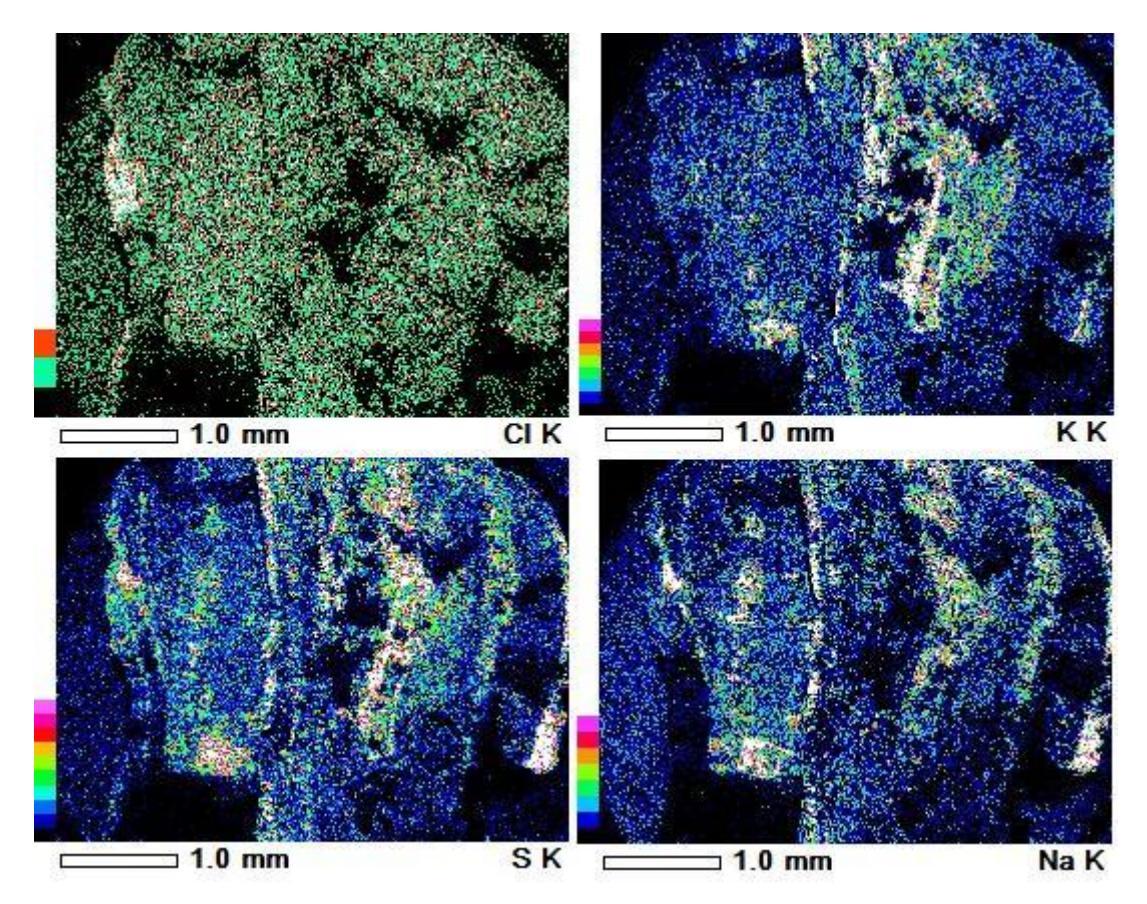
As seen in Figure 26, high concentrations of chlorine was only encountered close to the tube surface. Sulphur and sodium concentrations seem to follow each other neatly.

Figure 26 – Concentration of the elements Cl, K, S and Na. Bright colours such as white and pink represent high concentrations whereas dark colours represent low concentrations.

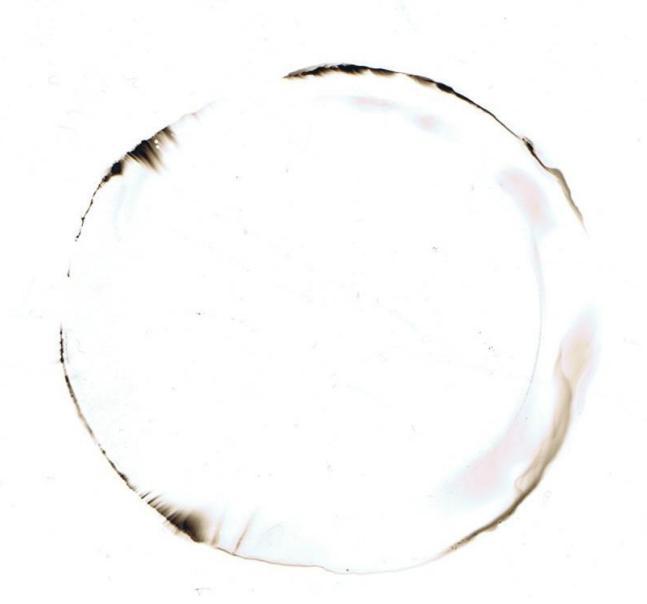
To confirm the finding and suspicions, a Baumann print was also done for the tube sample. As seen in Figure 27 to the left, the print revealed high quantities of sulphur in most parts of the tube.

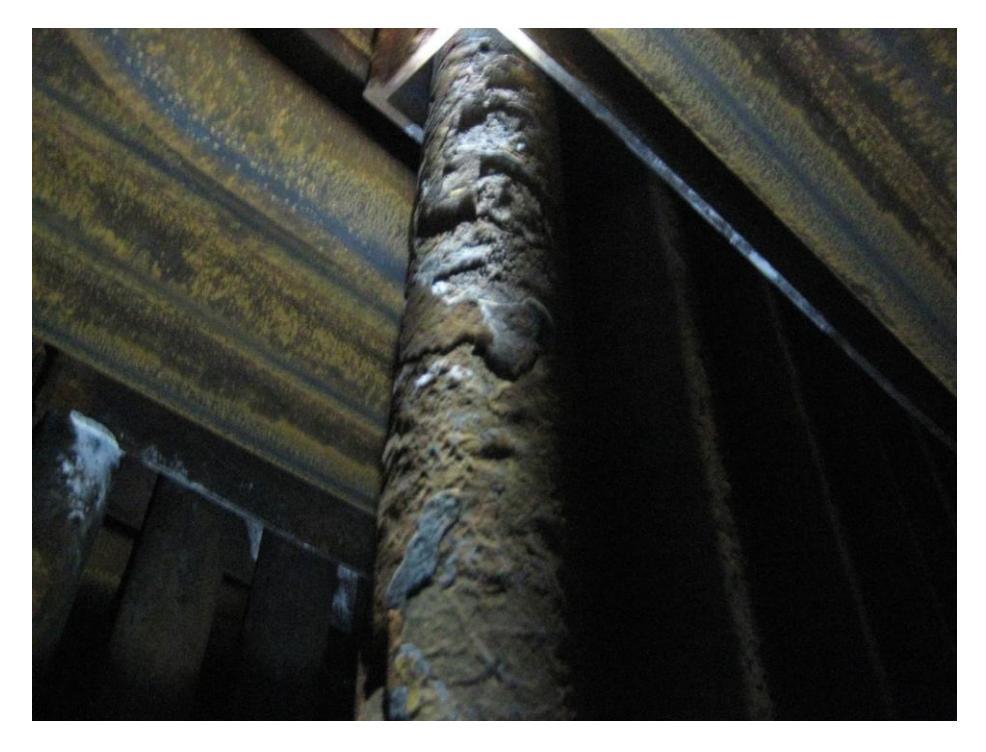
In 2009 a full thickness measurement was recommended to be done and eventually measurements were carried out at the two highest sootblowers. However, once again the responsible NDT-company was slow to communicate the results, even though the minimum wall thickness was found to be 4,1 mm which is far below the minimum requirement of 5,82 mm following the ASME code (Safe Control Boiler Service, 2009). Despite the recommendation of a full thickness measurement in the superheater, no measurements were taken below the level of the two highest sootblowers. During the outage in 2010, tube samples from the outlet tube on panel 14 were taken and analyzed. The results are presented further on in this case description. The appearance of one of the tubes with severe corrosion can be seen in Figure 28.

Figure 28 – Photo of tertiary superheater tube close to the boiler roof (courtesy of Safe Control Boiler Service)

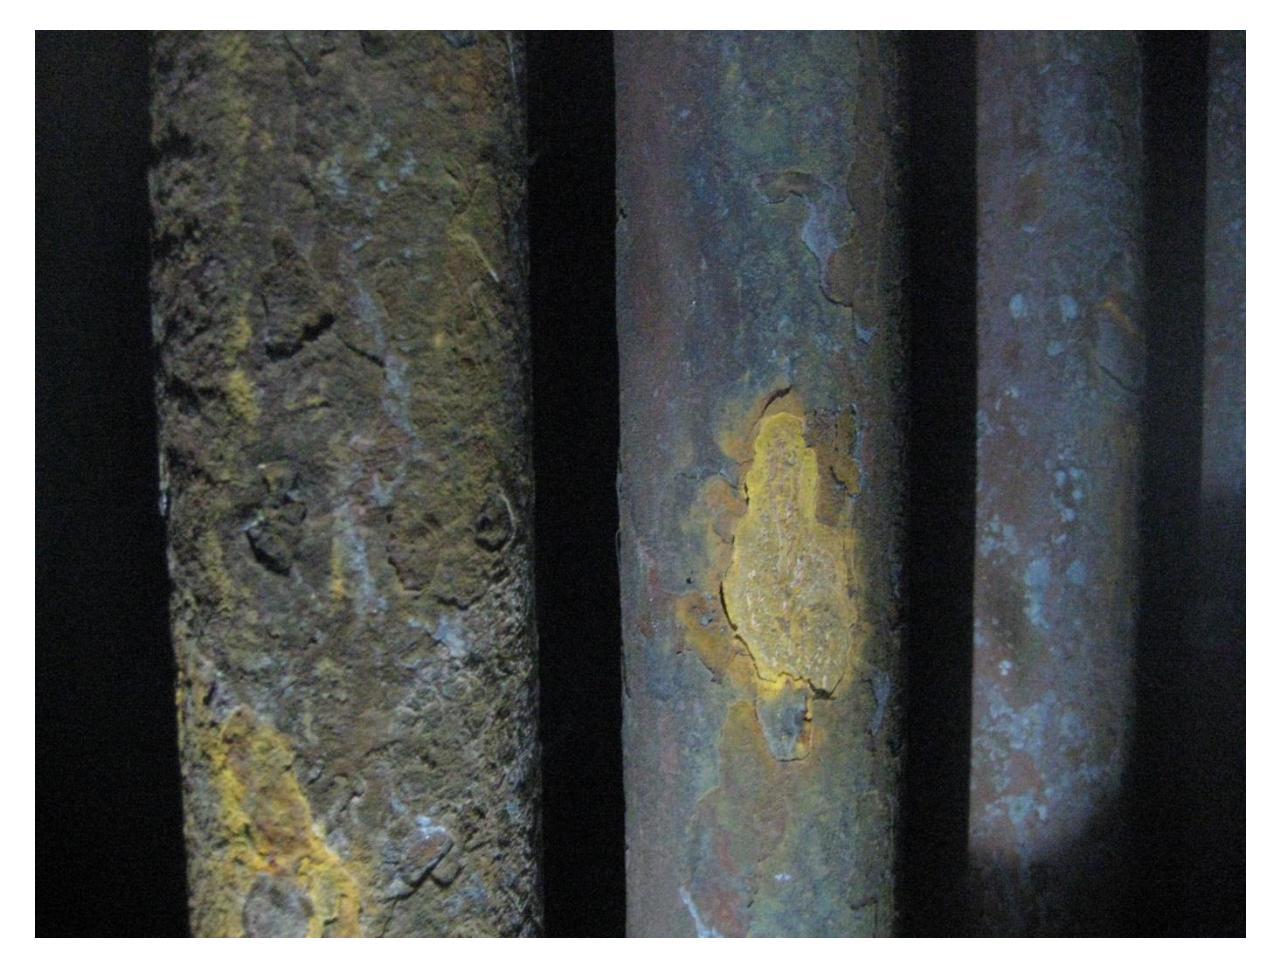
Figure 30 – Photo from tertiary superheaters in Valdivia showing severe corrosion on the outmost tube and diminishing corrosion damages on the tubes further inward the panel (picture courtesy of Safe Control Boiler Service)

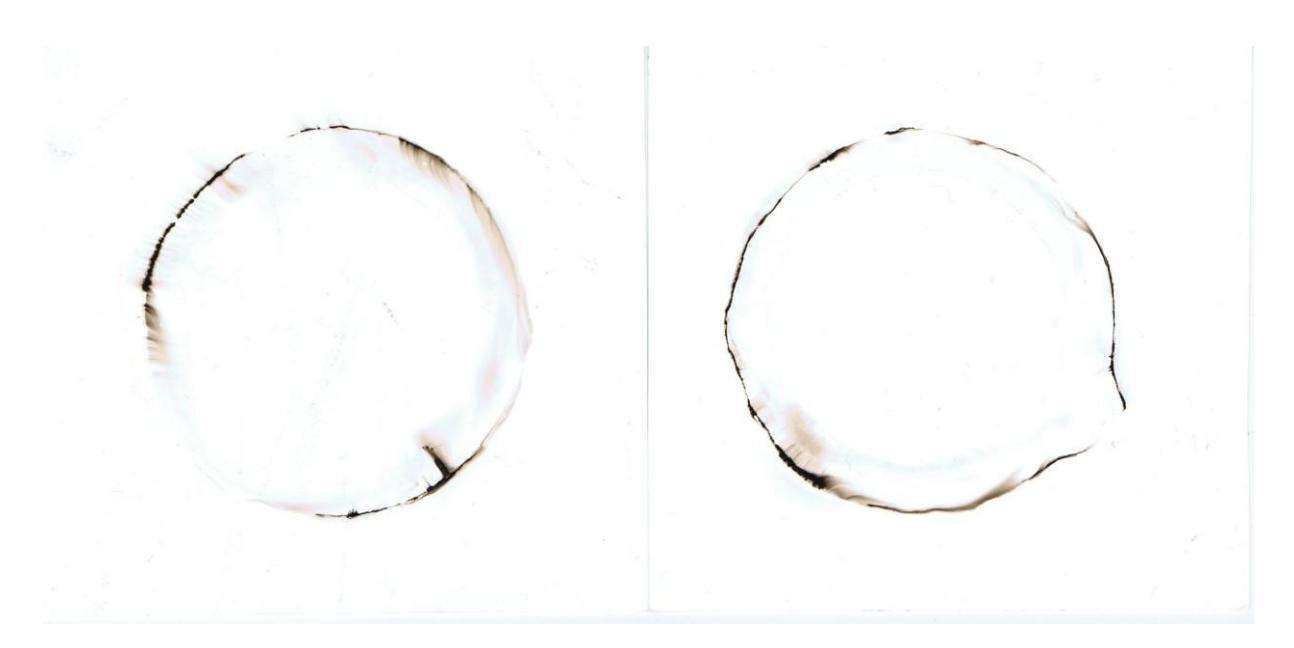
Figure 38 – Baumann sulphur print made with the tube samples from Valdivia. The upper sample is to the right in the picture and the lower sample is to the left.

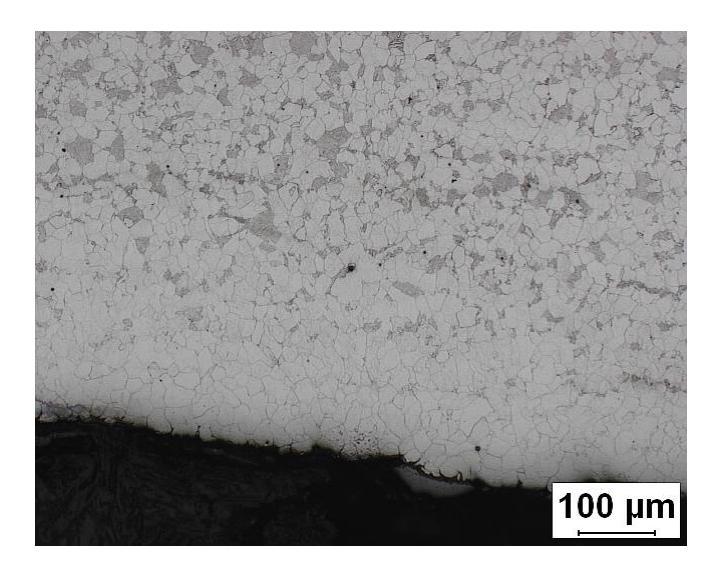
Figure 40 – The steam-side of the sample showing a decarburized zone in areas closest to the steam side. The decarburized zone consists of only ferrite (bright grains in the picture)

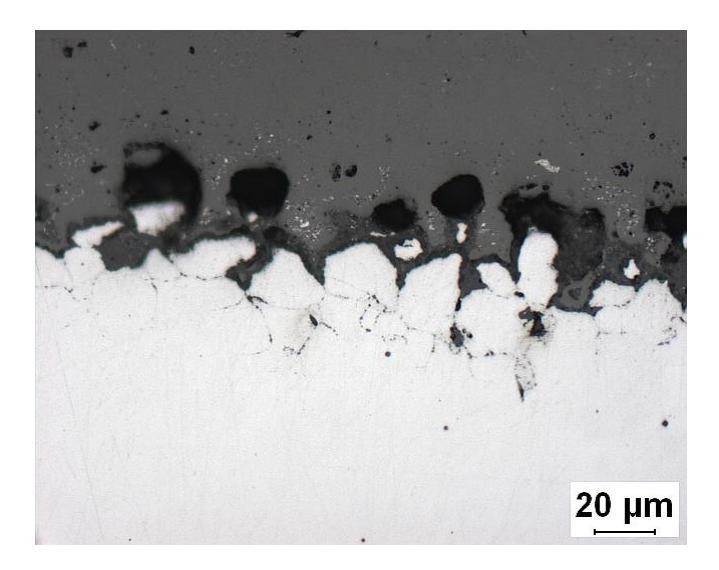
Figure 41 – The metal/oxide interface on the gas-side of the sample showing intergranular corrosion

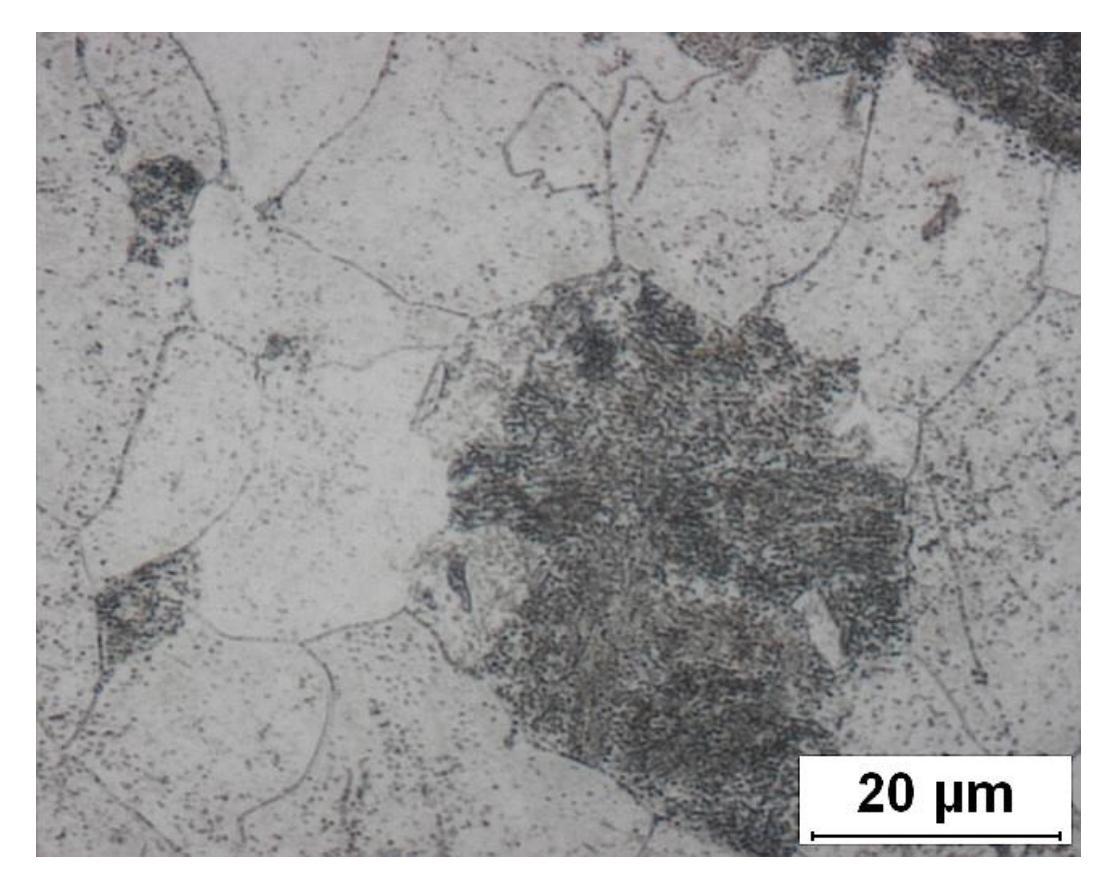
Figure 42 – A close up on the microstructure towards the gas-side of the sample consisting of spheroidized pearlite and ferrite.

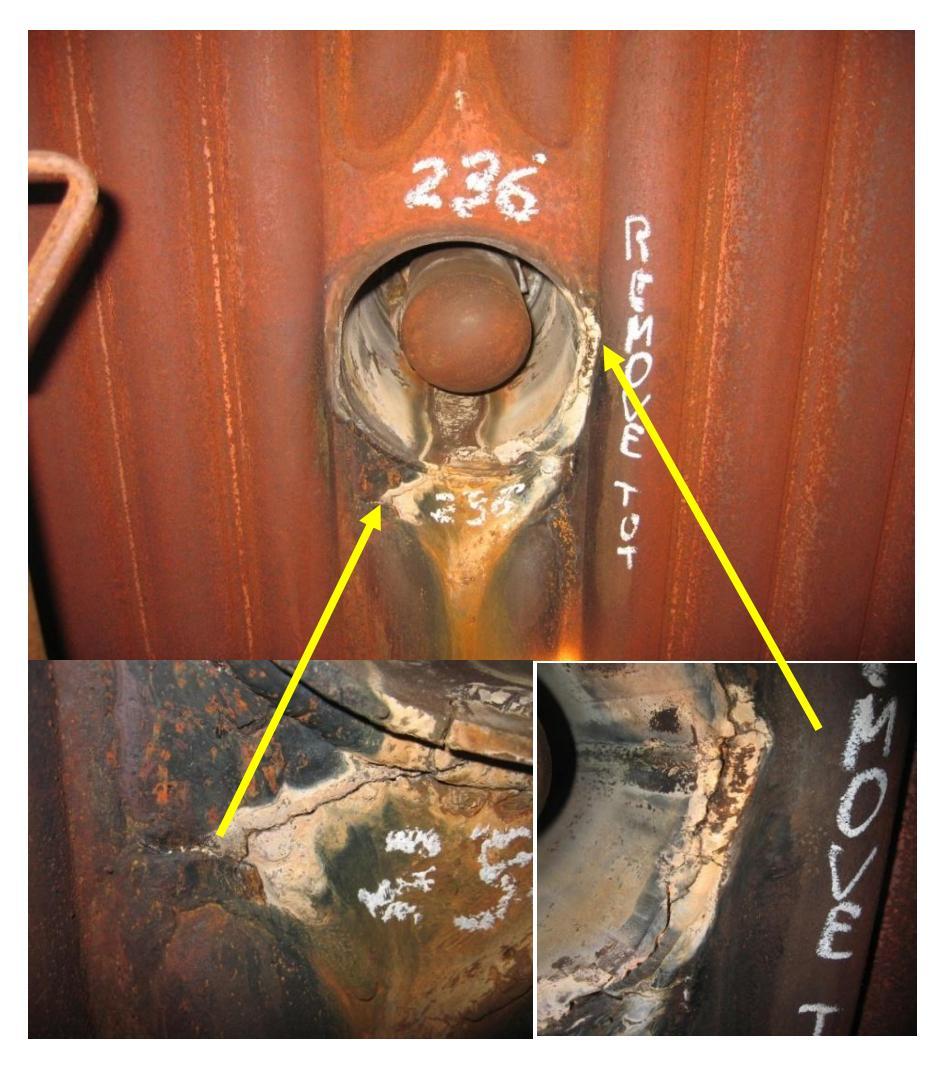
Figure 54 – Sootblower wall box with severe cracks
