## Methods and Equipment for Non Destructive Testing of Reinforced Concrete in Harbour Docks

*Master of Science Thesis in the Master's Programme Geo and Water Engineering*

FRANCISCO RIPOLL CANDEL

Department of Civil and Environmental Engineering  
Division of GeoEngineering  
Road and Traffic Group  
CHALMERS UNIVERSITY OF TECHNOLOGY  
Göteborg, Sweden 2010  
Master's Thesis 2010:28

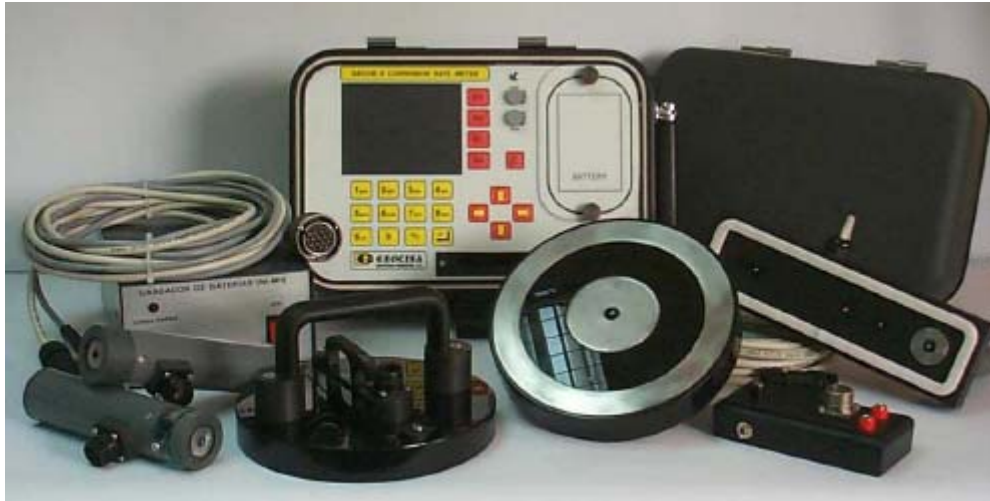
Figure 5.1 GECOR equipment

The last model developed is the GECOR 8. It has three different sensors. The sensor A is used for measurement in aerial structures and for measurement in structures with cathodic protection. The sensor B is employed for mapping of Corrosion Potential and Resistivity. Finally, the sensor C is used for measurements in submerged or very wet structures.

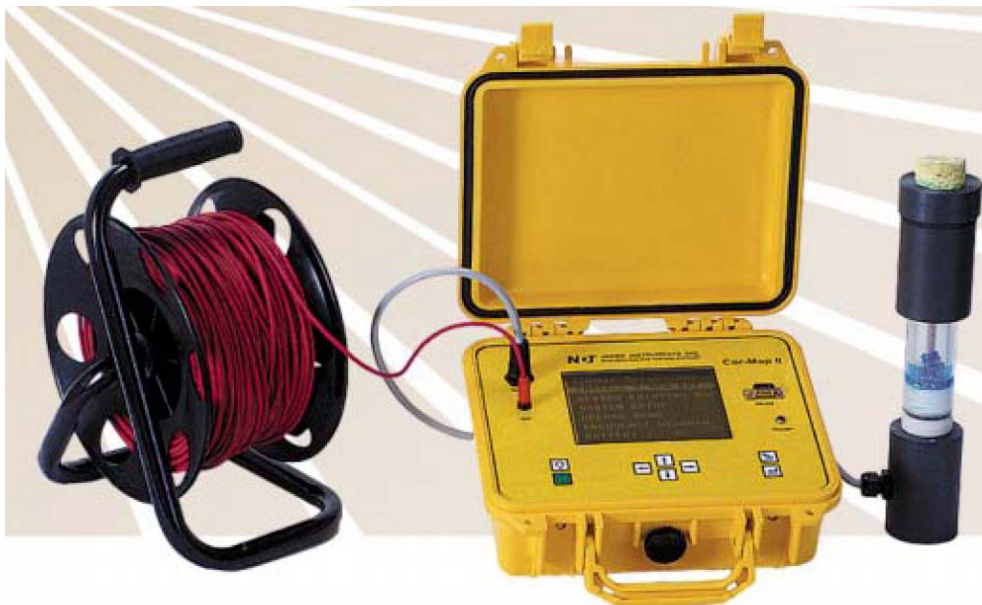
Figure 5.5 The CorMap equipment

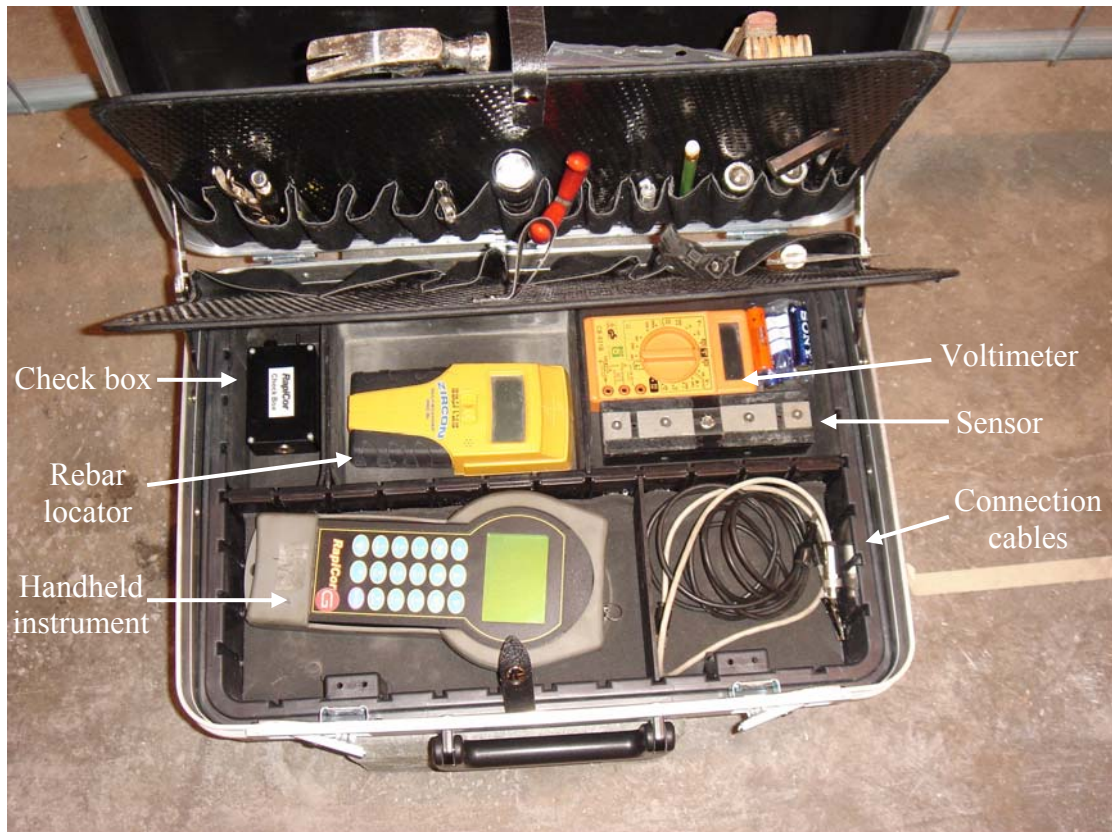
Figure 5.6 Suitcase with the devices needed to carry out the tests.

The RapiCor equipment is based in the Galvanostatic Pulse Method (GPM). It was developed by SP (Swedish National Testing and Research Institute), Borås, Sweden.

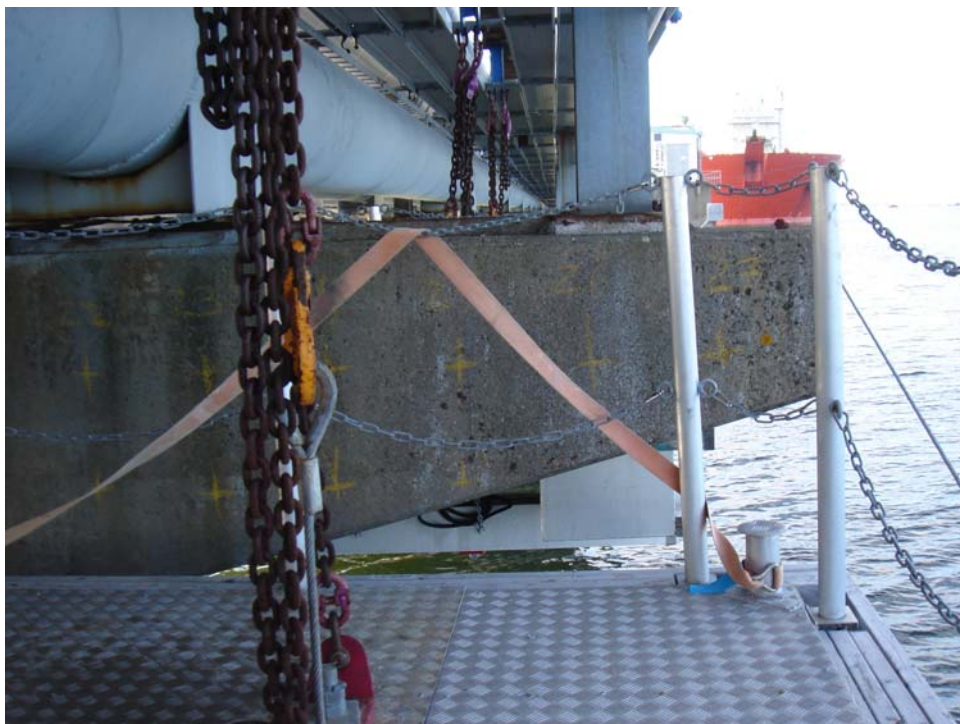
Figure 7.1 Marking the grid at the beam of the Surface 2 (Torshamnen).

The establishment of a reference system with some landmarks which certainly are not going to be removed is also important to recognize the test points after the destruction.

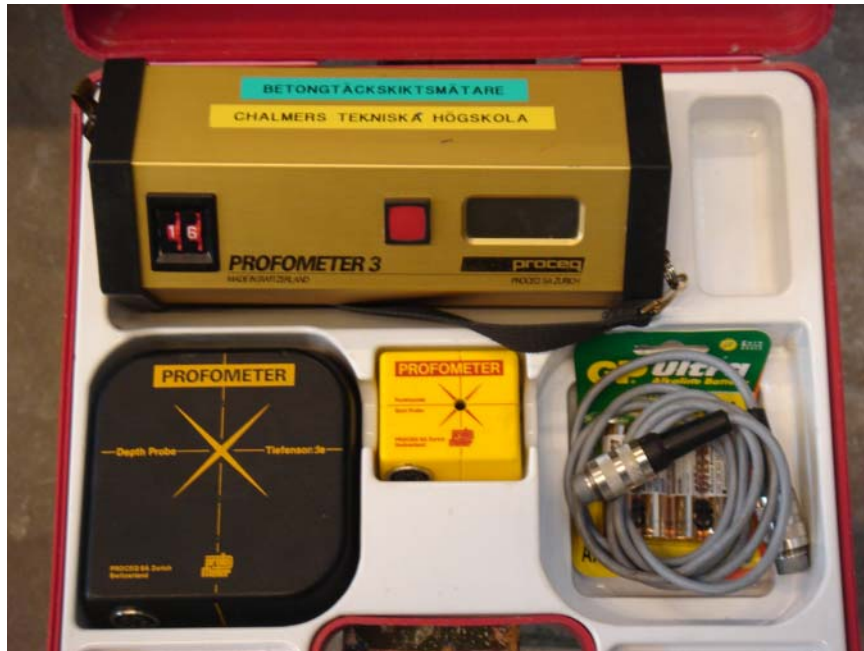
Figure 7.2 The cover detector PROFOMETER 3.

The method used in this case was the utilization of a cover detector which calculates the cover thickness only placing the sensor over the concrete surface. This equipment can be used also as a rebar detector.

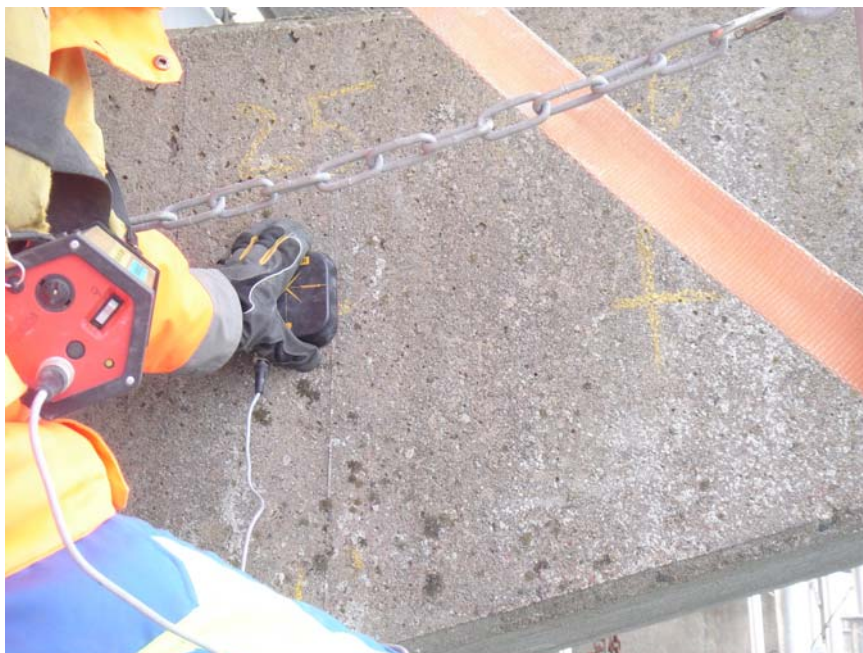
Figure 7.3 Using the cover detector on the beam at Torshamnen.

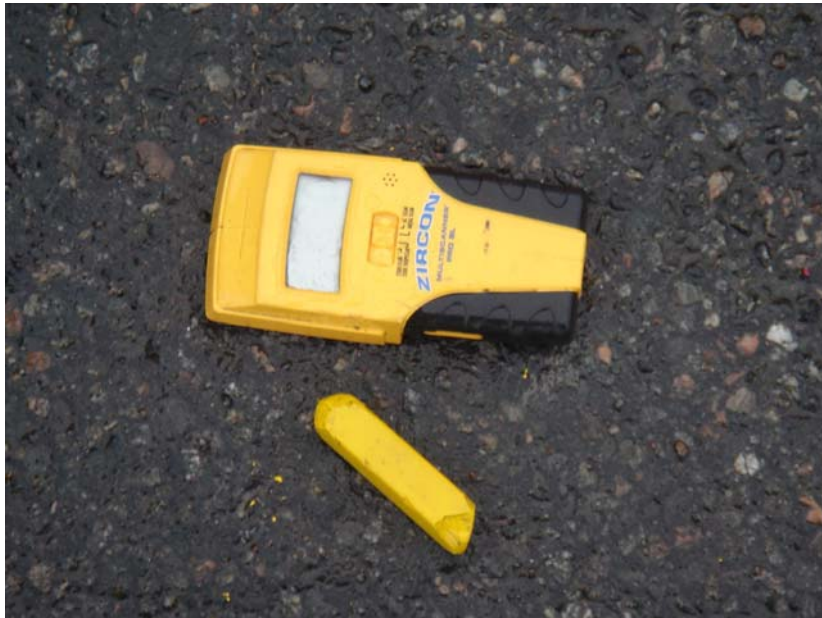
Figure 7.4 Rebar locator used to detect the exactly position of the bars.

First of all, using an accurate detector, it's necessary to exactly detect the position of the bar.

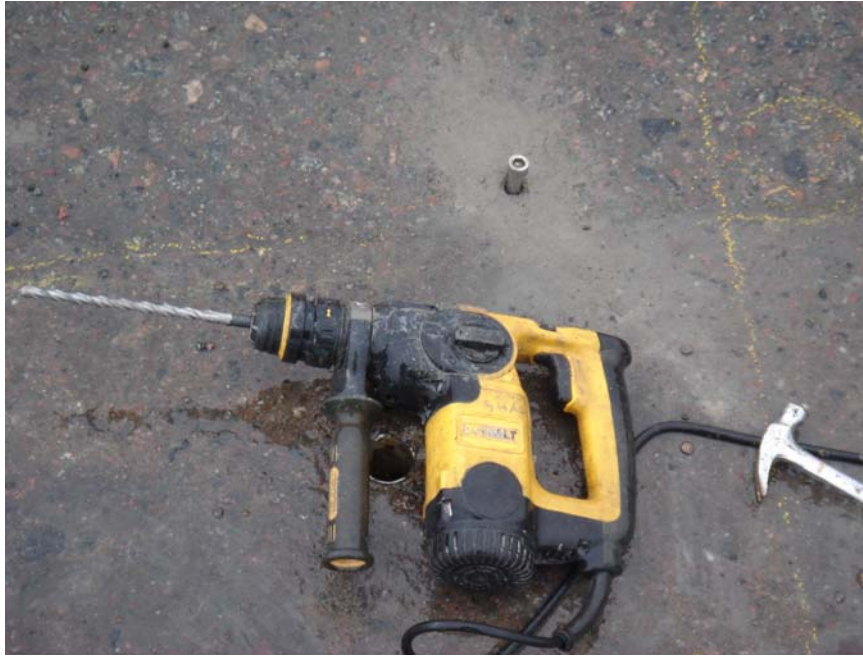
*Figure 7.5 Volt installed.*

Then, with the driller, drill a hole to the rebar trying to surround it with a smaller diameter bit to get a better connection. With the help of a hammer install the bolt.

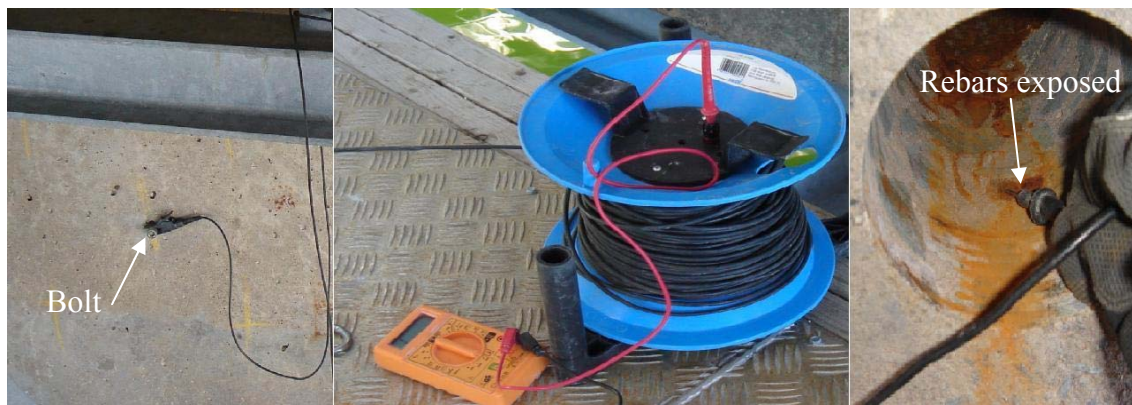
*Figure 7.6 Checking the connectivity of the beam at Torshamnen.*

After the bolt is installed it's necessary to check the electrical connection. For this purpose a multimeter can be used. To ensure the good connectivity, the resistivity should be only a bit bigger than the resistivity of the cable drum.

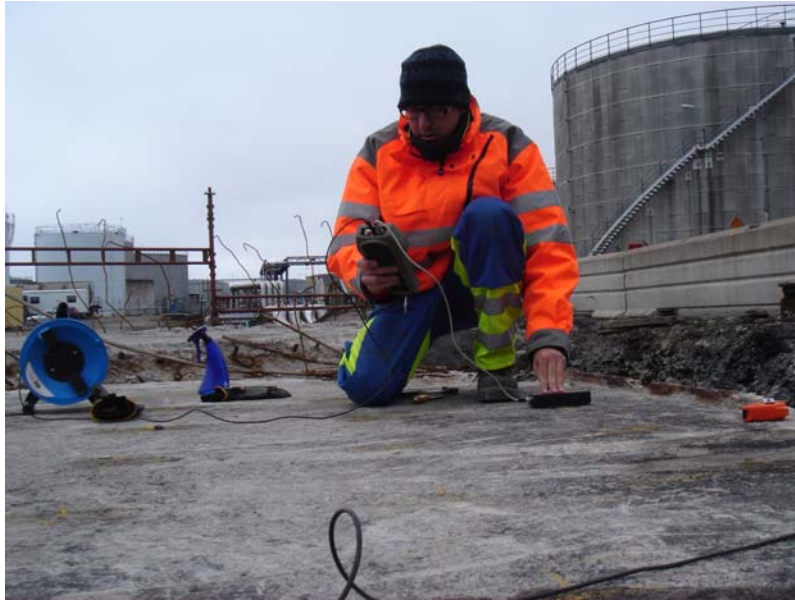
Figure 7.7 Testing with RapiCor at Skarvikshamnen.

At this moment only remains to connect the cable with the hand held equipment and the sensor and it's possible to realize the tests.

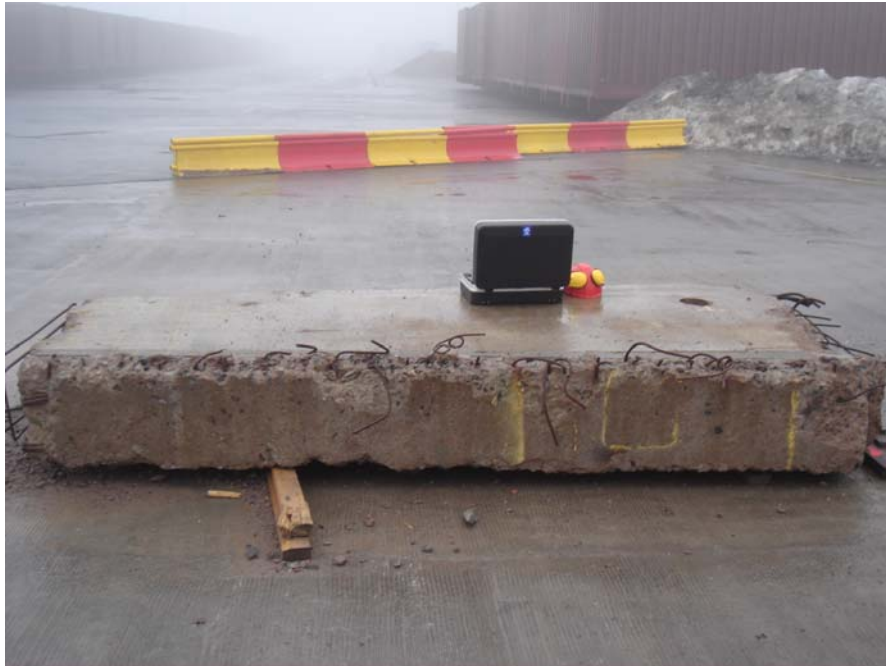
The sample B was a piece of a dock which was destroyed time ago. It was placed at the same place as the surface 1 (Älvsborgshamnen) for the training with the equipment. It was tested during three days.

This sample was a plate of 4x1x0.6 m.

*Figure 8.4 The sample B at Älvsborgshamnen.*

The electrical connection was easily established using the rebars which were coming out of the concrete. Because they were corroded was necessary take out the rust to get the connection.

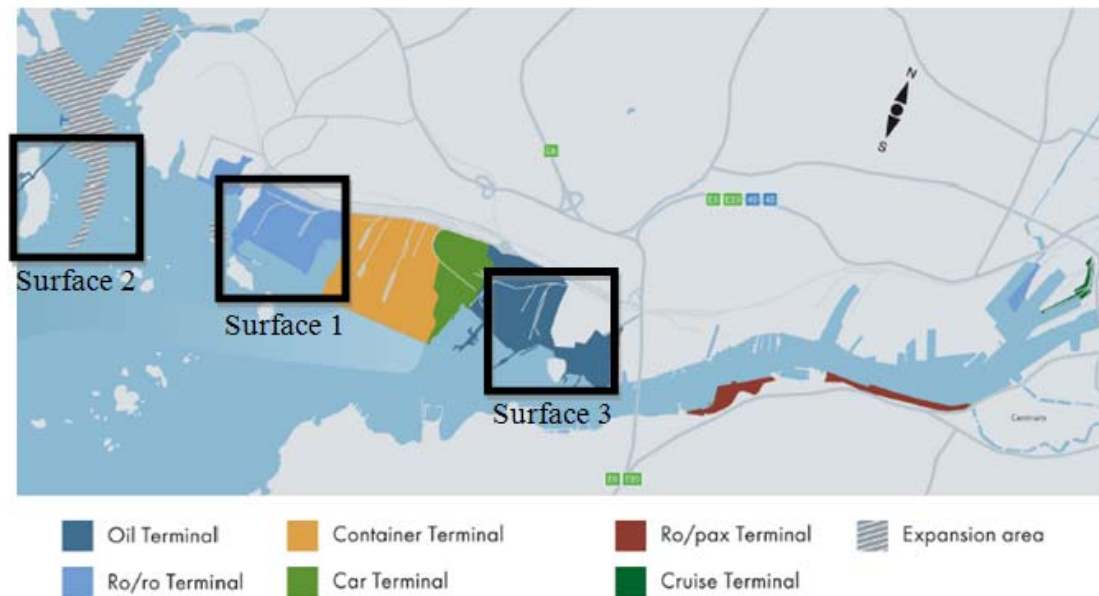
*Figure 9.1 Location of the three surfaces tested at the Port of Gothenburg.*

The areas tested are at Älvsborgshamnen (ro-ro terminal), the quay 710; at Torshamnen (oil terminal) the quay 800; and a road bridge at Skarvikshamnen (oil terminal).

The first surface was a triangle of 35 m<sup>2</sup> on the upper surface of the quay, the second one was a beam below a bridge over the seawater of 11 meters long and the third one was the deck of the road bridge over the pipelines at the crossroads of Bentylgatan with Oktangatan, 28m<sup>2</sup>.

Going along the river the chlorine ions concentration varies. The Surface 2 which is placed downstream is subjected to a higher chlorine ions concentration than the Surface 3 which is upstream.

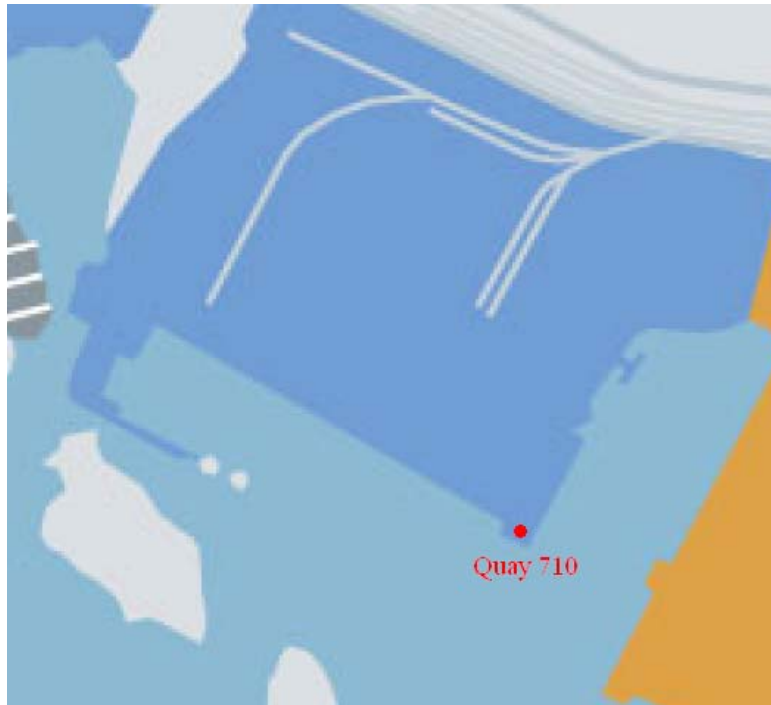
Figure 9.2 *Emplacement of the Surface 1 at the quay 710 (Älvsborgshamnen) where the tests were carried out.*

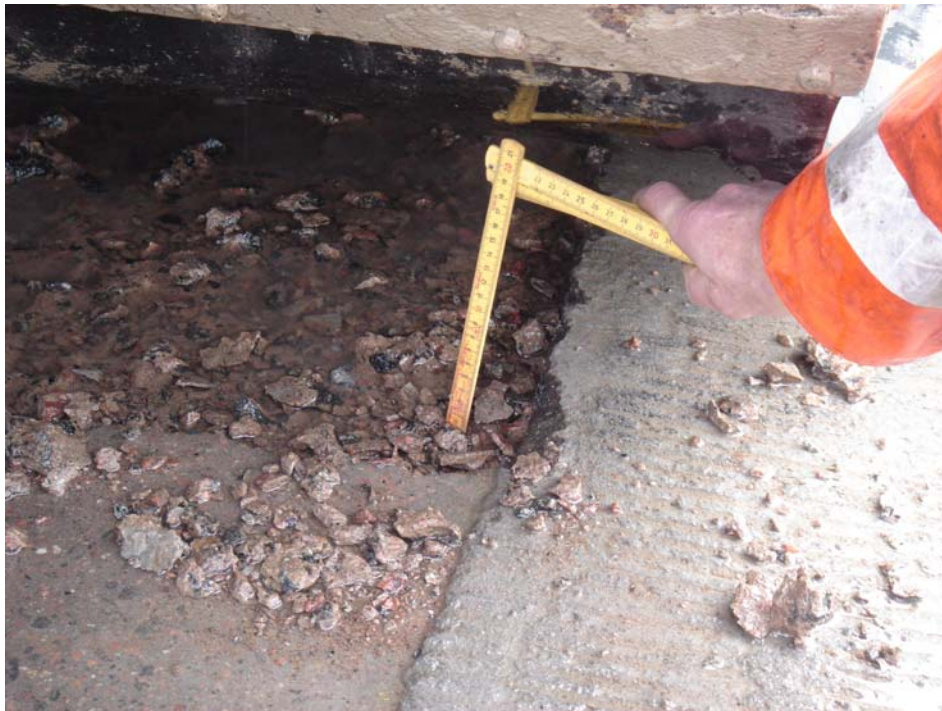
*Figure 9.12 Checking the depth after the first waterblasting.*

After the tests were carried out, the Surface 1 was waterblasted going down around 30 mm (see Figure 9.12)

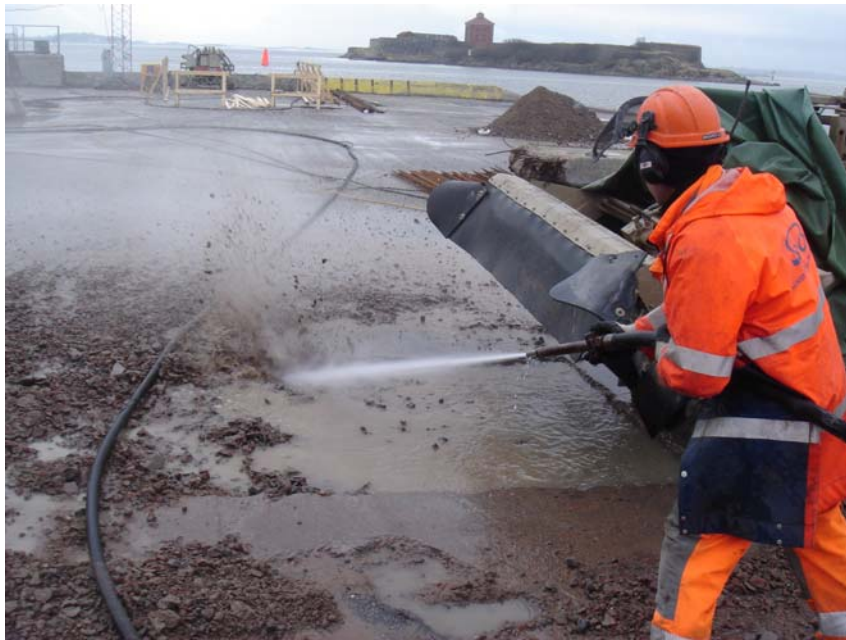
*Figure 9.13 Cleaning the Surface 1 taking away the rubble.*

After the waterblasting the surface was cleaned and dried with a water pump.

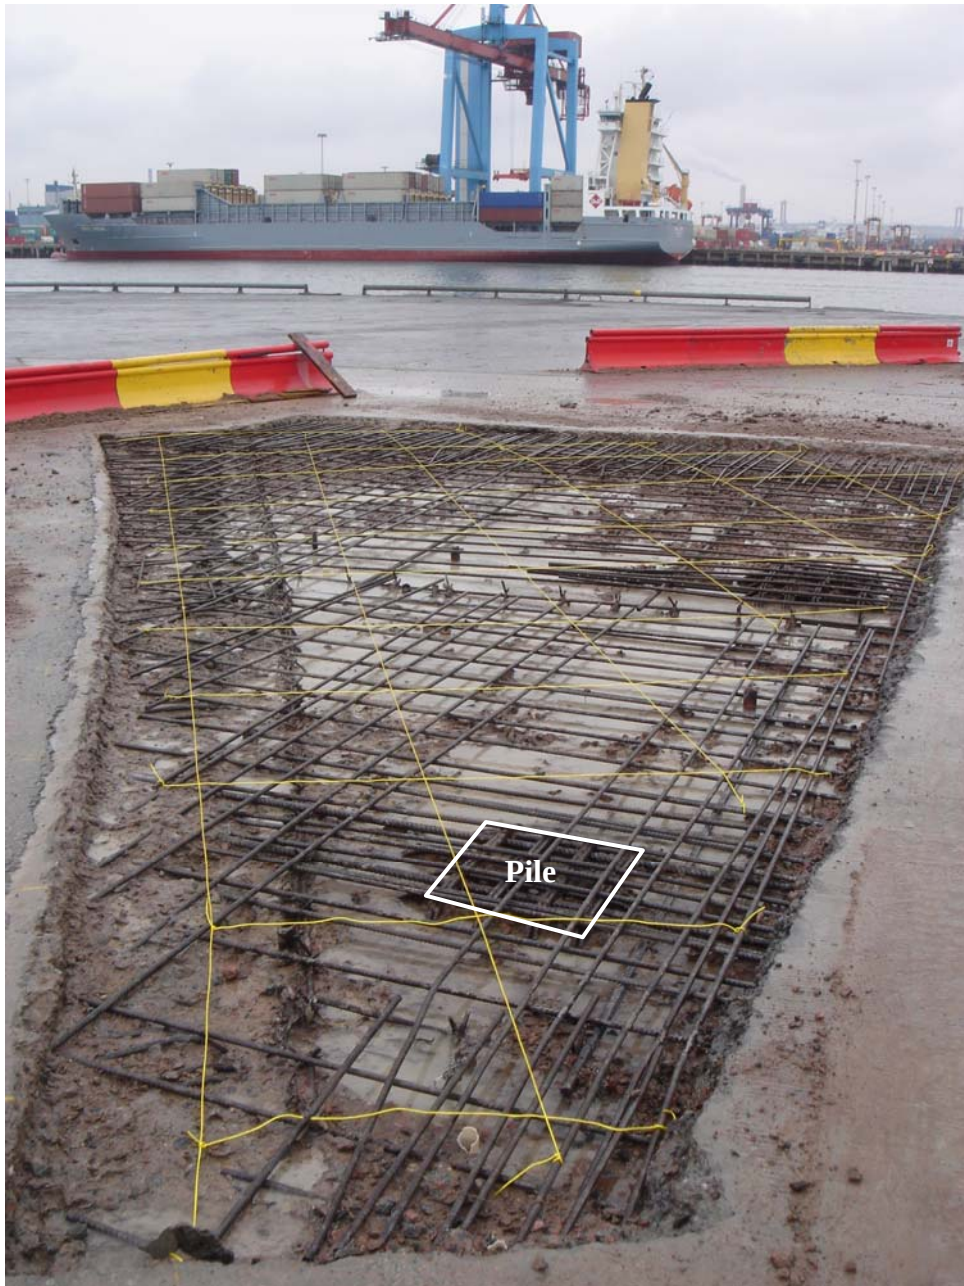
*Figure 9.16 Grid at the Surface 1 waterblasted with one pile marked.*

After the Surface 1 was finally destroyed arriving until the underneath part of the bars, the grid was drawn another time (now using a yellow cord).

- The variations in the steel density produced by the reinforcement of the piles (which can be seen at the Figure 9.16) modify the corrosion rate leading to wrong corrosion indexes. These variations are very difficult to calculate because the bars are in different depths and it's hard to know until where the polarization current is arriving. Increasing the steel density the corrosion rate decreases and vice versa.
- The waterblasting process use pressures around 800 bars, besides taking away the concrete also moves some bars which came loose. For this reason sometimes it's difficult to evaluate the accuracy.

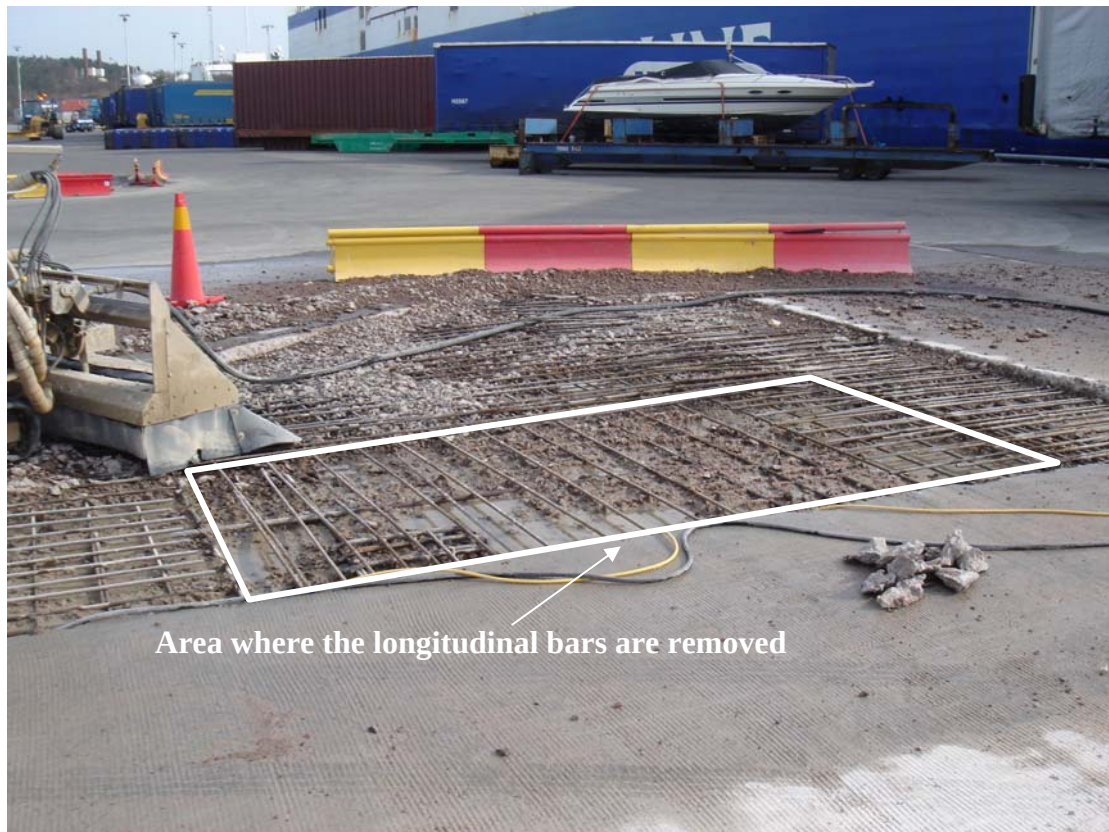
*Figure 9.19 Surface 1 with some bars removed because the waterblasting process.*

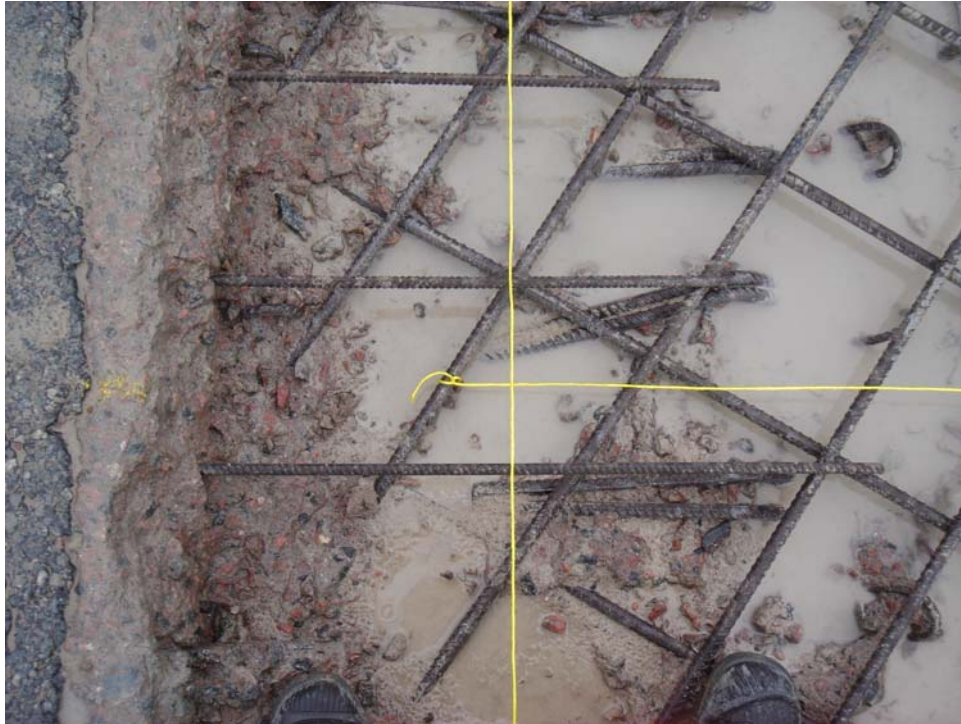
*Figure 9.20 Test point L1M7 of the beam. No corrosion damages detected.*

- The direction of the reinforcement is not the same than the beam, in fact, it's in the same direction that in the main surface. This fact not seems to affect in a certain extent to the final results.
- The measurement point L1M7 of the beam was classified as a "Moderate" (Figure 8.9). Observing the bars under this point no damage can be detected. This error may be due to the decreasing steel density which is affected by the polarization current since there's no any bar is just under this point, Figure 9.20.

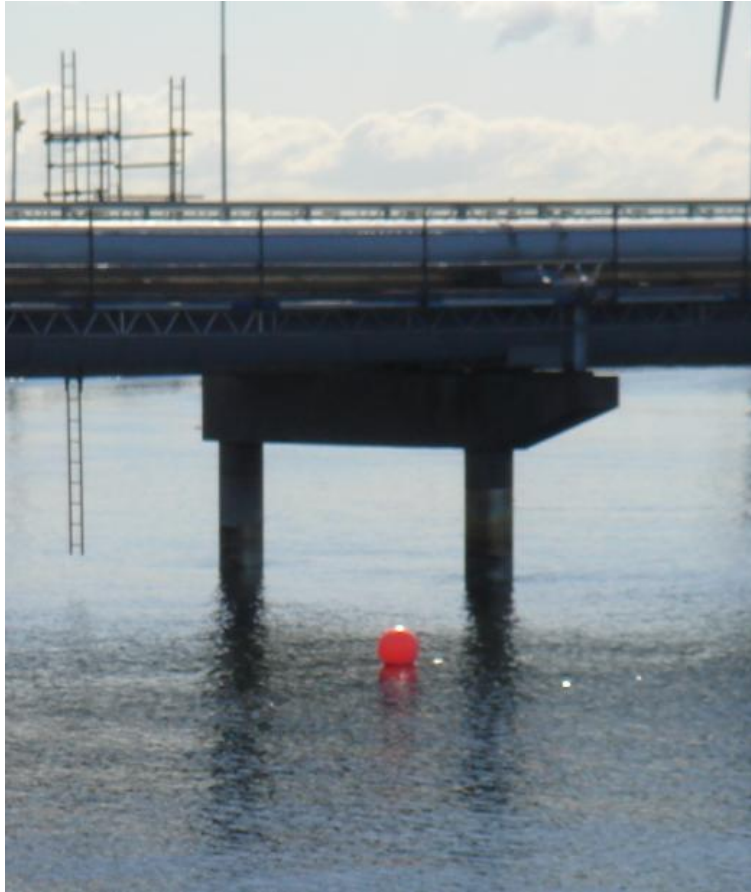
*Figure 9.23 Position of the Surface 2 in the bridge.*

This Surface 2, for its testing, was divided in three different sides. The side A was the frontal view of the beam which was oriented to the land side. The side B was the opposite of the A, it means, oriented to the sea side. Finally, the side C was the upper surface of the beam. The bottom part of the beam was not possible to be tested because of the position of the scaffolding.

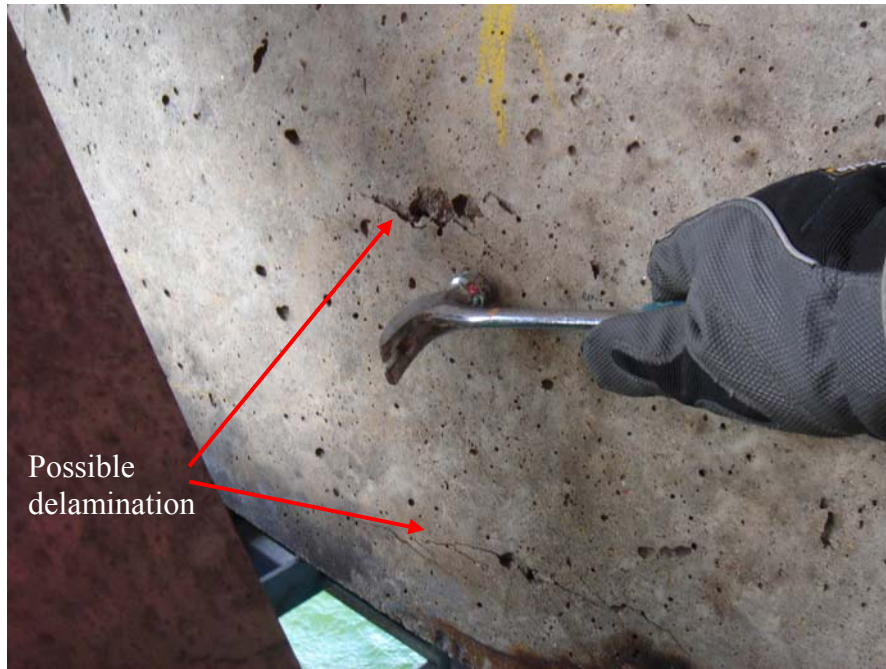
*Figure 9.28 Hitting with the hammer to find the possible delamination.*

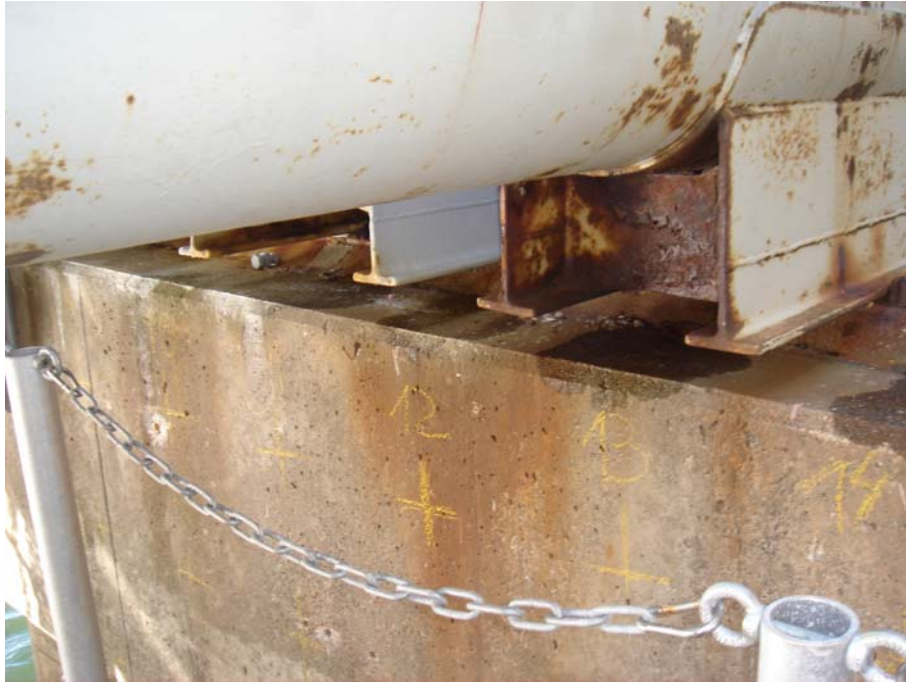
*Figure 9.29 Testing the side C. The supports of the pipelines prevent some tests.*

After the two vertical sides were tested, it was the turn of the horizontal side C. A lot of test points were not possible to be tested because all the supports of the pipelines, the piles and the slab of the service way.

The grid used was the same of the other sides longitudinally and three lines in the transversal direction matching up with the longitudinal bars which are represented at the Figure 9.31 and 9.32.

- The steel structures which are around the surface tested interfere in the measurements of the cover meter (see Figure 9.29). For this reason the cover depth of the test points at the side C were calculated using the construction drawings (Figure 9.31).

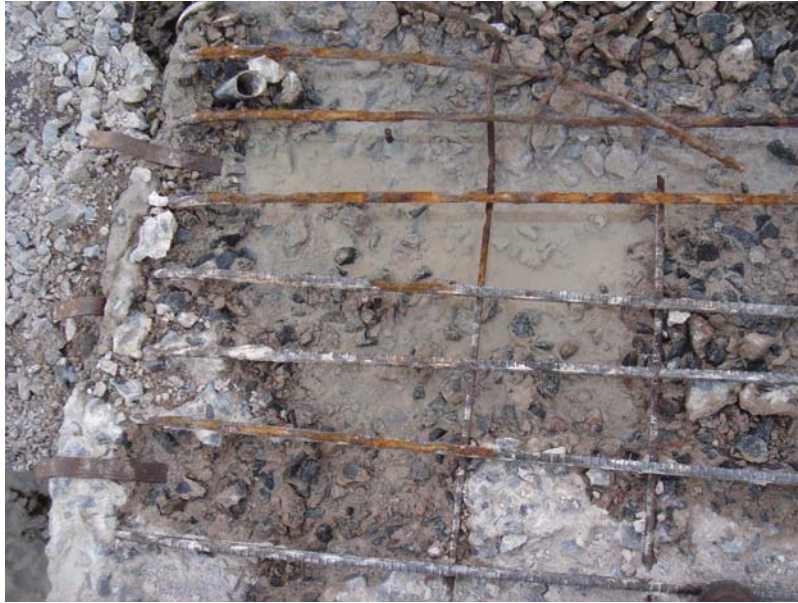
*Figure 9.43 Detail of the damages at the side A test points L6M13 and L6M14.*

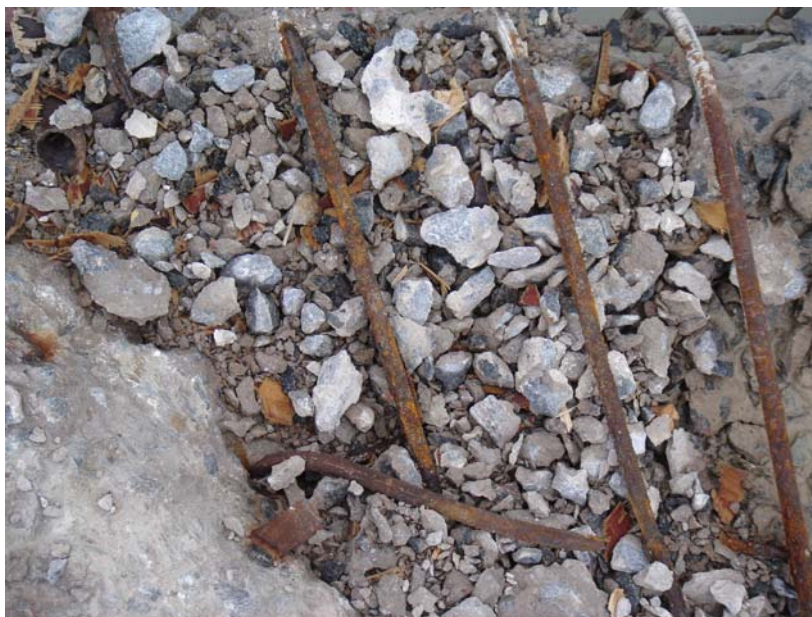
*Figure 9.44 Detail of the damages at the side A test points L7M1 and L8M1.*
