Analysis of Parameters Affecting Permanent Deformation in Road Pavement

Based on Measurement Data from LTPP-Roads

Master of Science Thesis in Geo and Water Engineering

CHALMERS UNIVERSITY OF TECHNOLOGY

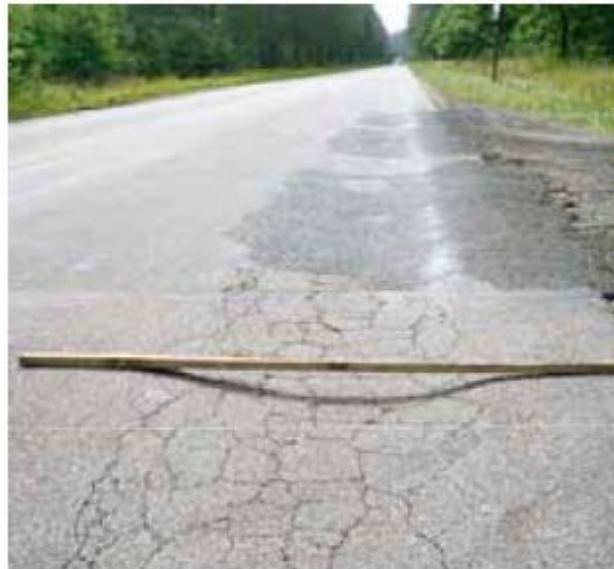
Figure 2-9 Rutting in the unbound layer (Kolisoja & Dawson 2006)

Rutting is an undesired phenomenon in a pavement for several reasons. For the road users, it gives an increase of fuel consumption due to increased friction, increased risk of hydroplaning in wet weather conditions and increased risk of skidding when the water freezes to ice. The rut depth depends on several factors and it can vary along a road, which may cause discomfort to the road users due to unevenness, Kolisoja & Dawson (2006). Figure 2-9 illustrates rutting on a road.

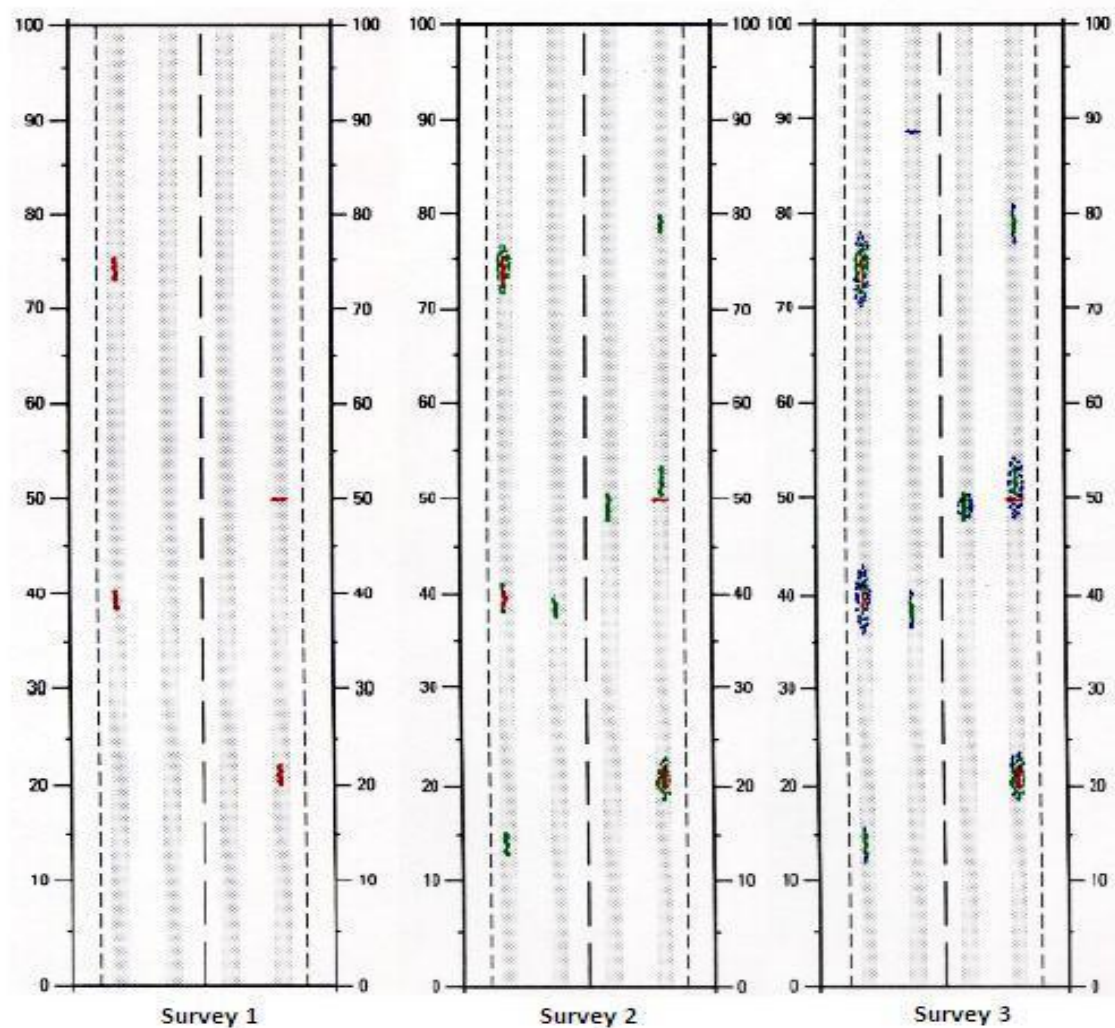
Crack index, $Si = 7$

Figure 2-22 shows an example of the size and development of the crack index.
