## Sustainable and affordable water and wastewater solutions for a low-income housing cooperative in Cochabamba, Bolivia

Master of Science Thesis in the Master's Programme Industrial Ecology

Master's Thesis 2010:139

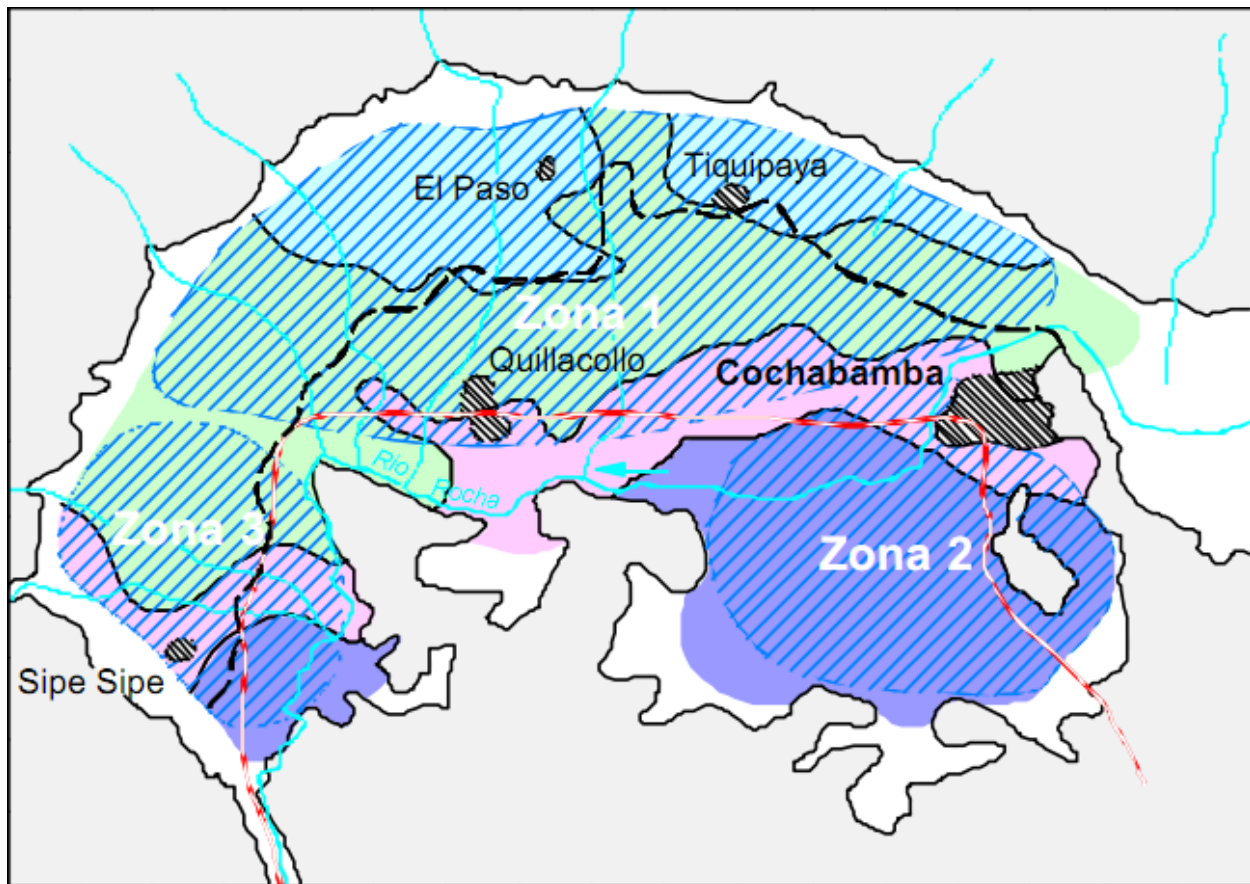
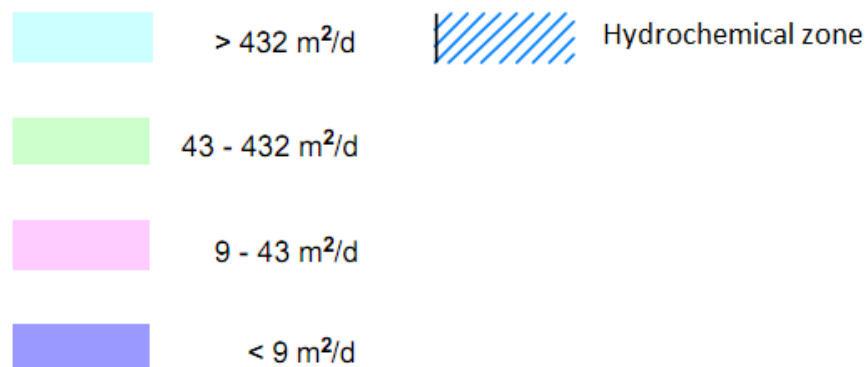
Distribution of transmissivities

**Figure 1.** Transmissivities and hydrochemical zones in the Central Valley of Cochabamba (taken from Neumann-Redlin, 2000, and modified).

The transmissivities of the aquifers vary from more than  $400 \text{ m}^2 \text{ day}^{-1}$  in the northern parts of the valley to less than  $9 \text{ m}^2 \text{ day}^{-1}$  in the south. The recharge of the aquifers mainly takes place in the north of the valley through infiltration of surface water from the mountains. In the area where the cooperative's lot is located the transmissivity is between 9 and  $43 \text{ m}^2 \text{ day}^{-1}$ . Three deep wells (up to 550 meters in depth) have shown that the conductivity diminishes with increased depth due to layers of mud that restrain recharge. Because of these layers, the production capacities of deep wells only slightly exceed those of wells that exploit more shallow aquifers. Also, water quality diminishes at large depths (Neumann-Redlin, 2000).

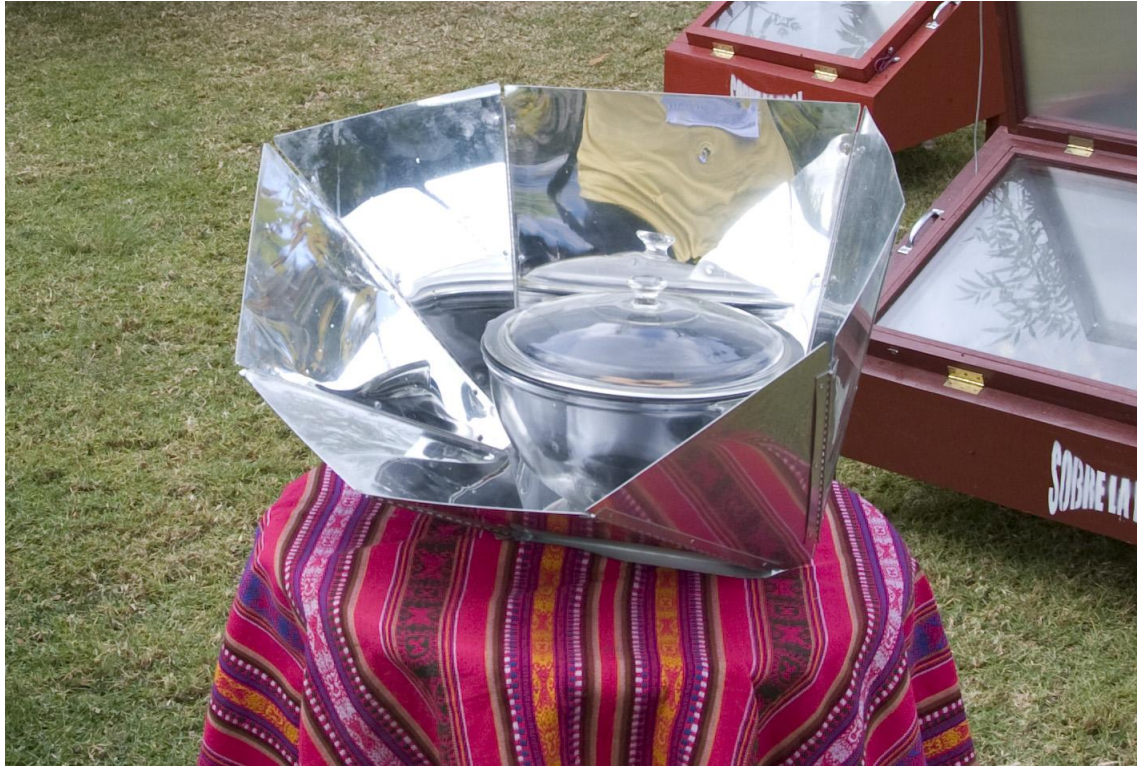
**Figure 2.** A solar cooker, shown at an exposition in Cochabamba.

Solar cookers use reflecting surfaces to concentrate the solar radiation to a vessel. Pathogens are killed at about 65°C. Simple solar cookers can pasteurize about one liter of water per hour. The Cochabamba climate offers lots of sunny days, and the altitude makes the sun radiation stronger than at sea level, facts which further increase the benefits of using solar cookers in the region.

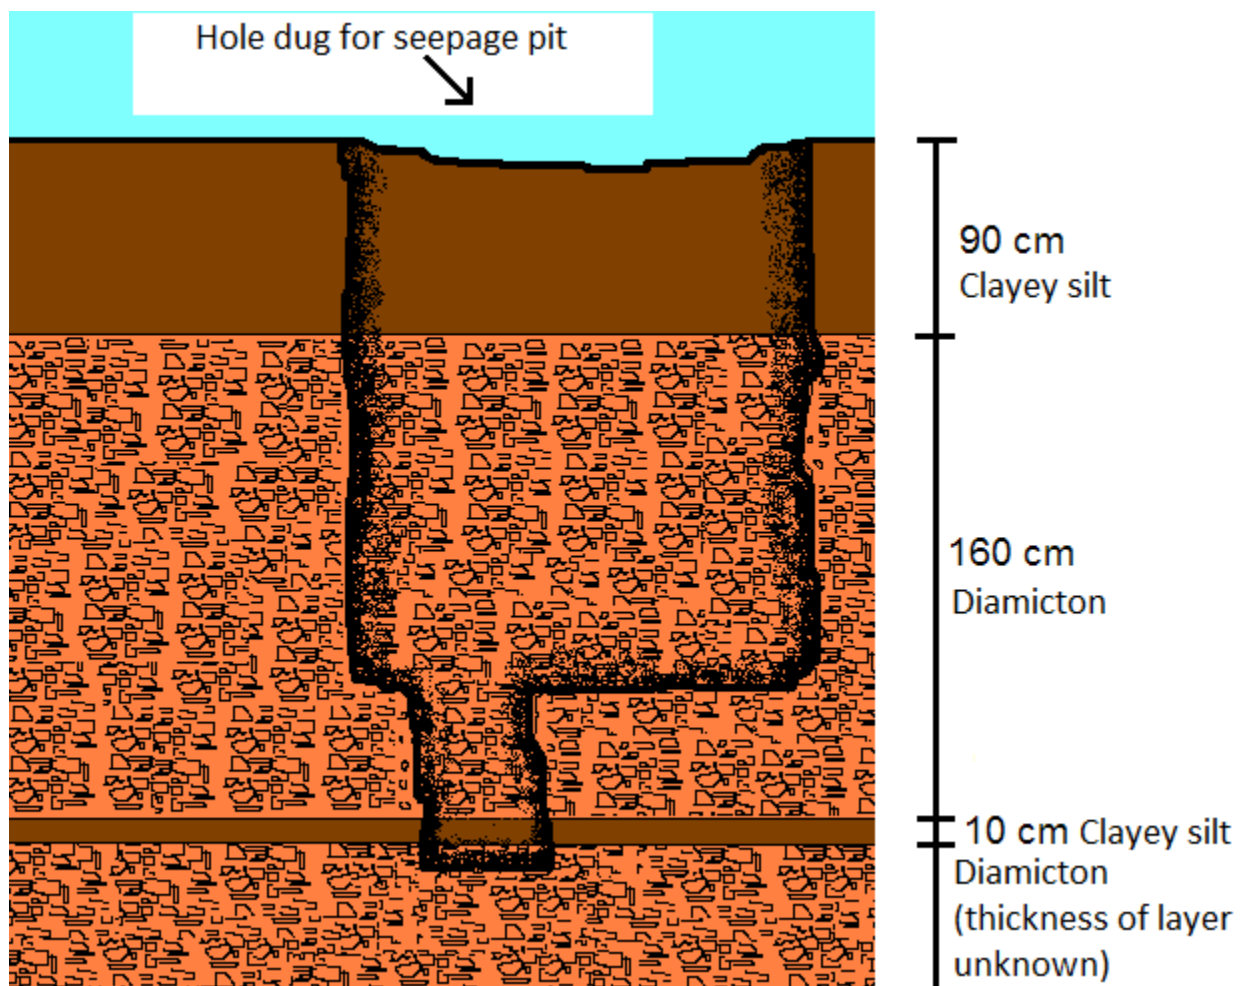
**Figure 3.** Thickness of the soil layers observed in the hole dug for the infiltration well for the centro comunitario, and in a smaller hole at its bottom excavated for a percolation test.

For the centro comunitario, the Procasha technical staff has designed a septic system consisting of a septic tank followed by a seepage pit with a depth of about 2 m and a diameter of about 1.5 m. It will be filled with filtrating material (rock material of different coarseness). An excavation has been dug, in which the soil profile shown in figure 3 can be observed. Diamicton is a poorly sorted sediment, which means that it contains a wide range of granular sizes. In this case, the diamicton contains rocks, gravels, sands, silt and perhaps a little clay. It is considerably more permeable than the clayey silt present at the sight.

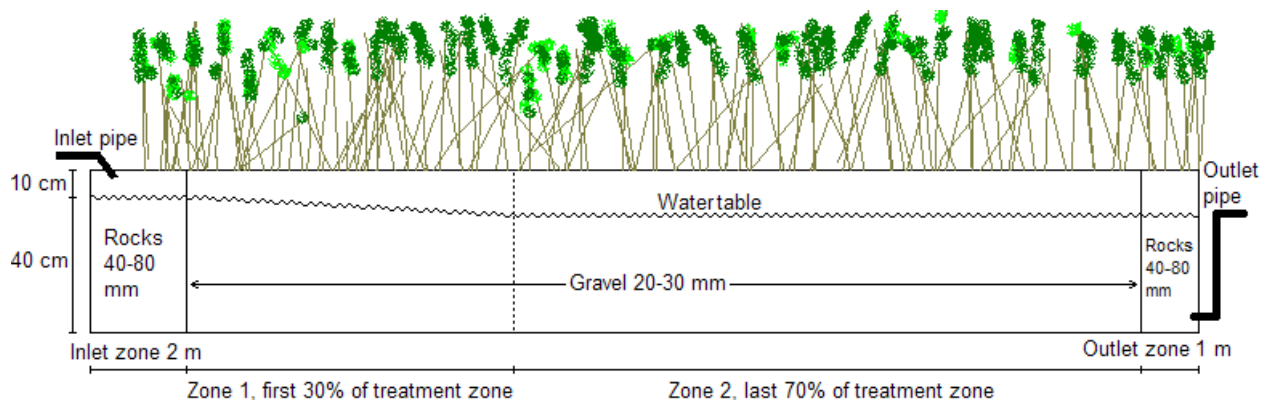
**Figure 4.** Schematic drawing of a constructed wetland as seen from the side.

The media at the first two meters, as well as at the last one meter, of the wetland should be constituted by rocks with a size of 40 to 80 mm, to facilitate distribution and collect the flow, as well as to prevent clogging (EPA, 1999).

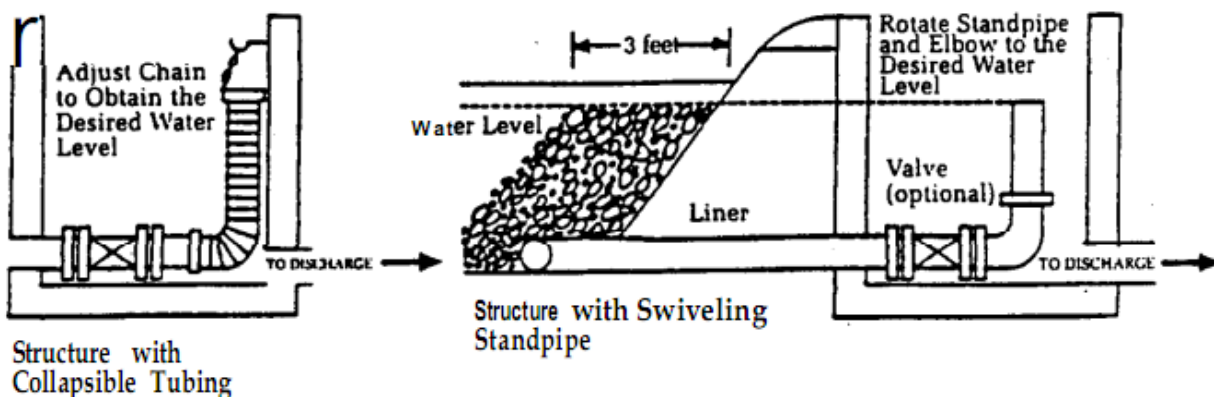
**Figure 5.** Examples of mechanisms for water level control at the outlet. Drawing taken from Davis (1994).

In order to make it possible to control the water level and to drain the wetland, a mechanism at the outlet is usually installed. Figure 5 shows two simple but well-functioning solutions.

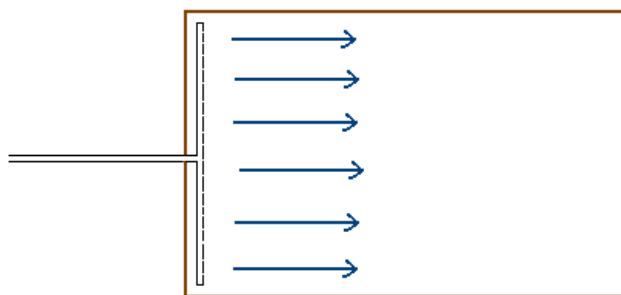
**Figure 6.** A perforated pipe distributes the incoming water evenly over the width of the wetland, as seen from above.

In order to evenly distribute the water over the width of the wetland, it is recommended to use a perforated pipe that lets the water out across the width of the wetland, see figure 6.

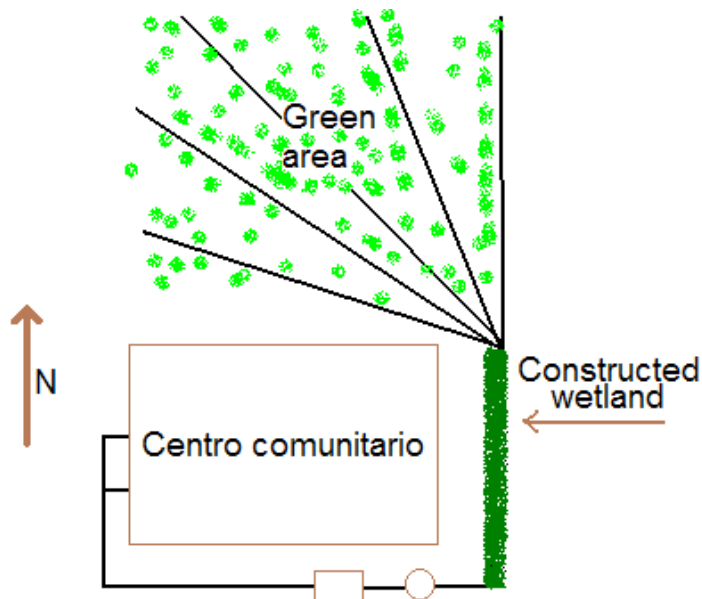
**Figure 7.** After passing through the septic tank and the wetland, the treated wastewater could be led by underground perforated pipes to irrigate the plants of the cooperative's green area. Pipes are shown as black lines in the illustration.

Procasha has a positive attitude towards the idea of reusing the treated wastewater for irrigation of the cooperative's green area. The Procasha architect María Esther Soto has an idea for a system of perforated pipes shallowly buried in the ground, through which the treated water flows and infiltrates the ground at plant root level. To avoid the need for another pump, the outlet of the wetland would have to be located high enough for the water to flow through the system by gravity. This could be obtained by using the soil that is removed when excavating the wetland pit for constructing walls that allow the wetland surface to be located above the surrounding ground level, as long as the soil is compacted enough to keep the water within the wetland. The lot has a slight inclination to the east, which aggravates the project since the wetland is located to the southeast of the green area (see figure 7), and elevating the wetland would partly or fully neutralize the effects of the inclination.

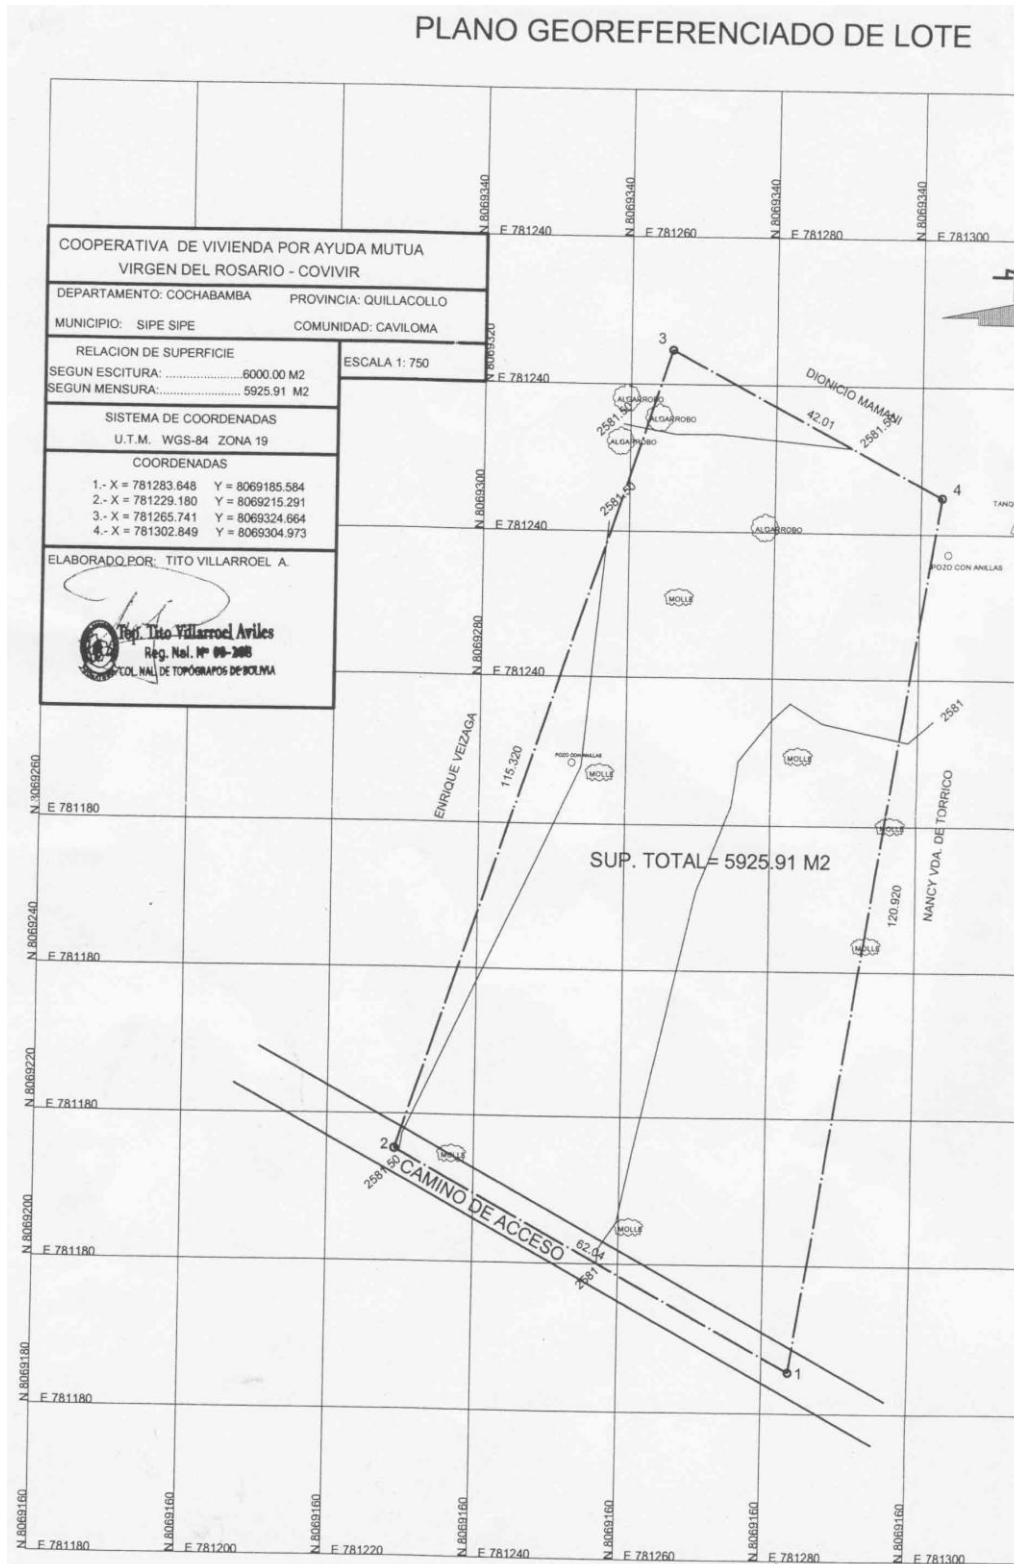
## Appendix III

Plan of the lot of COVIVIR with contour lines (i.e. lines showing the elevation above sea level)

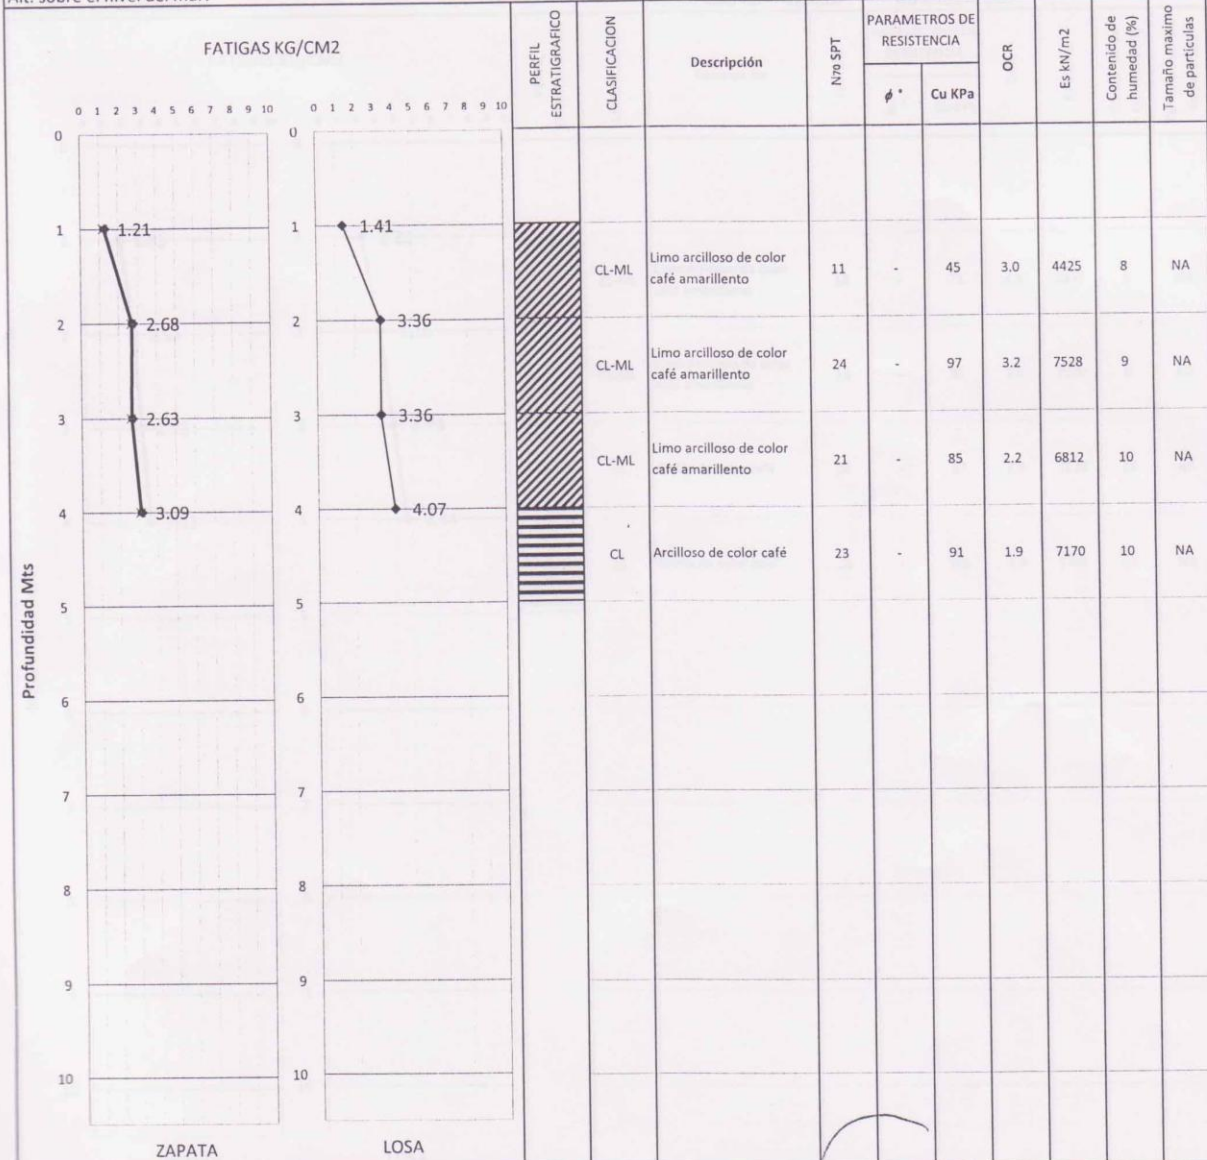
● B = 1 Mt.    — B = 2 Mts.  
 ● B = 3 Mts.    — B = 4 Mts.  
 — B = 5 Mts.

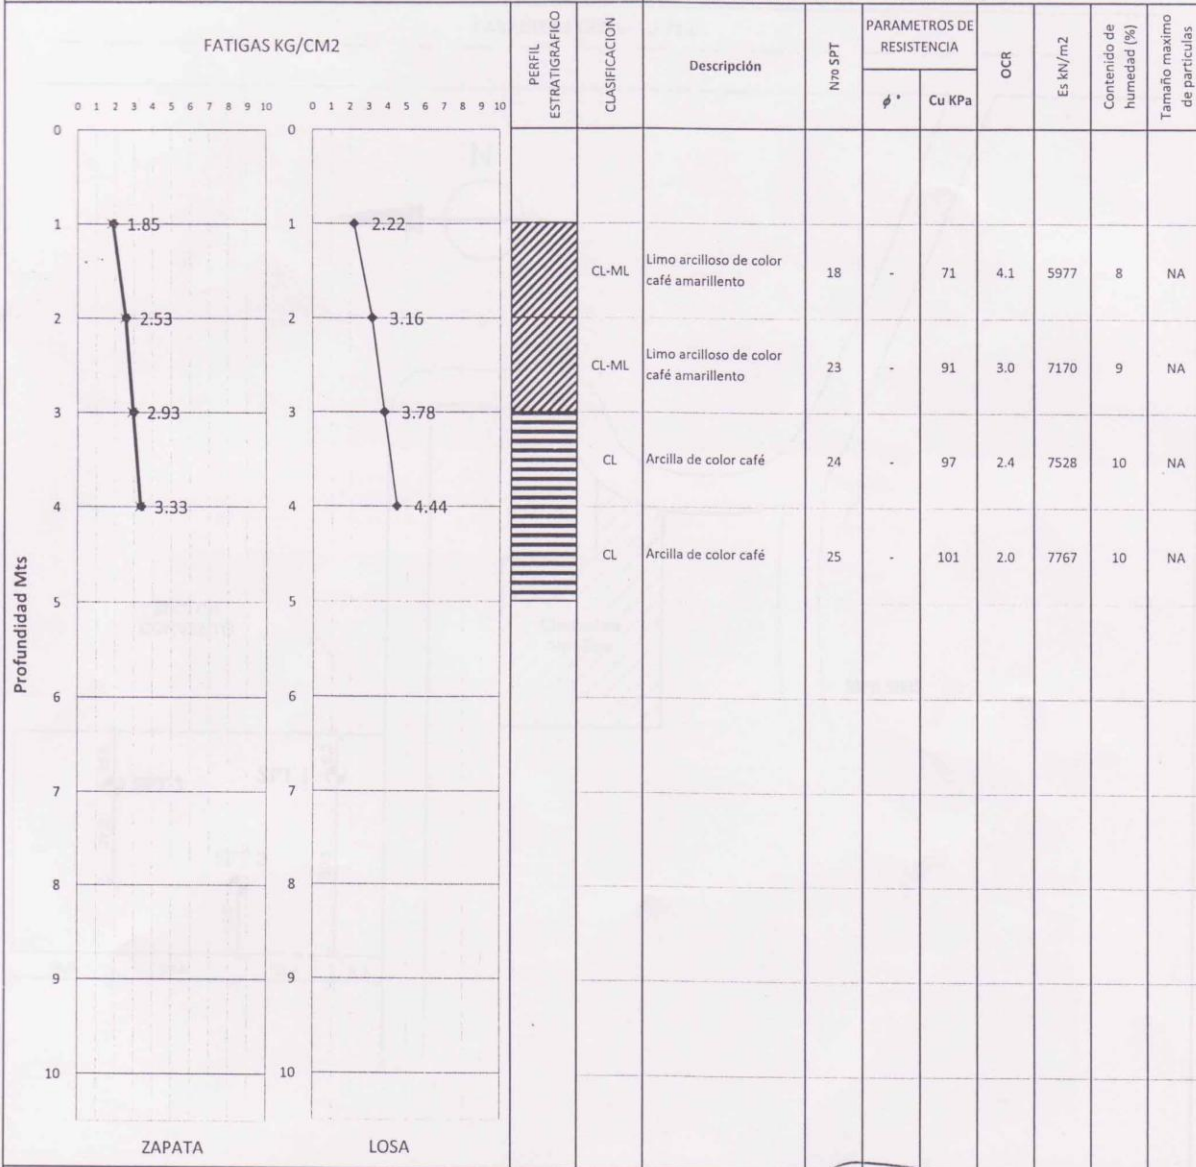
—●— B = 1 Mt. —■— B = 2 Mts.  
—●— B = 3 Mts. —■— B = 4 Mts.  
—●— B = 5 Mts.

Donde B es el ancho de zapata

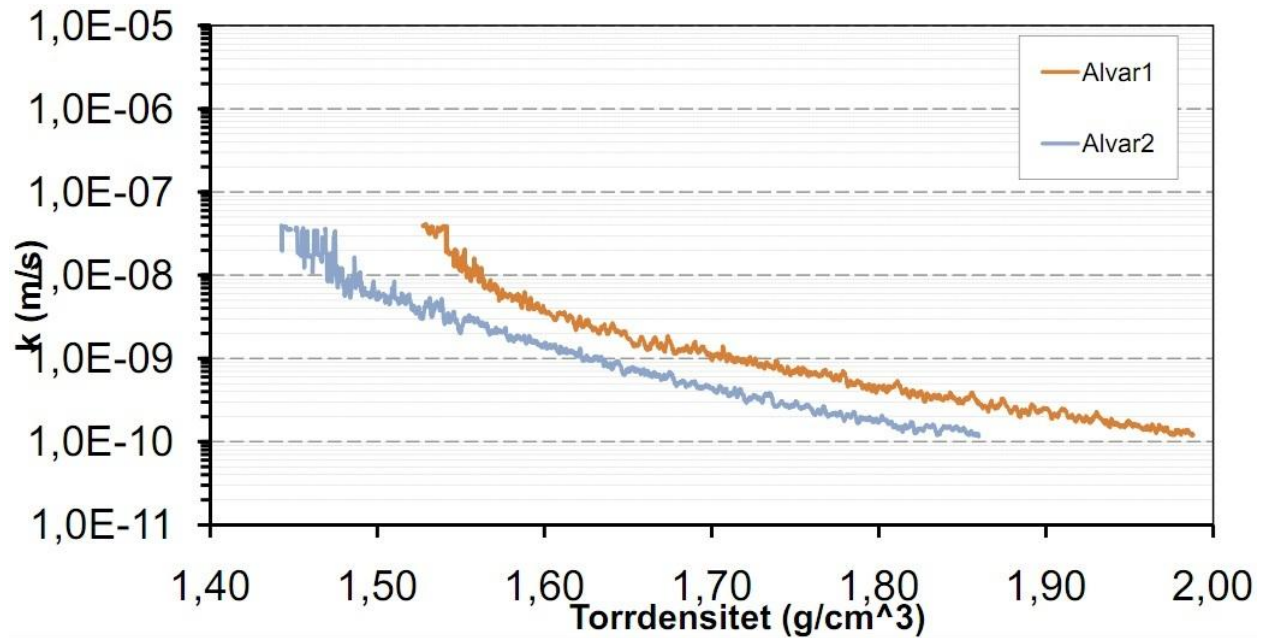
## Appendix VI

Test results from Chalmers University of Technology laboratory of geotechnology, for hydraulic conductivity. Two different samples, Alvar1 and Alvar2, were tested under different pressures (the X-axis). The hydraulic conductivity is shown at the Y-axis.
