FE-analysis of Vårby Bridge

Investigation of fatigue damage in a composite bridge

Master of Science Thesis in the Master's Programme Structural Engineering and Building Performance Design

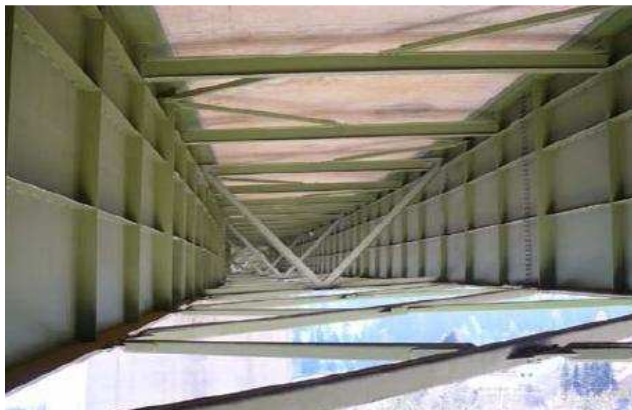
Figure 2.1: Studied bridge by Greiner & Taras, 2009

One of the reports is from Austria (Greiner & Taras, 2009) and investigates a continuous composite bridge, Figure 2.1, which suffers from fatigue cracks. The bridge is 560 m long with spans varying between 70-84 m. In the report a comparison by numerical analysis was made with a second bridge from Austria with structural conditions that were similar to the main object. Also retrofitting methods are tested and evaluated.

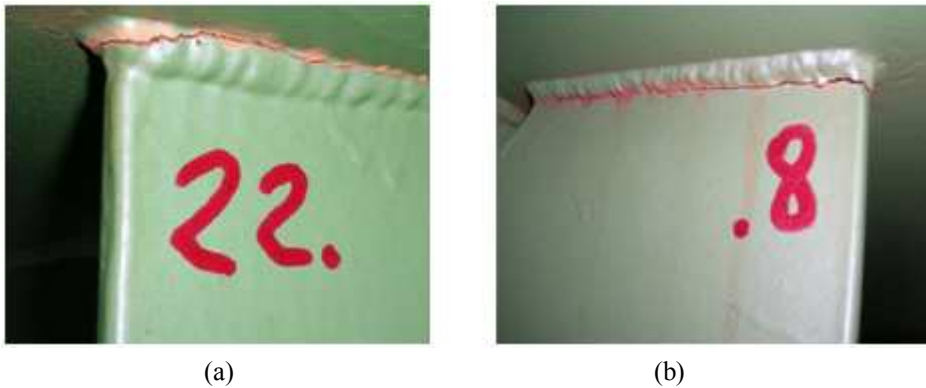
Figure 2.2: (a) root crack; (b) toe crack, Greiner & Taras (2009)

The damages found in the Austrian bridge are both root and toe cracks in the welded joint between vertical stiffener and the upper flange of the main girders, see Figure

2.2. Cracks are found in about 70 % of all these joints. The main causes for the fatigue cracks are change in the bridge construction due to more traffic and that fatigue was not considered in code regulations at the time of design for the bridge.

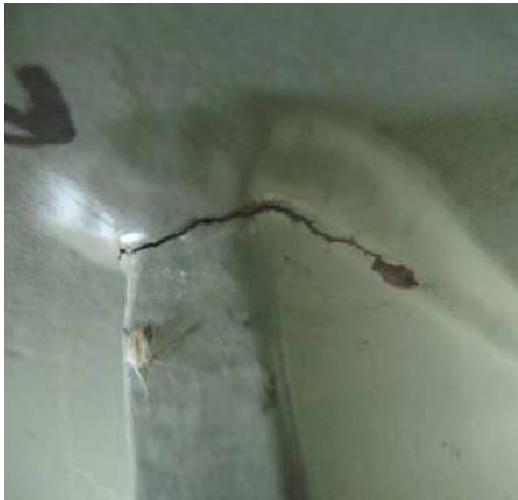
Figure 3.7: Toe crack at a vertical web stiffener, James & Kärrfelt, (2009)

During the visual inspection in 2006 cracks were found at several welded connections between the vertical web stiffeners and main girder top flange, see Figure 3.6. The cracks found were weld toe cracks, see Figure 3.7, caused by fatigue.

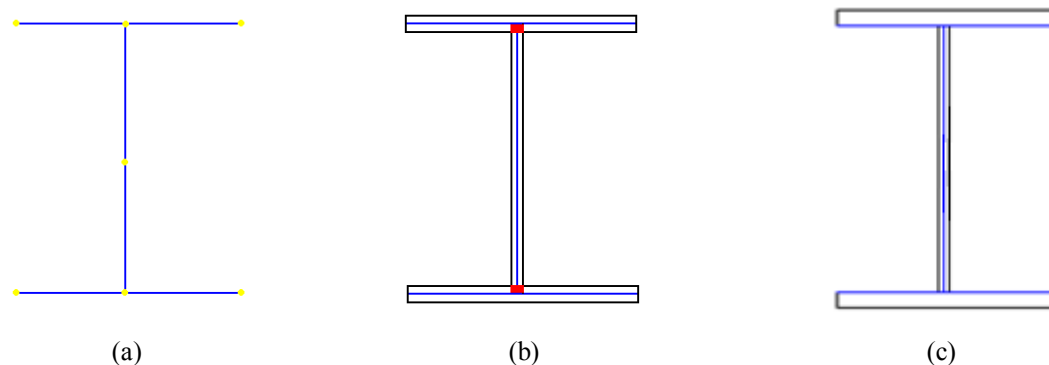
Figure 4.2: Cross-section of an I-girder with; a) infinite thin shell elements, b) elements assigned a thickness, the red marks show the decreased lever arm of the flanges leading to reduced stiffness for the cross-section, c) flanges attached by using offset giving the correct stiffness

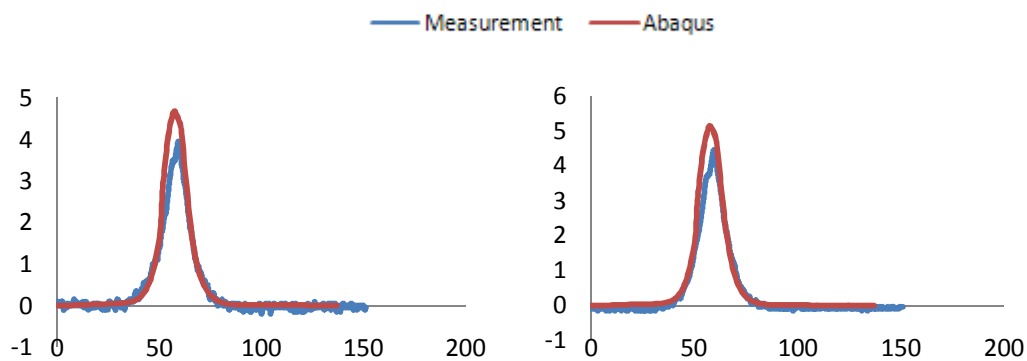
Figure 6.1: Influence lines for channel 9 and 10, mid lane

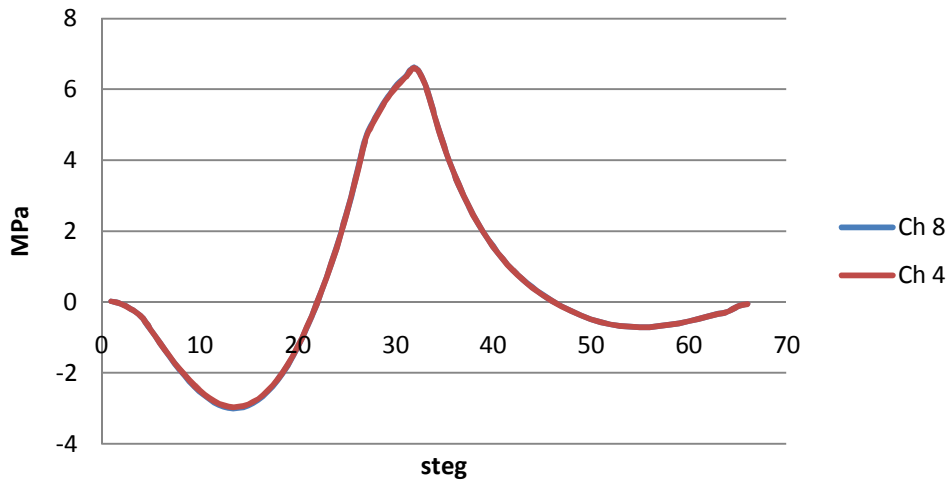
Figure 8.32: Load in mid span, symmetry check of the bridge model
