## Fatigue properties of austenitic Mn-steel in explosion depth hardened condition

Material used in highly stressed railway components

**Diploma Work in the Master Programme**

Master Thesis 33/2010

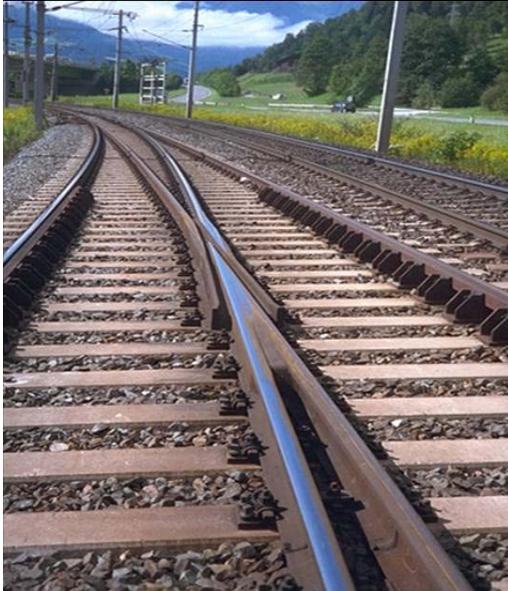
Figure 1. Turnout, most frequent in train operation.  
Courtesy by VAE.

When a train or tram wants to change track, turnouts and crossings are used. Another reason for crossings is when two lines cross but such crossings are more frequent used in slower tram traffic. See Figure 1 and Figure 2.

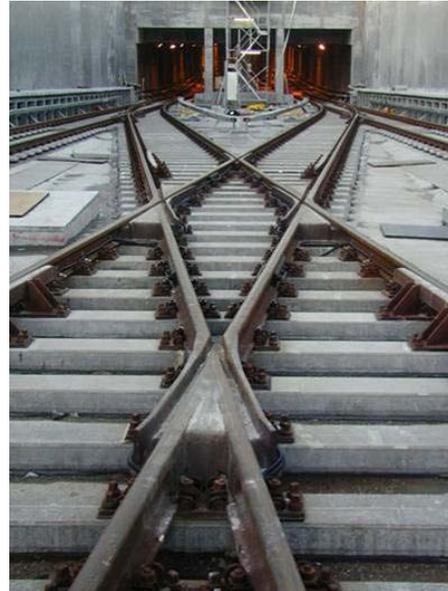
Figure 2. Crossings, more frequent in tram operation.  
Courtesy by VAE.

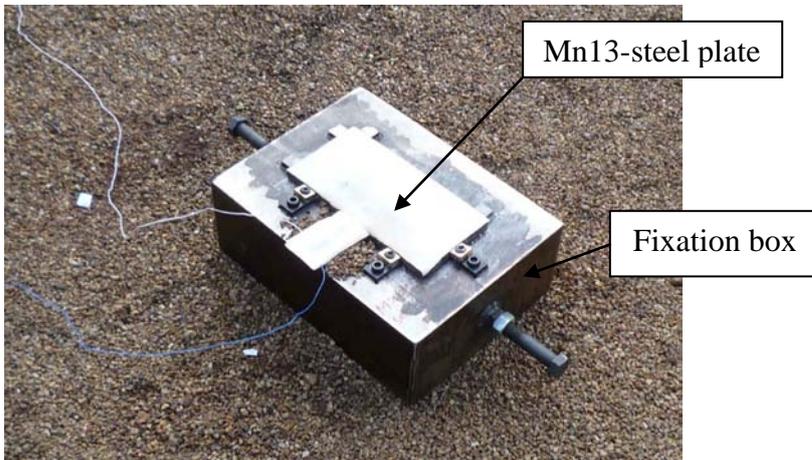
Figure 3. The plate of Mn-steel, hardened by explosion depth hardening. Courtesy by VAE.

The material investigated in this thesis is hardened by depth explosion. The plate of Mn-steel is covered with a layer of explosives. The plate is mounted on a fixation box to be fastened during the detonation. On ignition there will be a detonation, causing shock-waves to pass through the plate. This will give the material a larger amount of dislocation density and thus make the material harder. See Figure 3. (Ahlström 2009)

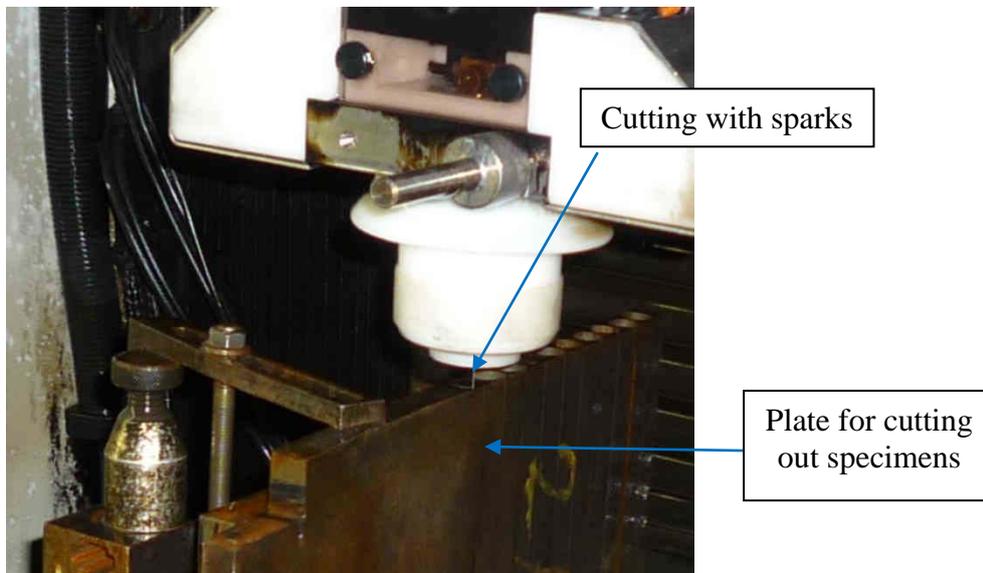
Figure 4. Electro discharge machining. Courtesy by VAE.

Electro discharge machining - EDM, is a method where electro discharges (equal to sparks) is used and can be called spark or wire erosion. The specimens used in this master thesis were cut out with sparks. See Figure 4.

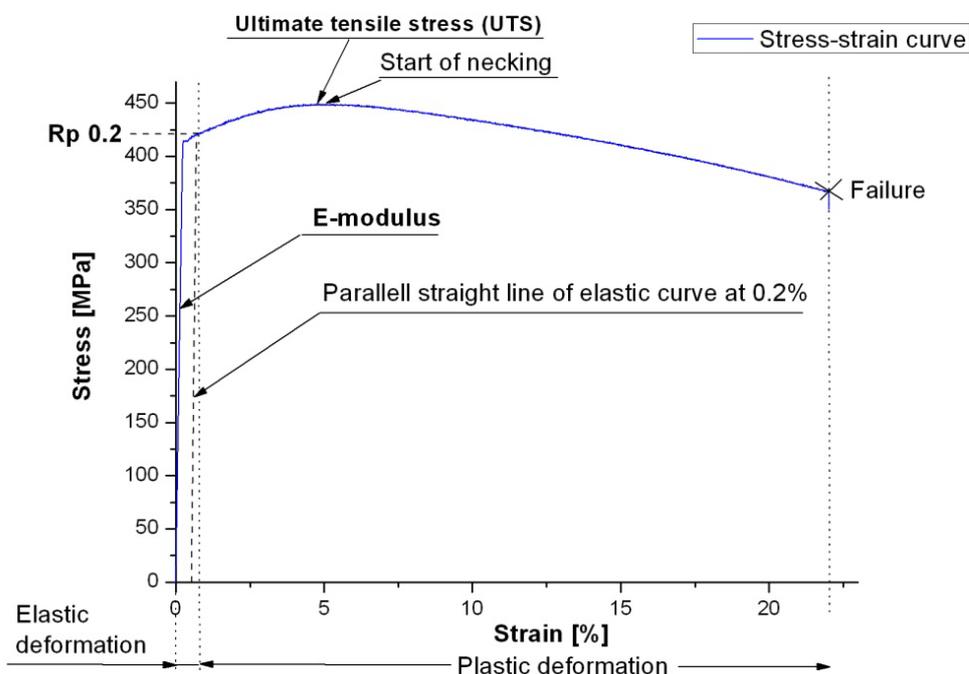
Figure 5. Schematic Stress/strain-curve

Tensile testing is a method, where uniaxial load is used and the material will be stressed under a certain load in tension. The continuously increasing load makes the material go through elastic, plastic and failure part. The material will become permanently plastically extended during the test. The strain,  $\varepsilon$  [%] and stress,  $\sigma$  [MPa] can be used to characterise the properties of a material and is used in a stress-strain curve. See Figure 5. (Dieter, 2003) (Callister, 1997)

Fracture strain is when the material failure and break. Units used for fracture strain is [%]. See Figure 5.

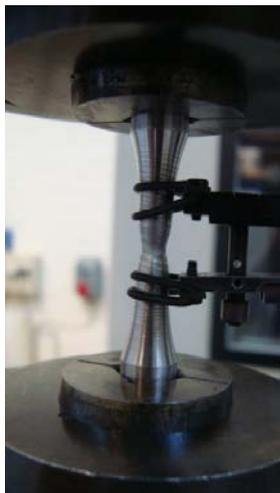
Figure 6. Necking of a ductile and heterogeneous material

If the material is deformed and quite soft, ductile and heterogeneous, there will be a localised reduced diameter during tensile testing and it is called necking. See Figure 6.

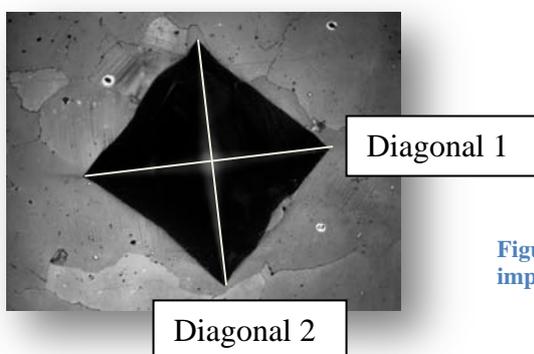
Figure 7. Vickers testing method, measuring of the diagonals of imprint.

The experimental part of Vickers method works like this: A sample is placed in the machine and a pyramidal indenter is pushed with a certain load against the surface of the sample. The two diagonals of the pyramidal area is measured with a ruler on a microscopy screen. See Figure 7.

An average value of the two diagonals is taken and compared with a table to get a hardness number in unit Hardness Vickers, HV.

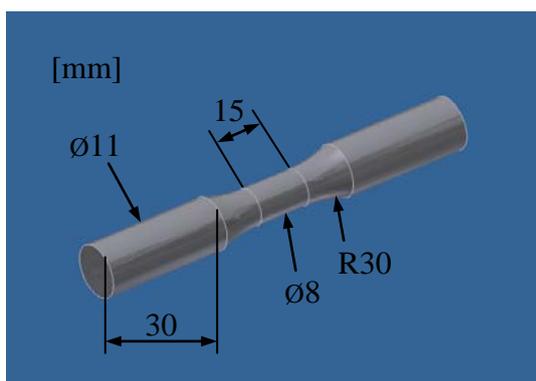
Figure 8. Appearances and dimensions of test samples.

### 4.1 Test specimens for tensile and fatigue testing

In the as cast Mn13 tested previously within the MU16 CHARMEC project, a gauge diameter of 6 mm was used. For this study, the diameter was increased from 6 mm to 8 mm. The reason of the changed diameter was to avoid buckling during testing. The total length was approximately 100 mm.

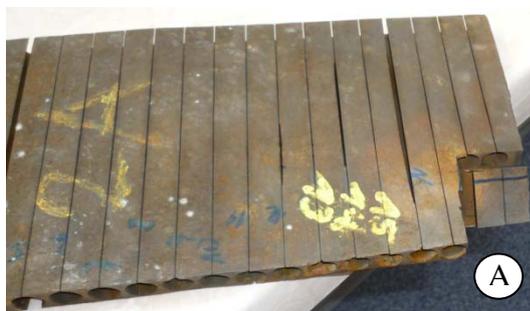
Figure 9A. Samples cut out of plate A/B

The preparation and the machining of the samples were completed by VAE in Austria. The cast block was split into two pieces called plate C/D and A/B respectively. Thereafter each plate was hardened by depth explosion from both sides. Samples were cut out by electro discharge machining (18 samples from plate C/D and 13 samples from A/B). See Figure 9A and 9B.

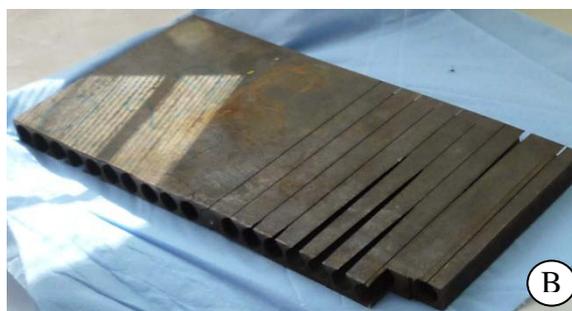
Figure 9B. Sample cut out of plate A/B

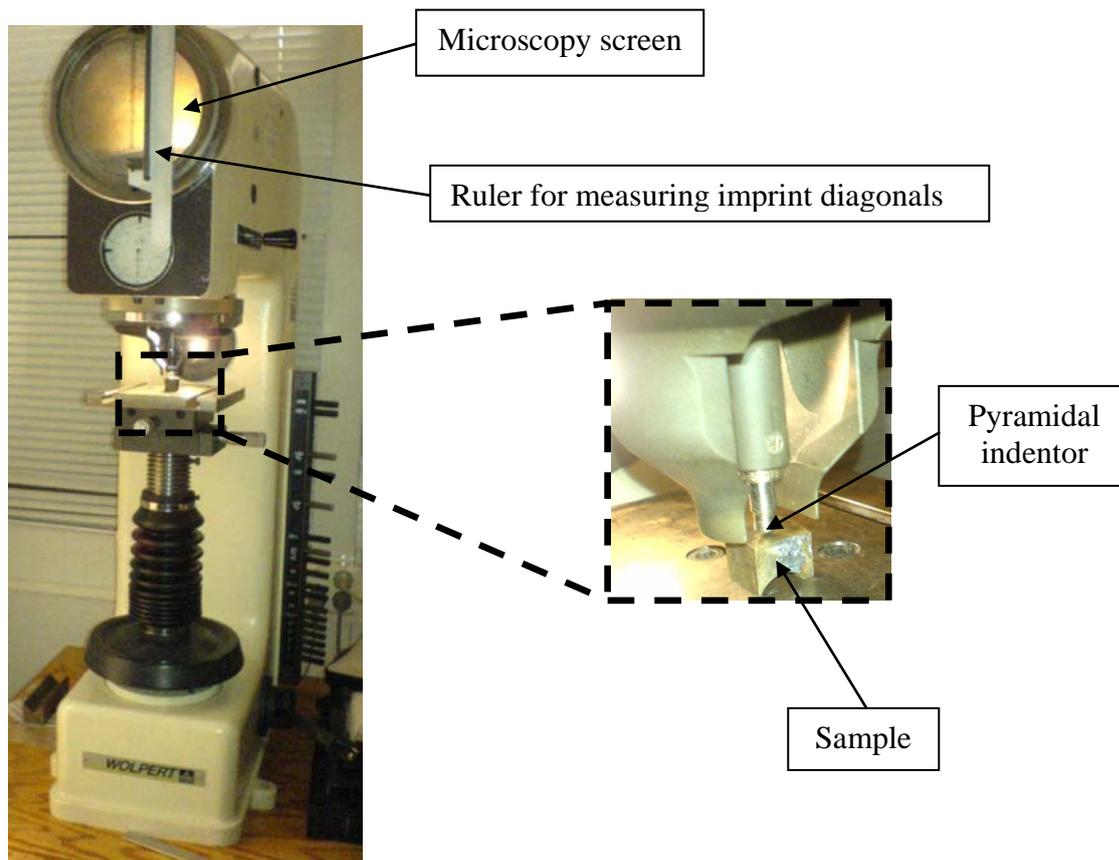
Figure 10. Hardness testing machine, Wolpert probat dia testor 2RC 7021.

The hardness testing was performed in a Wolpert machine, where prepared samples were placed on a table. The pyramidal indenter was pushed against the surface with a certain indentation load (30kg) and was held for about 10-15 sec (called dwell-time). The machine had a microscopy screen, where the imprint could be seen. The diagonals of the imprint were measured at the screen (with a magnitude of 500×) with a ruler. See Figure 10.

Another function of the microscope was to place the indent at a proper position on the sample.

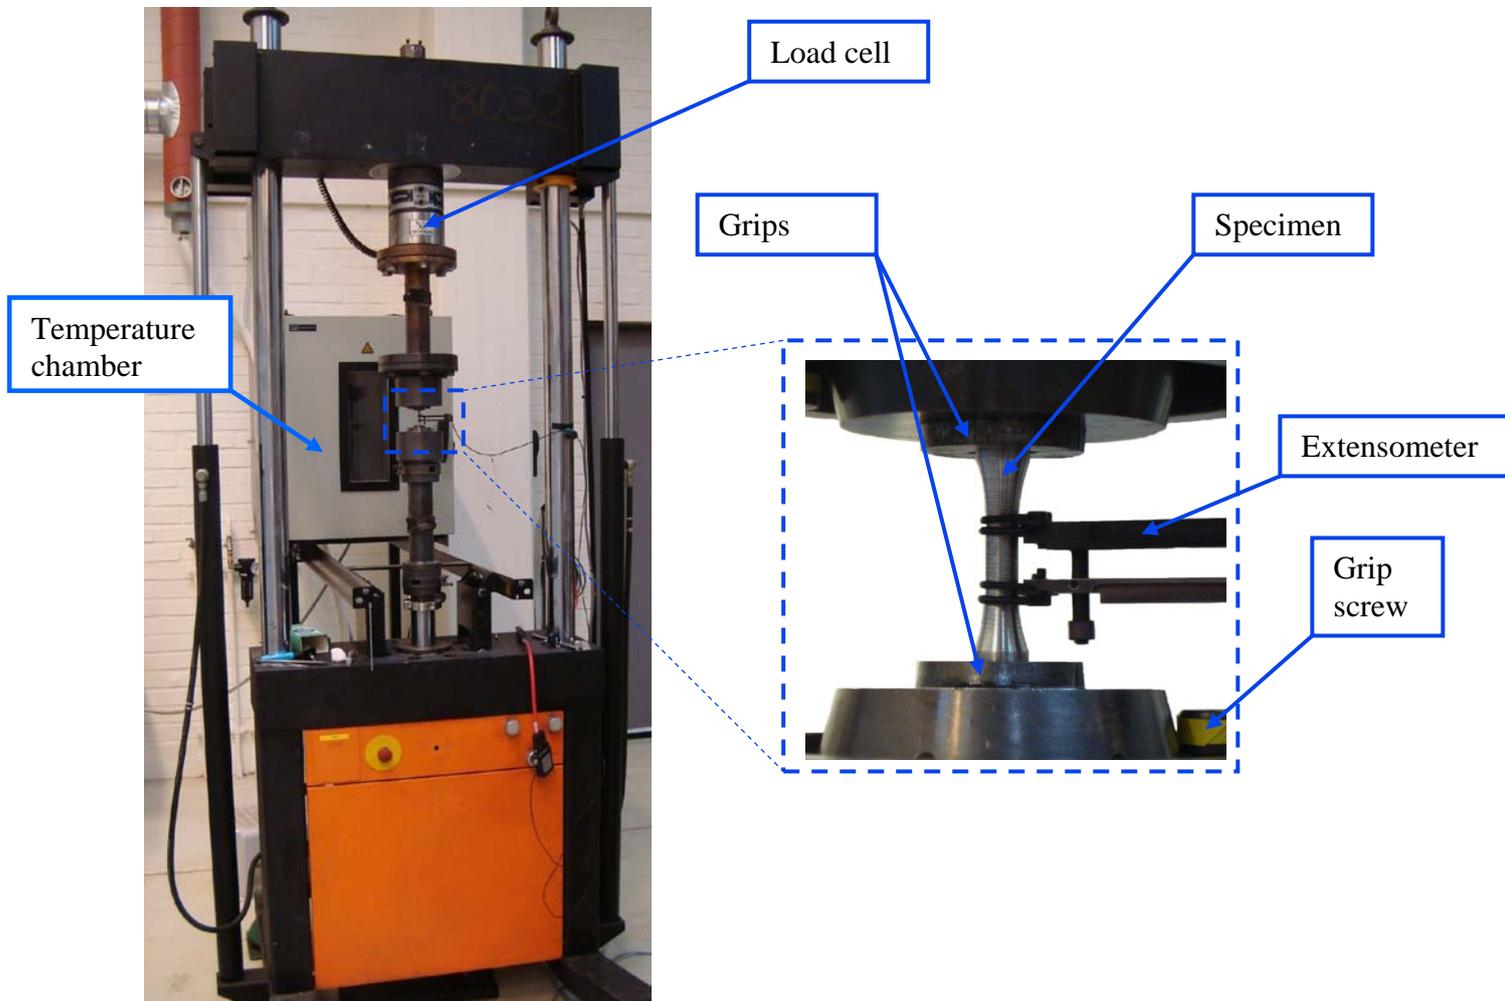
Figure 11. Tensile and fatigue machine, Instron 8032.

The Instron 8032 machine is servo-hydraulic, which was both used for tensile and fatigue testing during the thesis. See Figure 11.

Before using the hydraulic Instron 8032 machine and computer equipment both for tensile and fatigue testing, the pump had to be turned on and the process was checked according to instructions done by Martin Schilke and Johan Ahlström.

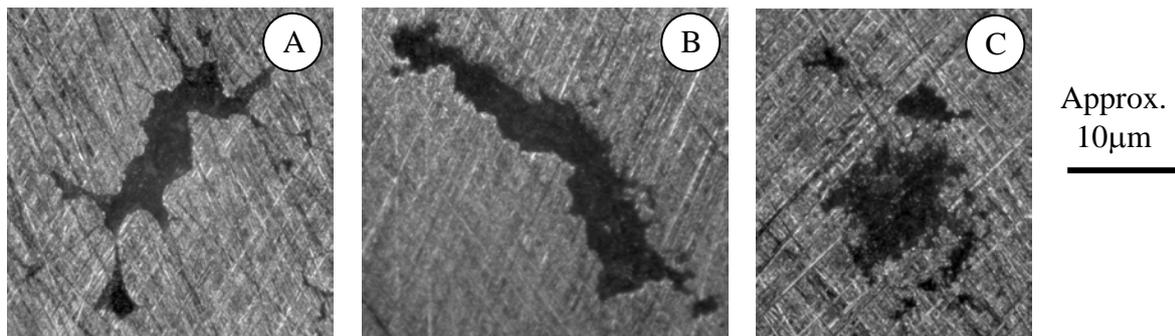
Figure 13. Defects in the material A. Slag B. Slag C. Pore

Both inner and surface defects could be seen during X-ray testing. Examples can be seen at Figure 13A, B and C.

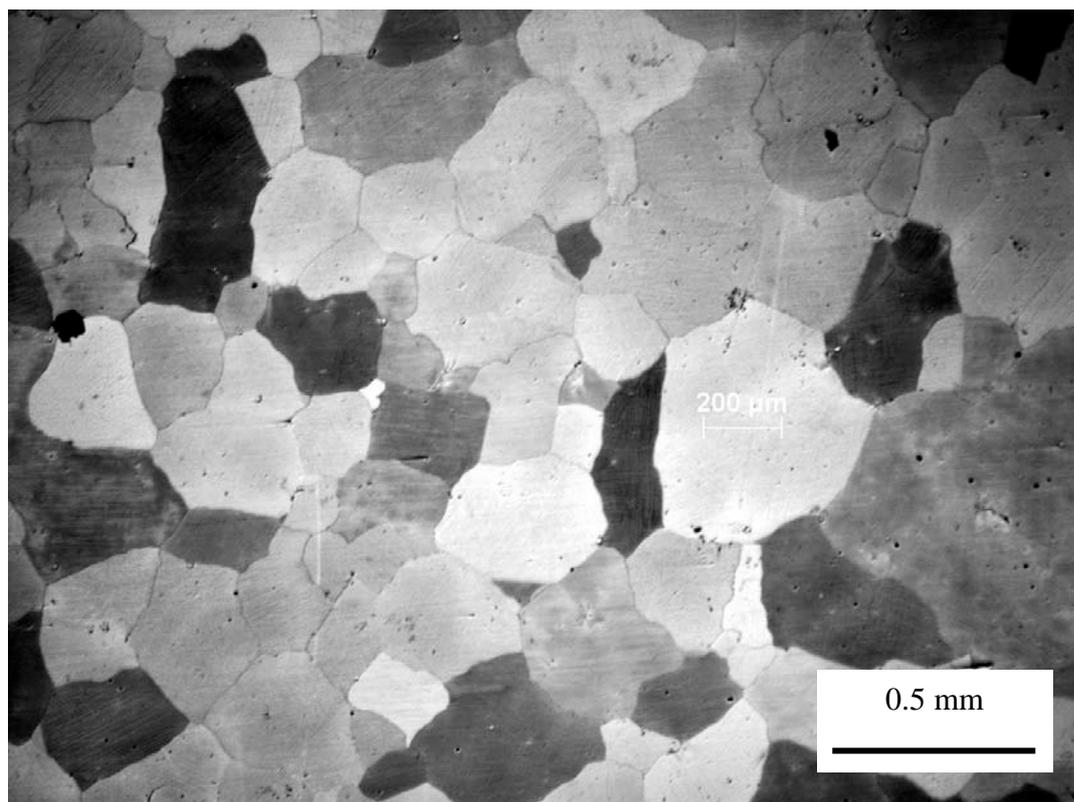
Figure 14. Microstructure of Mn-steel, hardened by explosion depth hardening.

When looking at the microstructure of the austenitic Mn-steel, there were some quite large black areas that were pores in the material. Small black dots look like carbides. Due to the high amount of Mn in the material, the microstructure can remain austenitic. The size of the grains differs a lot. See Figure 14.

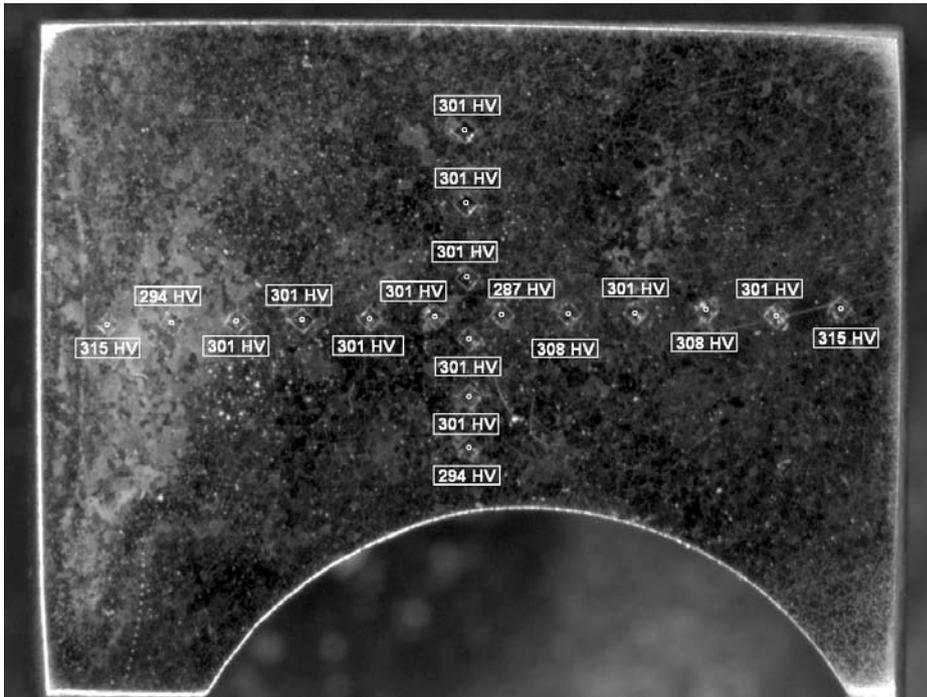
Figure 15. Hardness testing of plate C/D

There have been 18 hardness measurements at a piece cut from plate C/D and it showed an average value of the hardness at approximately 301HV. See Figure 15.

The plate A/B had a higher average value of the hardness, but there was a small variation through the thickness in the both plates and a possibly explanation to that could be the explosion depth hardening.

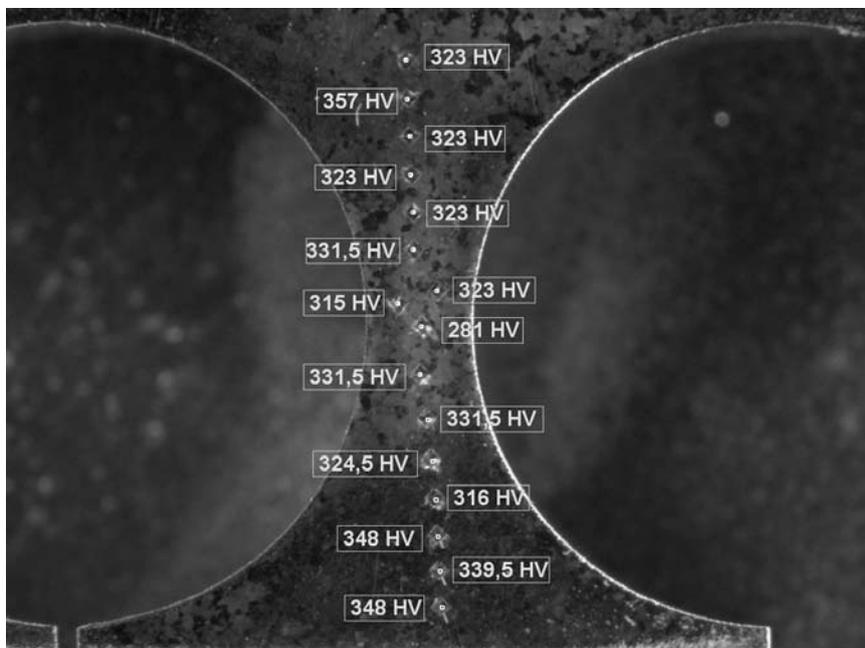
Figure 16. Hardness testing of plate A/B.

There have been 16 hardness measurements made on a piece cut out from plate A/B and it showed an average hardness value of approximately 327HV. See Figure 16.

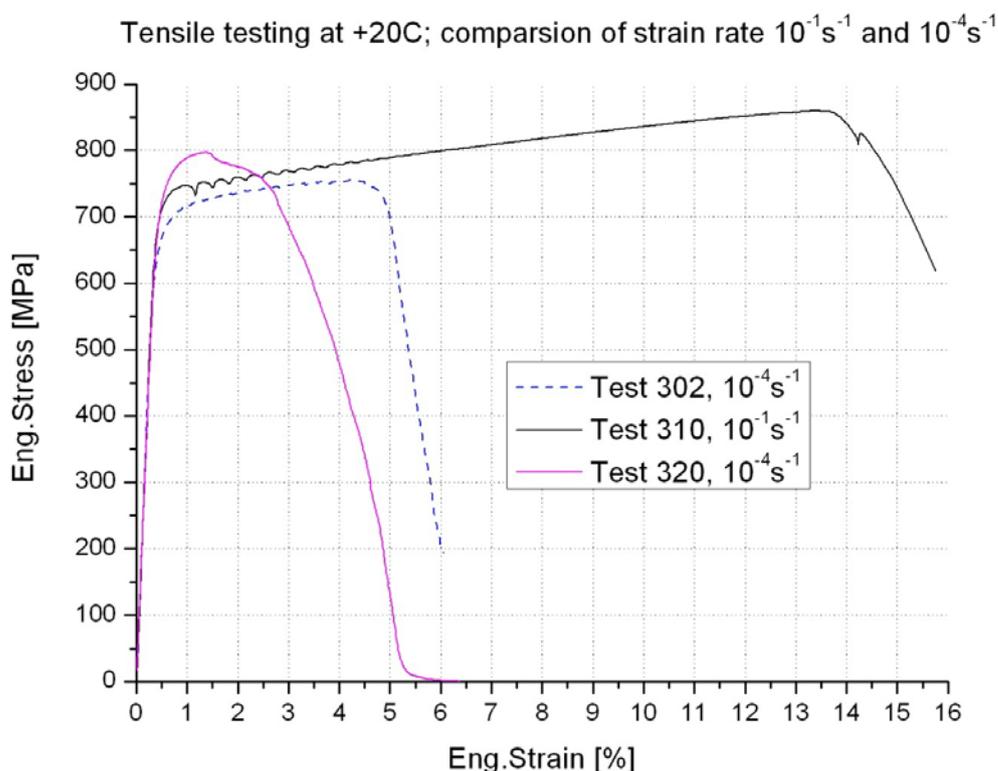
Figure 17. Tensile testing at  $20^{\circ}\text{C}$ , with different strain rates.

The tensile testing was performed at three different temperatures with two different strain rates. A comparison between each temperature was made and the results can be seen in Figure 17, 18 and 19.

Three tests were completed at room temperature, where the slower ( $10^{-4}\text{s}^{-1}$ ) strain rate showed a maximum fracture strain of 4.5% and the faster ( $10^{-1}\text{s}^{-1}$ ) strain rate had a value at approximately 13.5%. The maximum stress level reached was roughly 850MPa for the fast tensile test and the slow had a maximum of 800MPa. More specific values of ultimate tensile strength – UTS, offset yield strength  $R_{p0.2}$ , strain hardening ratio and plastic deformation [%] for  $+20^{\circ}\text{C}$  can be seen at Figure 17 and table 3.

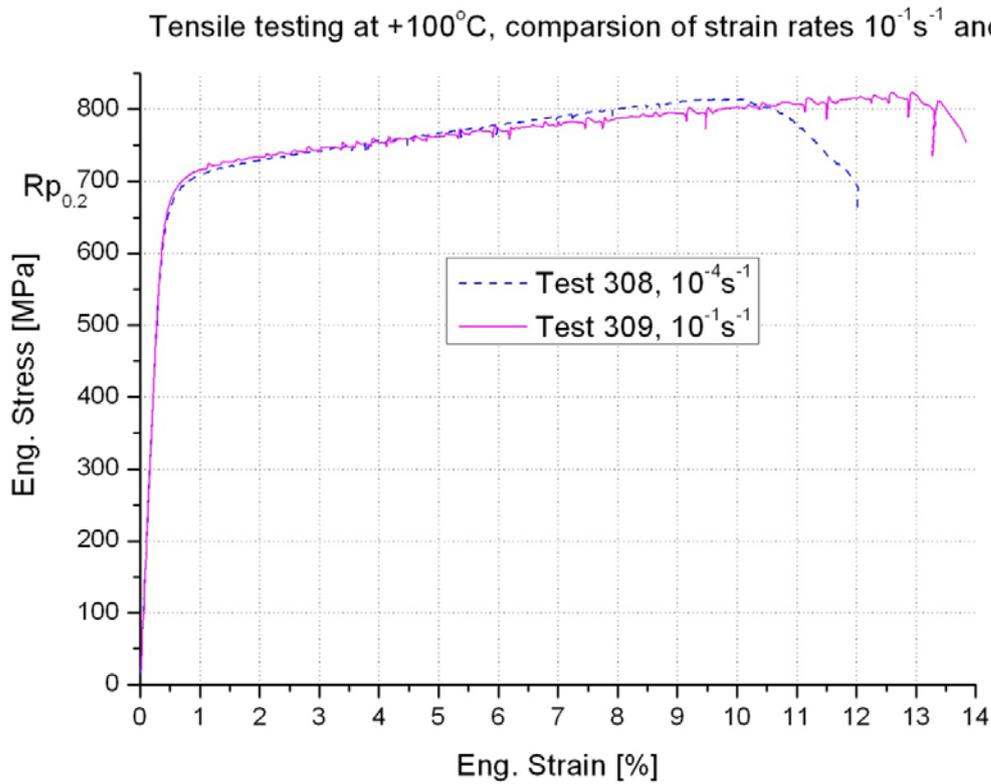
Figure 18. Tensile testing at 100°C, with different strain rates.

Two tests were made at the temperature +100°C, where the slow and fast stress/strain curve kept the same shape. The slow could resist up to 10% strain and a stress level over 800MPa. The fast could resist higher strain up to 13% and a stress level of almost 830MPa. Look at Figure 18 and Table 4 for UTS, Rp0.2, strain hardening ratio and plastic deformation valid for the comparison at +100°C.

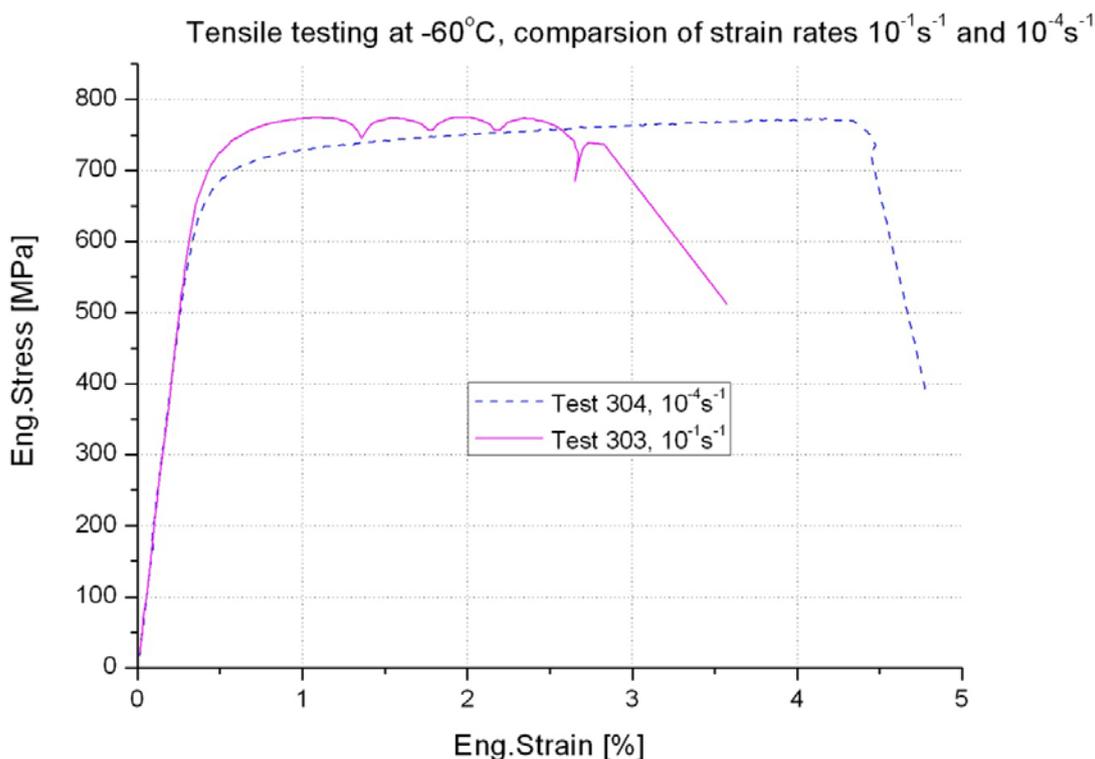
Figure 19. Tensile testing at  $-60^{\circ}\text{C}$ , with different strain rates.

Two tests were made at the temperature  $-60^{\circ}\text{C}$ , where the faster test showed a bit different curve compare the other tests. The fast one did break earlier than the slower one, with a strain level on 2.5% and stress level on 780MPa. The slow one had a longer strain level up to 4.5% and stress 750MPa until break. See Figure 19 and comparison of UTS, Rp0.2, strain hardening ratio and plastic deformation in table 5.

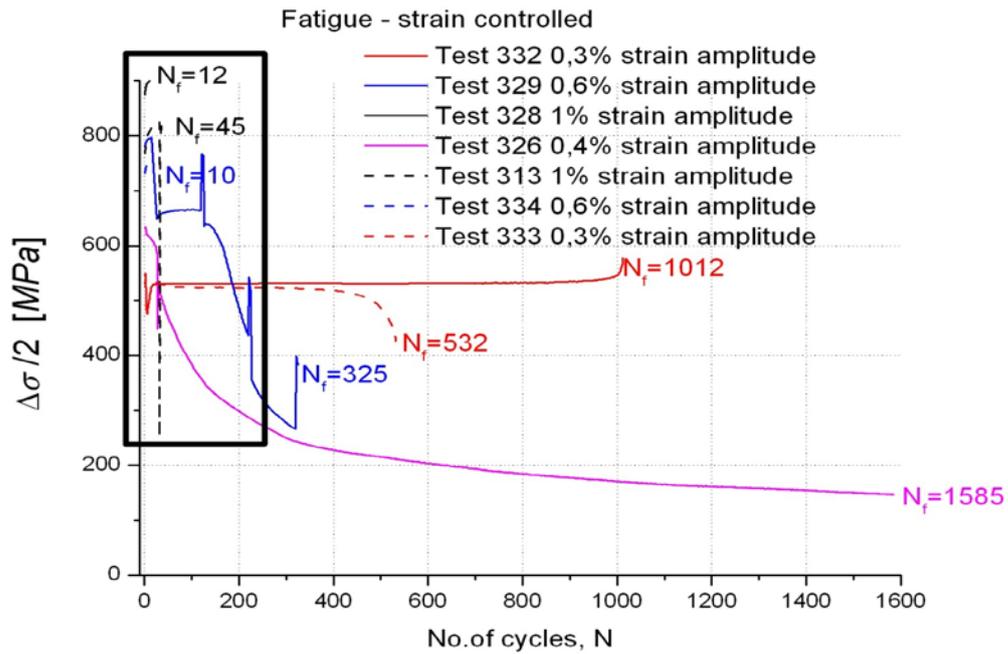
Figure 20. Strain controlled tests. Stress measured vs. number of cycles.

Strain controlled fatigue testing was performed with two tests at each strain amplitude level for 0.3, 0.4, 0.6 and 1%. The 0.3% was an extra level of strain amplitude, introduced because the material could not resist 1% and fractured within a few cycles. The results of the strain controlled testing had large varieties in both lifetime and stress measured. Every curve was first increasing and then decreasing besides for one strength test at level 0.3% (Sample 332). See Figure 20 and a closer look at Figure 21.

A comparison of a maximum reached stress level during the tests at each different strain level resulted in 0.3% ~540MPa, at 0.4% >600MPa, at 0.6% ~750MPa and at 1% >800MPa. Look at Figure 20 and Figure 21.

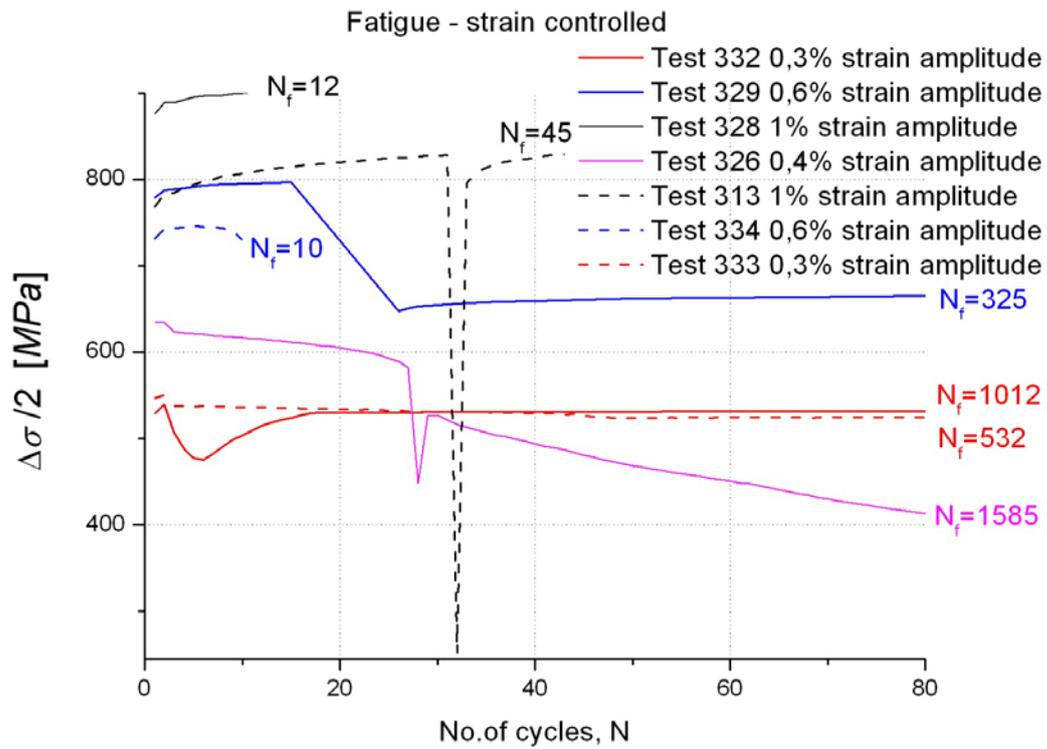
Figure 21. Strain controlled tests, enlargement of figure 20.

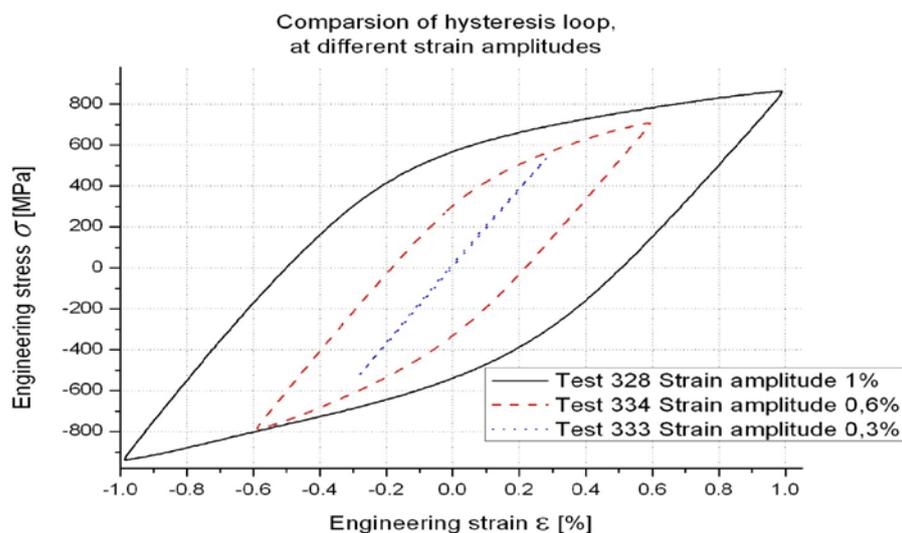
Figure 22. Hysteresis loops for strain level 1%, 0.6 %, and 0.3%

The plastic strain in each cycle became smaller than in the as-cast Mn13 steel due to the higher strength of the Mn13 EDH material. A comparison of the different strain amplitudes can be seen in the hysteresis loops at Figure 22.

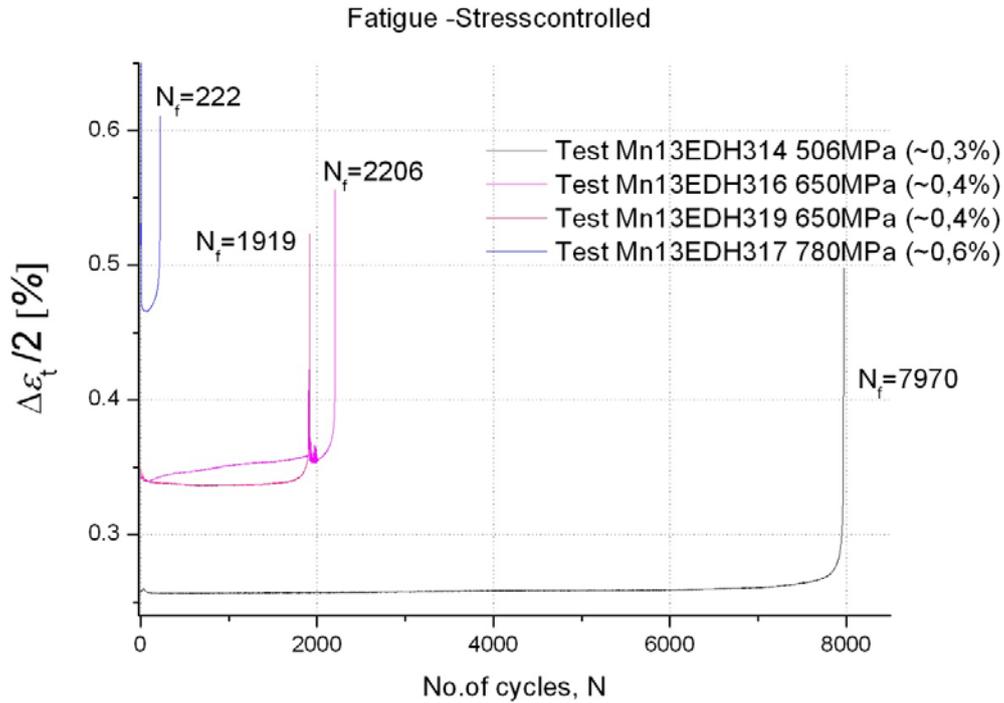
Figure 23. Stress controlled tests. Strain was measured vs. number of cycles.

The maximum levels of stress amplitudes chosen for stress controlled tests were transferred from the maximum stress levels recorded in strain controlled tests. The levels used for stress controlled measuring was 506 MPa (~25kN; ~0.3%), 650MPa (~32kN; ~0.4%), 780MPa (~38.5kN; ~0.6%) and 840MPa (~42kN; ~1%). See Figure 23.

The curves at Figure 23 showed that the material first hardens (seen as the decreasing first part of the curves), stabilise at values lower than the strain amplitude aimed for. Towards the end of the test, cracks grow larger giving “softening” of the test bar finally leading to failure. Due to the different stress levels used in strain and stress controlled tests; the results were not directly comparable. Also in the stress controlled tests we can expect large influence of defects on strain amplitude development and fatigue life.

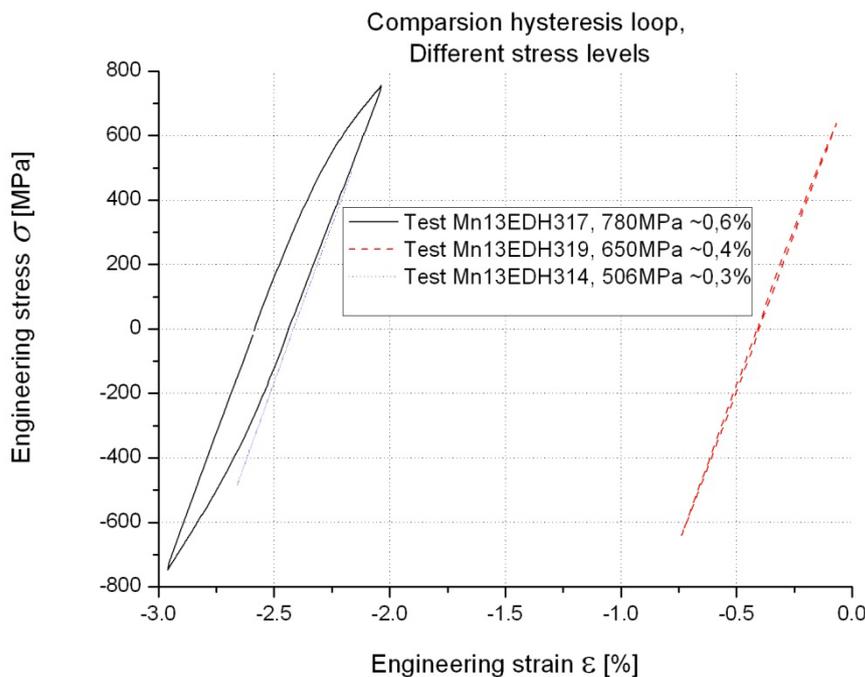
Figure 24. Comparison of hysteresis loops, different stress levels and relative strain axis markings.

A comparison of the hysteresis loops at different strain amplitudes can be seen in Figure 24. The strain axis is to be seen as a relative scale and does not correspond to actual strains.

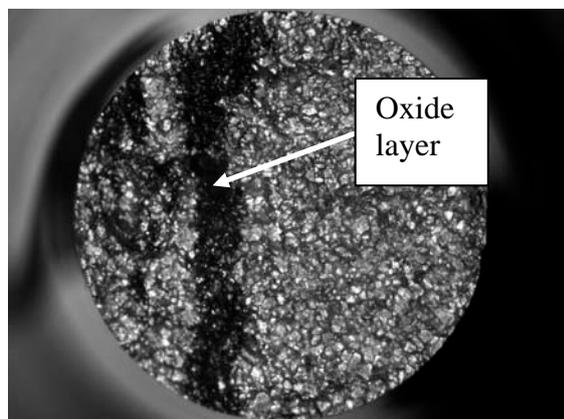
Figure 25. Sample 334 – dark part - oxide layer

The fracture surface of the specimens varied a lot, due to different defects in the material like pores, surface defects like scratches, pores or slags. However, intergranular crack propagation was dominating and the individual grains could be seen. Also cracks along the testing direction could be seen. To see some fracture surfaces and defects look at Figure 25, Figure 26, Figure 27 and Figure 28.

Stresses in combination with defects made the material start cracking, growing and finally break. The outcome was checked with stereo microscopy and dark areas seen on the pictures are the starting point of the crack. The defects weaken the material, gave a shorter fatigue life and lower ductility compared to a more homogeneous material.

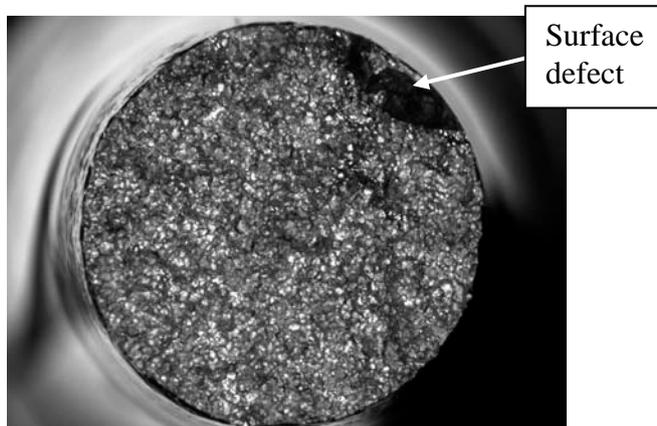
Figure 26. Sample 320 – dark part - surface defect

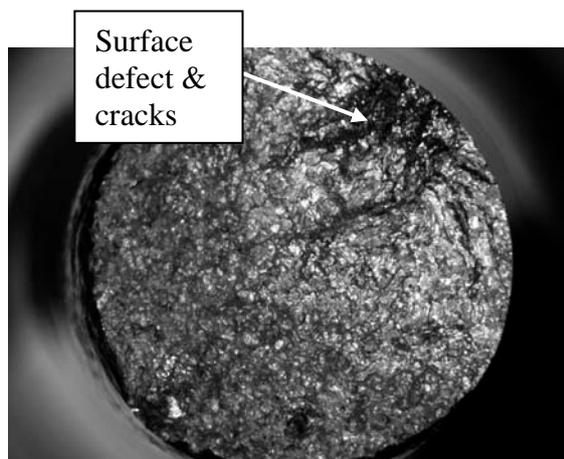
Figure 27. Sample 318 - Surface defects and cracking

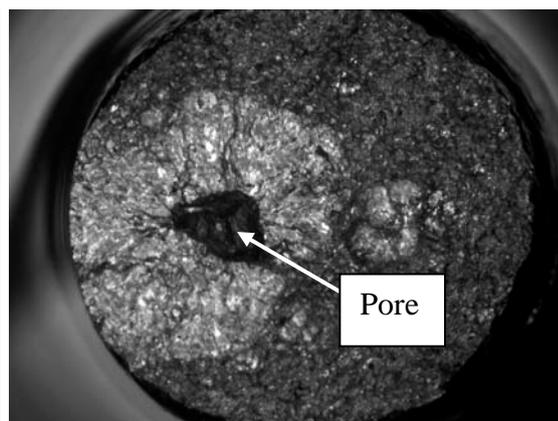
Figure 28. Sample 316 – dark part - Pore
