Detection of Electrical Treeing in XLPE Exposed to AC and DC Stress

Diploma Work in the Master programme of Electric Power Engineering

Department of Materials and Manufacturing Technology
Division of High Voltage Engineering
CHALMERS UNIVERSITY OF TECHNOLOGY
Gothenburg, Sweden, 2010
Diploma work No. 23/2010

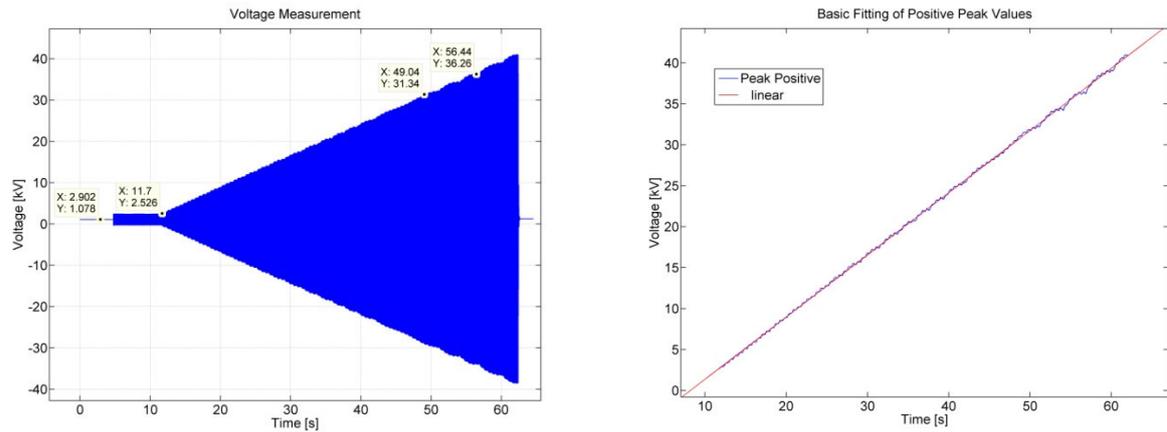
Figure 4.12 Left: Voltage measurement in LabVIEW for applied AC with a ramping rate of 0.5 kV/s. Right: Linear fit of the ramping for an AC voltage signal with a ramping rate of 0.5 kV/s. These measurements were made with a capacitive voltage divider.

The left hand pictures in Figures 4.12 and 4.13 display the measured voltage for the two ramping rates investigated, plotted in Matlab. The marker tips seen in the figures specify; the offset voltage value, the voltage level when the automatic ramping function was turned on and the peak voltage at the time for treeing inception. The offset voltage could differ at each test due to the floating ground potential of the measuring card and was corrected for, see Formula 4.1. The voltage level at the start of the ramp was also included in the formula. In Figure 4.12 two treeing inception voltages are specified; the lower corresponds to a tree at a kink and the higher one to a tree originating from the wire. For the test shown in Figure 4.13 no tree appeared at a kink.

The lower ramping rate of 0.5 kV/s is an arithmetic mean of the obtained ramping rates from Matlab applying linear fitting, the values span from 0.53 kV/s to 0.54 kV/s. See the right hand plot of Figure 4.12 for the ramping. Also 3.9 kV/s is an arithmetic mean in the same manner, with values between 3.82 kV/s and 3.89 kV/s.

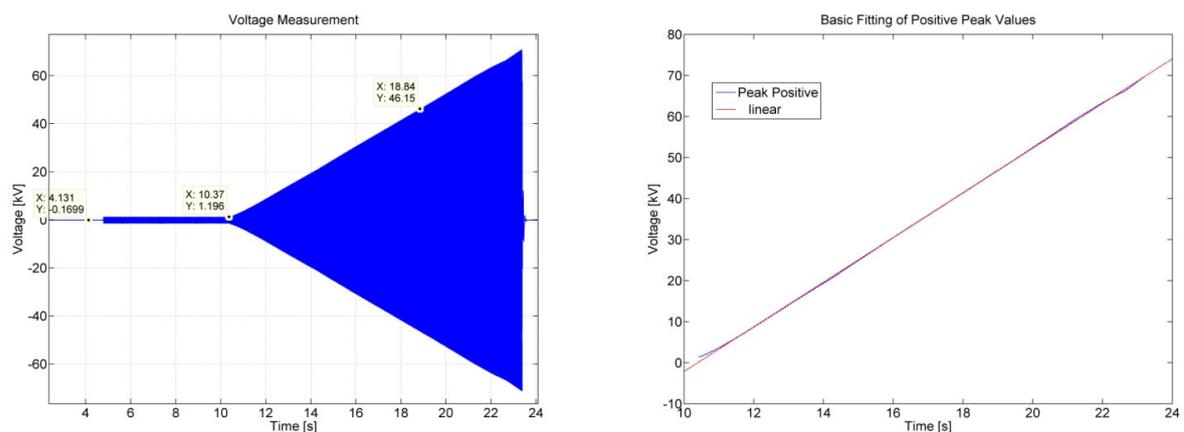
Figure 4.13 Left: Voltage measurement in LabVIEW for the applied AC with a ramping rate of 3.9 kV/s. Right: Linear fit of the ramping for an AC voltage signal with a ramping rate of 3.9 kV/s. These measurements were made with the third resistive voltage divider.

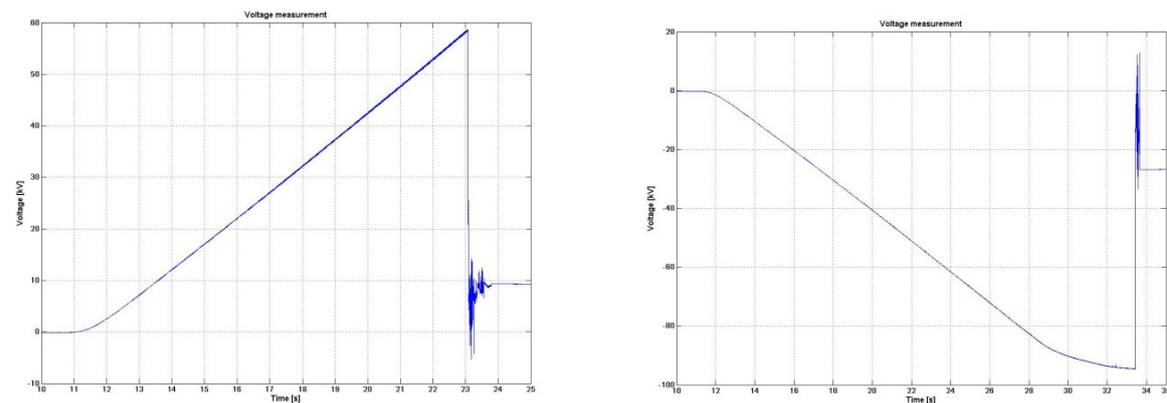
Figure 4.15 Left: The voltage at the test object at test with positive DC voltage polarity. Right: The negative DC voltage at the test object.

The voltage across the test object can be seen in Figure 4.15. The very steep voltage drop was due to breakdown of the insulation and the residual voltage left at the test object was later removed by grounding the circuit. The ramping speed was calculated for all tests and for positive voltage polarity it varied between 5.25 kV/s and 5.34 kV/s, with an arithmetic mean of 5.3 kV/s. For the negative DC voltage the ramp speed varied between -5.39 kV/s and -5.46 kV/s, with an arithmetic mean of -5.4 kV/s. The asymmetric AC voltage might be the source of this discrepancy.

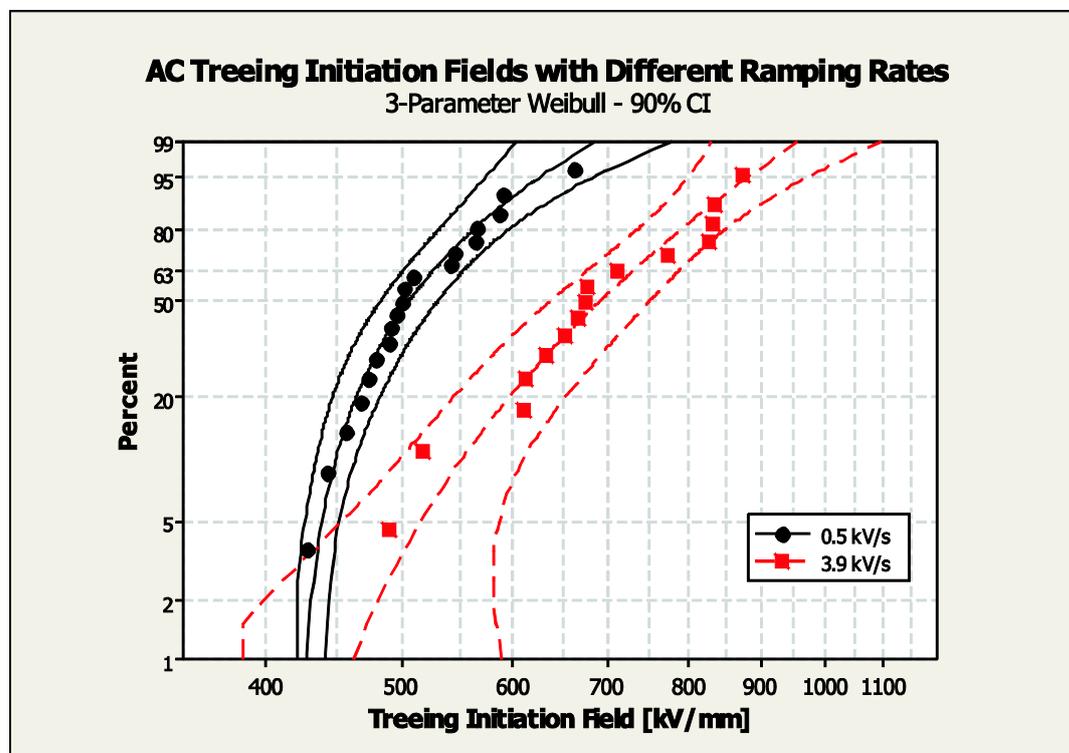
Figure 5.3 Comparison of 3-parametric Weibull probability plots of AC treeing initiation fields with 0.5 kV/s and 3.9 kV/s ramping rates.

It can be seen from Figure 5.3 that a higher ramping rate results in a higher treeing initiation field. For the ramping rate of 0.5 kV/s treeing initiation field ranges between 430 kV/mm and 660 kV/mm, as mentioned in Chapter 5.1.1, and for 3.9 kV/s it spans from 490 kV/mm to 870 kV/mm. The Weibull distribution parameters are specified in Table 5.2. The threshold parameters imply that failure will be noticed earlier for the higher ramping speed though this was not the case in practise. It might be due to the 90 % confidence interval and to the two lowest outlying values of the 3.9 kV/s ramping rate. The higher parameter values of shape and scale for the faster ramp rate indicate what can be seen in Figure 5.3, treeing initiation voltages are more spread, i.e. has a slower ageing process, than for the lower rate.

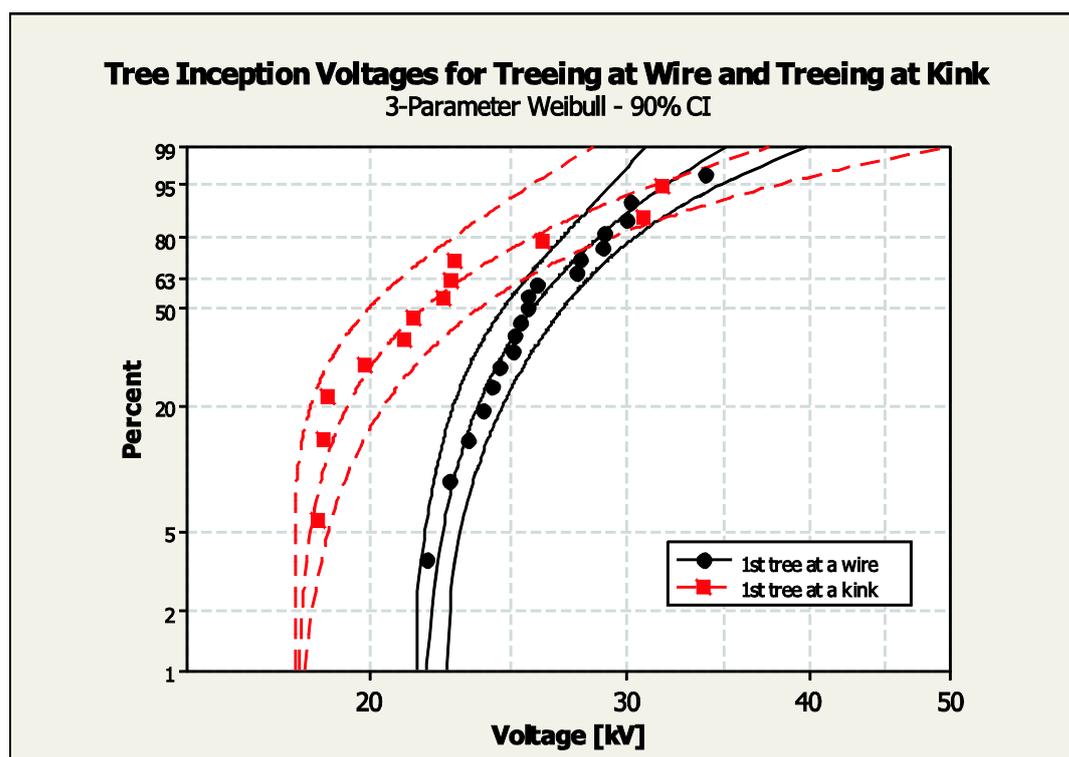
Figure 5.6 Comparison of tree inception voltages for normal treeing and treeing by kinks with 3-parametric Weibull distribution plot. Both plots with an applied AC voltage with a ramping rate of 0.5 kV/s.

Comparison of tree inception voltages for treeing at wire with treeing originating at kinks with a 3-parametric Weibull probability plot could only be made for AC with a ramping rate of 0.5 kV/s, see Figure 5.6. This due to only two samples found with trees at kinks for the tests made with the other ramping speed of 3.9 kV/s. This is not considered as enough data to draw conclusions from. The comparison was done with inception voltages instead of initiation fields since the relation of Formula 5.1 in Chapter 5.1.1 refers to the geometry of a conducting wire and not to the formation of a kink.

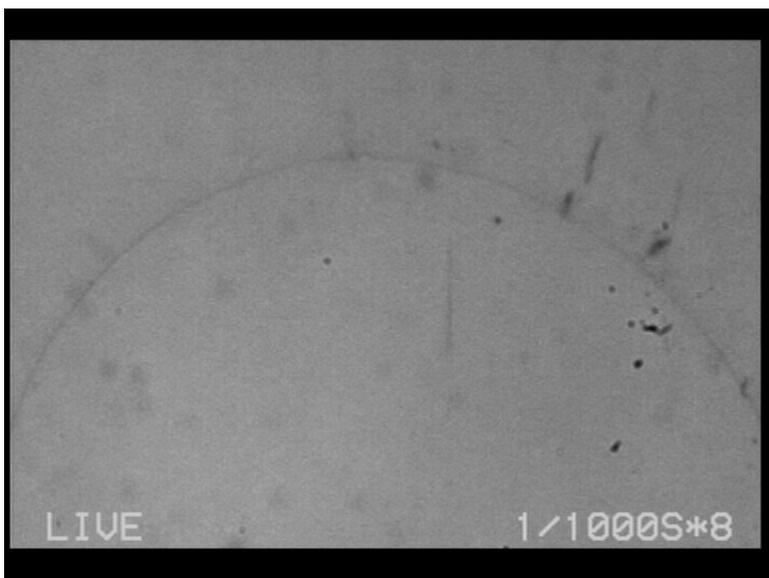
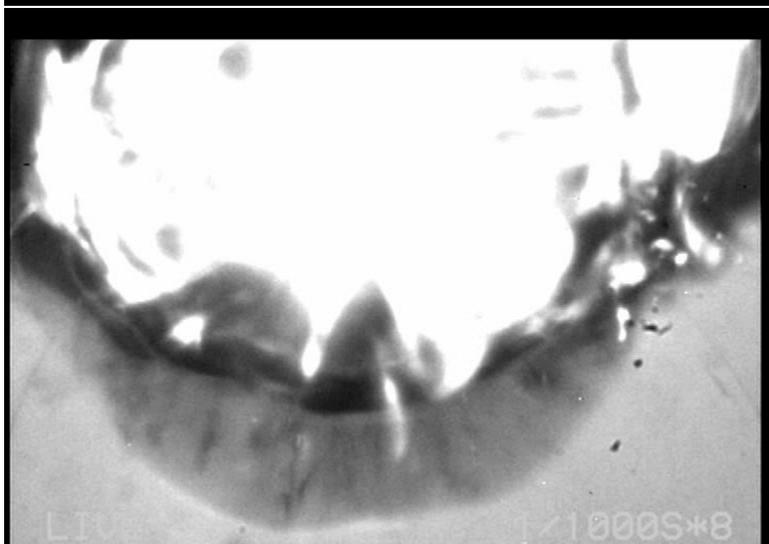
Figure5.12 Consecutive sequence of pictures. From the DC test with positive polarity and a ramping speed of 5.3 kV/s.

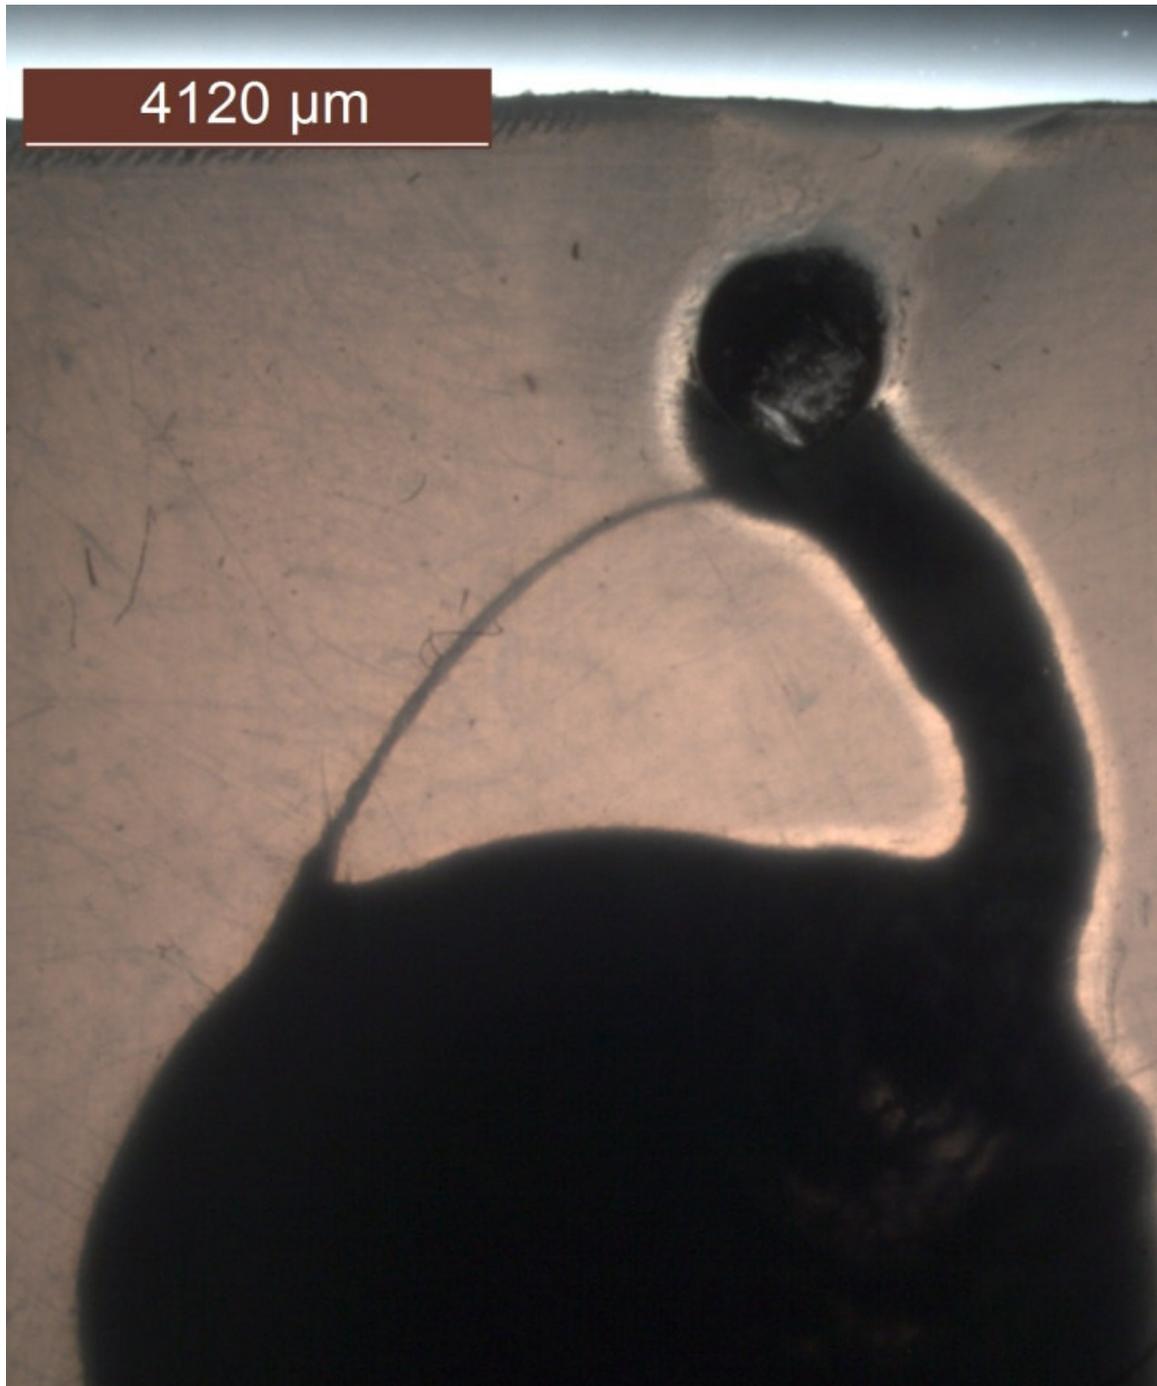
Figure 5.13 A distinctive breakdown channel, which has gone through the width of the test object and formed a wide tube around the wire on one side of the breakdown channel. Around the wire on the other side a smaller tube has been formed.

The second case, exhibited in the majority of the samples, has a wide tube formed along the wire on one side of the breakdown channel, see Figure 5.13. On the other side there is a narrower tube formed around the wire. This made it likelier to find remnants of trees there, as is the case for two of the test objects, where electrical trees have been spotted along this side of the wire. Examples of trees found along this side of the wire can be seen in Figure 5.15-5.17. These trees might have been present when breakdown took place or they might have been initiated by the breakdown itself. A hypothesis is that the thicker tree, shown in Figure 5.17, was affected by the formation of the tube around the wire while breakdown occurred, and thus was there before the breakdown, whilst the thinner trees in Figure 5.15 and Figure 5.16 were initiated or began growing at the breakdown or possibly by the oscillating voltage.

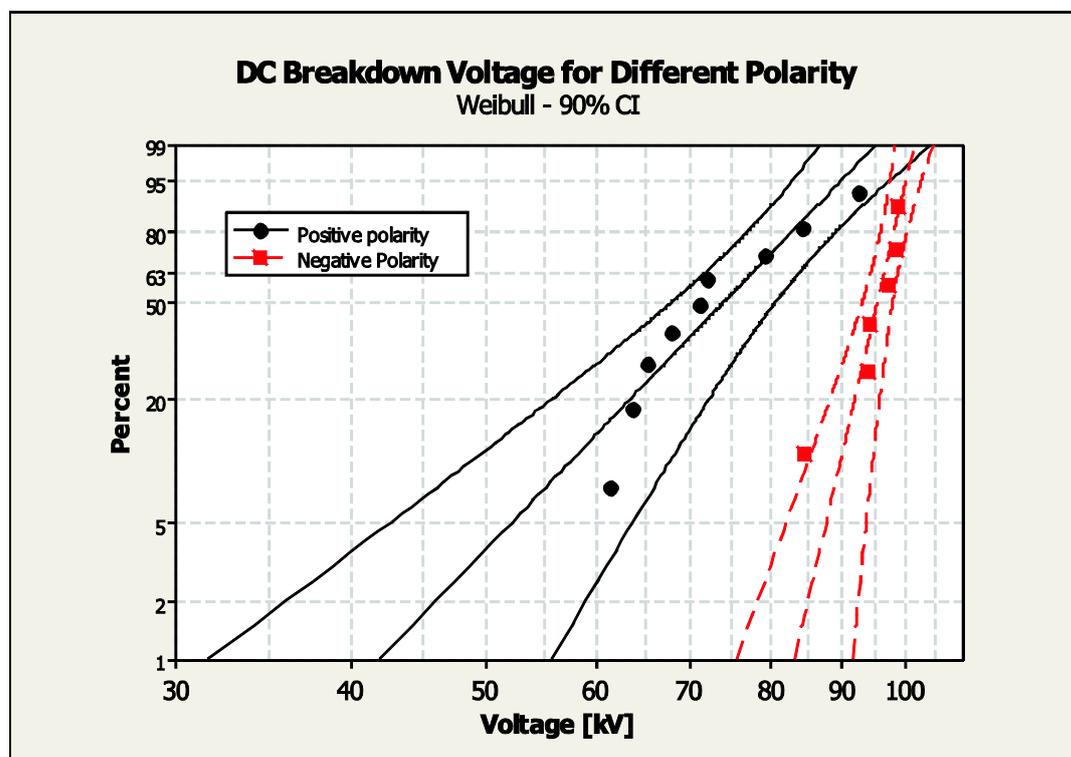
Figure 5.19 Two-parametric Weibull probability plot comparing the breakdown strength of the test object when stressed with negative and positive voltage at the faster ramp speed.

The breakdown voltage has been compared between positive and negative polarity of the applied voltage. A two-parameter Weibull probability plot of the breakdown voltage is shown in Figure 5.19. As seen the breakdown voltage is significantly higher for negative than for positive polarity. A higher DC tree inception voltage for negative polarity has been found by [3] and [19].

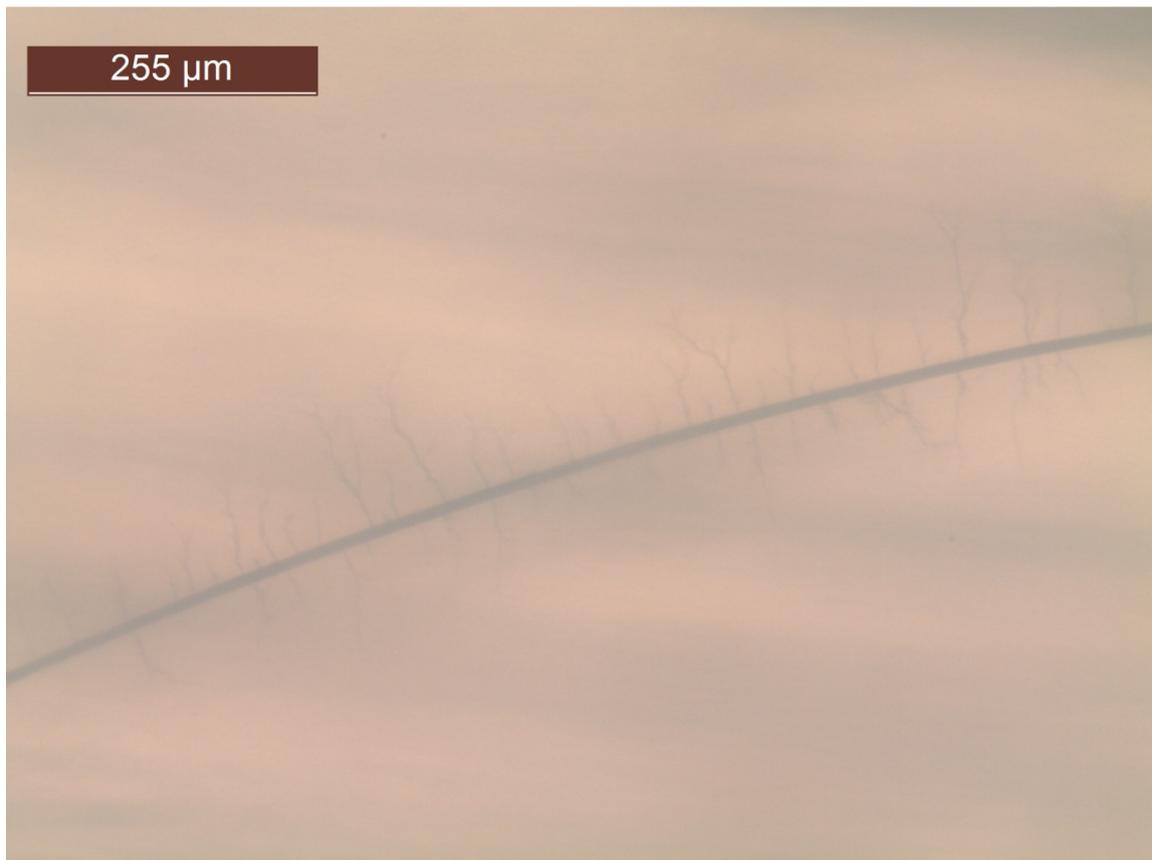
Figure 5.23 Example showing tree filaments, found in abundance on the two abandoned test objects.

For negative polarity flashovers occurred between the high voltage conductor and the ground, before it was possible to recognise any trees on the video or there was breakdown in the test object. After trying 17 times altogether on three separate test objects, where only the first one broke down, the testing for negative polarity was aborted. Afterwards, when studying these test objects with the microscope several hundreds of tiny tree filaments were found along the wire, growing both towards the ground plane and towards the semiconducting tab. A portion of these tiny trees along a part of the wire can be seen in Figure 5.23.

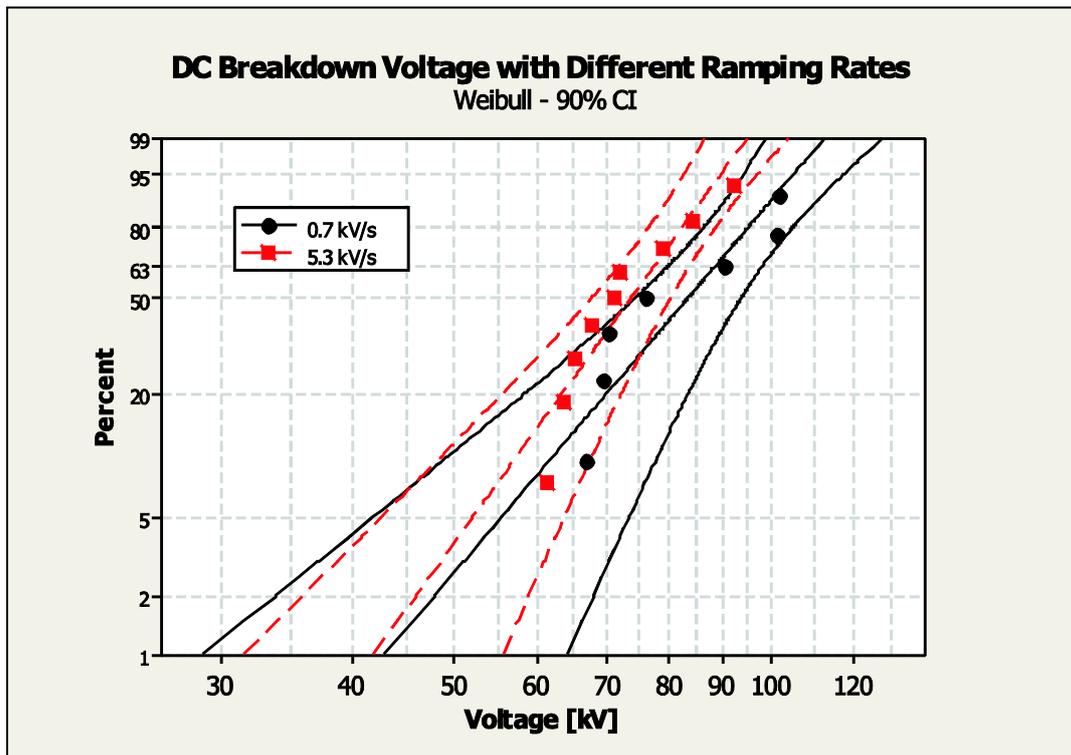
Figure 5.24 Two-parametric Weibull probability plot comparing the breakdown strength of the test object for the two ramping speeds at positive voltage polarity.

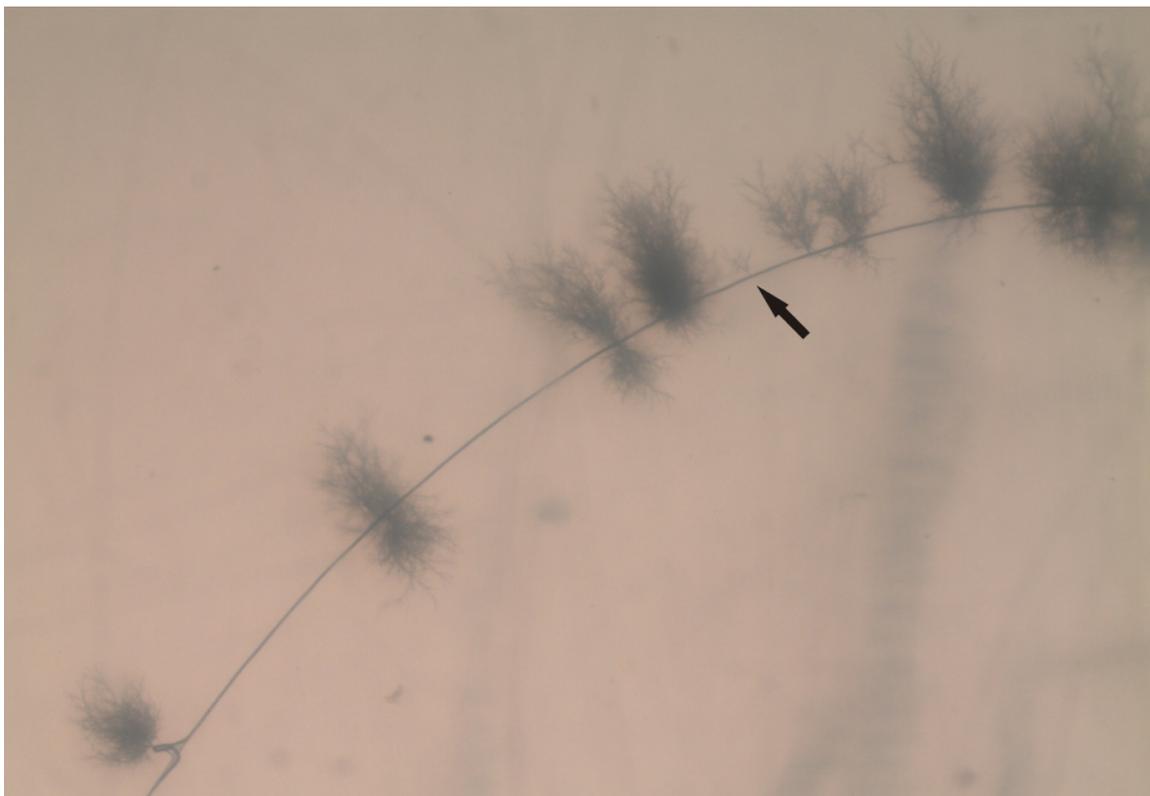
Figure 5.25 Several different varieties of trees found for AC voltage, the arrow is indicating a mini tree.

Figure 5.25 illustrates the different kinds of trees found in the AC test objects; bush tree at a kink, mirror trees, mini-tree indicated by the arrow and bush-branch at the right most in the picture. These trees differ greatly in appearance from the trees observed in the DC stressed test objects, see Figure 5.26, which display a thin branch-like structure with very few branches. These thin trees have only been found in a couple of AC stressed test objects where a breakdown channel was formed. Worth noticing is also that when exposed to either DC or AC voltage the trees can grow both towards the ground plane and towards the semiconducting tab.

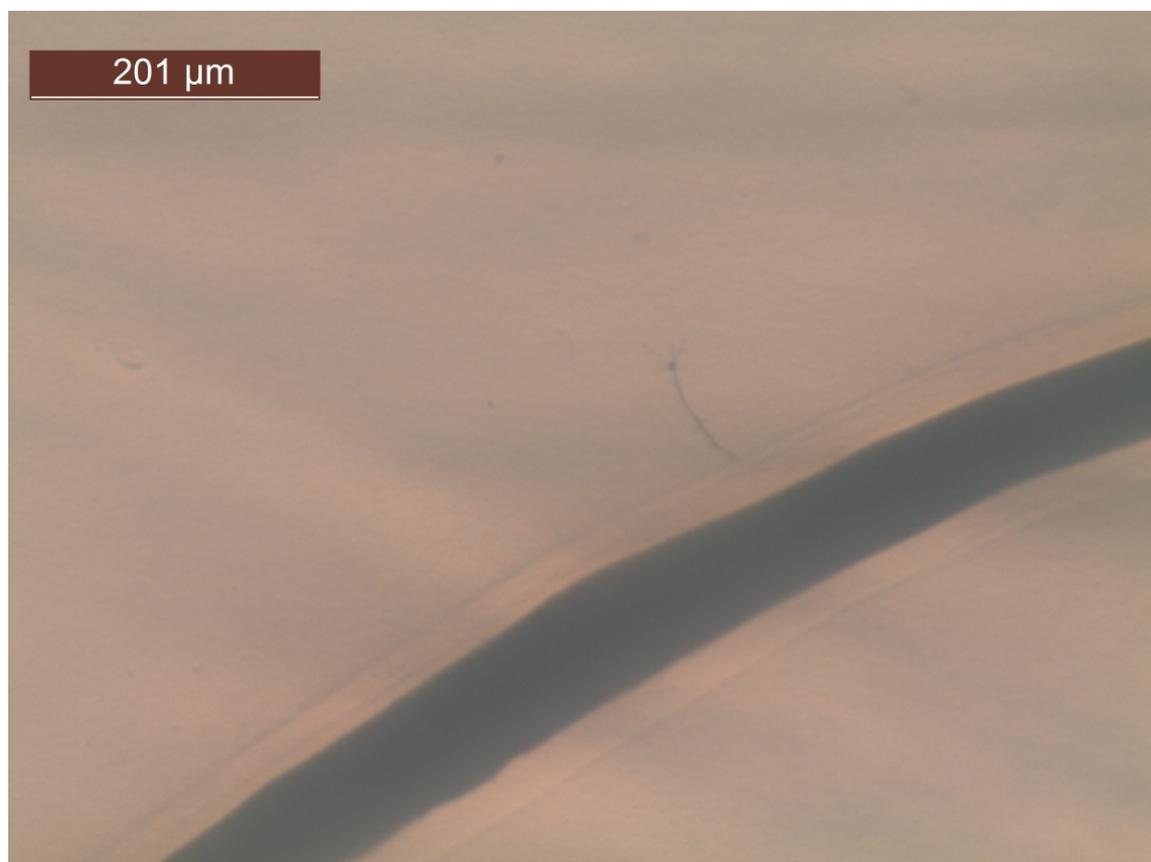
Figure 5.27 A tiny tree growing from the interface between the two different material morphologies. The test object was stressed by the negative voltage.

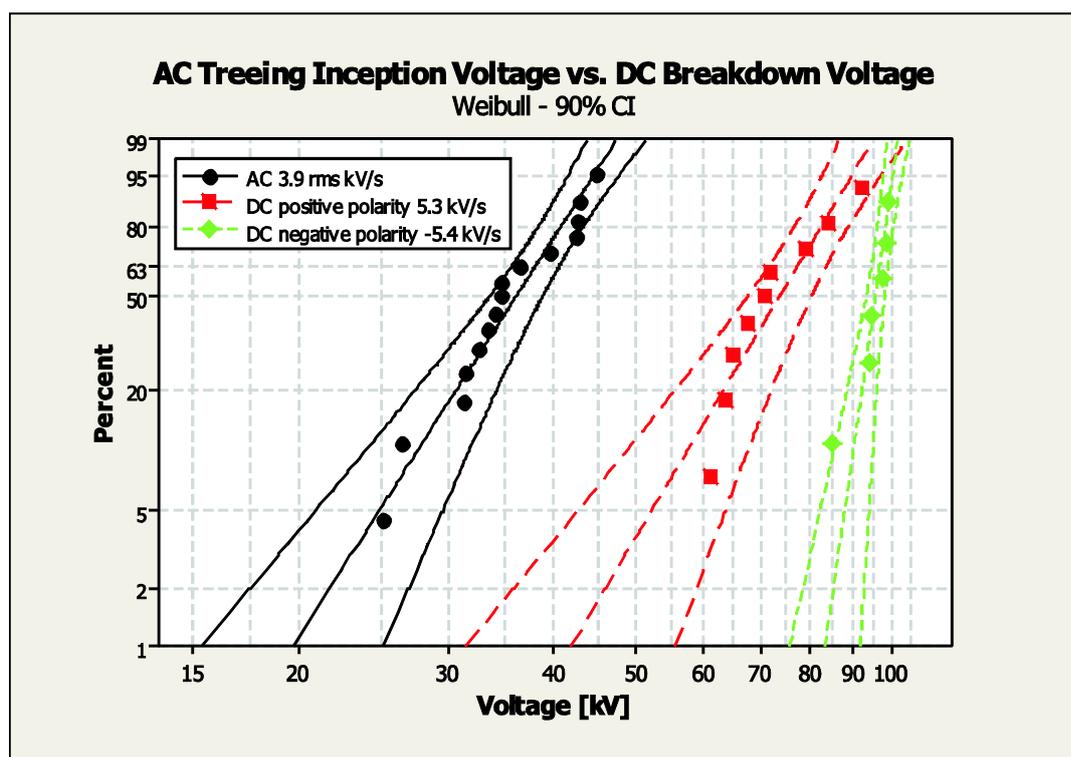
Figure 5.28 Two-parametric Weibull probability plot comparing AC treeing inception voltage with DC breakdown voltage for the ramping speed of 0.5 kV (rms).

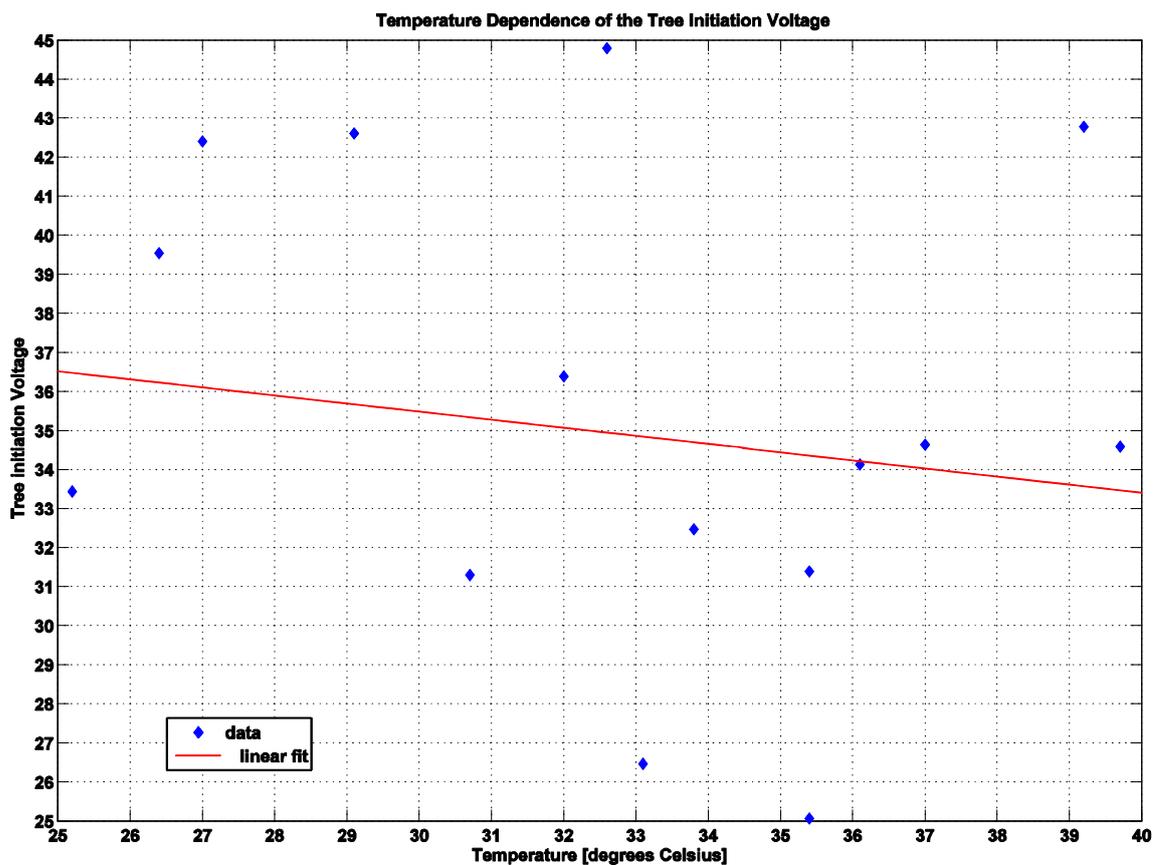
Figure 5.29 Correlation between temperature and tree initiation voltage for the AC test using the ramping speed of 3.9 kV/s.

The temperature of the transformer oil was only measured for the DC experiments at 0.7 kV/s and for the AC test with a ramping rate of 3.9 kV/s, since a thermometer had not been acquired for the earlier conducted tests. The transformer oil became significantly heated by the lamp, the temperature varying between 23 °C and 41 °C. For every breakdown test made, where there was no need to replace the oil, this temperature would rise. By incident the test object subjected to the DC voltage broke down when the oil kept approximately the same temperature, only ranging between 25.7 °C and 26.9 °C, which ascertains that the results achieved in this test are not affected by the temperature but also that the impact of temperature on the DC tests cannot be concluded. For the 3.9 kV/s AC test, the tree initiation voltage has been plotted against the oil temperature, see Figure
