## Anchorage Capacity of Corroded Reinforcement Eccentric Pull-out Tests

K. ZANDI HANJARI

D. CORONELLI

*Dept. of Civil and Environmental Eng.  
Structural Eng. / Concrete Structures*  
CHALMERS UNIVERSITY OF TECH  
Göteborg, Sweden 2010  
Report 2010:6

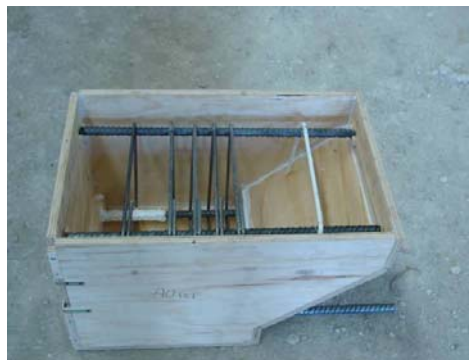
Figure 3.3. Photo of a fabricated mould for a beam-end specimen.

In total eighteen wooden moulds were made for the test specimens, see Figure 3.3. Two different reinforcement arrangement, with and without transverse reinforcement along the embedment length, were fabricated; the geometry of the specimens are given in Figure 3.4. The specimens were cast with the main longitudinal reinforcement of 20 mm in the horizontal position at the bottom of the moulds, and with a transverse reinforcement of 8 mm. A small concrete cover to the main bar, 1.5 times the main bar diameter, was used. The main bars were in contact with the concrete over a 210 mm embedment length; the bond-free zone over the support, 190 mm, reduced the direct effect of support pressure. As mentioned before, the areas outside the embedment length, the bond-free zone and the “nose”, were reinforced by transverse reinforcement to avoid any unfavourable failure mode.

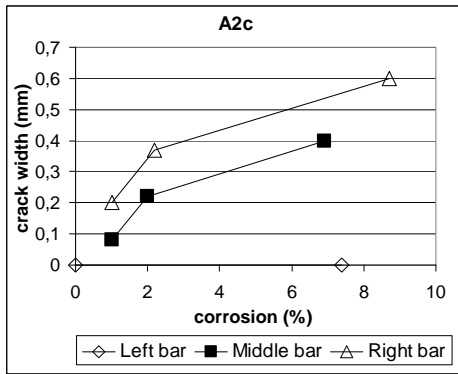
The corrosion level in correspondence of each point is the average attack value for the whole bar calculated from the circulated current at level 1 and from gravimetric measurements at levels 2 or 3.

Figure 5.6 Crack-corrosion diagrams and synthesis of results (opening, level 1, 2 and 3).

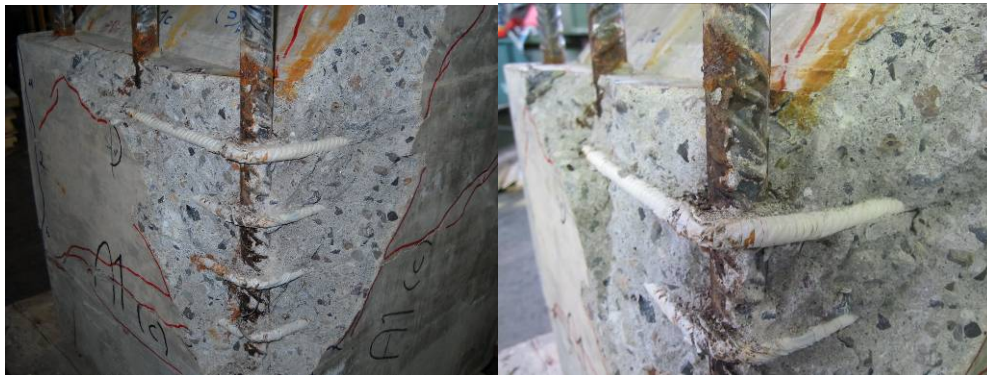
*Figure 5.8 The corrosion attack of the main bars from the bottom.*

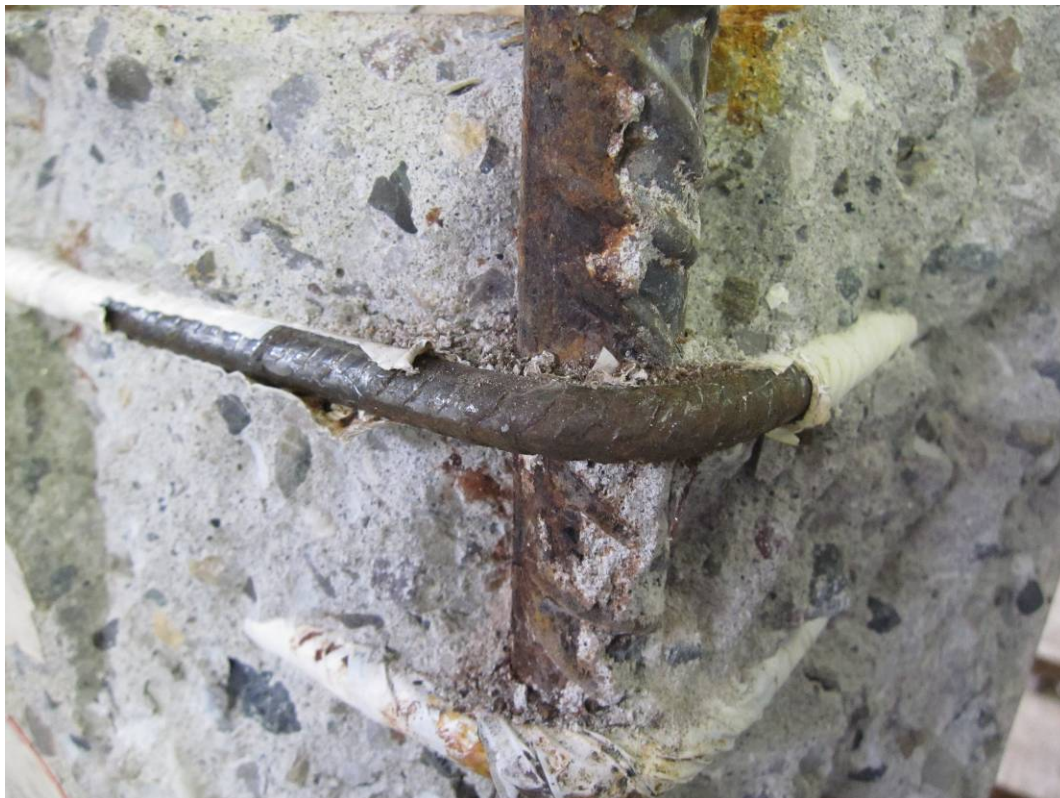
*Figure 5.9 Type B specimens: uncorroded stirrup surface, after removing the protection tape.*

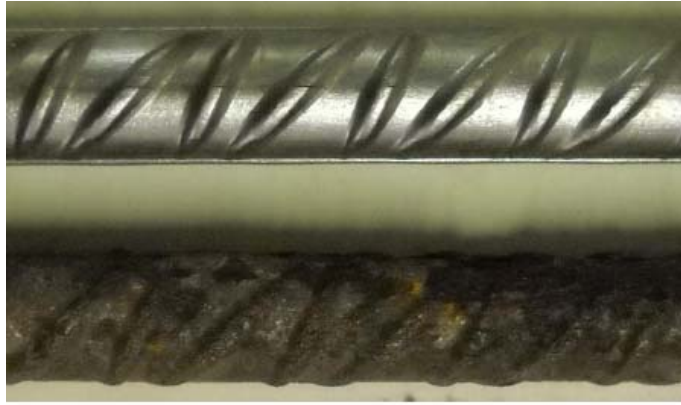
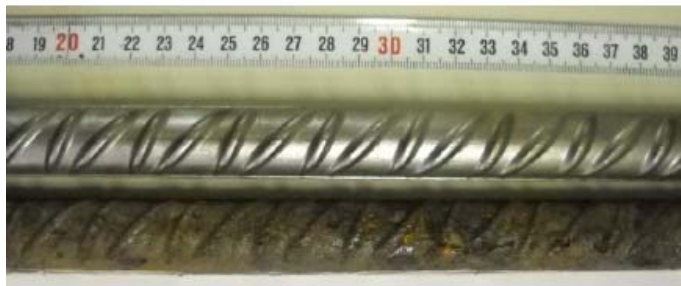
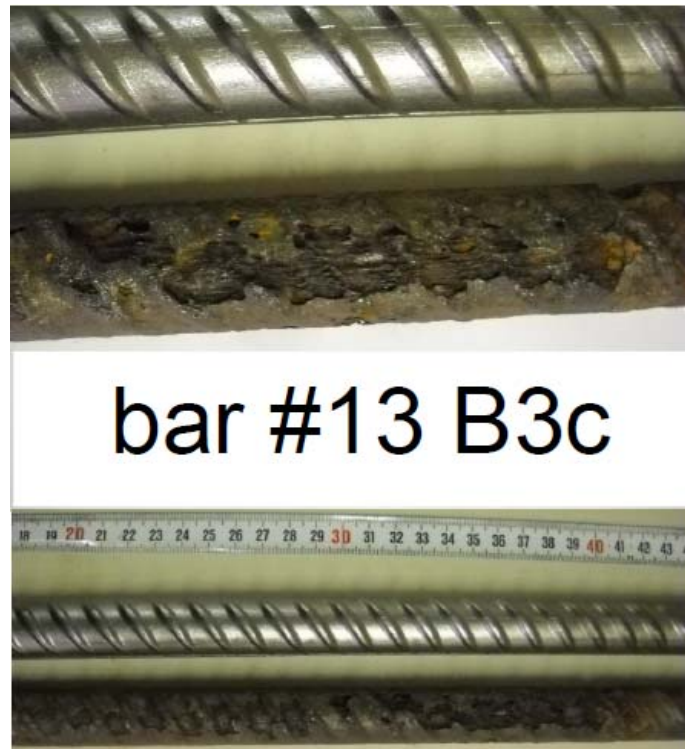
*Figure 5.11 Morphology of the corroded bar surface.*

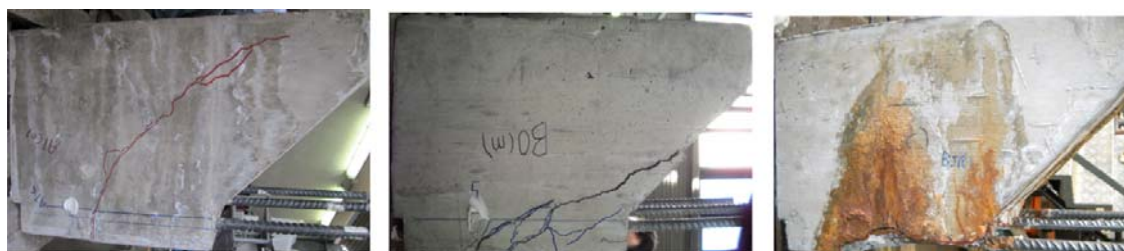
(c) splitting failure: splitting cracks parallel to the bar, mainly in corroded specimens.

Failure of the test specimen (F)

Splitting-induced pull-out failure (SP)

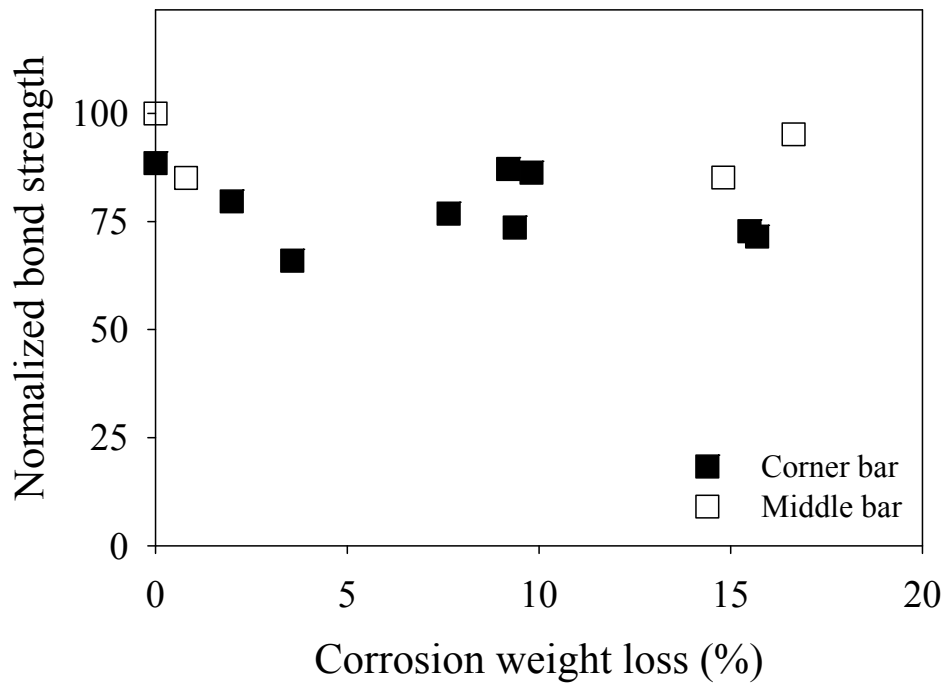
Figure 6.2 Overview of the test results in terms of bond strength normalized with respect to that of the middle bar in reference specimens, versus corrosion attack.

The average bond strength for each specimen is given in Table 6.1. The load measured on each bar was divided by the surface area of the bar along the embedment length to calculate the average bond stress. The types of the failures, i.e. failure of the test specimen (F), splitting-induced pull-out failure (SP) and splitting failure (S), were also reported in Table 6.1.

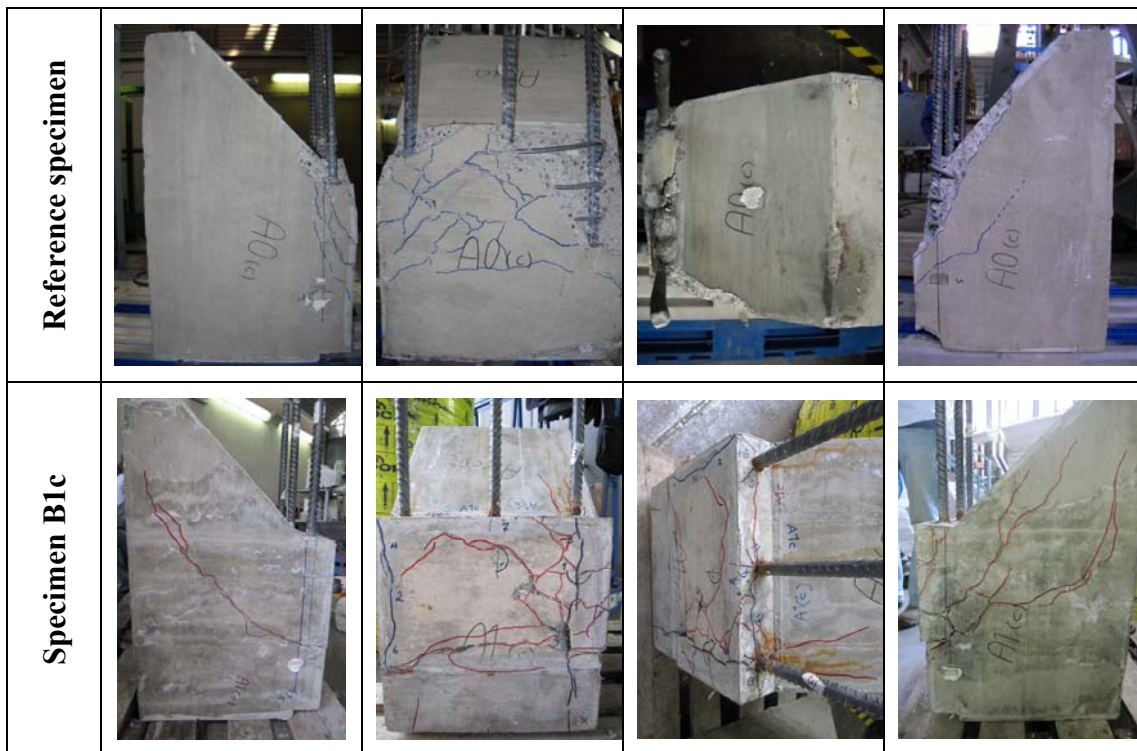
Figure 6.4 Average bond stress versus free-end slip measured in the pull-out tests for specimens B1c and the reference specimens.

A comparison of the results of specimen types A, B and C shows the importance of the stirrups in the remaining bond capacity of corroded specimens. The largest bond deterioration was seen in the type A specimens on the corner bars; this was because of the absence of stirrups as well as less portion of surrounding concrete available to a corner bar compared to that of a middle bar. The least bond deterioration was measured in type B specimens on the corner bars. This is believed to be caused by the effective interaction between the stirrups and the main bars at the angle of the corner. It can be concluded that, for large corrosion penetrations that cause extensive cover cracking, stirrups play an important role in terms of being the main source of confinement.

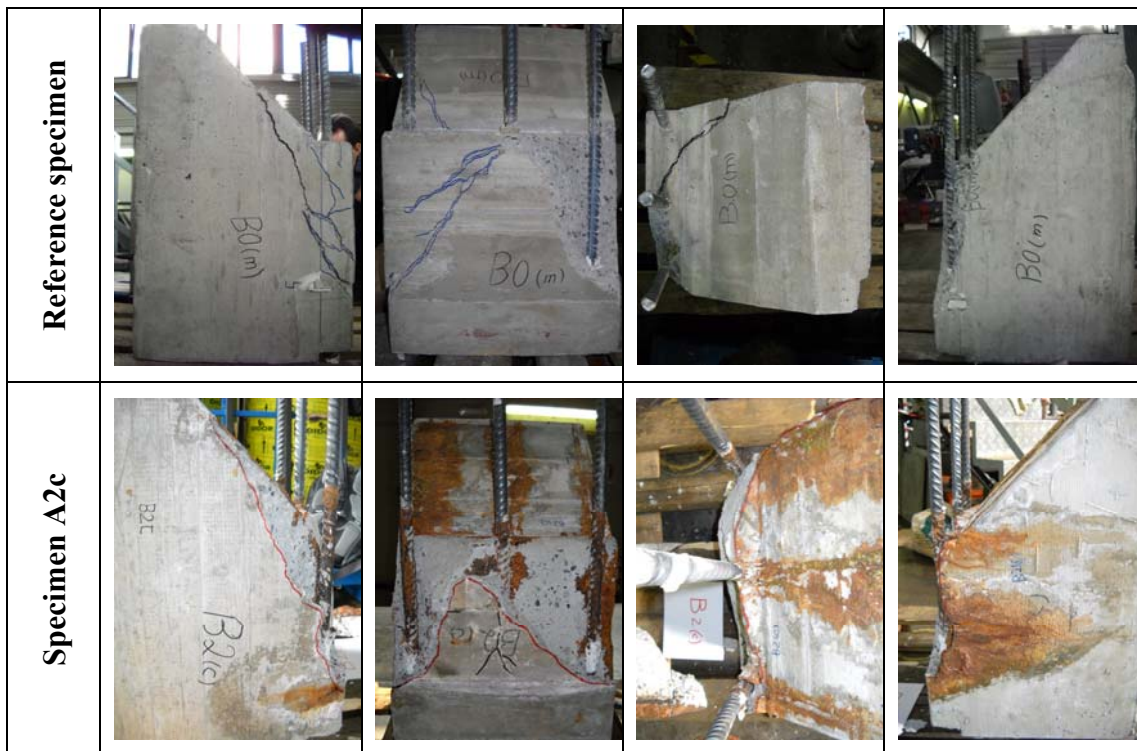
Figure 6.6 Average bond stress versus free-end slip measured in the pull-out tests for specimens A2c and the reference specimens.

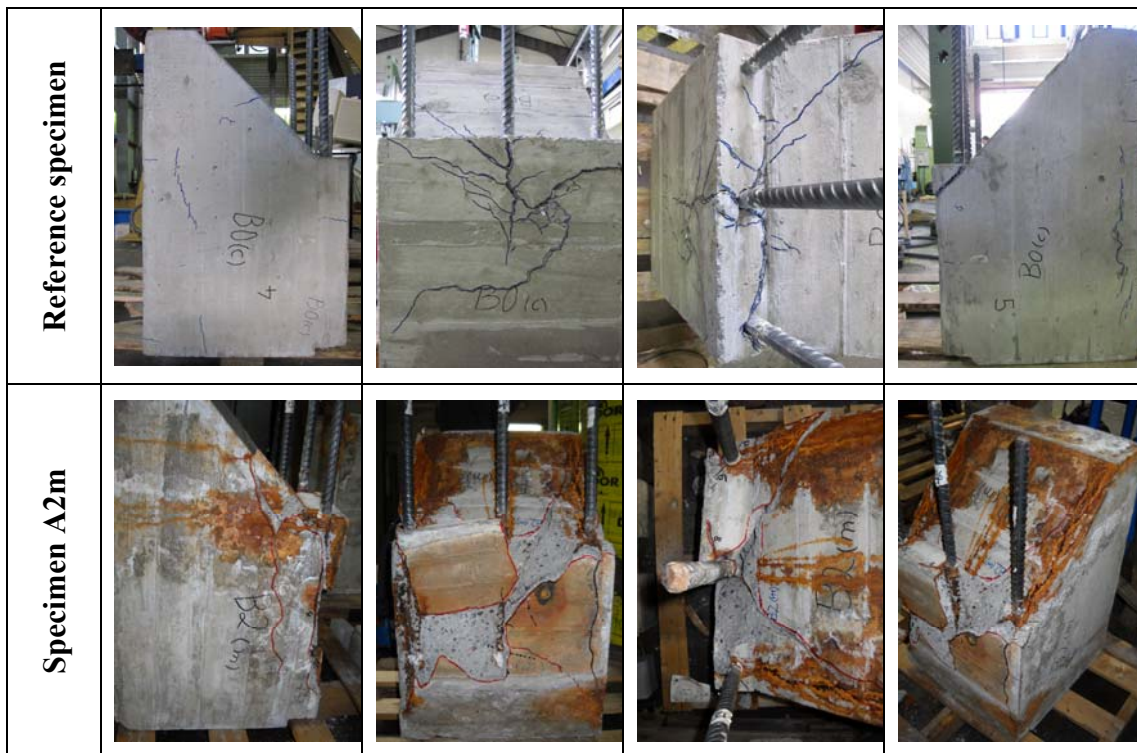
Figure 6.7 Average bond stress versus free-end slip measured in the pull-out tests for specimens A2m and the reference specimens.

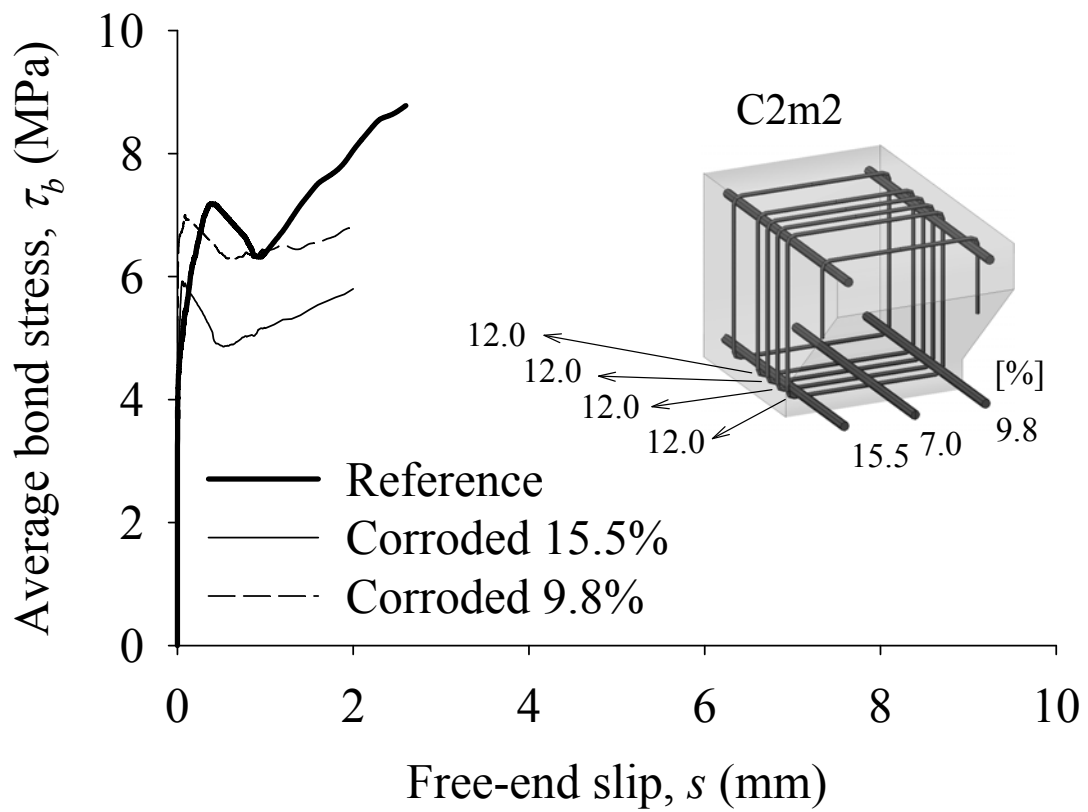
Figure 6.9 Average bond stress versus free-end slip measured in the pull-out tests for specimens C2m2 and the reference specimens.

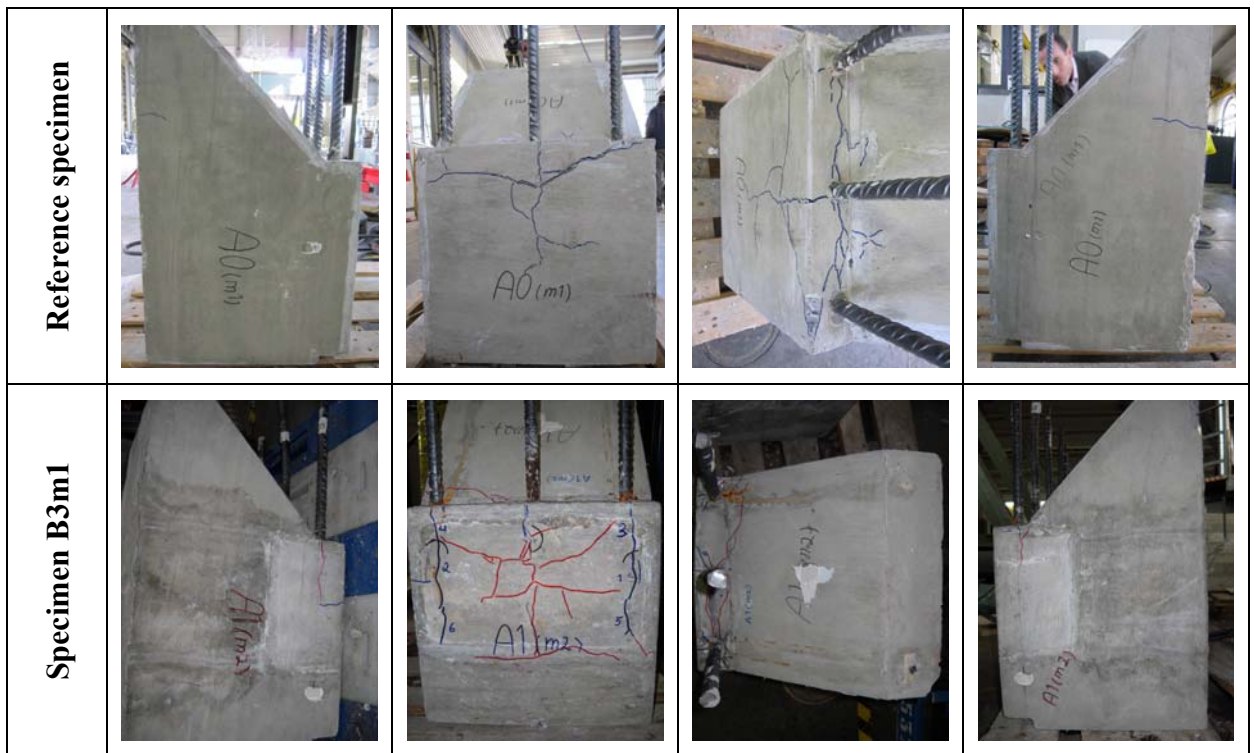
Figure 6.10 Average bond stress versus free-end slip measured in the pull-out tests for specimens B3m1 and the reference specimens.

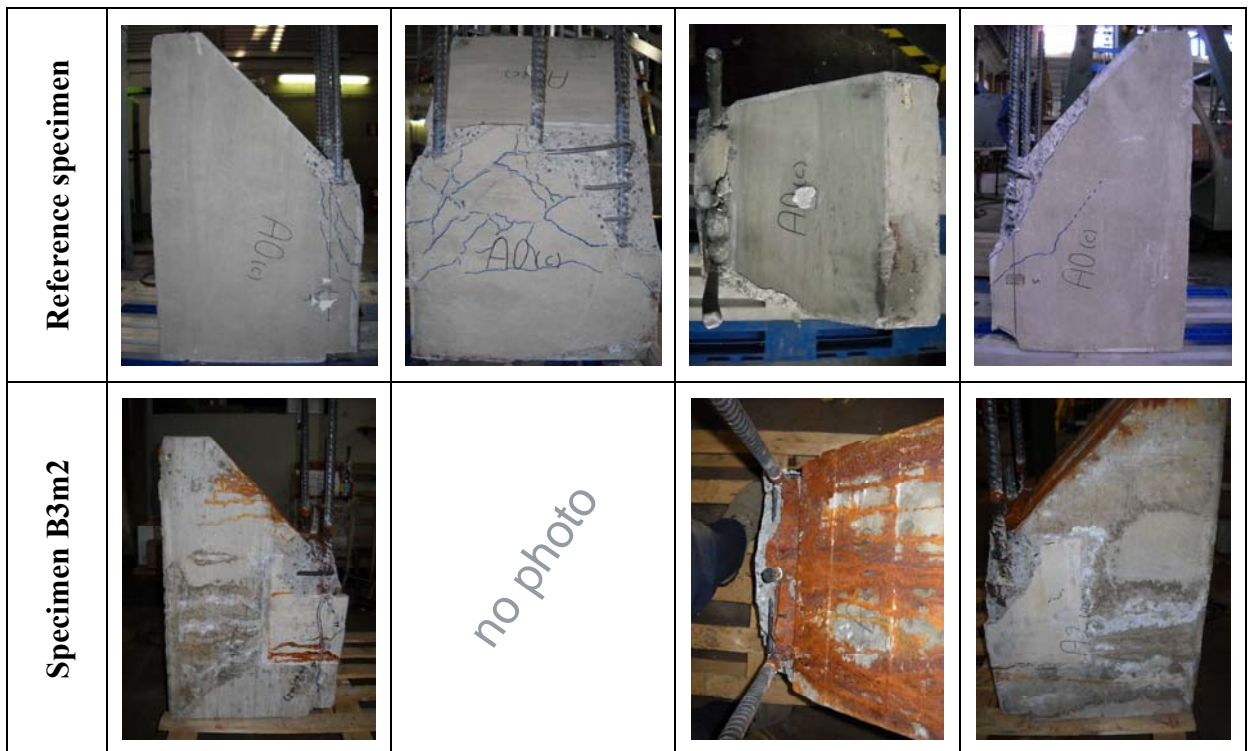
Figure 6.11 Average bond stress versus free-end slip measured in the pull-out tests for specimens B3m2 and the reference specimens.
