## Strengthening and repair of steel bridges

Techniques and management

*Master of Science Thesis in the Master's Programme Structural Engineering and Building Performance Design*

Göteborg, Sweden 2011

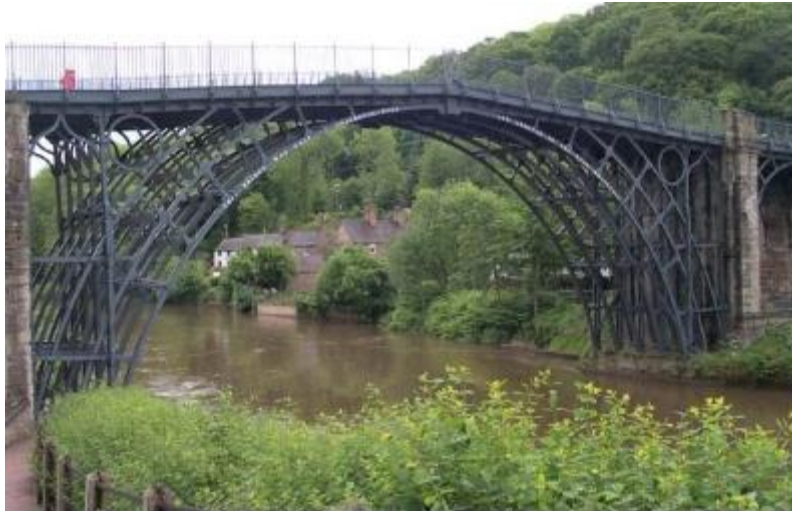
*Figure 2.1 The Iron Bridge in Coalbrookdale, UK [17].*

Cast iron came to use in the beginning of 1700 and the first iron bridge was done in 1800. Its name was Ironbridge in Coalbrookdale, UK, see figure 2.1.

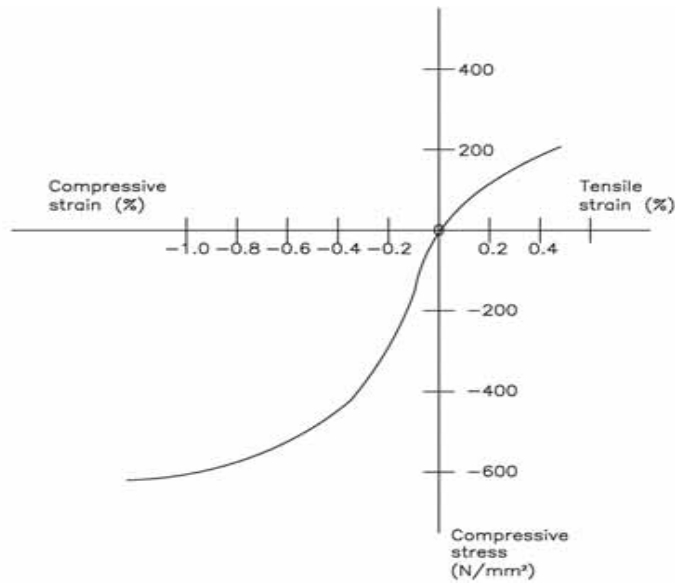
Figure 2.2 Stress-strain relationship for cast iron [1].

Cast iron is strong in compression and weak in tension. It is also brittle and sensitive for fatigue and shows size effect [1] [4]. As it can be seen in Figure 2.2, cast iron has non-linear relationship between stress and strain because of presence of graphite flakes. It can also be noticed that there is no yield point which can be defined accurately [1].

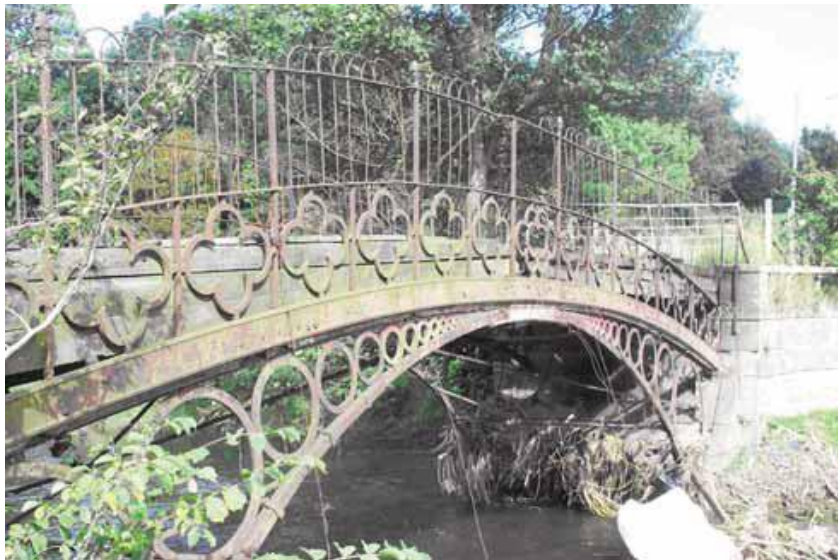
Figure 2.3 Cast iron after 50 years without maintenance, corrosion is evident [1].

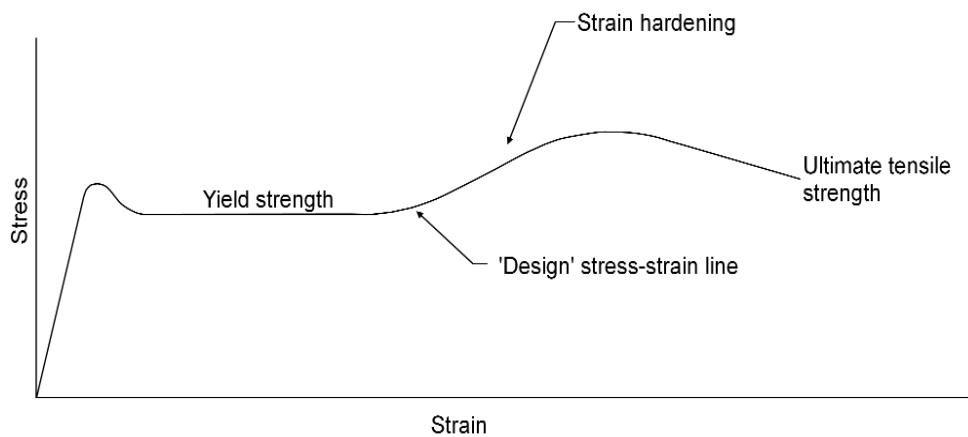
Figure 2.6 Stress and strain relation in modern steel [1].

The lower carbon content in the modern steel makes the material have a linear-elastic relationship between stress and strain. In Figure 2.6 upper and lower yield points can be seen as well as and the ductile-plastic area [1].

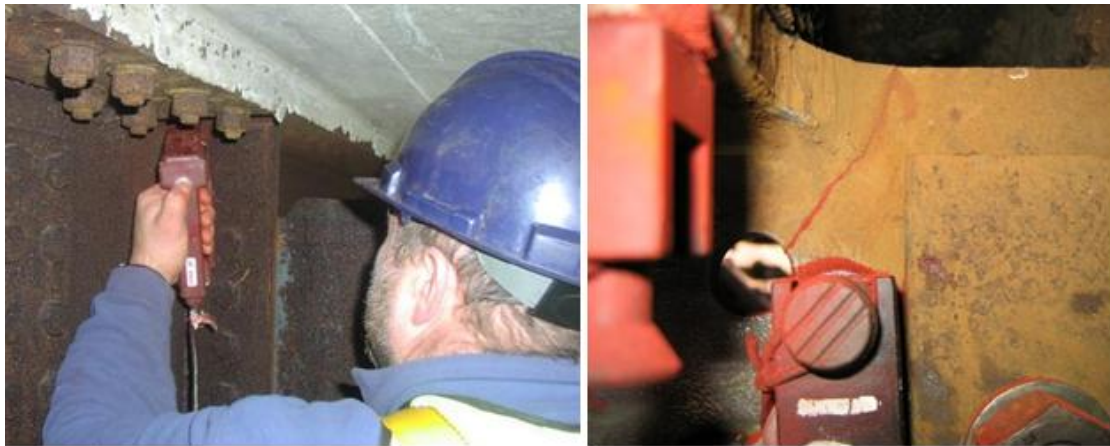
Figure 3.3 Operation of MPI test [23].

There are several factors that influence the success of this testing technique. Magnetic flux should be sufficient in the tested surface, conditions of lightning and the operator has experiences see Figure 3.3. The surface condition of the tested material is also influencing the success of the test [1].

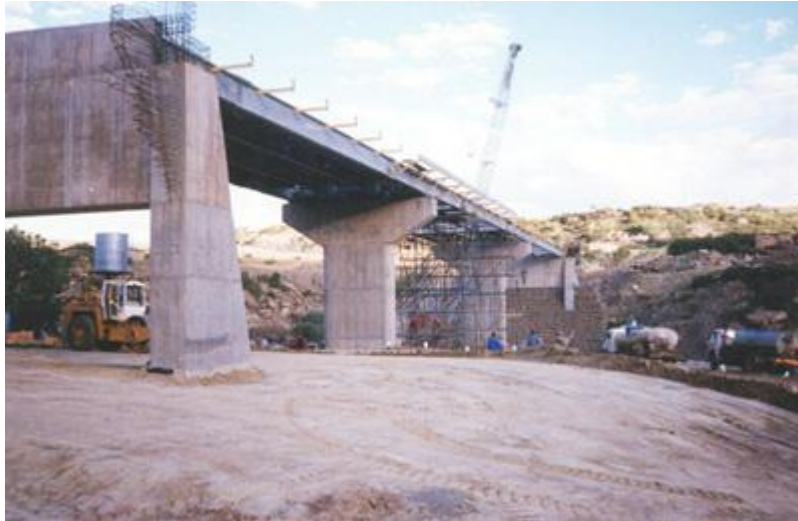
*Figure 4.3 Erection of continuous steel beam bridge (place and name of the bridge are unknown) [18].*

The most common used areas are pedestrian bridges and highway bridges. For longer spans, piers are required see Figure 4.3.

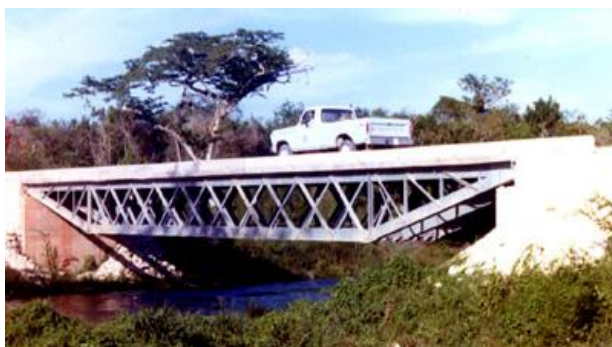
*Figure 4.5 Steel over truss bridge in Belize (name of the bridge is unknown) [18].*

This kind of bridges is very similar to the steel girder bridges, but in this case trusses are used instead of the girders, a typical example can be seen in Figure 4.4 and 4.5. The use of trusses makes the bridge lighter and deeper. The depth of the bridges is approximately 12 % of the span and this should be considered when an over truss bridge is erected over road- or waterway [18].

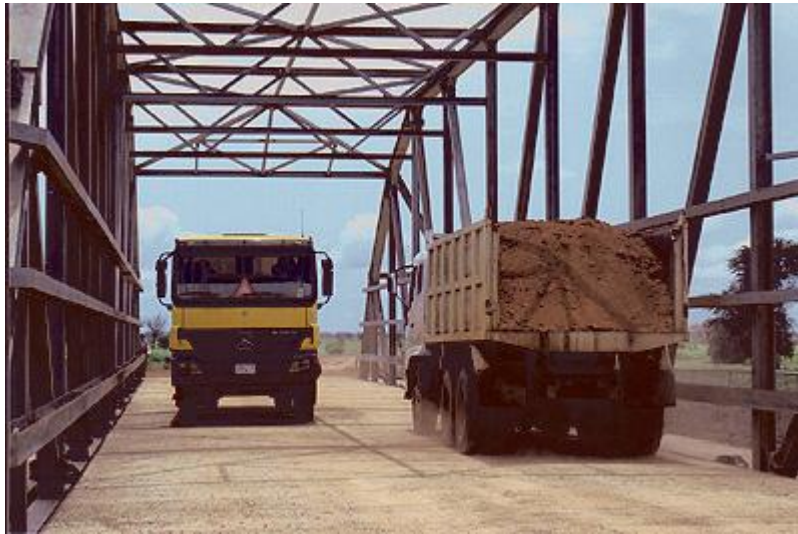
Figure 4.10 Trough truss bridge (name and place of the bridge are unknown) [18].

Trough truss bridges are simple to design and have a modern appearance, see Figure 4.10.

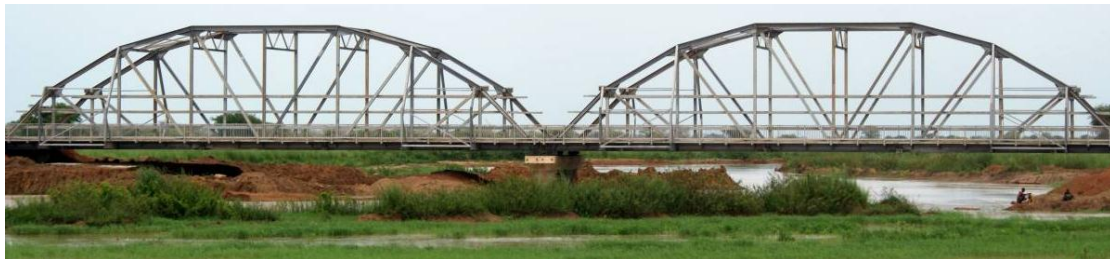
Figure 4.16 shows a steel bowstring girder bridge that is built in Sudan. Due to lack of big cranes the bridge is constructed by cantilever launch method [18].

Figure 4.16 Steel bowstring girder bridge in Sudan [18].

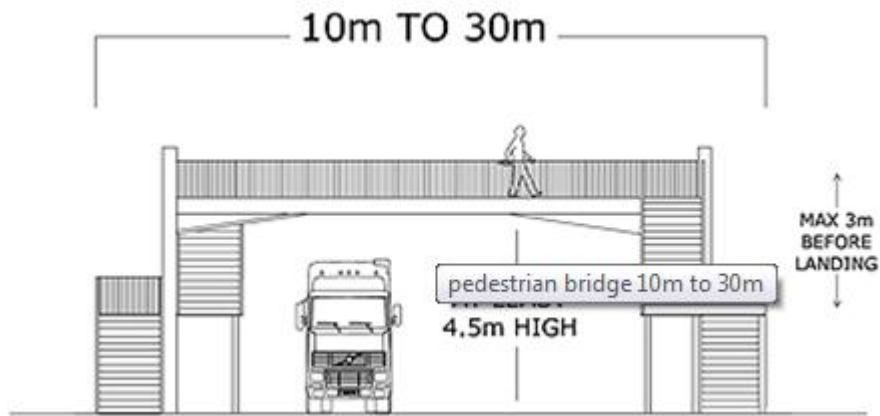
Steel pedestrian bridges are designed for pedestrians and can also be used by cyclists. Span can be between 10 m and 30 m and suitable over waterway, roadway or railway where there is no way for pedestrians and cyclists, see Figure 4.22. Minimum width of the bridge should be 1.2 m due to maintenance.

Figure 4.22 A typical pedestrian bridge with minimum headroom and span range [18].

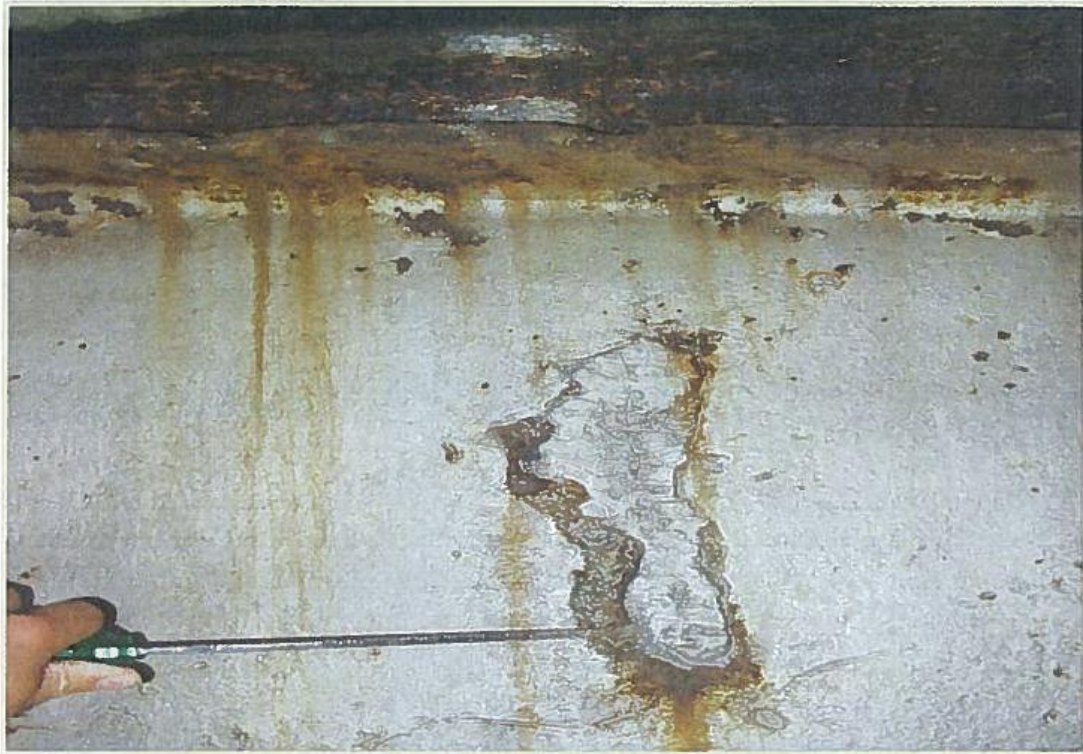
Blow holes are most common defect in cast iron and can be repaired in the factory. The reparation can be done by infilling the blow holes with non-structural material. This defect is not easy to detect on-site due to coating and painting [1]. Figure 5.1 shows an example where a defect in a beam that was over 100 years old and could not be detected till 2006.

Note the corrosion staining to the ironwork

Figure 5.1 A defect is older than 100 years [1].

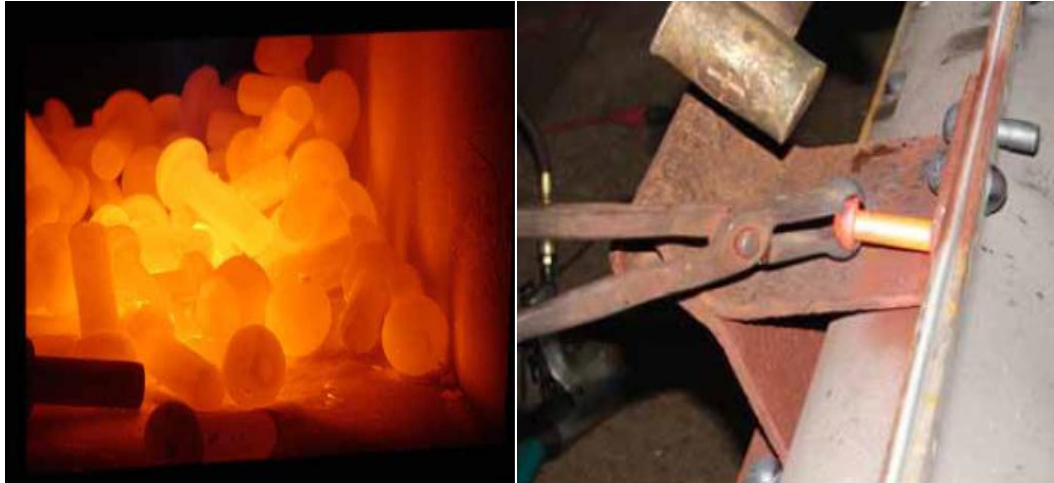
*Figure 6.5 Heating of the rivets and introducing the holes [15].*

When changing the existing rivets, single headed rivet is heated and then the shank is placed into the hole in the structure from one side see Figure 6.5 [1].

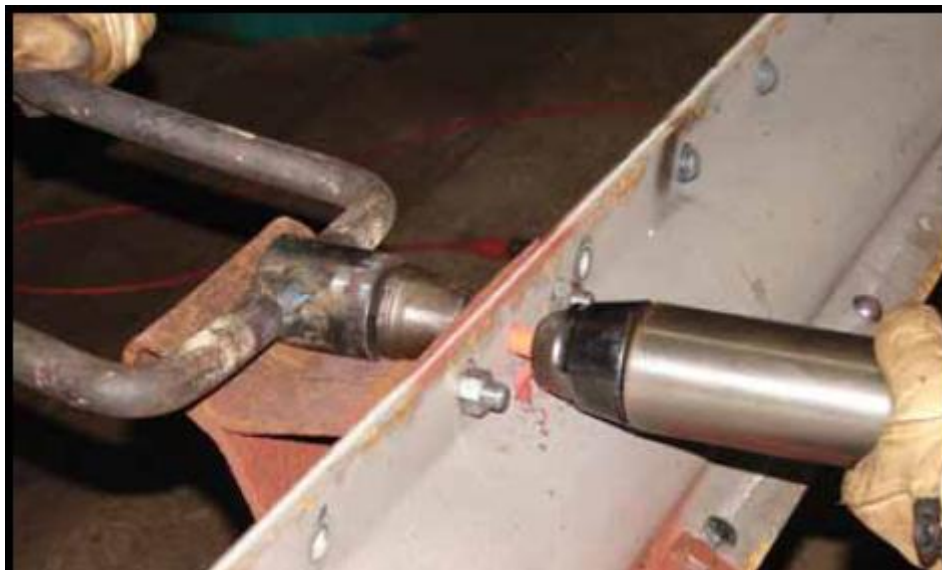
*Figure 6.6 The second rivet heat is shaped [15].*

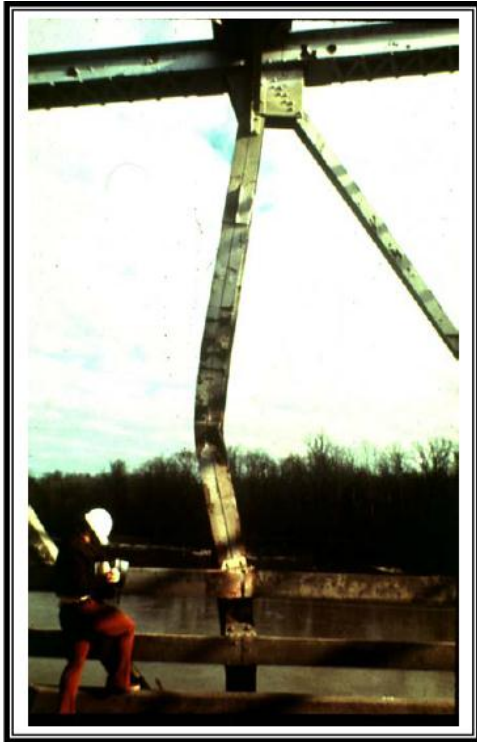
(a) Category W damage on a built-up double channel truss member. The damage was caused by a log falling from a truck on a bridge in North Louisiana.

Bending about weak axis, see Figure 6.11 [11].

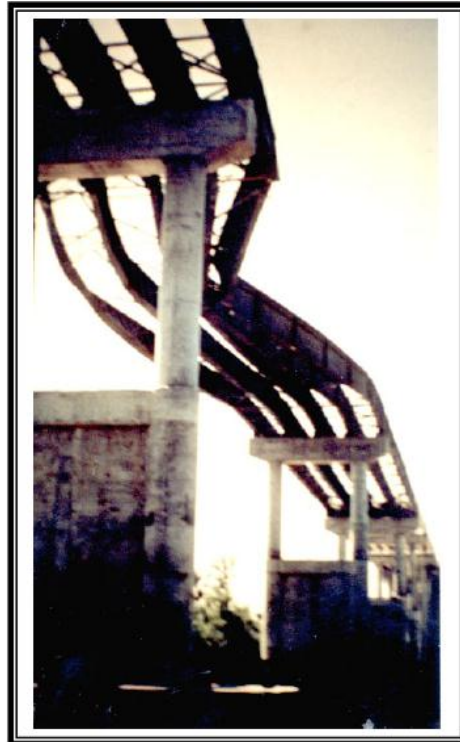
(b) Category W damage to main girders during construction of a Louisiana bridge.

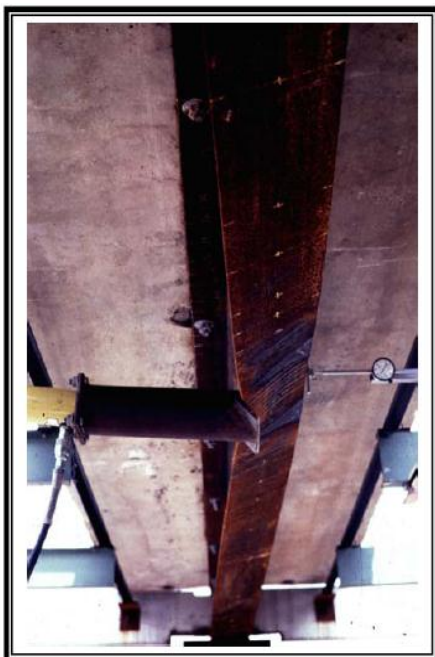
Torsional or twisting damage about longitudinal axis of the member is included in this category. Two examples are showed in Figure 6.12 and Figure 6.13 [11].

*Figure 6.12 Category T, in this case the damage caused by hydraulic jack for experiment [11].*

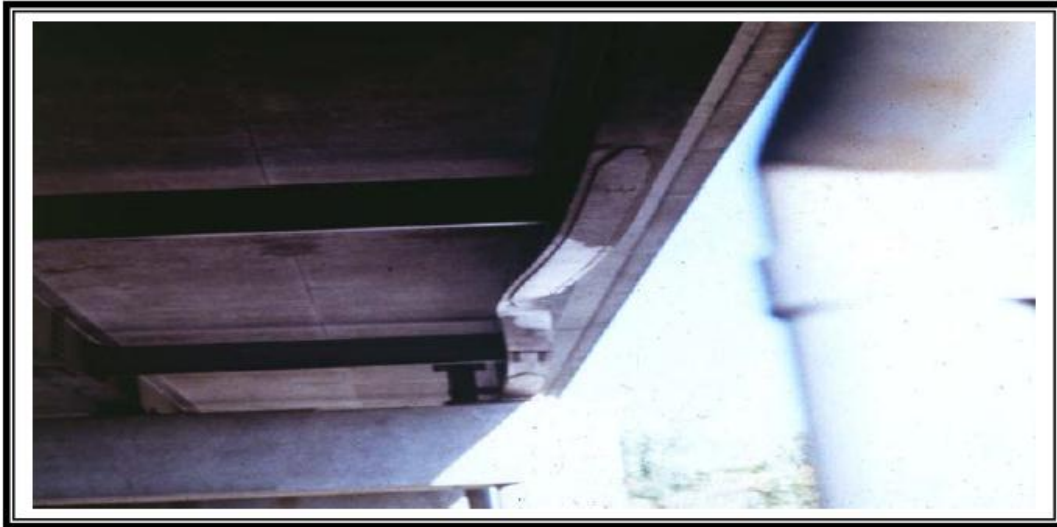
**Category T damage on a composite bridge girder impacted by an over-height vehicle in Wisconsin.**

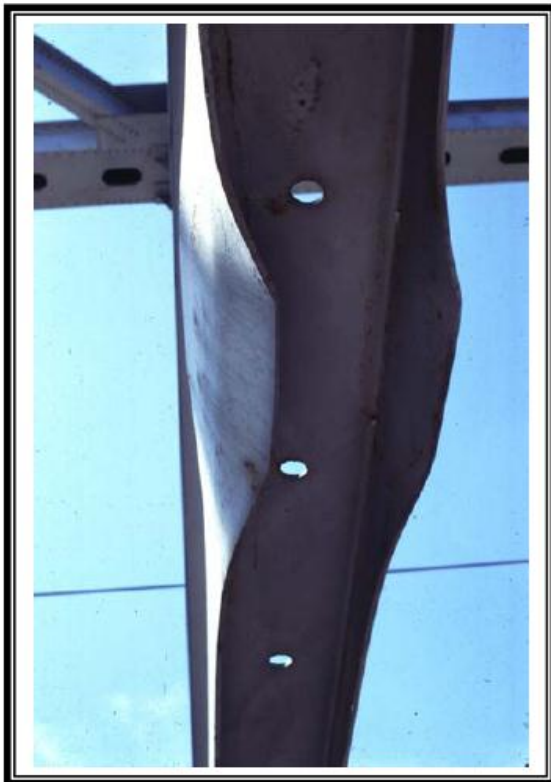
**Category L damage showing flange buckles on wind bracing on Mississippi River Bridge in Greenville, MS.**

This category includes damages such as local flange and web buckling, web crippling, bending in plates etc., see Figure 6.14 [11].

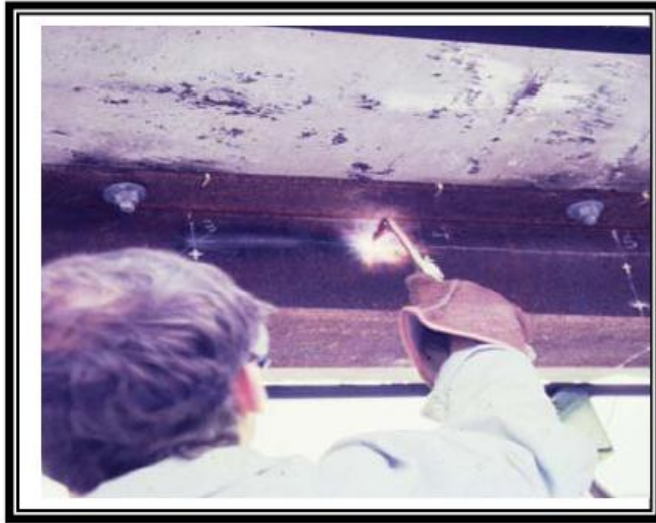
Figure 6.18 Line heating in the web [11].

Line heating is used to repair bended plate about weak axis and also bulging in the web. A bulging in the web can be repaired by applying the straight line heating on the convex side of the deformation [2] [11]. Figure 6.18 shows line heating process.

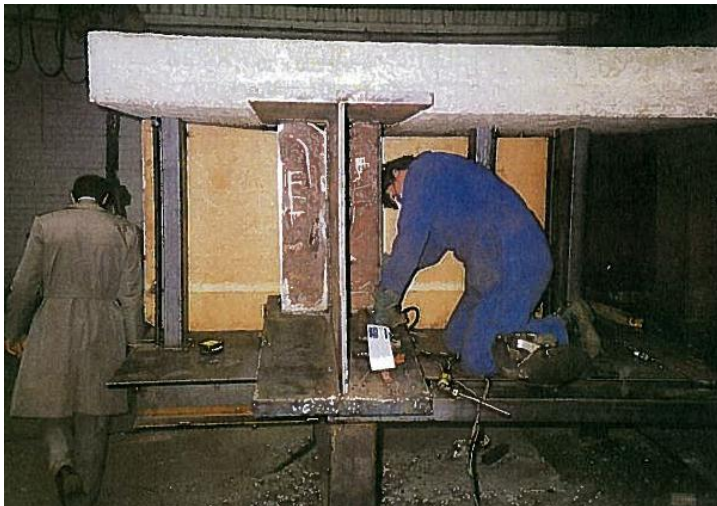
Figure 7.1 A mock-up was built before the operation [3].

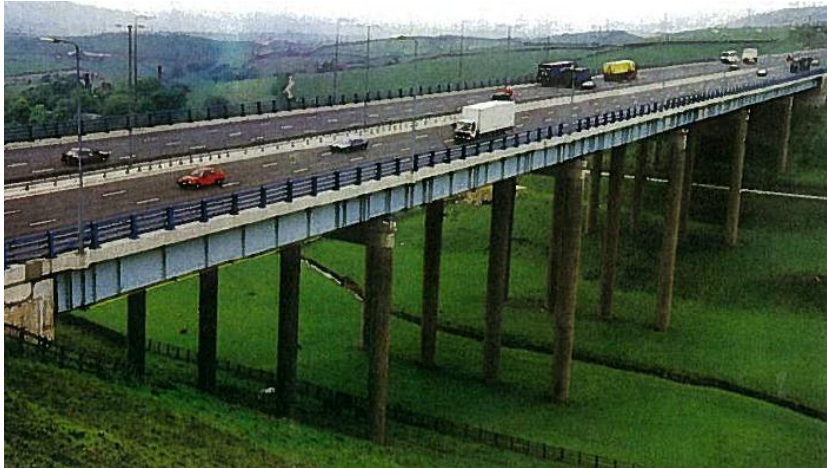
Rakewood Viaduct is carrying M62 motorway and consists of six continuous spans see Figure 7.2. The maximum height of the Viaduct is 36m see Figure 7.3 [3].

Figure 7.2 Rakewood Viaduct [3].

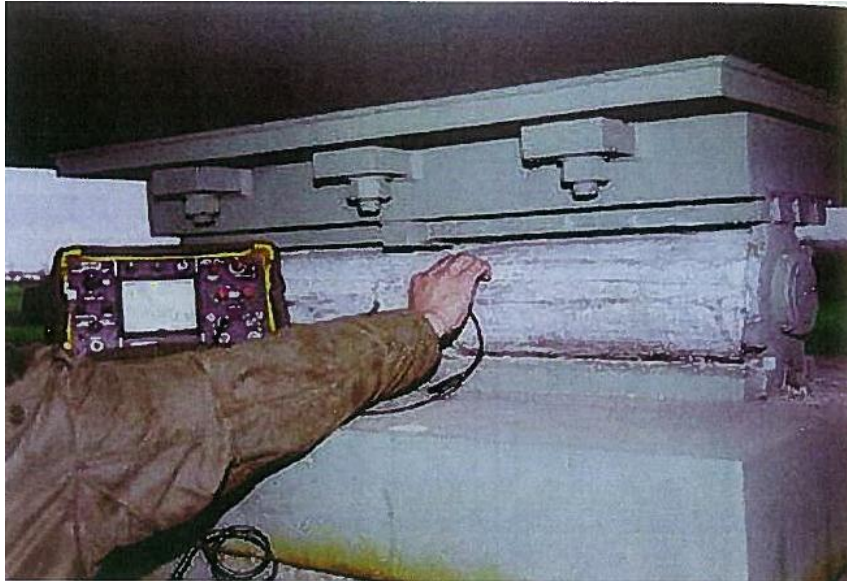
Figure 7.5 The damaged rolling bearing [3].

A crack was found in one of the rolling bearings and a piece of the roller had been cracked away see Figure 7.5. The roller bearings had a poor fatigue resistance and some of them were already cracked. The longitudinal stiffener along the bottom flange was also included to the strengthening operation due to the failed assessment of their bending moment. Shear capacity of the box girder web was insufficient (12 m from the support).

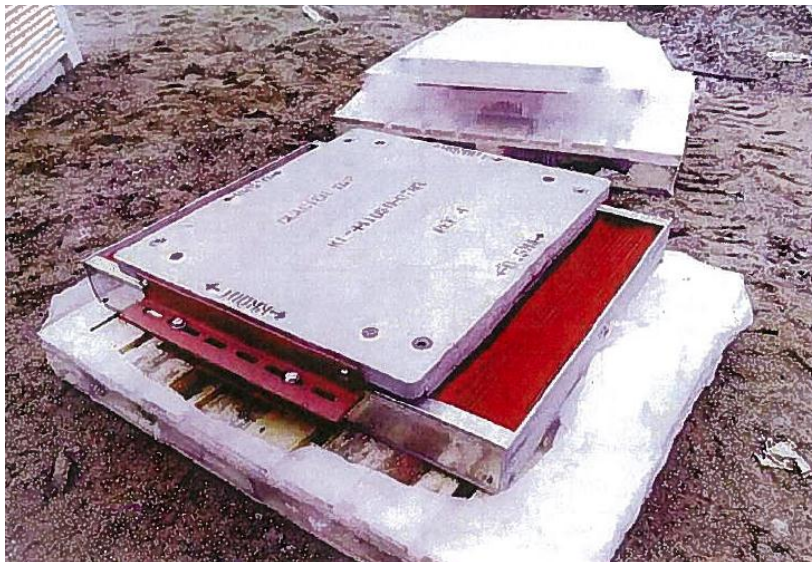
Figure 7.6 An inverted pot bearing in package [3].

Installation of strengthening: Firstly, doubler plates were welded to the transverse stiffener at the jacking points and then the jacks were installed. Damage in the web welds were repaired after jacking. Instead of the rolling bearing, inverted pot bearings were installed see Figure 7.6 [3].

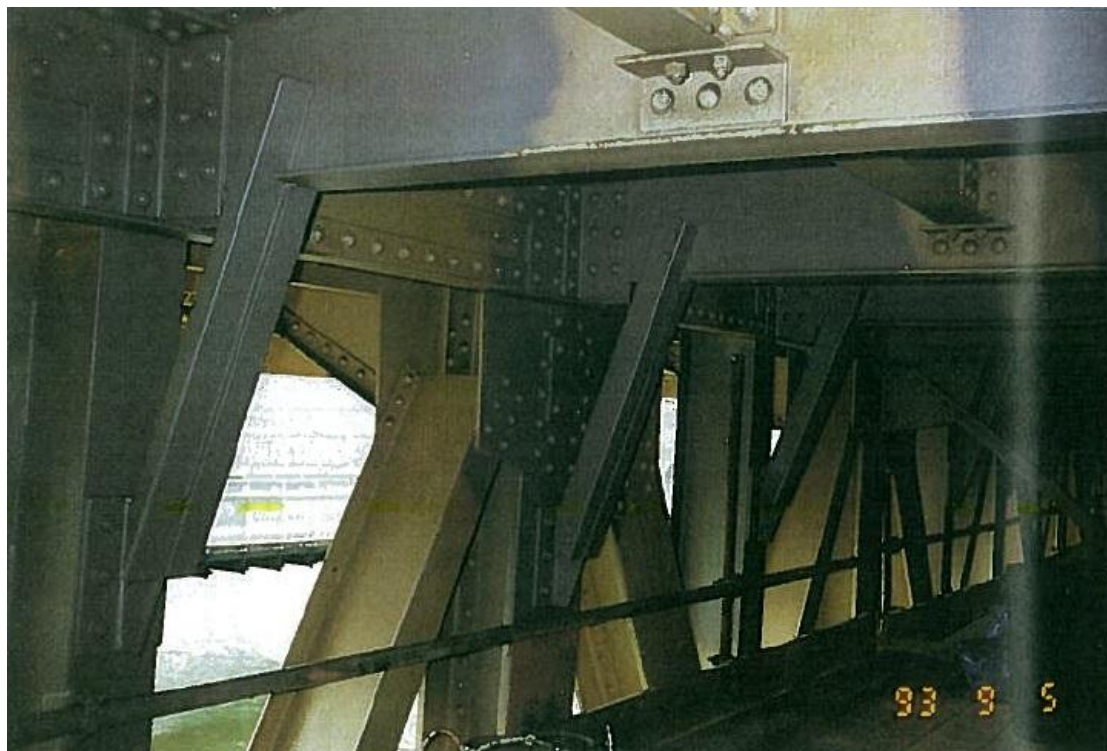
Installation of strengthening: Cross members were supported by knee brackets (diagonal struts) see Figure 7.11 [3].

Figure 7.11 Diagonal struts-Conwey Bridge [3].

Inspection before the operation	The internal lattice structure inspected.
Tests before the operation	Steel grade tested.
How fasten?	The brackets were connected to the structure by HSFG bolts, see figure 7.11. New parapet was jointed to the new brackets by prestressing bars see Figure 7.10.
Traffic	Traffic was limited to 7.5 t weight during installation of the bracket and traffic was diverted for heavier loads.
Tests after the operation	Welding between the stiffener and the lower rib was tested by MPI.
Time	Generally yes, the operation done in estimated time.
Economic aspects	Generally yes, The operation done in estimated cost.

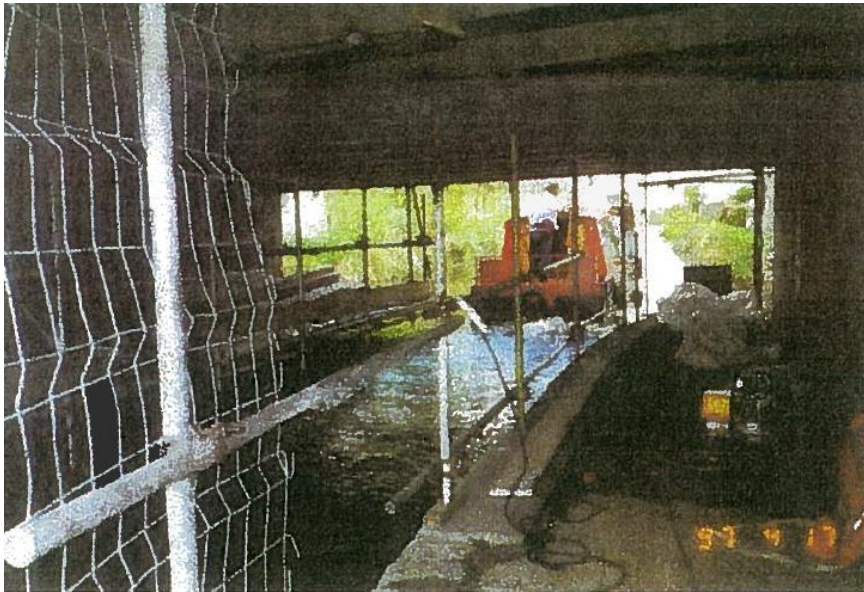
Figure 7.16 Working platform [3].

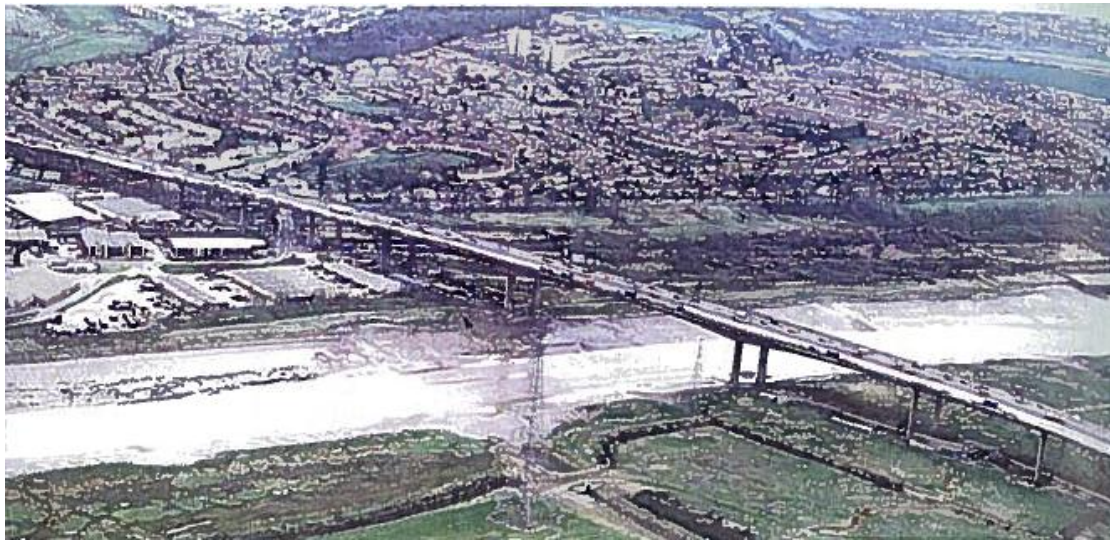
Avonmouth Bridge is carrying M5 and is located in UK, see Figure 7.19.

*Figure 7.19 A view of Avonmouth Bridge [3].*

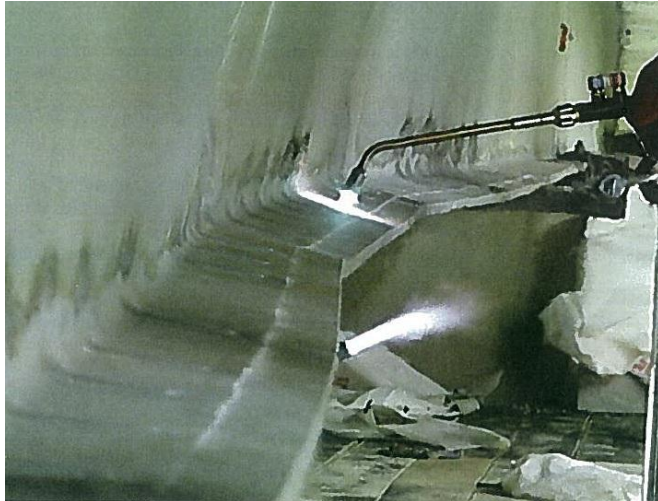
An accident had happened on the southernmost beam and damaged bottom flanges over the whole three lanes. The maximum displacement of the bottom flange was occurred over lane 1 and was 500 mm; see Figure 7.24 [3].

Figure 7.24 Straightening work of damaged beam [3].

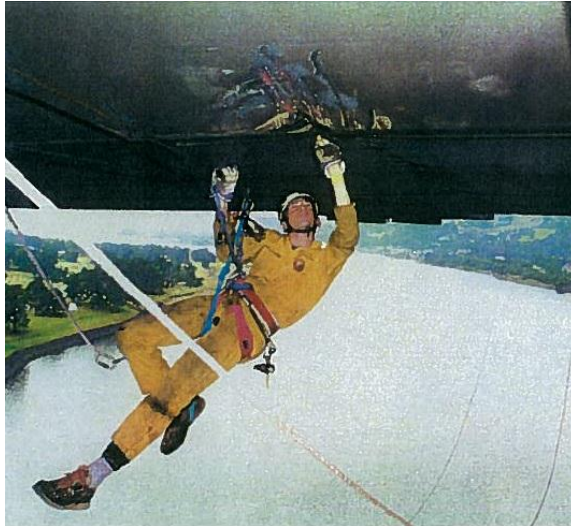
In August 1996, a collision was happened between the bridge and an oil rig when the oil rig passed the river. The collision resulted in damage in the bottom flange, see Figure 7.26 [3].

Figure 7.26 Damage caused by a collision [3].

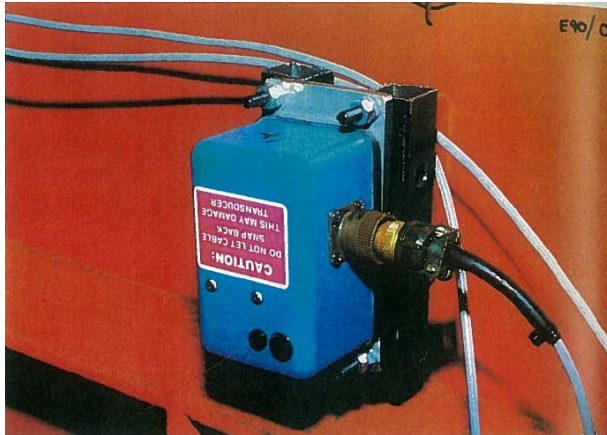
Figure 7.27 Sensor to measure displacement [3].

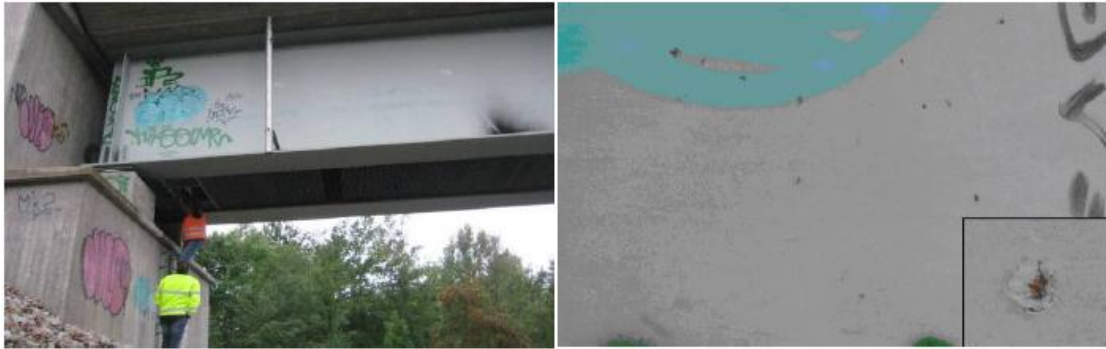
Figure 7.28 S and N abutments, on the right side graffiti can be seen and on the left side damage from stone can be seen [19].

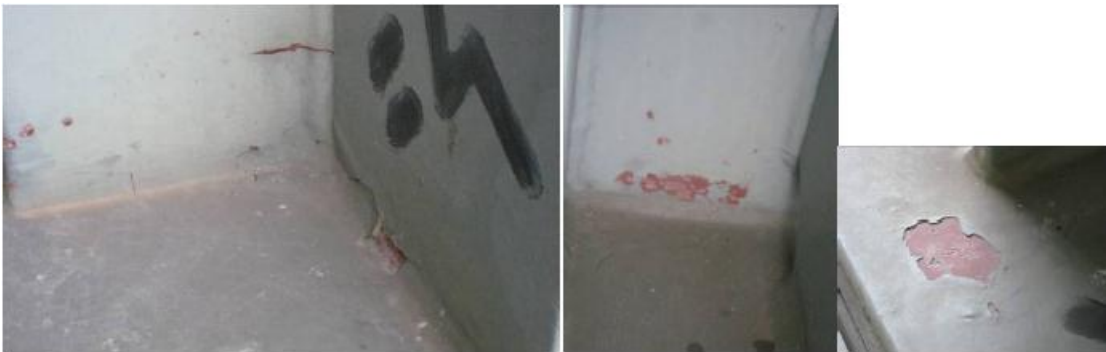
Figure 7.29 Flaking of painting, S abutment [19].

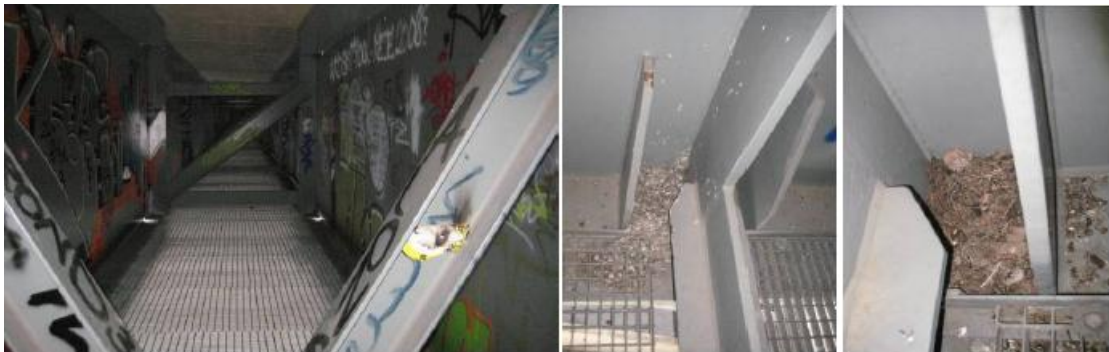
Figure 7.30 Graffiti and a roost inside of the bridge [19].

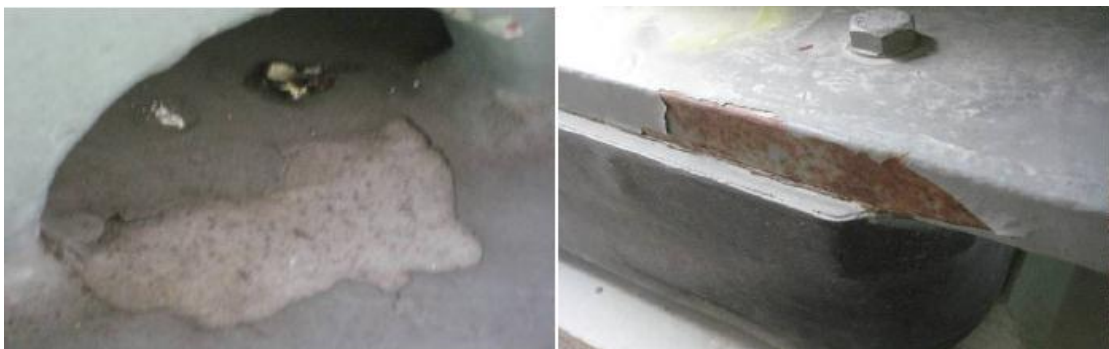
Figure 7.31 On the left side flaking of painting next to a notch in S abutment and on the right side flaking of bearing painting in N abutment [19].

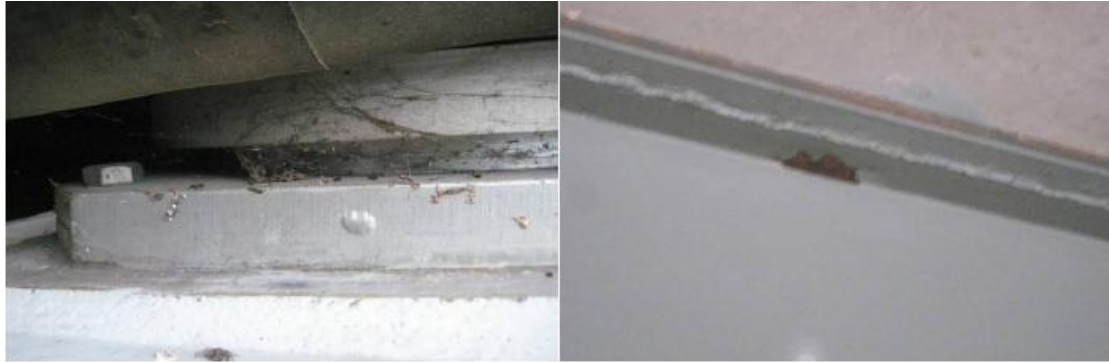
Figure 7.32 On the left side a blowhole without rust in S and N abutment and on the right side a rust under painting [19].

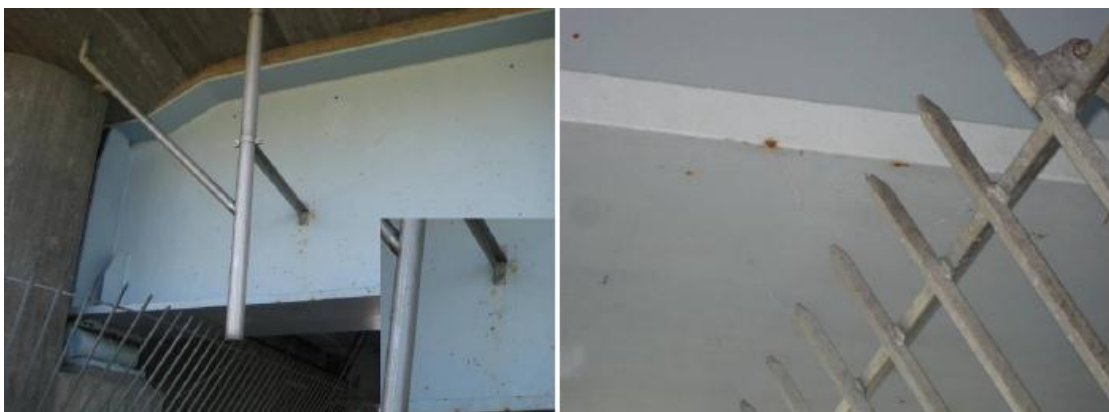
Figure 7.33 Damage from stone throw and rust on bottom flange, East abutment [19].

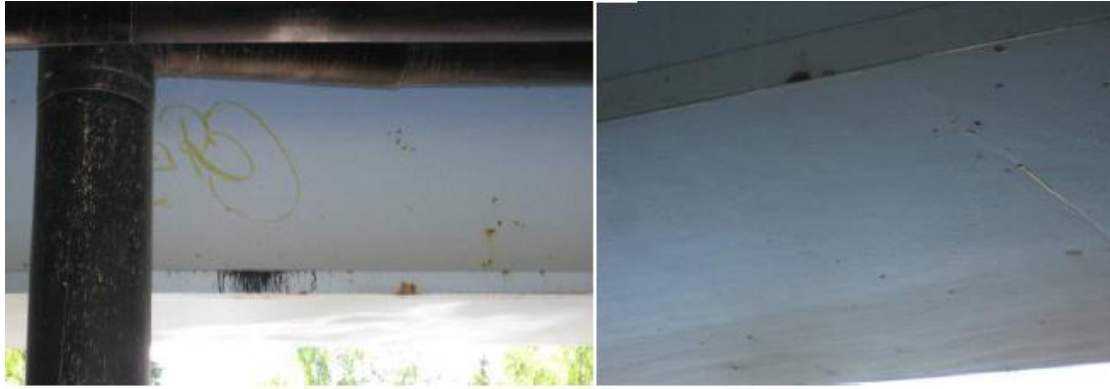
Figure 7.34 Rust on the main beam [19].

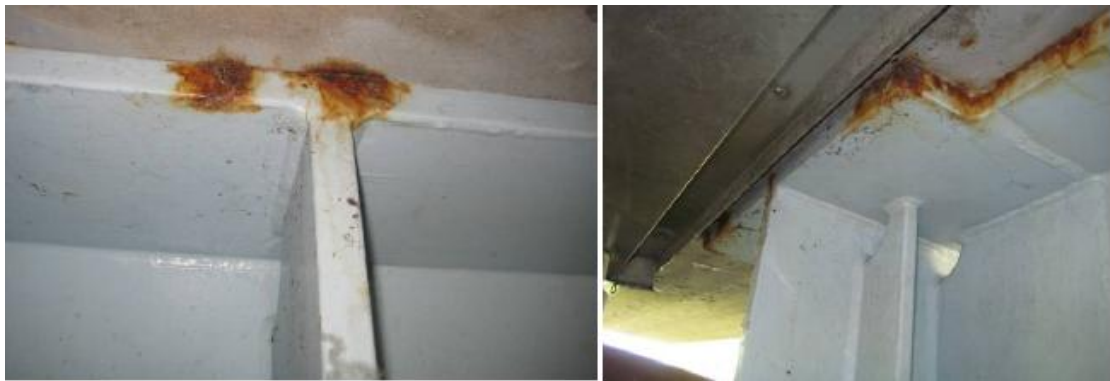
Figure 7.35 On the left side rust detected on top flange against concrete and on the right side rust occurred on splice [19].

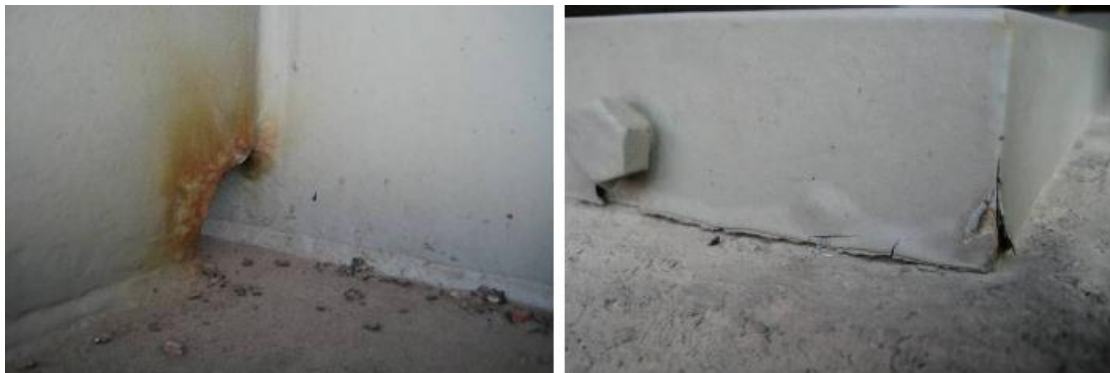
*Figure 7.37 On the left side rust created on a notch and on the right side paint of the bearing loosened (in N abutment) [19].*

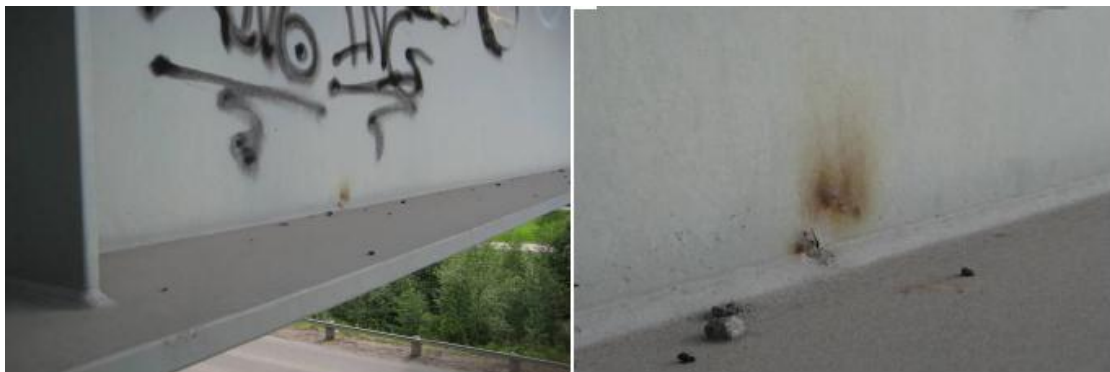
*Figure 7.38 Graffiti, stone throw and rust [19].*

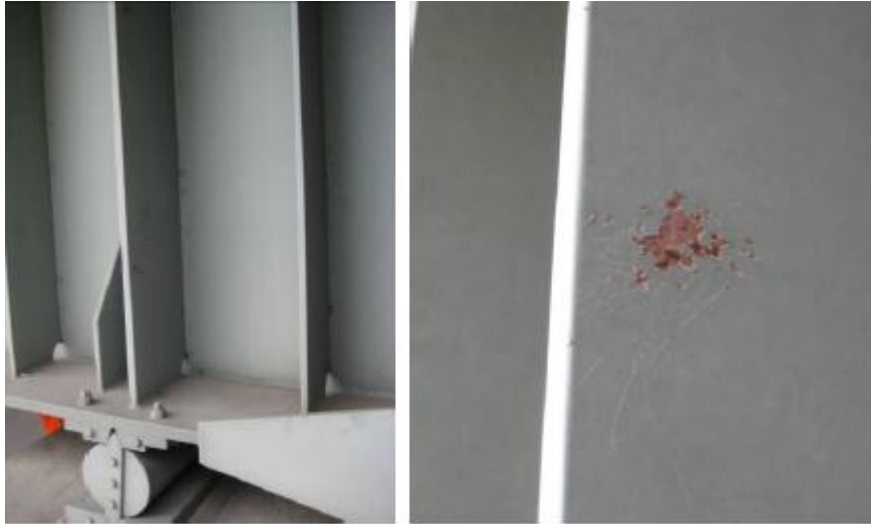
Figure 7.39 Detected damage on stiffener [19].

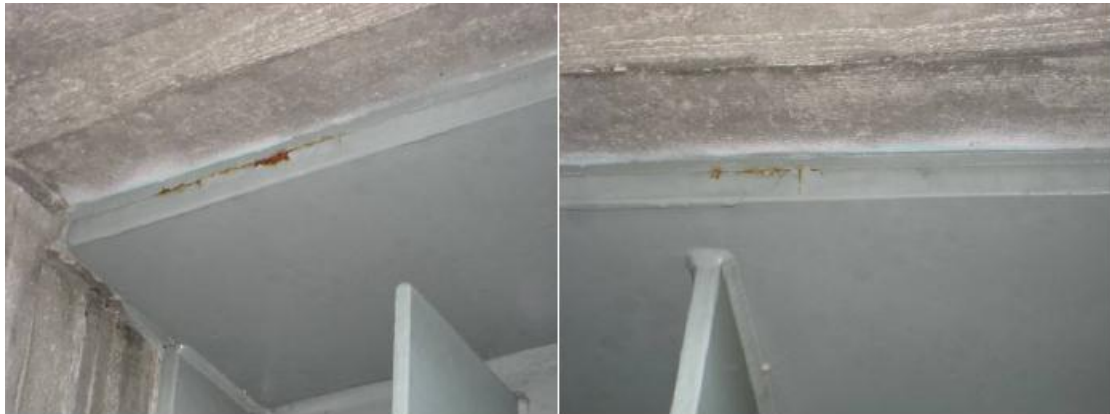
Figure 7.40 Rust created between the top flange and concrete [19].

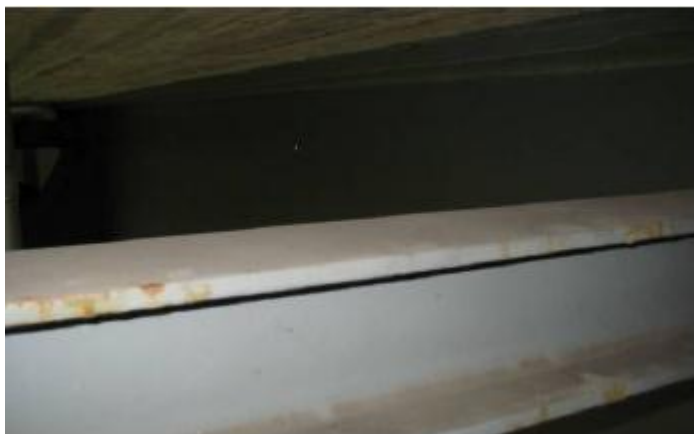
Figure 7.41 Rust created on cross-beam [19].

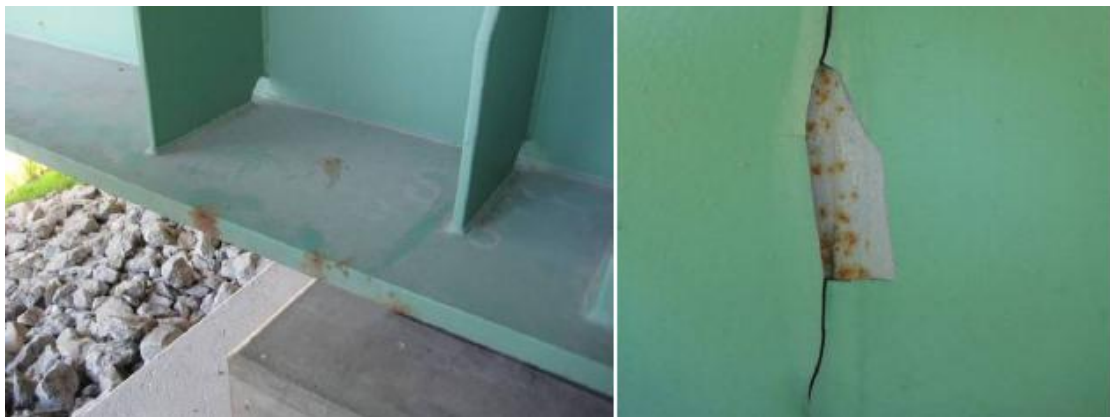
Figure 7.42 On the left side rust created on bottom flange and on the right side cracked paint, paint flaking and rust in main beam can be seen [19].

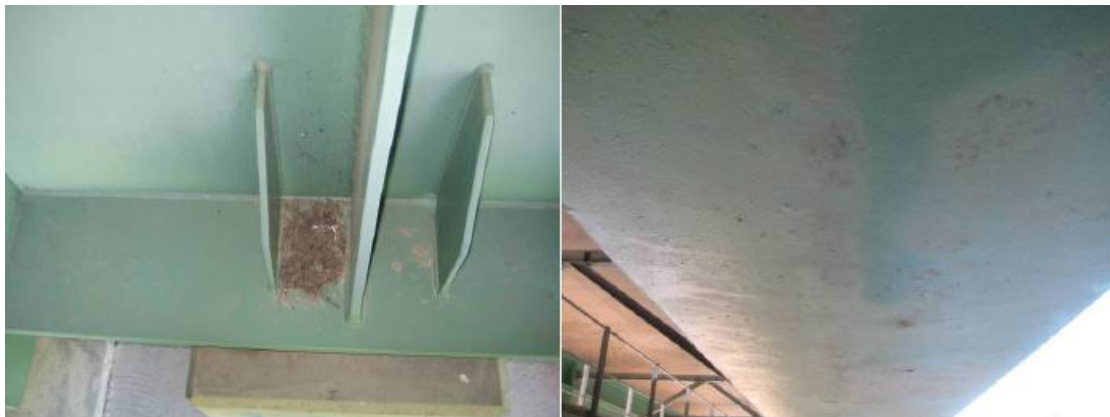
Figure 7.43 A roost and rust in bottom flanges [19].

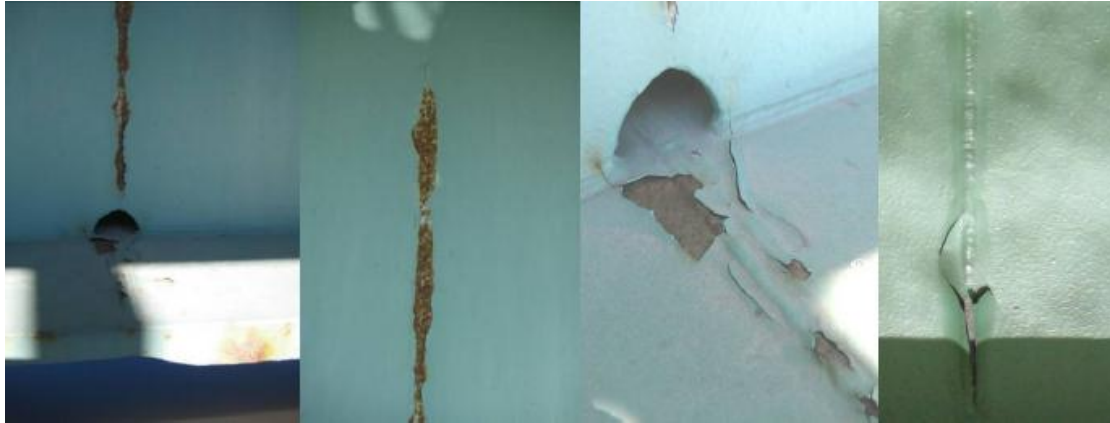
Figure 7.44 Paint flaking and rust created on main welds [19].

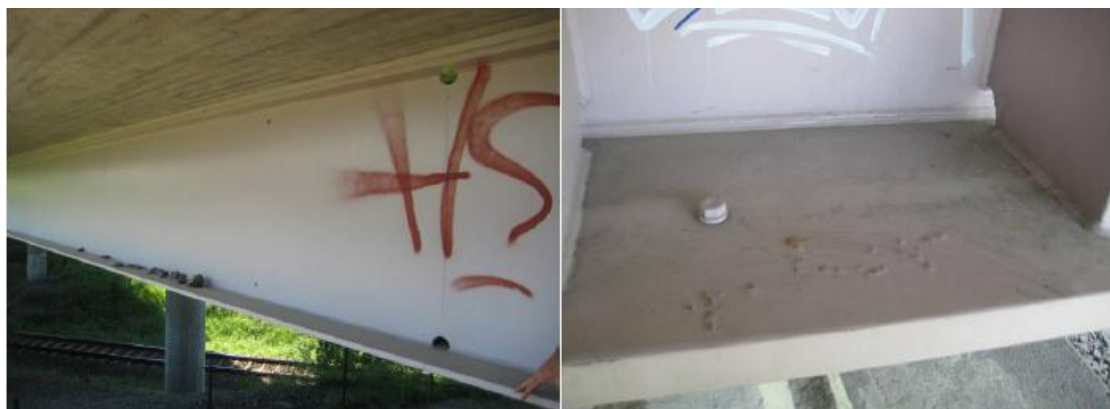
Figure 7.46 On the left side graffiti and stones can be seen and on the right side rust blisters can be seen [19].

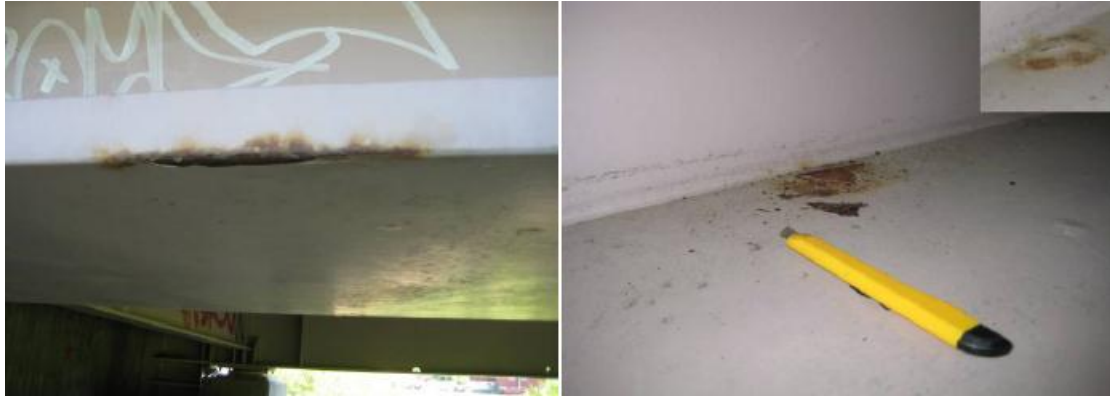
Figure 7.47 On the left side rust damage occurred and on the right side rust blisters occurred [19].
