## Strengthening and repair of steel bridges

Techniques and management

*Master of Science Thesis in the Master's Programme Structural Engineering and Building Performance Design*

Göteborg, Sweden 2011

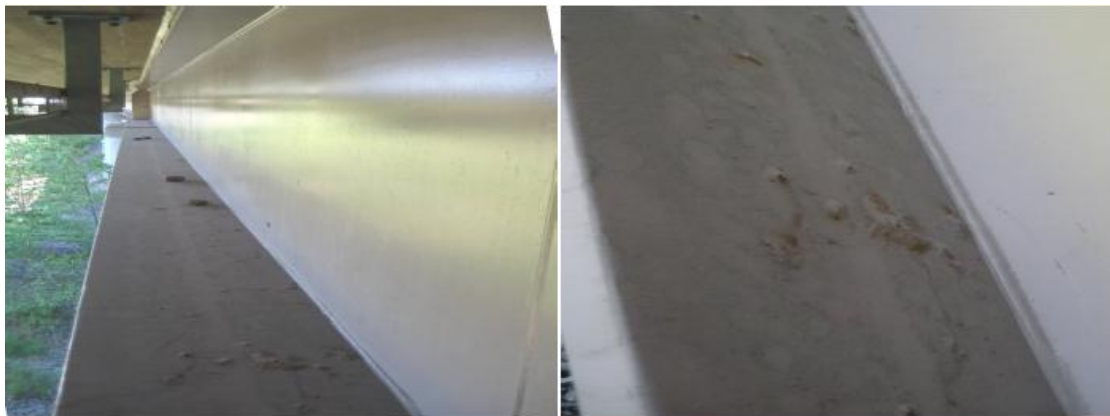
Figure 7.48 Rust damages on bottom flange [19].

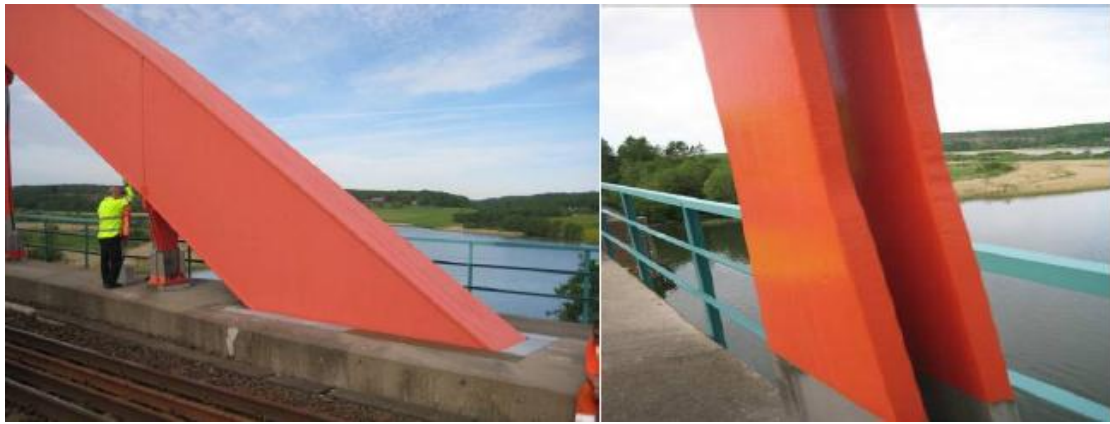
Figure 7.49 Bottom part of the arch was re-constructed and stainless steel used [19].

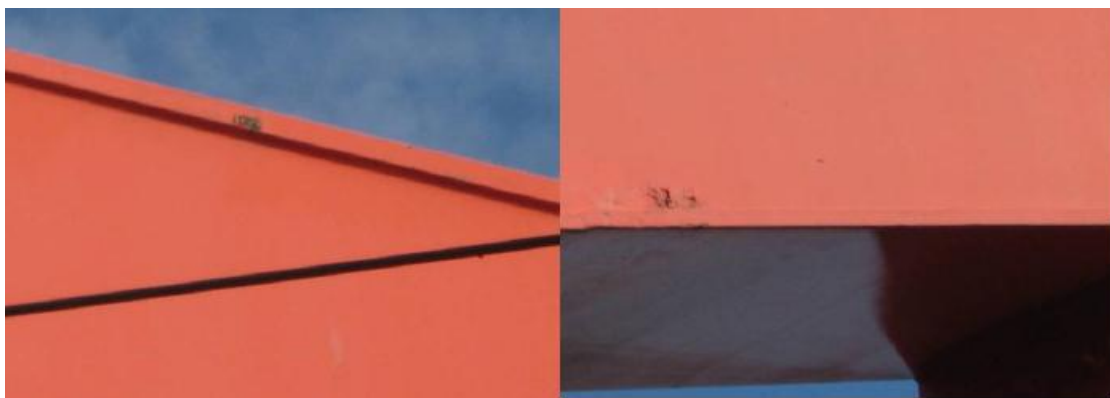
Figure 7.50 Rust created [19].

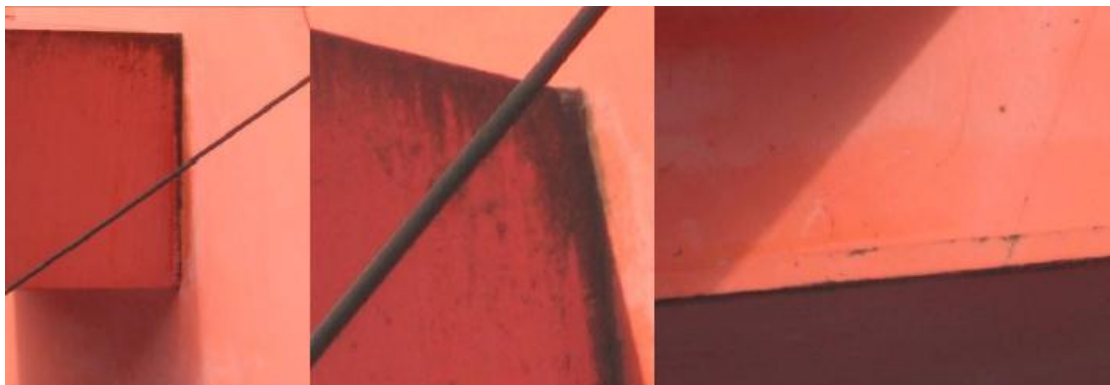
Figure 7.51 Dirty components causing corrosion [19].

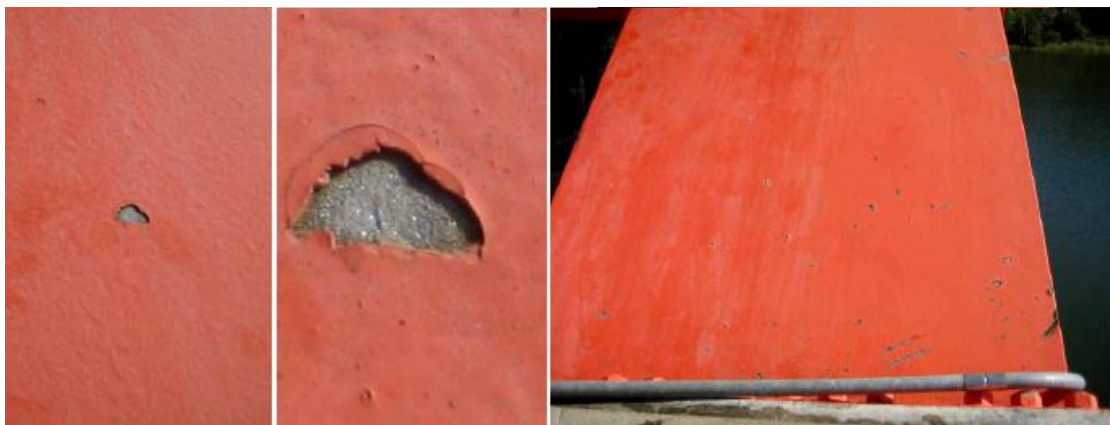
Figure 7.52 On the left side a damage caused by stone throw by trains can be seen and on the right side damages caused by climbing can be seen [19].

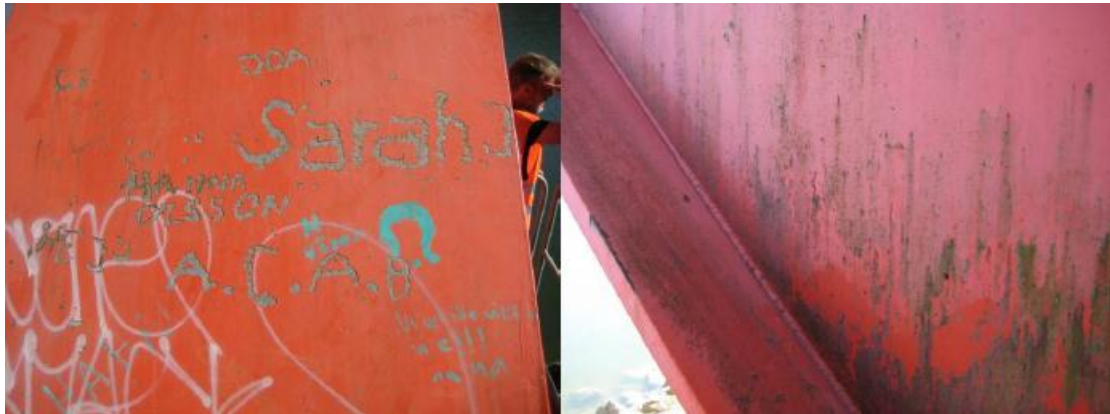
Figure 7.53 On the left side damage caused (have to be repaired) by humans and on the left side fouling can be seen [19].

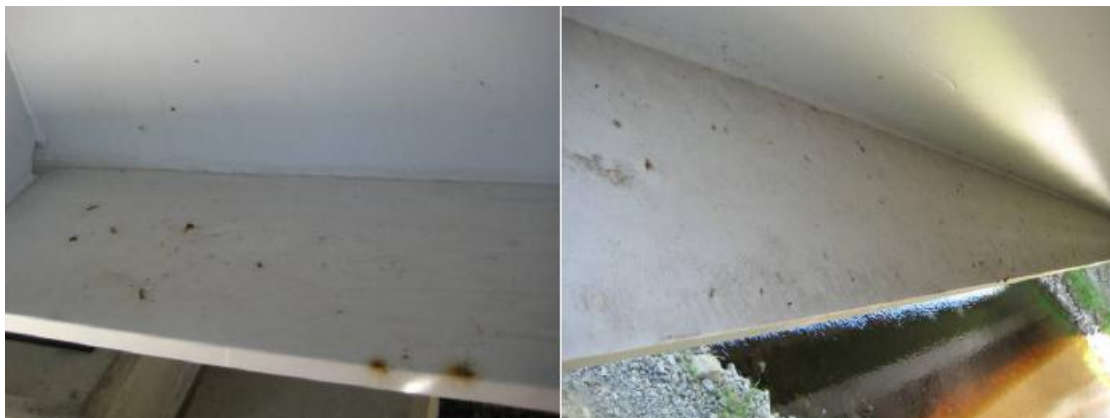
Figure 7.54 Deep-seated rusts on the flanges [19].

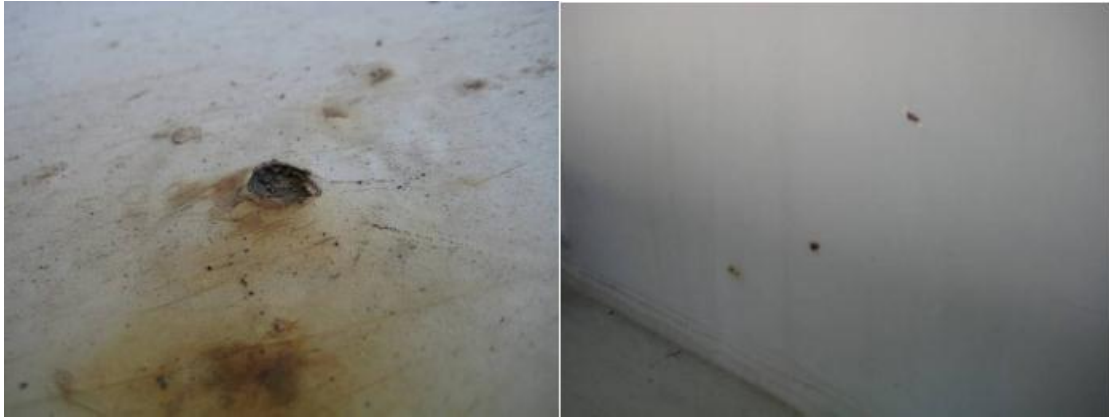
*Figure 7.55 On the left side deep-seated rust can be seen and on the right side stone throw damages can be seen [19].*

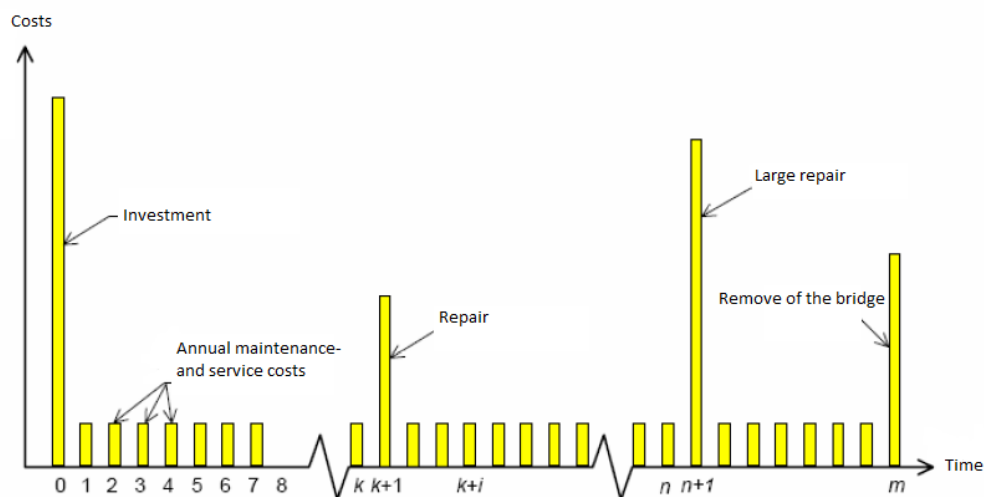
Figure 8.7 Typical LCC analysis for bridges [20].
