Structural evaluation of possible storey- extension of medium-rise buildings from 1965-1975

*Master of Science Thesis in the Master's Programme Structural Engineering and
Building Performance Design*

Department of Civil and Environmental Engineering
Division of Structural Engineering
CHALMERS UNIVERSITY OF TECHNOLOGY
Göteborg, Sweden 2012 Master's Thesis 2012:102

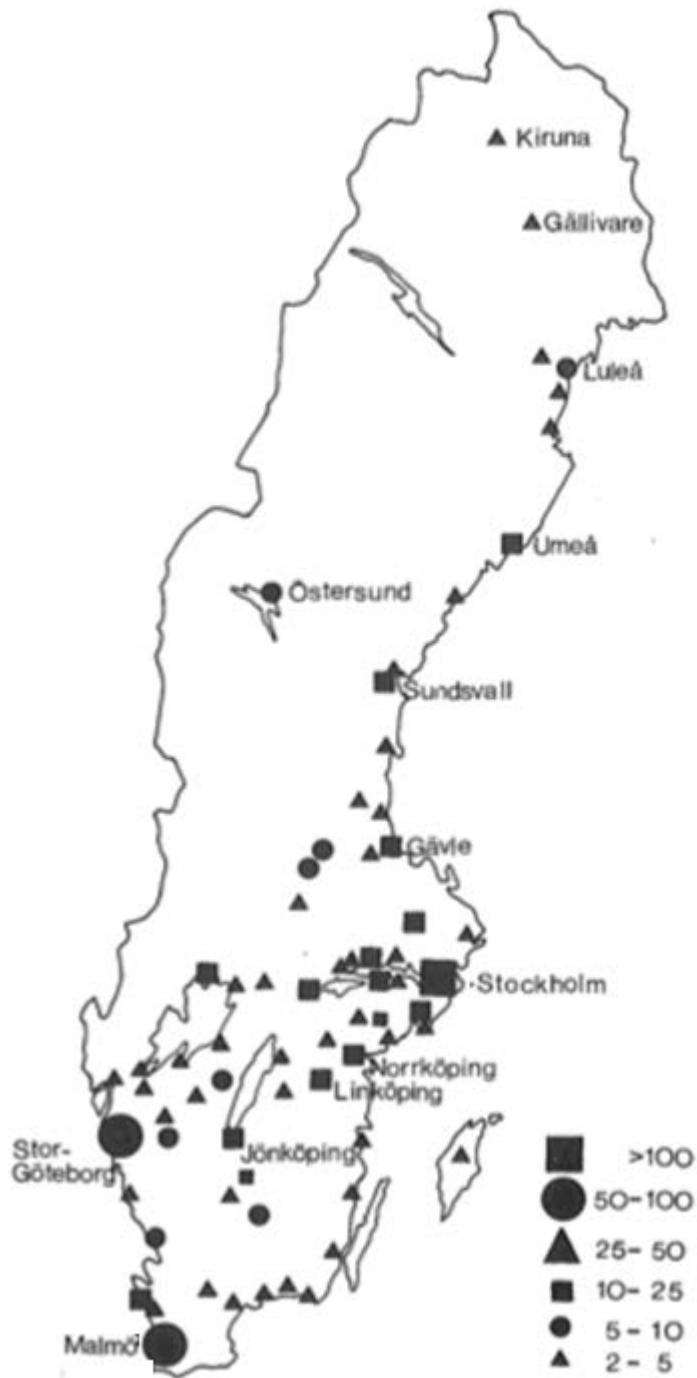
Figure 1 Production of apartments in the number of thousands built during the years 1961-1975 (Modified from Hall 1999)

A common opinion is that ‘the Million programme’ only affected the major cities in Sweden. However, the fact is that, as can be seen in Figure 1, buildings were built throughout the entire nation.

Slab blocks were, as already mentioned, the most common buildings during ‘the Million programme’. These houses exist in a number of varieties spread out all over Sweden as can be seen in Figure 1, and represented between 75 and 90 percent of the annual apartment production, as can be seen in Figure 5. Lower slab block, slab block with three stories were popular even before ‘the Million programme’ began and were the single most common building type during those years. Almost half of all buildings were built as slab blocks with three stories, see Figure 6 (Hall 1999).

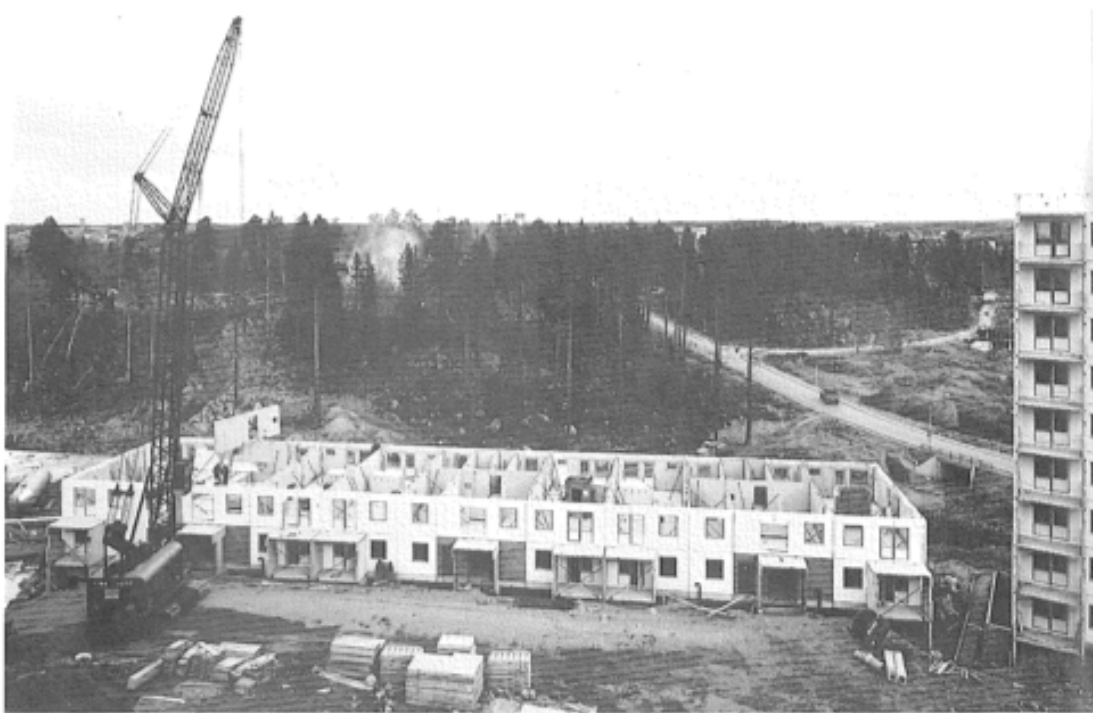
Figure 4 Picture of a typical house built with prefabricated elements (Vidén & Lundahl 1992)

production of about 2500 apartments a year. However, as the technique evolved and the method was cultivated, the production increased and in 1971 about 20000 apartments were constructed (Vidén & Lundahl 1992). Figure 4 shows a typical assembling of a prefabricated building from ‘the Million programme’.

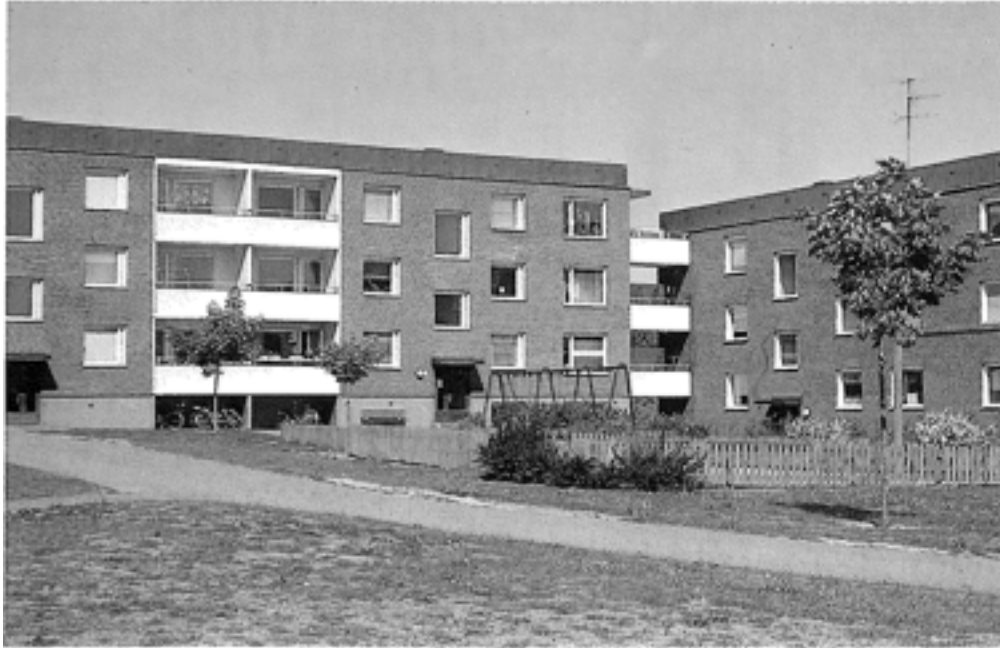
Figure 6 Typical Lower slab-block house, Härnösand (Björk, Kallstenius & Reppen 1992)

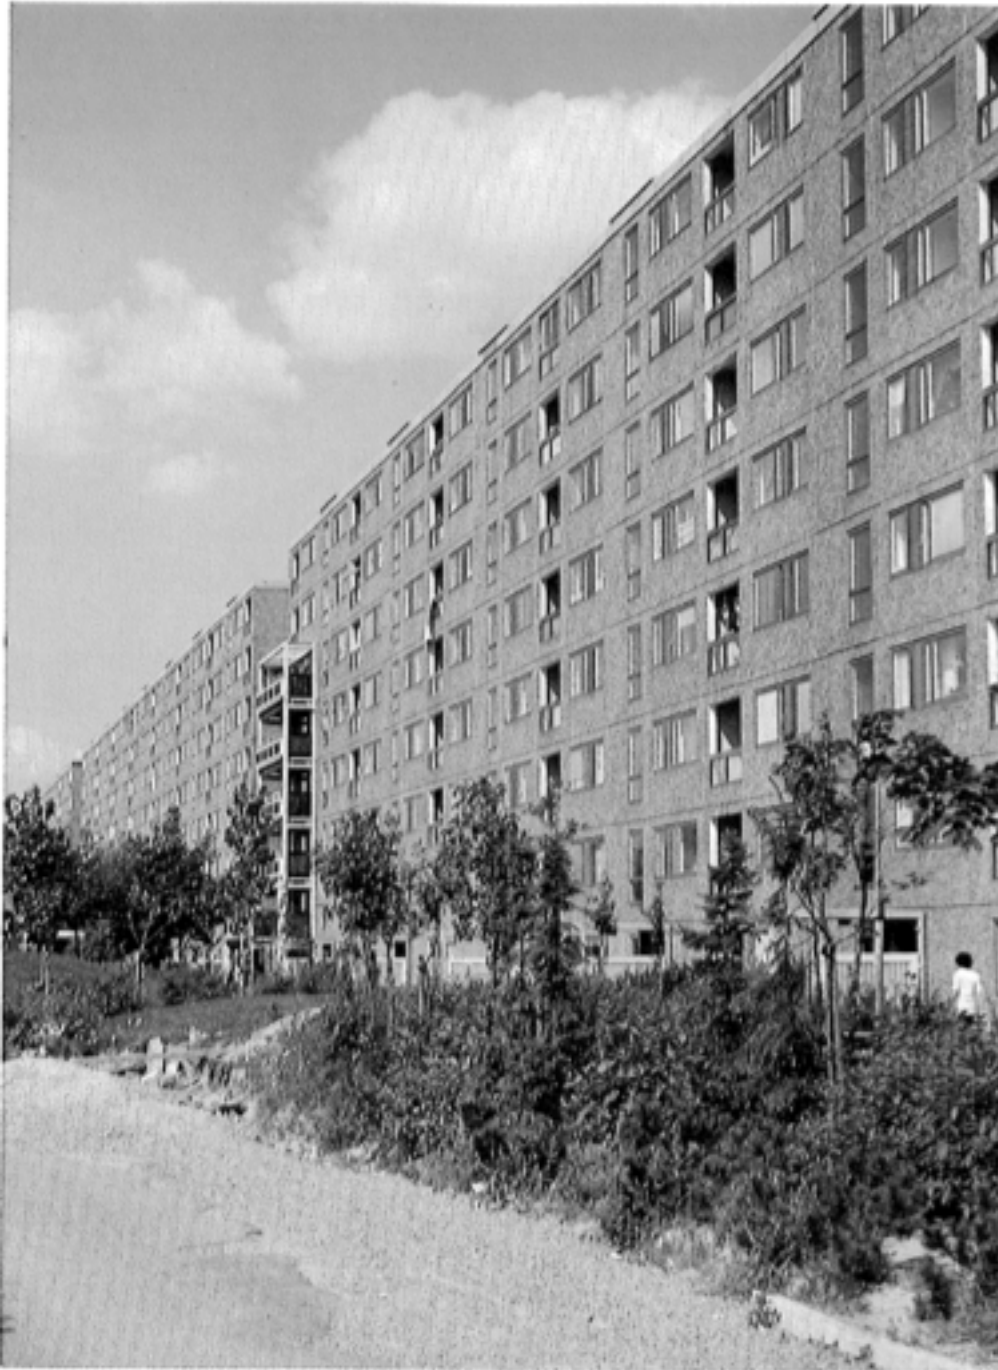
Figure 7 Typical higher slab-block houses, Gothenburg (Björk, Kallstenius & Reppen 1992)

Higher slab blocks, see Figure 7, represent a quarter of all houses built during ‘the Million programme’. Higher slab blocks have at least five stories (Flerbostadshus 2011) and are mainly located in the suburbs, but are also found in inner city areas where a complete remediation of earlier buildings was considered necessary. Higher slab blocks were always built with elevators and the larger buildings also had a furniture elevator installed (Vidén & Lundahl 1992).

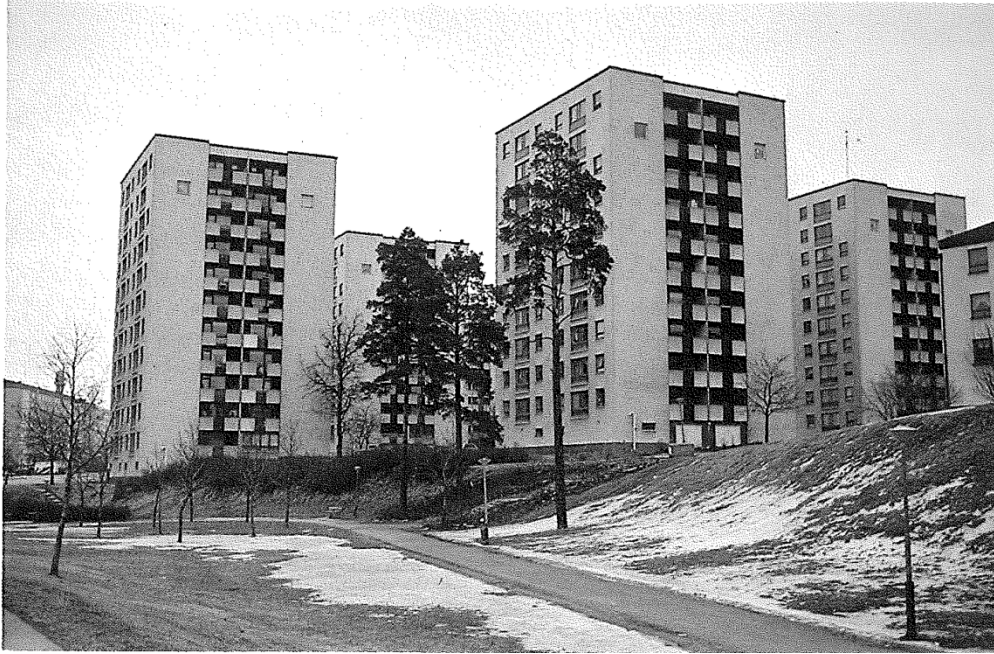
Figure 8 Typical tower blocks, Stockholm (Björk, Kallstenius & Reppen 1992)

Another very common design was the tower block design, see Figure 8. Tower blocks are buildings with a centered staircase that all apartments are arranged around. Tower blocks design was very common during the 1960s when approximately 20% of all apartment buildings being built were of this design. The financing rules between 1956 and 1962 benefited this sort of design. When ‘the Million programme’ was initiated, however, the production had decreased down to 9% (Hall 1999). Most tower blocks are between 6 and 8 stories high.

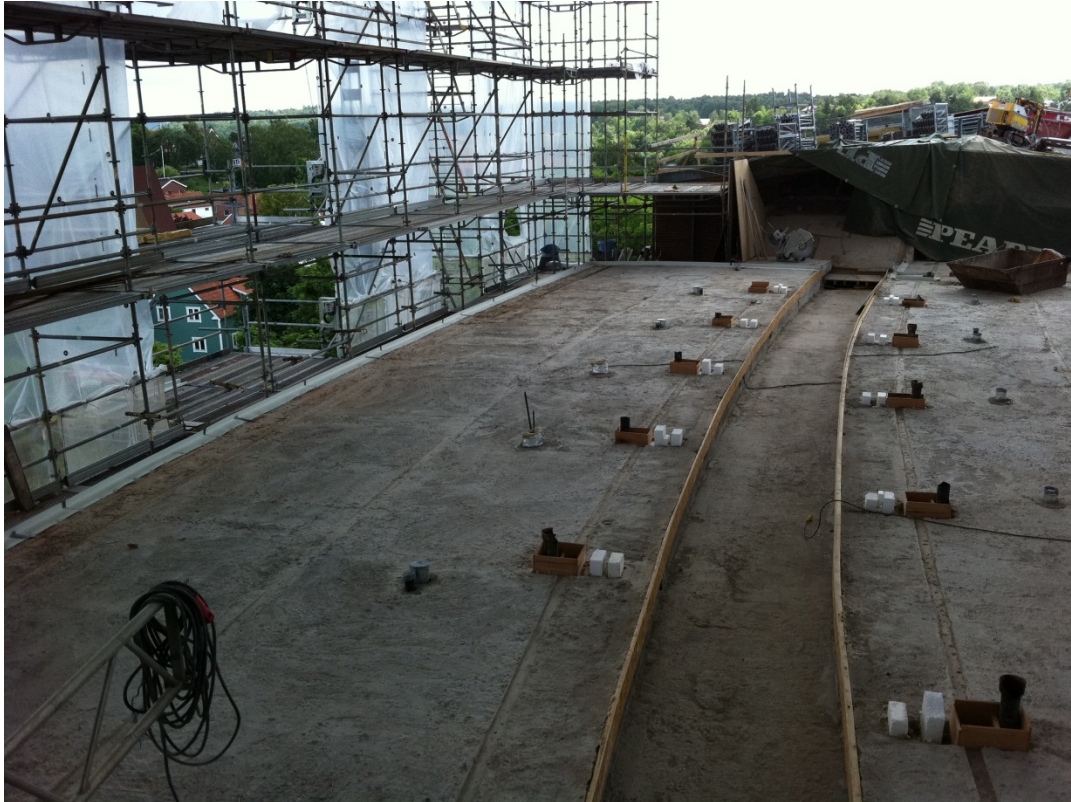
Figure 11 Removed roof structure exposes cavities and holes for rain and moisture, Emilsborg 3.

There is also a big problem connected with the fact that the old roof construction is removed. The building is then immediately exposed for moisture from rain and snow that easily could penetrate ventilation systems, staircases and other cavities see Figure 11.

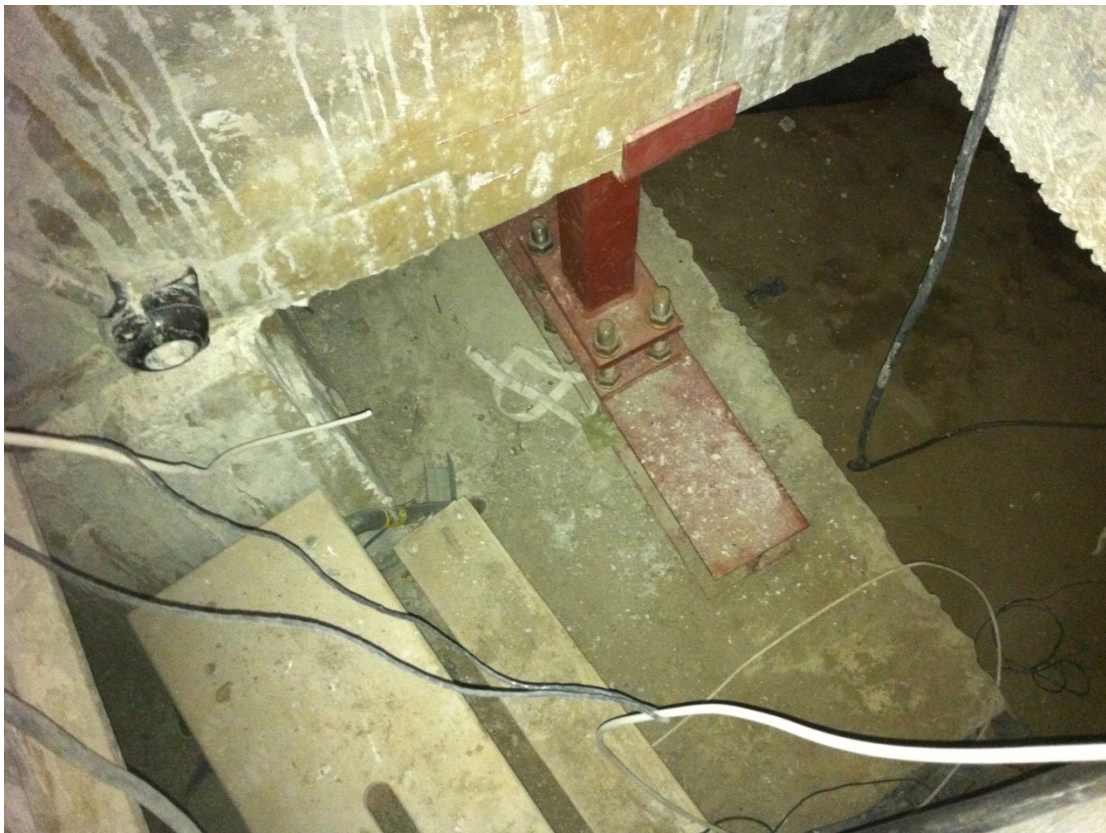
Figure 12 Steel beam supports at a plinth foundation, Fredslyckan

A suspended foundation is easier to strengthen, since it is built up with columns. These columns are exposed which allows workers to go beneath the bottom slab and perform strengthening measures. There are many ways to execute a strengthening of a suspended foundation. These reinforcements can be roughly divided into two solutions. One is to strengthen the building from underneath with piles. The other, and more suitable solution is to distribute the loads on the original column on a wider area. This is done to ease the pressure on the column and to avoid settlements in the soil. The easiest way to reinforce a suspended foundation is by using the latter solution and place two supportive steel-beams, one on each side of the original column, see Figure 12.

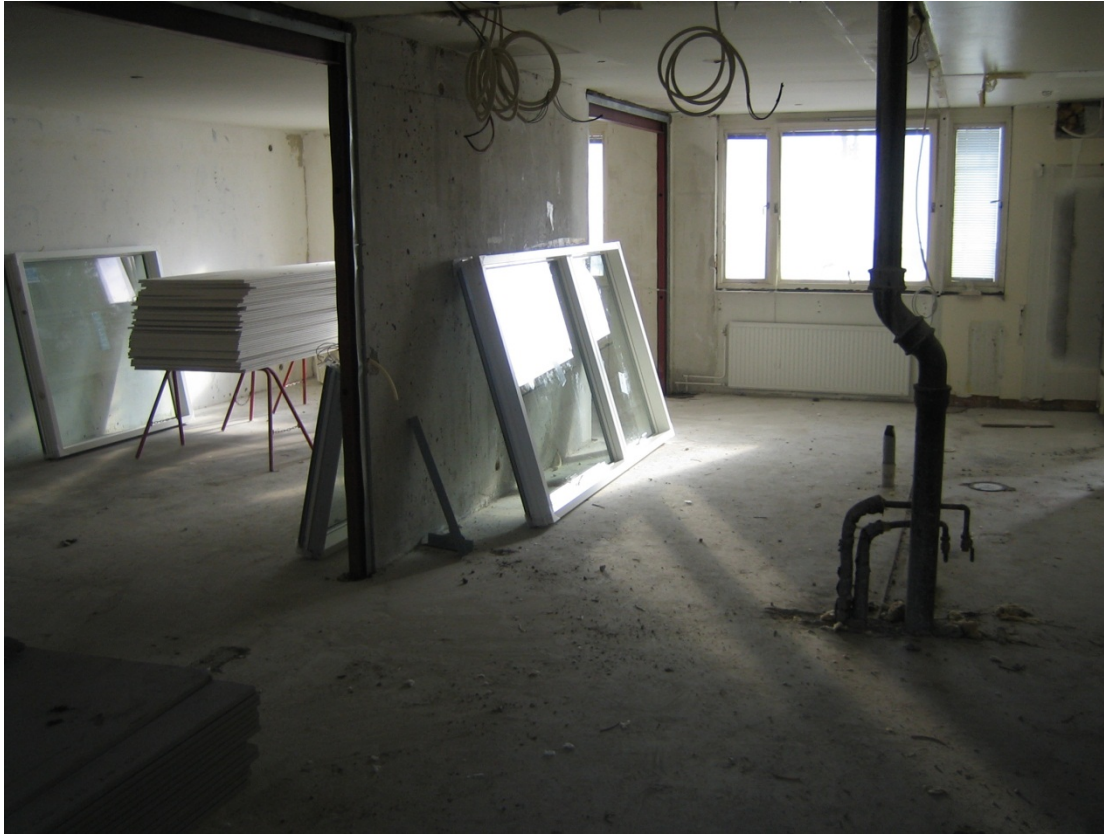
Figure 14 Openings of bearing wall to obtain a more spacious layout, Fredslyckan.

To make sure that a sufficient load-capacity remains after opening up a load-carrying wall, it is important that the loads are shifted in a proper way. An opening in a load-carrying wall without any precautions will not uphold an adequate load-capacity. The most common solution to allow for new openings is to simply frame the opening with steel members. The steel frame will then bridge the opening and shift the load to the remaining part of the load-bearing wall, see Figure 14. When creating this opening it is important to use temporary supports to prevent the tier from caving in.

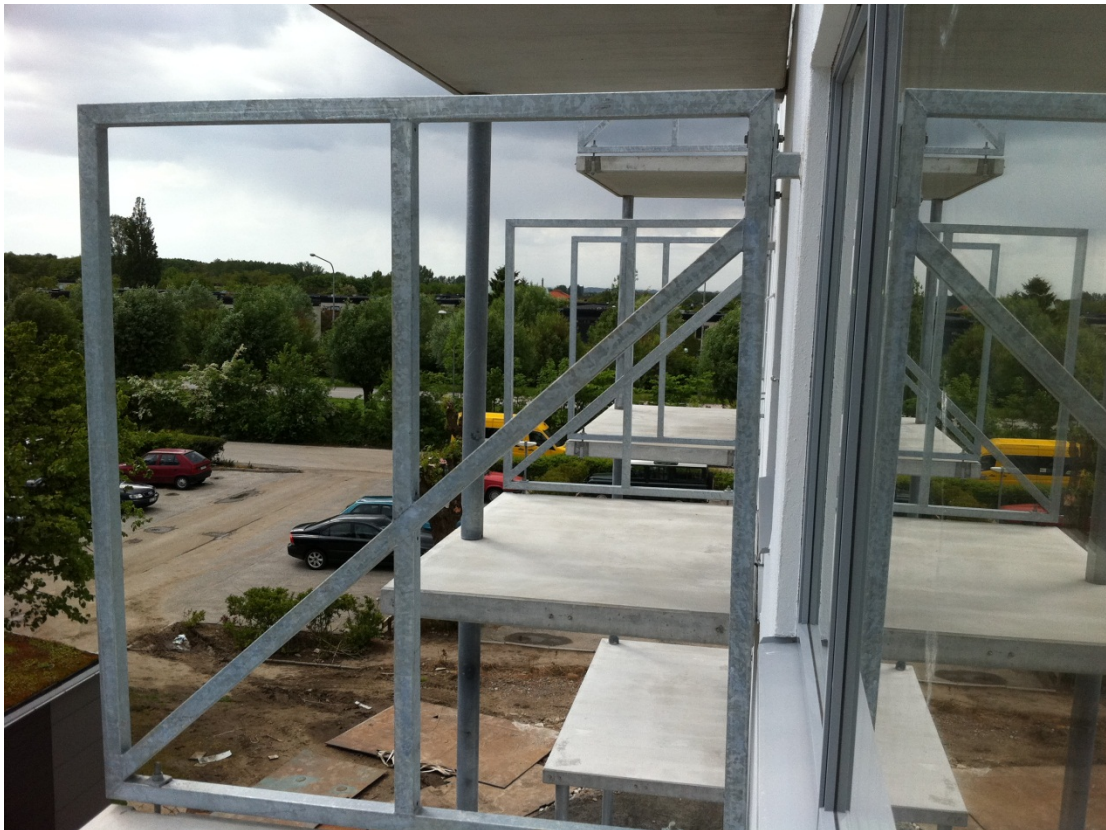
Figure 15 Inclined steel strut anchors the balcony to the building, Fredslyckan.

If the buildings have balconies that are made out of openings in the curtain wall, either exterior or freestanding balconies can replace them. This will lead to both a lower energy consumption and create more living space. Balconies that are installed on the façade do also create a more open impression. How an exterior balcony can be designed depends on the architect's proposal. A common way is to anchor a concrete slab with reinforcement bars that are grouted into the floor slab, but to avoid any extensive cutting in the concrete, other alternatives can be considered. Another alternative is to design freestanding balconies from concrete elements or steel columns that support the balcony slab. Another, slimmer, alternative is to place a steel column inside the façade and then anchor the balcony slab to that column with a steel strut and support it with a pillar at the end of the slab, see Figure 15.

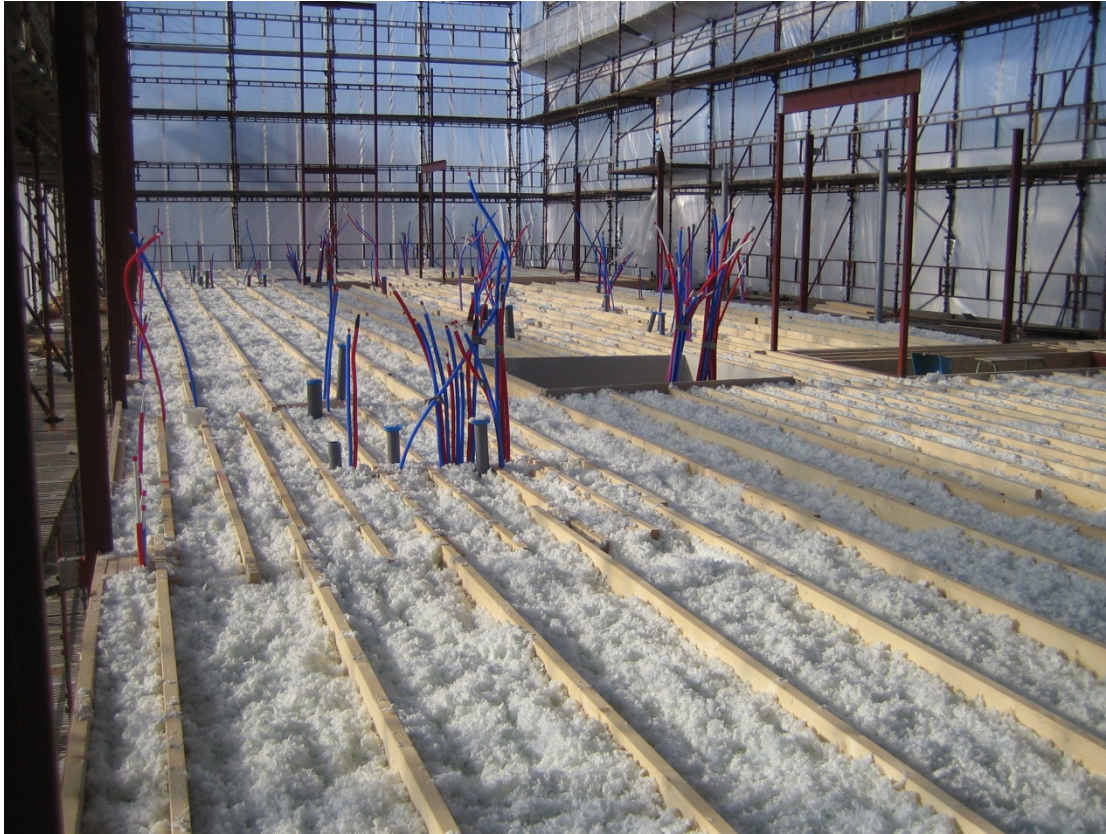
Figure 16 A wooden beam grid that lies on top of a steel grid (the steel grid is not visible), Fredslyckan.

This grid could then be used for both an acoustic barrier as well as an installation layer for electrical wirings and ventilation system. Another advantage is that openings for staircases can be avoided, if balcony access apartments with an exterior elevator are chosen.

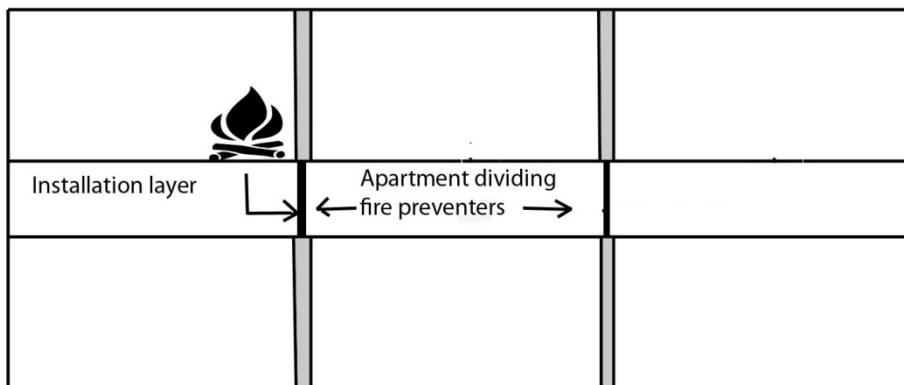
Figure 17 Simplified section of an installation layer with fire preventers.

When constructing the installation layer, it is absolutely vital that this layer is divided into segments to prevent fire from spreading underneath the apartments and destroy the entire building, see Figure 17.

This is easily avoided if the concrete elements are anchored to the floor slab. The installation floor will then be installed individually in between the concrete elements, which then act as fire preventers. A more problematical solution is the beam grid, where empty spaces exist inside of the grid. It is of great importance that fire preventers are installed when installing such a beam grid.

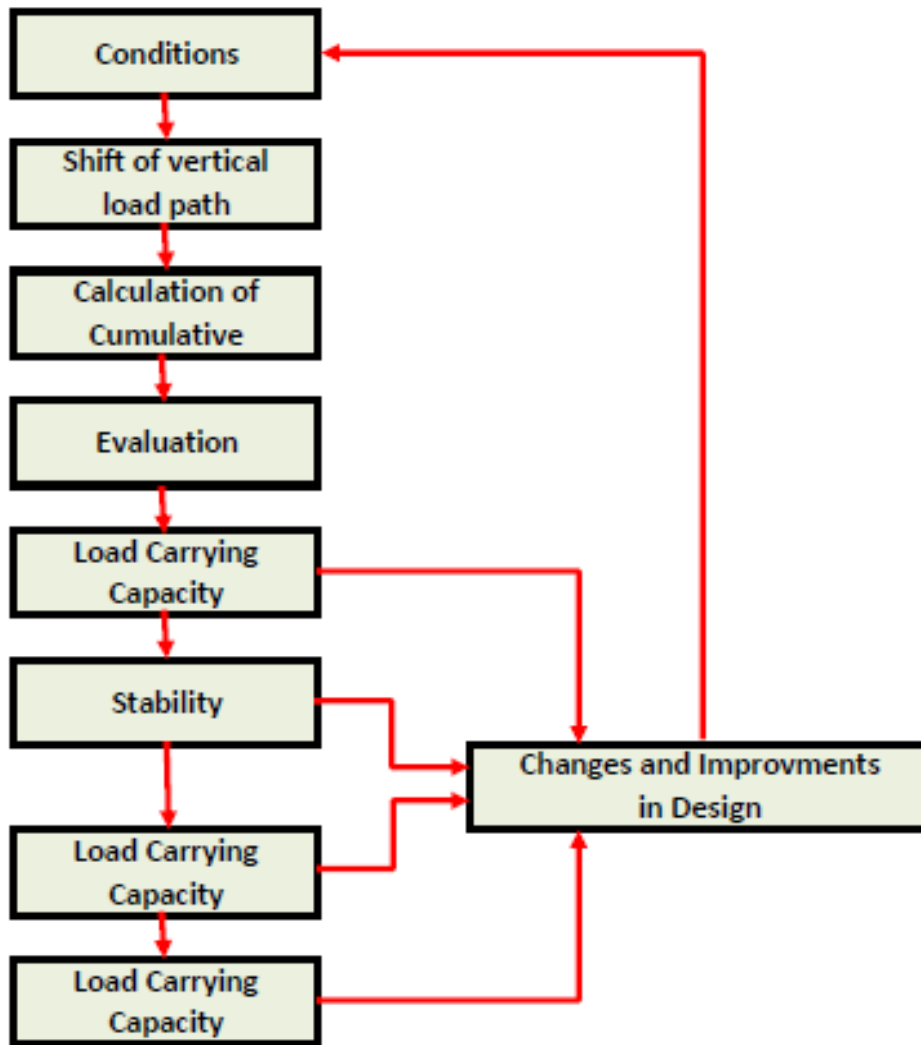
Figure 19 Flowchart illustrating the recommended procedure.

In the last two steps, step 7 and 8, the load carrying capacity of the columns and/or load carrying walls is checked. The procedure is the same as in step 5 where the resistance is compared with the load effect considering the cumulative load calculation from step 3. The capacity is verified for the new parts as well, but it is absolutely necessary for the original elements. If the capacity is not sufficient, strengthening measures need to be made. If such strengthening gets too problematic, it might be necessary the change the initial condition in order to create lighter load. If so, this needs to be agreed upon with the client. When checking the columns and the load carrying walls, one should also check for punching shear capacity where loads are concentrated on small areas on the slabs.

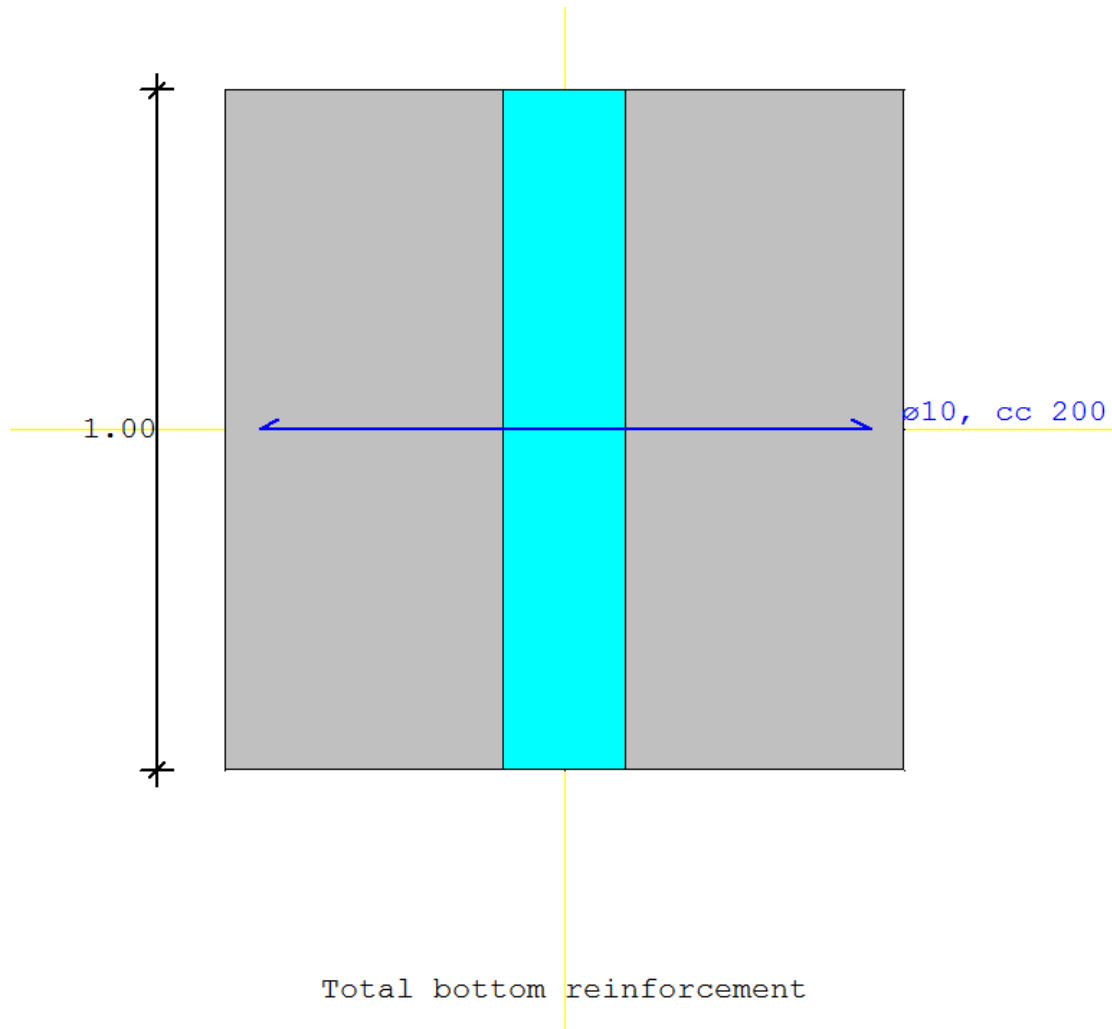
Figure 40 Needed reinforcement in the ground slab according to the calculation

The calculation was performed and the result was that the ground pressure is 161kN/m^2 , which is below the capacity of 200 kPa. The reinforcement for the ground slab needs to be $\phi 10\text{s}200$, see Figure 42. This is less reinforcement than $\phi 12\text{s}150$ that was provided in the ground slab according to Section 6.1.2.

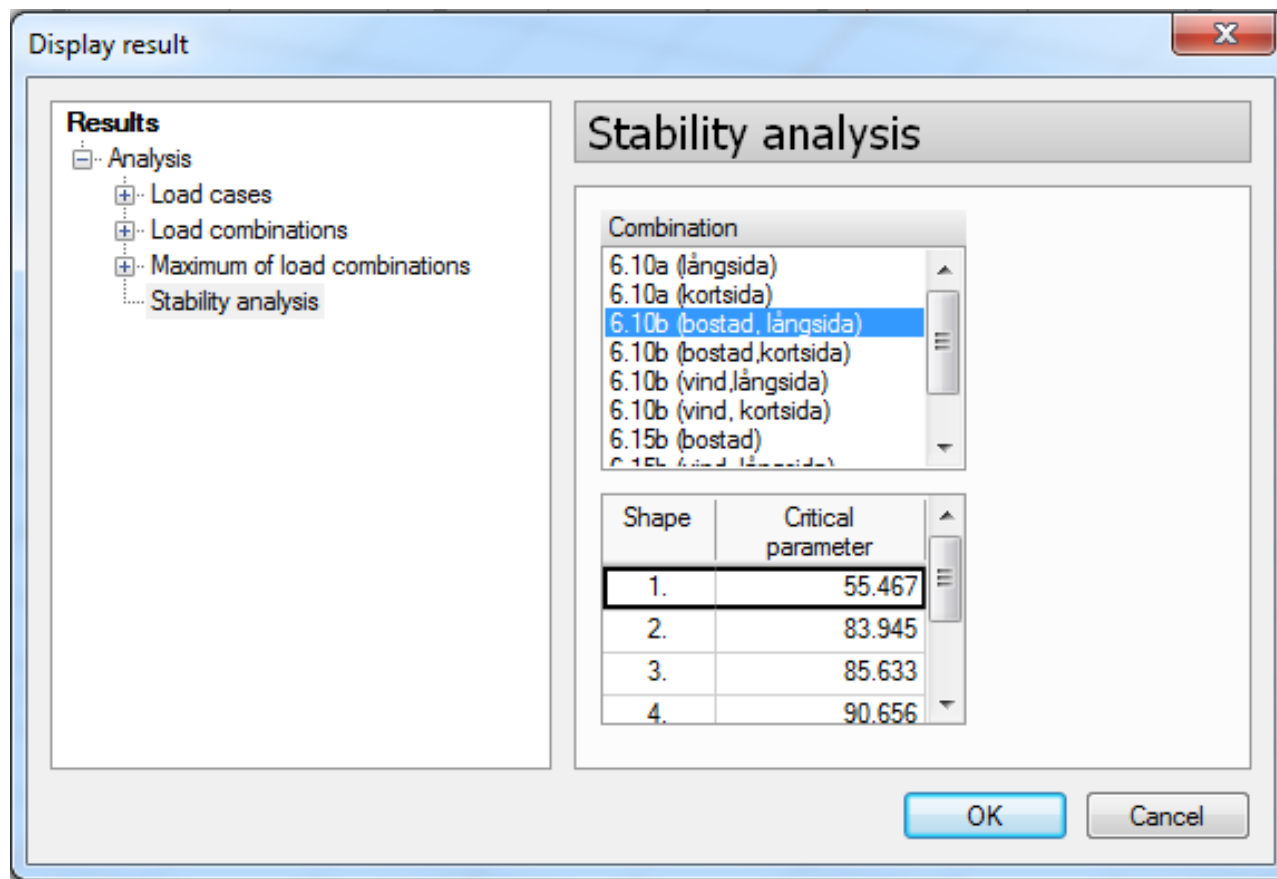
Figure 41 Stability analysis results

The stability of the structure with regard to buckling and similar needs to be checked. Also for this case, FEM-design was used. In FEM-design there is a function called stability analysis, which analyses the global stability of the structure. The results of a stability analysis give the global buckling mode shape and the critical parameter. In order for the global structure to be stable, the critical parameter must be more than 1. However, the developers of the program recommend that the value should exceed 5 (Strusoft, 2011). At the first glance at the case building it can be guessed that it is very stable because of the many load-bearing concrete walls. The program also showed that this is the case as the critical parameter for the worst case is 55,467 see Figure 41.
