Non-destructive evaluation of timber floors structure at Skansen Lejonet

Master's Thesis in the Master's Programme Structural Engineering and Building Technology

Department of Civil and Environmental Engineering
Division of Structural Engineering

Master's Thesis 2013:40

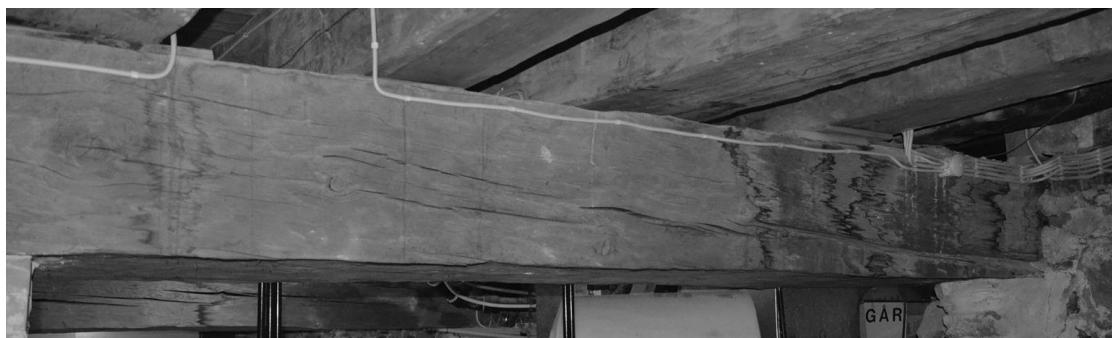
Figure 2.4 Example of discolouration in Skansen Lejonet on a primary beam (to the right).

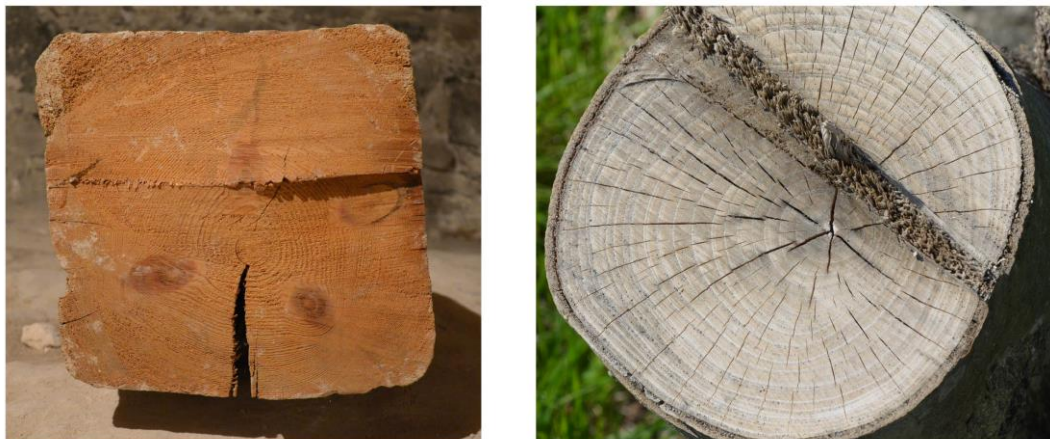
Figure 2.5 Cross-section of a removed timber part from Skansen Lejonet showing dense annular rings (Left), cross-section of a young tree with fast growth (Right).

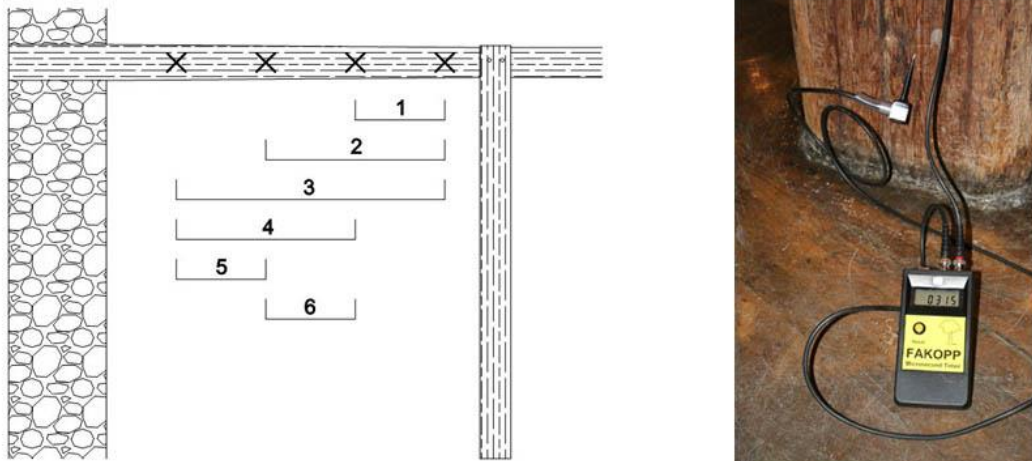
Figure 5.1 Approach for tracking eventual deterioration or different quality of wood in a member (Left), setup of stress wave measurement (Right).

When points suspected to damage have been identified, it is preferable to continue the detailed investigation with the test method associated with the least effort to quickly confirm deteriorated sections (Kasal & Anthony, 2004). Therefore one should start with the stress wave testing since this can be conducted quickly and systematically by surrounding a suspected area and then re-surround it in order to approach and map the location and extent of the damage (see Figure 5.1).

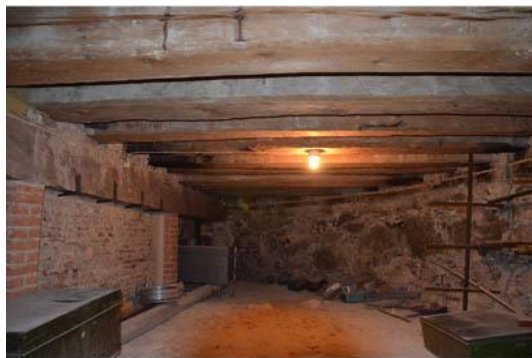
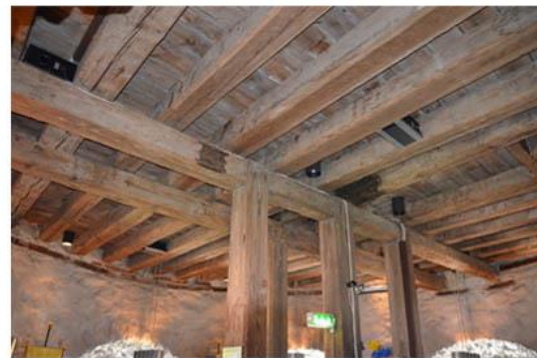
Figure 6.2 Illustration of both floor structures showing the general appearances. First artillery floor (Left) and second artillery floor (Right).

Both investigated floor structures consist of two primary beams which support a large number of secondary beams. Pine timber was used for the construction. Despite being referred to as secondary, the beams have large cross-sections, sometimes of the same size the primary beams. Each beam differs in cross-section from each other but the general cross-section is about 30x30cm, the beams have a close spacing of approximately 60-70cm and the longest members are 12-13m long. The primary beams are supported at the middle of each room by the staircase masonry and columns, respectively. There is no ceiling in either floor, so the timber floors are fully visible and accessible, except for a portion of the first artillery floor which is obscured by a recently built archive and the staircase masonry. Although the height in the second artillery floor, approximately 4m, is a limiting factor regarding accessibility, while the height in the first artillery floor is approximately 1.8m. Both timber floor structures are illustrated in Figure 6.2.

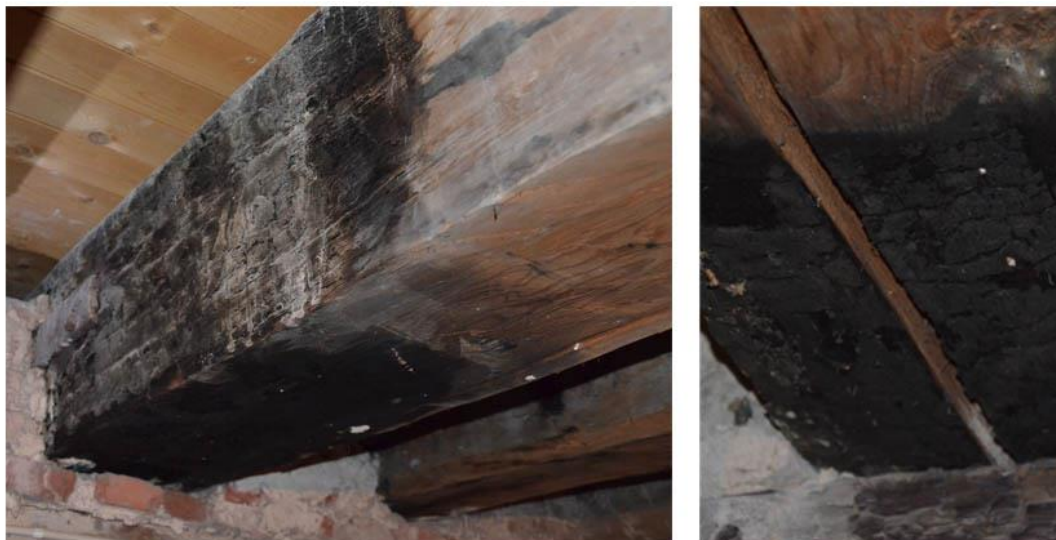
Figure 7.1 One of several charred beam edges at supports (Left) and the thickness of the charring is revealed by the crack (Right).

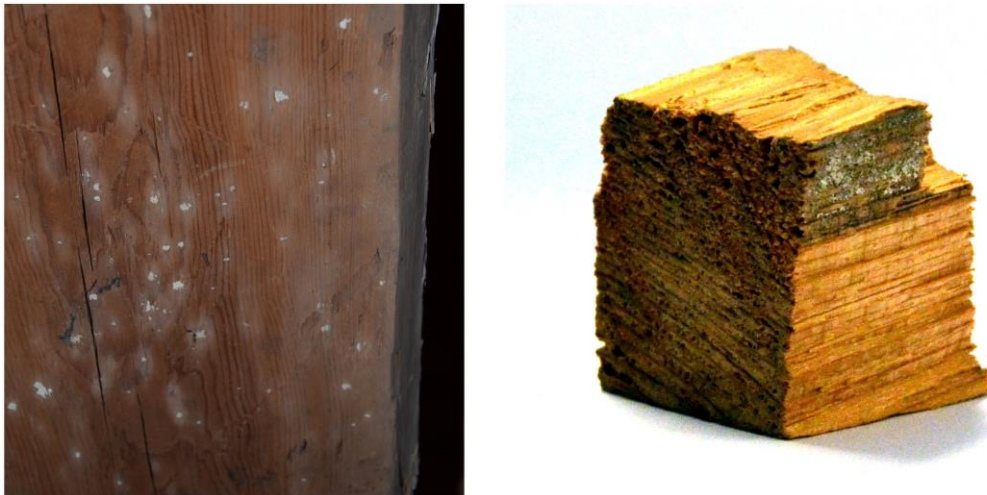
Figure 7.2 White specks and discolouration in the lower floor (Left) and piece from the removed part of beam P showing damage on the earlywood and fungal growth (grey spots, right).

White plaster-like specks could be found throughout the lower floor structure, pictured in Figure 7.2. Additionally yellow-green specks were found at some outer wall supports of the lower floor which raised concern. The specks were present at beams, sill plates and at the masonry. Both types of speck were suspected to have been caused by waste from refurbishment rather than being old fruiting bodies from fungal attack, despite the sometimes unexpected locations. Further inspection of the removed part from the beam P revealed fungal growth within the timber, adjacent to damaged earlywood which can be seen in Figure 7.2. Due to this find the origin of the specks as well as accompanying discoloration was reconsidered as possible fungal attack.

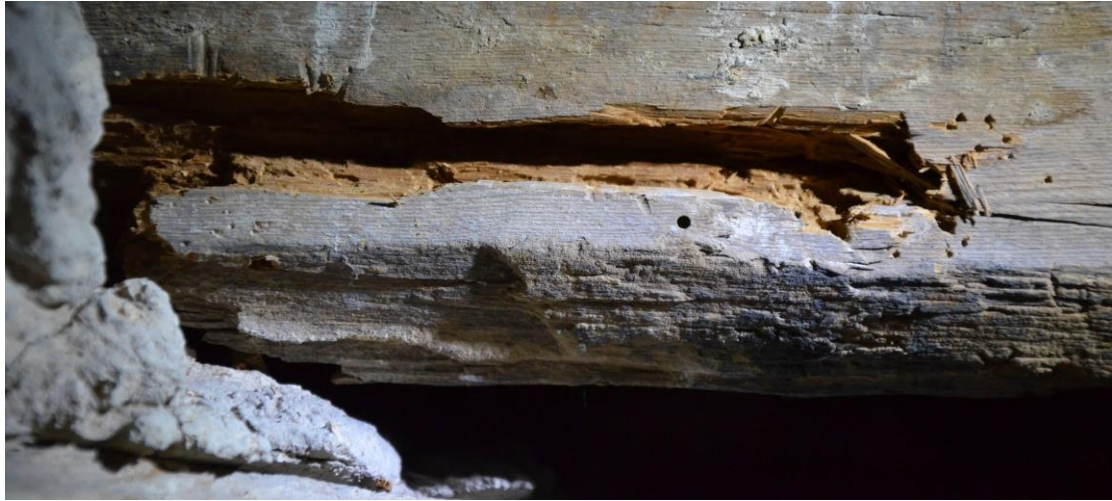
Figure 7.3 Damaged region at wall support of beam D in span 1 in lower floor. Several smooth holes (one visible near the centre of the image) raised concern about eventual damage close to the surface and the bottom face. After probing with a screwdriver the damage was revealed and explained as an insect attack.

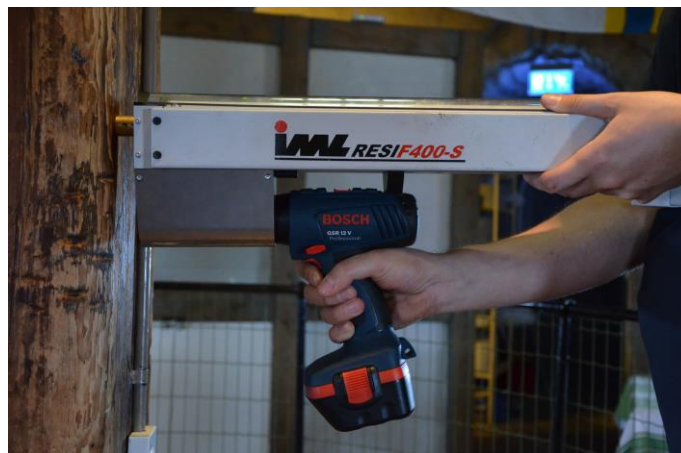
Figure 7.18 Electrical resistance drilling device driven perpendicular to the timber surface of a column during the in-situ testing.

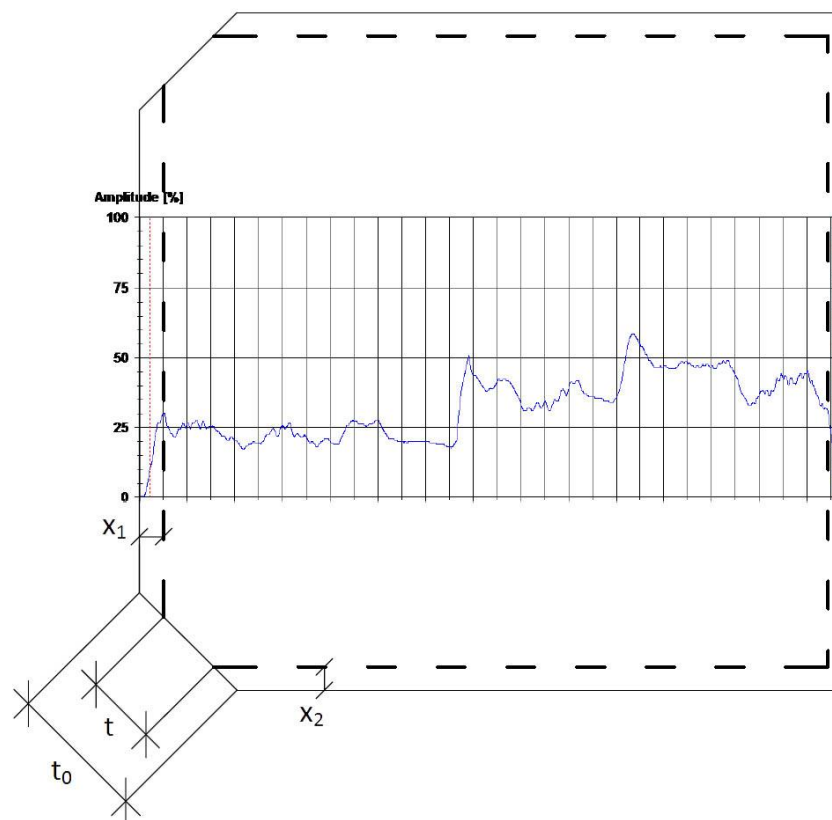
Figure 7.19 Principle of reduction of the cross-section dimensions as a result of the low relative resistances at the faces illustrated in the graph. Dashed line indicates reduced cross-section.

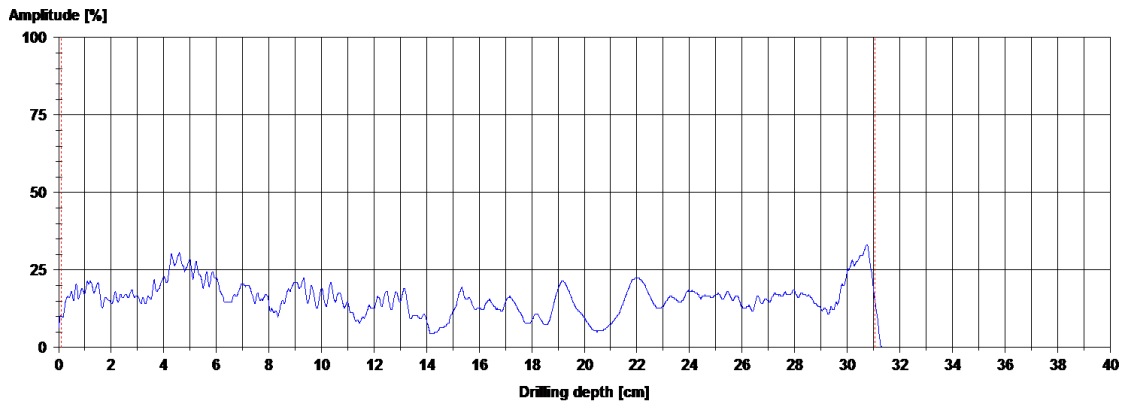
Figure 7.20 Resistance drilling graph R.35 indicating no interior deterioration in beam J in the lower floor at the charred support.

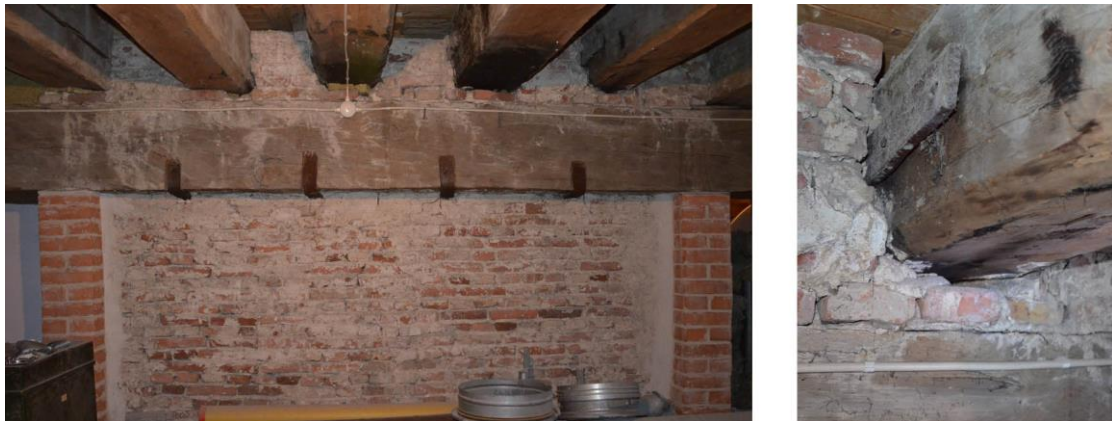
Figure 8.1 *Photography of primary beam 1 in first artillery floor, supported by the masonry structure (Left) close up view of the anchorage detail for the rightmost secondary beam K (Right), cf. Figure 8.2.*

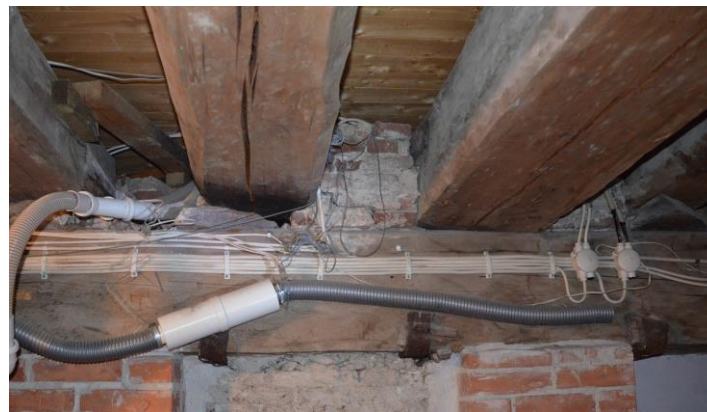
Figure 8.6 Middle support for primary beam 2 in the lower floor.

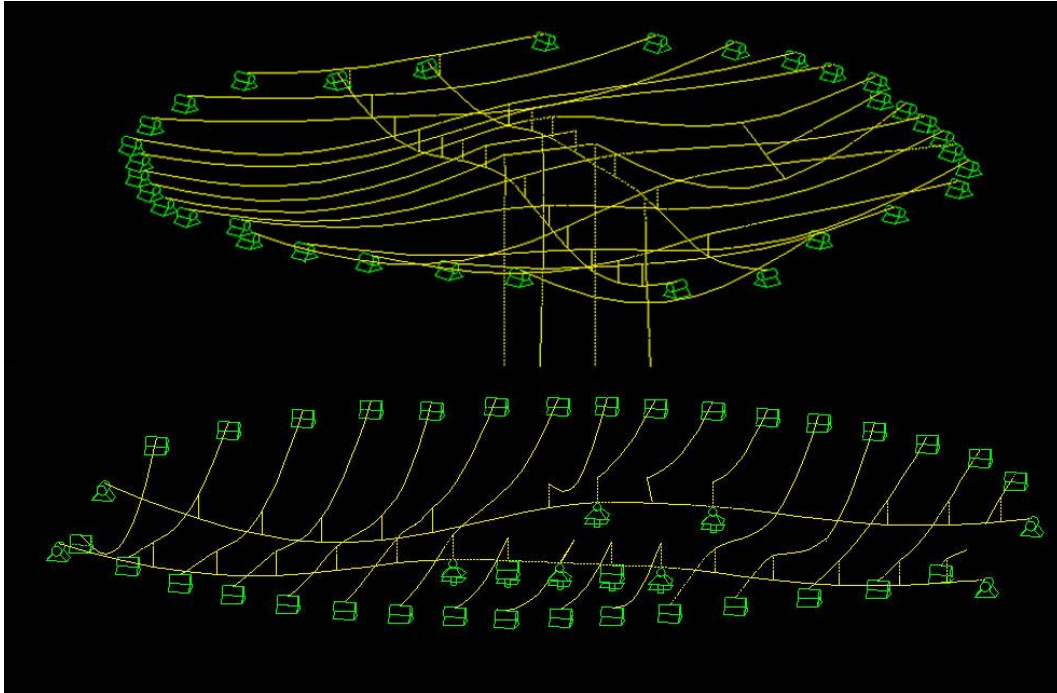
Figure 8.11 Deflections for model 8 (load combination acc. to Eurocode 1) in the upper floor (Top) and deflections for model 8 (load combination acc. to Eurocode 1) in the lower floor (Bottom). Note that the orientation relative each other is not the actual orientation.
