Improvements in the traffic system of Gothenburg

A case study on Express Bus Rosa including analysis and proposals of actions

Master of Science Thesis in the Master's Programme Infrastructure and Environmental Engineering

Master's Thesis 2013:43

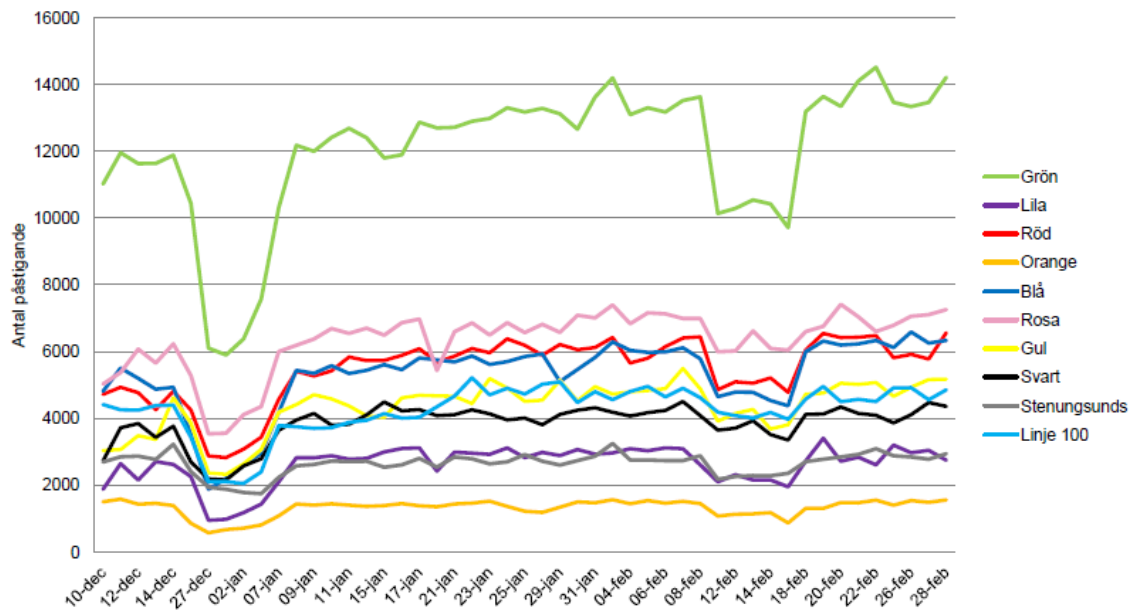
Figure 1: Number of boarding's on Express Bus Routes (Västrafik, 2013b).

During the period December 10 2012 till February 28 2013, Express Bus Rosa had somewhere around 6000 to 7000 boarding's per day. The apparent decline in late December and early January is due to decline in commuting during the Christmas and New Year's period. The schools winter break in Gothenburg in February also offers a clear effect in this chart.

Express Bus Rosa has since the start had a proper number of travel numbers. It has established itself as the line with the second highest number of boarding's, as shown in the diagram below. It also appears to follow the same travel patterns as the other express bus lines, with highs and lows on the same days and times.

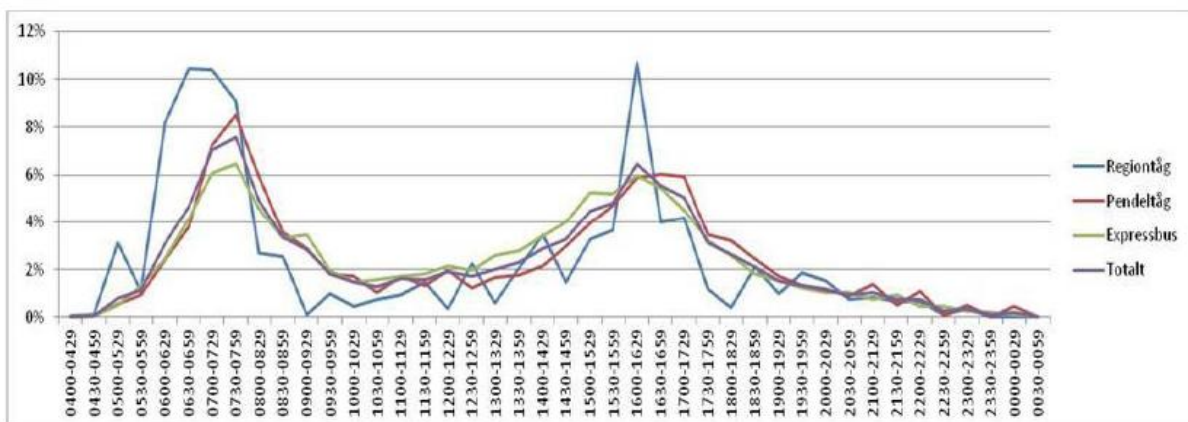
It is also possible to examine how travel is developing during a day. In figure 2 below, express buses are following the same pattern as other public transport analyzed by Transportstyrelsen. Notably, however, they do not have the same acute pattern such as regional trains but have smoothed the peaks and valleys. This is due to the flexibility in the departure among the passengers and short distances to stop positions.

Figure 2: The travel quantity divided during a day (Västrafik, 2013b).

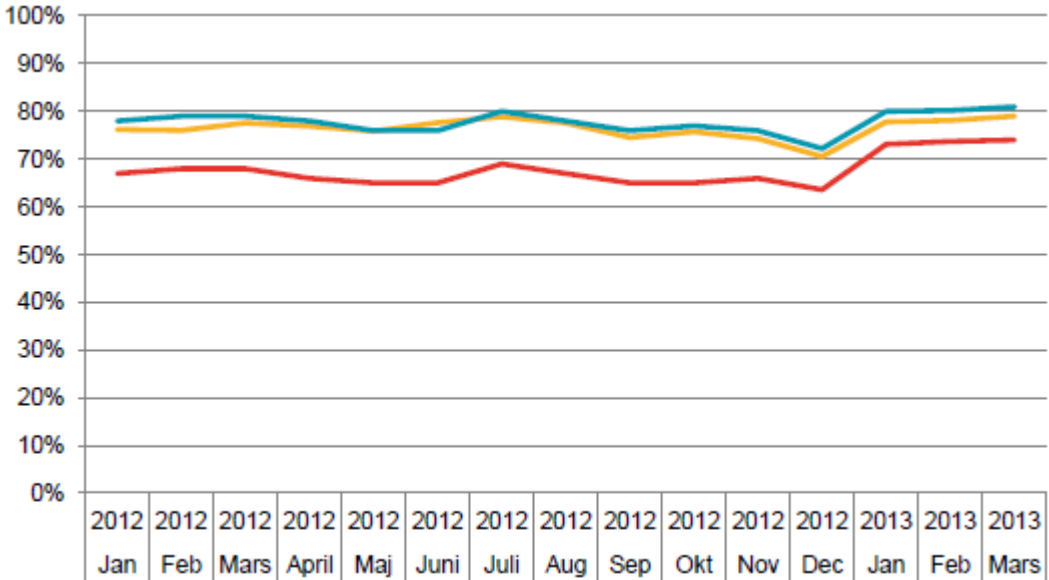
Another interesting parameter to look at is whether punctuality is good on the line or not. There is an overall correlation between bus rapid transit (orange), city line bus (blue) and express bus (red) where it is clear that punctuality is worse on the express bus routes. A positive difference, improved punctuality, takes place in December 2012 when the new timetable is introduced and it is also affected by the holidays for Christmas and New Year. This effect flattens out in January, February and March, but still a significant improvement than before.

The aim for punctuality of buses and coaches is currently that levels of 80% of departures are on time (Västtrafik, 2013b). This objective is met not for the first three months but parameters such as weather situation (season) and running-in period for new systems and congestion play a role. It is likely that the punctuality target will draw closer to the objectives even more during the summer period as holiday season draws down on travel, leading to higher margins in journey times.

Figure 3: The level of punctuality for bus rapid transit (orange), city line bus (blue) and express bus (red) (Västtrafik, 2013b).

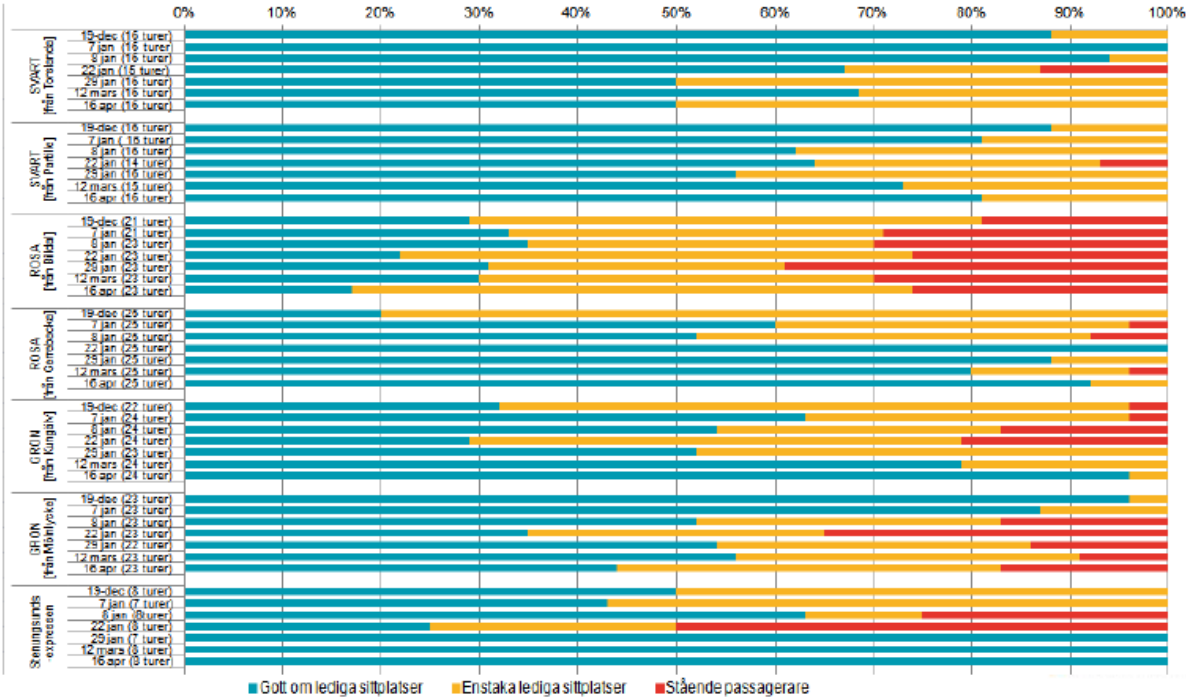
Additional data for express bus Rosa is how many of the seats that are occupied during the trip. The following chart is compiled during seven occasions between December 2012 and April 2013, during the morning hours of 07 and 09. The blue bar indicates occasions with plenty of seating, the yellow bar cases where there have been few vacant seats and the red bar shows instances of standing passengers.

In the diagram, the graph representing Rosa is on the third and fourth lines. The third row shows the journeys starting in Billdal in the south which goes north toward central Gothenburg. The fourth line represents trips that go from Gerrebacka in the north and are south-bound. It is clear that a travel from the southern areas many times exceeds the supply of

available space on the vehicle. In other words, there is room for expansion, such as higher frequency of traffic or vehicles with higher capacity.

Figure 4: Level of seat occupation on Express Bus Rosa (Västtrafik, 2013b).

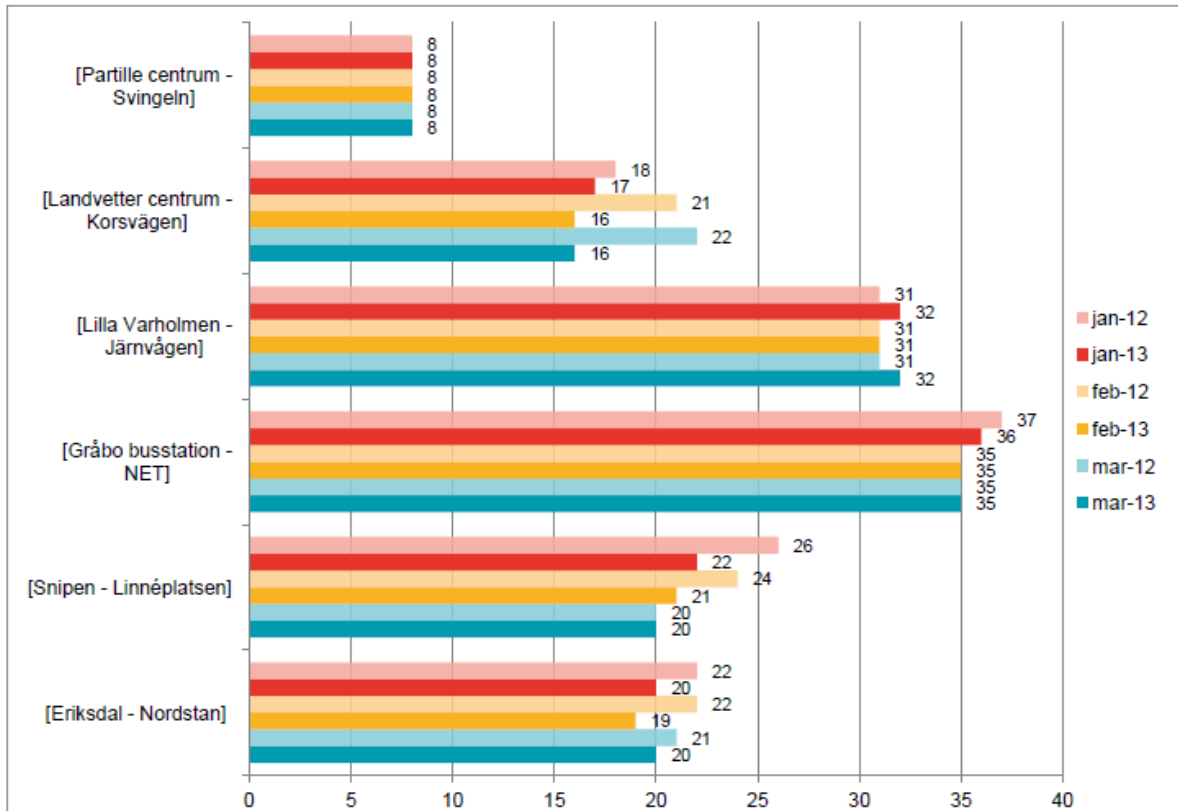
Travel times along the route were also analyzed after the introduction of the congestion charge in January 2013. The following diagram presents the travel times during the morning hours 06:30 to 08:30 and on six different occasions. It has not been evaluated for the entire stretch of express bus Rosa but for the Green and Blue lines, which tangential Rosa for longer distances. It is on the stretches Snipen - Linnéplatsen (Blue) and Eriksdal - Nordstan (Green). They operate via Highway 158/Dag Hammarskjöldsleden and E6, roads Express Bus Rosa also traffic.

On the stretch Snipen - Linnéplatsen, which in this study is represented by the blue line, a pretty clear change can be analyzed. Previous travel time, from January 2012 was 26 minutes for the distance, while after the introduction of congestion charging it was down to 20 minutes in March 2013. This can be traced to that Highway 158 has undergone renovations and long stretches now consists of separate bus lanes.

Express Bus Grön operates between Eriksdal in Kungälv and south to Nordstan in the central parts of Gothenburg. In the analyzes of the actual travel time a small but distinct difference is identified. Before it took 22 minutes, but now it only takes 20 minutes, which corresponds to a travel time reduction of 9.1%. This is due to the expansion of bus lanes on the E6 but also to a reduction in congestion in terms of traffic. Travelling time extension has been reduced from 73% to 11%, where 100% corresponds to a doubling of travel time compared to free-flow (Västsvenska Paketet, 2013).

Figure 5: Travel times on different routes around Gothenburg (Västsvenska Paketet, 2013).

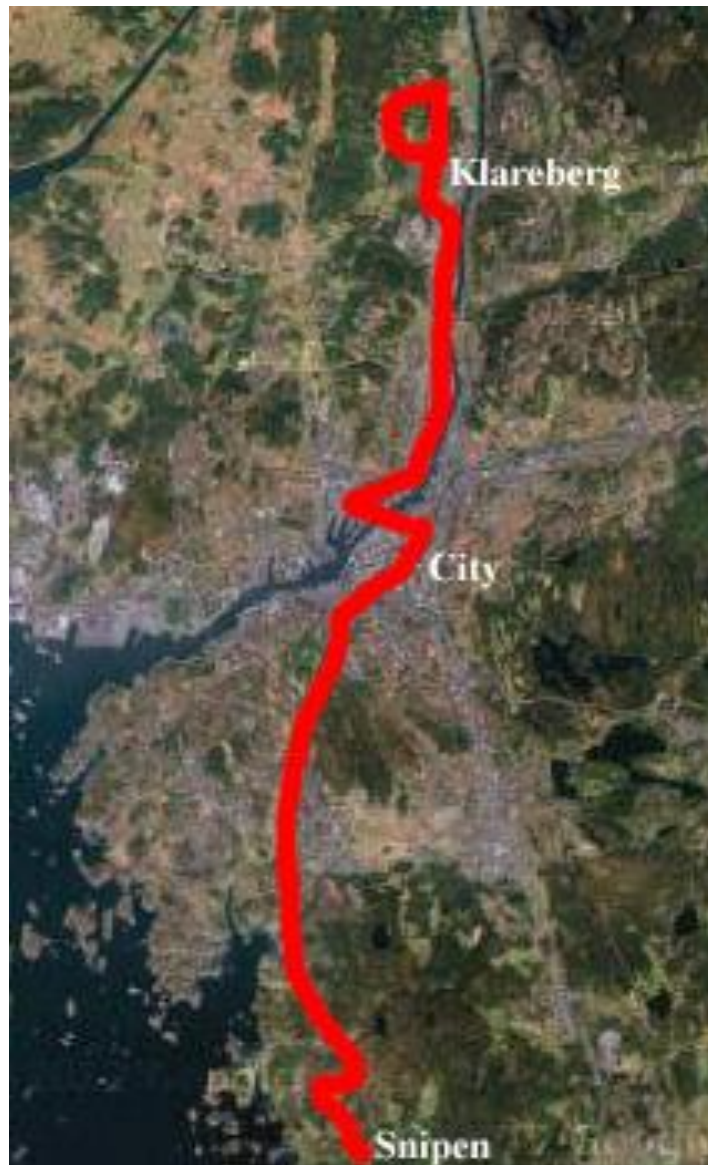
Figure 6: Aerial photo of the stretch for Express Bus Rosa.

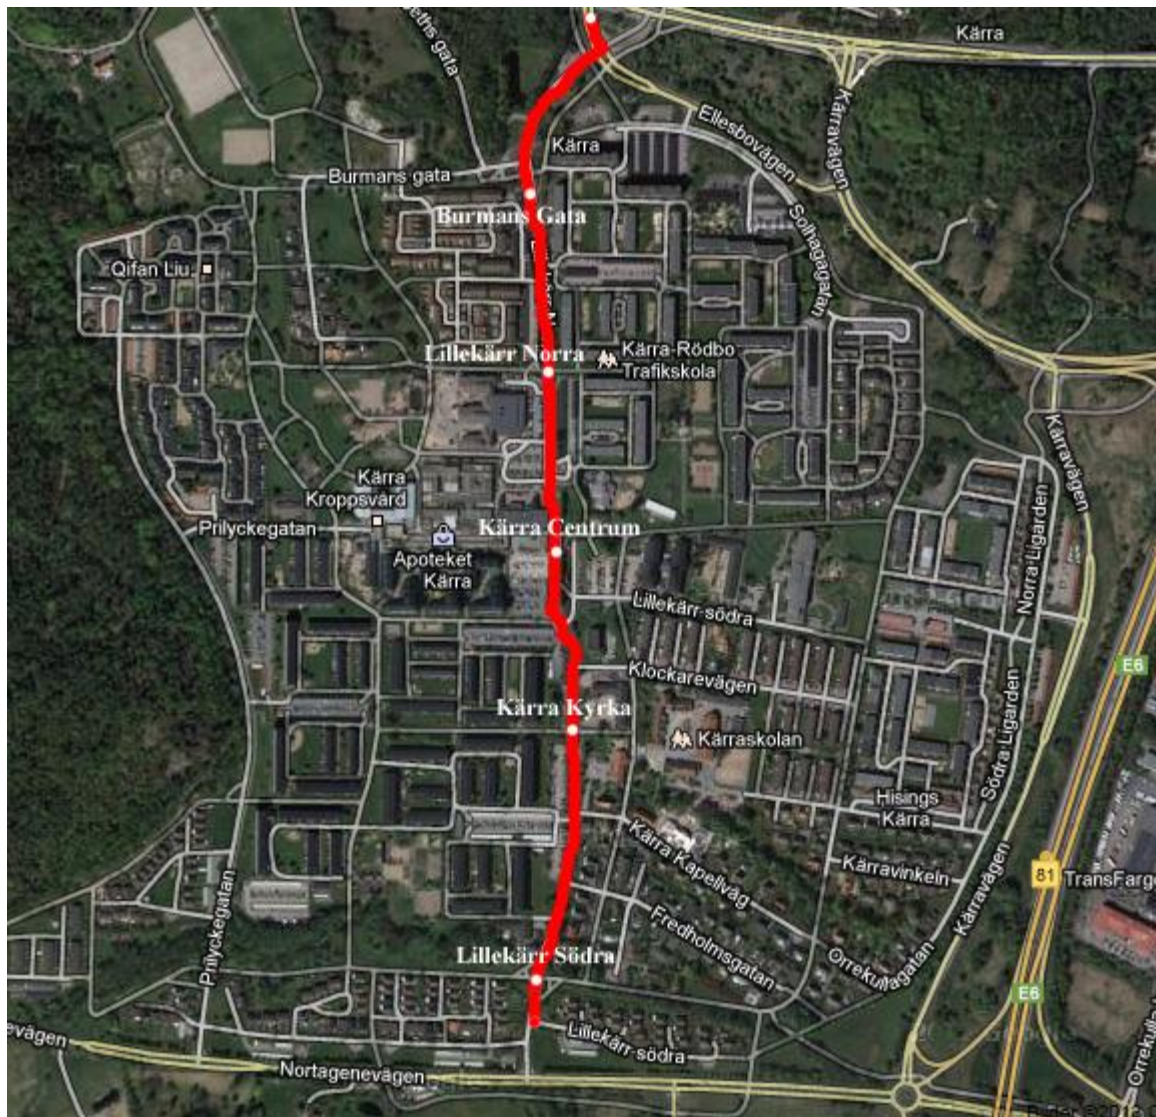
Figure 9: Aerial photo of the stretch Klareberg – Lillekärr Södra.

Bus stops: Klareberg, Burmans Gata, Lillekärr Norra, Kärra Centrum, Kärra Kyrka, Lillekärr Södra

Description: The route runs from Klareberg and throughout Kärra with several different types of areas. There are terraced areas and apartment buildings, detached villas and also school, sports hall and a town center with shops and services operated.

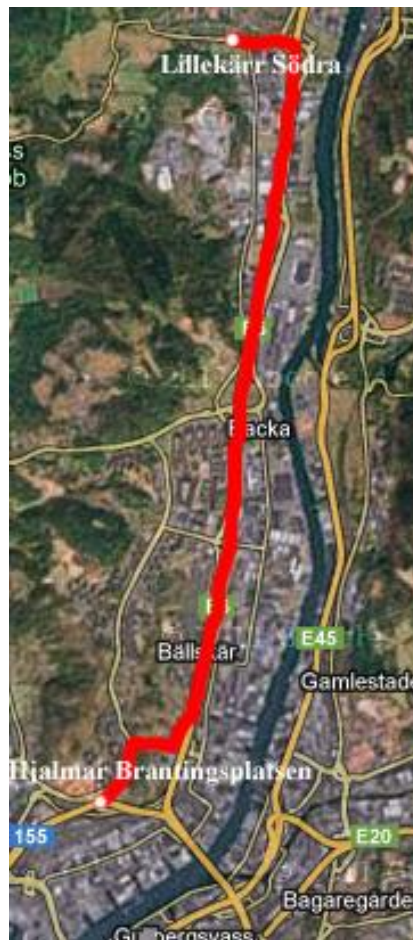
Figure 10: Aerial photo of the stretch Lillekärr Södra – Hjalmar Brantingsplatsen.

Bus stops: Lillekärr Södra, Hjalmar Brantingsplatsen

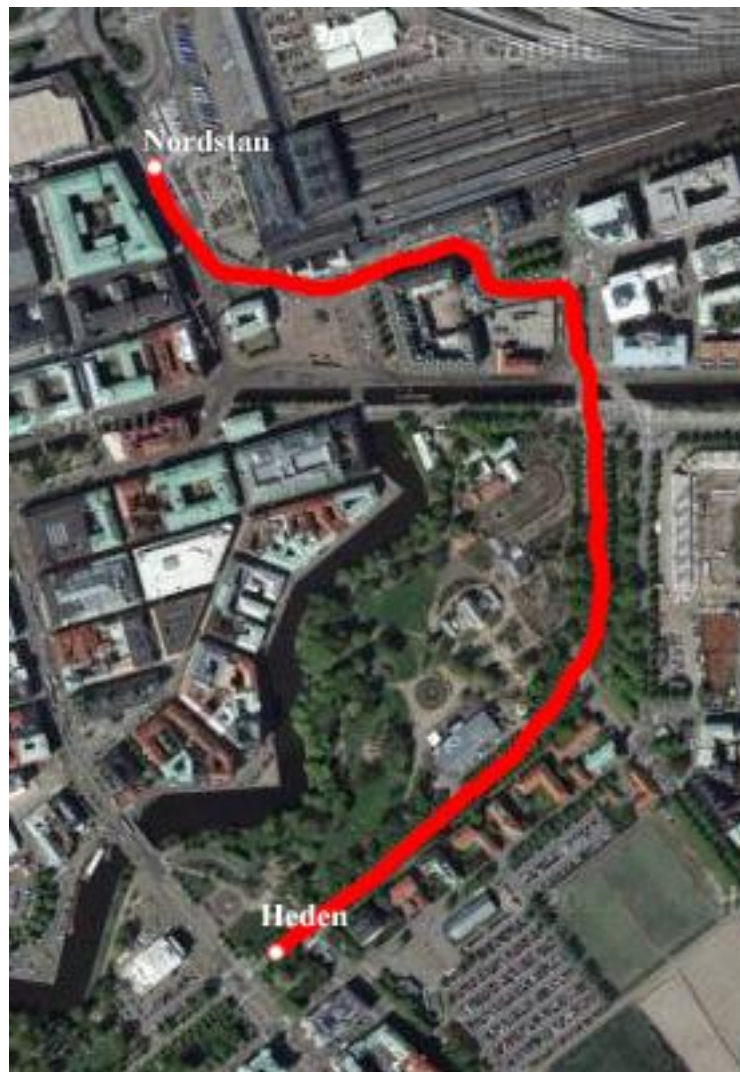
Figure 12: Aerial photo of the stretch Nordstan – Heden.

Bus stops: Nordstan, Heden

Description: The route runs through an urban area and in highly regulated traffic. In the short distance there are nine traffic signals that may give differences in travel time along this section of road.

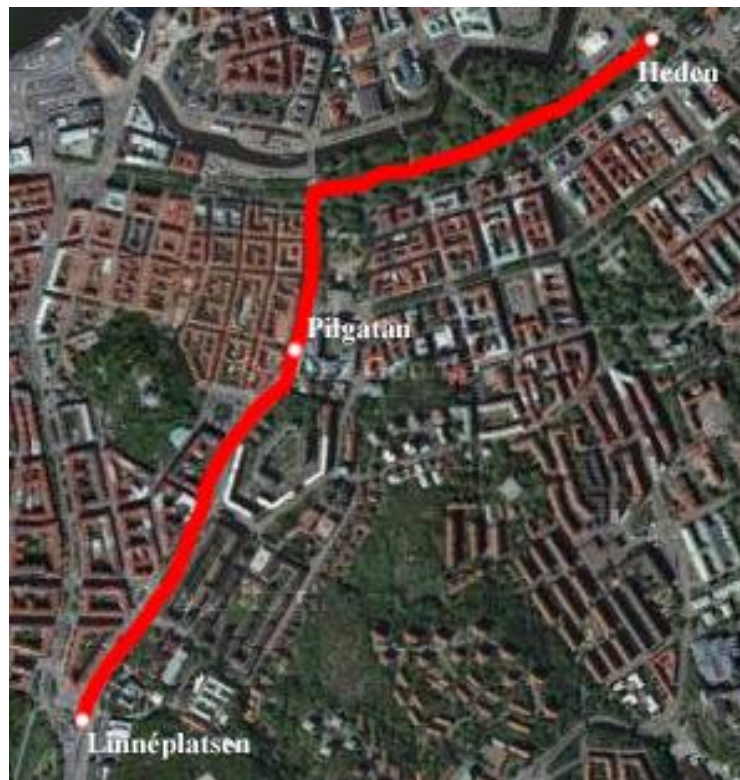
Figure 13: Aerial photo of the stretch Heden – Linnéplatsen.

Bus stops: Heden, Pilgatan, Linnéplatsen

Description: This route begins in Nya Allén and then bus Rosa turns up on Sprängkullsgatan. The road then turns into Övre Husargatan on the last part until Linnéplatsen. Much of the route is separate bus lane.

- In Nya Allén, Express Bus Rosa switches from the right lane to the middle lane, which in peak traffic can be problematic in terms of accessibility.
- Along the corridor, there are still many road works and it is sometimes a bumpy ride, from which the effects have been discussed previously.
- As the bus turns from Nya Allén and onto Sprängkullsgatan it passes a tight curve at high speed, which can cause an uncomfortable feeling.
- Sprängkullsgatan has a steep slope and the speed is very low, since there are several crossings for pedestrians along the way. It is also a relatively busy place with a lot of pedestrians and cyclists in motion as this is a common passageway for transportation between the city centre and Järntorget.

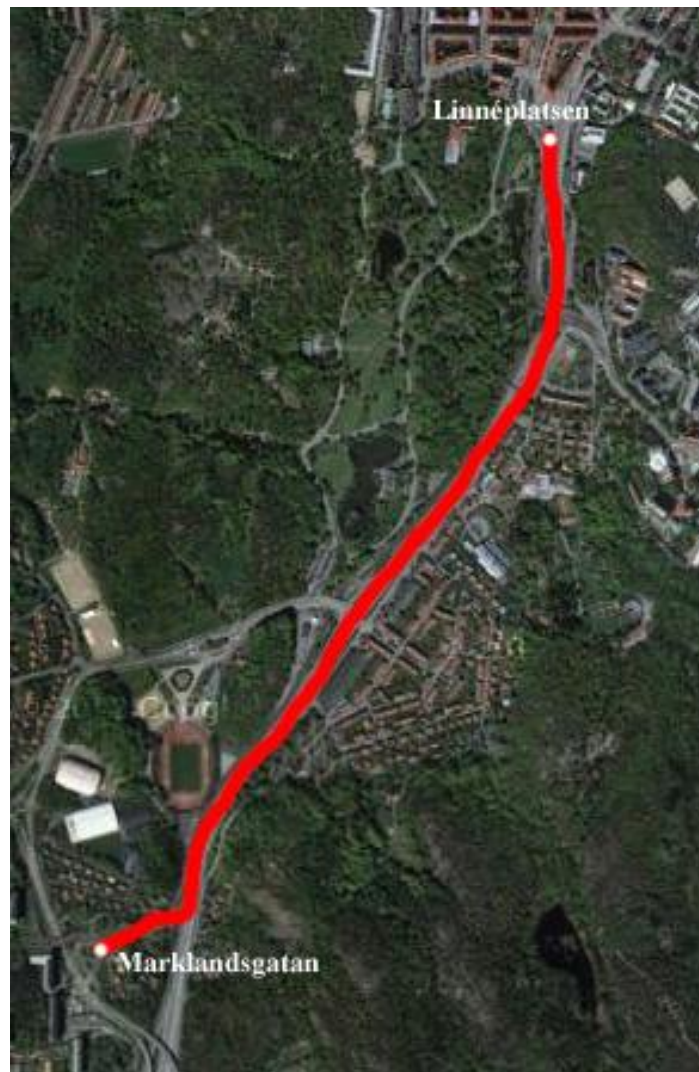
Figure 14: Aerial photo of the stretch Linnéplatsen – Marklandsgatan.

Bus stops: Linnéplatsen, Marklandsgatan

Description: Express Bus Rosa leaves Linnéplatsen via a separate bus lane but enters the regular lane at Dag Hammarskjöldsleden. It leaves the highway and turns into the node at Marklandsgatan, where this section ends.

- There is a bus lane from the bus stop at Linnéplatsen until the traffic signal that is controlling the traffic at Dag Hammarskjöldsleden. It can stand still for a while at this point when traffic is dense on the road.
- Express Bus Rosa then run at a good pace until the exit onto Marklandsgatan's bus stop, where there are a bus lane but a traffic signal that gives cyclists priority at the crossing which can cause jams.
- Marklandsgatan is a busy bus stop and it may then be queue at the stop position. The location is very important for Rosa as there are many passengers who go on and off here.

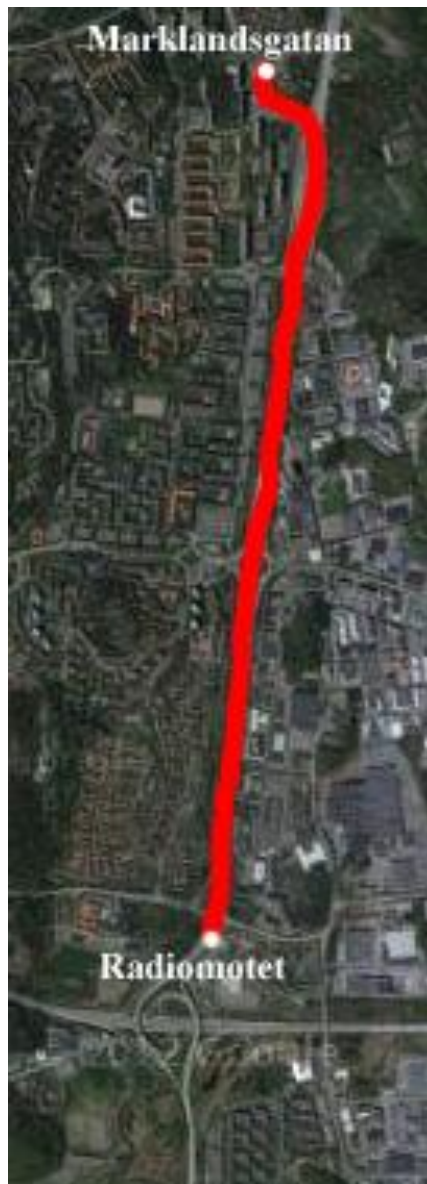
Figure 15: Aerial photo of the stretch Marklandsgatan – Radiomotet.

Bus stops: Marklandsgatan, Radiomotet

Description: The bus runs from Marklandsgatan, via Dag Hammarskjöldsleden and to the stop Radiomotet where the section ends.

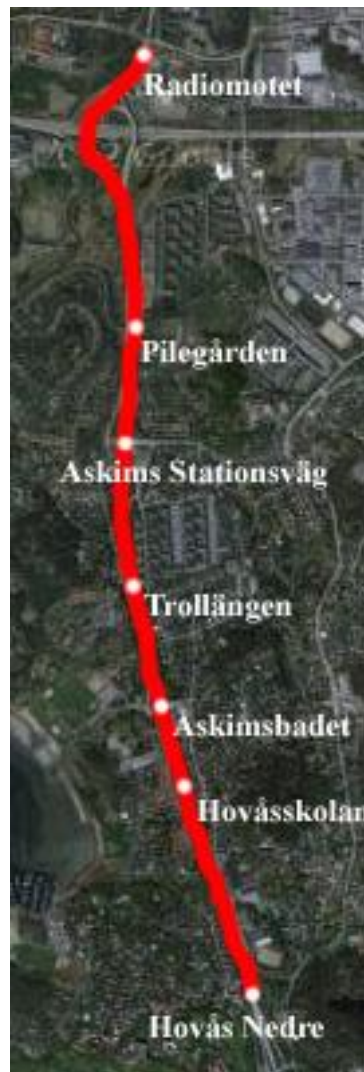
Figure 16: Aerial photo of the stretch Radiomotet – Hovås Nedre.

Bus stops: Radiomotet, Pilegården, Askims Stationsväg, Trollängen, Askimsbadet, Hovåsskolan, Hovås Nedre

Description: The section begins with the passage of Järnbrottsmotet for further travel south along Highway 158, also known as Säröleden. Periodically, the bus stops in an area consisting mainly of housing.

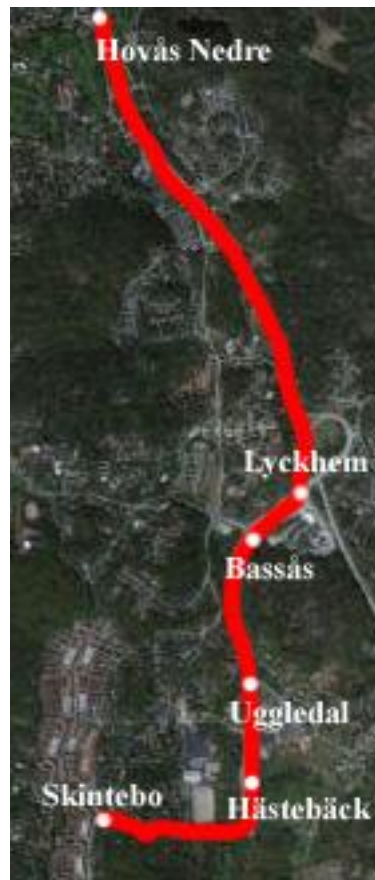
Figure 17: Aerial photo of the stretch Hovås Nedre – Skintebo.

Bus stops: Hovås Nedre, Lyckhem, Bassås, Uggedal, Hästebäck, Skintebo

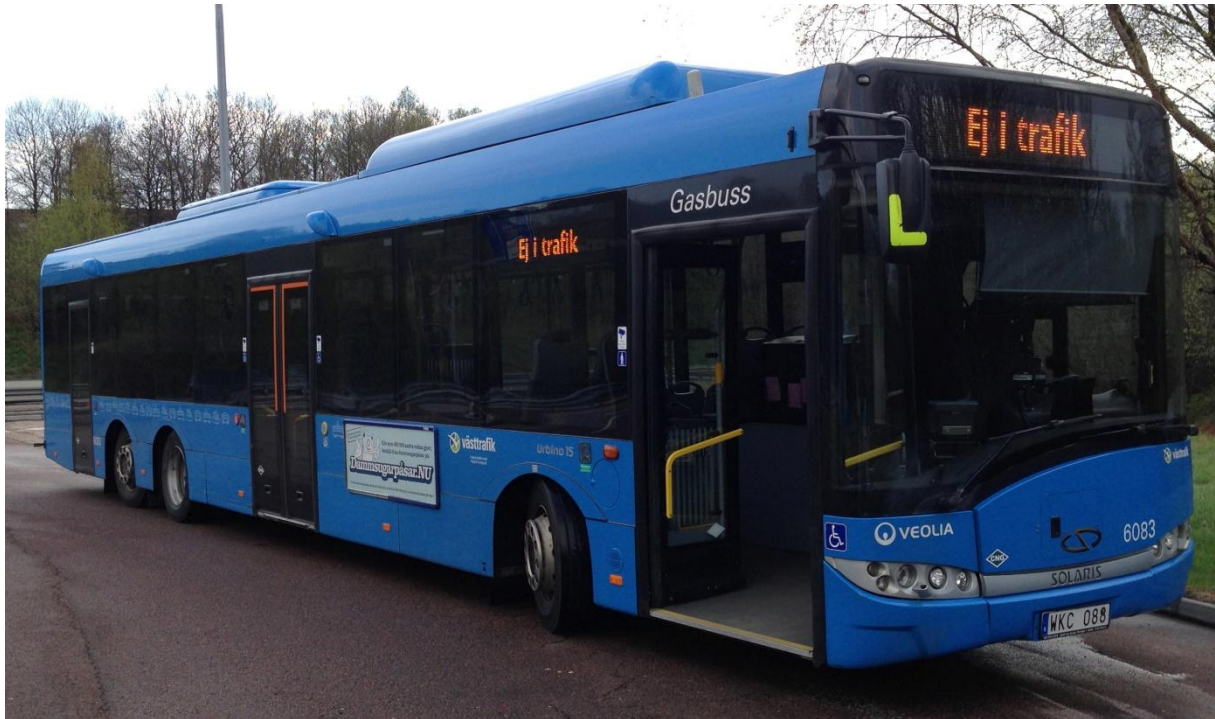
Figure 20: Solaris Urbino 15.

Both bus models are similar to each other, both in appearance and in terms of physical dimensions. They also have relatively equal capacity and both of them are used throughout the day, one is not specially used in the morning traffic. The geometric dimensions can be of importance when regarding road design, parameters such as the width, height, turning radius and similar concerns this.

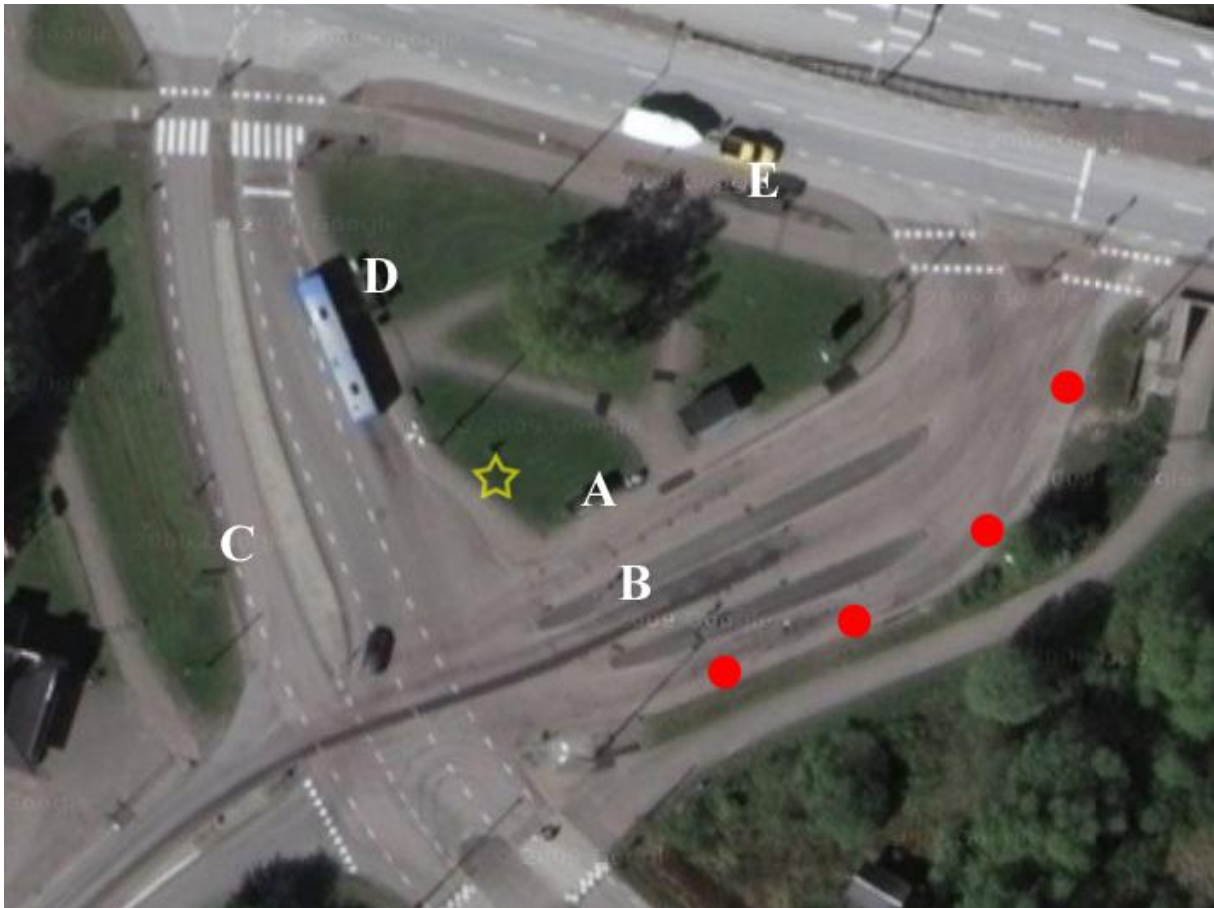
Figure 23: Aerial photo of the hub Klareberg.

Express Bus Rosa operates at position A, B and D, the other stops work for other lines. The yellow star marks the location of the electronic sign displaying upcoming departures. The buses are also parked temporarily, such as when drivers have a break. These locations are marked in the figure with red dots.

At the stop at Klareberg, Express Bus Rosa both begins and ends its journey in the northern parts. From here, the extra loop serving the area around Gerrebacka also starts and ends. There are six bus stops at Klareberg and Express Bus Rosa operates three of these.

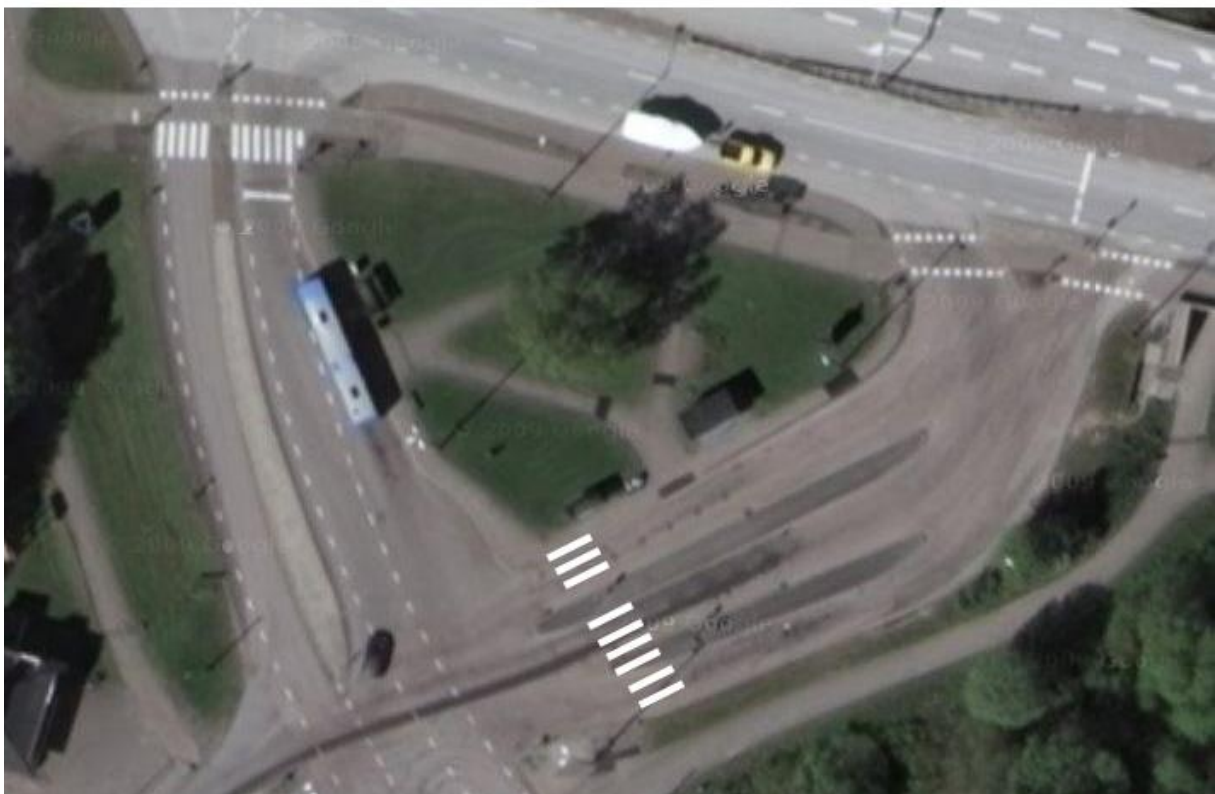
Below are sketches of how it could look like. It is both an aerial photo that presents the proposal from the top but also a street scene with the crosswalk plotted.

Figure 24: Aerial photo displaying the proposed crosswalk at Klareberg.

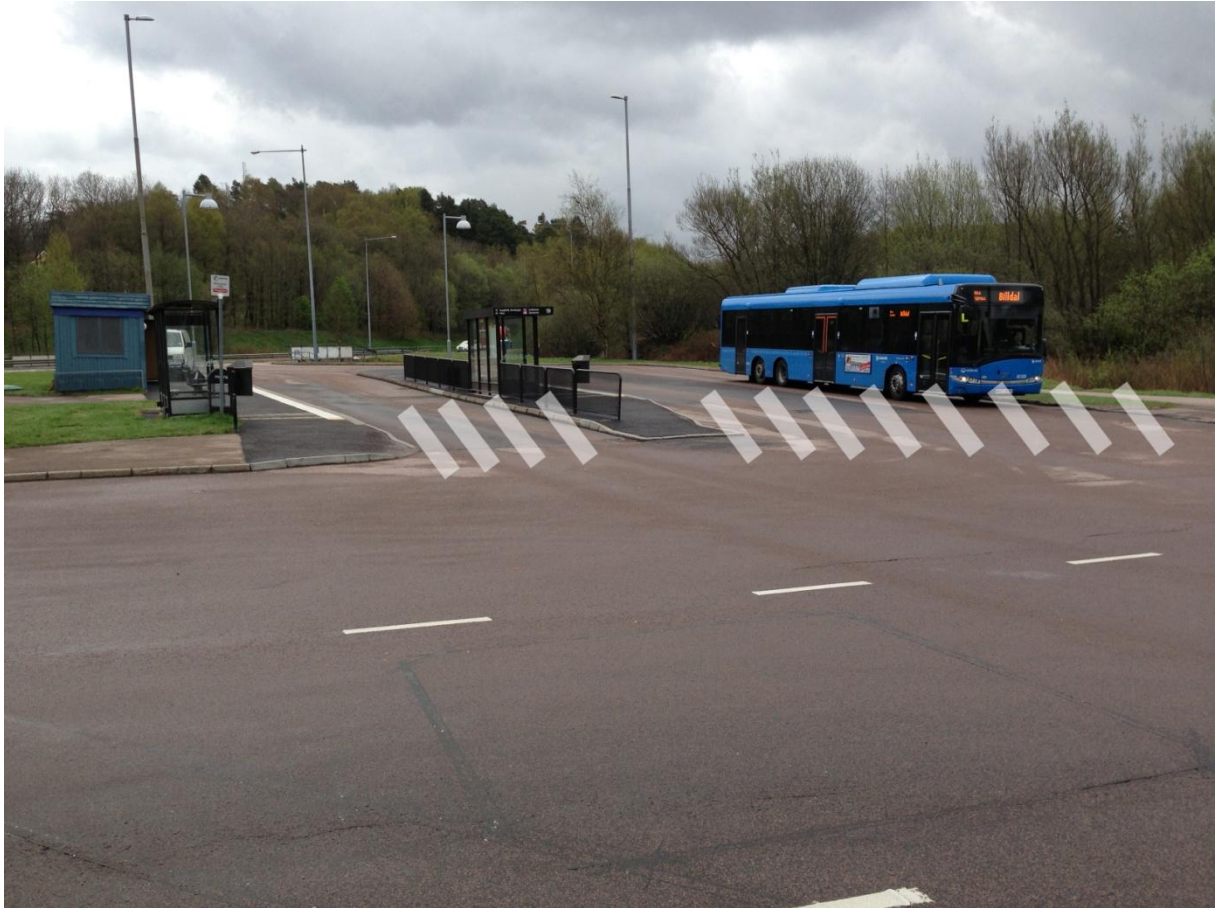
Figure 25: Sketch of crosswalk in Klareberg.

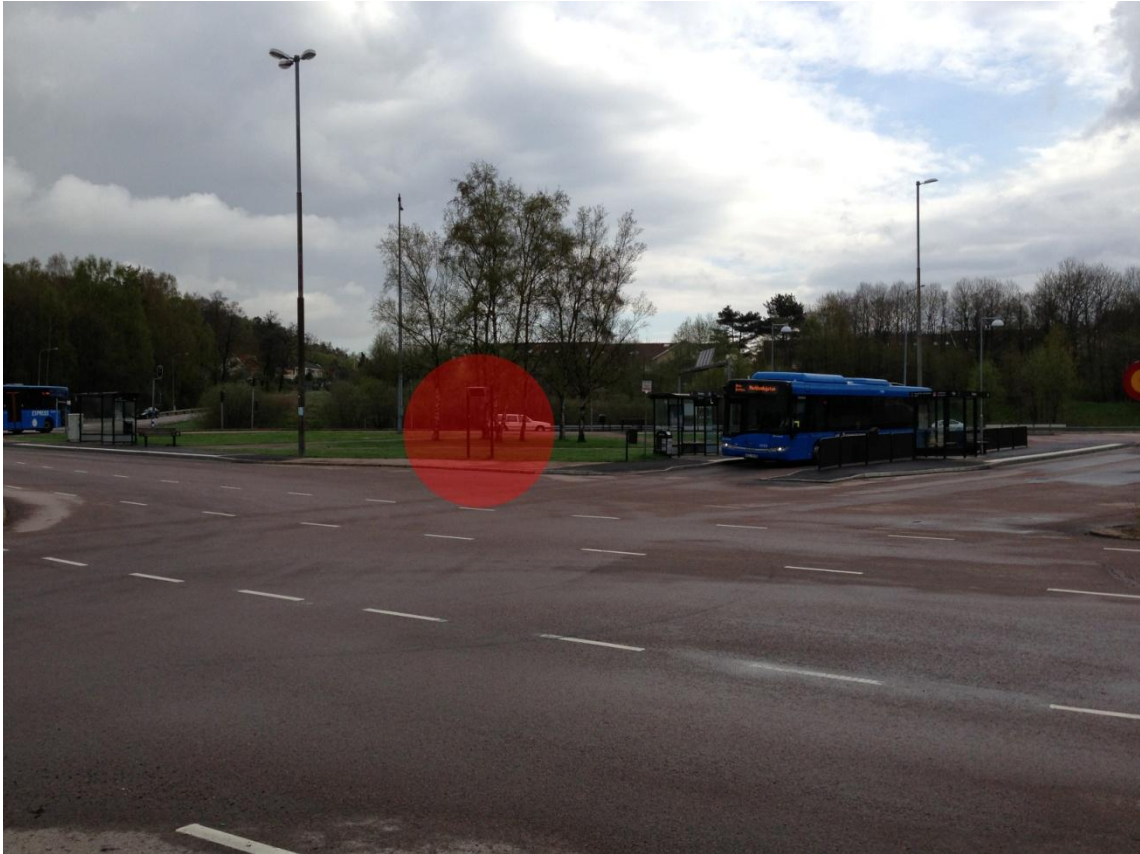
Figure 26: The electronic board displaying departures coming up.

Figure 26 shows the location of the electronic board, and thus there is a possibility to attach a map at the same posts as the board is attached on.

A second problem was that it is difficult to get an overview of the designation of the various stops. From the electronic display this is not possible. The proposal is to simply highlight the designation, the letters used, on different sides of the bus stops so that they can be seen from several different angles.

The current situation is there is no consequence on how it is displayed, it varies between the different stop. Ideally, it should be visible from the electronic display. There may also be installed a map of Klareberg and the various stops. It could be placed at the same poles as the electronic display. It would make it easier for travelers who are not so familiar with this hub.

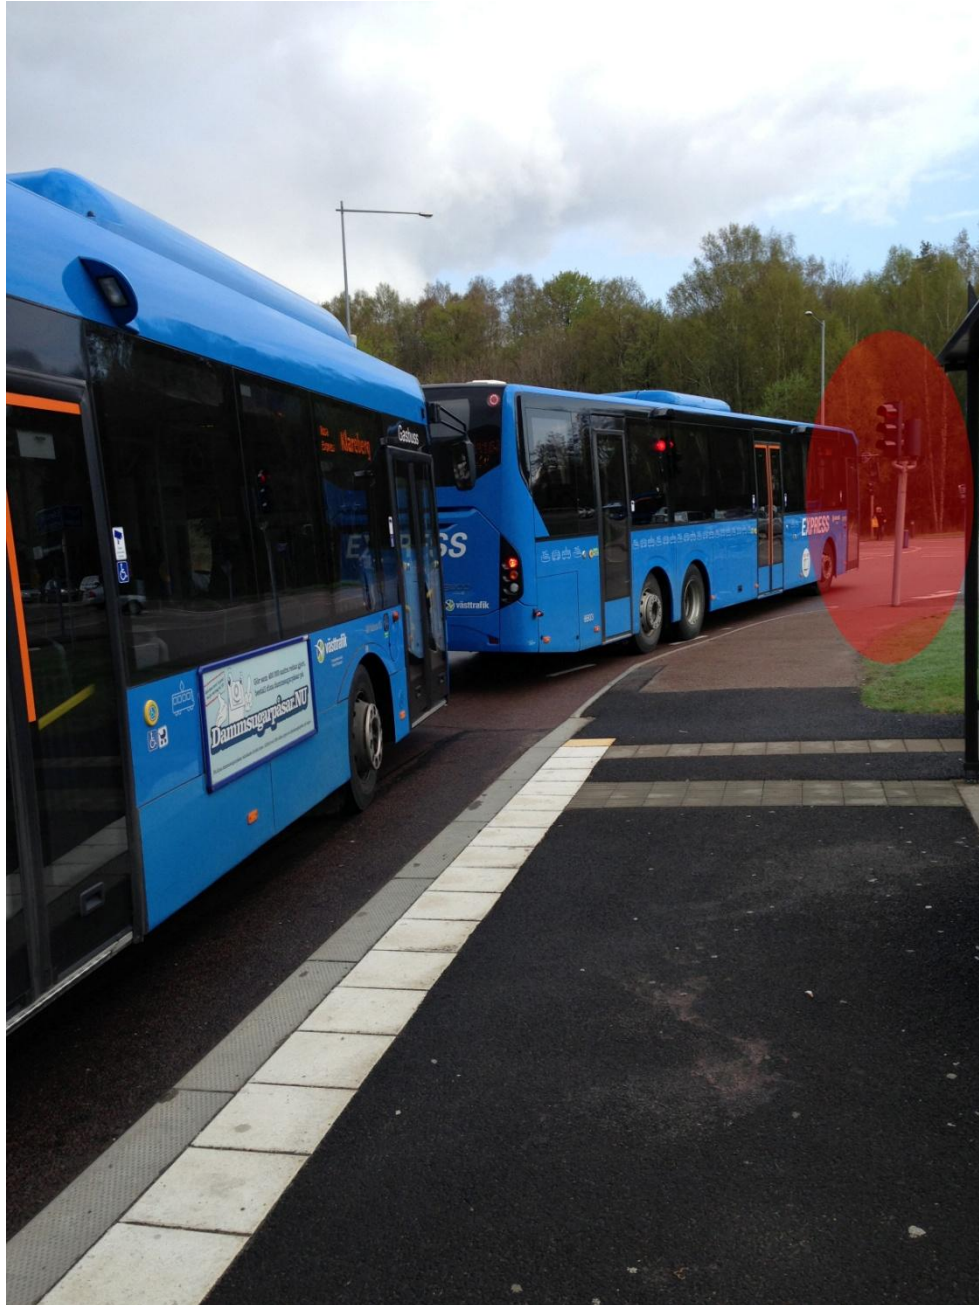
The following figure illustrates the current traffic signal and also how a queue is often formed at the site.

Figure 27: The traffic signal at Klareberg.

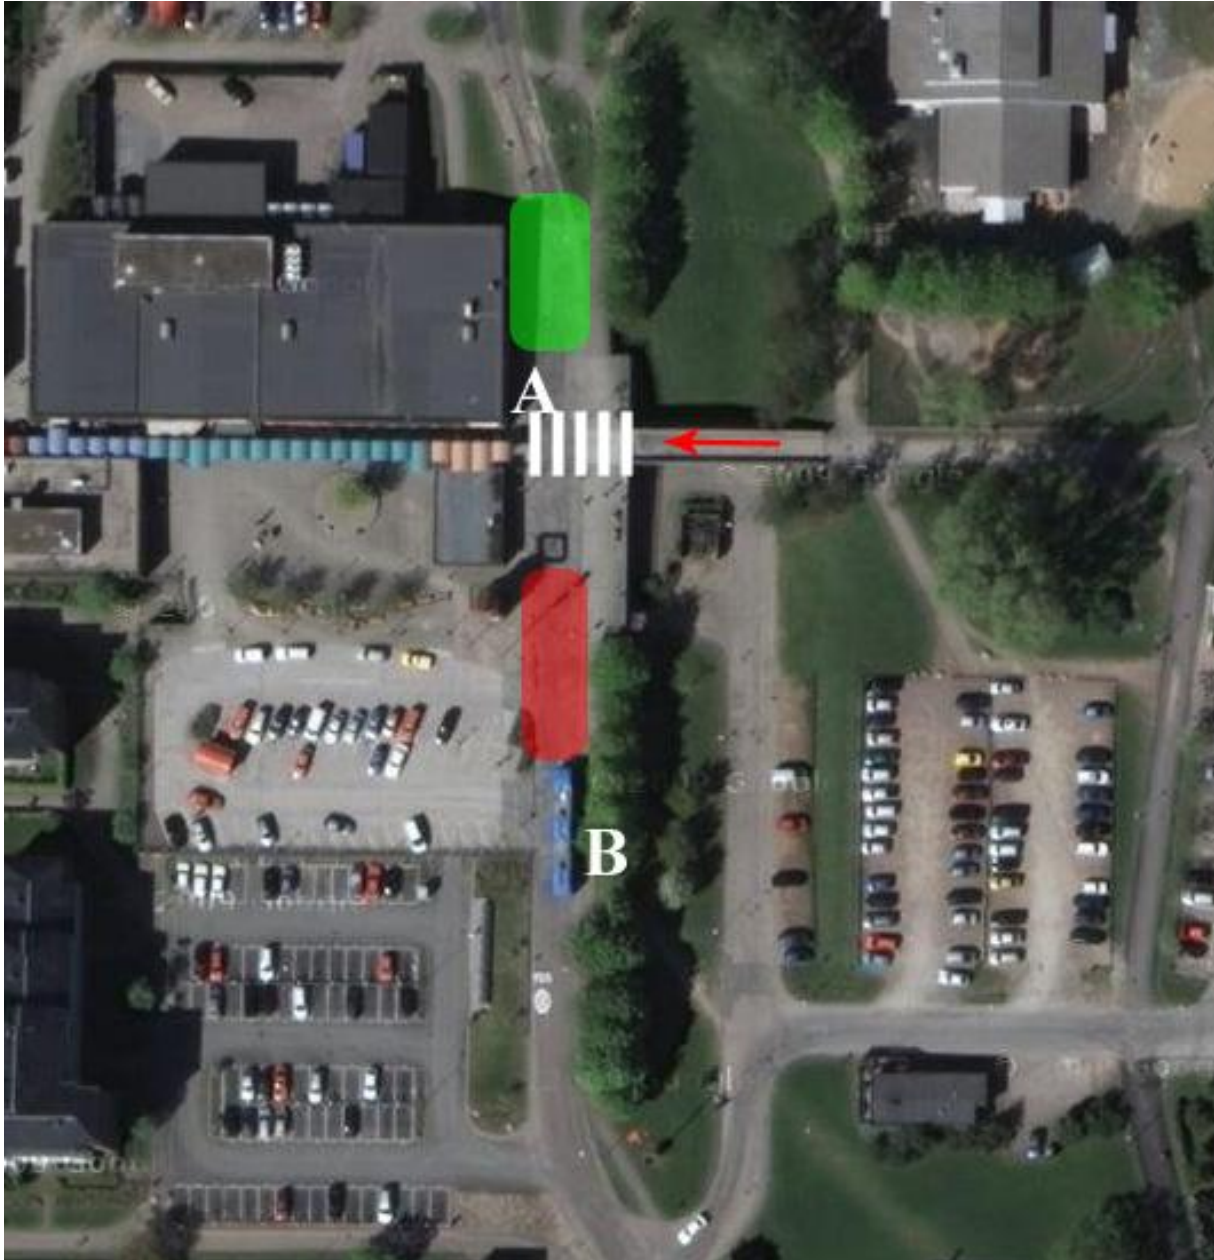
Figure 29: Proposals of actions at Kärra Centrum.

As before, the stop positions are marked with their letter designations. The red arrow indicates a flow of pedestrians moving from the residential area to the east, including the large parking lot and to the center building. The green area marks the aforementioned barriers and the red area marks an area where there is a high risk of pedestrians crossing the road.

In figure 29, the green area marked a place where temporary barriers are currently deployed. They serve their purpose now but should quickly be replaced by permanent refuges to ensure traffic safety. It would also be good for the overall impression of the place as it right now gives a cluttered and messy impression on the visitor. The following illustration highlights in red how the temporary barriers are placed at the moment.

In Figure 29, there is also a red marked area. In this area, there is a significant risk that pedestrians who just stepped off the bus or are heading for the stop at position B will take a short cut across the road. The picture below illustrates how it looks. The barrier rail lying in the road surface will prevent passage over the road but it is not fully safe as there is still a great risk of stepping out on the road.

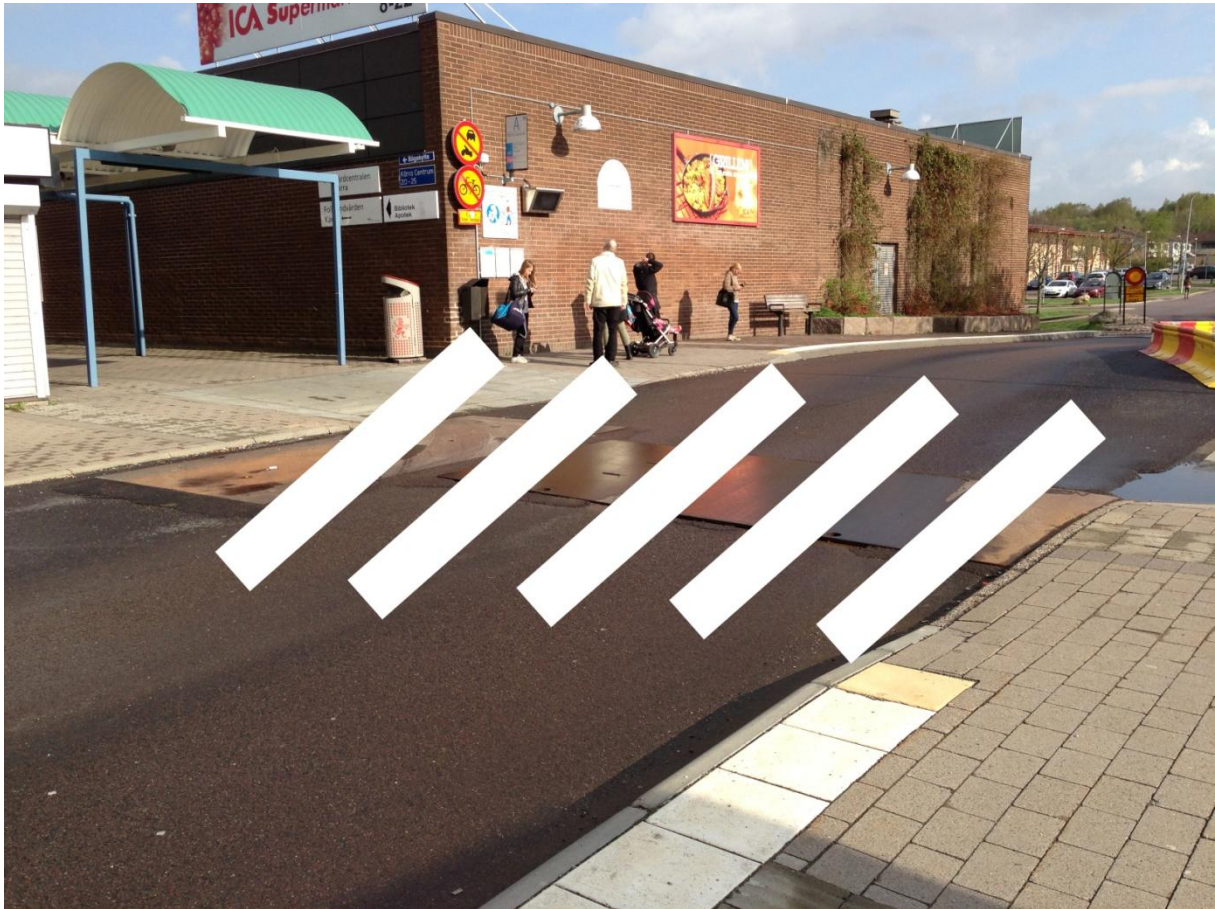
flow of pedestrians at this point. Road marking, signage and improved lighting are three simple steps that would improve this situation. A sketch of the design follows.

Figure 30: Sketch of proposed crossing at Kärra Centrum.
