Improvements in the traffic system of Gothenburg

A case study on Express Bus Rosa including analysis and proposals of actions

Master of Science Thesis in the Master's Programme Infrastructure and Environmental Engineering

Master's Thesis 2013:43

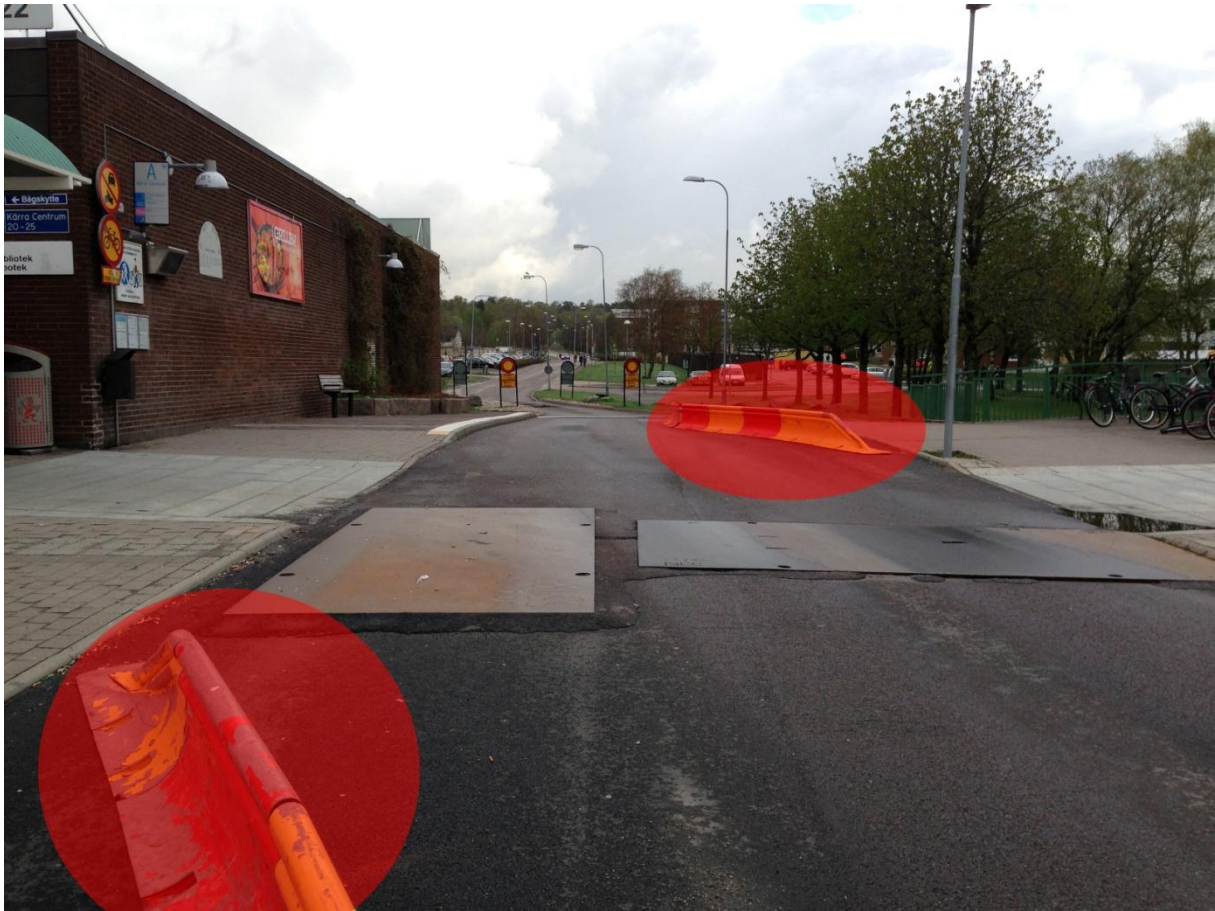
In figure 29, the green area marked a place where temporary barriers are currently deployed. They serve their purpose now but should quickly be replaced by permanent refuges to ensure traffic safety. It would also be good for the overall impression of the place as it right now gives a cluttered and messy impression on the visitor. The following illustration highlights in red how the temporary barriers are placed at the moment.

Figure 31: Red markings for temporary barriers at Kärrens Centrum.

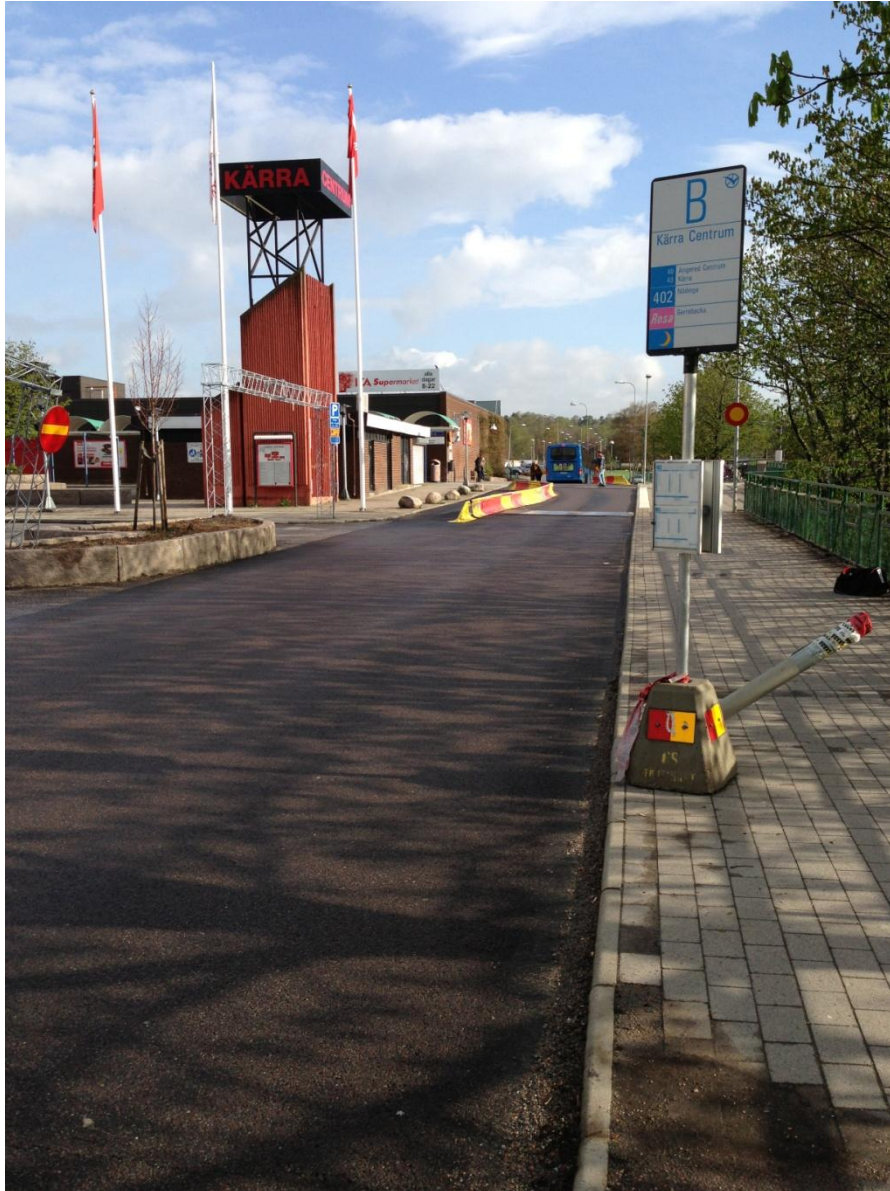
In Figure 29, there is also a red marked area. In this area, there is a significant risk that pedestrians who just stepped off the bus or are heading for the stop at position B will take a short cut across the road. The picture below illustrates how it looks. The barrier rail lying in the road surface will prevent passage over the road but it is not fully safe as there is still a great risk of stepping out on the road.

Figure 32: The stop position B at Kärre Centrum and the temporary barrier.

A measure for this problem is that the barrier is being converted into a permanent refuge. The position of the stop should also be made permanent for clarity towards passengers. In order to avoid unwelcome passes over the road, some kind of fence should be installed. One suggestion is that it follows the edge of the pavement towards the proposed crossing. Another suggestion is that it is built at the refuge.

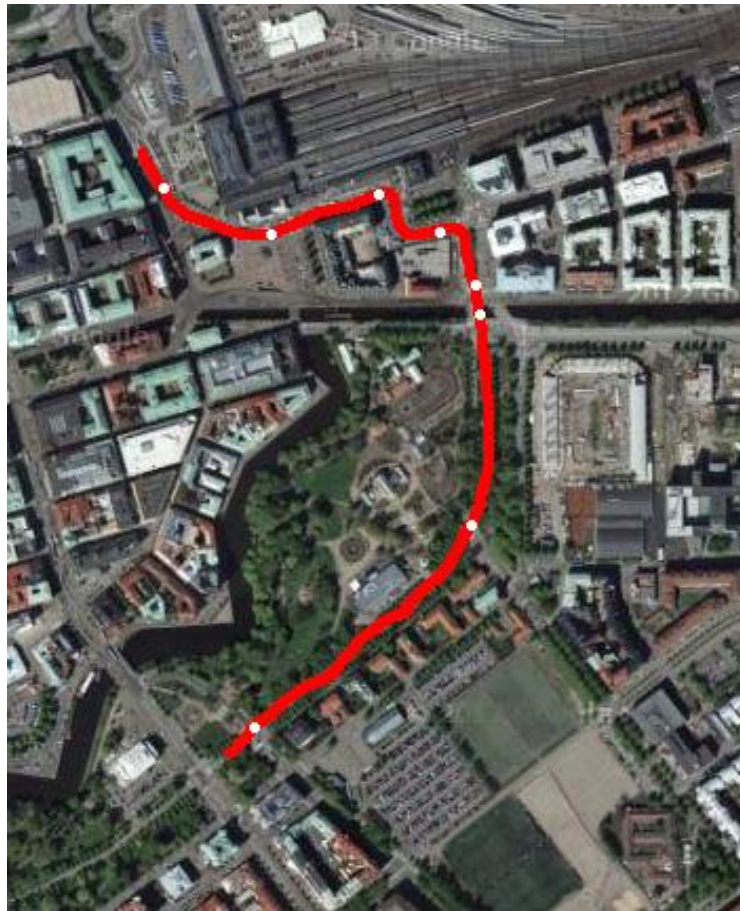
approximately five minutes. The problems identified on the route are particularly the many traffic signals that give differences in the speed of travel and travel time. Figure 33 shows the distance with a red line and the traffic signals are marked with white dots.

Figure 33: The stretch between Nordstan and Heden in central Gothenburg.

Description: The route runs through an urban area and in highly regulated traffic. In the short distance there are nine traffic signals that may give differences in travel time along this section of road.
