## Evaluation of Ground Penetrating Radar as a Non-Destructive Investigation Method in Concrete Elements

*Master of Science Thesis in the Master's Programme Geo and Water engineering*

Department of Civil and Environmental Engineering  
Division of GeoEngineering  
Road and Traffic Group  
CHALMERS UNIVERSITY OF TECHNOLOGY  
Göteborg, Sweden 2014  
Master's Thesis 2014:5

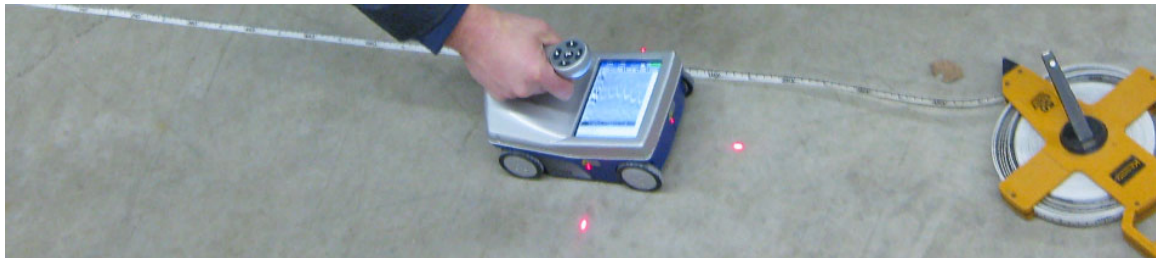
*Figure 1 Example of a handheld GPR unit (GSSI, 2013c)*

Current GPR units have evolved into compact and user-friendly instruments that can gather large amount of data in a relative short time, see figure 1 for an example of a modern high resolution GPR unit.

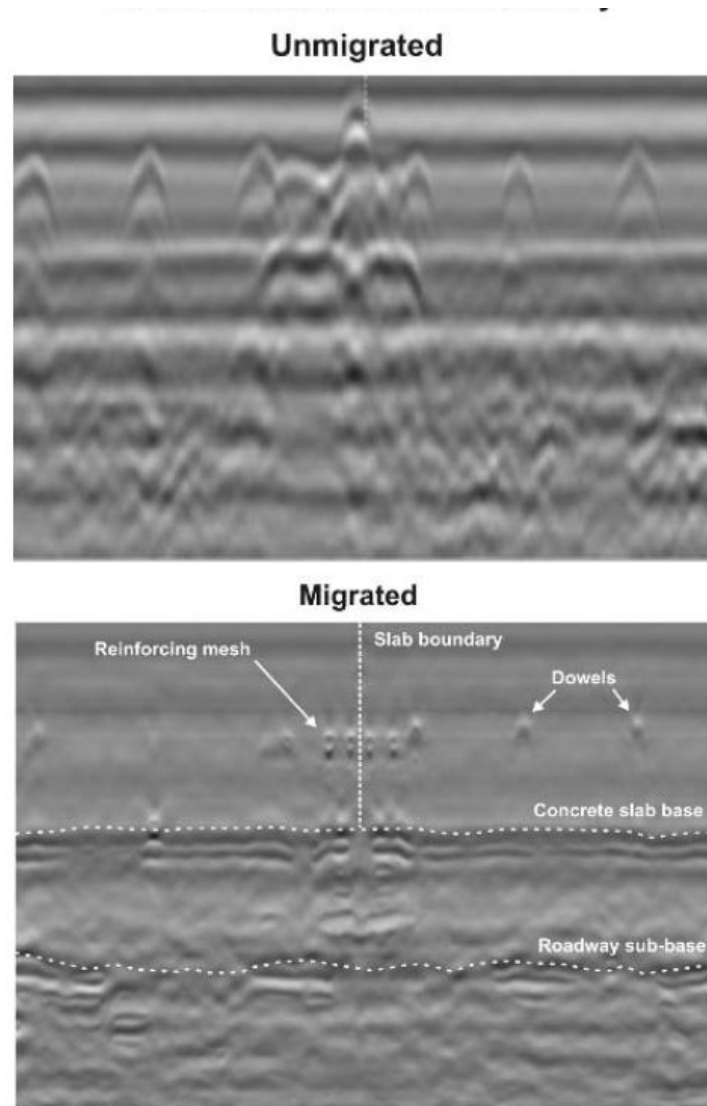
Figure 9 Example of a successful performed migration (Cassidy, 2010)

The migration techniques were originally developed for the seismic industry and it is mainly used to improve section resolution and develop a more spatially realistic image (Cassidy, 2010). Migration is one of the most controversial processing techniques and it tends to be less successful with GPR, especially when scanning complex heterogeneous sites. However, migration technique can in certain situation be applied very successfully on a range of different applications, see Figure 9 for a successful migration. This method can be very advantageous when investigating the existence of rebar in concrete, as a good performed migration will collapse hyperbolae to a point source and dipping reflections will be repositioned into their correct location.

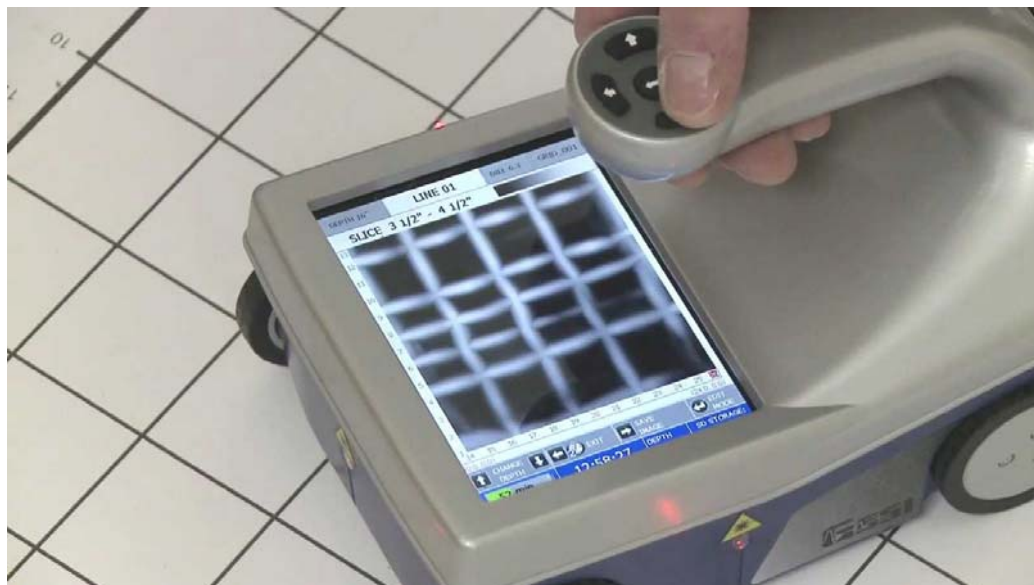
Figure 14 Image of the StructureScan Mini HR when performing a 3D scan (GSSI, 2013c)

According to GSSI the main purposes for the StructureScan Mini HR is to perform concrete inspections and locate metallic and non-metallic targets, structure inspections such as bridges, walls balconies and garages, measure slab thickness and void location (GSSI, 2013c).

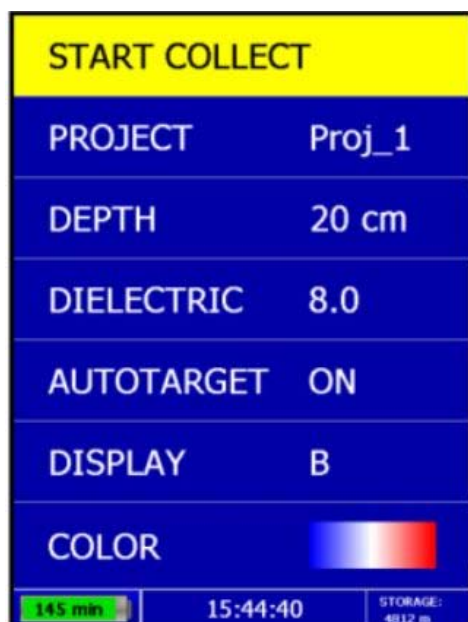
Figure 15 Available settings on the StructureScan Mini HR before starting a 2D scan (GSSI, 2013c)

The StructureScan Mini HR can be used in two different modes, 2D and 3D. When using the apparatus in 2D mode a b-scan is performed (GSSI, 2013c). However the information from an a-scan can be retrieved afterwards and with the help of the Radan software a c-scan can be created. Before starting a 2D scan the settings of the apparatus can be modified to the user's preference, see figure 15. All setting can be modified post scan in both the apparatus and in Radan, except for the scan depth

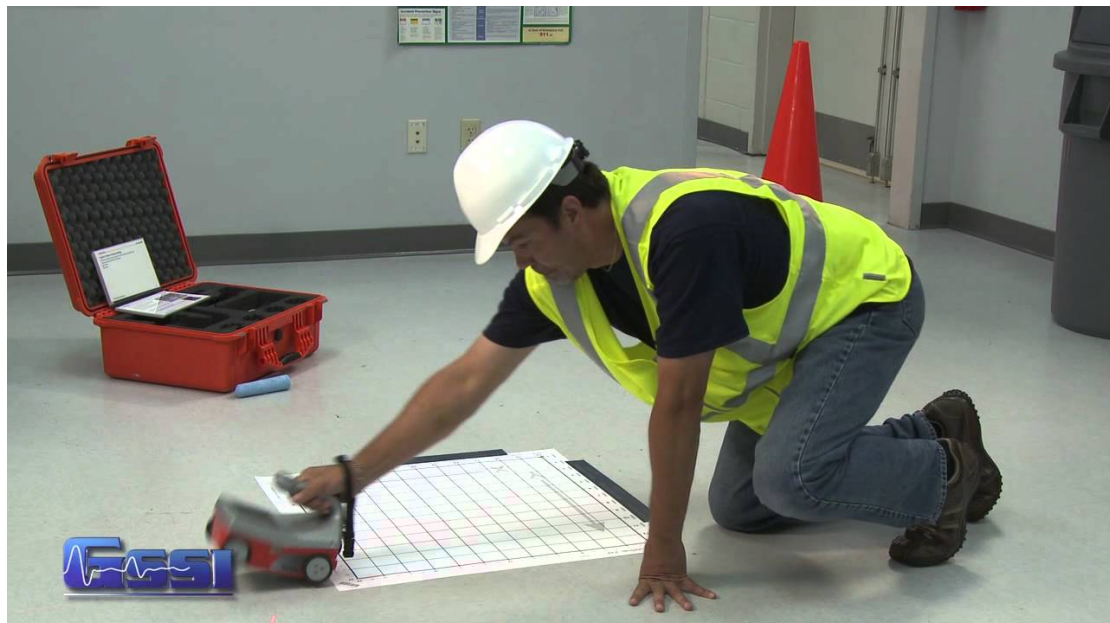
Figure 17 3D scan is performed on a 60x60 cm grid (GSSI, 2013c)

performed. See Figure 17 for an example of a grid that used when performing a 3D scan.

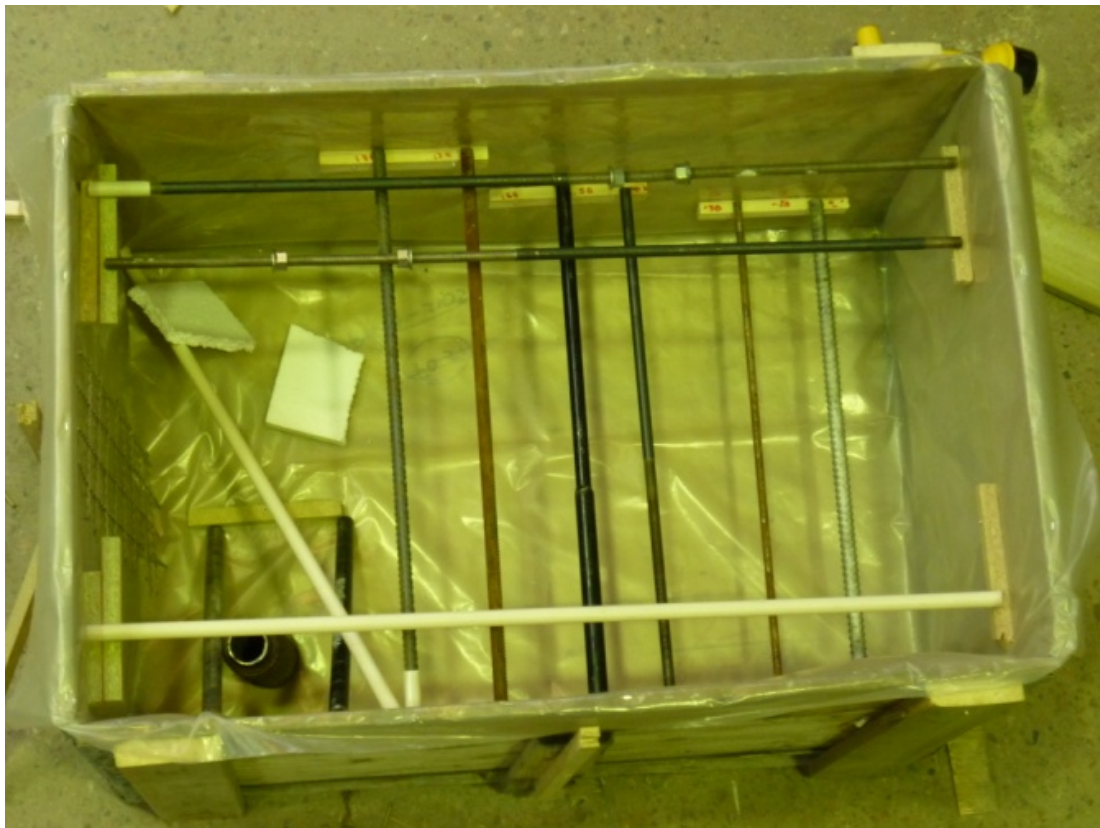
*Figure 18 The moulding form and the embedded artefacts of test specimen 1*

Test element 1 is a 120x60x50 cm concrete cuboid. Different artefacts have been placed inside the specimen at different positions to create a testing environment where identification of different object will be performed. Also in the left part of the element, see Figure 18, an area has been created to test the 3D capability of the hardware.

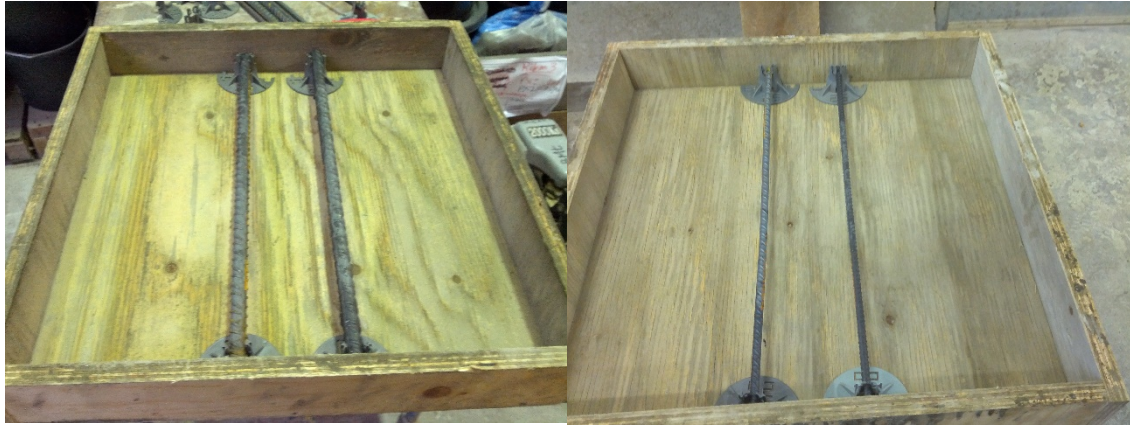
Figure 19 The moulding forms and the embedded artefacts of test specimens 2-5

Test specimens 2-5 are 50x50x8 cm concrete cuboids with two rebar placed in each. In two of the specimen rebar with the thickness of 16 mm in diameter have been placed and in the other two rebar with the thickness 8 mm in diameter, see Figure 19. The rebar in specimen 2-5 are all placed 25 mm from the bottom. The purpose of the elements is to be able to create structures with different layers

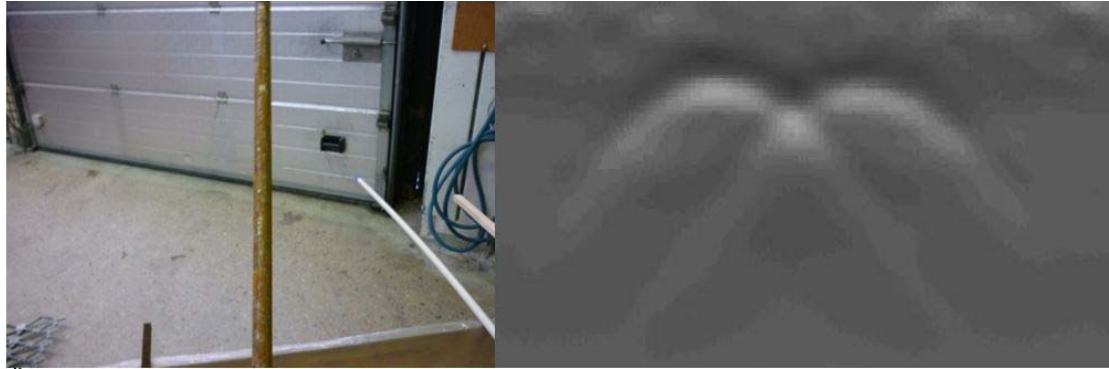
Figure 23 Metal rod in test specimen 1, diameter 12 mm, and its corresponding scan result, right hyperbola.

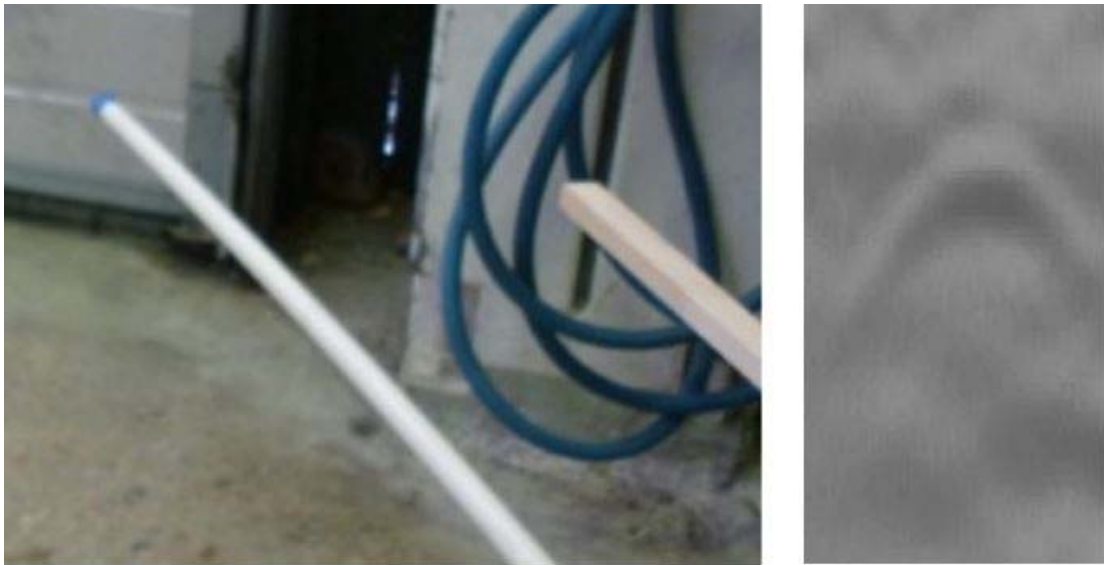
Figure 27 PVC pipe used in test specimen 1, diameter 20 mm, and its corresponding scan result

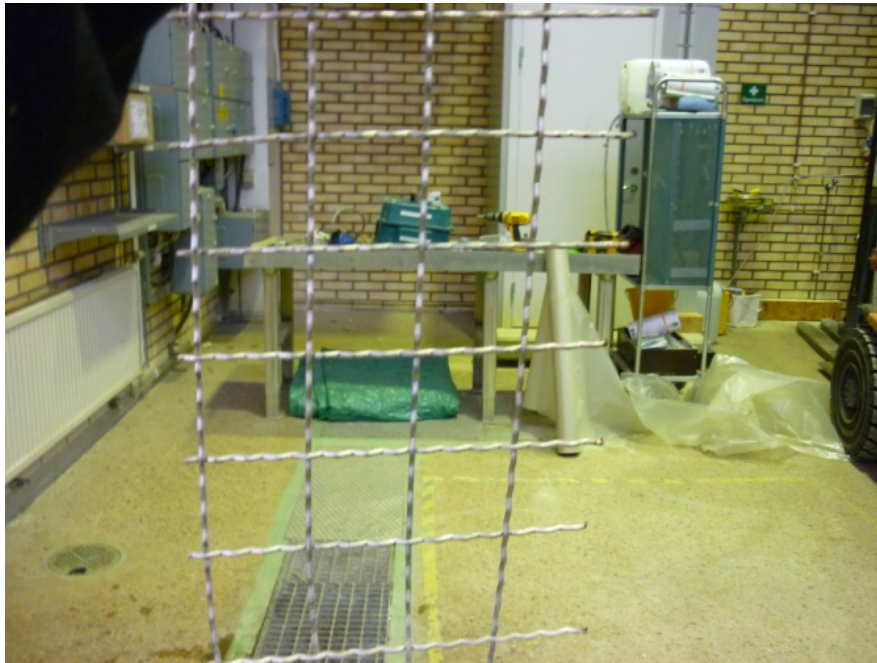
Figure 28 Rebar mesh used in test specimen 1

3D scans are useful when investigating more complex constructions. Figure 28-30 shows a rebar mesh, its location in test specimen 1 and the result of the 3D scan

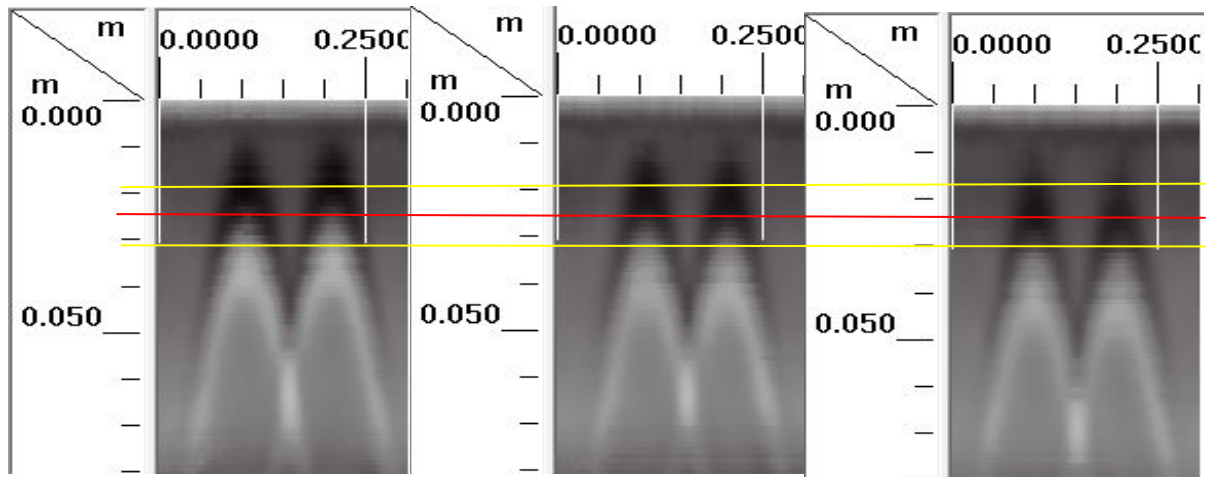
Figure 34 result of B-scan of test specimen 3-5. The red line indicates the location of the rebar, the yellow line indicates acceptable measurement error according to GSSI.

According to GSSI, the StructureScan Mini HR has a measurement accuracy of  $\pm 6,4\text{mm}$ . To evaluate the accuracy of this statement three of the test specimens 3-5 have been scanned, as the depth of the rebar are known. The results of the scan, see Figure 34, show that the depth measurements are within the acceptable margin of error.

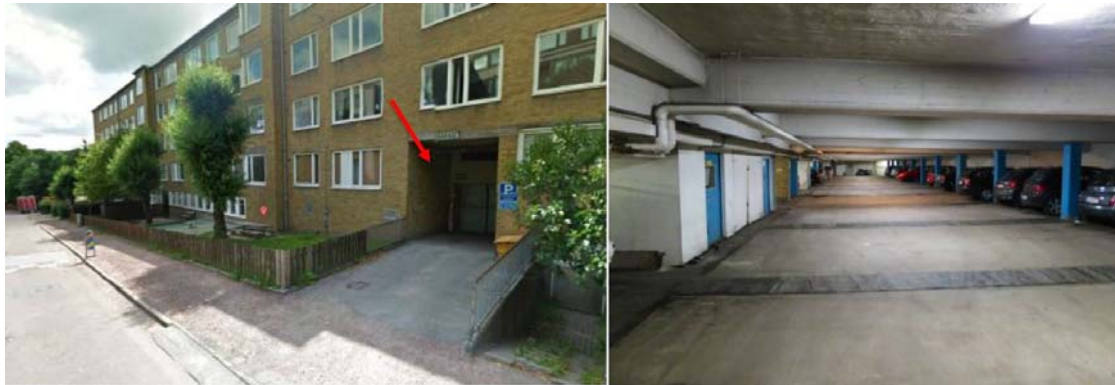
Figure 39 Picture taken outside of Jungmansgatan 55

As a part of the study a damage investigation was performed on the garage at Jungmansgatan 55 in Gothenburg, see Figure 39. The parts presented below are a part of the damage investigation, however only parts relevant to the GPR investigation will be included.

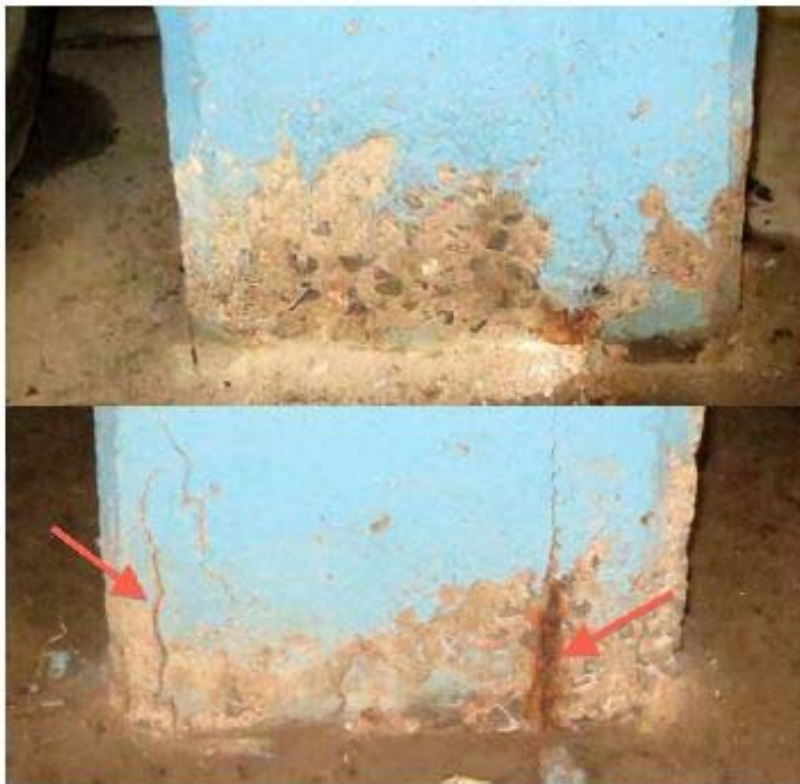
Figure 41 Column, located in the upper level, showing rust stains and corrosion cracks.

The garage consists of a two level underground garage, where each level has a separate entrance. The lower level of the garage was in much better condition than the upper level. On the upper level reinforcement corrosion was found on many vertical elements and rust stains were visible, see Figure 41. A 5 mm bituminous layer strip was applied perpendicular to the driving strips, where it was observed that water was accumulating along the edges, see Figure 42.

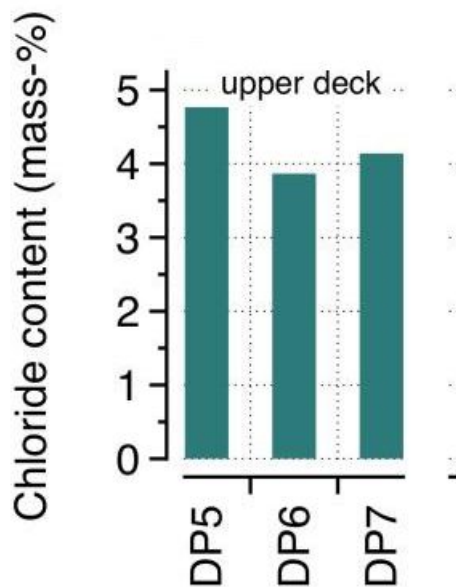
Figure 43 Chloride content in the three samples from the upper deck (CBI, 2013)

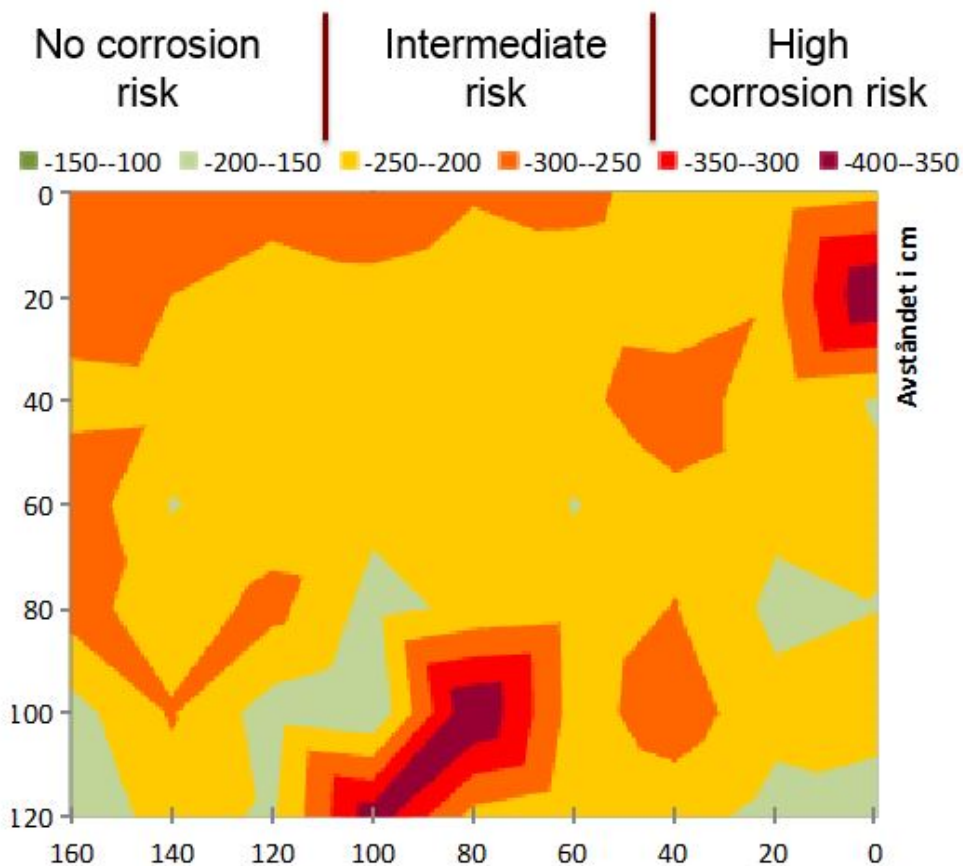
Figure 45 Result of HPC test on the sample area (CBI, 2013)

To evaluate the risk of corrosion a half-cell potential measurement was performed. The method measures the negative charge and an increased risk of corrossions is encountered when the measurements reaches values below -250 mV, see Figure 45 for the results of the half-cell potential measurement. The measurement shows that there are locations with very high negative values and high probability of corroded reinforcement. The drill core with corroded reinforcement in Figure 44 is extracted just outside of the upper left corner, indicating that this area is severely corroded.

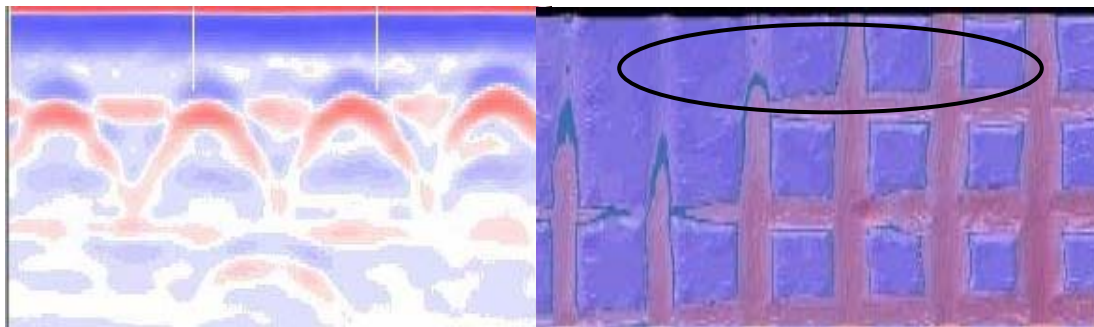
Figure 47 B-scan of the highlighted in the 3D scan

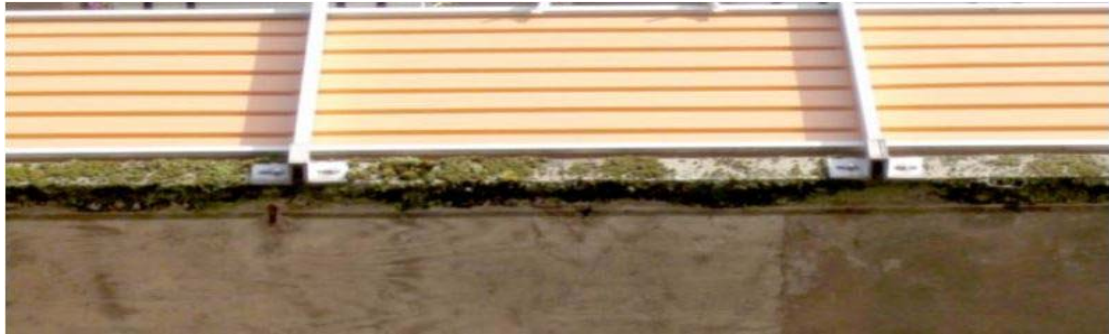
*Figure 50 Image showing the construction of the balcony plates*

The construction of the balconies is not favorable when it comes to protecting the concrete slab from different weather conditions. The slab is unprotected from rain and as can be seen in Figure 50, the balcony plates are placed in the inside of the edge of the concrete slab and will lead the rainwater directly onto the edge. This exposure will raise the relative humidity of the concrete and raise the carbonization rate of the concrete.

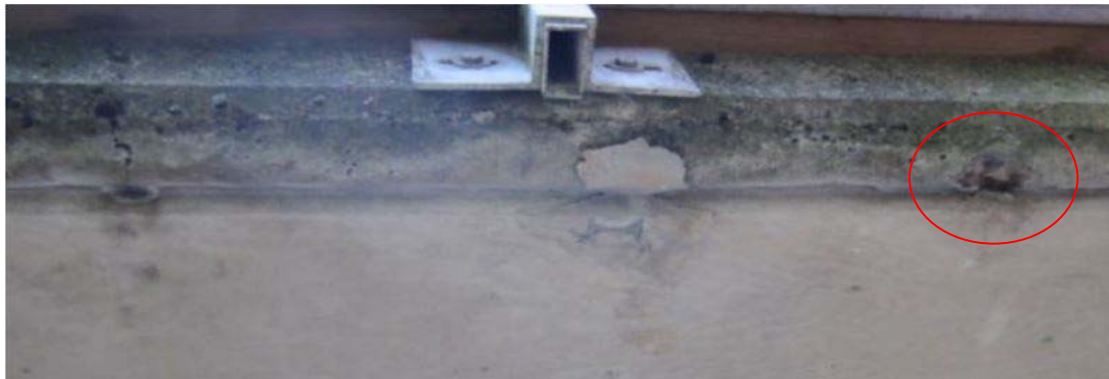
*Figure 51 Corrosion crack found on the underside of a balcony*

Another consequence of the unprotected concrete slab is the hefty growth of moss on the edges, which will create an acidic environment and speed up the concrete deterioration and rebar corrosion. Corrosions that has already started and can be seen in Figure 51 and 52

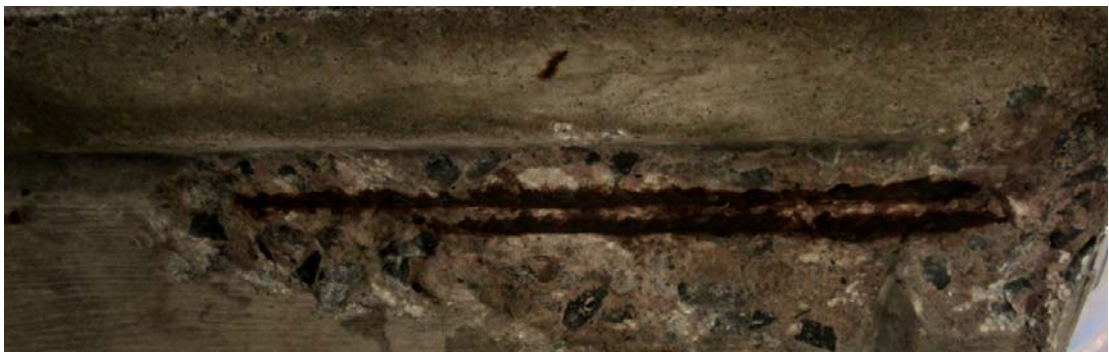
*Figure 52 Corroded rebar on the underside of a balcony at Ivargårdsgatan*

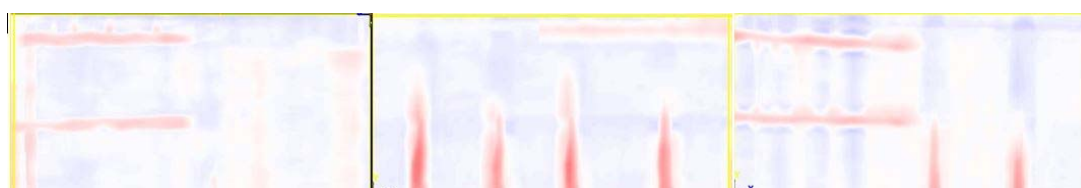
Figure 57 Rebar located at a depth of 15 cm or less, 1<sup>st</sup> floor

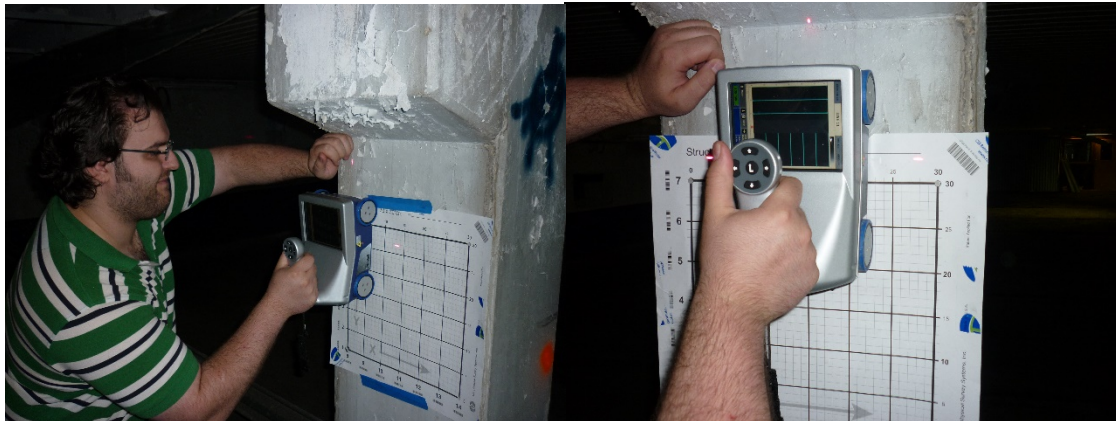
Figure 58 Performing 3D scans on column

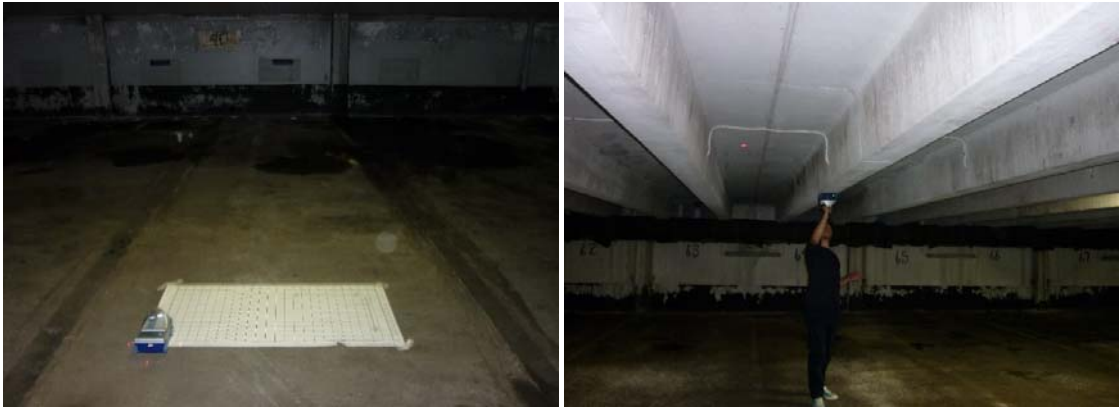
Figure 60 Onsite images of the floor element

The mapping of the floor element is more complex and both 3D and onsite mapping had to be used to map the position of the reinforcement. In Figure 60 and 61 the element can be seen onsite and in a 3D model.
