## **Tests on Anchorage of Naturally Corroded Reinforcement in Concrete**

Lundgren, K., Tahershamsi, M., Zandi, K, and Plos, M.

*Materials and Structures*, 2014,

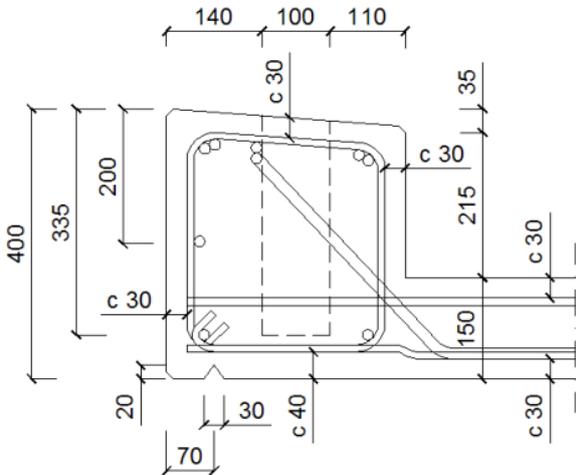
Fig. 1 Cross-sectional detail of the edge beam. Adapted from the bridge drawings; all dimensions are in [mm].

In Fig. 1, the geometry of the edge beams is shown. These beams were 350×400 mm<sup>2</sup> in cross-section, with a small inclination of the upper surface. The edge beams were reinforced, both longitudinally and transversally, with ribbed bars. The longitudinal reinforcement consisted of four bars Ø16 Ks60 bundled into pairs in the upper part, two bars Ø16 Ks60 at the bottom, and one bar Ø16 Ks60 at mid-height of the cross-section to the left in Fig. 1. The transverse reinforcement consisted of Ø10 s300 Ks40. Ks 60 and Ks 40 are old Swedish notations for steel reinforcement with a characteristic yield strength of 600 and 400 MPa, respectively.

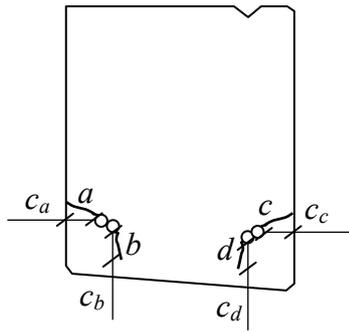
Fig. 2 Notations for concrete cover measurements and spalling cracks.

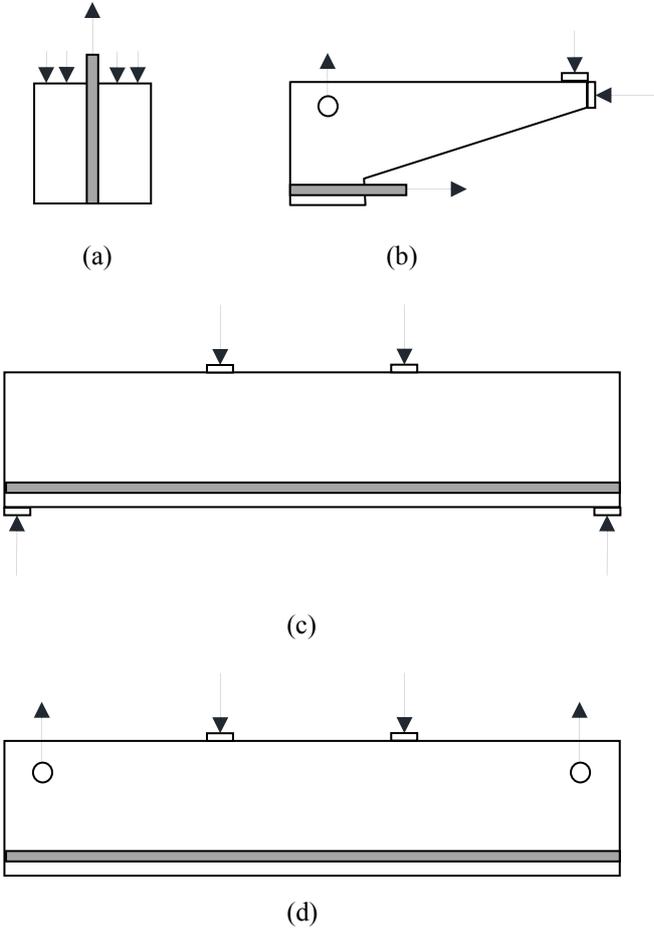
Fig. 3 Principles of possible test set-ups: a) a pull-out test; b) a beam-end test; c) a directly supported four-point bending test; and d) an indirectly supported four point bending test.

Four different test configurations, as illustrated in Fig. 3, were considered when the test set-up was selected: a pull-out test; a beam-end test; a directly supported four-point bending test; and an indirectly supported four-point bending test.

The pull-out test was excluded for several reasons. First, it would have been difficult to grip the bundled bars. Second, the eccentric position of the bars would have complicated the test. Finally, the region around the bars would have been disturbed in preparing specimens for pull-out tests, thus influencing the bond properties. Otherwise, as it has a well-defined anchorage length, the pull-out test would have been preferable.

The beam-end test has also a well-defined anchorage length and better represents structural behaviour than the pull-out test. However, also this test set-up involves the difficulty of

The directly supported four-point bending test has the advantage of excluding any gripping of the bundled bars. Furthermore, because inclined shear cracks often propagate to direct support, it will most likely result in better defined anchorage length in comparison to the indirect support. A concern regarding this test set-up is that the support pressure will to a large extent influence the anchorage behaviour. With external transverse pressure acting in the anchorage region, i.e. along the transmission length, both bond stiffness and strength increase, see e.g. Lundgren and Magnusson (2001) or Zandi Hanjari (2010). As the major influence of corrosion on bond is that the confinement is reduced due to cracking and eventually spalling, it would be inappropriate to use a test set-up which compensates for this weakness as support pressure is not always present in real anchorage situations, e.g. in splices or cut-off regions. Finally, for severely damaged members with cover spalling in the end regions, a test configuration using direct supports would be impossible without repairing the specimens to obtain a flat surface for the supports. As our intention was to study the effect of spalled covers, this would be considered unacceptable. Therefore, the test set-up using a directly supported four-point bending test was left out.

The four-point bending test, indirectly supported by suspension hangers, does not include the problems of gripping the bundled bars, and the part with spalled cover can be left as it is. A disadvantage of the test set-up, however, is that it required strengthening of the available specimens for them to be able to withstand the hanging support reactions. With a carefully designed strengthening, this test set-up was thus considered to be the optimal choice with least disturbance and influence on the natural damage of the edge beams while capturing the structural behaviour.

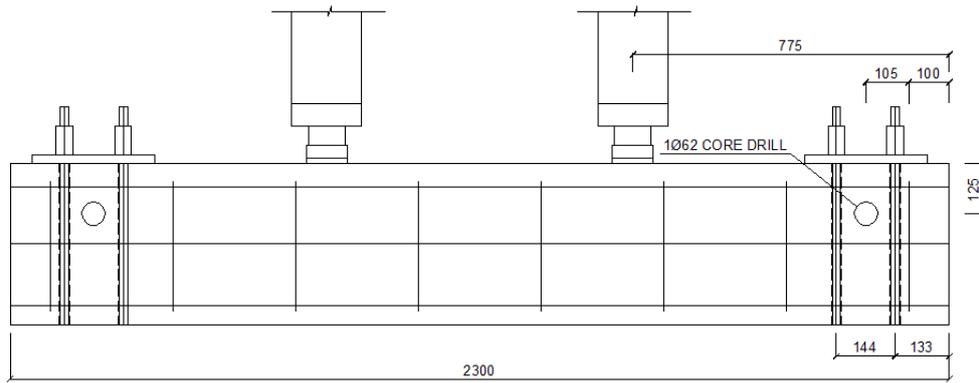
Fig. 4 Test set-up with dimensions in mm (symmetric).

The four-point bending test, indirectly supported by suspension hangers, was designed in detail so that an anchorage failure could take place. This was performed in a parametric study prior to actual testing by simulating the test set-up using both two- and three-dimensional Non-Linear Finite Element Analyses. For more details of the analyses, see Berg and Johansson (2011). Several parameters were investigated; the most important parameters were the location of the suspension holes and the position of the concentrated loads. With respect to shear capacity, it was considered to be important to place the load so that the load path crossed at least one stirrup. The parametric study showed that it would be preferable to obtain a rather large shear span; such a span would increase the bending moment, which in turn would increase the tensile stresses in the main reinforcement, thereby making it more likely to obtain anchorage failure. Furthermore, it showed that it would be preferable to place the suspension holes rather close to the end; when they were placed further into the beam, the shear crack appeared further away from the end, resulting in longer anchorage lengths with a more unstable and brittle behaviour.

Local failure around the suspension hole was critical independently of the test settings; therefore, it was concluded that the beams needed to be strengthened through transverse reinforcement. Internal mounting was considered the most promising option. In the method selected, vertical holes were drilled and reinforcing ribbed steel bars were bonded using epoxy adhesive, see Fig. 4. The number of strengthening reinforcing steel bars and their location, dimension and steel quality were designed to avoid the strengthening reinforcing steel to yield. With respect to the load-carrying capacity, it was considered essential to provide the beam with pairs of strengthening bars on both sides of the suspension hole. As the beams were strengthened, the suspension holes could be placed either in the upper or lower parts of the beam. The placement of the holes in the upper half was chosen to avoid the cracking around the suspension hole affecting the anchorage of the main bars. A pilot test showed that without additional measures, anchoring the strengthening bars became critical after the region around the suspension holes had started to crack (Berg and Johansson 2011). To provide additional anchoring of the strengthening bars, they were anchored at the top of the beam with hexagonal nuts and flat steel plates.

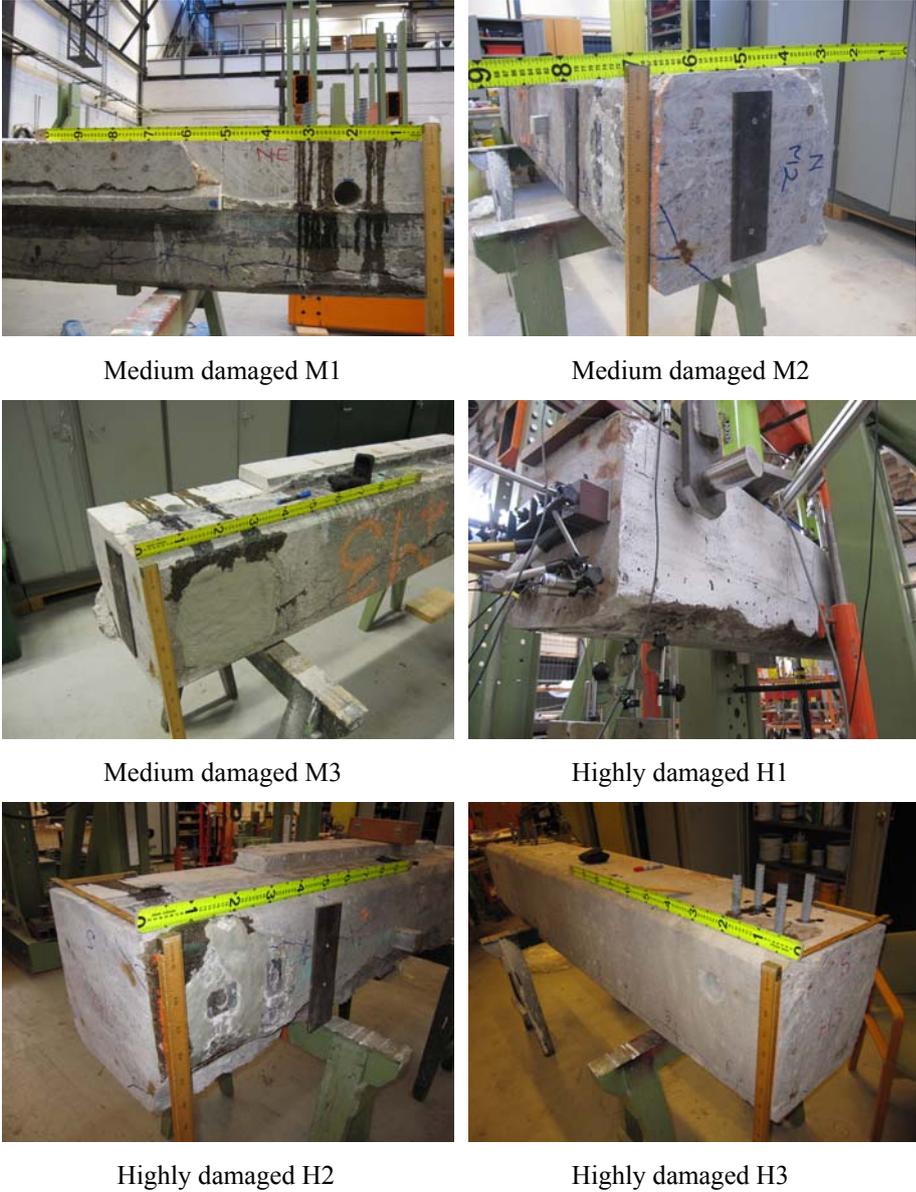
Fig. 5 Photos of corroded damaged specimens before testing, the side that later failed. Note that specimen H3 was considered to be Highly damaged even though there were only splitting cracks on the side that failed, as the other side had cover spalling.

Before the tests, existing cracks and spalling of the cover were documented. Photos of the corrosion damaged specimens before testing are shown in Fig. 5. The crack widths of the splitting cracks on the side of the beam that failed are shown in Table 5; the notations of the cracks are similar to the covers (see Fig. 2). Since one side of the beam had cover spalling, specimen H3 was considered to be Highly damaged. However, in the test, the specimen failed on the other side, where there were only splitting cracks.

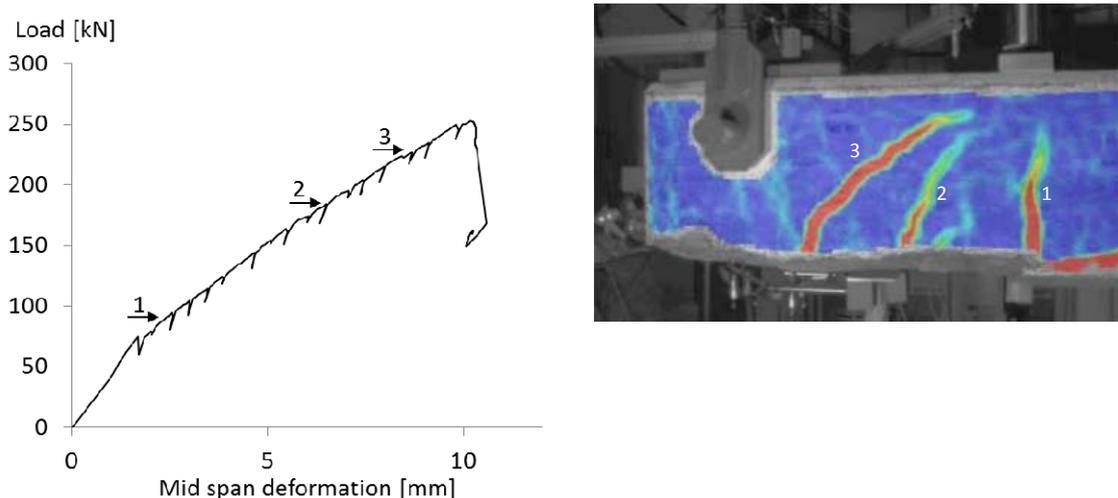
Fig. 6 Test H3. a) Average load in each of the hydraulic jacks versus measured deformation at mid span (not corrected for support settlements), b) Crack pattern measured with digital image correlation during the test. 1-3 marks when the cracks appeared.

Eight test specimens were successfully tested. All beams evidenced similar behaviour in terms of crack development and failure mode. An example of a load versus mid-span deformation graph, together with cracks appearing, is shown in Fig. 6. In this particular test, the crack pattern was measured by digital image correlation. The first flexural cracks occurred at around 80-110 kN near the centre of the beam. With increased loading, flexural-shear cracks began to appear in the shear span. The inclined shear cracks occurred at around 160-180 kN (see Table 6). Thereafter, the load continued to increase; the anchorage was then effectively loaded and the bond capacity came to play an important role. In some tests (as in the test shown in Fig. 6), second shear cracks closer to the support began appearing at around 220-240 kN.

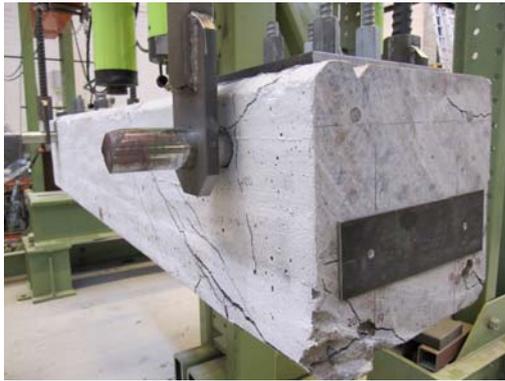
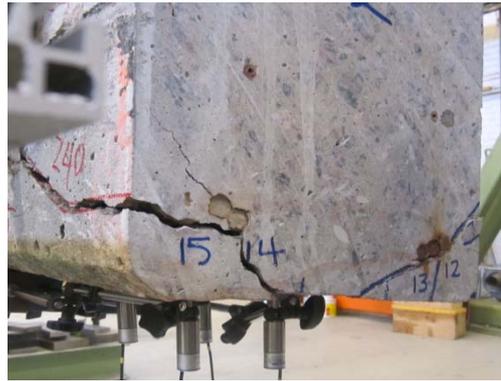
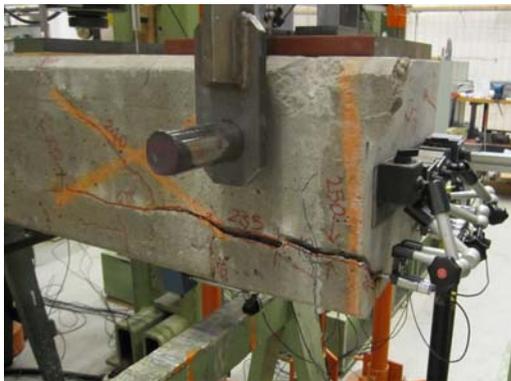
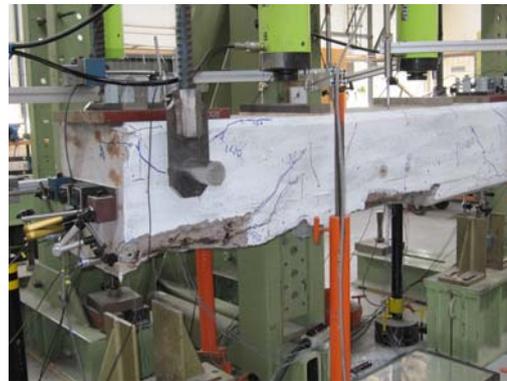
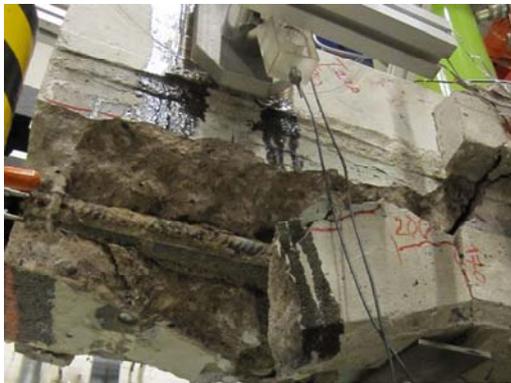
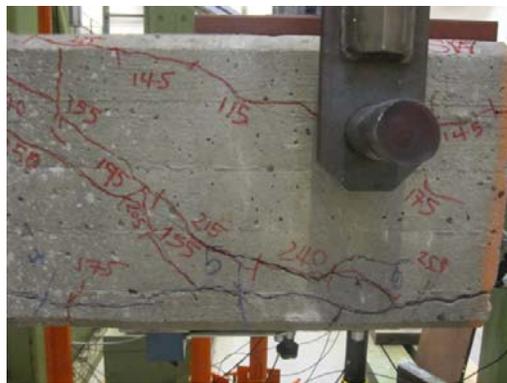
Fig. 7 Failure and crack pattern on some of the beams after testing.

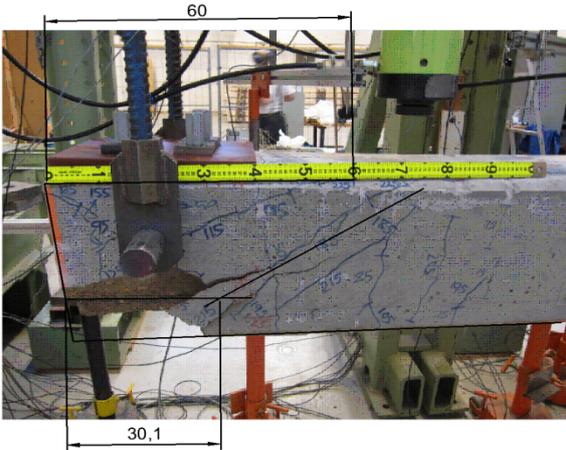
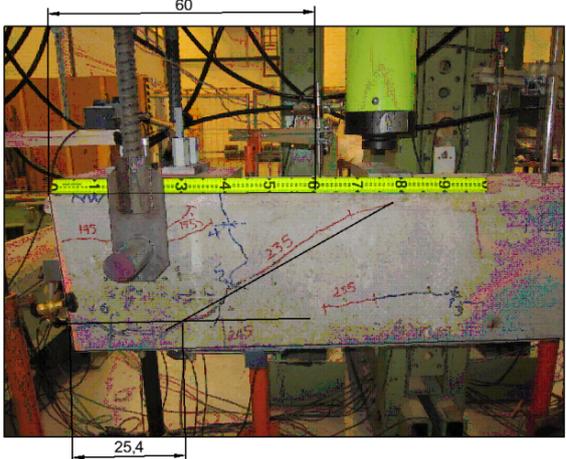
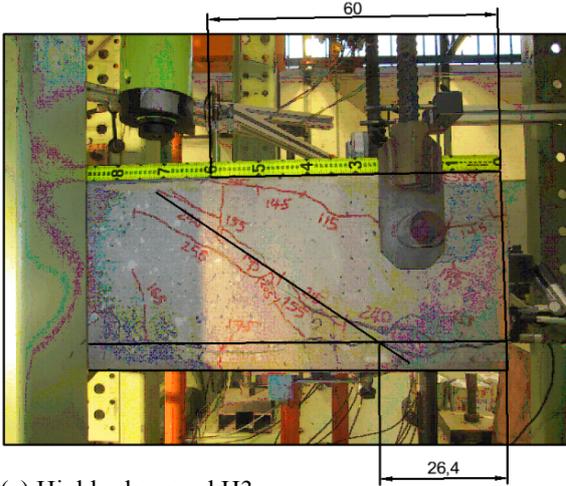
Fig. 8 Available anchorage length in some of the beams; measured from the end cross section to the point where the main bars and the inclined shear crack intersect.

After the tests had been completed, the available anchorage length was evaluated based on the crack pattern. It was measured from the point where the main bars and the inclined shear crack intersect to the end cross section (see examples in Fig. 8). Only the section of the beam that failed was evaluated; however, the available anchorage length was evaluated on both the

back and front sides. The average of the back and front sides is given in Table 8. As seen, the available anchorage lengths show only small variations; thus, the position of the shear crack was more greatly impacted by the load arrangement than by the corrosion level.

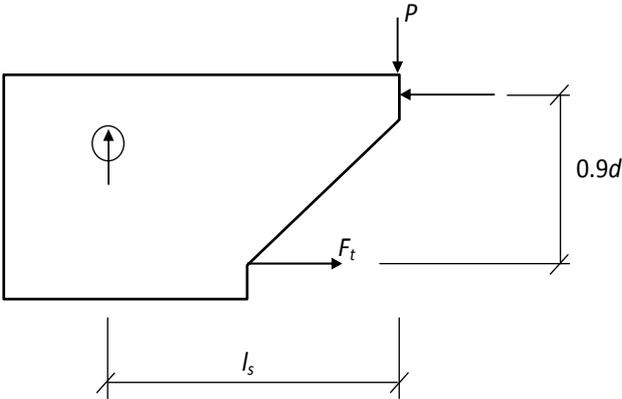
Fig. 9 Assumptions for estimation of the tensile force in the longitudinal reinforcement.

The tensile force in the longitudinal reinforcement,  $F_t$ , was estimated by assuming that no forces were transferred over the inclined shear cracks (see Fig. 9). The inner lever arm was estimated to be  $0.9d$ , where the effective height,  $d$ , was taken as the average of the main bars. From equilibrium, the tensile force in the longitudinal reinforcement was thus calculated as follows:

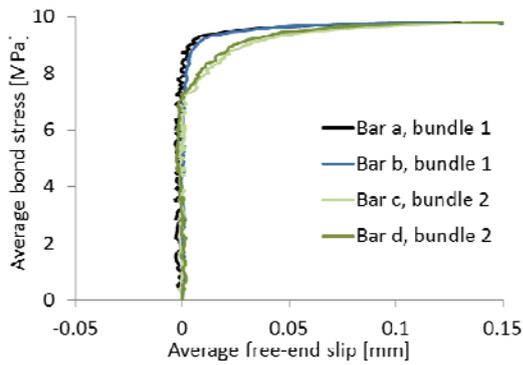
Fig. 11 Average bond stress versus the measured free-end slip, for all bars at the side that failed in test R1. Note that only the first part with small slip values is shown.

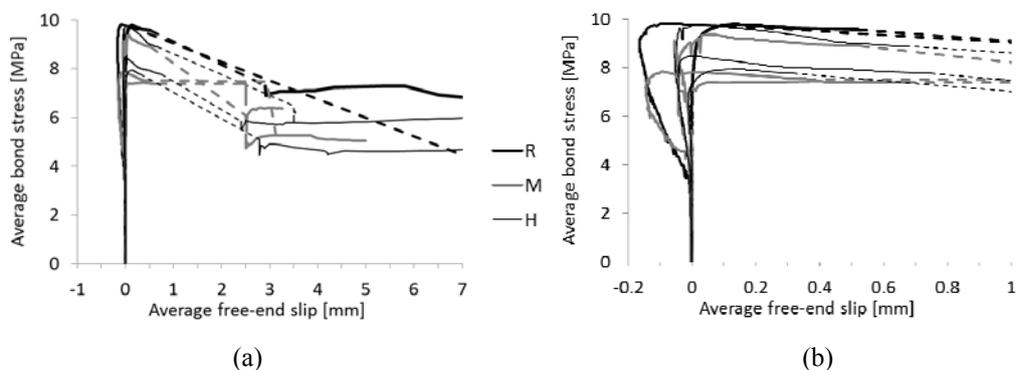
Fig. 12 Average bond stress versus the average measured free-end slip, for all tests. Dashed parts indicate that there is a jump in the measurements. (b) is an enlargement of (a)

In Fig. 12, the average bond stress, calculated from Equations 1 and 2, is plotted against the measured average free-end slip for all tests. As seen, the measured slip is often negative in the beginning but in later tests, it was verified not to be a really negative slip (Gestsdóttir and Guðmundsson 2012) but was rather caused by a deformation of the end cross-section between the reinforcement bars and the plate where the LVDTs measuring the slip were attached (see Fig. 13). The test results by Gestsdóttir and Guðmundsson (2012) showed that this finding only had any substantial effect on the first part and explained the negative slip values. The results of the measurements in this study are, therefore, still of interest and show a trend when the end slip starts increasing and the levels thereof. As seen in Fig. 12, the average end slip started to increase at a load slightly below the maximum load in all tests. A stable slip increase could be registered until the maximum load was reached, and initially with decreasing load. At a slip varying between 0.15 to 0.7 mm in the different tests and a load slightly smaller than the maximum load, the tests were unstable; thus, the slip suddenly increased with decreasing load, causing brittle failures. A residual bond capacity of around 70% of the maximum bond capacity could be seen for large slip values in most tests.

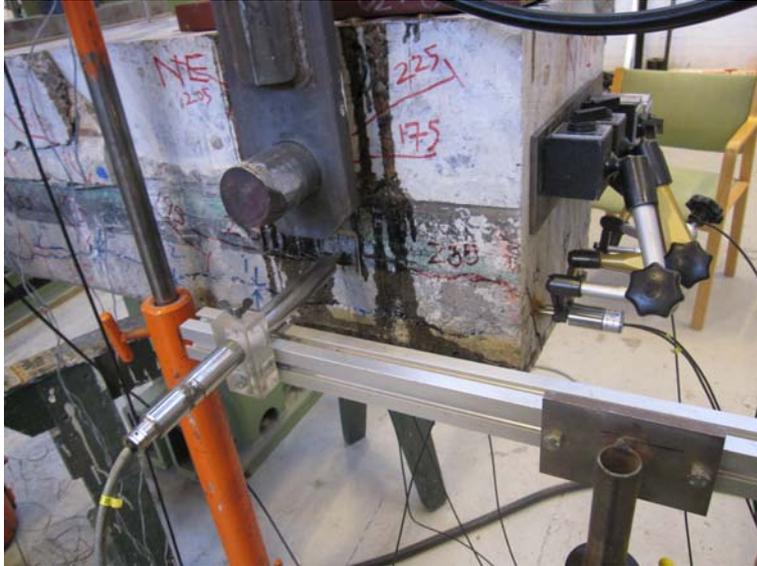
Fig. 13 Attachment of LVDTs measuring the free-end slip of the longitudinal bars.

As mentioned in Section 4.2, the free-end slip of the longitudinal reinforcement bars was measured at the end faces. It was noted from the measurements that the free-end slips of two bundled bars were in all tests quite similar; i.e. the two bundled bars always slipped together. Furthermore, the difference between the two bundles in the cross-section was also minor. An example of the variation of the slip in the different bars can be seen in Fig. 11. Typically, one of the two bundles started to slip slightly before the other bundle. However, the difference between the different bars in one test was minor; therefore, average results will mainly be discussed below.

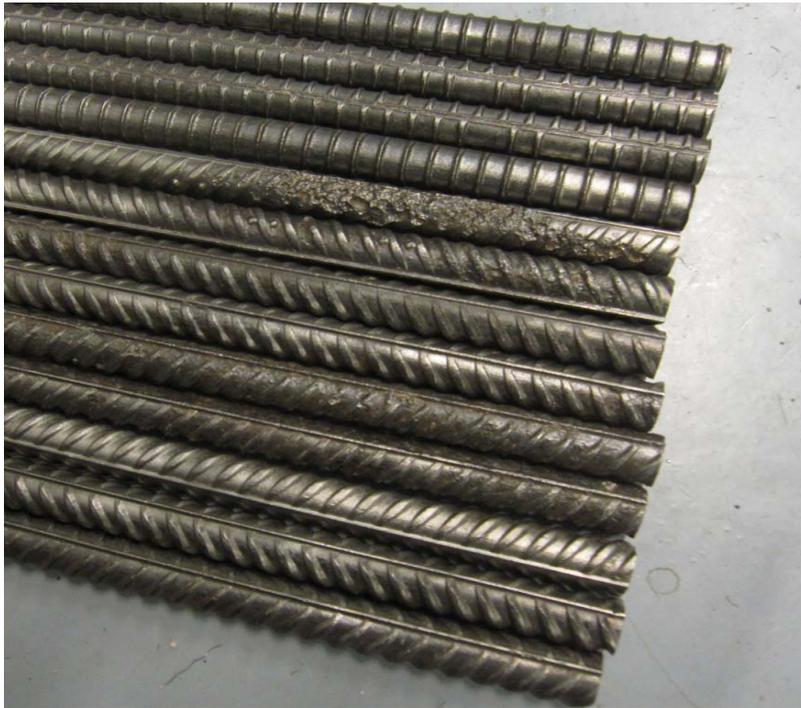
Fig. 14 Reinforcement bars, from top to bottom from specimens R2, H3, and M1.

Three of the specimens were broken after the bending tests, and the main reinforcement was taken out and cleaned. The three specimens were chosen to be a Reference specimen (R2), a Medium specimen (M1), and a Highly damaged specimen (H3). The reinforcement bars in the R2 specimen didn't show any signs of corrosion, while the reinforcement bars from the M1 and H3 specimens showed severe pitting corrosion damage (see Fig. 14). Typically, the pitting corrosion took place on one half of a reinforcement bar, in some cases almost completely eliminating the ribs; while the other half of the reinforcement bar was almost undamaged. The side of the bar that was damaged shifted, sometimes by only a decimetre but on other occasions by an interval of half a metre. The parts of the bars at the ends where anchorage failure took place were cut to 580.1 mm long pieces, using a lathe to enable a high degree of precision.

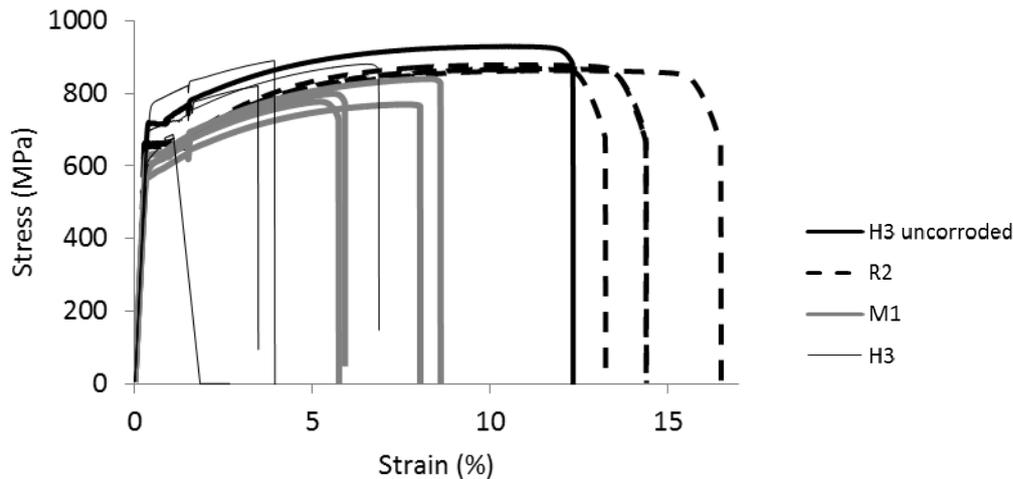
Fig. 15 Stress versus strain in tensile tests of reinforcement bars.

After cleaning and weighing, the bars were tested in tension. The length of the free parts of the bars in the tests was 440 mm; results are shown in Fig. 15. As seen, the bars from the Reference specimen R2 actually had approximately the same yield strength as the bars from the Highly damaged specimen H3. The uncorroded part of the bar from specimen H3 is probably a better reference; compared to that, the yield strength of the corroded bars was reduced by 0.5-20% and the ultimate strength by 4-26%, on the average 10 and 13% , respectively. It is the pitting corrosion that causes the reduction in capacity to be larger than the weight loss. The pitting corrosion is also the cause of the large reduction in ductility which can be seen in Fig. 14; the ultimate strain was roughly halved for the bars from the Medium damaged specimen and only one third remaining for those from the Highly damaged specimen compared to those from the Reference specimen. In the results of other researchers, the ductility of the reinforcement is also decreased by corrosion, see e.g. Du et al. (2005), Almusallam (2001), and Cairns et al. (2005).
