Comparing rubber modified asphalt to conventional asphalt

Assessment of Trafikverket's road survey tool

Master's Thesis in the Master's Programme Infrastructure and Environmental Engineering

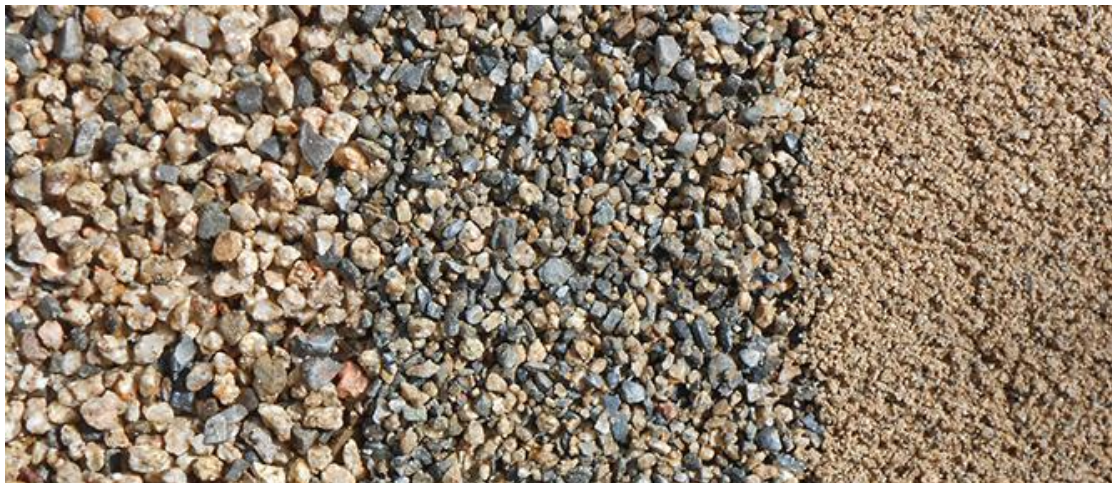
Figure 1: Different sizes of aggregates (Werner Corporation, n.d.)

Aggregates are crushed hard stones of different fractions. The main requirements for aggregates are the particle size distribution curve, the flakiness index and Ball-Mill value (Parhamifar, 2014). Aggregates are the most important part within an asphalt concrete surface to provide the essential resistance to the load and wearing. That is the reason why aggregates are present in a high amount in the asphalt concrete pavement.

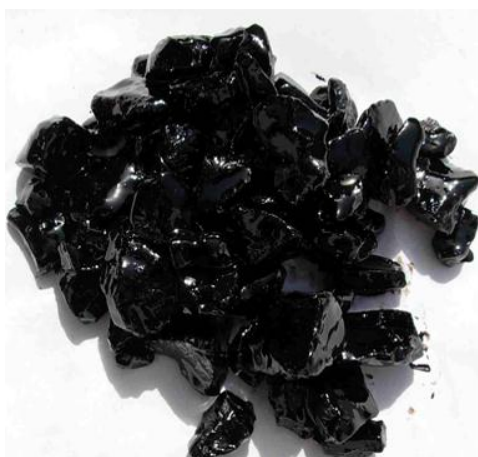
Figure 2: Aggregates covered in bitumen (Petro Asian FZC, n.d)

The key ingredient of the asphalt mixture is bitumen (binding material). It is a bi-product from the oil production and is necessary to keep the aggregates attached to each other, see Figure 2. Additional functions of the bitumen are to prevent the aggregates from crushing, giving it strength to shape itself without failing, as well as giving the asphalt its bearing capacity (Parhamifar, 2014).

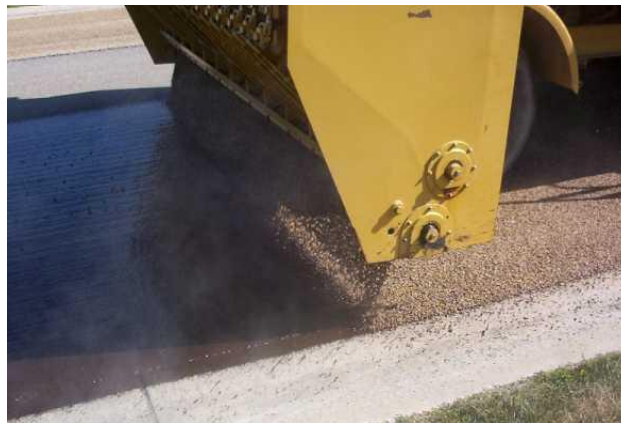
In the chip seal coating procedure the hot asphalt- rubber liquid is sprayed on the road surface, followed by aggregate material. The hot liquid is sprayed with a special distributor truck and the aggregates are spread out immediately and evened out with a roller as illustrated in Figure 4 (Carlson & Zhu, 1999). This technique however is mainly used in the US and not common in Europe, due to the bad working environment including fumes (Nordgren, 2015).

Figure 4: Chip seal coating. Spreading out aggregates on hot asphalt- rubber liquid (City of Mankano, n.d)

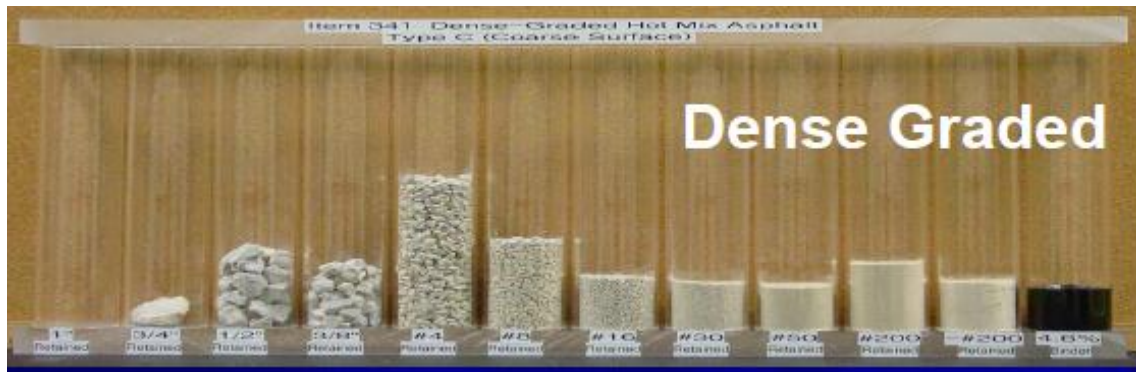
Figure 6: Dense graded asphalt mix (Way, George, 2012)

Dense graded asphalt contains a well proportioned mixture of bituminous binder, aggregates, filler material, and/or some additives to change the final properties (Queensland Government, 2009). In dense graded rubber asphalts the rubber content varies between 5-10% by binder weight (Amirkhanian, 2013). It can be used in several layers of the road body as an almost impermeable layer to let water run off the road surface and improving the riding quality of the road, if used as a surface layer. The drawbacks though, are its sensitivity to hot climate and temperature variations, which could cause thermal cracking and a high risk of mirroring and less effective retroflection. In Figure 6 below, an example of a dense- graded asphalt concrete mix composition can be observed.

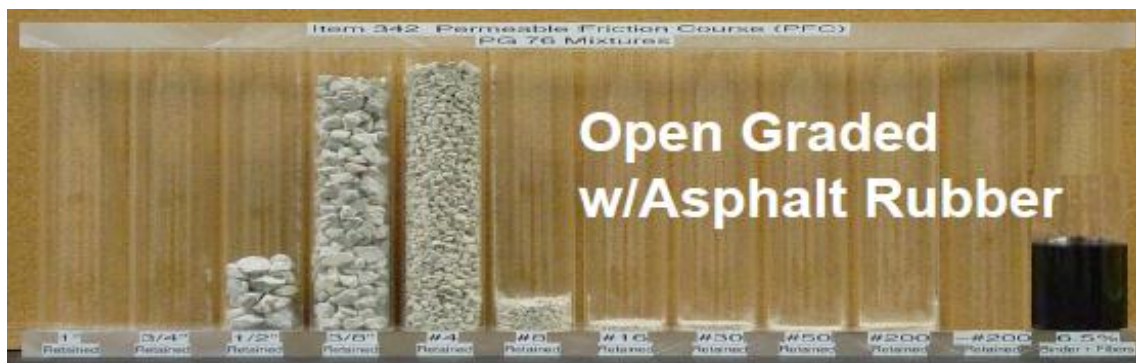
Open graded asphalt is composed of bituminous binder, aggregates and filler with or without additives (Queensland Government, 2009). It usually contains 12% to 20% rubber of the total binder mass if rubber asphalt is mixed (Amirkhanian, 2013). Only small amounts of fine material are used in order to achieve a high percentage of air voids. Figure 7 clarifies the proportions in an open gradation, especially the high content of larger aggregates. This type of asphalt is applied as a friction course with the purpose to decrease noise, increase skid resistance and increase surface drainage for higher safety.

Figure 7: Aggregate content in open graded asphalt mix (Way, George, 2012)

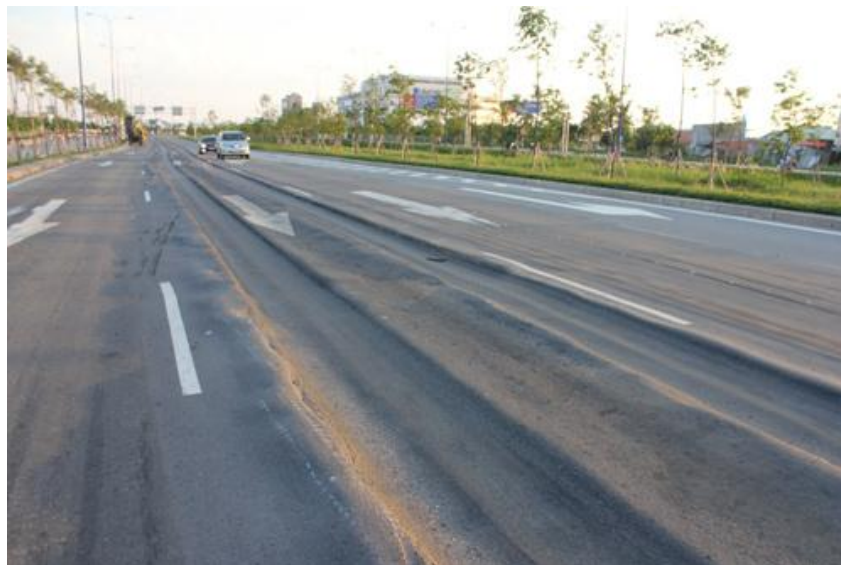
Figure 10: Extreme rutting in wheel paths (Auto Vina, 2012)

Rutting appears in form of surface depression or compression in wheel tracks. This can be caused by deformations of any of the pavement layers or subgrade. This occurs either as a result of bad compaction during construction or plastic movement during warmer temperatures and high traffic loads, see Figure 10 (Huang, 2003). In Nordic countries the use of studded tires is common, which also cause rutting by wearing out material each time a vehicle passes over the surface (Nordgren, 2015).

It can be measured as rut depth in mm with a dipstick every 15 meters or with help of a photographic distress survey (Huang, 2003). Nowadays, the rut depth is measured with either 15 or 17 lasers on a measurement car. The data for 17 lasers may be incorrect when measuring on smaller roads, due to driving on the road side marking and measuring from the wrong origin. There the measurement with 15 lasers is recommended considering that the lanes in Sweden are getting more narrow (Nordgren, 2015).

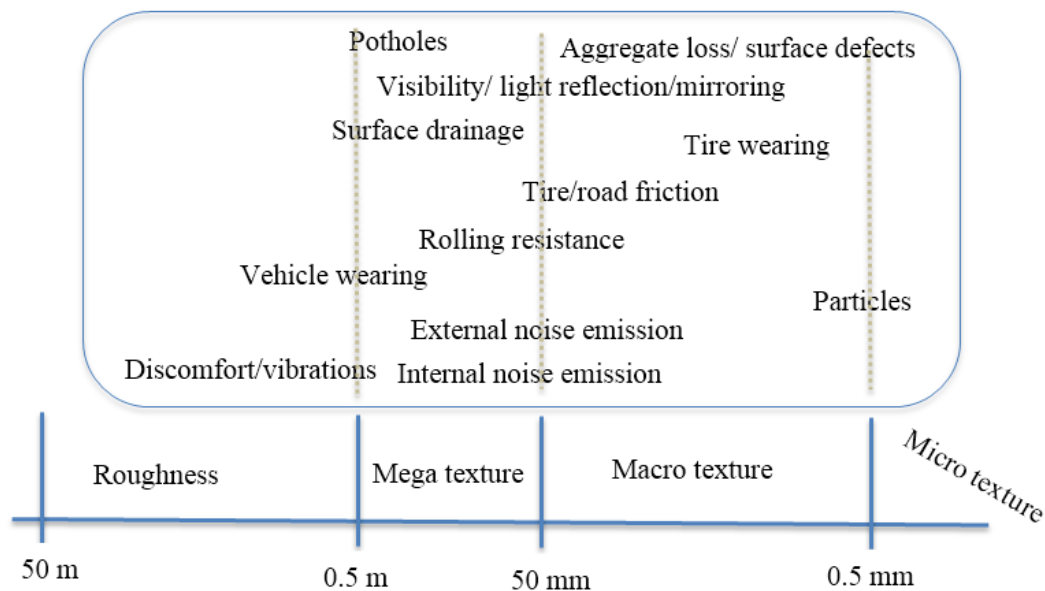
Figure 11: Micro-, macro-, and mega texture with respective wavelength interval as well as irregularities after (Lundberg, et al., 2011)

The surface texture has great influence on many road properties and affects friction, intern- and extern noise emission, rolling resistance, tire wear, dewatering, drainage, light reflection as well as possibly the generation of particles. Macro texture is measured between 0.5 and 50 mm and affect properties as illustrated in Figure 11.

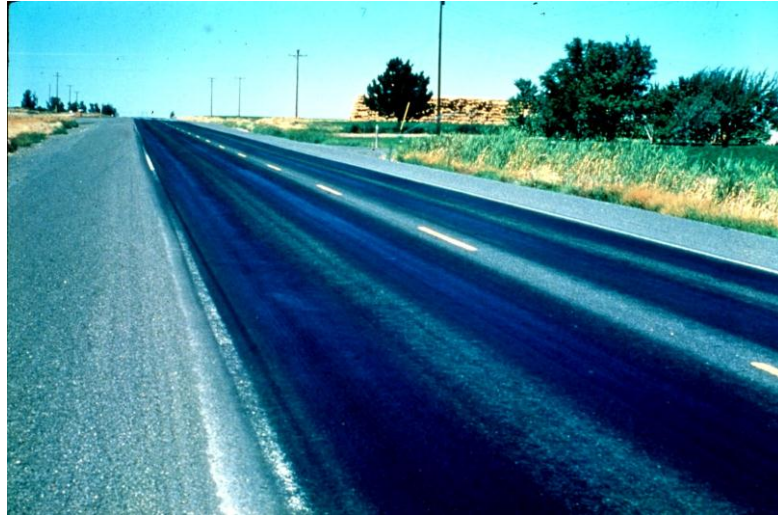
Bleeding on the pavement occurs when the bituminous part of the asphalt liquefies and appears on the surface, see Figure 12. This can be due to a high amount of binder or low amount of air voids in the asphalt mixture. It can decrease the skid resistance and make the surface appear shiny, reflecting and sticky (Huang, 2003).

Figure 12: Bleeding in the wheel paths (Pavement Interactive, 2010)

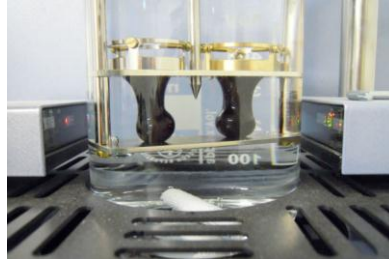
Figure 14: Ring and Ball method (Bieder & Jenzer , 2011)

With this method the temperature for the bitumen's softening point is determined, see Figure 14. Bitumen is filled into a ring, cooling down to room temperature and a steel ball is placed on it. Then the sample is placed in a beaker full with water and heated up until the ball falls through the binder. The achieved temperature gives the value of the softening point (Lund University , 2014).

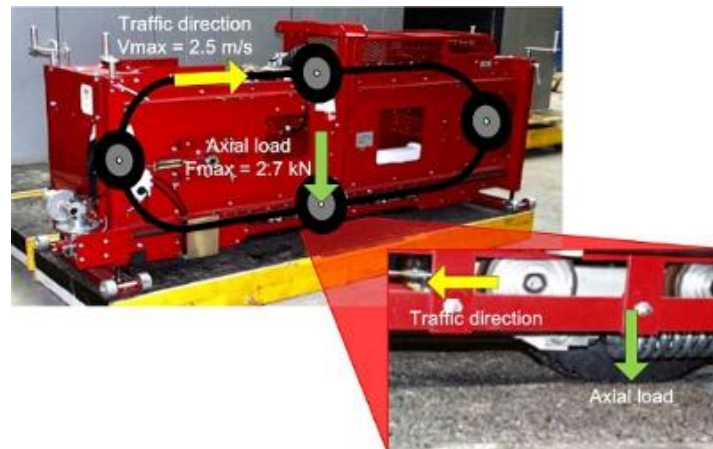
For this test a plate of asphalt is made and tested in a simulator, which can simulate different traffic loads. With this method, possible rutting can be recreated in order to determine the resistance of the asphalt mix, see Figure 16.

Figure 16: Tools for Accelerated Pavement Testing (EMPA, n.d.)

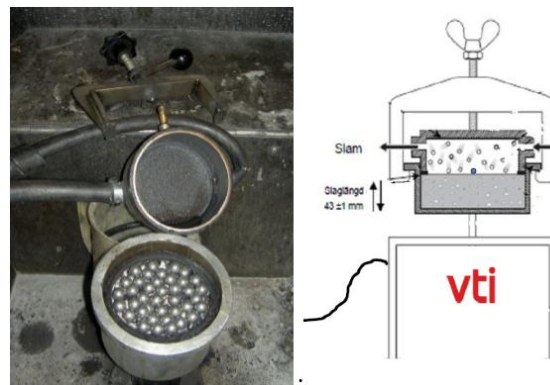
Figure 17: Test equipment and sketch (Lind, 2012)

The Prall test is used to measure the abrasion caused by studded tyres during the winter season. The specimen is tested for 15 minutes with 40 steel spheres see Figure 17. The abrasion value is measured in mm (Lind, 2012).

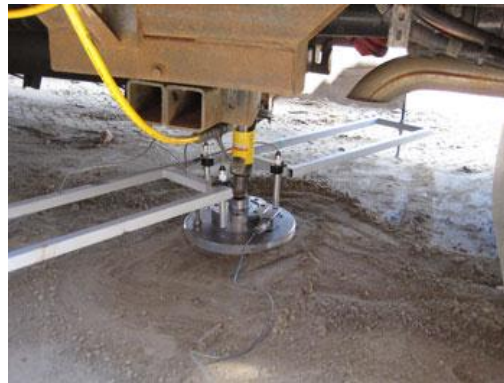
This test is for the bearing capacity of the aggregates in field. A hydraulic strength is added to the plates and the settlements are measured depending on added load, see Figure 18. After that a graph settlements against bearing pressure gives the bearing capacity (Subadra Consulting Ltd, n.d.).

Figure 18: Hydraulic Jack for plate bearing capacity measurement (Iowa State University, 2015)

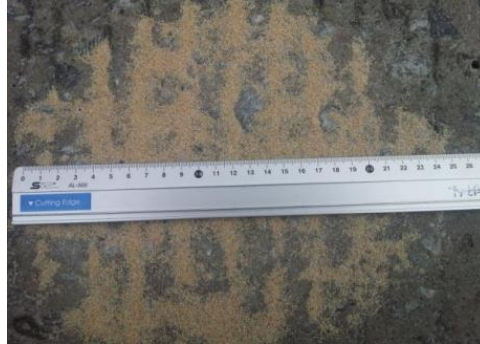
Figure 22: Sand Patch Test (Kim, et al., 2013)

The mean profile depth can also be measured manually or with different technologies. The manual method is the Sand patch test, in which 25 cm³ of sand are filled into the apertures and spread (Kim, et al., 2013), shown in Figure 22. Further on the mean texture depth (MTD) can be calculated with Equation 10. Nowadays, glass is used instead of sand for the patch method due to it being less sensitive to moisture (Nordgren, 2015).

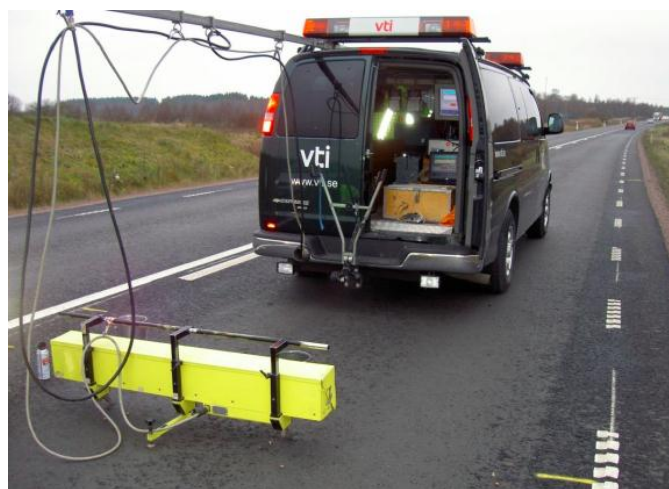
Figure 24: Laser profile meters (Karlsson, 2015)

VTI uses more advanced measurements. The roads are closed in order to avoid any disturbances from traffic. For measuring the surface wearing (especially from studded tires) a laser profile meter is used that measures the profiles in estimated 1240 points per cross section (415 points per meter) see Figure 24. Moreover an area of 1m² is marked and divided into 11 lines, which is measured each year. The goal with these procedures is to help identifying how much aggregates are torn out each year and how resilient the wearing course is.

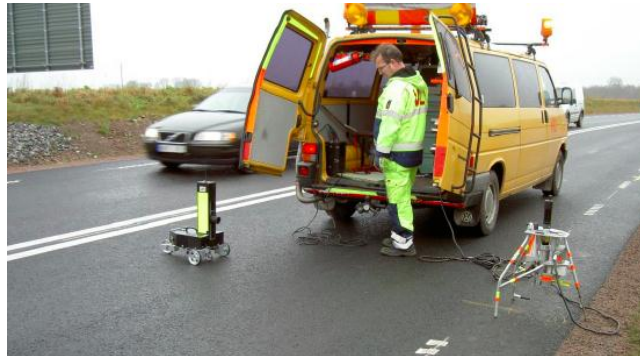
Profiles are measured with Primal (Figure 25), a method where sampling points are marked with colour and a steel nail to be sure the same spot is measured each time. A

robot rolls from the middle line between the lanes and moves towards the verge, taking measurements each 4th millimetre. The cost for this survey is much higher than for the Objektsmätning and can be for 5 to 10 km up to 100'000 SEK on a high traffic road (Nordgren, 2015).

Figure 25: Profile cross section measurement with Primal (Karlsson, 2015)

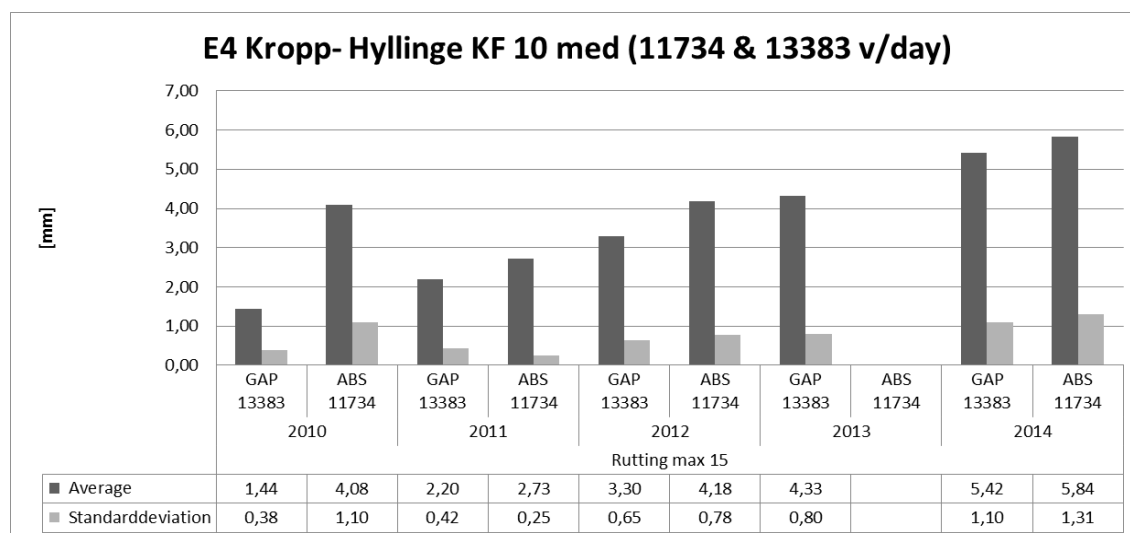
Figure 28: Average values and Standard deviation of rutting on GAP and ABS, high traffic volumes

The values in Figure 28 and Figure 29 deviate between 18- 40% from the average values, which indicates an uneven rut pattern.

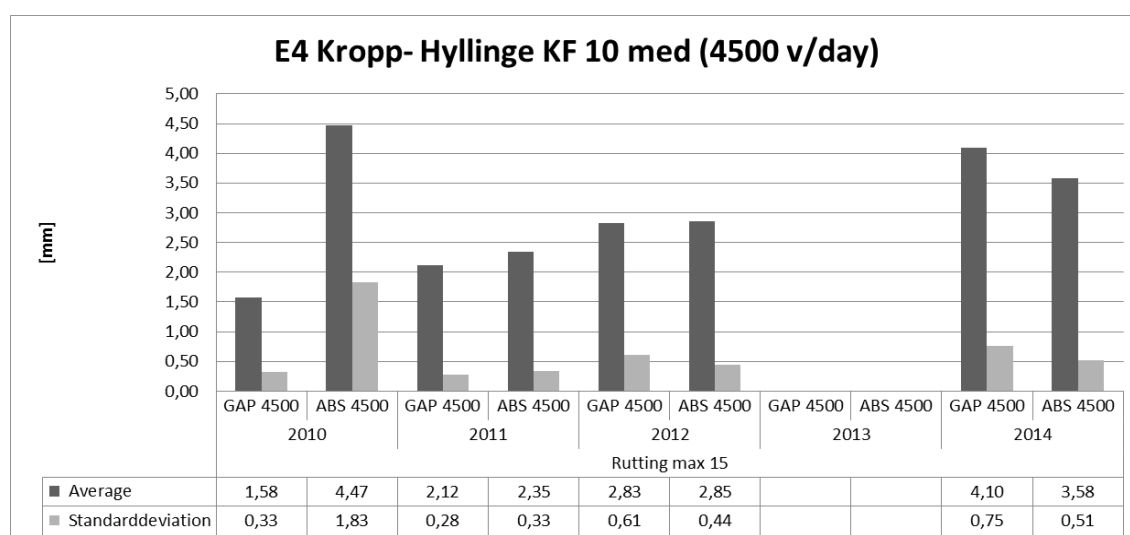
Figure 29: Average values and standard deviation of rutting on GAP and ABS, low traffic volume

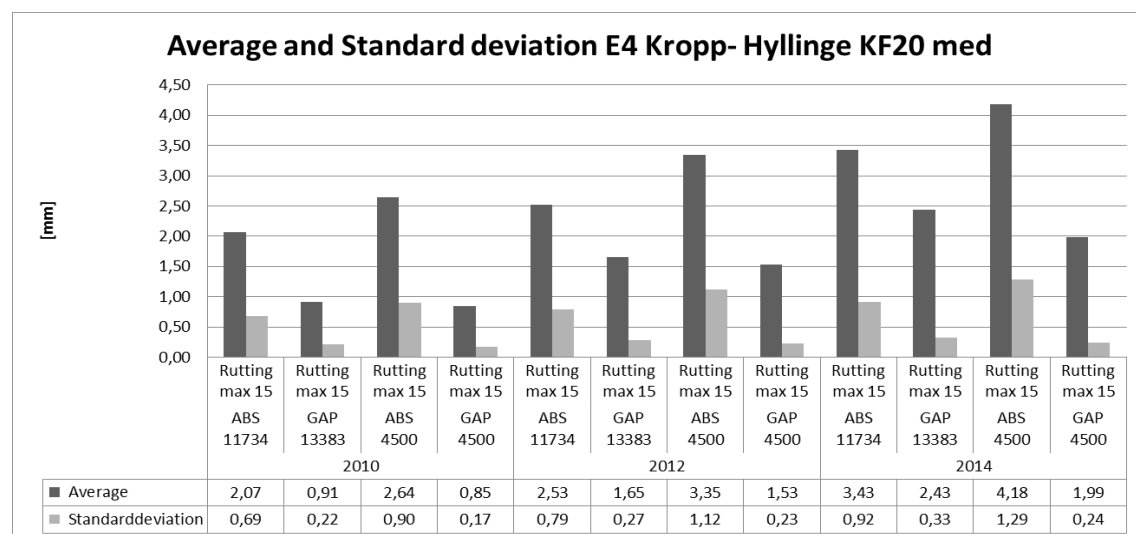
Figure 31: Average values and standard deviations for rutting, MPD left, middle and right on ABS and GAP

The measurements on this lane differ from those on the first lane. The ABS has much higher rutting and a much higher standard deviation than the GAP (Figure 31).

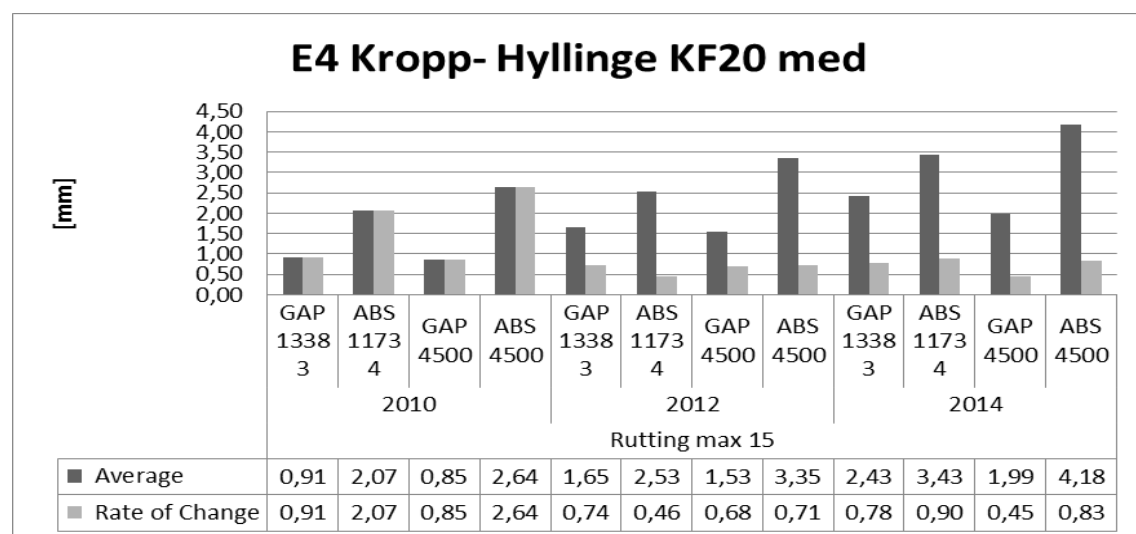
Figure 32: Average values and rate of change for rutting on GAP and ABS

Knowing that there was a difference in time when the asphalts were laid, the average values are not comparable. On the other hand the rate of change in Figure 32 provides information on how fast the two surface layers deteriorate. According to the rate of change in 2012 the rut depth increases by 0.73 mm for the GAP and 0.56 mm for the ABS in two years. In 2014 the rut depth increased by 0.74 mm for the GAP and 0.87 mm for the ABS in two years.

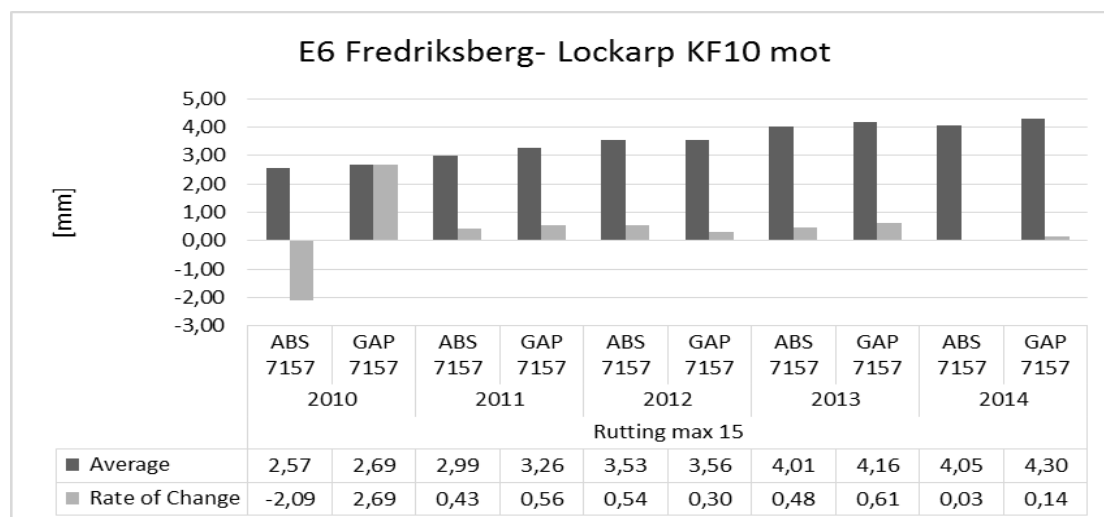
Figure 34: Average values and rate of change for rutting on GAP and ABS with traffic volume of 7157 vehicles per day

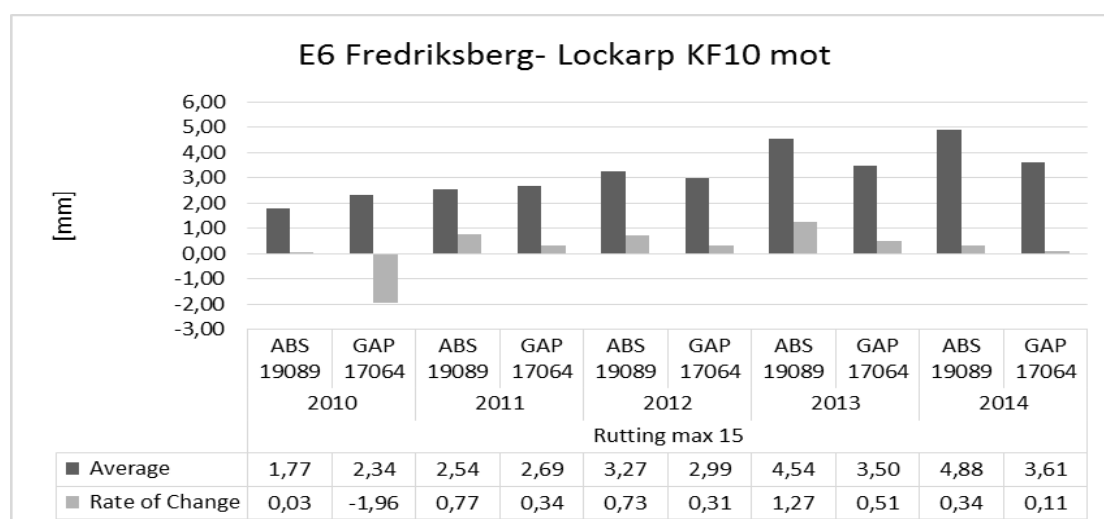
Figure 35: Average values and rate of change for rutting on GAP and ABS with traffic volume of 17064 and 19089 vehicles per day

In the sections with higher traffic the picture changes. As illustrated in Figure 35 the rutting is larger for ABS than for GAP, however this can be related to the higher traffic on the ABS section.

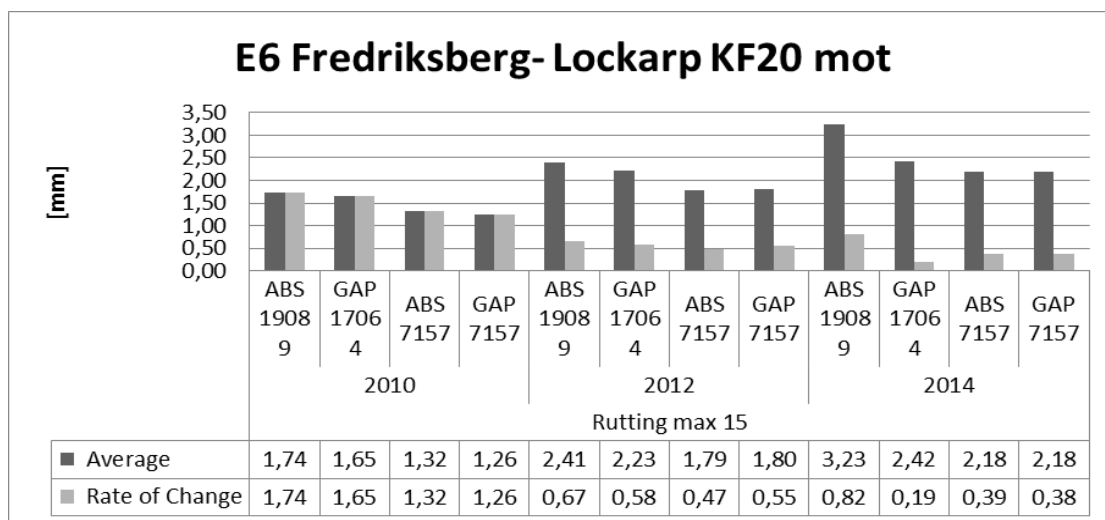
Figure 36: Average values and rate of change for rutting on GAP and ABS

The measurements for the second lane are made each second year. In Figure 36 below the rut depths from 2010 to 2014 can be compared for the different sections. On the sections with higher traffic, the rut depths on the rubber modified asphalt are smaller than on the standard asphalt. The rate of change is larger for the ABS, which is an indicator for faster deterioration. On the other sections the rut depth are very similar.

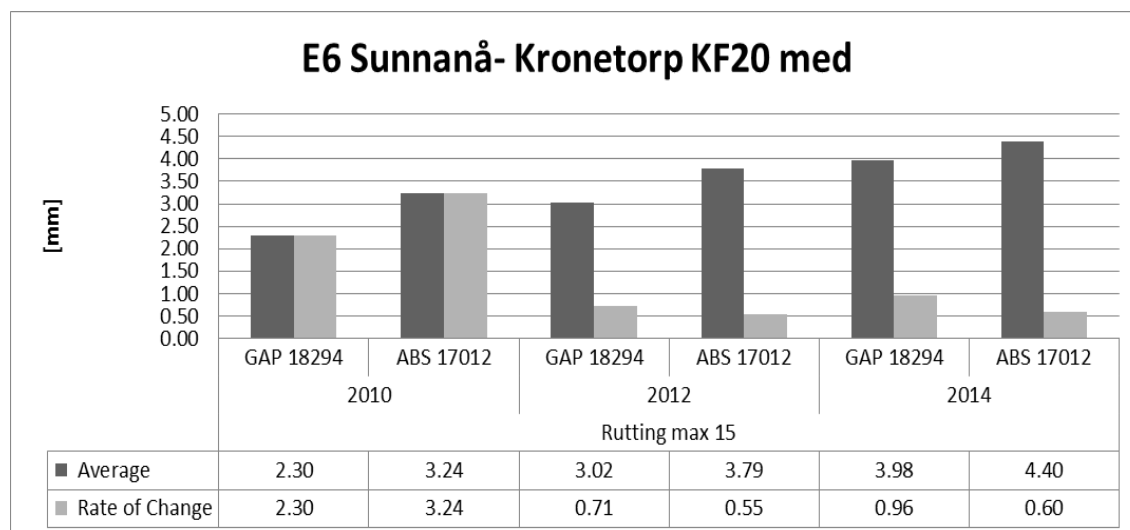
Figure 45: Average values and rate of change for rutting on GAP and ABS

The traffic on the second lane is the same and even the same materials were used in the same order. Measurements were done each second year. Figure 45 describes the average values and rate of change for rutting from 2010 to 2014. On this lane the results are clearer than on the first one. The rate of change for the GAP is higher than for the ABS indicating that it is deteriorating almost twice as fast. This could once again be related to the higher traffic, which is higher by more than 1200 vehicles per day.

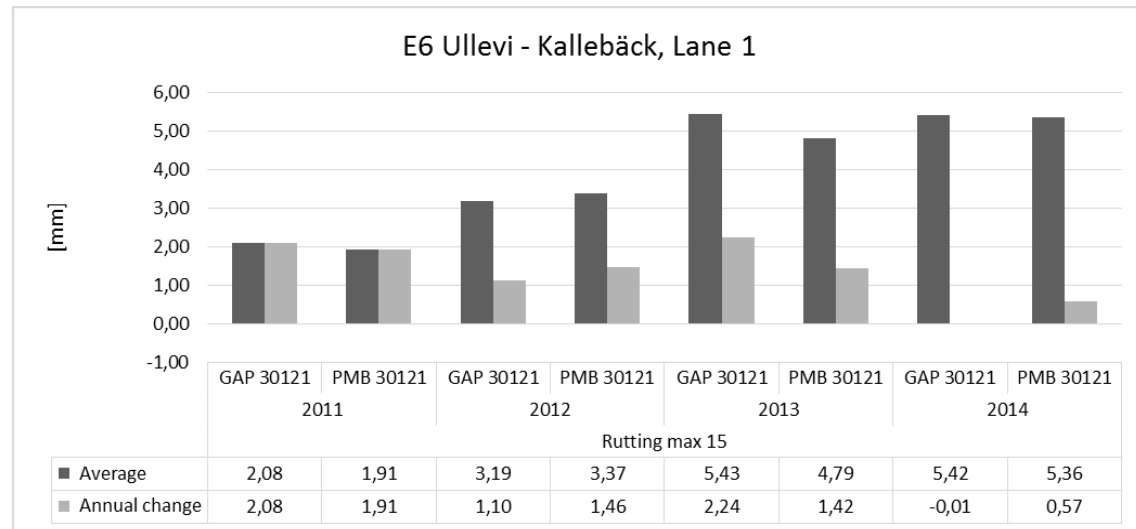
Figure 47: Average value and annual change for rutting on PMB and GAP, lane 1

In Figure 47 below the average values for rut depth and the annual change are presented. The initial rutting is larger for the rubber modified asphalt. The following years, rutting increases for both with different rates of change. The values are slightly higher for the GAP except for 2012.

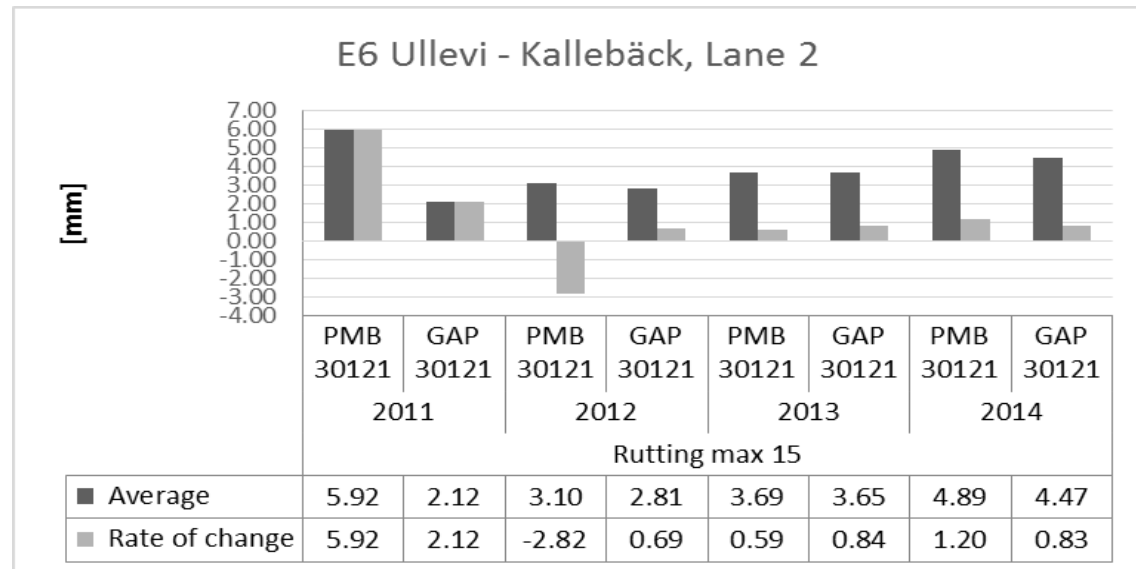
Figure 48: Average value and annual change for rutting on PMB and GAP, lane 2

The second lane indicates a different behaviour (Figure 48). The high value for PMB in 2011 is from the measurement before the new pavement was placed and cannot be interpreted as initial rutting. Starting the comparison from 2012 the PMB has a higher rut depth despite being placed after the GAP.

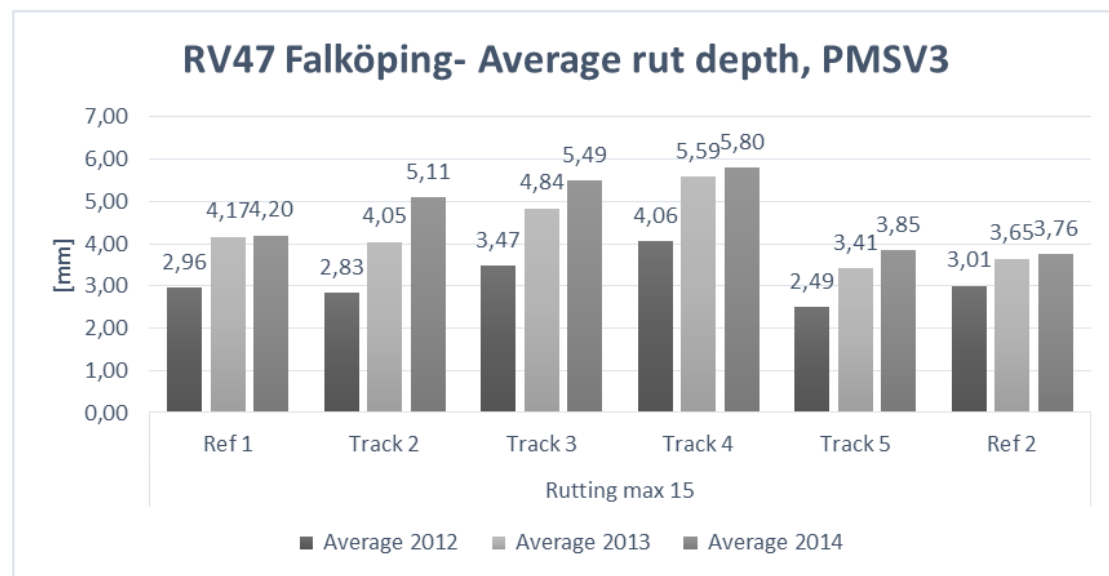
Figure 50: Average rut depth for test track on RV47, Falköping- PMSV3

In the sections where the traffic flow is 4489 vehicles/day, the rut depths for tracks 3, 4 and 5 are higher than the reference track as well. The only exception is track 5 in years 2012 and 2013 where the rut depths were lower. In general the modified asphalts were more sensitive to rutting compared to the reference asphalts. The difference between modified and conventional PMB asphalt covers a large range and varies between -4.4% and 54%.

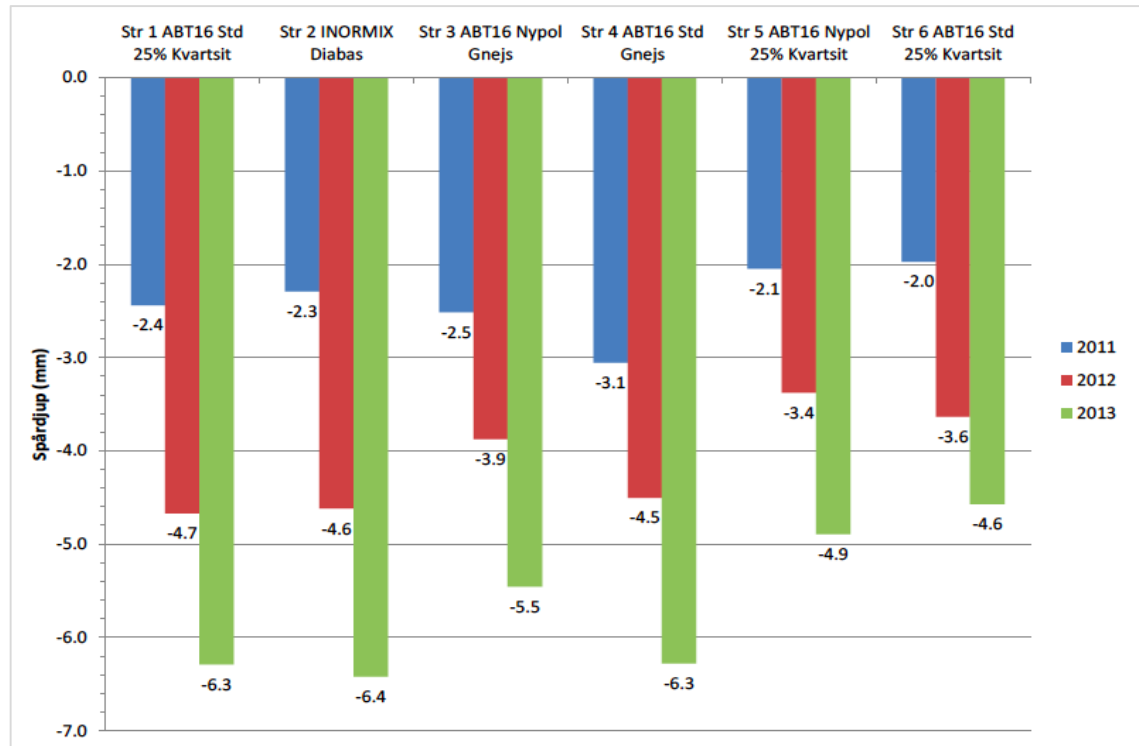
Figure 52: Average value for rut depth for each section 2011, 2012 and 2013 (Karlsson, 2015)

Figure 52 and Figure 53 represent the results from the VTI measurement for the same road. The results are similar to those from PMSV3, regarding the modified asphalts, which had higher rut depths than the reference tracks. Only in 2011 and 2012 track 2 was lower in rutting than reference track 1. The increase in rut depth (Figure 53) also supports the fact that the modified tracks are on an average more sensitive to rutting.

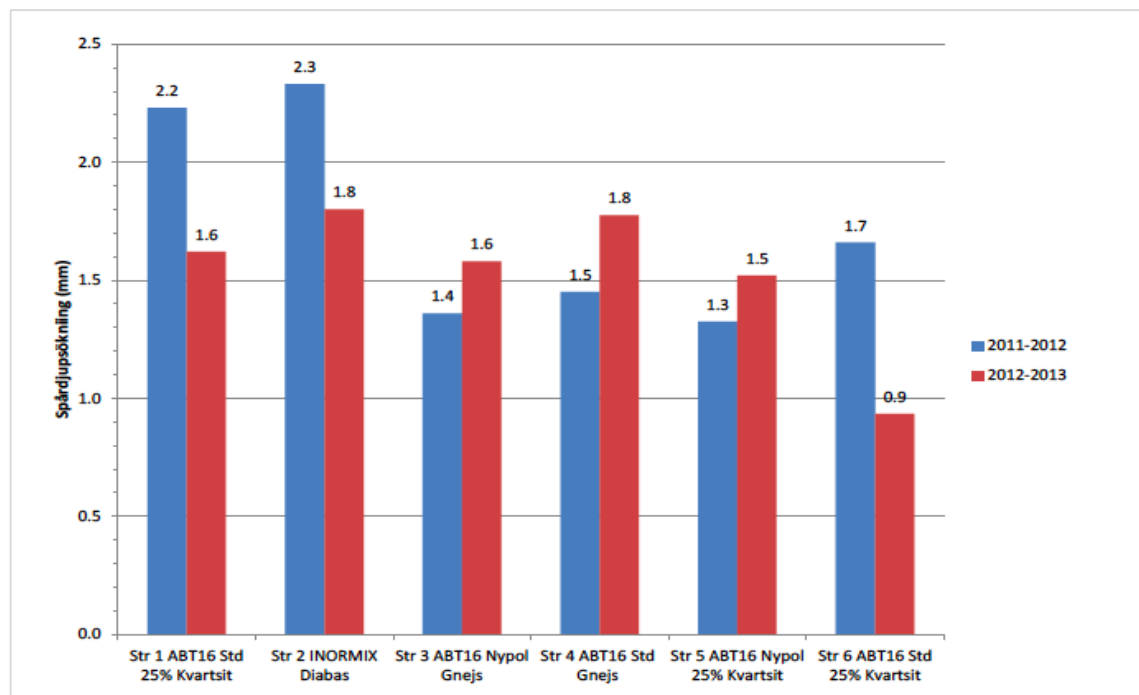
Figure 53: Rut depth increase from 2011- 2012 and 2012- 2013 for each track (Karlsson, 2015)

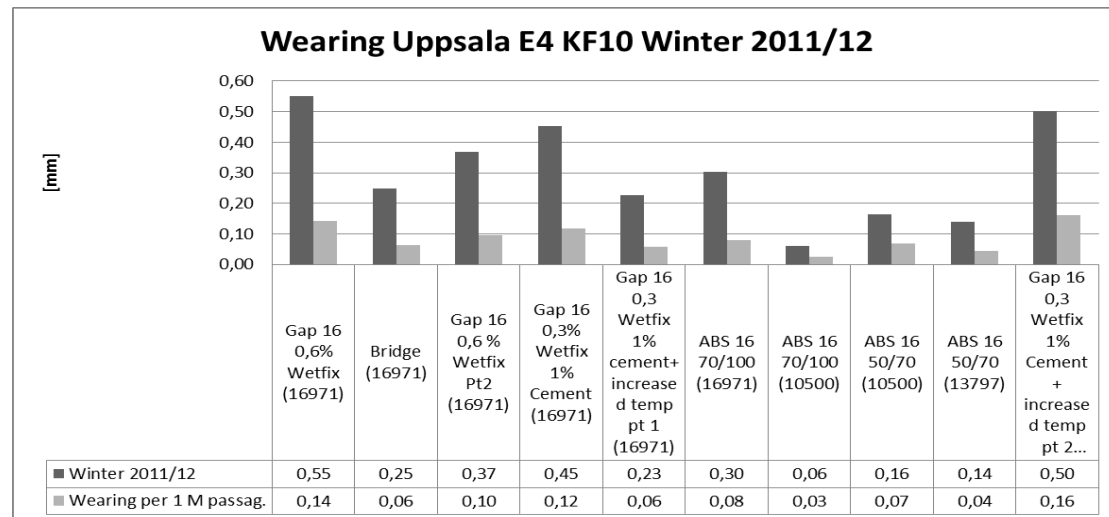
Figure 58: Wear of studded tyres caused by 1million wheel passages during winter 2011/2012, lane 1

As previously described it was of interest to analyse the degree of influence from studded tires on rutting. The data in Objektsmätning enabled studying wearing during one winter season on the E4. In order to collect the necessary data the road condition was measured in fall 2011, before the use of studded tires and in spring 2012 when the winter season was over. The results are presented in the figures below.

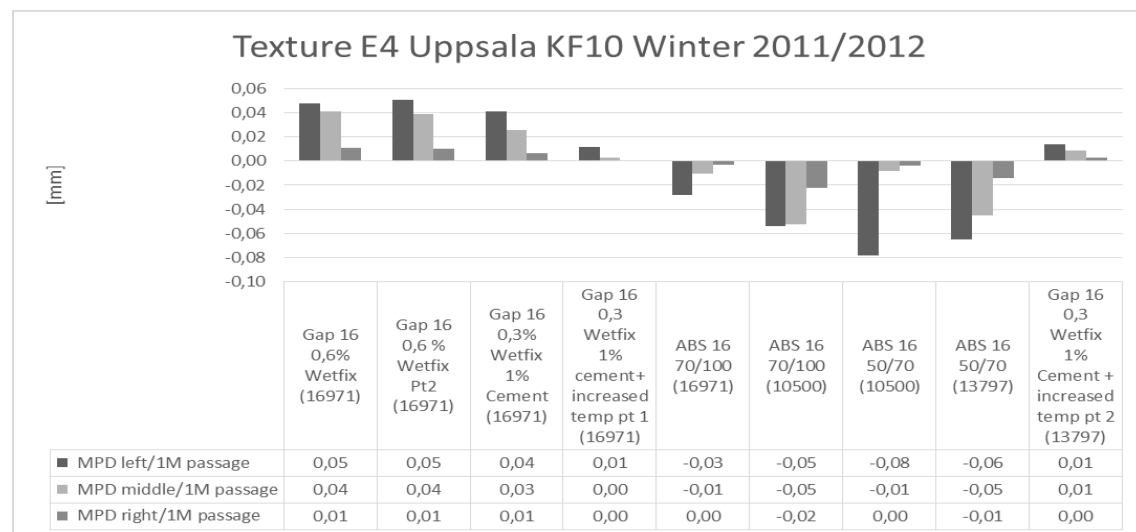
Figure 59: Texture change during the winter 2011/2012, E4 Uppsala KF10

In Figure 59 the results are presented for texture changes on the different test sections. The changes on sections with the rubber modified asphalt have a positive change, which means the profile depth is increasing. The MPD's on the standard asphalt sections show a negative change, i.e. the profile depth is decreasing over time. The largest changes happen on the left part of the road (MPD left) and the least changes happen on the right side (MPD right).

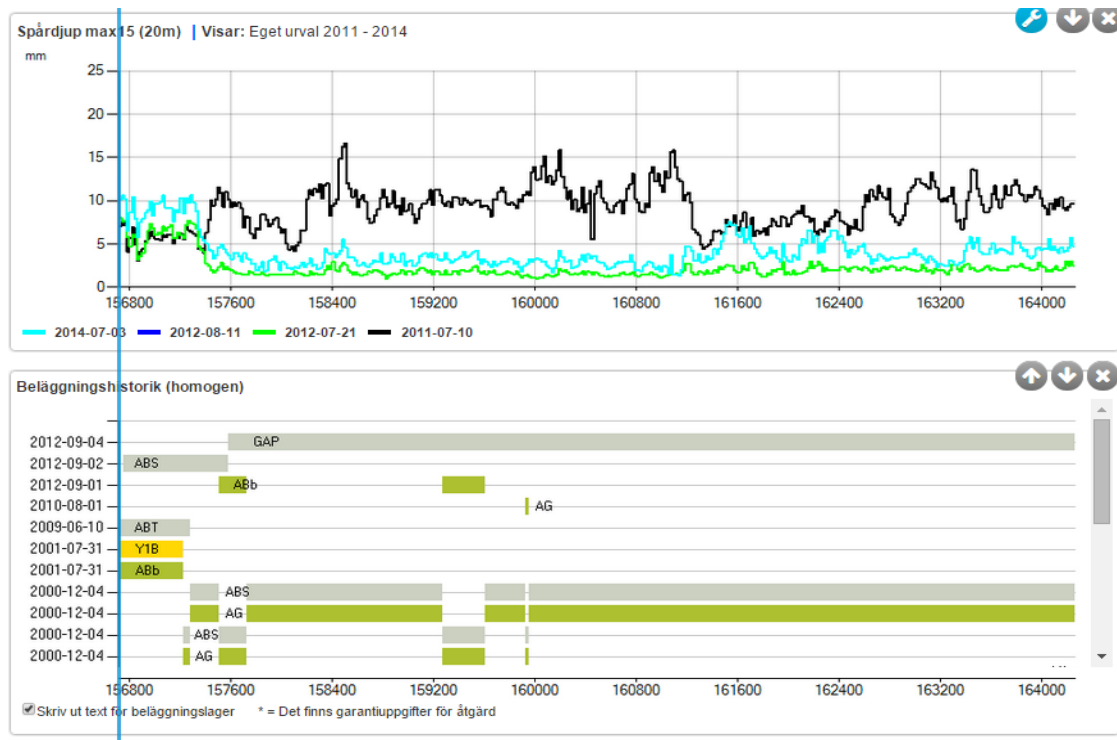
Figure 63: PMSV3 history graph and rutting max 15 for E4 med track 156720 to 164260

Furthermore, the reference track shall be from the starting point 156720 to 157540 and the GAP track from point 157540 to 164260. These points are also registered in PMSV3 however when looking at the measured data the reference track shows unexpectedly high values, see Figure 63. It is assumed that the registration is wrong. Therefore no proper analysis and comparison between the tracks can be done due to the unknown starting point of the reference track.

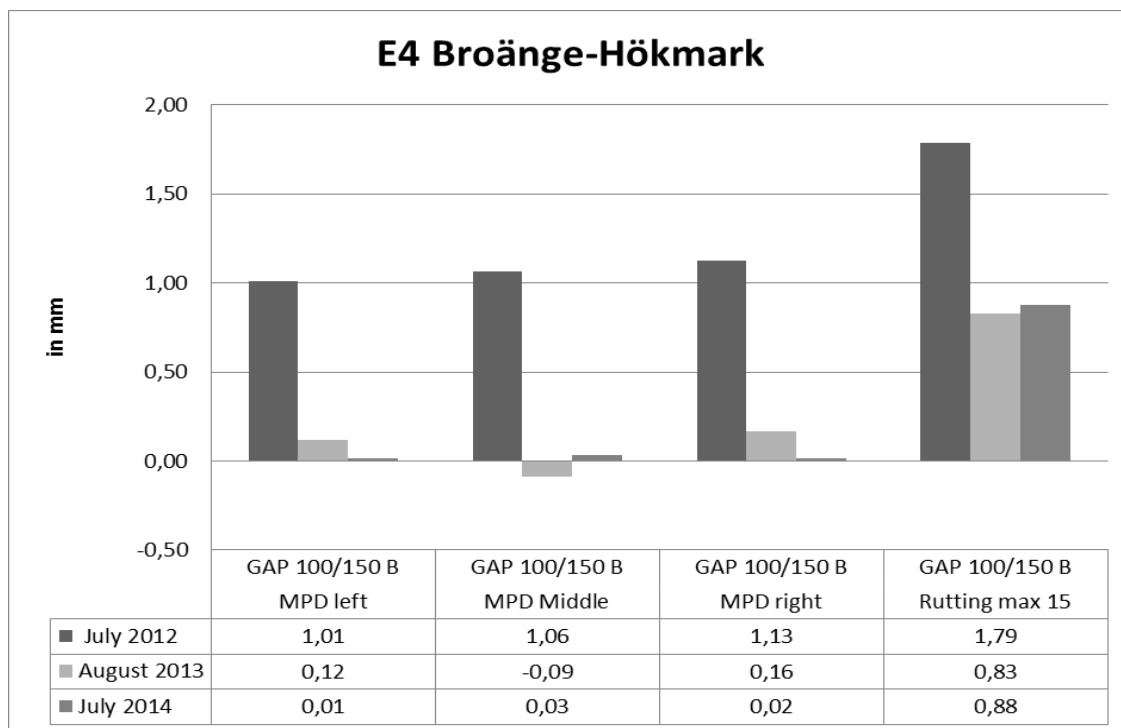
Figure 64: E4 Broänge- Hökmark - Annual change for MPD and Rutting

For the change of rut depth after the first month the value increased by 1.8 mm and in the following years the values increased each year by approximately 0.8 mm.

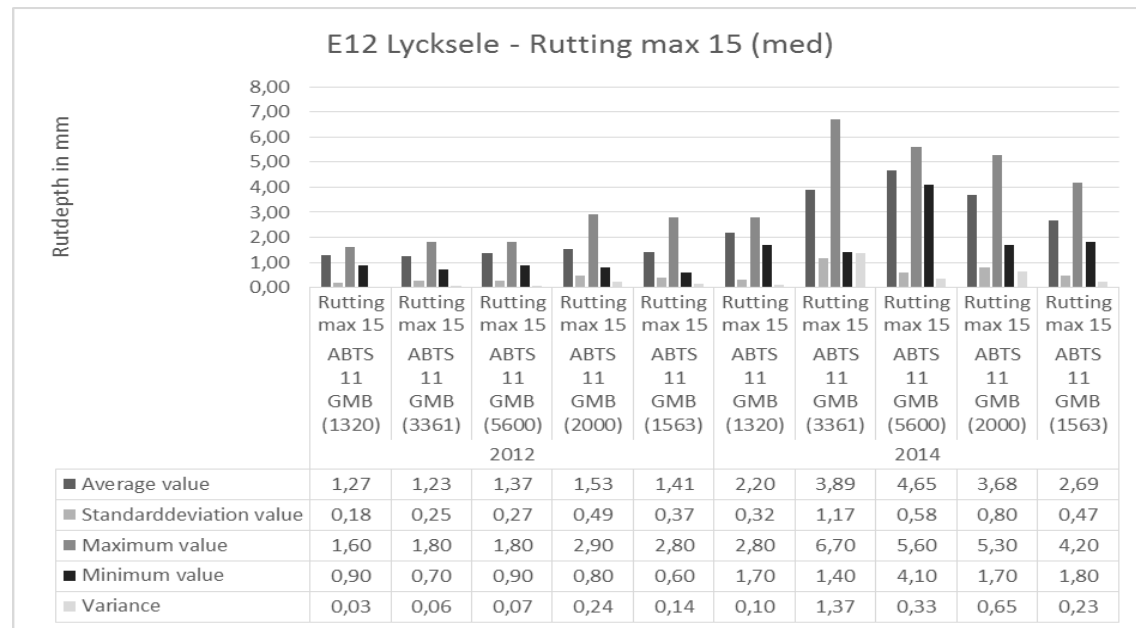
Figure 68: Rutting max 15 (med) for ABTS11 with GMB and different traffic load

Figure 68 shows the average, standard deviation, maximum, minimum and variance of rut depth max 15 for the ABTS 11 tracks with rubber for different amounts of traffic and for years 2012 and 2014. The graphs show that during the first months after asphaltting the average value varies only a little, however the highest value is found at the track with the highest amount of traffic. After two years the values show a similar change. This means that parts with the highest traffic have also the highest average values. Here it must be mentioned that the track with traffic of 3361 has the highest maximum value and the lowest minimum value and a standard deviation of 1.17, where for the track with the highest average the standard deviation is only 0.58.

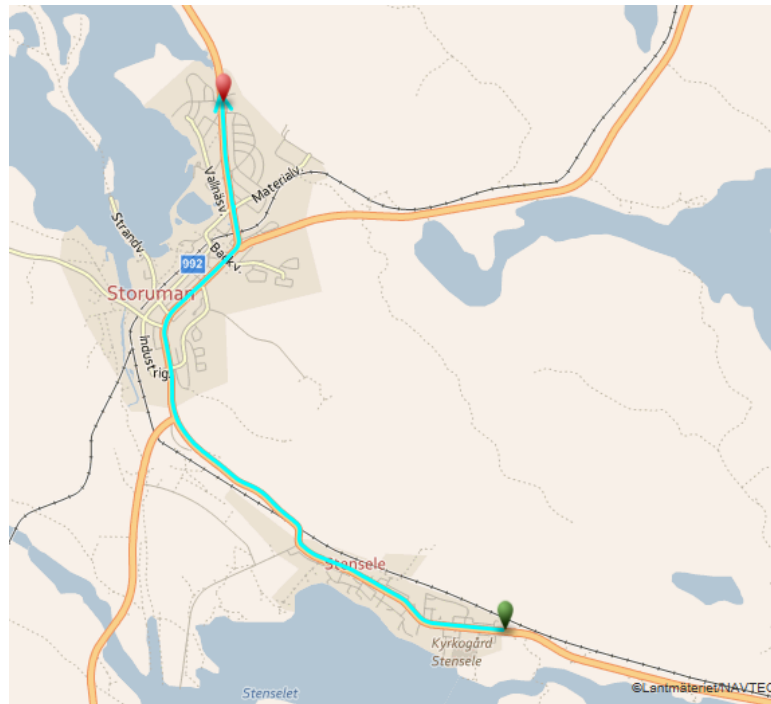
Figure 73: Stensele to Storuman 252081 to 259558. (Trafikverket PMSV3, 2015)

However, within PMSV3 the pavement types and year are not registered correctly. Therefore data from Svevia, pictures from PMSV3 and the Report from Nordgren & Tykesson, 2011 were taken to choose the exact track of the pavement types, see Figure 73.

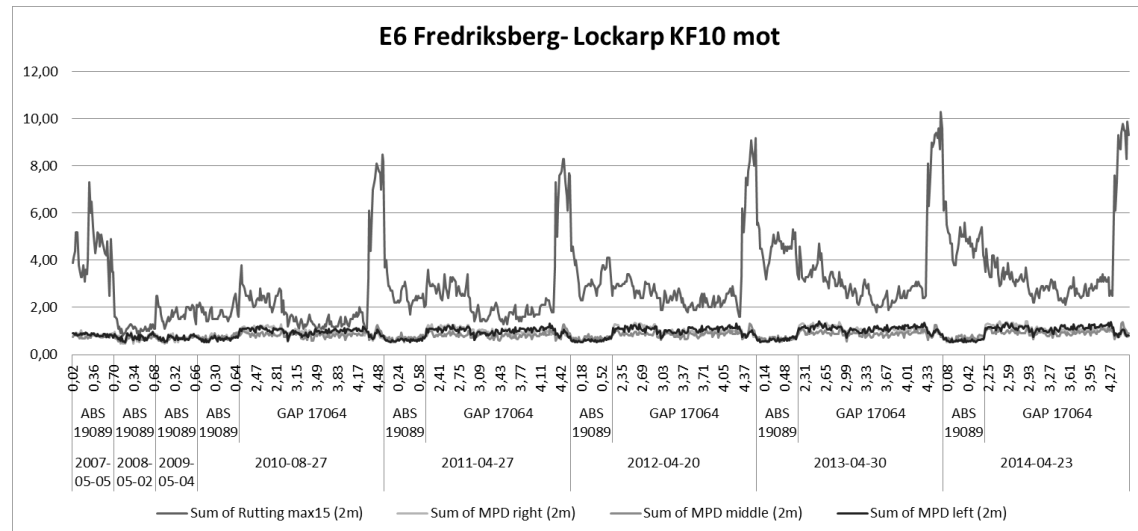
Figure 92: Rutting and MPD left, middle and right with traffic volumes 17064 and 19089 vehicles per day

Figure 92 and Figure 93 in Appendix II: E6 Fredriksberg-Lockarp Appendix II: E6 Fredriksberg-Lockarp demonstrate the road condition regarding rutting and MPD and were separated according to similar traffic in order to evaluate each asphalt type's resistance to wearing. The reason for the high peak in the end of each measurement for the GAP is unknown.
