Comparing rubber modified asphalt to conventional asphalt

Assessment of Trafikverket's road survey tool

Master's Thesis in the Master's Programme Infrastructure and Environmental Engineering

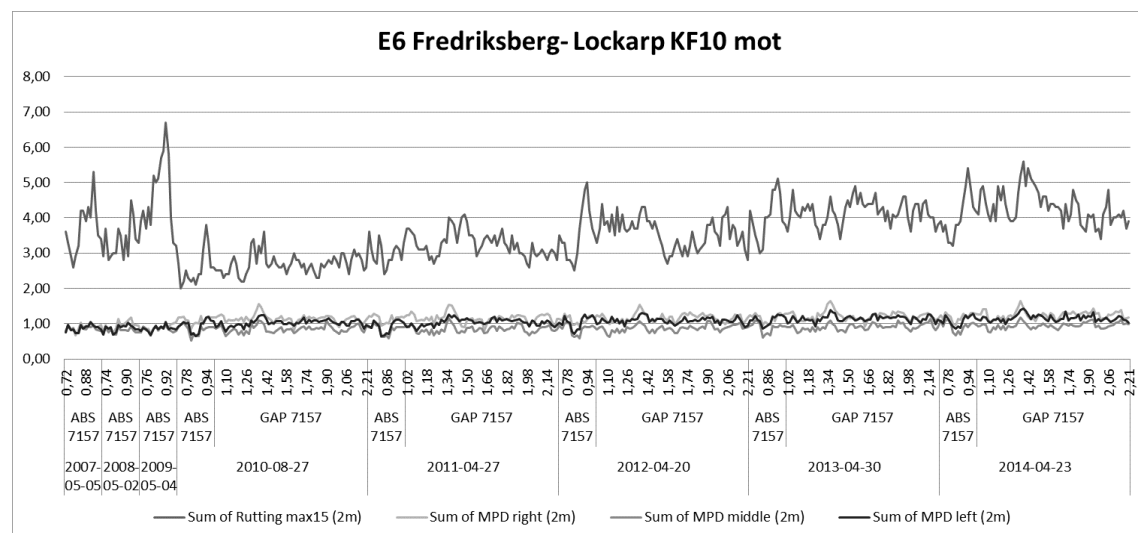
Figure 93: Rutting and MPD left, middle and right with traffic volume 7157 vehicles per day

Figure 92 and Figure 93 in Appendix II: E6 Fredriksberg-Lockarp Appendix II: E6 Fredriksberg-Lockarp demonstrate the road condition regarding rutting and MPD and were separated according to similar traffic in order to evaluate each asphalt type's resistance to wearing. The reason for the high peak in the end of each measurement for the GAP is unknown.
