Safety assessment and improvements for urban intersections

A study about traffic safety in Gothenburg

Master's thesis in the Master's Programme Infrastructure and Environmental Engineering

Department of Architecture and Civil Engineering
Division of Geology and Geotechnics
Urban Mobility Systems
CHALMERS UNIVERSITY OF TECHNOLOGY
Master's Thesis ACEX30-19-20
Gothenburg, Sweden 2019

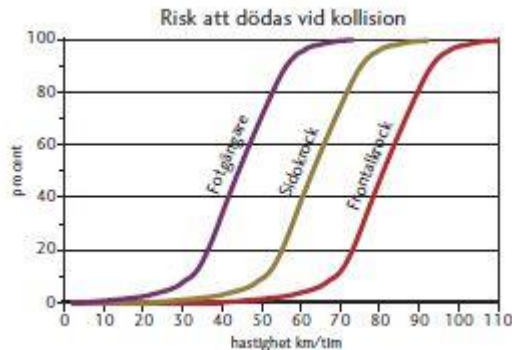
Figure 1 Collision force curve where the x-axis is the speed (km/h) and the y-axis the percentage of the risk of being killed in traffic. The first line represents pedestrians, the second side collision and the third a head-on collision (Swedish Municipalities and County Councils, 2008).

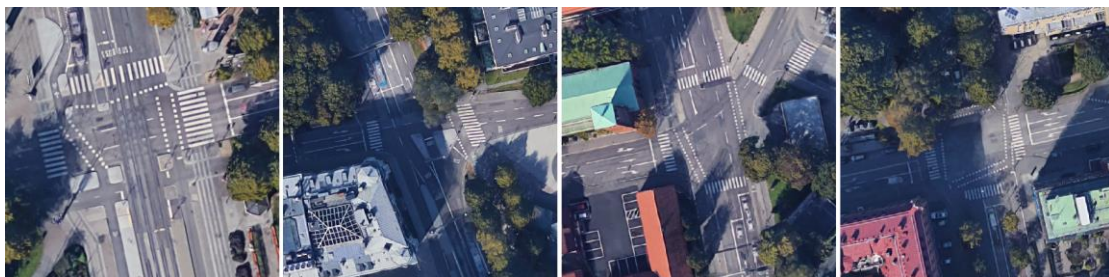
Figure 12 Intersections with similar AADT. From the left: Intersection 14, 1, 15 and 8 (Google maps, 2019).

Intersection 14 is the intersection with the most injuries out of all the 20 investigated intersections. The intersection is located very central with many buses and trams crossing, together with a broad flow of pedestrians and cyclists. The traffic is one-way bound from east to west and only public transport are outbound in the south leg. Intersection 1 and 15 also contains one-way streets with direction from west to east and inbound traffic in intersection 1 is limited to buses. Intersection 8, with the least injuries in this context, has no public transport and all legs are roads with traffic in both directions. Based on each above description it could be argued that intersection 14 has a more complicated traffic situation, followed by 1 and 15. Intersection 8 would then have the most comprehensible traffic situation, with no buses, trams, no one-way street and many lanes in the incoming legs. An overview of the four intersections can be seen in Figure 12.

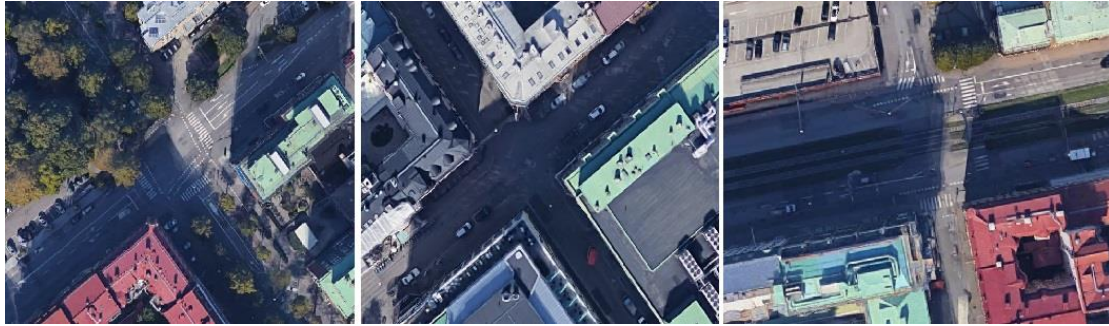
Figure 13 The intersections that have the same amount of accidents with injuries. From the left: intersection 8, 10 and 16 (Google maps, 2019).

It is notable when investigating the intersections that they all are different in the design. Intersection 10 is a small intersection located in direct proximity to buildings and has three legs that are one way. Both intersection 8 and 16 are larger signalized intersections. Intersection 16 has a tramway passing the intersection straight through from east to west and is the only intersection where public transport passes the intersection. All of the intersections have buildings that more or less surrounds the road with varying distances. The number of lanes is also different and both intersection 8 and 16 have more lanes than intersection 10 which makes the area larger and gives a better sight for the drivers. Since the tramway goes through intersection 16 a larger area opens up which gives a good sight for the road users. An overview of the intersections can be seen in Figure 13.

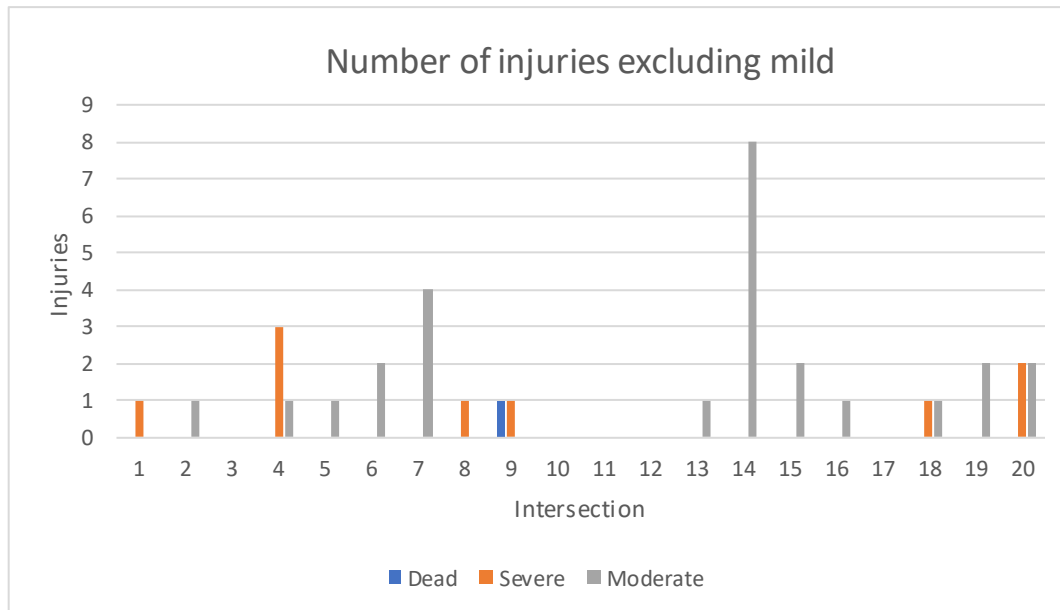
Figure 15 Number of injured persons for each intersection excluding the mild injuries. The figure is based on information from Strada. Author's own copyright.

When excluding the mild injuries, it can be seen that the figures change and that some intersections that previously seemed to be very unsafe, due to the many mild accidents, might not be more unsafe than others in terms of the severity of the injuries.

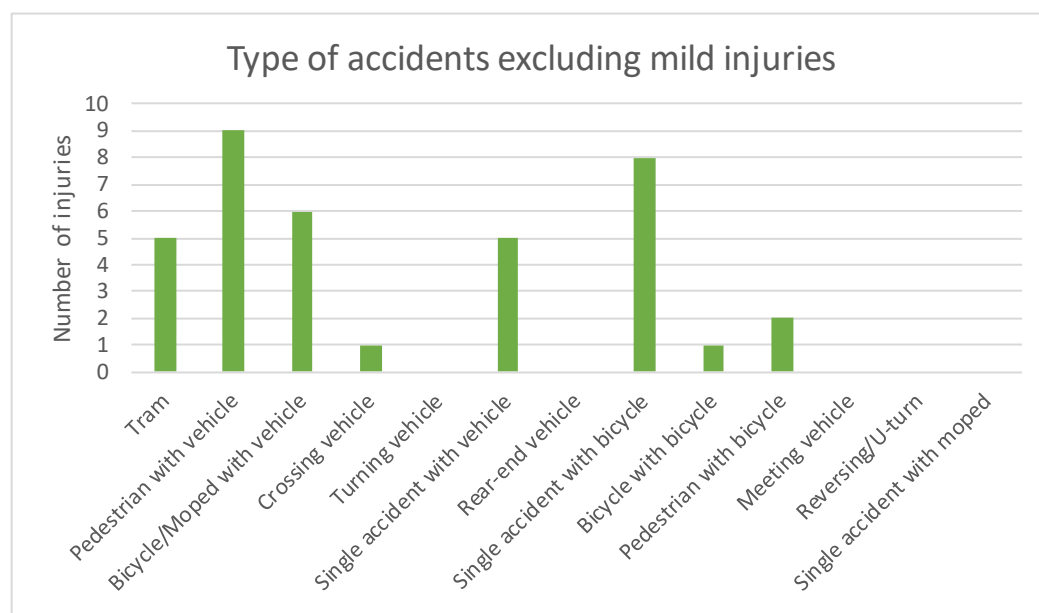
Figure 18 Fatal, severe and moderate injuries for all investigated intersections in Gothenburg. The figure is based on information from Strada. Author's own copyright.

The differences between the types of accidents for all severity levels and the types of accidents when excluding mild injuries are analysed. It can be observed that the leading type of accident for accidents overall is the rear-end accidents which have no injuries when excluding mild injuries. The same pattern is seen in the type of accident “crossing vehicle” where only one of the 42 accidents was of higher severity level than mild. The leading type of accident without mild injuries is pedestrian with vehicle where the share of more severe accidents is 9 out of 43, which is approximately one fifth of the total number of accidents. The same can be noted for accidents involving tram, bicycle or moped in conflict with vehicle as well as single vehicle accidents. Some types of accidents have a large share of high severity level accidents, such as bicycle with bicycle and pedestrian with bicycle. For example, the only accident involving bicycle with bicycle is a moderate accident and for the type “pedestrian with bicycle” two of three were of higher severity level than mild. However, because of the very low number of these accidents in total it can be considered as uncertain numbers. In general, it can be noticed that it is the unprotected road users that are in risk to get more serious injuries considering all types of accidents.

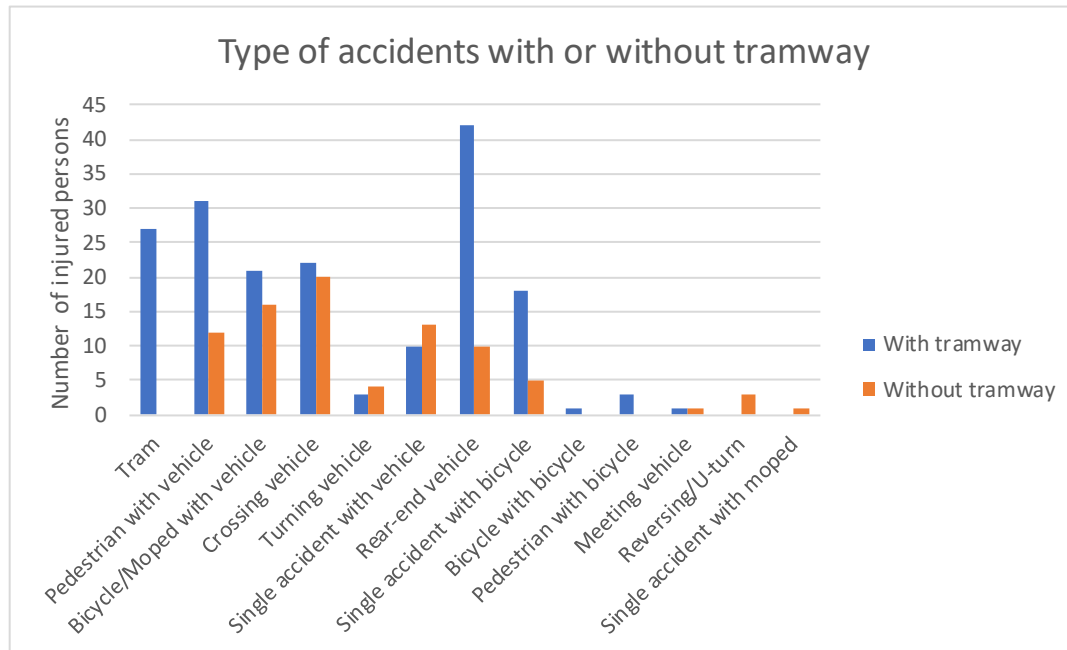
Figure 19 Number of injured persons depending on if a tramway is located in the intersection or not. The figure is based on information from Strada. Author's own copyright.

have a tramway rail located in connection to the intersection, Table 2 in Section 4.1. Figure 19 shows the types of accidents with the investigated intersections divided into intersections with tramway and intersections without tramway. As can be seen in the figure accidents involving trams are the third most common type of accident in intersections with tramway. However, it is the rear-end accidents which are the most prominent in intersections with tramway, followed by collisions between pedestrians and a vehicle.

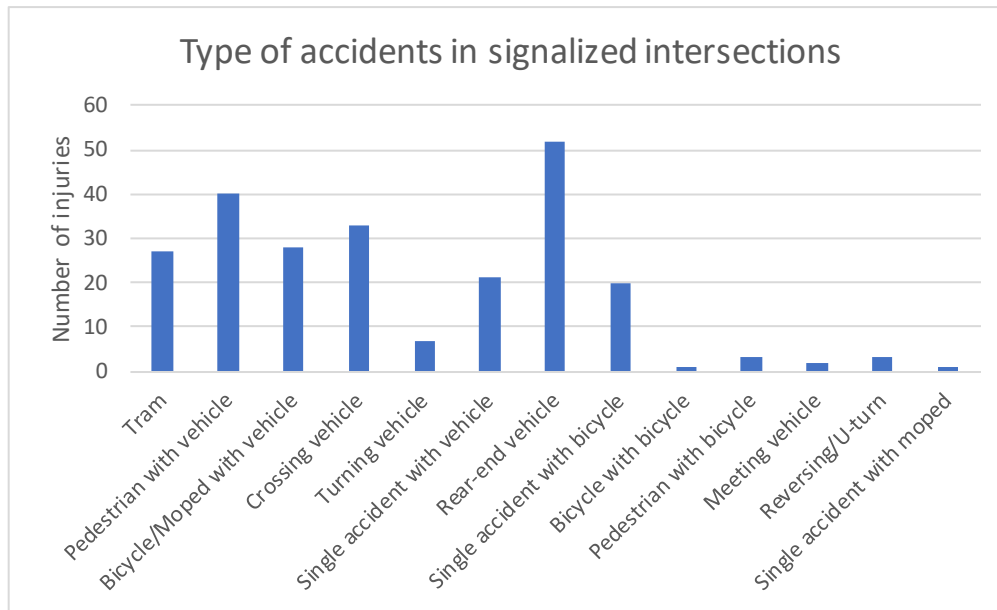
Figure 20 Number of injured persons in signalized intersections. The figure is based on information from Strada. Author's own copyright.

In signalized intersections rear-end accidents is the type of accident that has resulted in the most injured persons, Figure 20. For the non-signalized intersections crossing accidents and bicycle/moped with vehicle accidents have resulted in the most injured persons, Figure 21. The total number of accidents with injuries in the signalized intersections is 238 while in the non-signalized it is 26. However, it is important to notice that only six intersections are non-signalized in this study, Table 2 in Section 4.1.

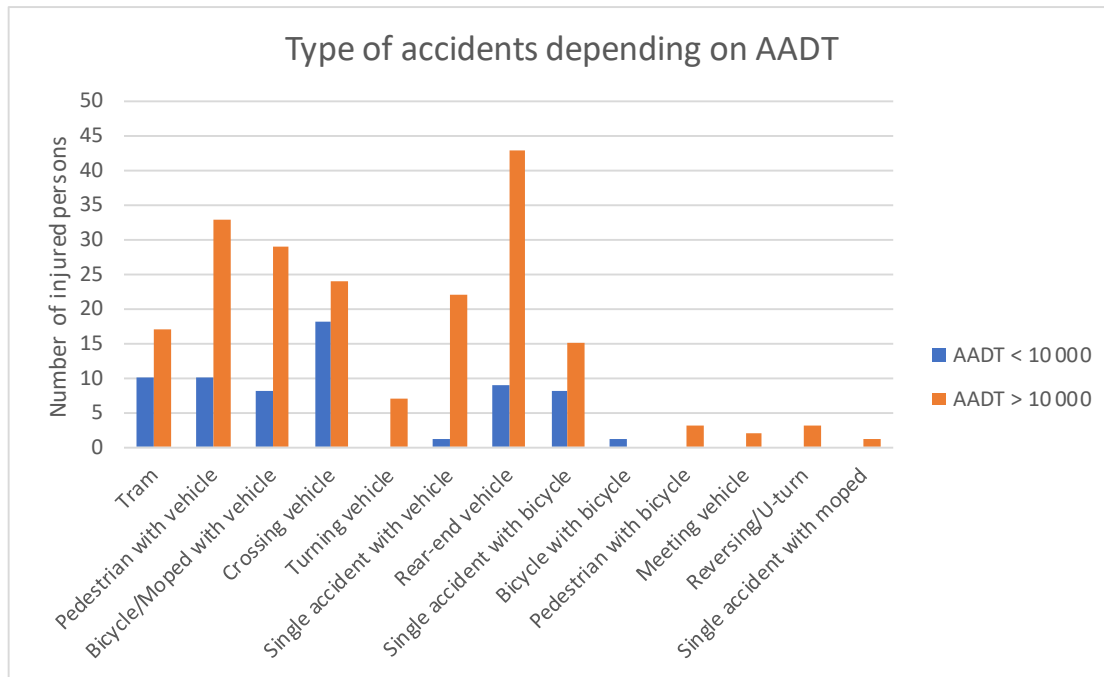
Figure 22 Number of injuries depending on AADT. Author's own copyright.

In Figure 22 it is found that it has occurred several more accidents with injuries in the intersections with higher flow, a total of 199, than for the intersections with lower flow where the number of injuries is 65. This means that in total 75% of all accidents in the investigated intersections occur in the intersections with AADT higher than 10 000. In the intersections with lower AADT it is also significant that there have not occurred any fatal or severe accidents, meaning that all of those with a higher severity level have occurred in the ten intersections with the highest flow, Table 3 in Chapter 5.

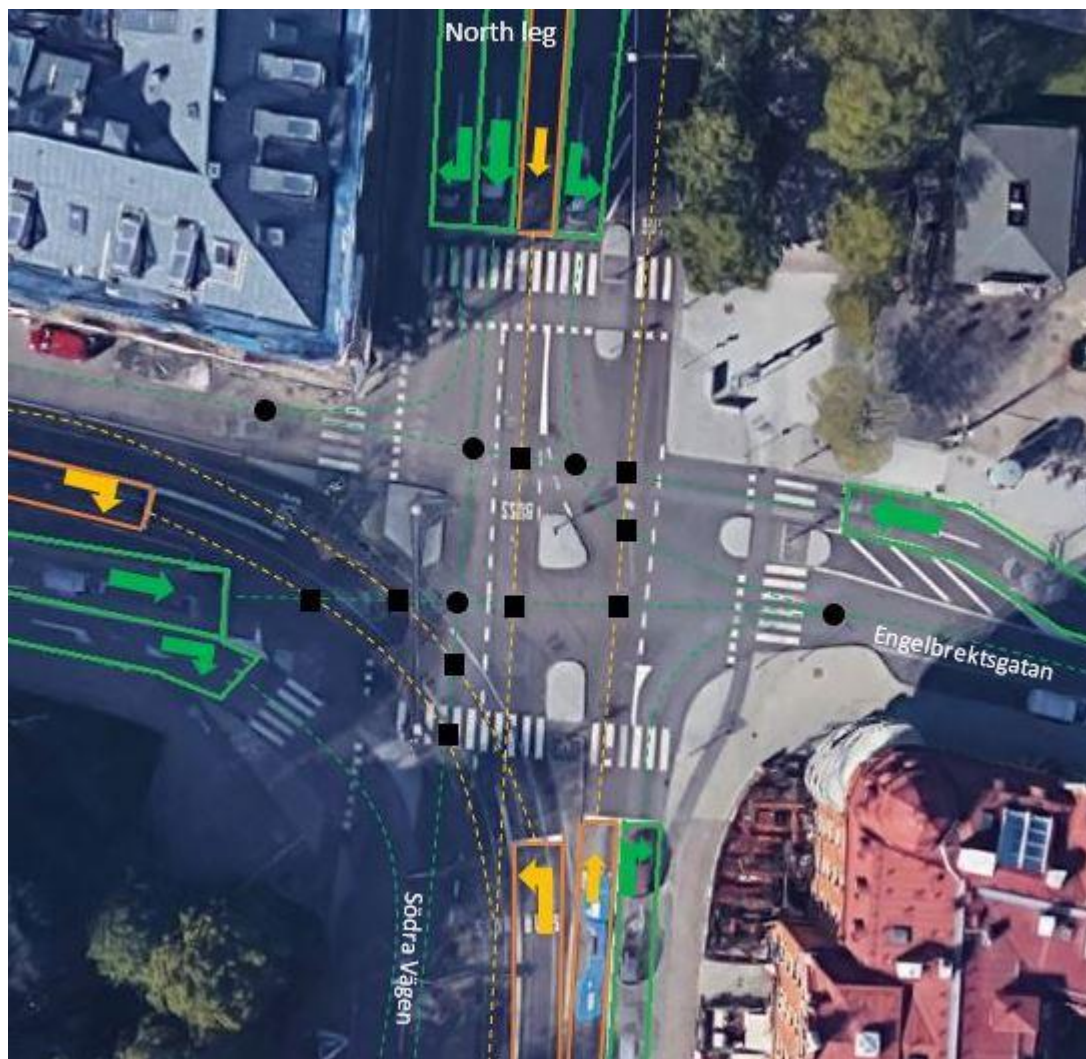
Figure 23 Map over intersection 7 marked with bus and tramway rail in orange and road in green. Theoretical conflict points marked by black circles for private vehicle-private vehicle conflict and black squares for private vehicle-public transport conflicts. Figure adjusted from Google maps (2019).

The intersection is located in central Gothenburg with the main street Kungsporsavenyjen parallel to Södra Vägen. The tramway rail is located in between the lanes in the middle of the street and passes from south to west in each direction, Figure 23. The incoming legs have different number of lanes where east and south have one incoming lane while north has three and west has two. There is an incoming bus lane in the north and south leg, with the bus passing the intersection in both directions. The drivers on the south leg is only allowed to turn right to the east leg in the intersection, also the east leg is only allowed to drive straight through the intersection.

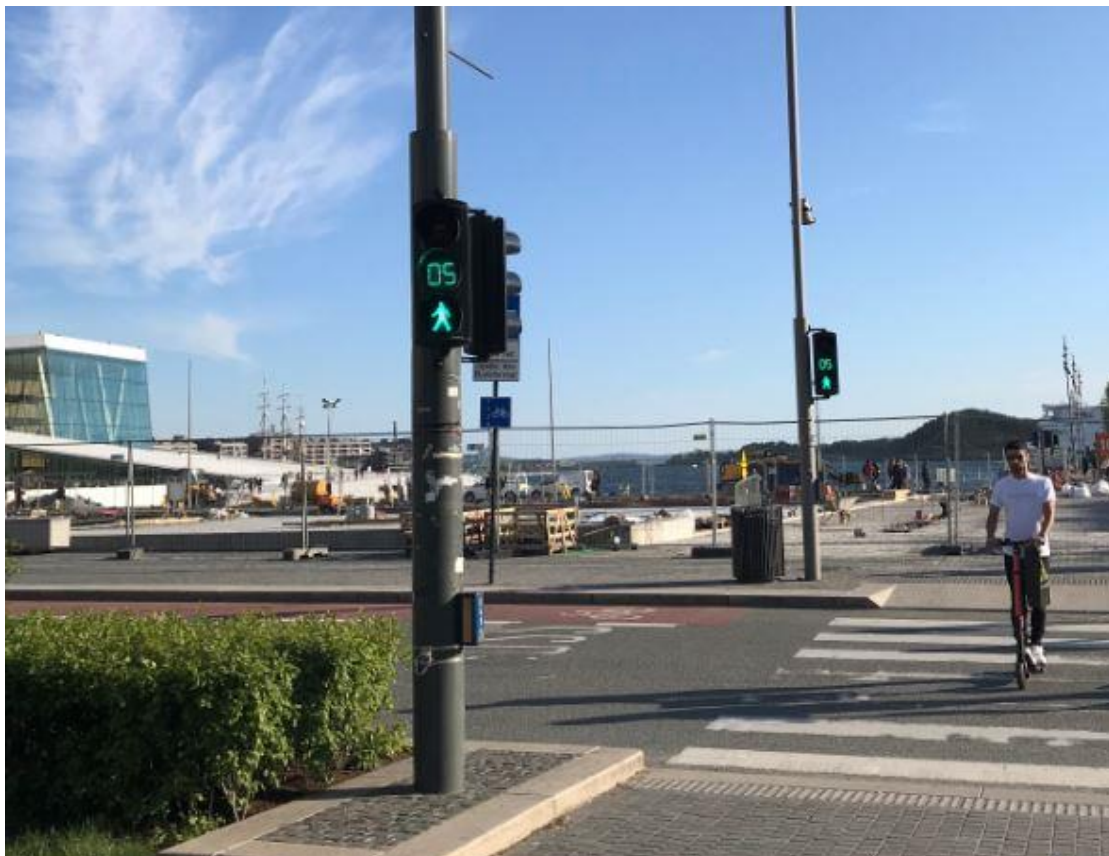
Figure 25 Traffic signal countdown timers for pedestrians implemented in Oslo, Norway. Author's own copyright.

One option is to change the traffic lights to shorter green time for vehicles and thereby pedestrians do not save as much time by illegally passing the zebra crossing. However, this might be a worsening for the vehicles since it takes longer time to get past the intersection. It also can contribute to irritation and may affect the drivers' attention since a longer waiting time can lead to distraction. Furthermore, it is possible to insert traffic signal countdown timers for the pedestrians, Figure 25. These types of traffic signals show how many seconds there are left until the pedestrians are allowed to pass the zebra crossing. By implementing this type of traffic signals the pedestrians may get more comfortable while passing the zebra crossings since they do not have to rush over it, depending on how much time there is left. It might also have the effect that the pedestrians see that they do not need to illegally cross the zebra crossings since there are just a few seconds left until they are allowed to cross.

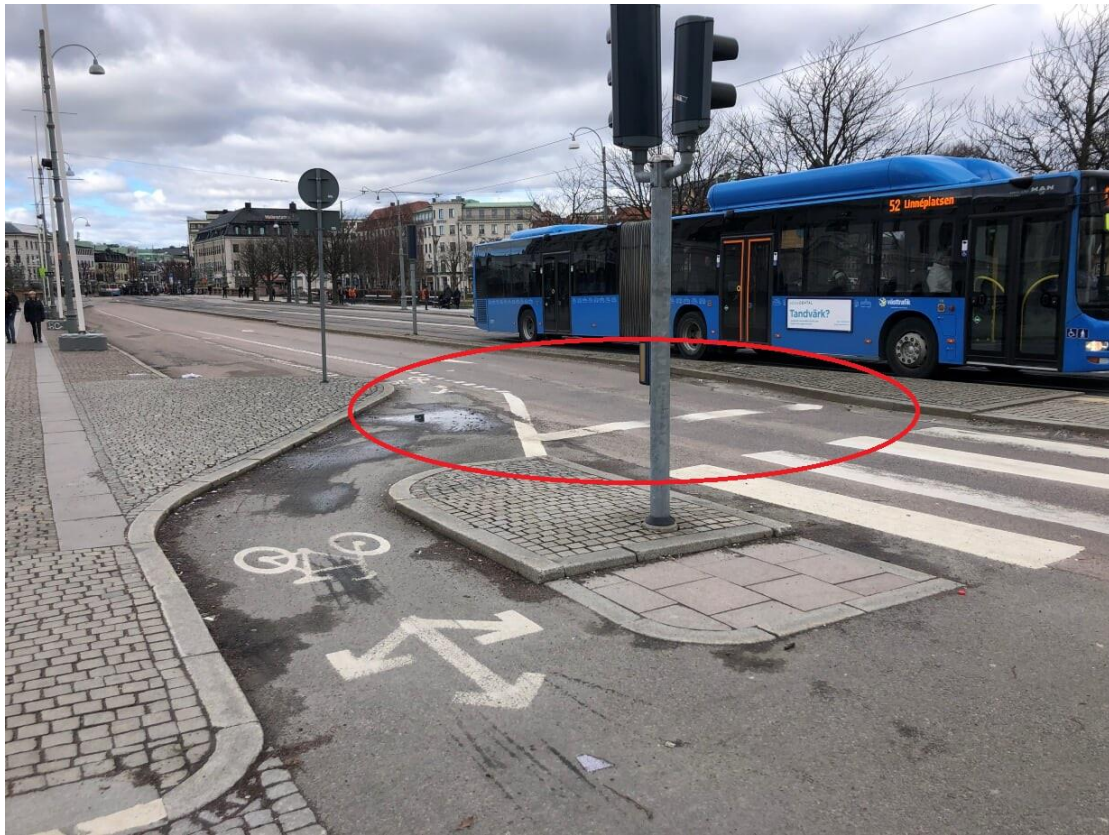
Figure 27 North leg of intersection Nya Allén/Kungsporsavenyen. The red marking represents the area where the bike box should be placed, by withdrawing the stop line for vehicles and making the cyclists stop in front of the vehicles. Author's own copyright.

bike box in this lane will probably increase the awareness of cyclists and thereby decrease the risk of collision between cyclists and vehicles.

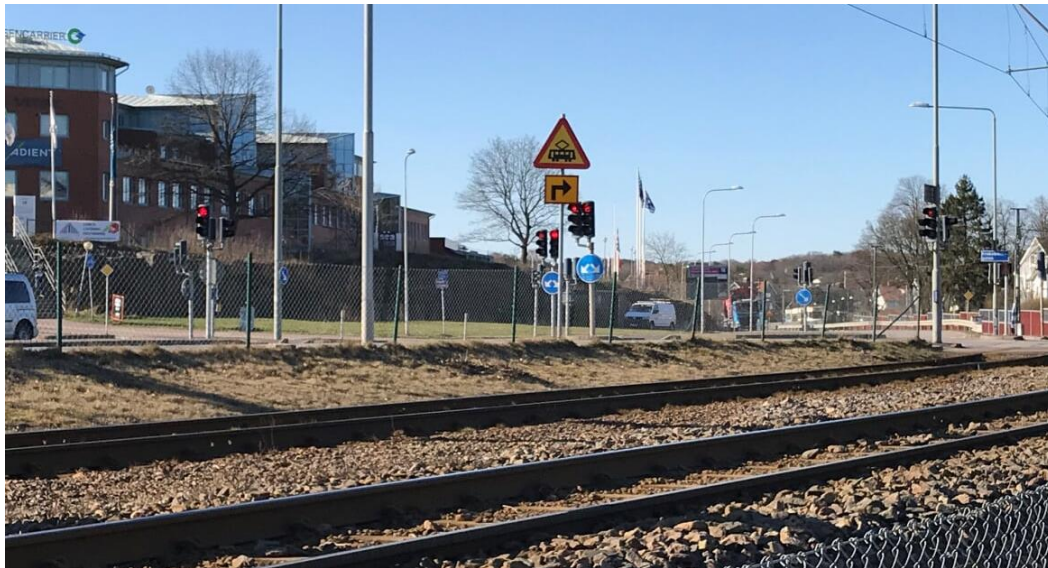
Figure 30 Intersection seen from the east leg, including with a warning sign for the trams. Author's own copyright.

From the field study it was seen that there are some safety improving measures in the intersection, there are for example railings separating the tramway rail from other transport modes. There are also warning sounds when a tram is approaching and on the east leg of the intersection there is a warning sign for oncoming trams, Figure 30.

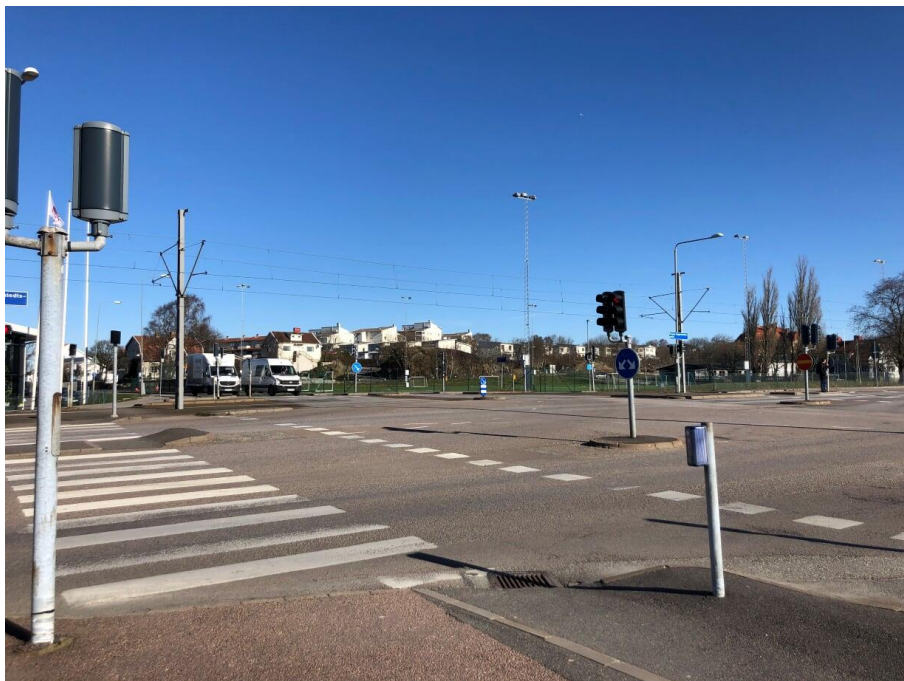
Figure 31 Picture of the intersection from the corner between south and west legs. From this perspective it can be difficult to perceive the tramway rail. Author's own copyright.

The sight is good in the intersection and the intersection is open with wide lanes. Even though the intersection has good sight it can cause drivers to not perceive the tramway rails and a possible oncoming tram, see example in Figure 31. Improvement suggestions for this intersection are therefore focused on increasing the awareness of the tram when it is approaching and the tramway rail for vehicles and cyclists.

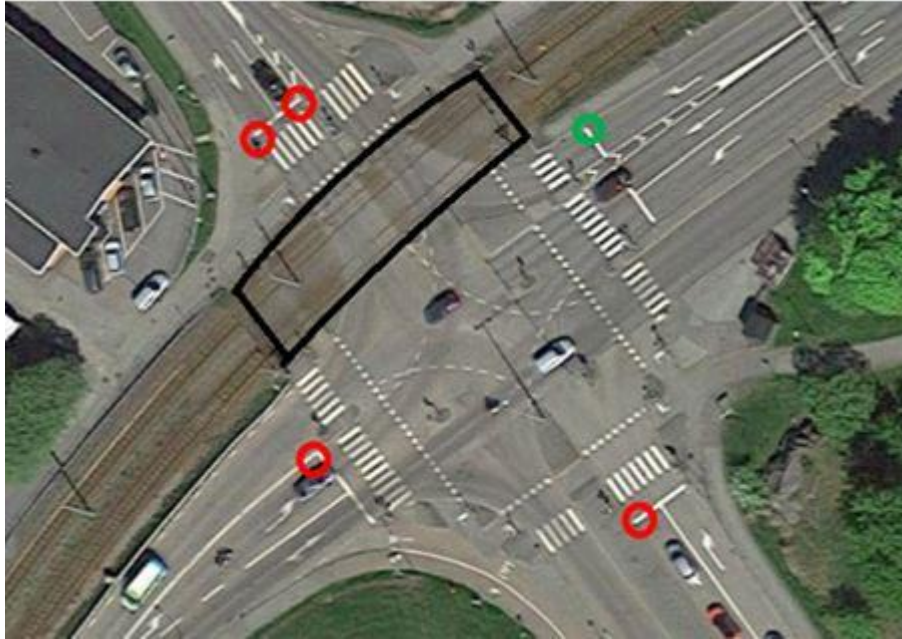
Figure 32 Improvement proposal for intersection 19. Black area represents the area of marking the tramway tracks with lines and different coating. Red circles are where warning signs for trams should be placed and green where the existing sign is located. Figure adjusted from Google maps (2019).
