The Vajont slide

Facing the complexity of nature

Bachelor thesis in Geology and Geotechnics

Bachelor thesis ACEX10-19-32

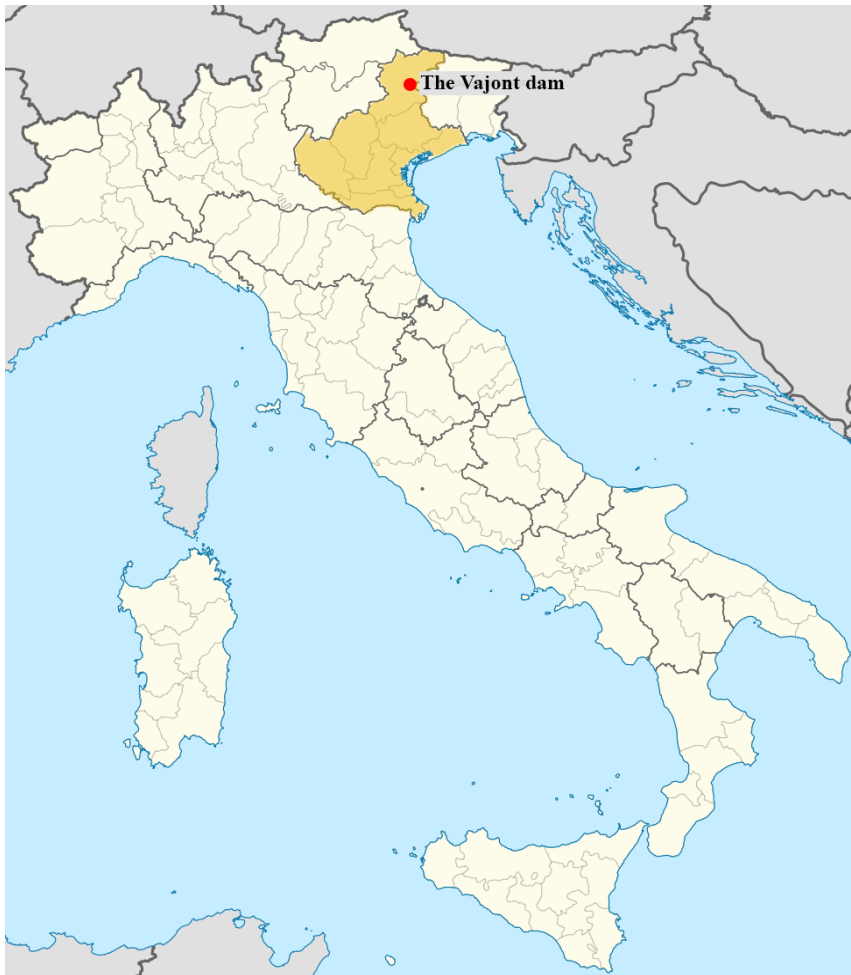
Figure 1. The location of the Vajont dam. Author's own copyright.

The Vajont dam is constructed in the Piave river which runs through the valley by the mountain Mount Toc located in the southeast Alps domain (Wolter, Stead, Ward, Clague & Ghirotti, 2019), figure 1. The Piave river runs through the town of Longarone and is surrounded by smaller villages such as Erto and Casso. The location of the dam in relation to the surrounding communities will later prove to be of crucial importance, with regards to the damage that was caused on each community.

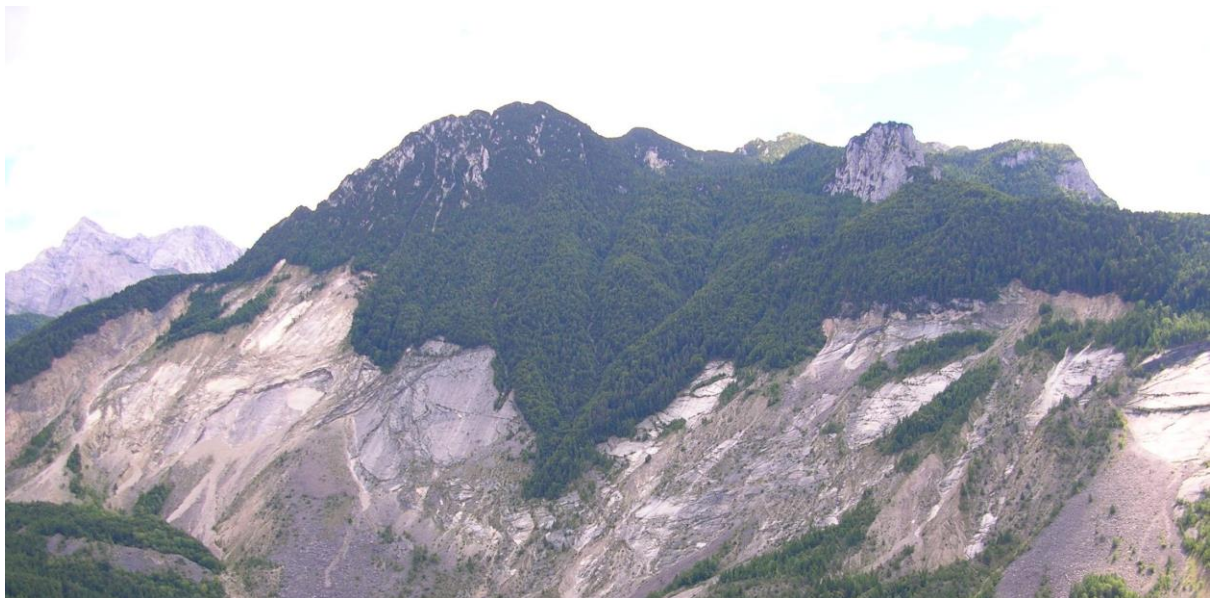
Mount Toc, see figure 2, consists of limestones of the Fonzaso and Socchèr formations but also thin intercalations of clay (Wolter et al., 2019). The southern part of the village Erto syncline is an area with a high sensitivity of displacement (Massironi et al., 2013).

Figure 2. The area of the landslide, Mount Toc (Montagna, 2005). CC-BY.

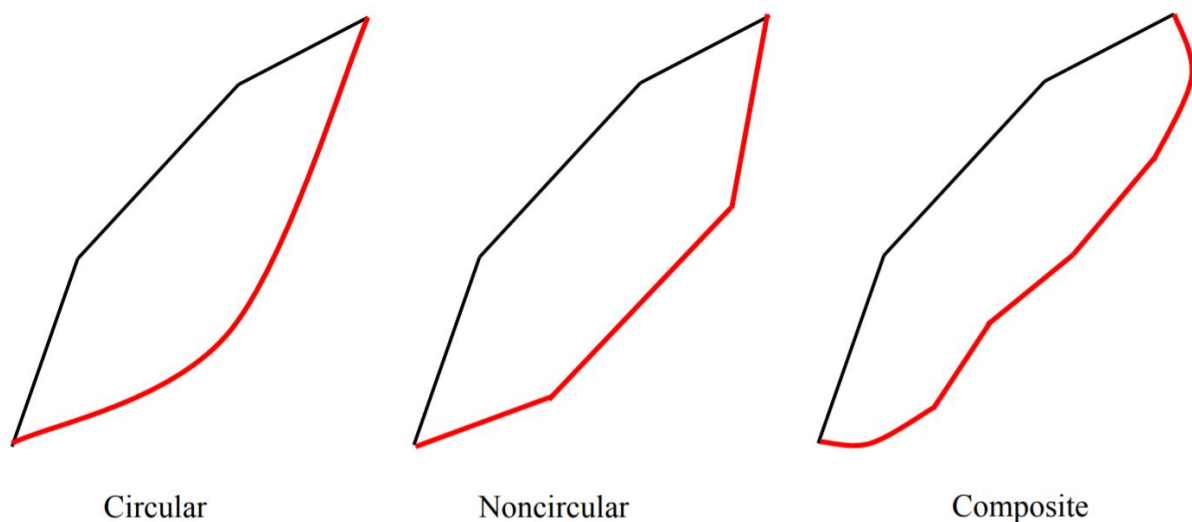
Failure in a slope can be initiated due to tectonic damage or temporary conditions such as water pressures (Stead & Eberhardt, 2013). The failure surface geometry considered is therefore important to mention when discussing rock slopes since it determines how the slope will react to the conditions mentioned (Stead & Eberhardt, 2013). Huang (2013) writes that there are three types of failure surfaces, which are presented in figure 8.

Figure 8. Failure surface geometry. Authors own copyright.

The first type of failure surface, see figure 8, is the circular failure which is also called the cylindrical failure surface. This type of failure surface occurs if the materials in the slope are homogeneous with no weak layers (Huang, 2013). The second type is the non-circular failure surface. It consists of a series of planes which explains why it is also known as a plane failure surface. The failure surface will occur at a point when the critical failure surface is located along the bottom of the weaker layers. This occurs if weak layers exist at the start or end of the slope surface (Huang, 2013). The last type of failure considered is the composite failure which is circular and defined as a partially plane failure surface. It is plane because the failure surface will follow the point of weakest strata when the circle cuts a layer of weak material (Huang, 2013).

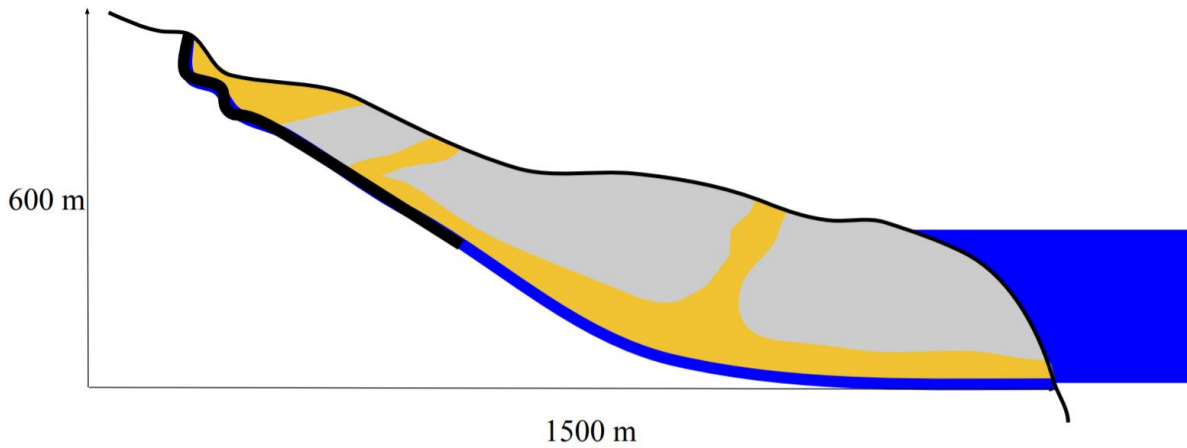
The figure below displays the same geometry as in figure 11 in the previous case. However, figure 12 below illustrates a water level in the reservoir. The water has not permeated the rock mass, but fully saturated the sliding surface.

Figure 12. Castelletto section of Mount Toc with water in the reservoir. Author's own copyright.

In comparison to figure 12, figure 13 below is similar but with the addition of the uplifting force from the water, U , and the hydrostatic water pressure, Q . The hydrostatic water pressure is then divided into sine and cosine components of the angle, ϵ . This is in order to evaluate its components and its effect on the factor of safety.

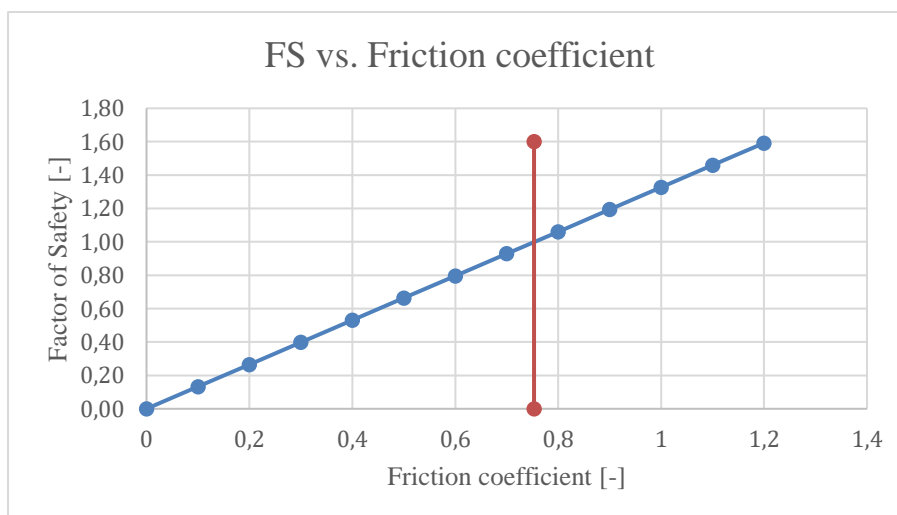
A first sensitivity analysis is presented in figure 17, where the factor of safety, FS is plotted against the friction coefficient. The figure shows that when the friction coefficient is lower than 0,754 the equilibrium state is lost. After this point, the risk of failure increases remarkably. This is due to the factor of safety being lower than, $FS < 1$.

Figure 17. Factor of safety vs. Friction coefficient. Author's own copyright.

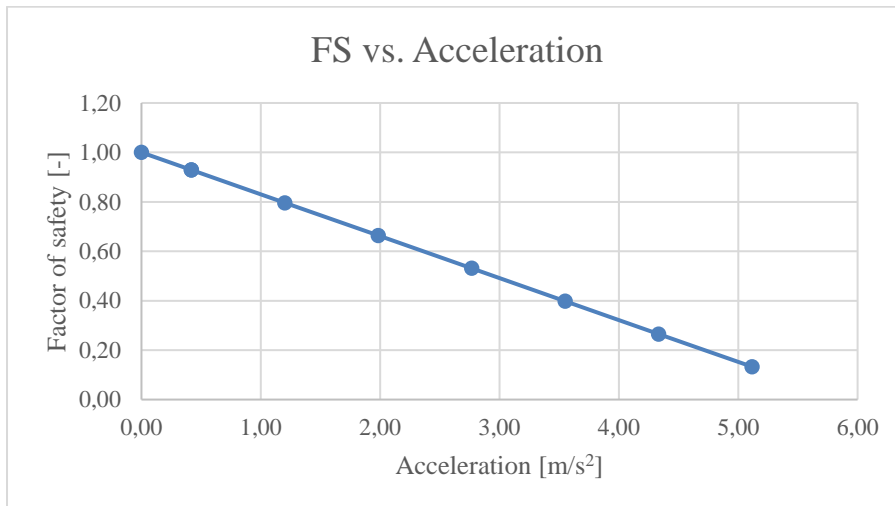
The following graph was plotted in figure 18 to illustrate the relation between the factor of safety and acceleration. As expected, the decrease in the factor of safety leads to a remarkable increase in acceleration. Furthermore, this also increases the velocity and displacement of the landslide.

Figure 18. Factor of Safety vs. Acceleration. Author's own copyright.

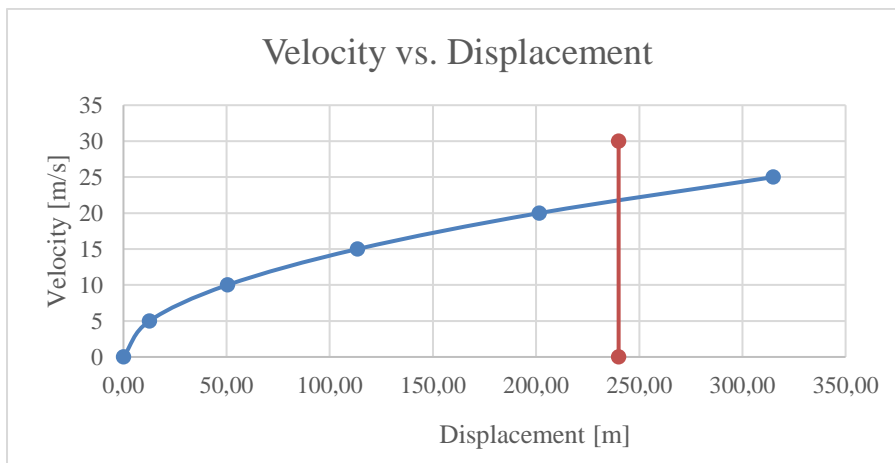
As a conclusion the velocities and displacements in table 6 is plotted in figure 19. The orange line at the displacement of 240 m marks the maximum allowed sliding distance which was justified by Müller (1987).

Figure 19. Velocity vs. Displacement. Author's own copyright.

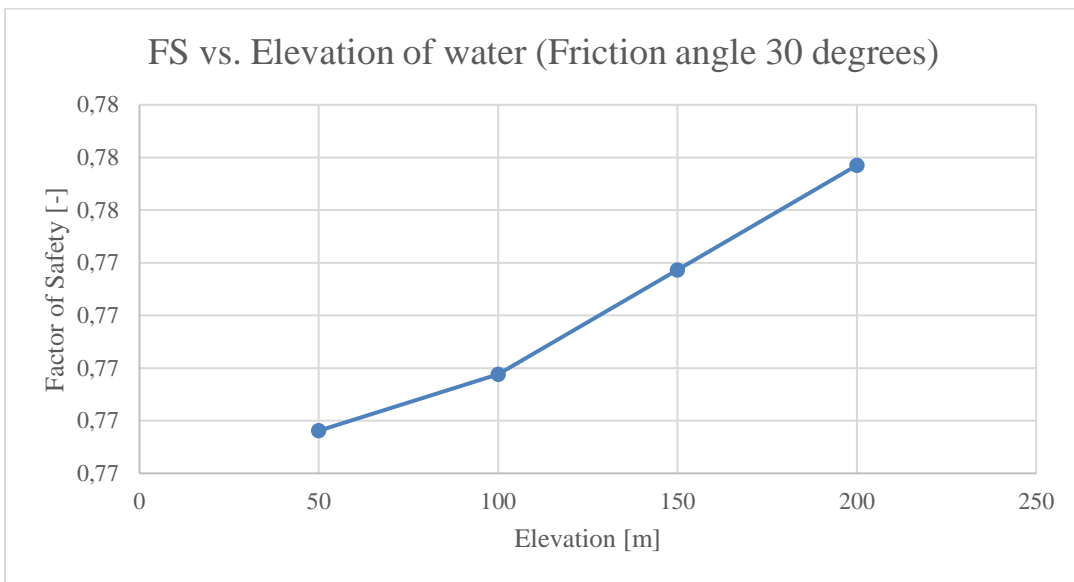
Compared to the figure above, figure 21 has assumed a friction angle φ of 30 degrees. In this case, the factor of safety increases as the elevation of water increases. Despite the effect of water pressure and uplift force the factor of safety increases. This is due to the change in friction angle.

Figure 21. Factor of Safety vs. elevation of the reservoir for a friction angle of 30 degrees. Author's own copyright.

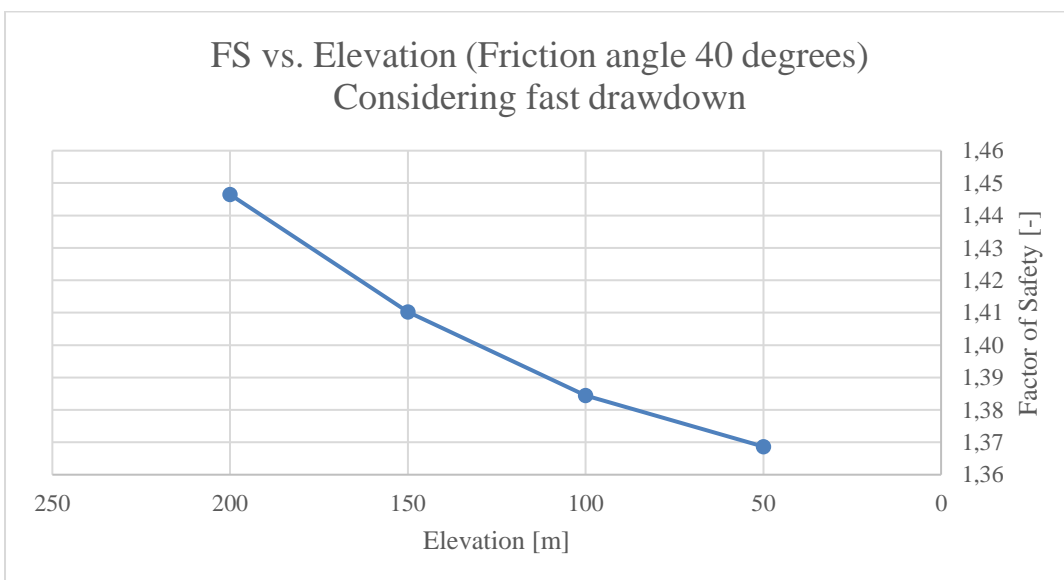
In figure 23 the factor of safety is based on the elevation of the reservoir, for a friction angle of 40 degrees. As can be seen in figure 23, the factor of safety decrease as the elevation decreases.

Figure 23. The impact of fast drawdown on the Factor of Safety vs. elevation of the reservoir for a friction angle of 40 degrees. Author's own copyright.

Figure 25 illustrates the same relation as figure 23 and figure 24. However, here the friction angle is reduced to 21,1 degrees. The graph in figure 23, figure 24 and figure 25 all behave similarly and the factor of safety decreases as the elevation increases.

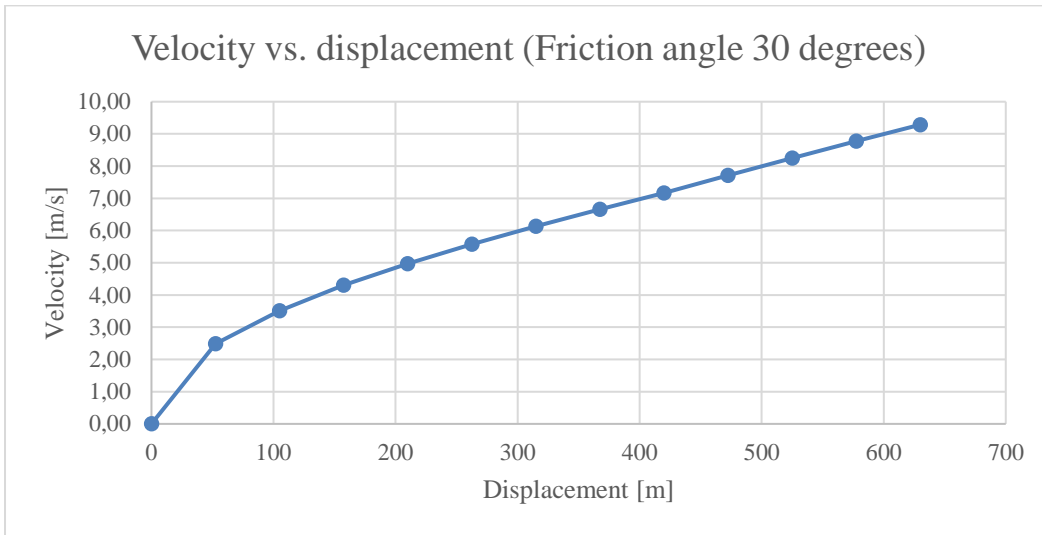
As illustrated in figure 26, the velocity is plotted as a function of the displacement for an interval between $200\text{ m} \leq h_w \leq 500\text{ m}$. The values of the water depth elevation presented above are only three points that have been taken into consideration. However, the remaining values were also calculated in 25 m intervals between the values presented of the water elevation in table 12, 13, 14 and 15. This is in order to obtain an accurate graph in figure 26 and 27.

Figure 26. Velocity vs. displacement for a friction angle of 30 degrees. Author's own copyright.

In figure 27 as the displacement increases, the velocity increases similarly to the previous case. The difference between figure 27 compared to figure 26 is that velocity increase in a faster rate in relation to the displacement in figure 27. This is a result of the difference in the value for the friction angle.

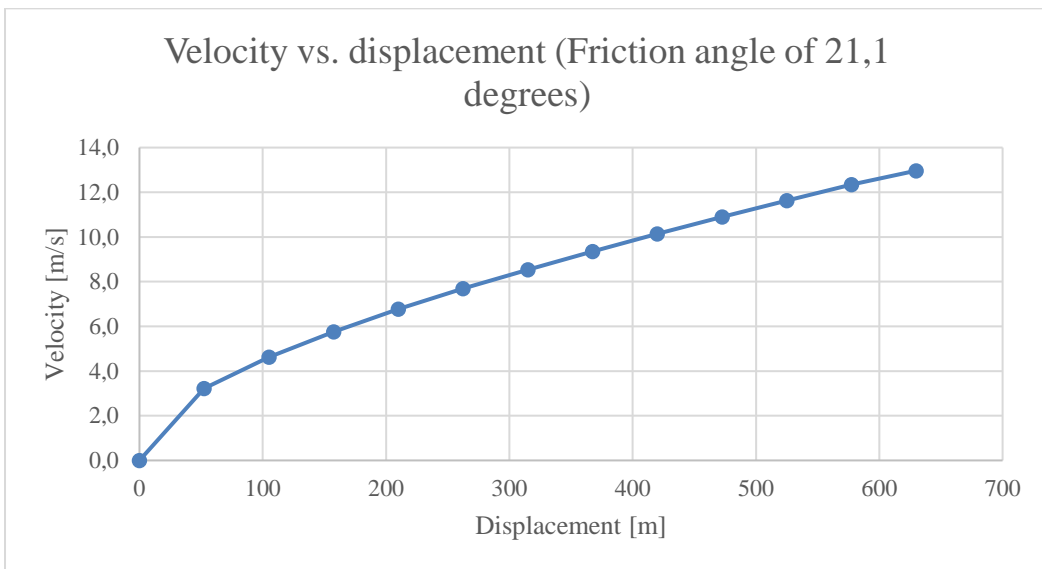
Figure 27. Velocity vs. displacement for a friction angle of 21,1 degrees. Author's own copyright.

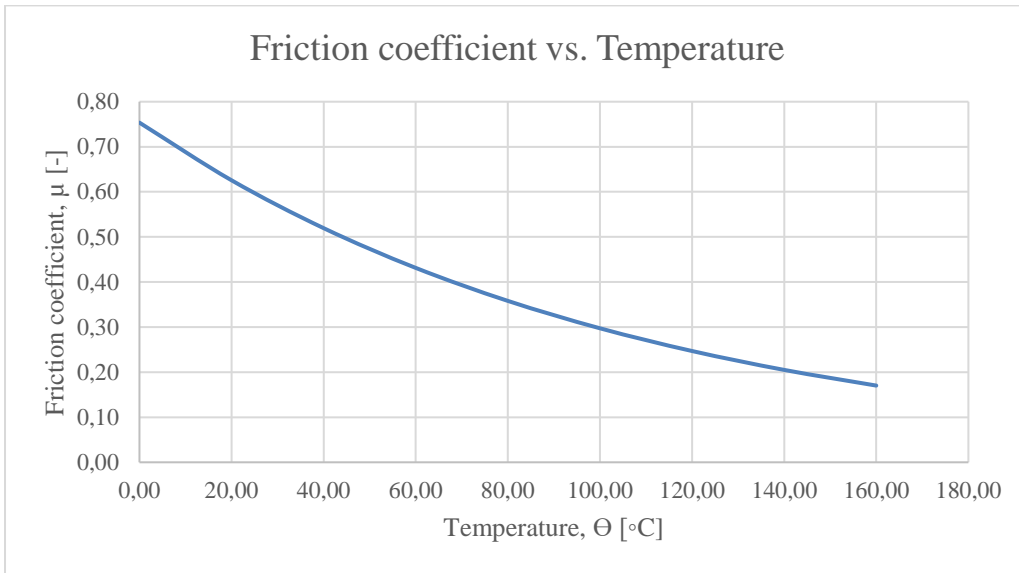
The graph in figure 28 describes the correlation between the friction coefficient and the temperature of the landslide according to the values obtained in table 16.

Figure 28. Friction coefficient vs. Temperature. Author's own copyright.

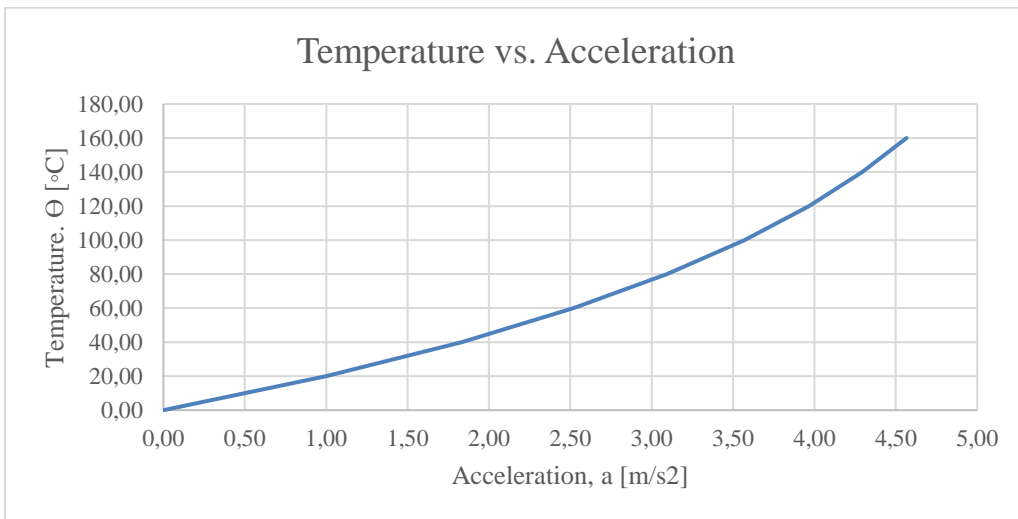
Figure 29 illustrates the relation between acceleration and temperature of the landslide. As the acceleration increase the temperature follows a slightly positive exponential curve.

Figure 29. Temperature vs. Acceleration. Author's own copyright.

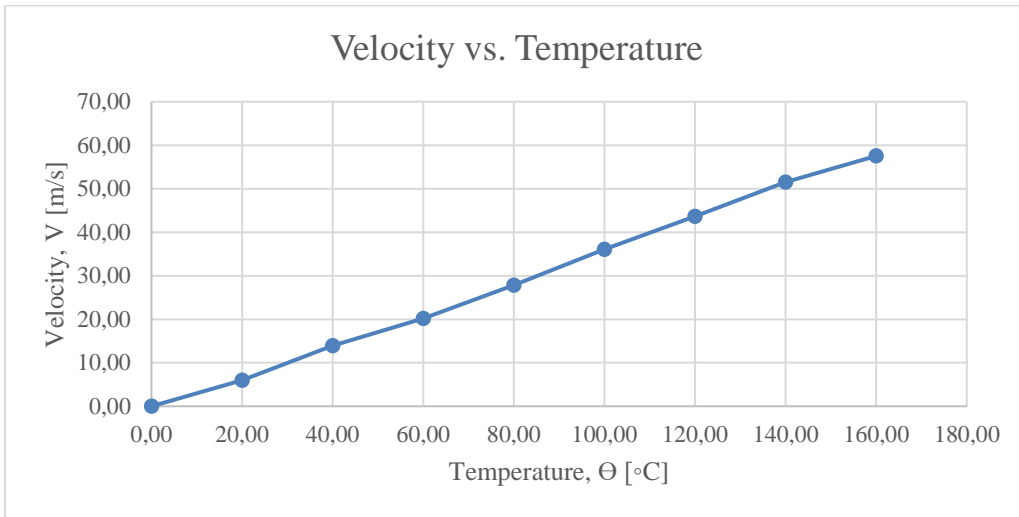
In figure 30 the relation between velocity and temperature of the landslide is shown. The temperature increases linearly as the velocity increases.

Figure 30. Velocity vs. Temperature. Author's own copyright.

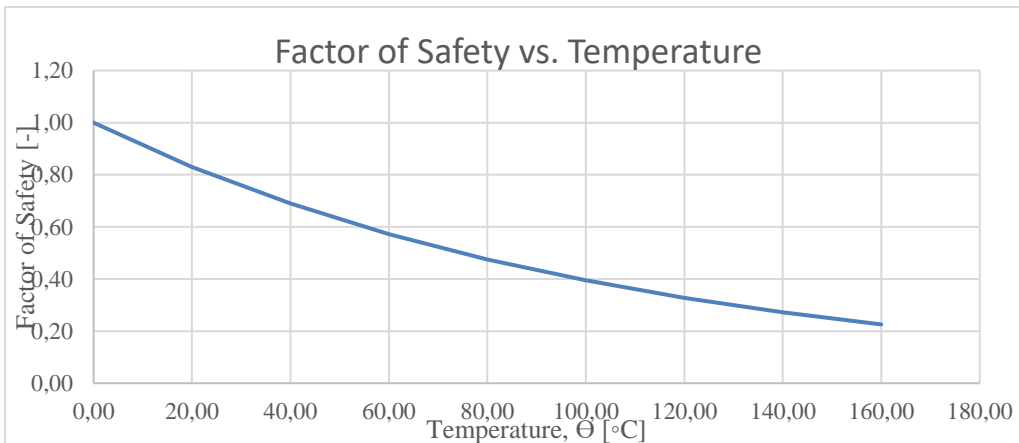
Figure 31 shows the link between factor of safety and the temperature of the landslide. As can be seen in figure 31 the factor of safety decreases as the temperature increases. Hence, the factor of safety is sensitive to high temperatures.

Figure 31. Factor of Safety vs. Temperature. Author's own copyright.

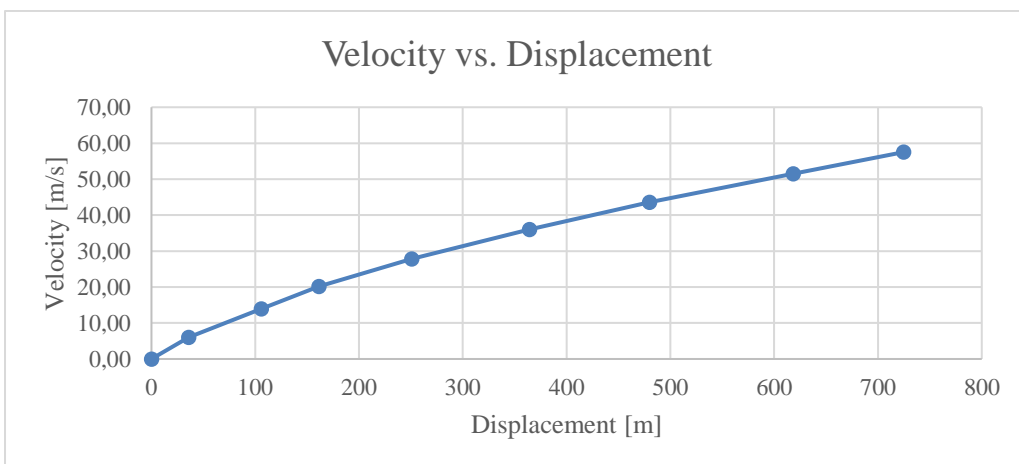
As can be seen in figure 32, the displacement increases for higher velocities.

Figure 32. Velocity vs. displacement. Author's own copyright.
