Vibrations during Resonance Frequency Analysis of Dental Implant Stability

Master of Science Thesis

Department of Signals and Systems
Division of Biomedical Engineering
CHALMERS UNIVERSITY OF TECHNOLOGY
Göteborg, Sweden, 2007
Report No. EX104/2007

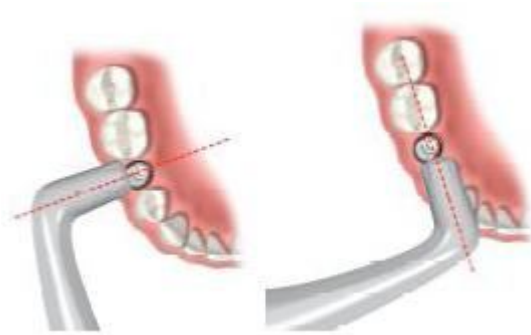
Figure 1. Left jaw: Measurement in bucco-lingual direction. Right jaw: Measurement in mesio-distal direction. [6]

Most of the implants have two different stability values. The highest value is normally in the mesio-distal direction and the low value in the bucco-lingual direction. Both values reflect the stability situation and it could therefore be useful to follow both values. Osstell AB recommends the users to do measurements in both these directions. [6] Figure 1 shows measurements in bucco-lingual and mesio-distal directions.

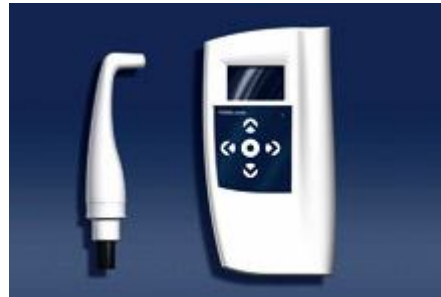
Figure 5. Instrument and probe. [11]

Figure 5 shows the instrument and the probe.

When Osstell™ Mentor is turned on, the instrument measures automatically without any activation from the user. [6] Signals are transmitted and received continuously, and during one measurement cycle with Osstell™ Mentor there are 4 different pulse frequencies transmitted in an interval of approximately 2-8 kHz. The center frequencies of the 4 pulses are 3 kHz, 4,4 kHz, 5,8 kHz and 7,2 kHz and their amplitudes are different from each other. The reason to the difference in amplitude is that Osstell™ Mentor can not deliver as high amplitudes for high frequencies as for lower frequencies. Osstell™ Mentor is designed to deliver as high amplitude as possible for every frequency. Each pulse is transmitted 4 times, which means that totally 16 pulses are transmitted during one measuring cycle, and from the received spectra a mean value is calculated for each frequency area. [8] In figure 6 the transmitted signals in the frequency spectrum are shown.

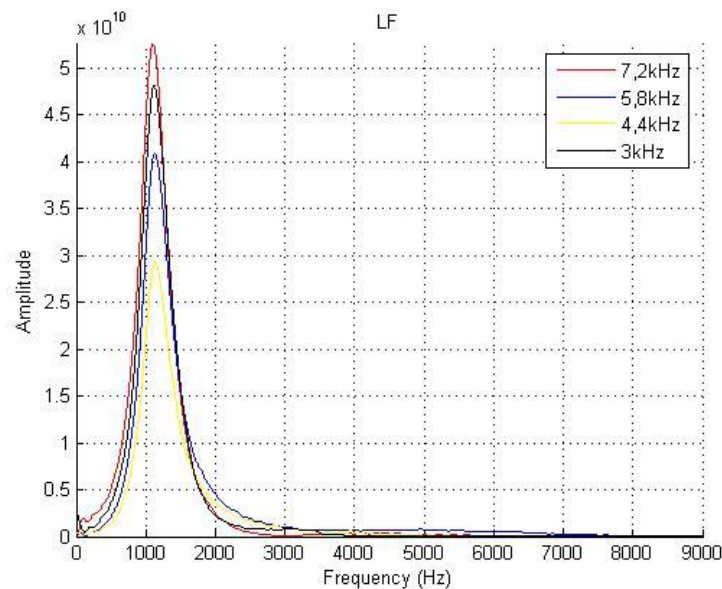
Figure 15. Measurement in the low frequency area.

In the next measurement the SmartpegTM was held with less pressure than in the previous measurement and the result is shown in figure 15.

In the second measurement the strongest frequency response was registered with the 7.2 kHz pulse. The closest pulse to the frequency response was the 3 kHz but from figure 15 it was noted that the frequency response was outside the transmitted frequency area. OsstellTM

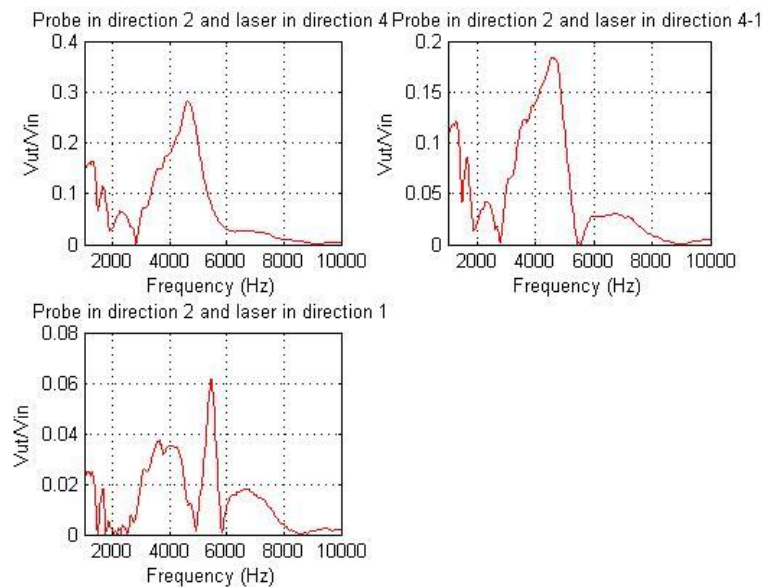
Figure 19. Probe in direction 2 and laser in different directions.

The figure shows that the same two resonance frequencies as in the earlier figure were found and that the Smartpeg™ was vibrating in mainly two directions when being stimulated from one direction. A resonance at 1 kHz is also to be found in this measurement.

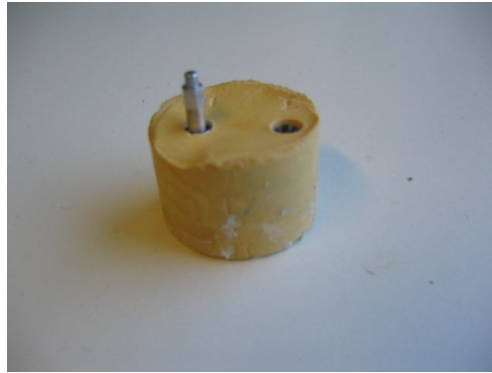
Figure 26. Two implants cast into 20 gram of plaster. A SmartpegTM is placed in the left implant.

measurements were preceded. Figure 26 shows the plaster model with two implants applied. There is a SmartpegTM in the left implant.

In this chapter the affect of different physical disturbances in the implant/ Smartpeg™ interface is analyzed. To receive a simple and clean frequency environment in the frequency spectrum, the measured Straumann implants were cast into 20 gram of plaster. Next after that, a Smartpeg™ was screwed into one of the implants with a force of 5 Ncm, and the

The resulted resonance frequencies from the measurements were at about the same frequency as the measured self resonance of the SmartpegTM and implant screwed into a vice, which was presented in chapter 4. Hence it is possible that the measured frequencies in these measurements are self resonance of the SmartpegTM and not the implant/plaster interface. The measurements are still interesting to study if new resonance frequencies can occur when the implant/ SmartpegTM interface is disturbed.

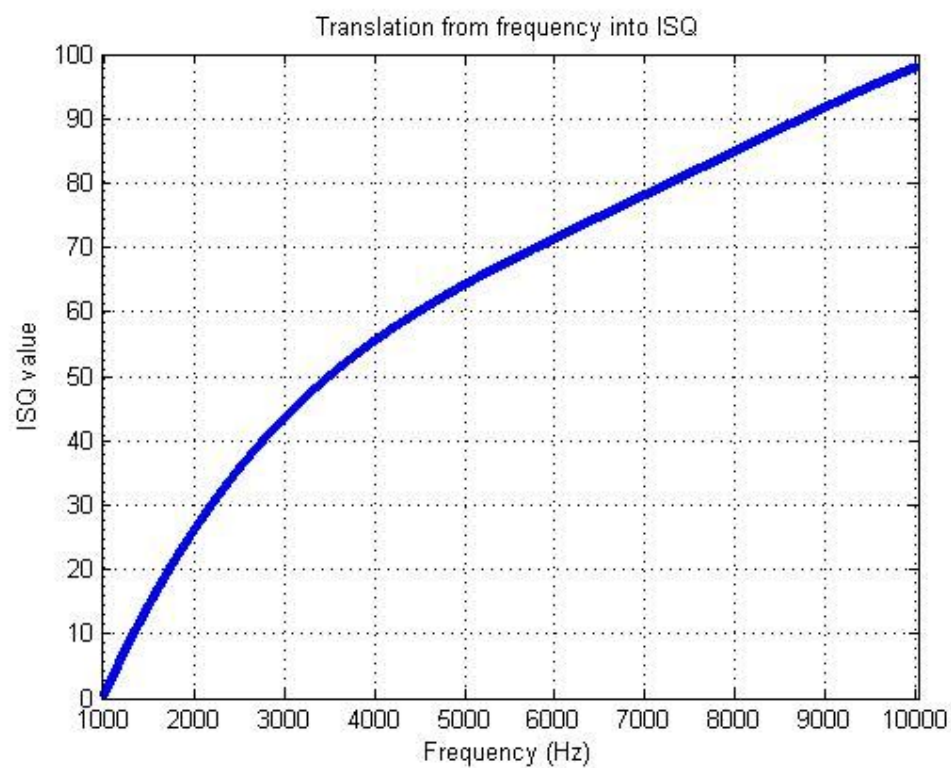
Appendix 2: Translation from Frequency into ISQ

Figure 27. Translation from frequency into ISQ. [13]

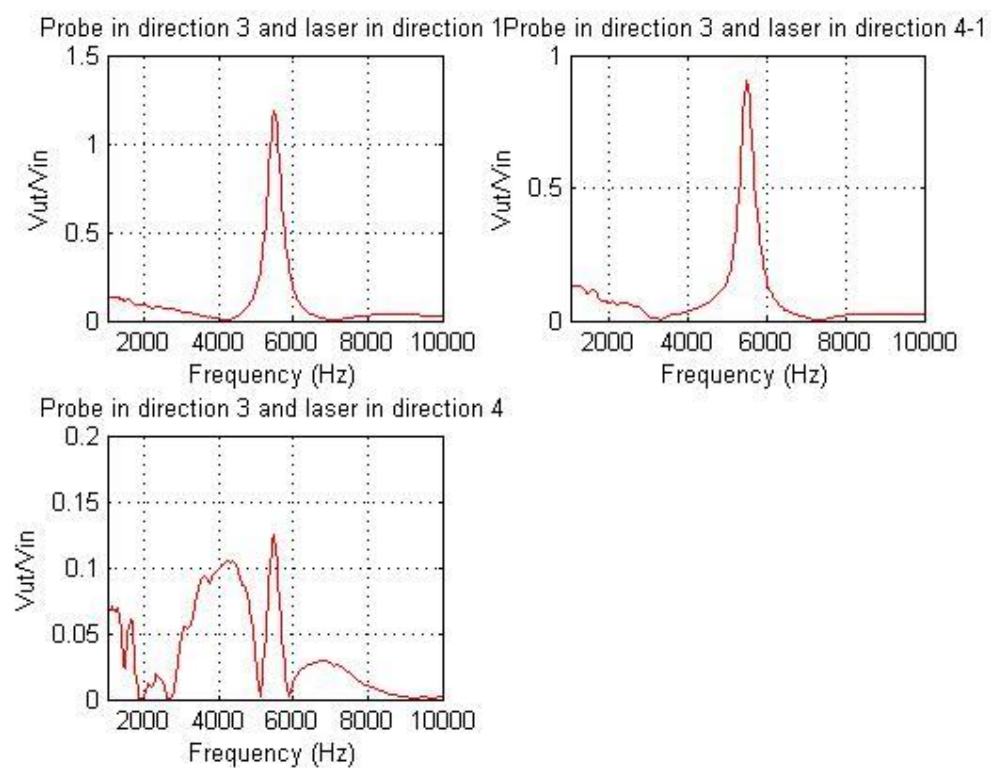
Appendix 3.1: Probe Direction 3, Different Laser Directions

Figure 28. Probe in direction 3 and laser in different directions.

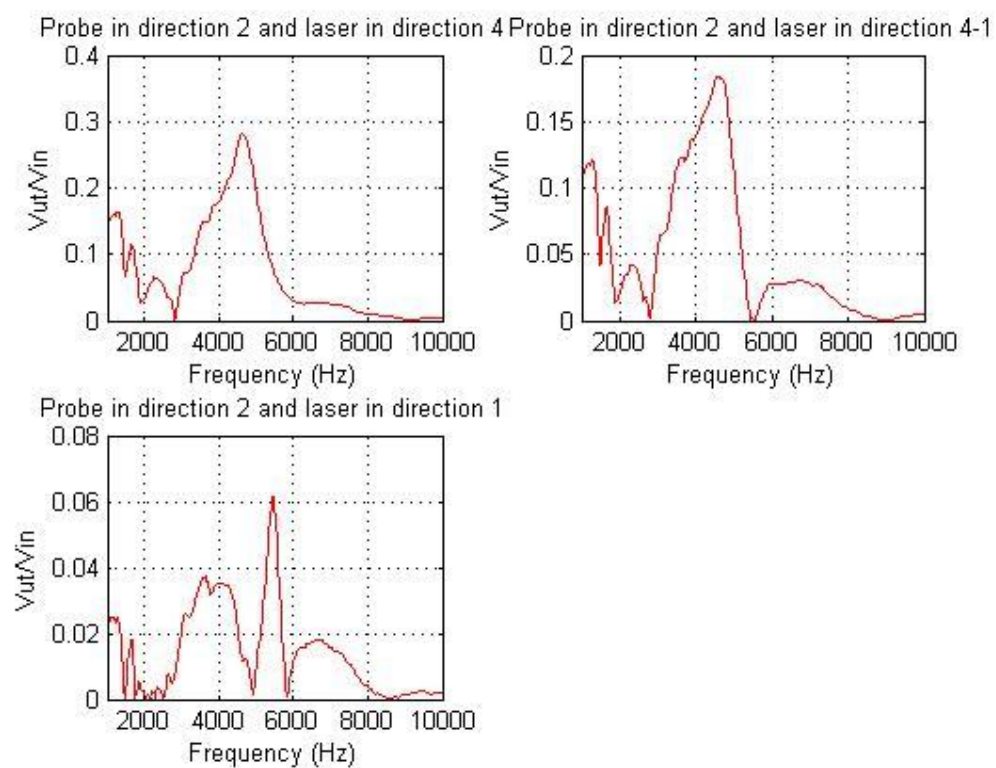
Appendix 3.2: Probe Direction 2, Different Laser Directions

Figure 29. Probe in direction 2 and laser in different directions.

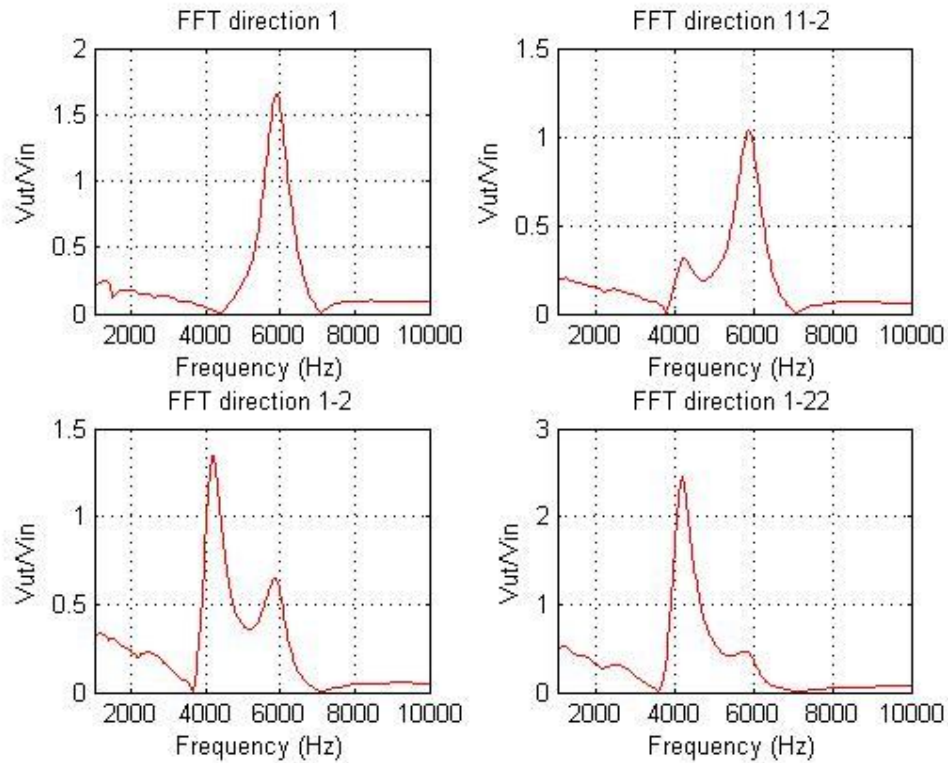
Appendix 4.1: Plastic Jaw, Implant 3, Direction 1 to 1-22

Figure 34. The lowest frequency peak is at 4169Hz and the high peak is at 5855Hz.

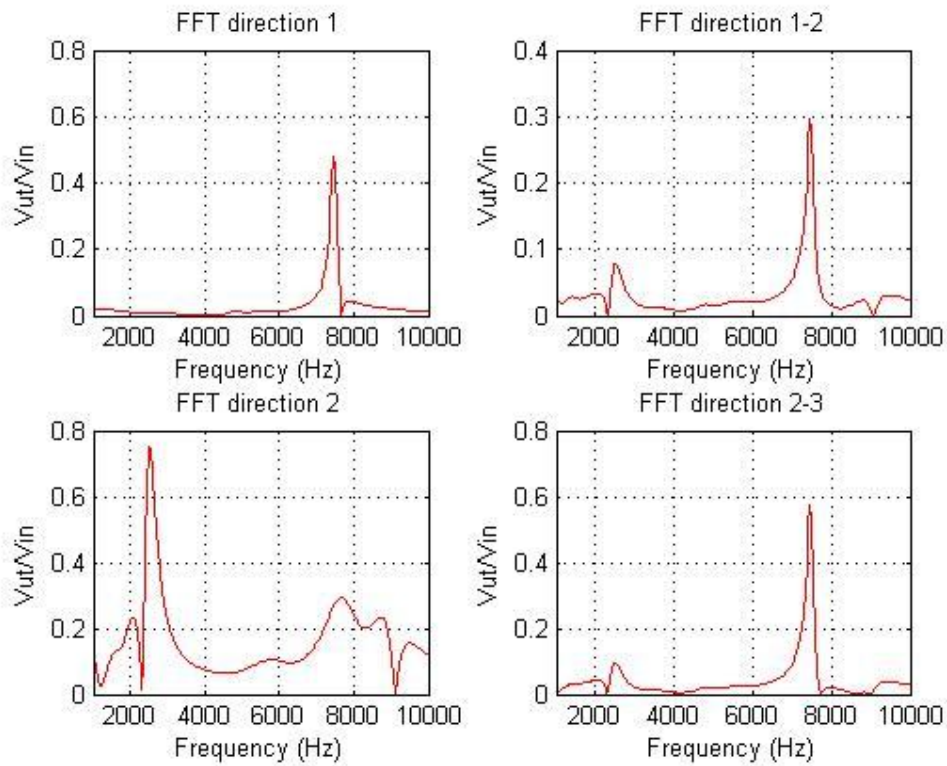
Appendix 6.1: Smartpeg™ Attached into Plastic Cylinder, Implant 1

Figure 52. The lowest frequency peak is at 2512Hz and the high peak is at 7456Hz.

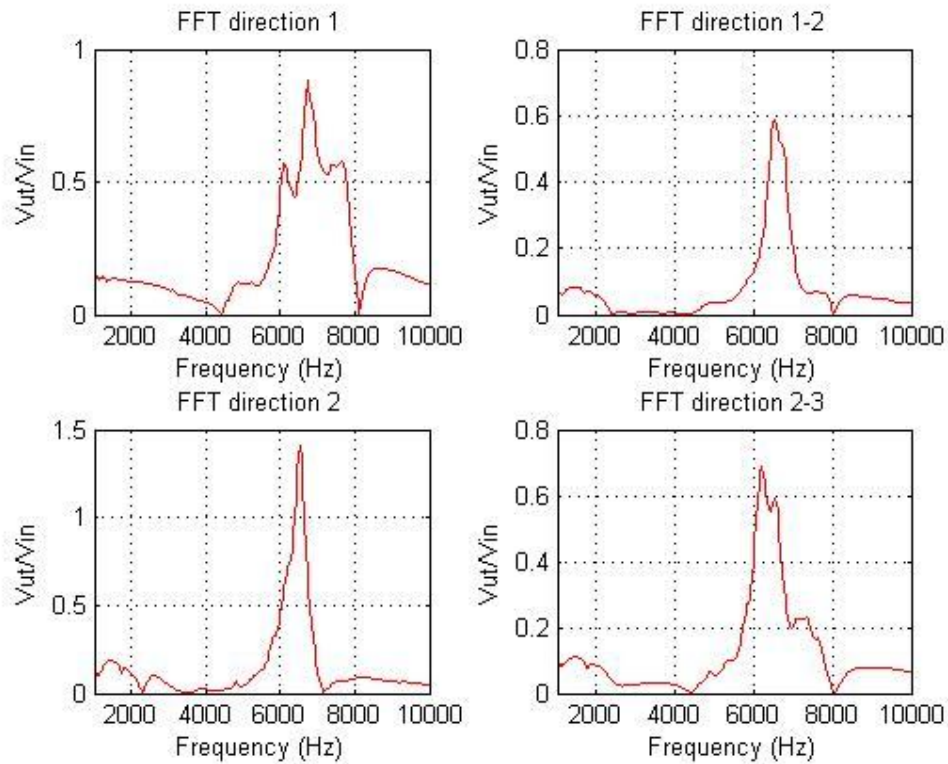
Appendix 6.2: Smartpeg™ Attached into Plastic Cylinder during Pressure, Implant 1

Figure 54. In direction 1 the lowest frequency peak is at 6095Hz, the strongest at 6722Hz and the highest at 7674 Hz. In direction 1-2 and 2 at 6531Hz. In direction 2-3 at 6201 Hz, 6531Hz and at about 7330 Hz.

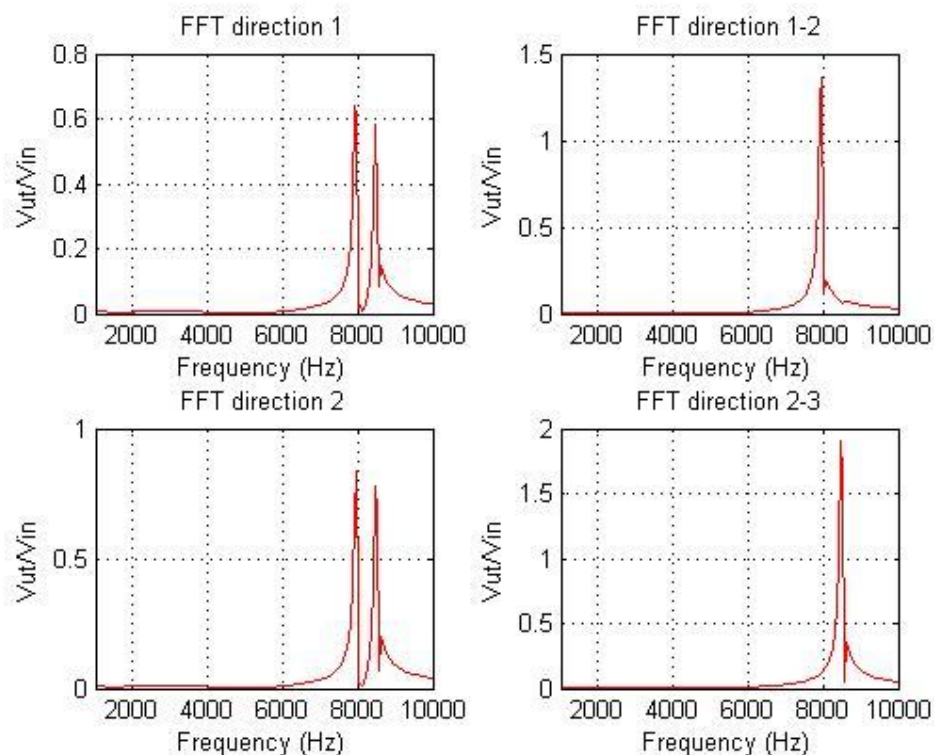
Appendix 8.3: Error made by Metal and Glue, Error 1

Figure 82. The lowest frequency peak is at 7943Hz and the high peak is at 8463Hz.

In the next measurements an error made of thin metal thread was fastened in the way described before. The differences between the resonance frequencies were about 250-500 Hz. The larger difference in 8.3 was due to the fact that the lower frequency response became lower which, in a similar manner as in the case with soft error, is assumed to be owing to that the Smartpeg™ was sloping when the metal error was applied. In 8.4 the difference between the frequency responses was about 250 Hz, which was smaller than in 8.3. This may be a result of wear on the glue or the metal error when the Smartpeg™ was screwed into the implant for a second time. This led to a smaller slope which resembled the normal cases.

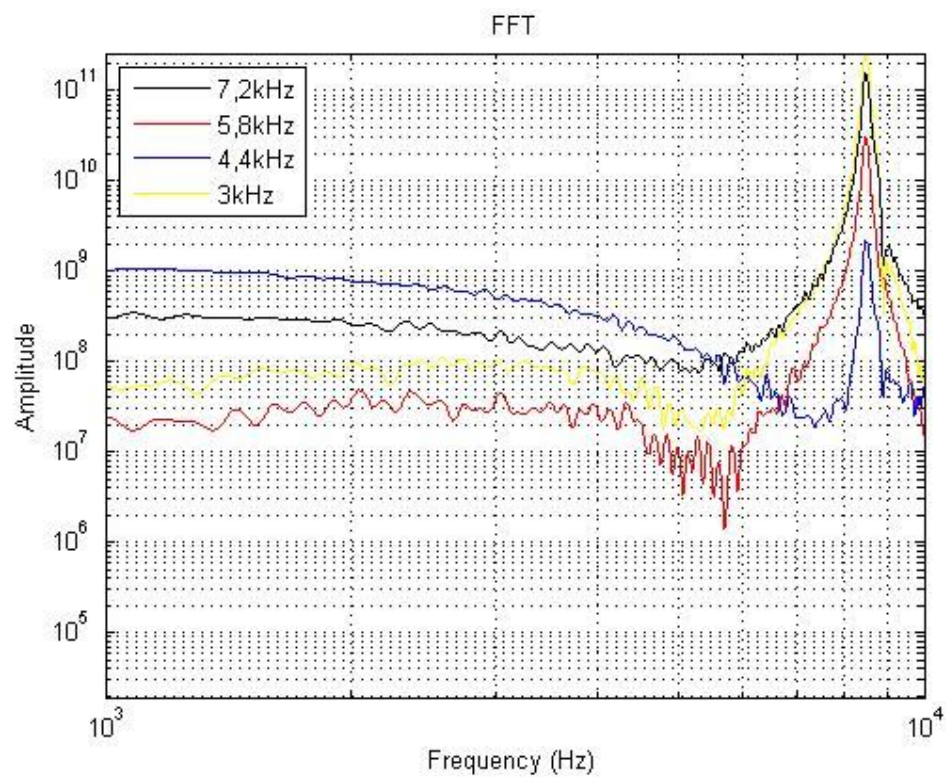
Appendix 11.1: Disturbance: 1 kHz, 3 Volt

Figure 128. Disturbance at 1 kHz.
