# DENSITY CALIBRATION USING X-RAY EQUIPMENT FOR IN-SITU ASSESSMENT OF TIMBER STRUCTURES

Wood density is related to several properties that have a large influence on its quality. In this article, an X-ray image calibration procedure is presented which allows the determination of density properties for in-situ assessment of timber structures. This non-destructive method is useful for evaluation of the internal condition for global assessment of the structure. The density calibration method of X-ray images was verified on a timber beam specimen with good agreement and an average accuracy of 97%. The values obtained from the image calibration presented very good linear correlation coefficients ( $R^2$ ) between the measured density and the greyscale from X-ray images ranging from 0.90-0.98. Besides the opportunity of determining mechanical properties of timber, its main advantage over conventional techniques is the detection and quantification of internal damage, defects, disturbances and deterioration that reduce mechanical properties of the structure. Furthermore, this study indicates a good opportunity for the development of a successful future tool for in-situ assessment of timber

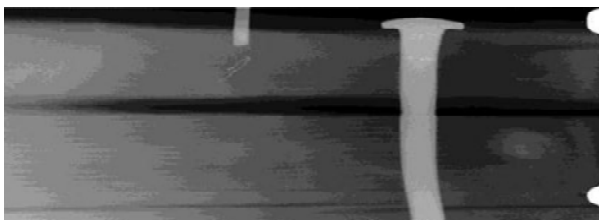
**Figure 2:** Clear deterioration of the metal fastener due to corrosion in the shrinkage crack of the beam [3].

Since corrosion in metal fasteners might cause severe failure, radiographic equipment as a tool can be used to detect corrosion inside the structure which through appropriate action can prevent collapse of the structure [2]. Using commercial image editing programs, distances can be measured quite accurately towards some reference unit and the actual capacity of the fastener can be recalculated. Figure 2 shows a corroded nail as a result of a shrinkage crack in timber. No information on whether the nail is galvanized or not is provided.

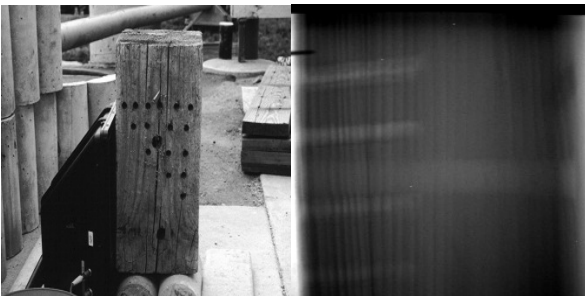
**Figure 4:** Simulated deterioration that caused loss of cross section results in an deviation of the greyscale on the X-ray image [1].

Figure 4 shows a simulated termite attack that makes the determination of a cross section loss possible through image enhancement, whereas on the other hand decay does not leave an abrupt change in wood and makes the detection of gradual transition for cross section loss problematic.

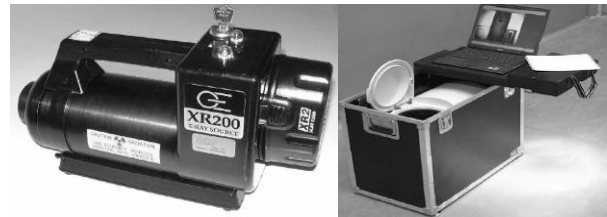
**Figure 7:** X-ray system and X-ray recording process [9] Technical issues related to the X-ray equipment, see [www.elp-gmbh.de](http://www.elp-gmbh.de)

The X-ray-system consists of an X-ray generator, a digital imaging system and a reusable phosphor layered imaging plate that capture the intensity levels from the X-ray exposed objectives, see Figure 7.

The battery-powered portable X-ray source, Inspector XR200<sup>®</sup>, from Golden Engineering Inc. was used for this study. This generator produces pulsed short duration X-rays up to an energy level of 150 kV across the x-ray vacuum tube. The pulses can be set from 1-99. Both the distance to the object and the intensity level steered by the pulses should be adapted to achieve the right exposure level. The X-rays leave the tube in a 40 degree exit angle, which is decisive for the minimum distance to the specific object for maximum utilization of the imaging plate.

The digital image plate system DIMAP<sup>®</sup> from Logos Imaging Inc. was applied to scan the photographic X-ray images. The laser scanner releases the accumulated energy from the image plate and stores the image at selectable resolution on the laptop's imaging software where every single image can be post-processed regarding particular details.

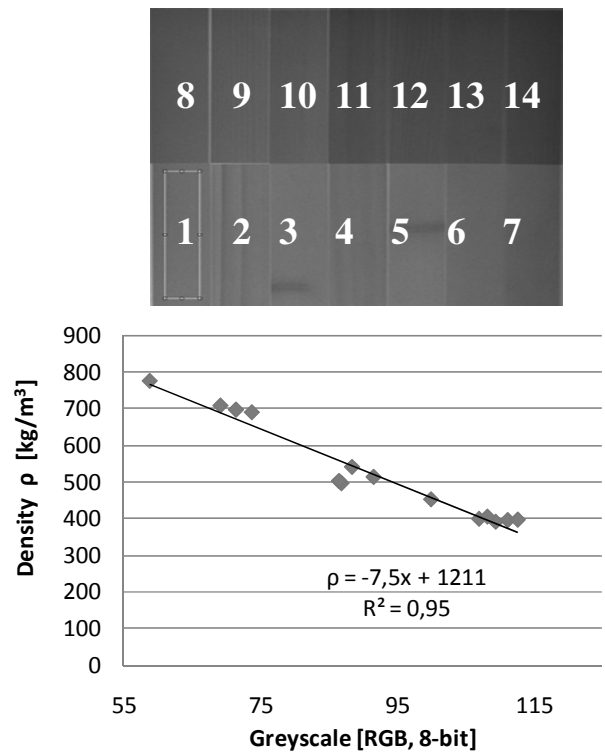
**Figure 12:** Results from Image 2 configuration show the relationship between density and mean greyscale of the marked area.

X-ray images of the different evaluated image configurations and their associated graphic results are presented in Figures 11-15. The result of calibrating / predicting the density using X-ray radiation showed strong relationships between the densities of the test specimens and the greyscale of the recorded X-ray image. The relation up to a certain level provides excellent linear correlation. This is especially valid for soft material as wood/timber up to a level of 1000-1200 kg/m<sup>3</sup>. An extreme test of materials with large differences in density, steel, timber and concrete, resulted in a correlation that is exponential/potential. This test was used to invest the possibilities to carry on with the research, but is not presented here. The correlation values ( $R^2$ ) vary between 0.90-0.98. This variation shows the sensitivity of small differences in density, the influence of radiation energy, the dosage that reach the single object and small deviations in the accuracy of the perpendicular position of the generator towards the object.

The marked areas on the images, see Figures 11-15 show the areas used in the different species for the output of the mean greyscale. The decision on the size of the areas were subjective due to the influence of visible deviations of not evenly distributed shades over the pictures. This is due to several reasons, mentioned in Section 4.2. A mean area distribution spreads the influence of not significant extreme min. and max. values for the evaluation and therefore shows a representative result.

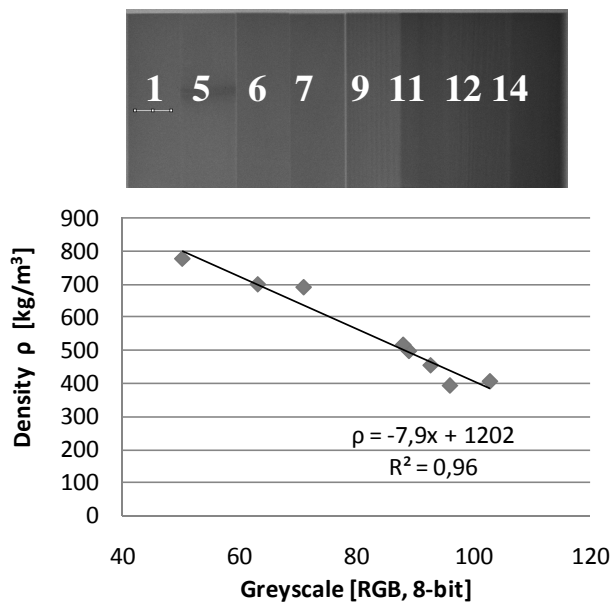
**Figure 15:** Results from Image 5 configuration show the relationship between density and mean greyscale of the marked area.
