THESIS FOR THE DEGREE OF LICENTIATE OF ENGINEERING

Energy Efficiency and Preservation in Our Cultural Heritage: EEPOCH

Department of Architecture

CHALMERS UNIVERSITY OF TECHNOLOGY

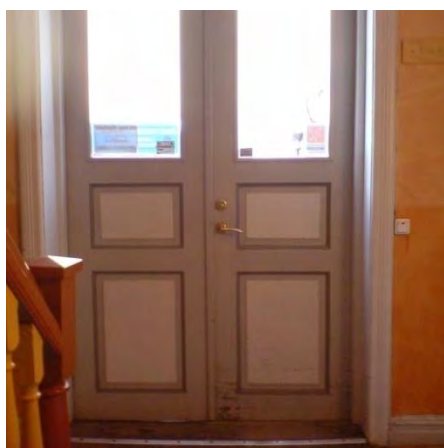
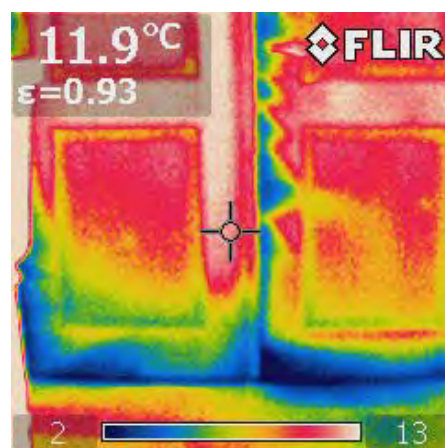
Photo 2a and IR photo 2b. The main entrance door on the east façade is not airtight and the IR photo shows the lack of draught preventers. The temperature outside is 0°C and at the coldest spot +2°C on the inside of the door. Photos Heidi Norrström.

The heating system is supplied by district heating with 95 % renewable energy sources. The distribution system in the buildings is hydronic heating with a radiator system. Average use of water in the last four years is 600m³/year of which an estimated 33 % is heated for hot tap water use. Bought district heating is 186 MWh/year. Hot tap water accounts for 12 MWh/year of this and the calculated heat loss through the ventilation is 47 MWh/year. The key figure for district heating is 176 kWh/m² per year. Calculated total demand is 173 MWh/year and the key figure should be 163 kWh/m² per year. The difference in figures is likely due to infiltration of air into the building envelope. Using an IR camera gave some possible answers.

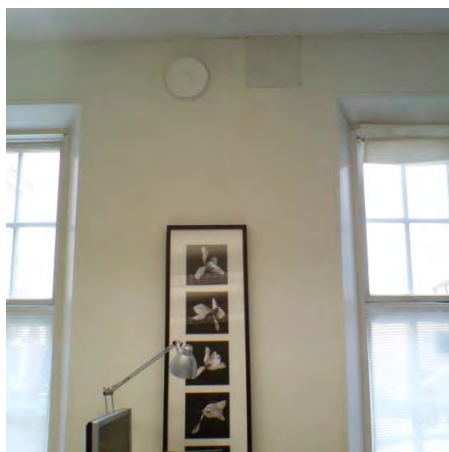
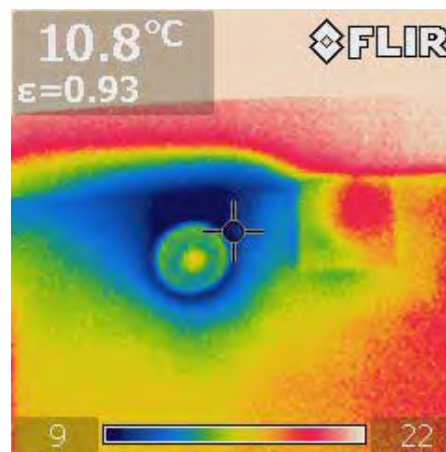
Photo 3a and IR photo 3b. The supply air is distributed by fresh air vents in the external brick walls in Fattighuset. Photos Heidi Norrström.

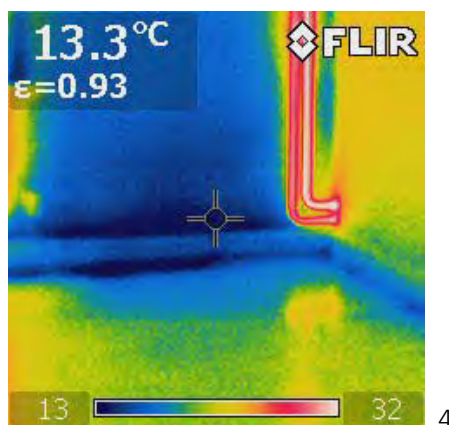
IR photo 4. The thermal bridge where the floor adjoins the wall, at the ground floor, has a low surface temperature giving $f = 0.66$ and indicating that there is a risk for condensation and mould growth in the construction. As seen at the slightly lighter blue shade on the moulding mounted where the floor and the wall meet, it is trying to mitigate the impact of the thermal bridge as it should do.

than the 0.7 that is stated as the lower limit. On the ground floor in a room facing west, the following temperatures give $f = (13 - 0) / (19.5 - 0) = 0.66$. This value is also lower than 0.7. The interior wall temperatures measured by two of the air vents on the east walls were $+8^{\circ}\text{C}$ and $+9^{\circ}\text{C}$ which indicates that there is a risk. $f = (9 - 0) / (22.2 - 0) = 0.4$ and $f = (8 - 0) / (17.1 - 0) = 0.46$ which both are below 0.7. The outcome of adding a thin layer of lime plaster or nanogel/aerogel or vacuum insulation could be calculated with regard to the outer walls' ability to handle heat transmission and moisture.

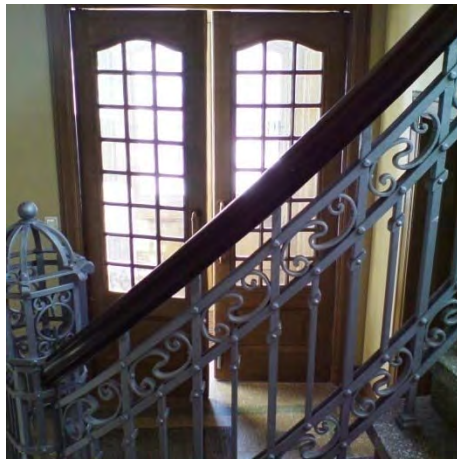
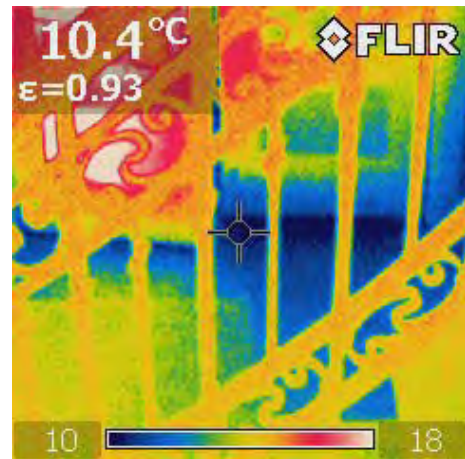
Photo 6a and IR photo 6b. There is a constant draught from the main entrance doors at Teatern which has to be taken care of. Photo Heidi Norrström.

The entrance doors are not airtight and measures have to be taken to ease the cold draught. There is an internal wind catcher with extra doors to open and a radiator is placed inside the outer doors. The doors could be adjusted and draught preventers mounted. The temperature between the outer and inner doors was +9.4°C and on the inside of the building it was +10.4°C. Outside temperature was +0.6°C.

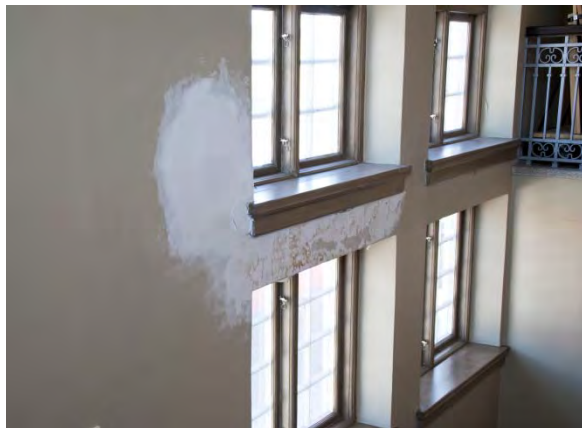
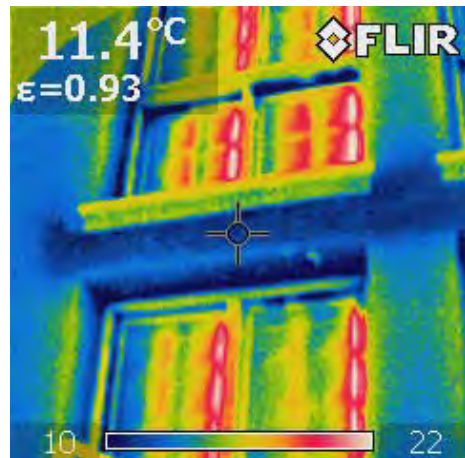
Photo 7a and IR photo 7b. Severe damage has appeared on the first floor and the low surface temperatures is giving $f = 0.71$ just above the limit of risk for condensation and mould growth in the construction. Photo to the left by Maja Lindman and photo to the right by Heidi Norrström.

The signs of moisture problems on the interior walls are not good. They appear on the west wall and the north and also in the ceiling up on the balcony in the theatre. Using equation no.3 for checking the risk of condensation at the dew point and mould growth inside a construction shows that there are no risks on the south façade but on the ground floor to the west the temperatures in °C were $\Theta_{si} = +15.5^{\circ}\text{C}$, $\Theta_e = 0.6^{\circ}\text{C}$ and $\Theta_i = +22.0$ giving $f = (15.5 - 0.6) / (22.0 - 0.6) = 0.69$ which is slightly lower than the 0.7 that is stated as the lower limit. In the theatre foyer on the first floor, west wall, the temperatures in °C were $\Theta_{si} = +11.1^{\circ}\text{C}$, $\Theta_e = 0.6^{\circ}\text{C}$ and $\Theta_i = +15.7$ giving $f = (11.1 - 0.6) / (15.7 - 0.6) = 0.69$ which also is slightly lower than the 0.7 that is stated as the lower limit.

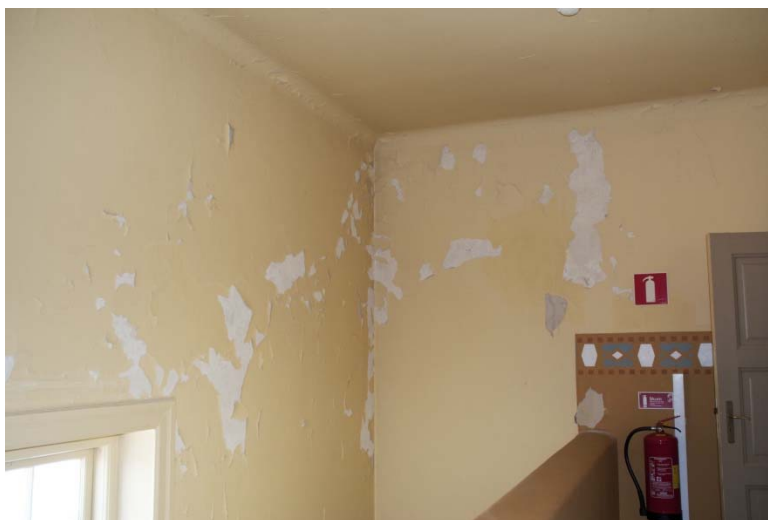
8

Photo 8. The paint is flaking off in one of the staircases on the north side of Teatern.

The temperatures at the walls and in the back stairwell, north façade, are very low. The f values are 0.2 and 0.45 at two measured spots of thermal bridging. Between two of the windows placed above each other on the west wall is a severely damaged area which they have tried in vain to mend. The f value is calculated to $f = (11.4 - 0.6) / (15.7 - 0.6) = 0.71$ and this is just above the limit. One reason could be precipitation drawn into the structure from the outside causing moisture damage. Since it appears in only one place, below one of the windows, it is possible that the window construction

itself is part of the cause. A slight discolouration is also visible on the interior surface as if a steel or iron reinforcement has rusted inside the wall. Another reason or cause could be moisture emanating from the inside.

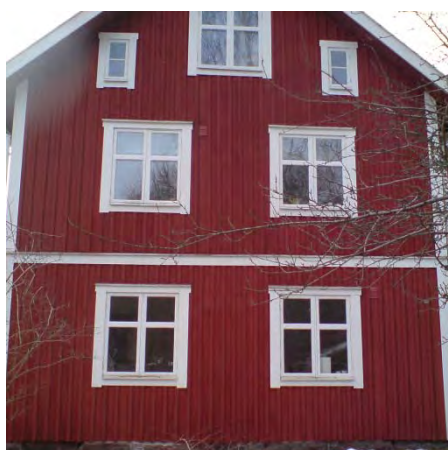
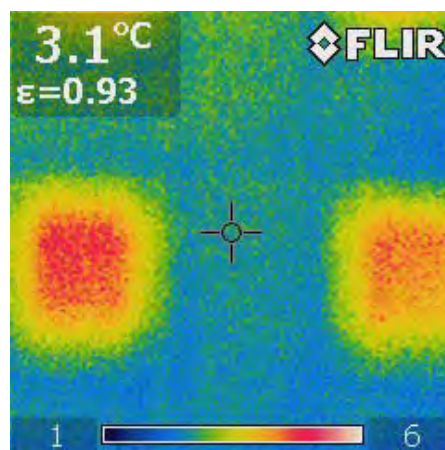
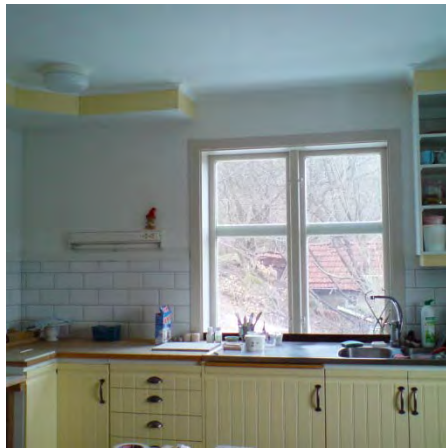
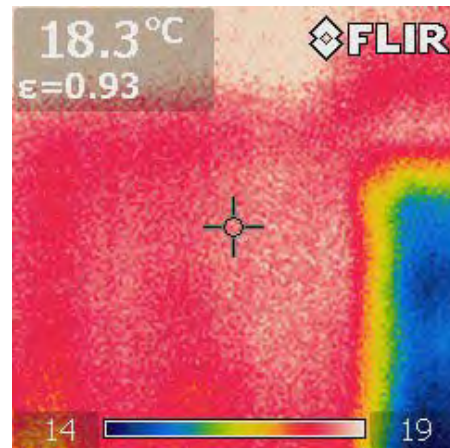
Photo 10a and IR photo 10b shows the exterior, photo 11a and IR photo 11b shows the interior. All four photos are taken on the ground floor. The northeast façade of Tyreshill show favourable, but energy consuming, conditions in the building's structure. Photo Heidi Norrström.

In this object the IR camera gave a positive view of the state of the façades. Up to the left is the northeast façade and the picture to the right shows the surface temperature on the wall between the two windows on the ground floor. Down to the left is the same spot seen from the interior side and the picture to the right shows the interior surface temperature. The indoor air temperature on the ground floor was +18.4 and the outdoor temperature was +2.3°C. The construction seems to be dry and healthy but too energy consuming.

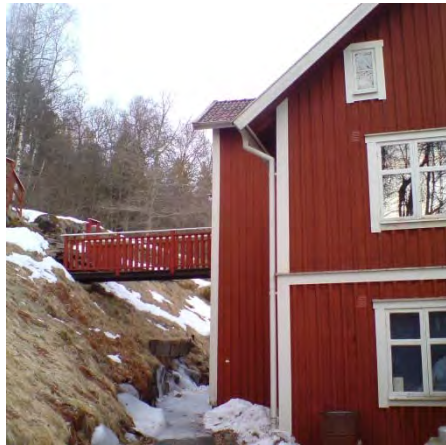
12

Photo 12. To the left in this picture the ice forming on the ground is shown. The hillside is leaking water which freezes in winter. Above the ice is a bridge leading to the garden at an upper level in the terrain. Photo Heidi Norrström.

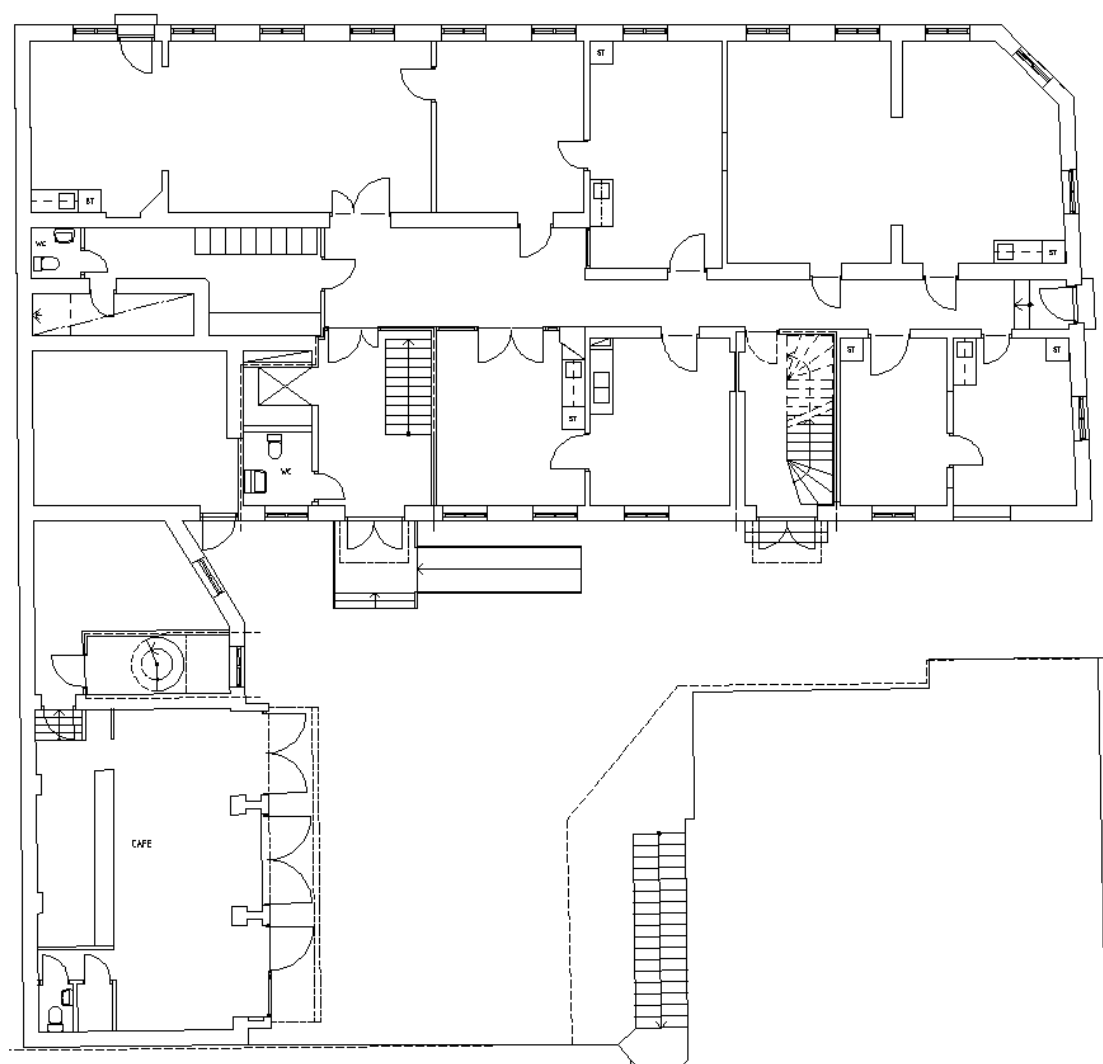
Drawing 13. Plan, ground floor, Fattighuset. Drawing from Industristaden AB. Scale 1:250.

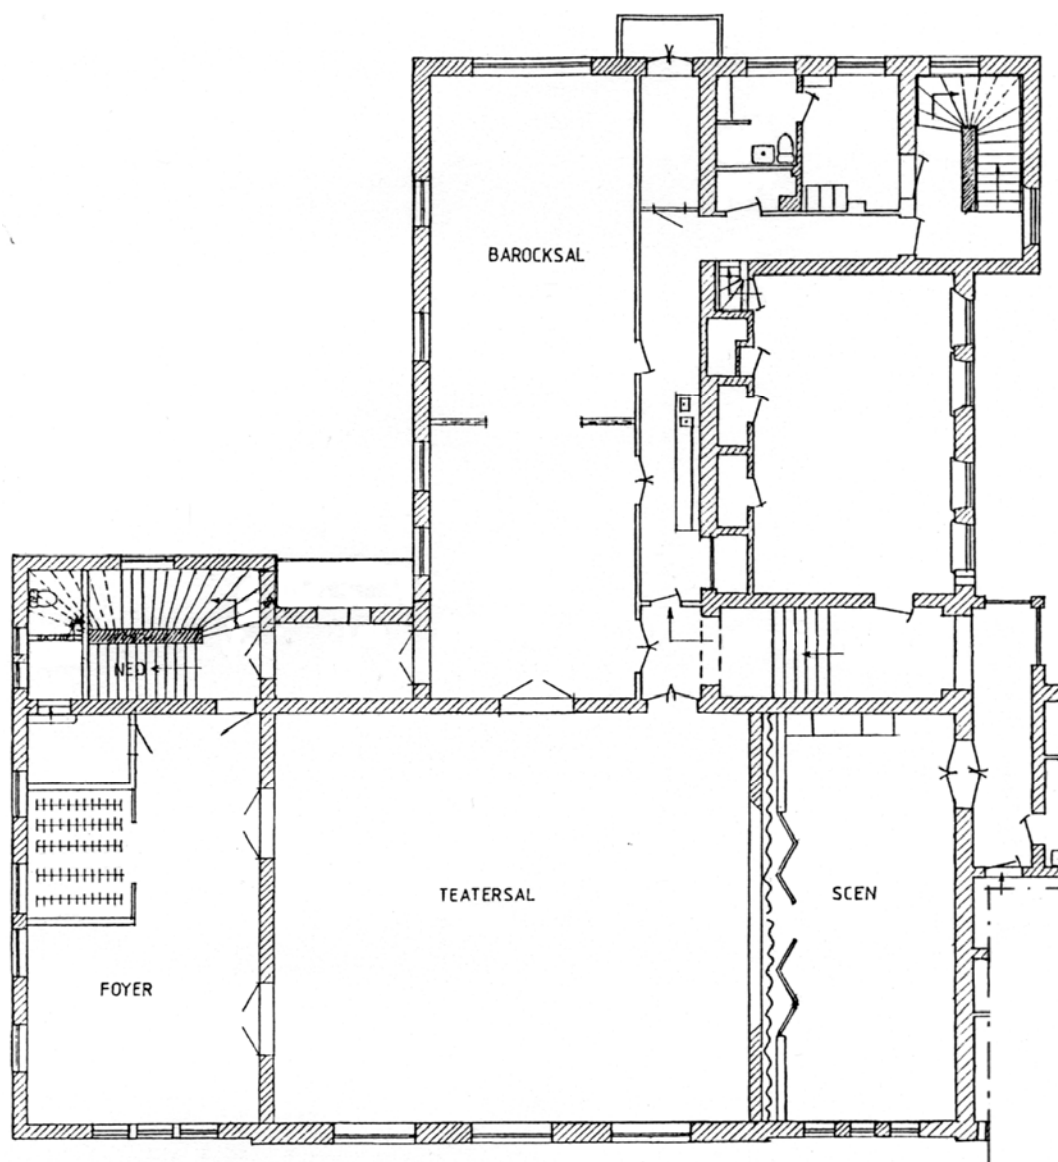
Drawing 14. Plan, first floor. Drawing made by the municipality of Laholm before the restoration. Scale 1:250.

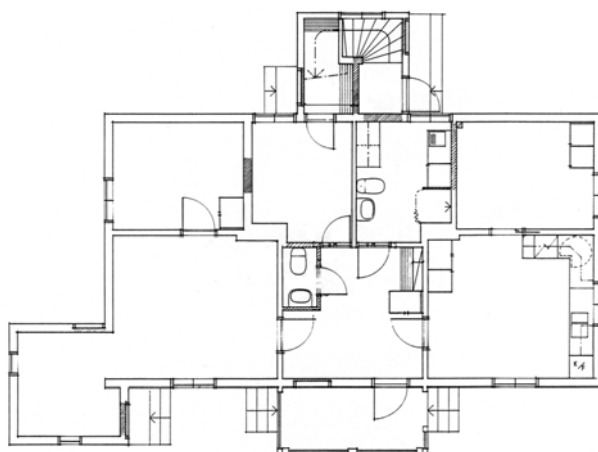
Drawing 15. Plan, ground floor, Tyreshill. Drawing made by architect Håkan Larne. Scale 1:250.

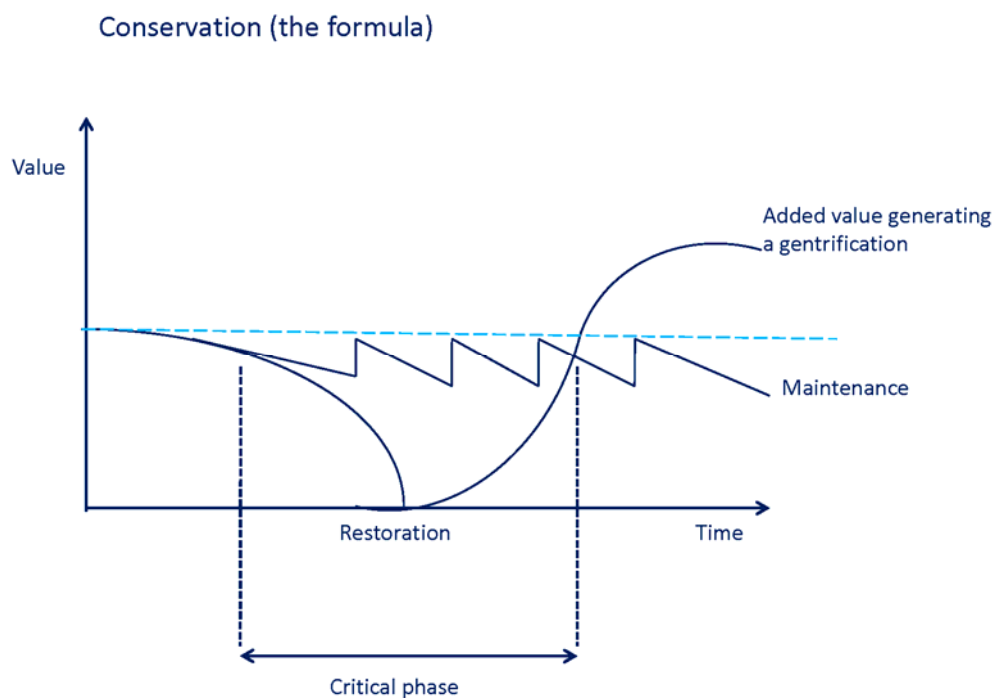
Figure 7 is an attempt to reproduce a diagram showing the critical phase in conservation, and the two different approaches to action. The lighter blue dashed line is the object's original nominal value.

Conservation works with respect for the original, with a minimum of intervention and with use of original material. All actions must be reversible and 're-treatable', i.e. they must ensure that it is possible to re-treat the object to its former, original state and original appearance. For this, thorough documentation is needed before, during and after actions. This is also a prerequisite for preventive work with continuous maintenance as opposed to long-term decay followed by restoration. Rosvall showed a diagram on the critical phase of conservation, which has been recreated below.
