Retrofitting of old Exterior Wall with Vacuum Insulation Panels

Measurements of Thermal Properties, Moisture Performance and Practical Considerations

Thesis for the Degree of Licentiate of Engineering

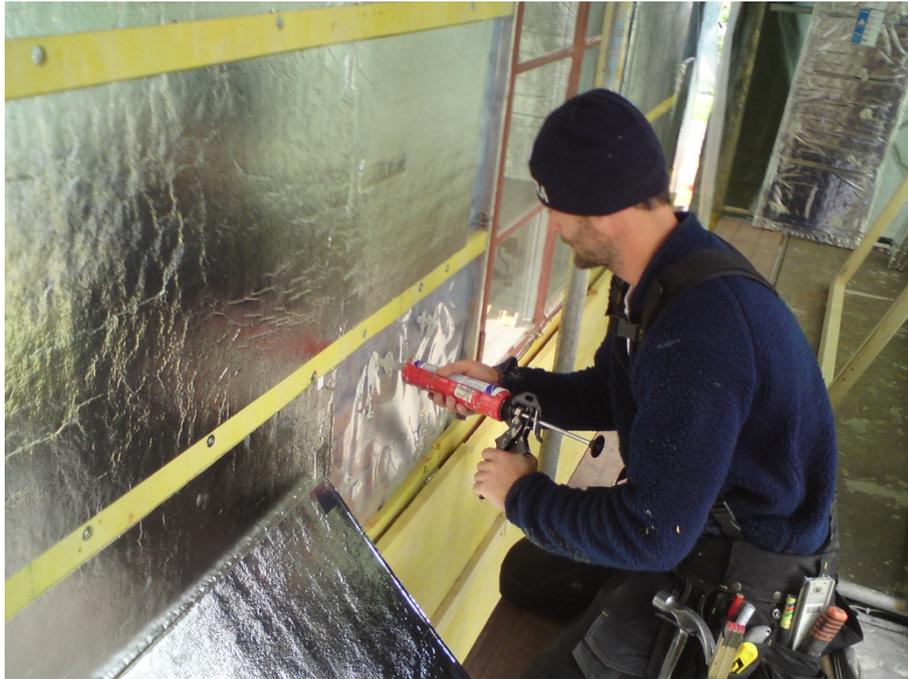
Cover:

A vacuum insulation panel (VIP) is mounted on the exterior wall of an old protected multi-family building from the 1930s in Gothenburg. Strips of mineral wool are placed between the VIP to allow attachment of the exterior wooden cover boarding (Photo: Pär Johansson).

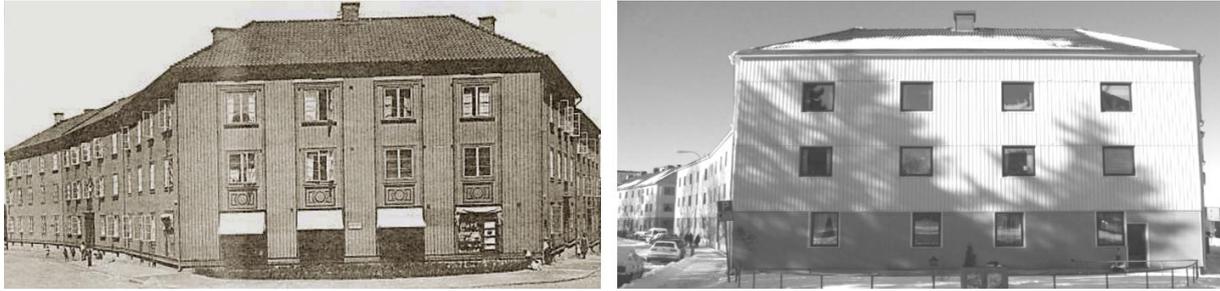
Figure 1.2. Original façade of a county governor's house in 1930 (left) and in 2005 (right). The wall was retrofitted in the 1970s by adding 95 mm mineral wool and a corrugated steel sheet façade on the exterior of the wall (Photo from Sören Nilsson's collection of postcards; Melica, 2006).

Peterson *et al.* (1982) studied three different solutions for adding insulation to the exterior walls of the building. Both solutions with exterior and interior insulation were considered but were too expensive, changed the aesthetics of the building or reduced the room areas to much to be possible in this building. A solution used in buildings that were retrofitted by adding insulation to the exterior walls was to remove the existing wooden cover boarding and replace it with 95 mm mineral wool covered by a corrugated steel sheet façade, see Figure 1.2.

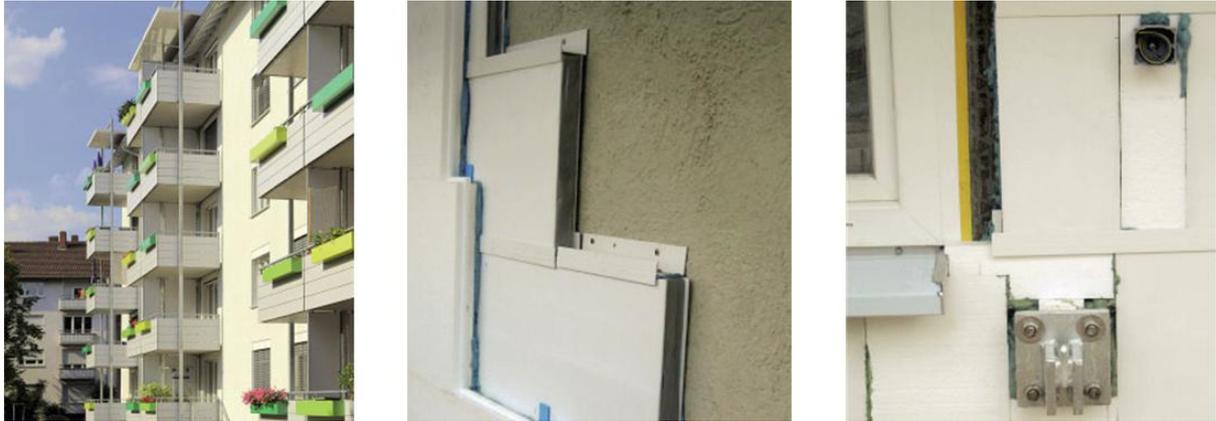
Figure 2.3. VIP used in the retrofitting of a multi-family building in Germany. The 40 mm thick VIP is attached to the façade in a rail system and covered on the exterior by 50 mm EPS. The design of the wall has aimed to maximize the surface covered by VIP (Photo: Schöck Balkonsysteme GmbH, Brillux GmbH & Co. KG).

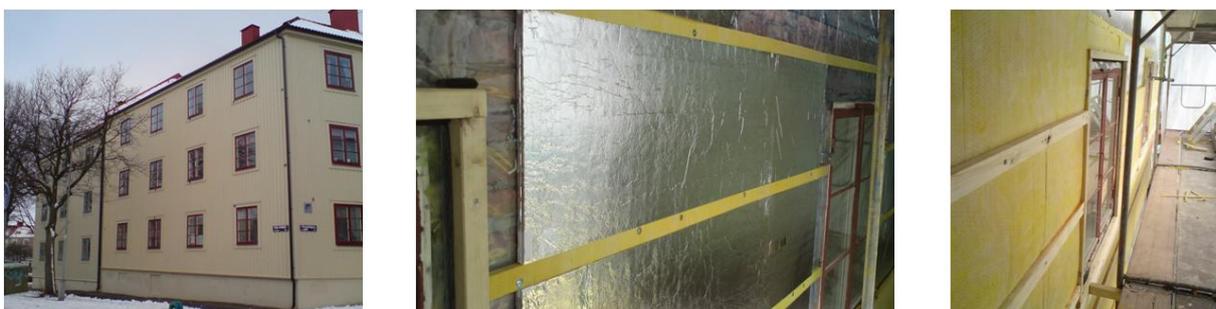
Figure 2.4. The multi-family building in Gothenburg was retrofitted with VIP. Mineral wool covered the VIP and was used at places where VIP could not be used (Photo: Pär Johansson).

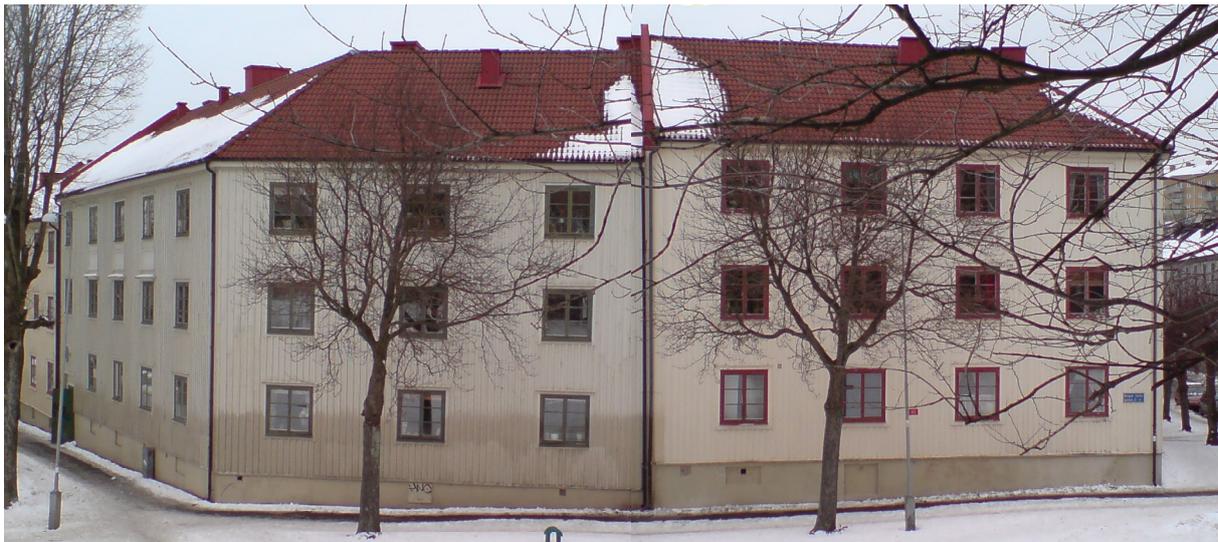
Figure 4.1. The three story county governor's house from 1930 chosen for the field study. The right part was retrofitted with vacuum insulation panels while the left part of the façade was left untouched as a reference case (Photo from Paper I).

The building chosen for the field study is a county governor's house (landshövdingehus) from 1930, see Figure 4.1. This is a typical historical building for the city of Gothenburg on the Swedish west coast. Most of them were constructed during 1876-1936 following an approval by the county administrative board to build two wooden floors on top of a brick or stone masonry ground floor in order to circumvent the fire regulations that limited the height of wooden buildings to two floors. At that time Gothenburg experienced severe lack of housing due to the massive migration of people from the rural areas surrounding the city. During the period 1880-1940 the population of Gothenburg more than tripled from around 100 000 to 300 000 inhabitants, creating a high demand on affordable housing. Today there are approximately 1 400 buildings left of this type around the city. However, the original stock was larger but due to the very low technical standards of the apartments in the buildings many of them were demolished in the 1960s and 1970s (Larsson, 1973).

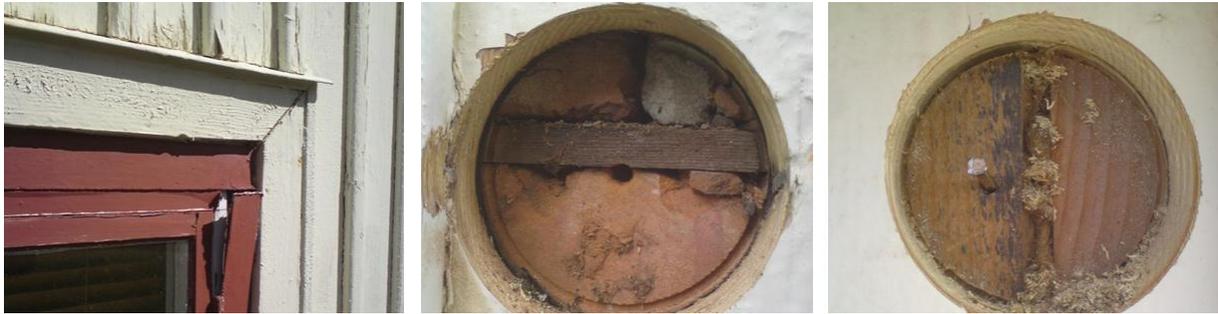
Figure 4.2. At a visit to the buildings, holes were drilled through the wooden cover boarding to investigate the condition of the materials behind. The worst places were around windows (left) and in the wooden laths found in the grout between the bricks (middle). The wooden planks had flax between the planks (right) to increase the air tightness of the wall (Photo: Pär Johansson).

was around 8% a few cm into the construction. In the brick grout, wooden laths were found which had a moisture quotient of 12% at the surface and 9.5% further in. The critical moisture quotient for mold growth on a wooden surface is around 20%. Figure 4.2 shows the condition of one of the window frames and the materials behind the wooden cover boarding.
