Coronelli, D. ; Zandi Hanjari, K. ; Lundgren, K. (2013) "Severely Corroded RC with Cover Cracking". Journal of Structural Engineering-Asce, vol. 139(2), pp. 221-232.

SEVERELY CORRODED REINFORCED CONCRETE WITH COVER CRACKING

Dario Coronelli ¹, Kamyab Zandi Hanjari ², Karin Lundgren ³

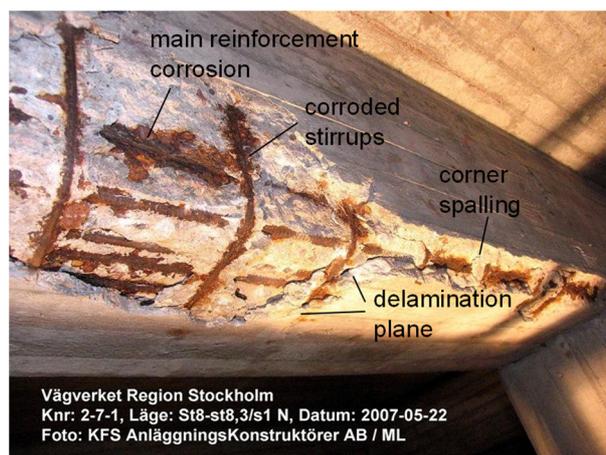
Fig.1 Delamination and corrosion of main bars and stirrups (photograph courtesy of Magnus Lindqvist)

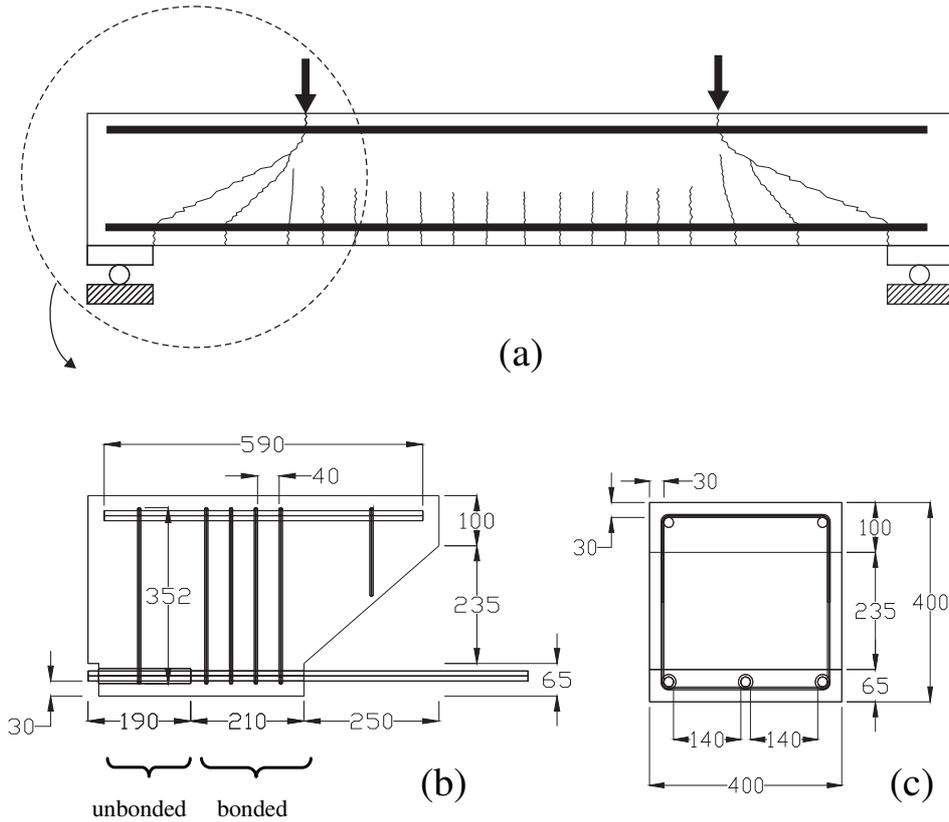
The specimens had the shape of a beam end after inclined shear cracking (Fig.2a). The concrete specimens (Fig.2b) were reinforced with longitudinal bars with 20 mm diameter and stirrups with 8 mm diameter. The main bars were in contact with the concrete over a length of 210 mm. A concrete cover of 30 mm to the main bar was used. The concrete was an ordinary type with an average cubic strength of 37.5 MPa without chlorides for the control specimens and 34.3 MPa with 3% chlorides in the mix of the specimens with corrosion.

Fig.2 Test specimens: (a) schematic illustration of a beam end; (b-c) geometry and reinforcement for specimens types B and C; in type A the stirrups in the bonded length were removed. All dimensions are in mm.

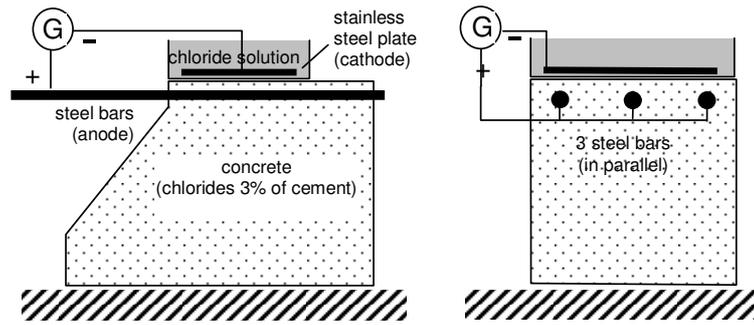
The specimens were corroded with an electrochemical method, using impressed current (Fig.3). The current flowed through the main bars across the concrete cover to a cathode placed at the top of the beam, inside a tank containing a solution of 3% chlorides.

Fig.3 Accelerated corrosion set-up.

The stirrups in Type B specimens were isolated using tape, to avoid corrosion. The stirrups in Type C were not isolated; thus they were in contact with the main bars. In these specimens, 45% of the surface through which the current flowed was made up of the stirrups and 55% of the main bars; these values were used to calculate the current that circulated in each type of reinforcement, and the corrosion level, as will be described in the following.

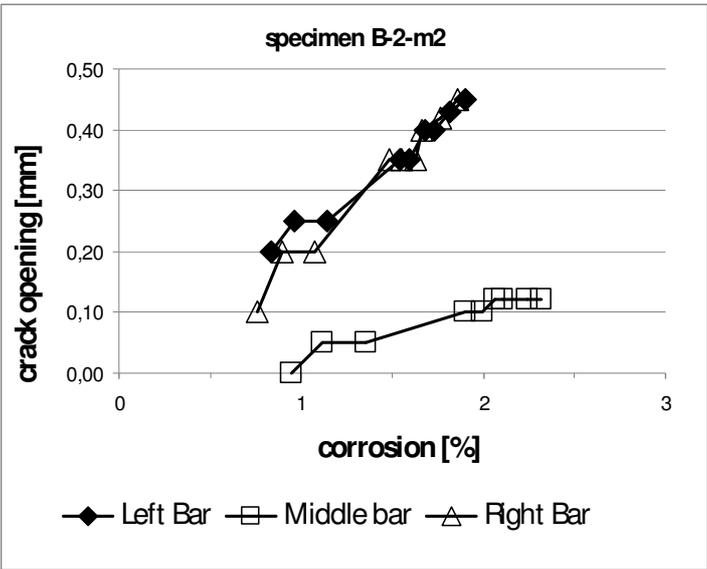
Between corrosion initiation and Level 1, all specimens showed longitudinal cracks along the main bars. The corrosion level at first cracking was about 30-50 microns average penetration (0.6-1.0% weight loss), with little difference in the three types of specimens. The first cracks opened on the top cover; here, measurements were made at intervals at all corrosion levels. The corrosion level at each measurement time was calculated from the circulated current, obtaining diagrams such as those shown in Fig.4.

Fig.4 Level 1, top cover crack width measurements.

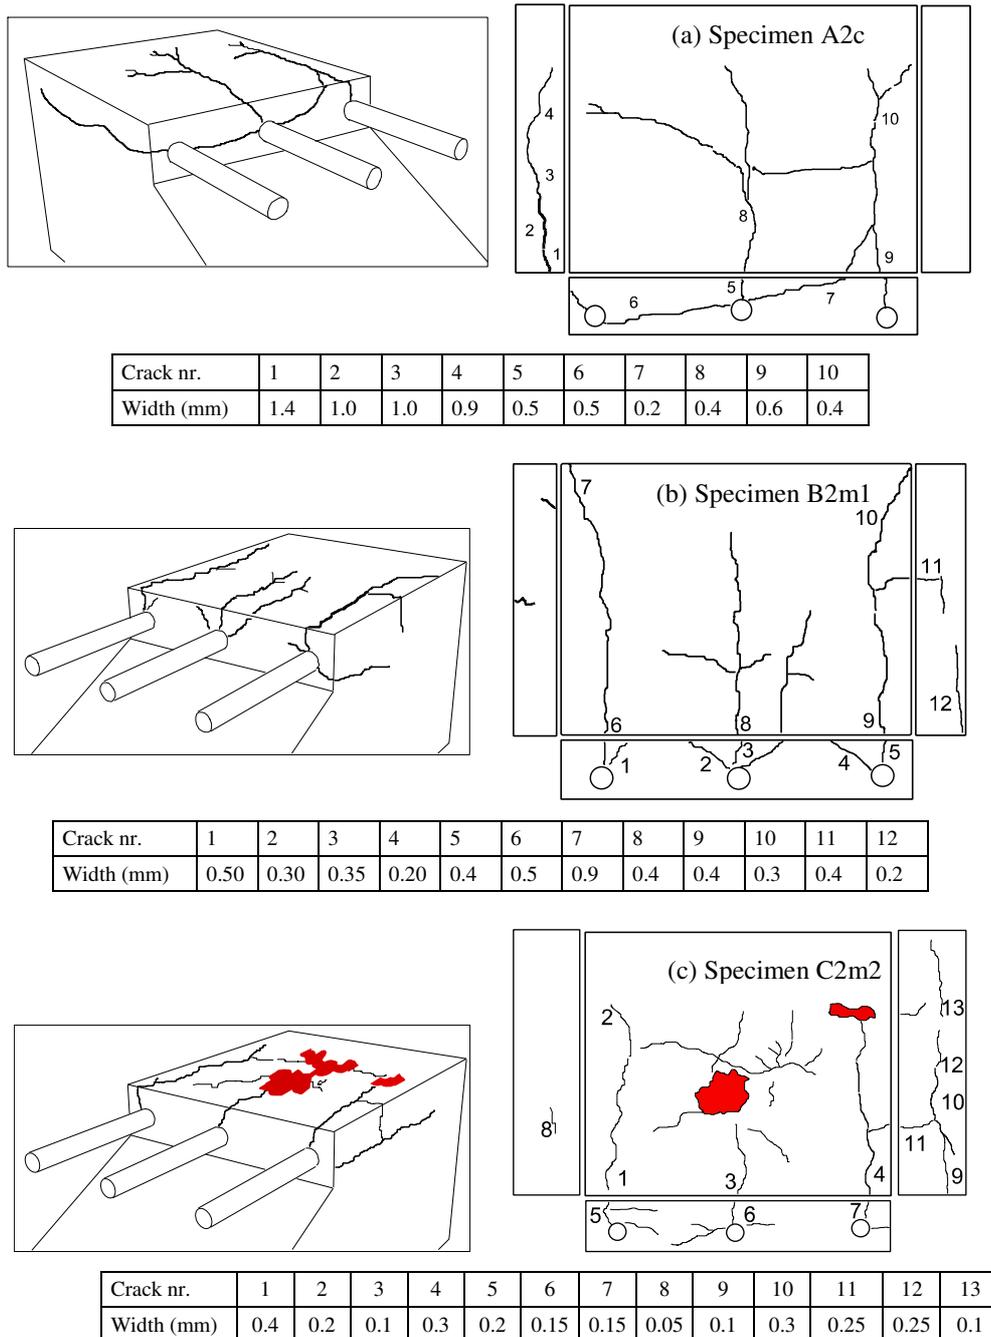
Moving from Level 1 to Level 2, parts of the cracks visible on the front of some of the specimens joined to form delamination cracks connecting two or three main bars (Fig.5). The measurements of the top cover cracks with a microscope were suspended because the accumulation of corrosion products made these observations inaccurate. Typical crack patterns are depicted for one specimen of each type in Fig.5, together with the corresponding crack widths in the tables.

Fig.5 Level 2 crack patterns and widths.

Specimens without stirrups (Type A): the cracks run mainly along the longitudinal reinforcement. These specimens showed fewer and wider cracks than those with stirrups. In one specimen (A2c) a delamination plane formed, with a maximum crack width of 1.4mm (Fig.5-a).

Specimens with noncorroded stirrups (Type B): longitudinal cracks opened in the top and side covers (Fig.5b). The crack pattern on the front cover had different features according to the specimen: either cracks radiating from the main bars to the closest point of the outer surface;

cracks lying in a horizontal plane; cracks in inclined planes forming a V-shaped pattern. Longitudinal and transverse cracks formed on the side covers.

Specimens with corroded stirrups (Type C): the presence of corroding stirrups caused a more complex crack pattern than for the other types of specimens. Type C specimens showed different types of cracking and damage in addition to the longitudinal cracks, opened at level 1 (Fig.5c):

- A top cover cracking with many small cracks opened, both longitudinally and in other directions;
- Initiation of delamination cracks, forming a plane connecting the bars; these could be observed on the front and on the side covers, in a plane parallel to the main reinforcement;
- Side cover cracks in transverse directions, with respect to the bar axis;
- Corrosion products in big stains on the outer surface of the top cover.

The cracks over the corroding stirrups on the top cover were very small. The maximum width for this last type of cracks shown in Figs.5c and 6b-c was around 0,1mm. The cracks were visible up to level 2; rust accumulation at level 3 made the visual observation of these thin cracks difficult.

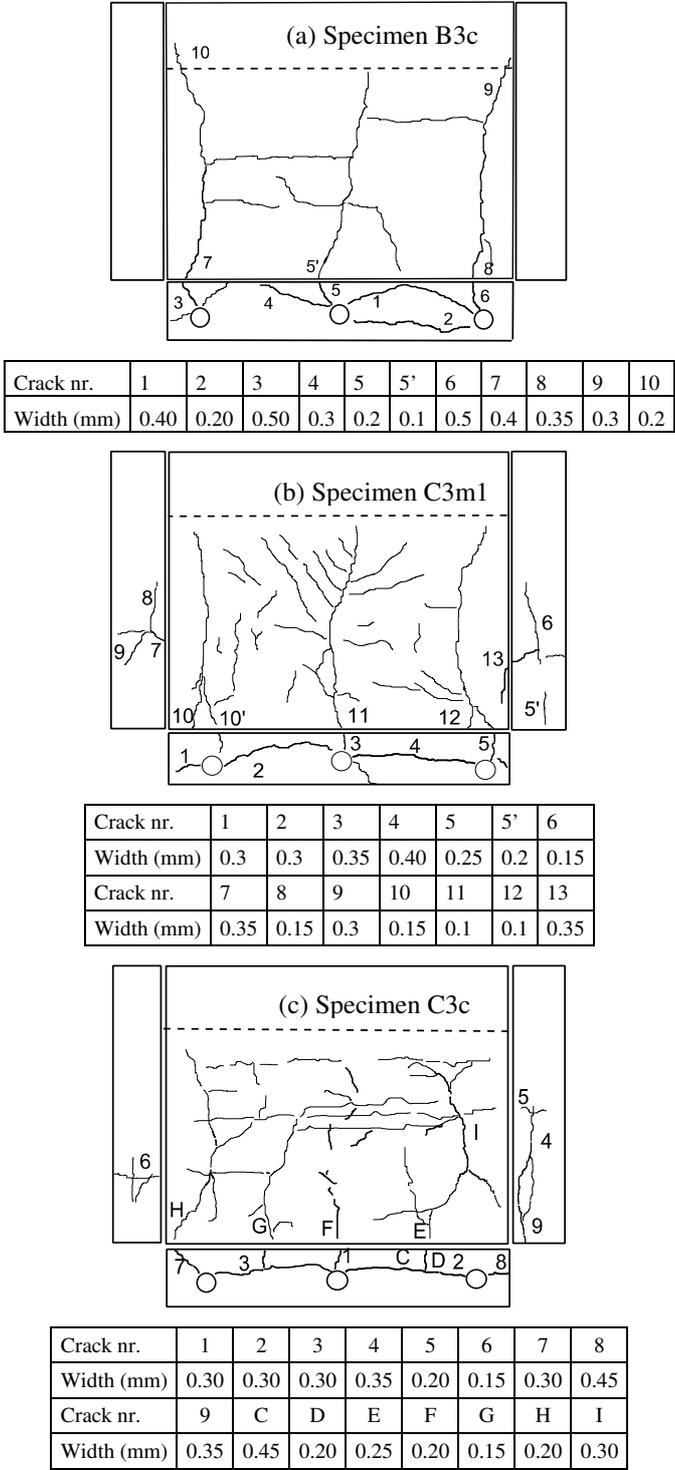
Crack patterns and maximum crack width values are shown in Fig.6 for three of the four specimens reaching level 3; specimen B3m2 (not shown in Fig.6) had cracks very similar to B3C. No specimen of Type A without stirrups was corroded up to this level.

The typical crack pattern is shown in Figure 6a for Type B specimens, with two curved splitting cracks, at an opposite curvature, connecting the middle and one of the corner bars. Similar cracks are known to occur in the double notch edge fracture test (Grassl and Rempling, 2006) where normal and shearing stresses act together, producing curved crack patterns.

Fig.6 Level 3 crack patterns and widths.

For Type C specimens, the cracks initiated at Level 2 developed into delamination cracks, visible on the outer surface both on the front of the specimen and on the lateral covers. The examination of the corrosion cracks breaking up specimen C3c with corroded stirrups after the load tests (Fig.7) highlights the presence of a delamination plane, running across the corroding stirrups and isolating the portion of concrete covering the stirrups. Fig.7 shows that these cracks connected with those originating from the main reinforcement, with a lot of rust accumulation highlighted by the rust stains and the oxides penetrating into the pores of the concrete.

1. In the absence of stirrups (Type A, Figure 10a), the corrosion cracks around the corner bars propagate through the side and top covers, and a corner cover spalling takes place. This was also observed in the tests specimen A2m, while a delamination plane formed in A2c (Fig.5a).
2. In the Type B specimens (non-corroding stirrups, Figure 10b), the cracks initiated from the corner and middle bars formed a delamination plane. As already mentioned, the curved cracks correspond to those observed in double edge notched specimens (Grassl and Rempling, 2006). This was also observed in both tests specimens B3c (Figure 6a) and B3m2.

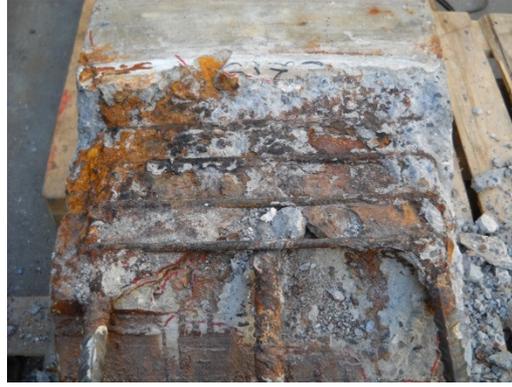
Fig.7 Delamination plane formed by corrosion cracks running across stirrups, specimen C3c: cover removed after the bond test on the specimen.

3. A different pattern was obtained when both longitudinal and transverse bars were corroded (specimens of Type C, Figure 10c). Cracks appeared transversely to the main bars, due to corroding stirrups before any of the former patterns occurred. Thus a more local cover crack pattern, mainly damage of the concrete between the stirrups, formed. The longitudinal cracks were also simulated, but with a smaller width than in the Types A and B. In addition, in the model a wide delamination crack runs between the central and corner bars, close to the level of the stirrups, without reaching the external surface of the specimen (Fig.11). This corresponds to the test results (Fig.7).

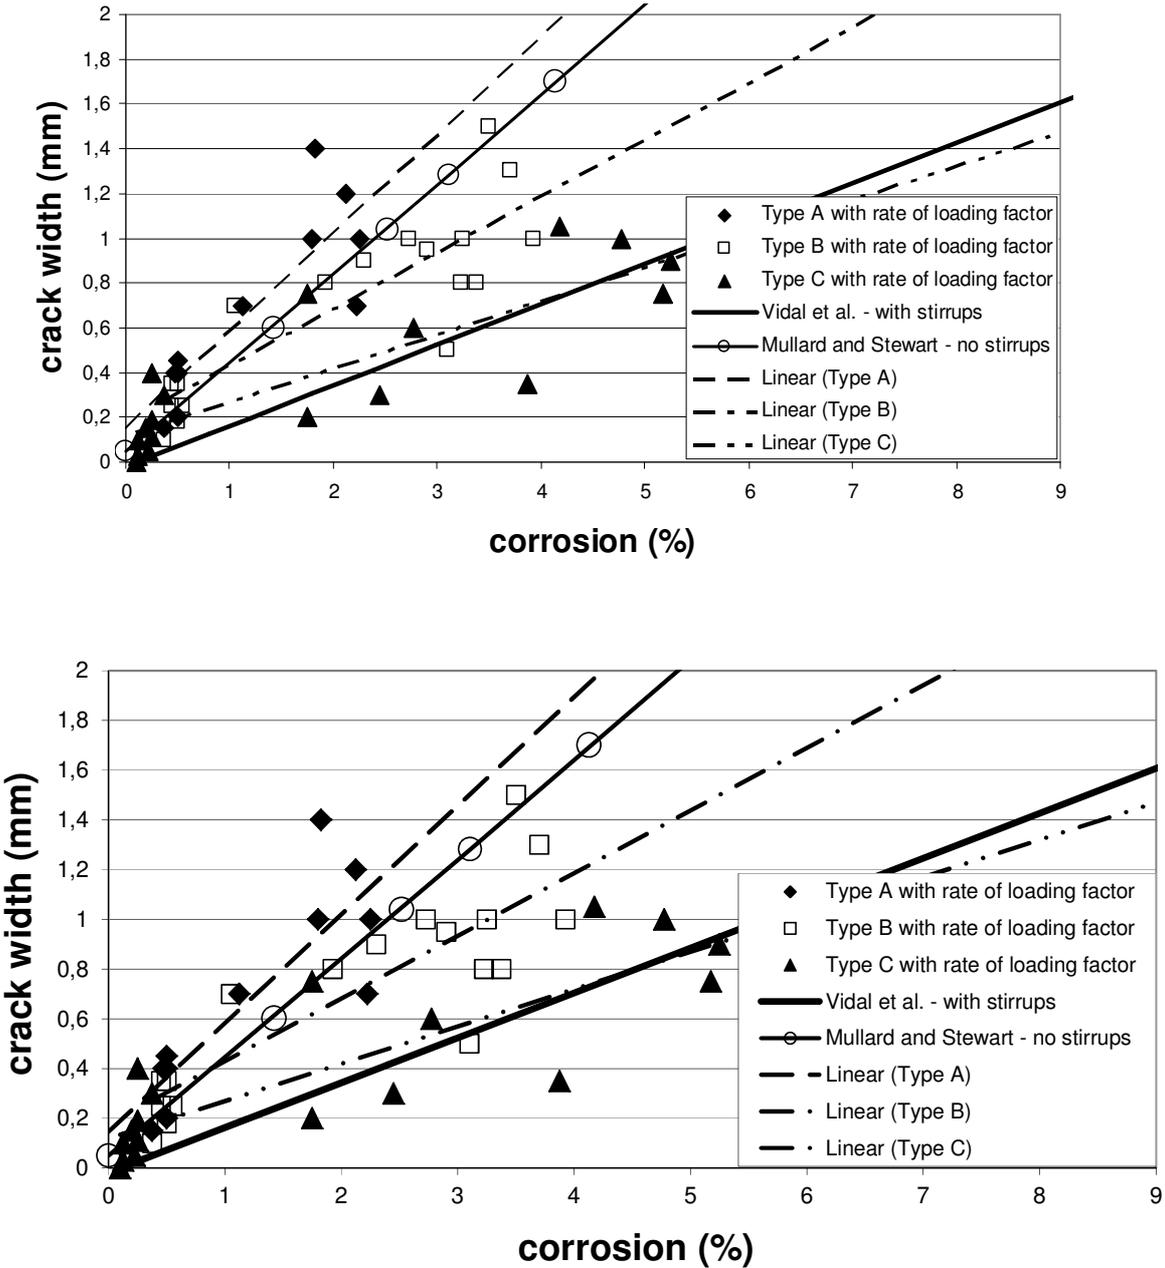
Fig.8 also shows the results in this experimental program for the main bars (divided in three groups, type A, B and C specimens). The corrosion is the average weight loss of the bar; this is a reasonable approximation for the corrosion of the bars in the tests, that was rather uniformly distributed, as generally seen in artificial corrosion tests. As already mentioned, the corrosion levels in Fig.8 for these tests are modified using Equation 2. The equivalent crack width is calculated as the sum of crack widths measured on the front cover (i.e. on the plane perpendicular to the main bars). This position was chosen because the presence of several cracks departing from the same main bar can be observed there, including the delamination cracks connecting the middle and corner bar.

Fig.8 Comparison of test results, considering rate of loading correction factor, with natural corrosion results by Vidal et al. (2004) and model by Mullard and Stewart (2011).

Fig.8 also shows the model by Vidal et al. (2004), obtained from crack width measurements along the main bars of beams corroded in a saline environment and subjected to wetting–drying cycles over periods of 14 and 17 years. The corrosion rate and the oxides produced were close to those actually observed in natural conditions. On the basis of the tests Vidal et al. proposed an empirical linear expression predicting crack propagation for the main bars:

The results for specimens without stirrups (Type A) show wider crack openings compared to the specimens with transverse steel. The crack widths for Type B and C specimens are lower, as also shown by the linear fit lines. This can be interpreted as the effect of the stirrup confinement. The smaller crack widths in specimens with corroding stirrups (Type C) can be explained as a result of a more spread damage of the cover, as will be further shown in the next section.

It is remarkable that the results obtained for the type C specimens in this study agree quite closely to the results of equation (1) by Vidal et al. (2004) for natural corrosion. The Vidal et al. (2004) model is based on tests with a range of cover/diameter ratios ($c/d=1.33-3$); in this study the c/d ratio was 1.5, which is within this range. The concrete strength was similar (45 vs 37.5 MPa cubic strength). The stirrups were 6mm or 8mm bars at 220mm for Vidal et al., while here 8mm at 40mm.

Results for Equation (3) are shown in Fig.8 with the parameters relative to the tests in this study: $k_r=0.25$, $i_{corr,exp} = 116 \mu A/cm^2$, and $i_{corr,real} = 1 \mu A/cm^2$ (Mullard and Stewart, 2011). Corrosion in Fig.8 is calculated as percentual weight loss. Equation (3) was obtained from tests without transverse reinforcement. The results show a good correspondence to the tests for Type A specimens.

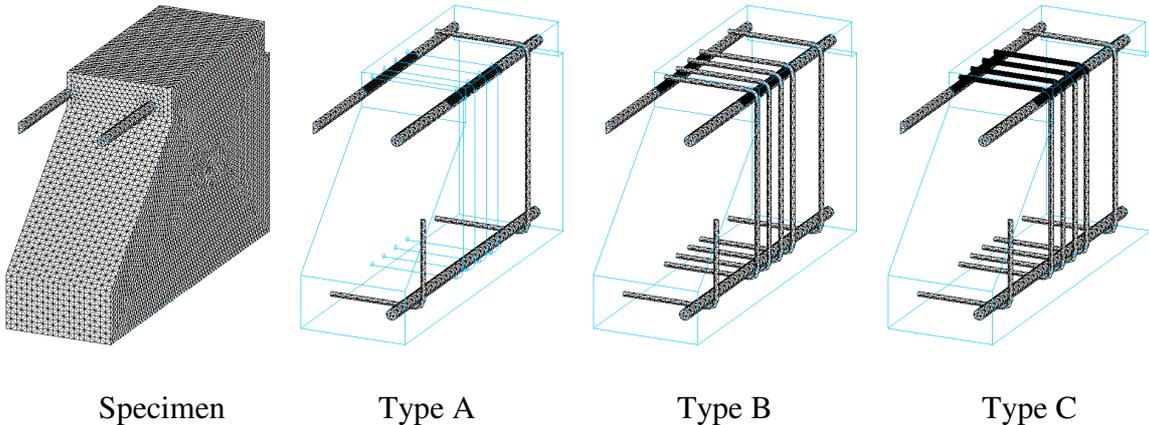
In a similar way as that in the experiments, the longitudinal bars were subjected to corrosion from the top cover, i.e. half of the cross-section was affected by corrosion; see Fig.9. The top leg of the stirrups was subjected to corrosion all around the cross-section. The vertical leg of

the stirrups was corroded down to the half of the longitudinal bar section. Unlike the experiments, the same corrosion penetration was imposed on all bars.

Fig.9 FE model of the specimens; the portions of the bars in dark grey were subjected to corrosion.

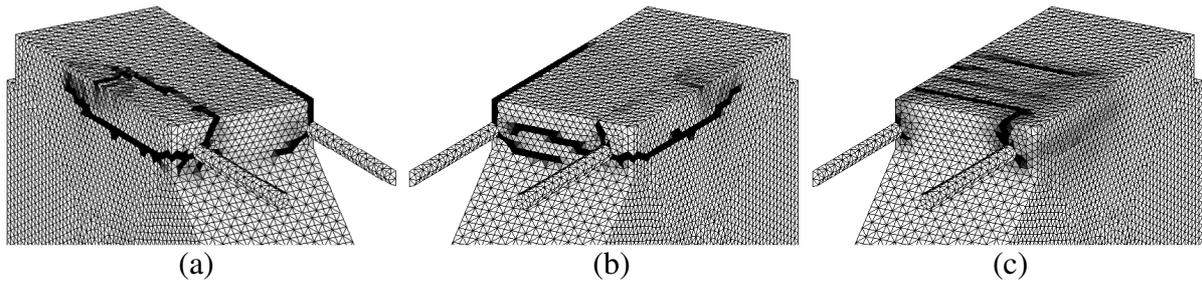
**Fig.10 Numerical (half of the specimen) crack patterns:
(a) Type A; (b) Type B; (c) Type C.**

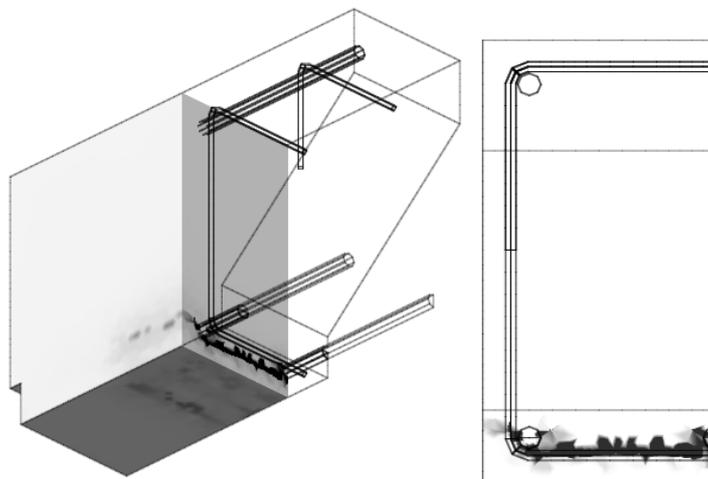
Fig.11 Numerical delamination crack pattern – Type C specimen.

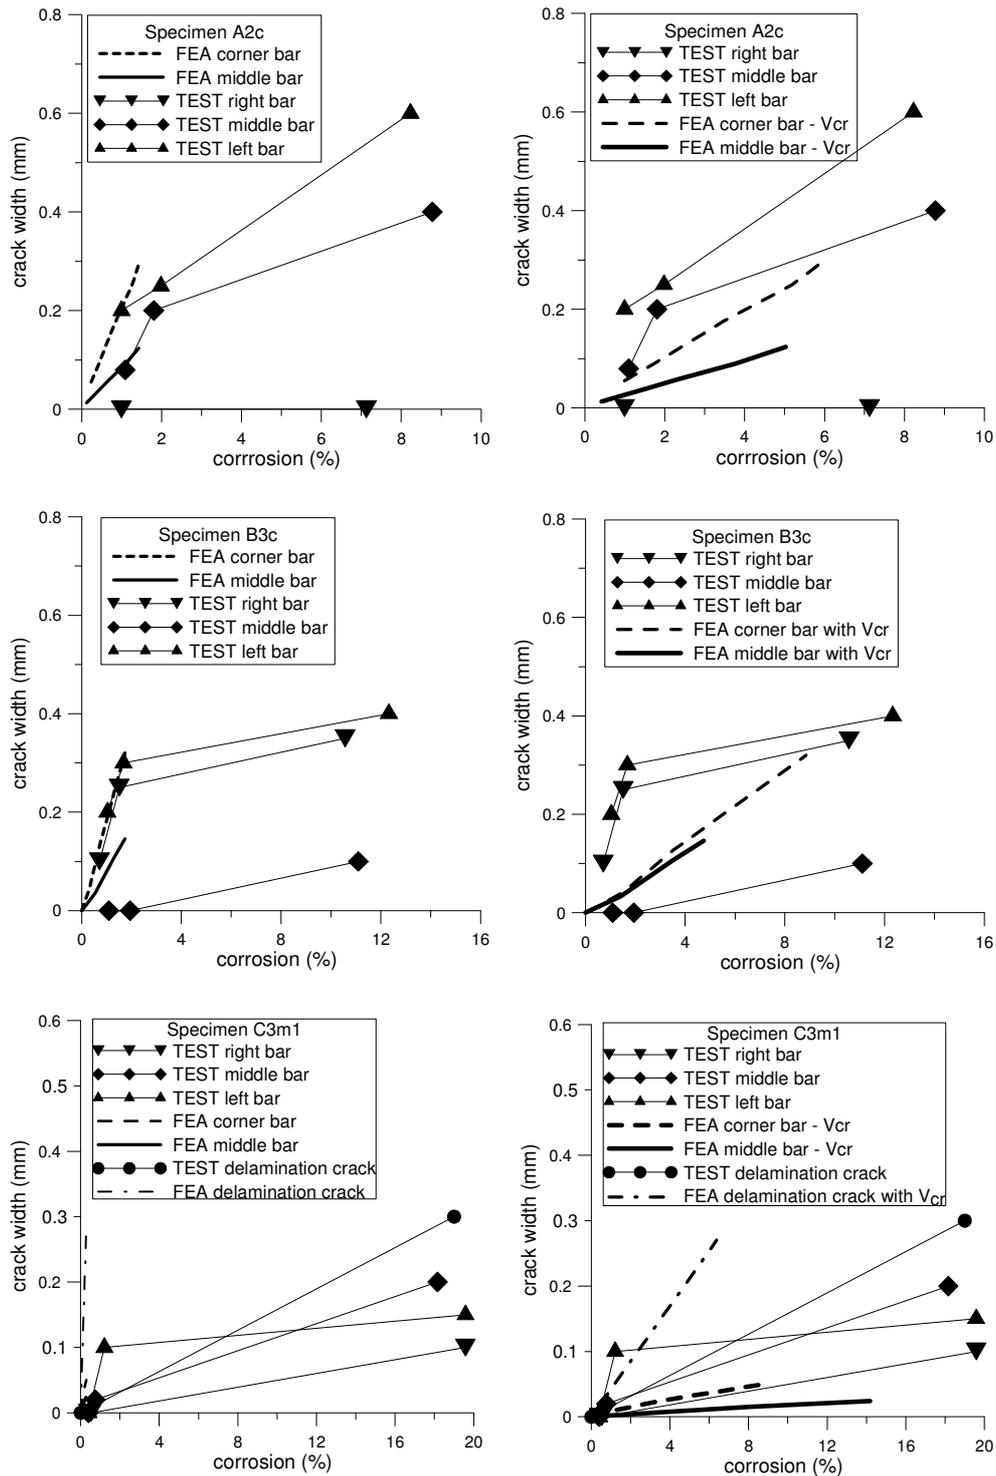
The crack widths on the top cover were evaluated from the numerical results for the nodal displacements on each side of the crack, and compared to the test results (Fig.12). The maximum crack width is underestimated for specimen A2c, is approximated correctly for B3c and is again underestimated for C3m1. The model correctly simulates the reduction of the top cover crack widths in the type C tests with respect to the other types of specimens. The maximum delamination crack width for the type C specimen is also shown, in good agreement with the test results.

Fig.12 Cracks vs corrosion level: FEA results vs test results up to Level 2 (Type A) and Level 3 (Type B and C).

The maximum amount of corrosion penetration was rather low in the numerical analyses compared with what was observed in the experiments (Fig.12, FEA results in the legend). The model simulates the volume of oxides accumulating around the bar (Equation 4), that is the input of the analysis. As shown by Val et al. (2009), initially this provides a reasonable estimate

The crack width to corrosion relation, adding *a posteriori* the contribution of the volume of the cracks in the calculation of the corrosion level is shown in Fig.12 (FEA with V_{cr} in the legend). The crack volume for each bar, divided by v_{rs} , accounts for several percentual points of corrosion. A better approximation of the test results is obtained. The low initial inclination of the diagrams, compared to the tests, indicates that differently from what assumed here, rust flow gradually in the cracks. The maximum experimental values of corrosion level are not reached, meaning that a significant quantity of oxides flowed out of the cracks, as was observed experimentally.
