Interior insulation retrofit of a historical brick wall using vacuum insulation panels: Hygrothermal numerical simulations and laboratory investigations

Building and Environment (ISSN: 0360-1323)

Johansson, P. ; Geving, S. ; Hagentoft, C. et al. (2014) "Interior insulation retrofit of a historical brick wall using vacuum insulation panels: Hygrothermal numerical simulations and laboratory investigations". Building and Environment, vol. 79 pp. 31-45.

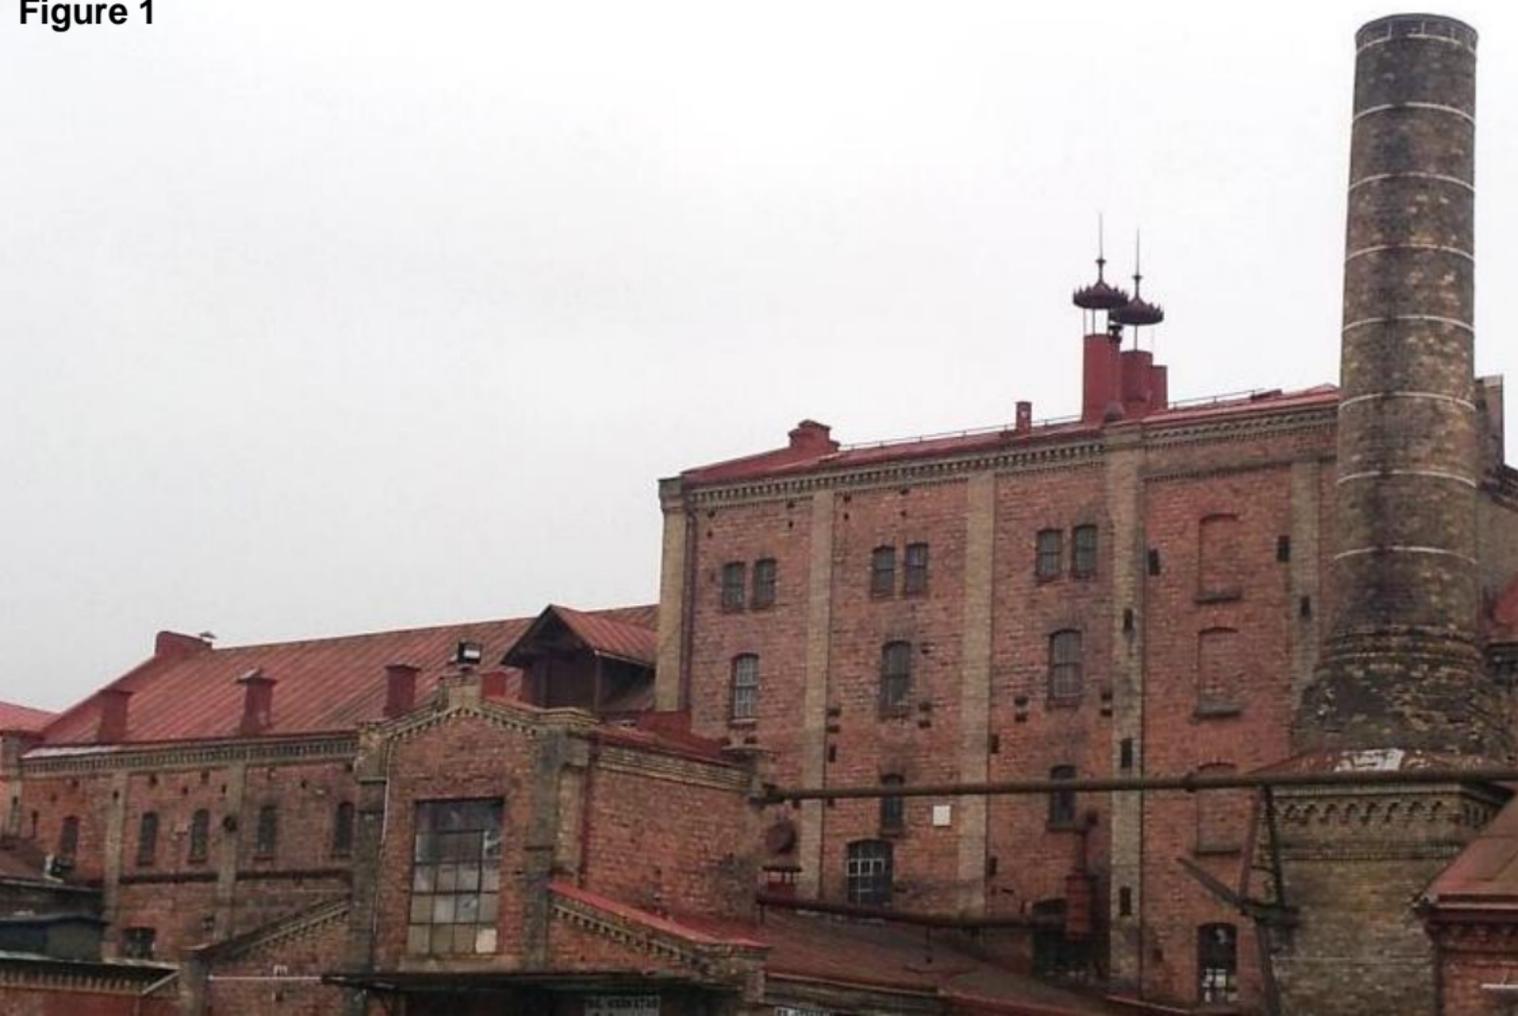
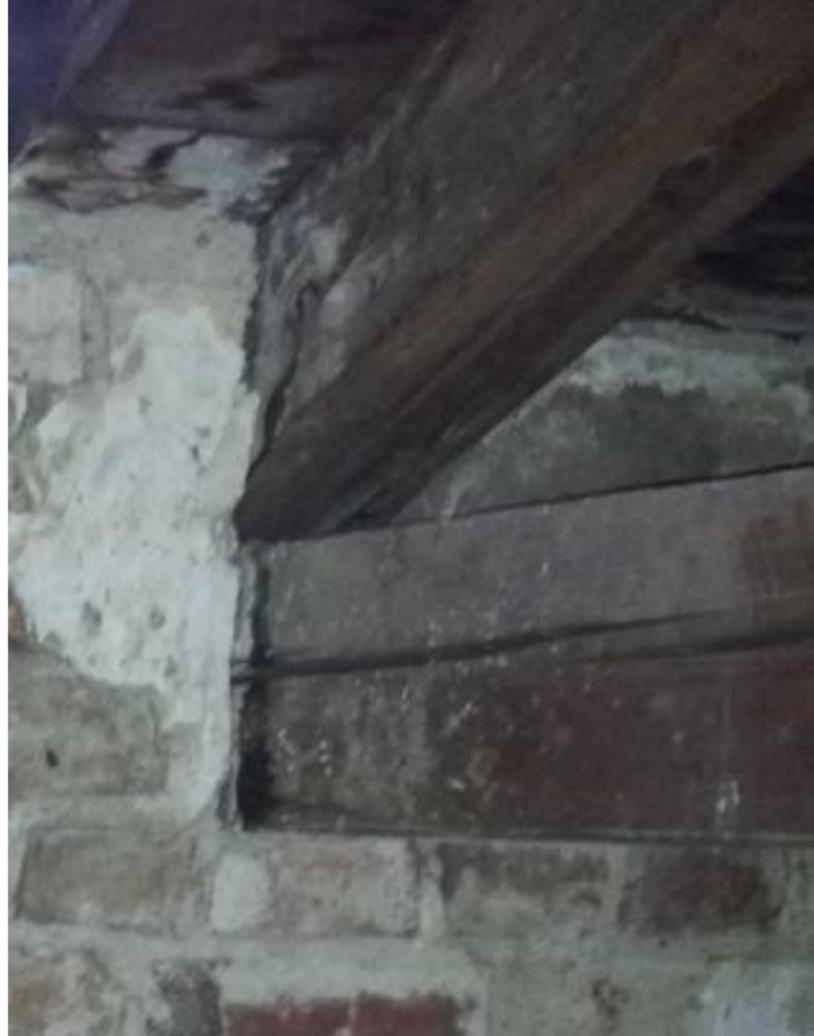
Figure 1

When retrofitting old buildings, the prerequisites are given by the existing construction. The intermediate floors in old brick buildings are often carried by wooden beams which are embedded in the brick, see Figure 1. Mold and dry rot can damage the wooden beams and the risk for that is higher when interior insulation is added because of the higher relative humidity in the wall. Inside the wall, there could be air leakage paths from the interior into the area around the wooden beam ends which can transport moist air from the interior. This will raise the moisture content even higher [19]. Also, driving rain could contribute to further raising of the moisture content in the wall and wooden beam ends, increasing the risk for moisture damages. Van den Brande et al. [20] studied the effect by rain water runoff on the water absorption of a façade. Depending on the type of material in the exterior of the façade, the additional water absorption by runoff varies. It was found that the effect was small for materials with a large capillary transport potential, such as brick and mortar. For other materials, the water absorption could be heavily underestimated since the drying of the surface is delayed by the presence of a water film on the exterior surface. In some cases the water absorption was doubled when taking the runoff into account compared to the case with no runoff.

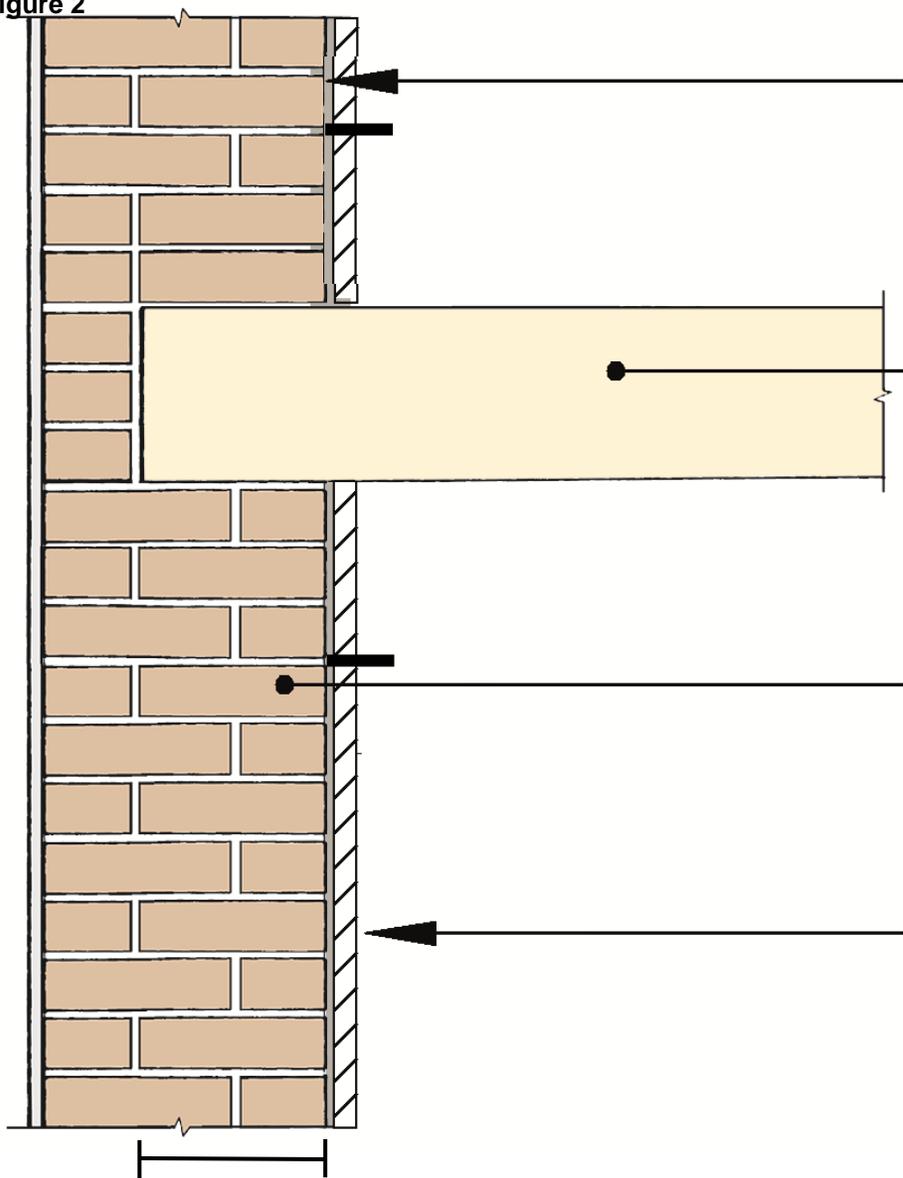
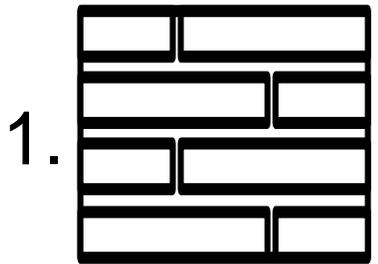
Figure 2

Interior plaster/
adjustment layer

Wooden floor beams
100x225 mm

Homogenous brick
wall 380 mm

VIP e.g. 20 mm

is substantially higher for the lime cement mortars and hydraulic lime mortars than for the pure cement mortars. This is caused by the larger pore structure in the cement mortars which reduces the capillary suction potential through the mortar [22]. Also the water vapor diffusion resistance factor is lower for the cement mortars than for the two other types of mortar. The difference between the two cement mortars, type N and type S, is mainly in the final strength. Cement type S has higher final strength than type N. Therefore type N is normally used in masonry work and type S is used in applications where a stronger adhesion is required [42]. The “Extruded brick” in Table 1 with a 10-12 mm thick layer of coarse lime cement mortar between the bricks (number 1 in Figure 2) was chosen for the following numerical simulations.

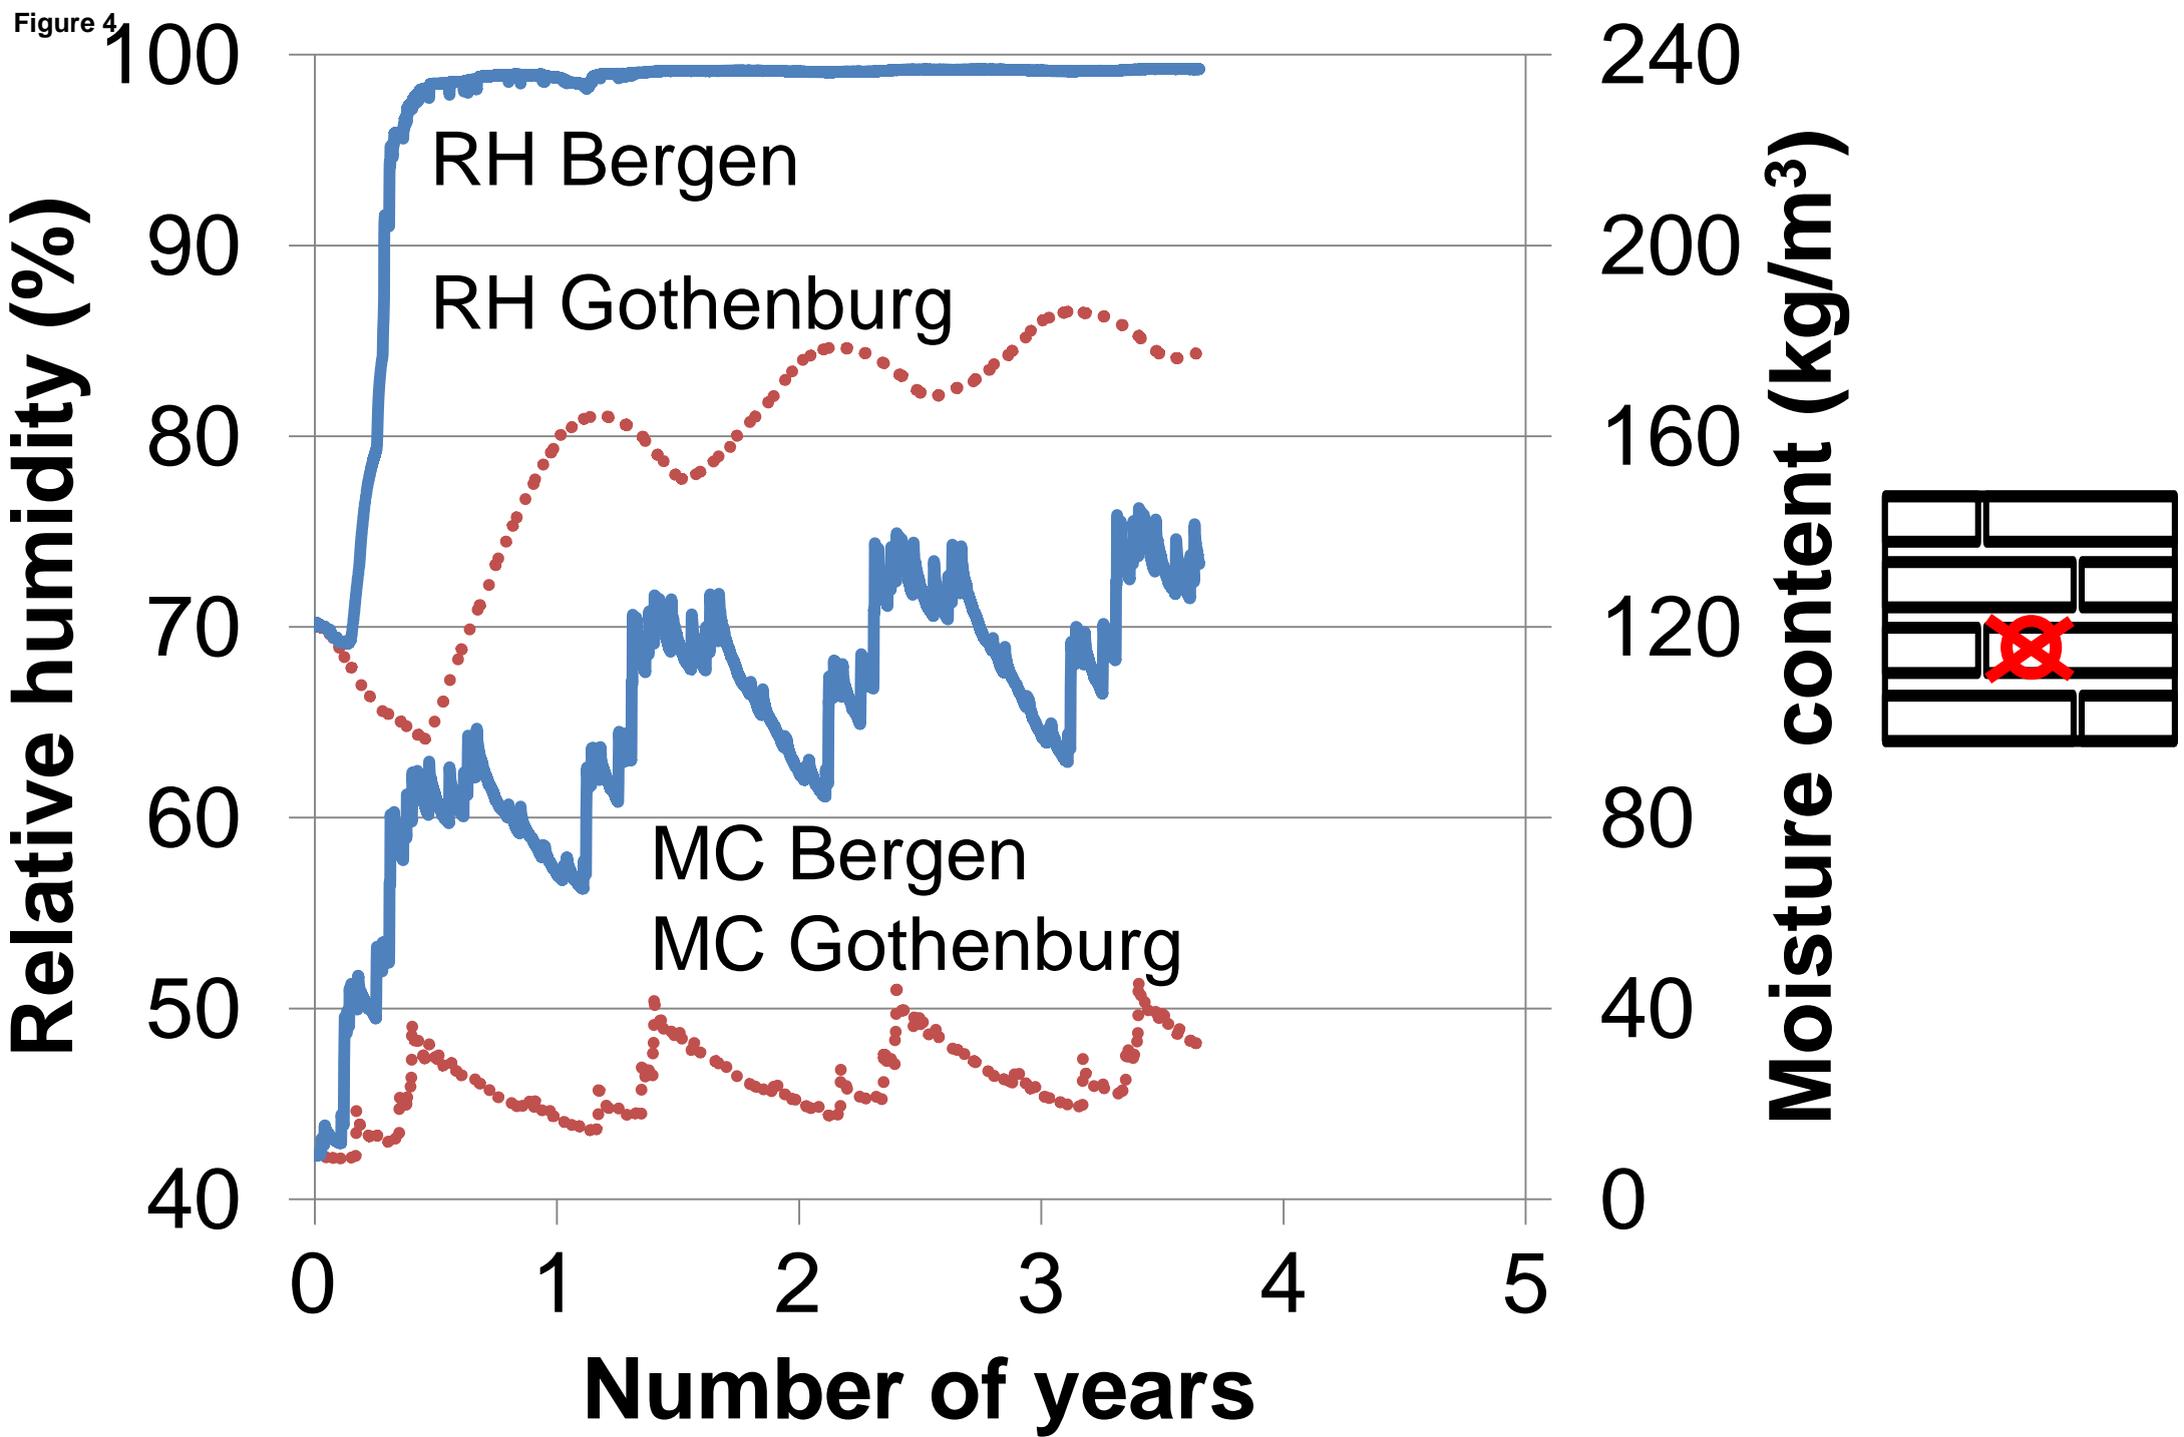
Figure 4

Figure 4. Numerically simulated RH in the middle of the wall (marked by the cross with a circle on the right) and the total moisture content (MC) in the wall. The wall was composed of 380 mm thick homogenous “Extruded brick”.

exposed walls [38]. For this numerical simulation, the wall was considered to be protected from most of the rain with a rain water absorption factor of 0.3. This rain water absorption factor is not supported by experimental data. It was chosen to allow a comparison between protected walls in the two cities without a too high moisture load on the wall. The rain water absorption factor of 0.7 gave a fast moisture accumulation in both cities. The dominant wind direction for both Bergen and Gothenburg is south which, therefore, was chosen as the direction of the wall. The numerical simulation results for the two cities of the total moisture content in the wall and the RH in the middle of the wall are shown in Figure 4.

The dominating moisture source is from the rain on the façade which means the materials will be wet and the moisture transported by capillary suction. During the simulated five-year period, the inward capillary moisture transport is 4 and 1.7 times larger than the moisture transported by diffusion through the middle of the wall in Bergen and Gothenburg, respectively. The RH in the middle of the wall in Bergen was close to 100% already after 1 year of numerical simulation. The brick wall in Gothenburg was not exposed to the same rain load as in Bergen. Here, the RH in the middle of the wall peaked at 88% in August of year 5. Also, the total moisture content in the wall in Bergen increased rapidly during the first years of the numerical simulation to stabilize during year 4 and 5. The maximum moisture content was 147 kg/m^3 in December of year 4. For the wall in Gothenburg, the moisture content was 48 kg/m^3 at maximum. However, the water was not evenly distributed in the walls. At the exterior surface of the brick, where there could be a risk of freeze-thaw damages, the moisture content was significantly higher. It was peaking at 298 kg/m^3 in Bergen and 211 kg/m^3 in Gothenburg which should be compared to the saturation moisture content of the brick which was 370 kg/m^3 . This gives a degree of saturation of 0.4 in Bergen and 0.13 in Gothenburg. However, the critical degree of saturation, i.e. when there is a risk of freeze-thaw damages in

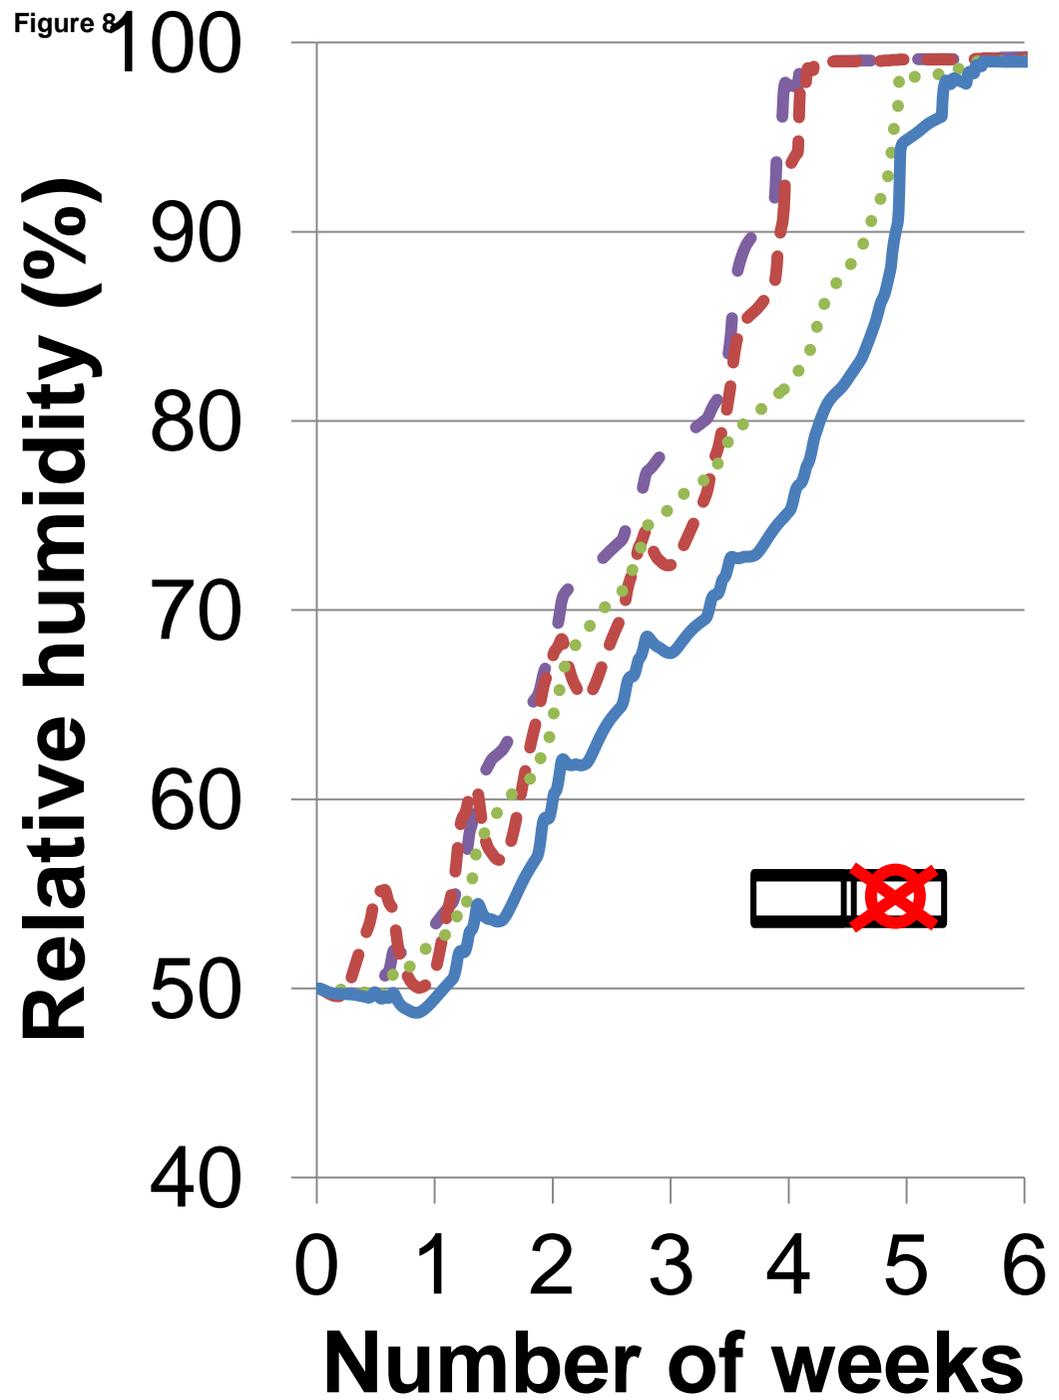
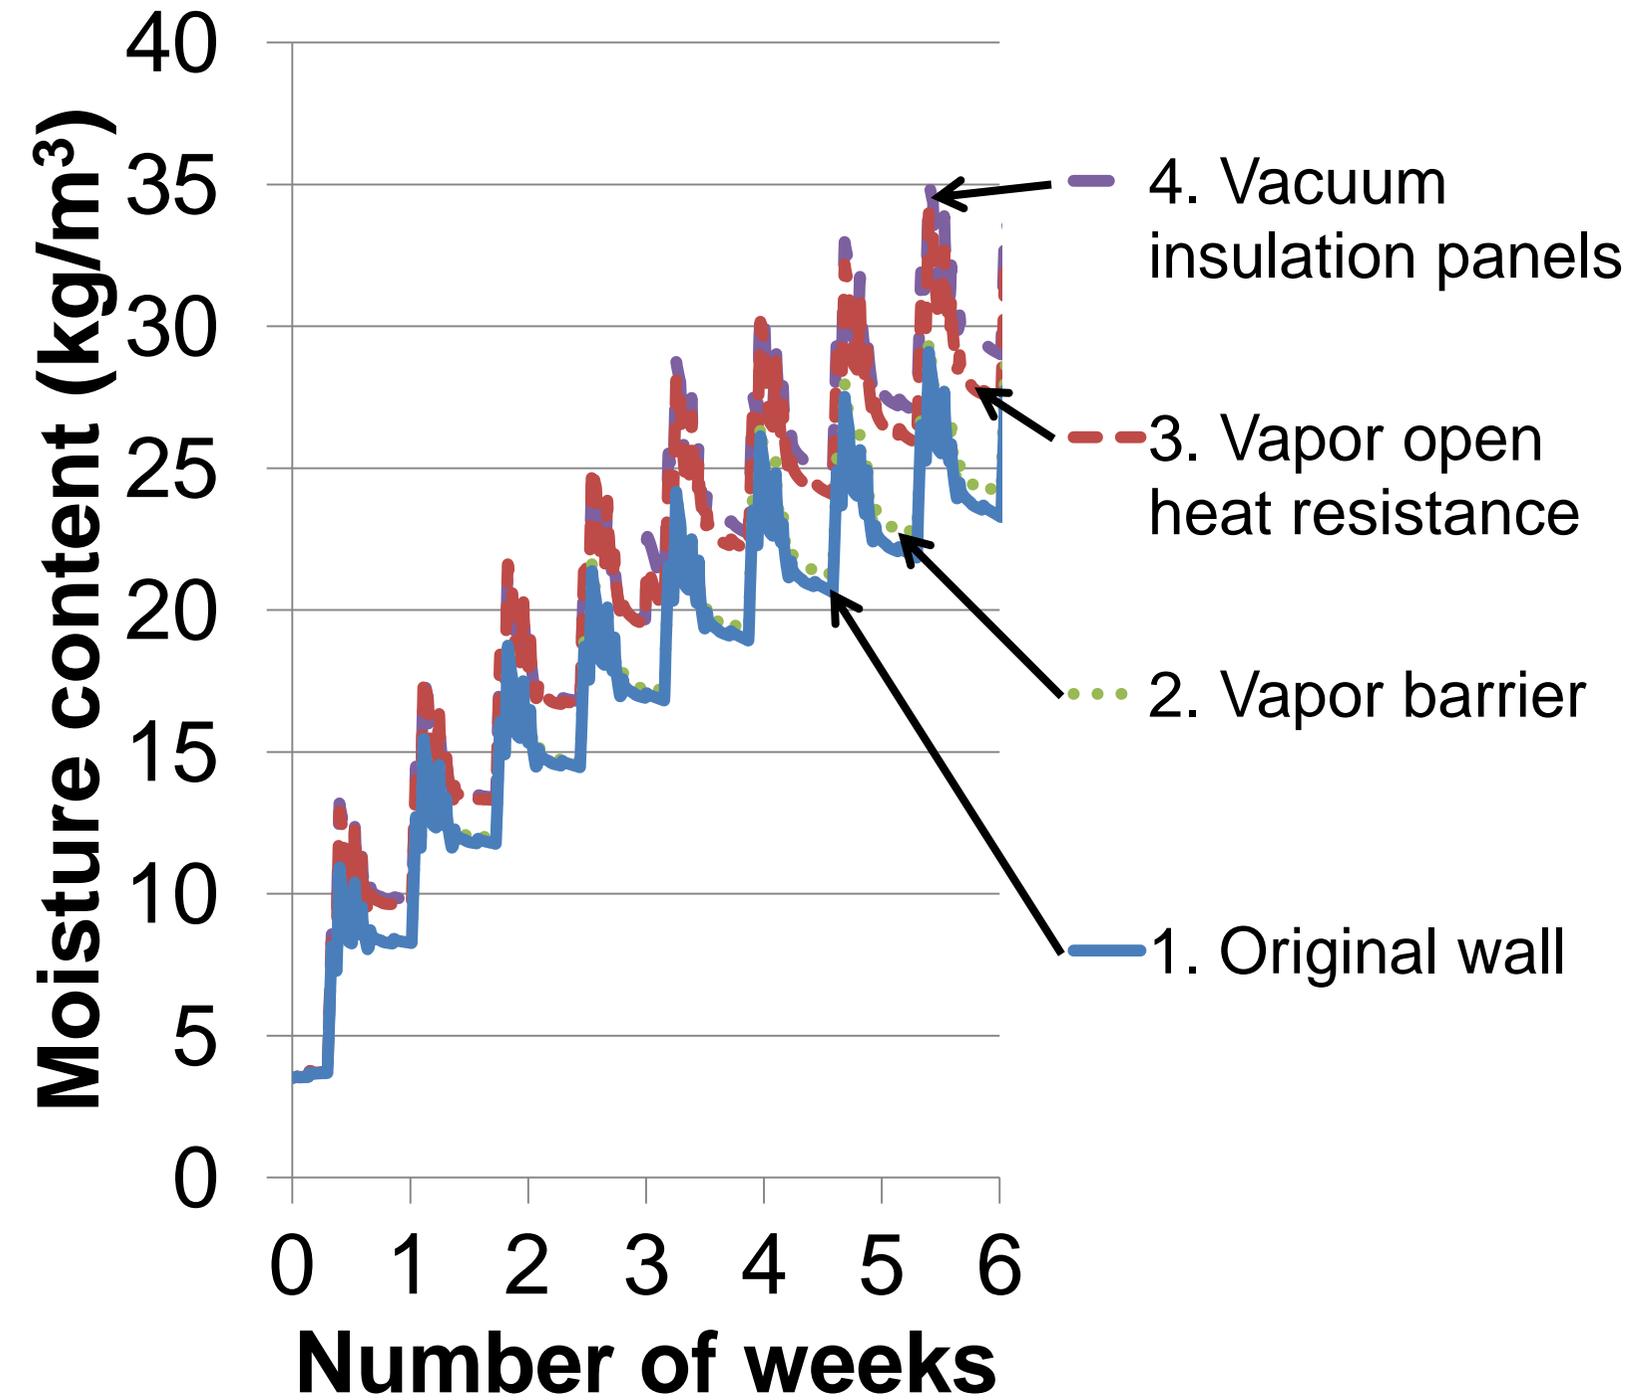
Figure 8

Figure 8. Left: numerically simulated RH 60 mm from the interior surface of the brick (marked by the cross with a circle next to the curves). Right: numerically simulated total moisture content in a 250 mm thick wall.

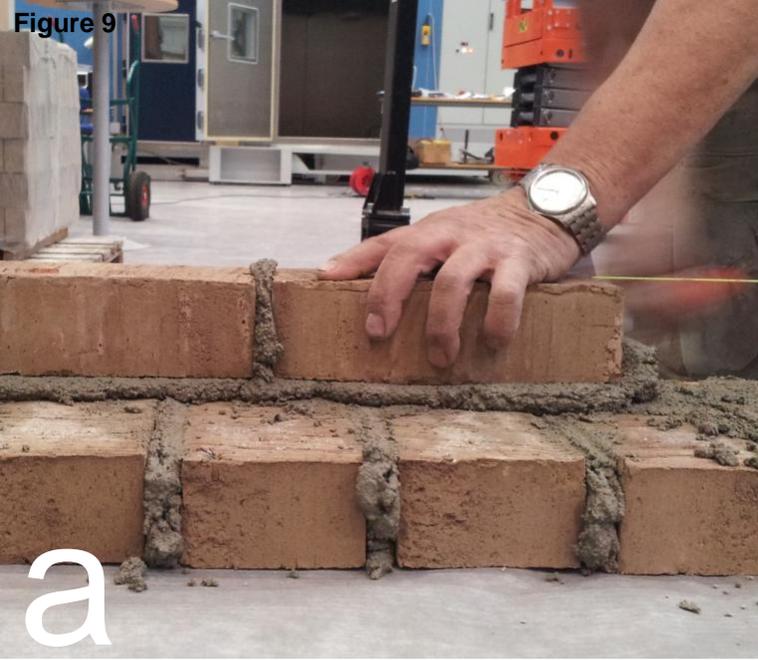
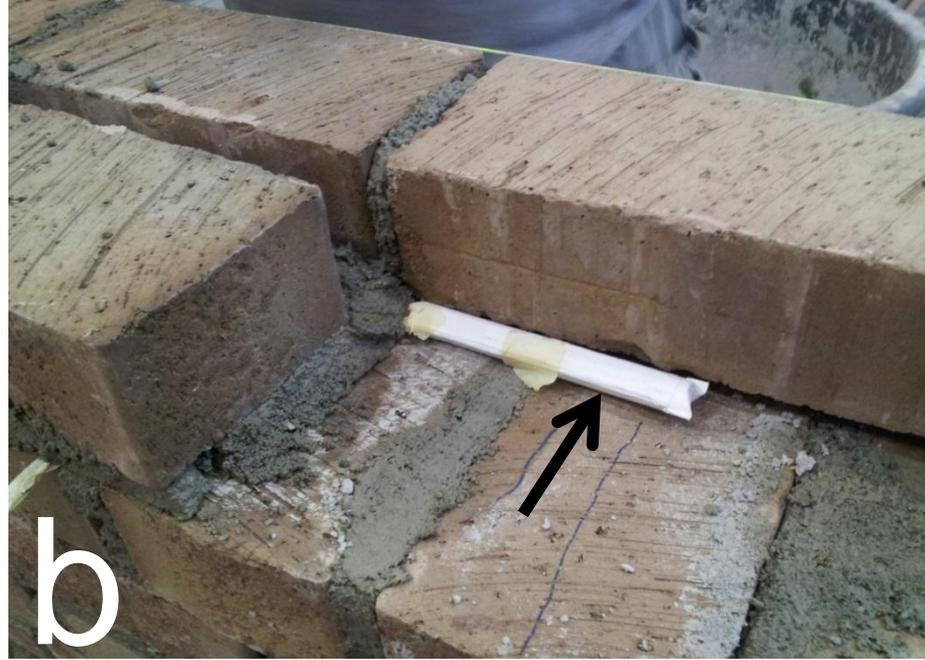
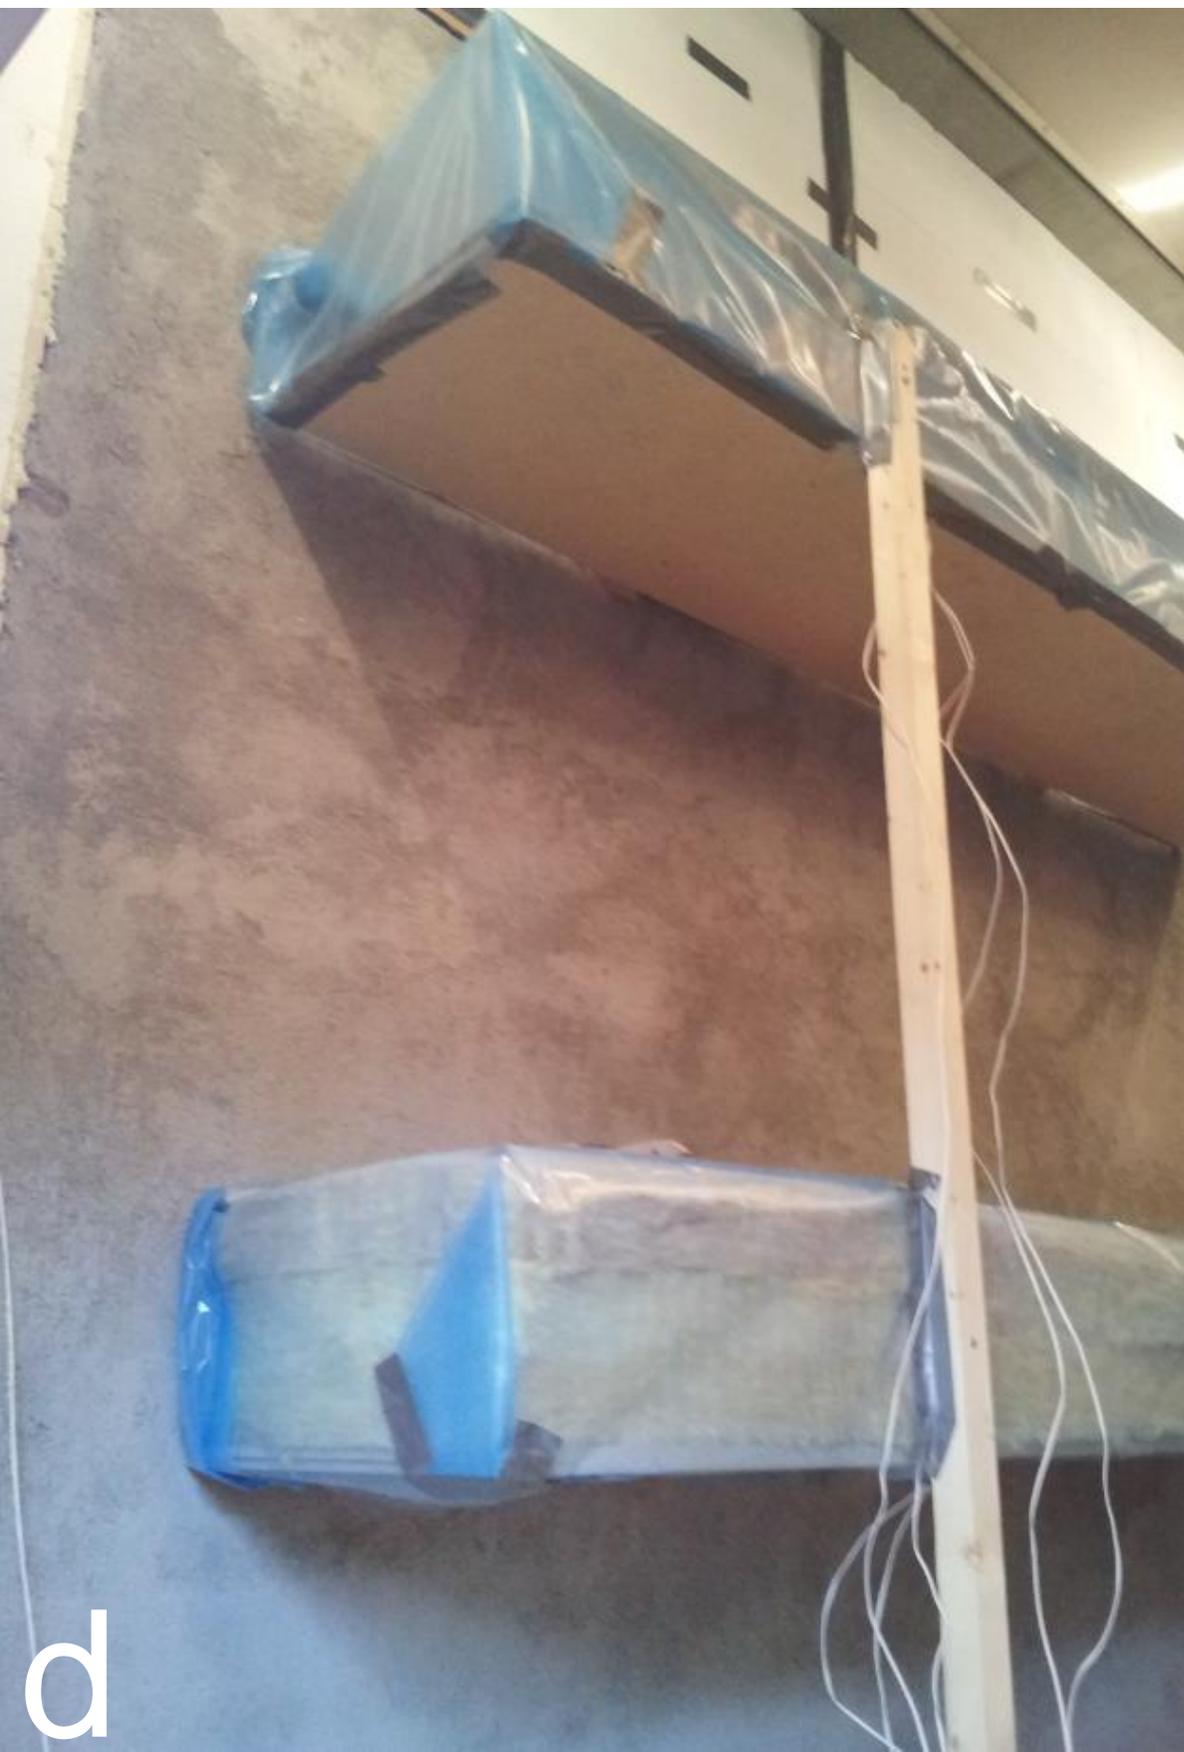
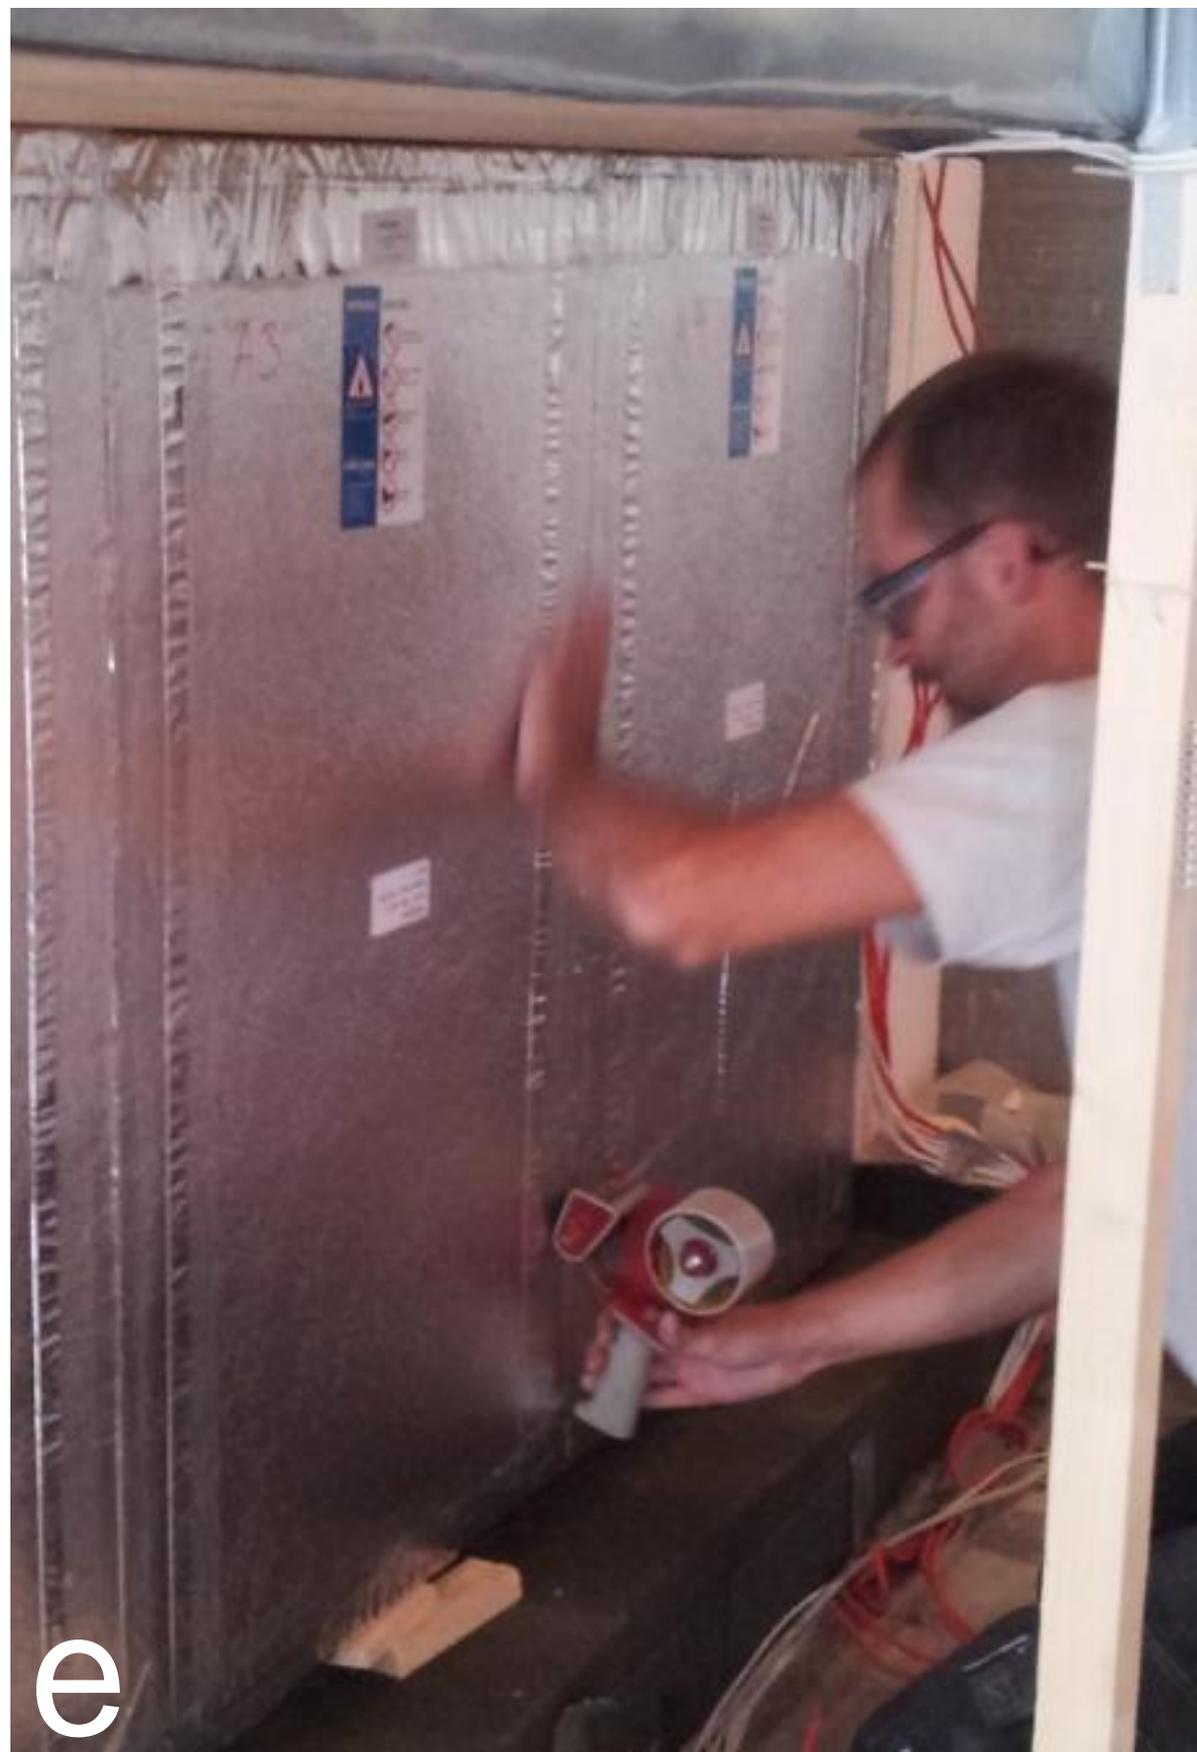
Figure 9

Figure 9. Photos from the construction of the wall in the laboratory of NTNU and SINTEF Building and Infrastructure. a: brick and mortar laid out, b: RH sensor (marked by the arrow) installed in the mortar in the middle of the wall, c: finished brick wall with the four voids for the wooden beams marked with black rectangles, d: wooden beams, made of spruce, and chipboards installed and wrapped in polyethylene foil, e: installation of the VIP which were glued to the wall with taped edges.

The size of the bricks was 226 mm x 104 mm x 60 mm (length x width x height) and the thickness of the mortar joints between the bricks were 10-12 mm, see Figure 9a.

The water accumulation in the upper part of the wall could interfere with the laboratory measurement results for the lower part of the wall. Therefore a rubber strip was installed on the exterior side of the wall to stop liquid water from being transported along the wall. Mortar was applied on the entire interior brick surface to make an even surface for attaching the VIPs. Four voids of 100 mm x 225 mm each (see Figure 9c) were created where the wooden beams, made of spruce, were installed after the wall had dried. The gaps between the brick and wooden beams were sealed with a mix of modelling clay and beeswax. Underneath the beams, chipboards were installed to simulate the intermediate floor, see Figure 9d. On the chipboard between the two lower beams, a layer of glass wool was added to simulate the thermal resistance of the intermediate floor while the space around the two upper beams was left non-insulated, see Figure 9d and Figure 10. A polyethylene foil was wrapped around the beams, the chipboards and over the space between them, see Figure 9d, to simulate the vapor resistance of the intermediate floor.
