## Building Retrofit using Vacuum Insulation Panels

Hygrothermal Performance and Durability

*Thesis for the Degree of Doctor of Philosophy*

PÄR JOHANSSON

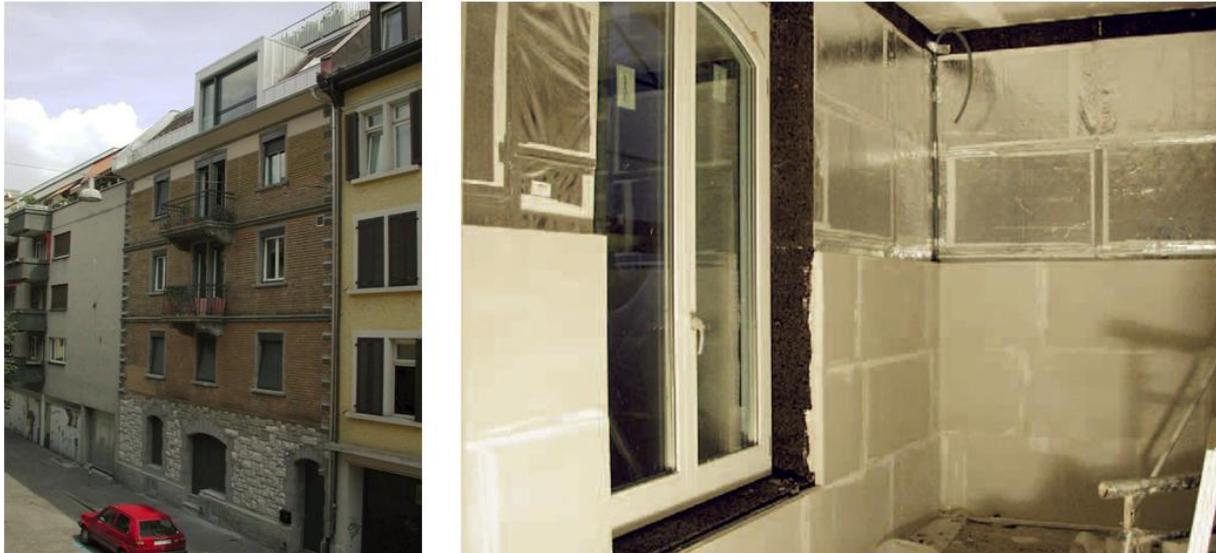
Figure 2.11. Interior insulation of a brick masonry wall in Zurich, Switzerland using 30 mm VIP covered by 60 mm plaster boards (Photo: Viridén + Partner AG).

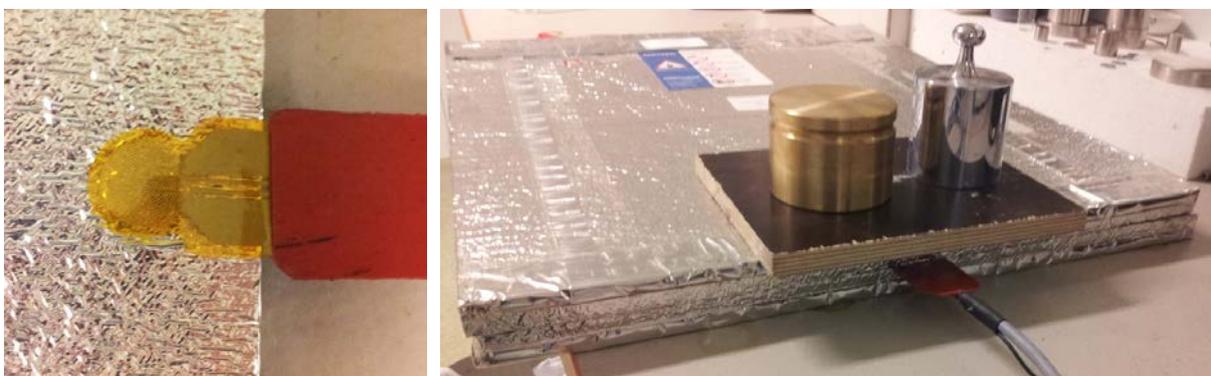
Figure 3.1. Left: TPS sensor on a VIP. Right: measurement setup with the sensor clamped between two VIPs. There was a pressure of 4.7 kPa applied on the upper sample to increase the contact with the sensor. (FIG 1 in Paper II).

The general and specific procedures of the TPS method for measurements of thermal properties are described in SS-EN ISO 22007-2. The method uses a sensor composed of a 10  $\mu\text{m}$  thick double nickel spiral, sandwiched between two layers of 25  $\mu\text{m}$  thick kapton (polyimide film). The spiral serves both as heat source and as electric resistance thermometer. A constant electric power is supplied through the spiral which develops heat by the electric resistance of the nickel raising the temperature of the sample. The rate of the temperature increase depends on how quickly the heat developed in the sensor is conducted away through the surrounding materials. Heating is continued for a period of time, with the voltage across the spiral being registered. As the current is held constant, the voltage changes in proportion to changes in the electric resistance of the spiral. The sensor is clamped between two samples of the material as shown in Figure 3.1. With knowledge of the temperature variation with time, i.e. the variation of voltage, and the supplied heat flow, it is possible to calculate the thermal conductivity and volumetric heat capacity of the material. The samples of the material should not be smaller than the penetration depth defined by Equation 3.2. Otherwise, the temperature in the sensor will be affected by the heat wave reaching the boundary.

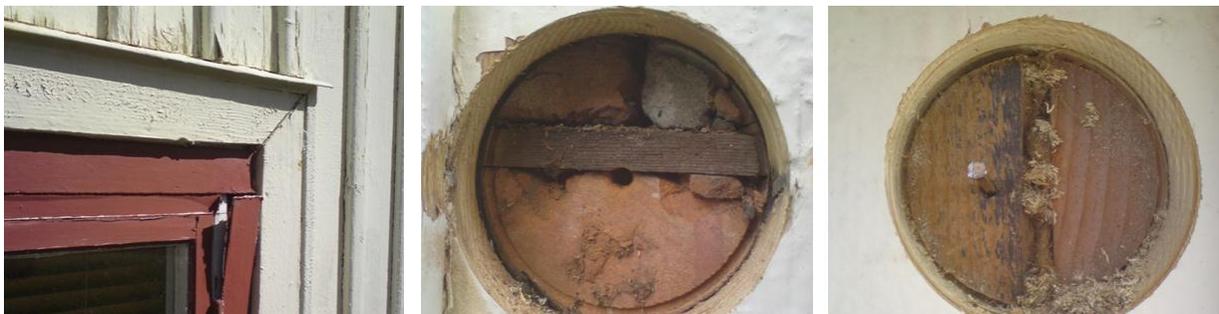
*Figure 4.2. At a visit to the buildings, holes were drilled through the wooden cover board to investigate the condition of the materials behind. The worst places were around windows (left) and in the wooden laths found in the grout between the bricks (middle). The wooden planks had flax between the planks (right) to increase the air tightness of the wall.*

The moisture content in the wall was measured in June 2010 when holes in the wooden cover board were drilled and the moisture quotient measured with a resistance moisture meters (pin-type). The moisture quotient was approximately 9% close to the surface of the wooden planks while it was around 8% a few cm into the construction. In the brick grout, wooden laths were found which had a moisture quotient of 12% at the surface and 9.5% further in. The critical moisture quotient for mold growth on a wooden surface is around 20%. Figure 4.2 shows the condition of one of the window frames and the materials behind the wooden cover board.
