Anchorage of naturally corroded bars in reinforced concrete structures

Magazine of Concrete Research (ISSN: 0024-9831)

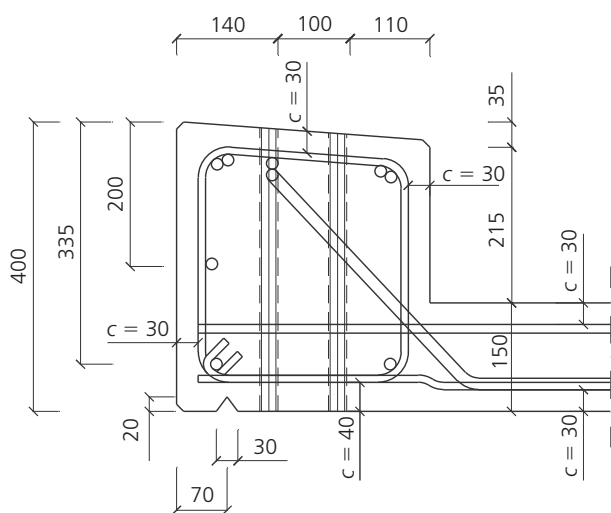
Figure 1. Cross-sectional details of the edge beam, adapted from bridge drawings. All dimensions are in mm; c is cover thickness

The geometry of the edge beams was suitable for bending tests, which made it possible to evaluate the anchorage behaviour at a structural level. Figure 1 shows the geometry of the edge beams. The cross-section of the beams was 350 × 400 mm², with a small inclination of the upper surface. Both longitudinal and transversal reinforcements in the edge beams were ribbed. The studied tensile reinforcements were four bars of Ø16 Ks60 bundled in pairs, see Table 1. The transverse reinforcement consisted of stirrups Ø10 Ks40 with a spacing of 300 mm. Due to differing precision in the construction stage, the concrete cover of the longitudinal reinforcement varied (see Table 2 and Figure 2). No sign of corrosion was observed around the longitudinal reinforcement bars close to the bottom surface of the edge beams. The longitudinal reinforcement bars closest to the upper inclined surface of the edge beams were severely damaged as they were the most exposed to de-icing salt; these were therefore more relevant for investigation of bond and anchorage behaviour.

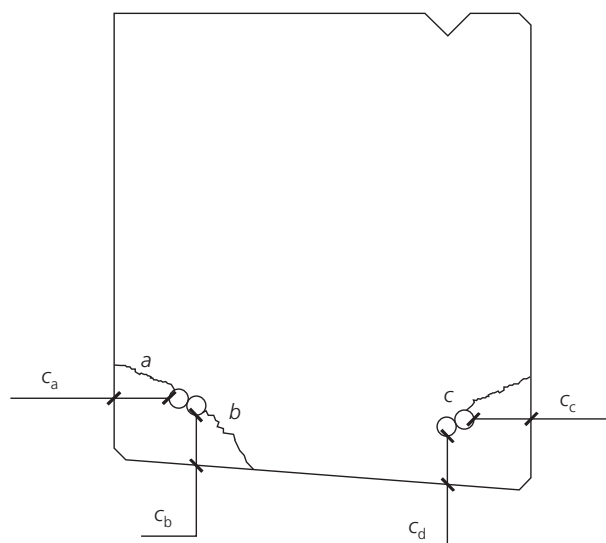
Figure 2. Concrete cover and spalling crack notations; the orientation of the cross-section in the test rig is also shown

from 0.1 mm to 1.5 mm (see Table 5 and Figure 2). Some examples of the damaged specimens are shown in Figure 4.

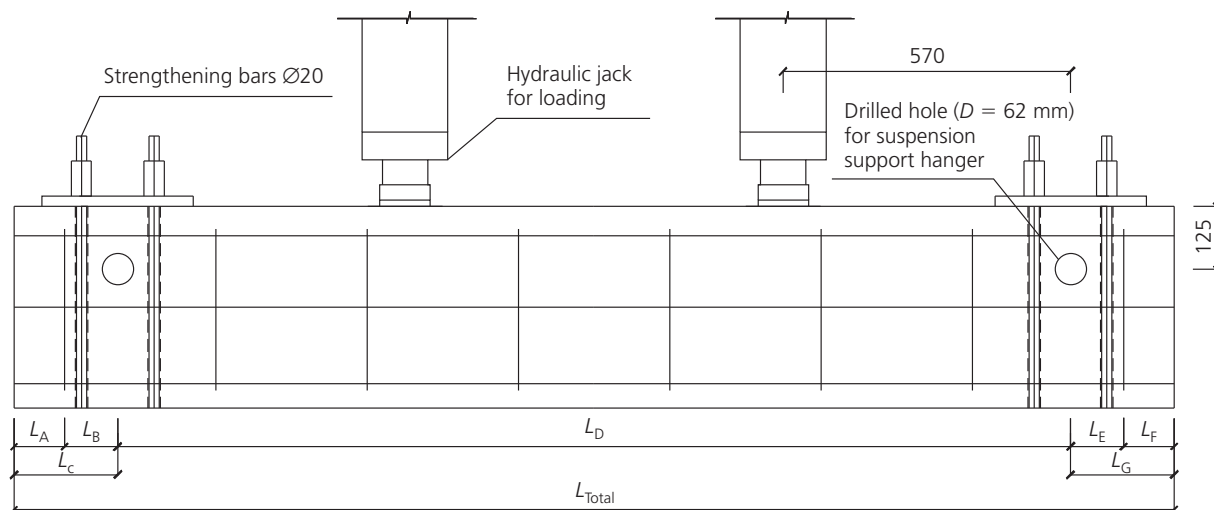
Figure 3. Symmetrical test setup showing the test specimen, loading jacks and holes for suspension support (dimensions in mm)

The test configuration was designed to secure anchorage failure for beams with different degrees of corrosion damage in one common test setup (Berg and Johansson, 2011). A four-point bending test indirectly supported by suspension hangers was chosen (Figure 3). Since it was considered important to have the suspension holes positioned between two stirrups, the holes were located in advance. In some cases, it was necessary to move the support hole closer to the centre of the specimen in order not to drill the outermost stirrups. In such cases, the two support holes were both moved closer to the centre to maintain symmetry of

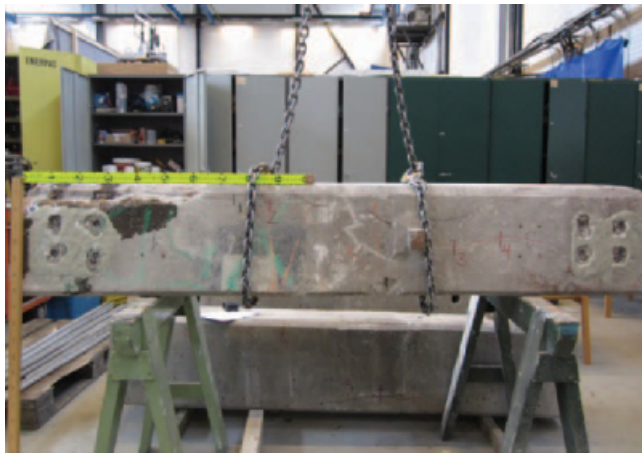
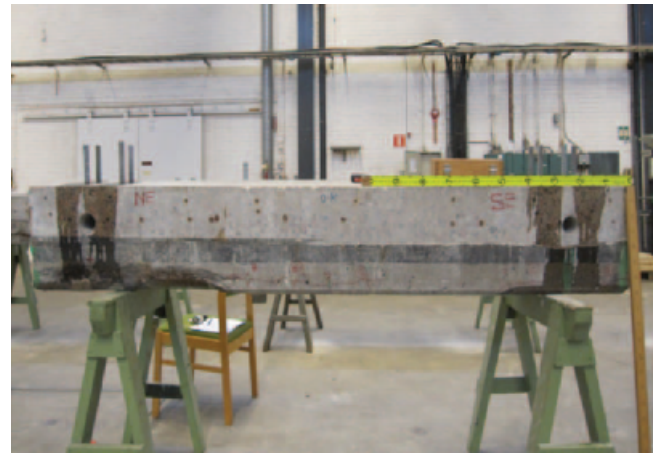
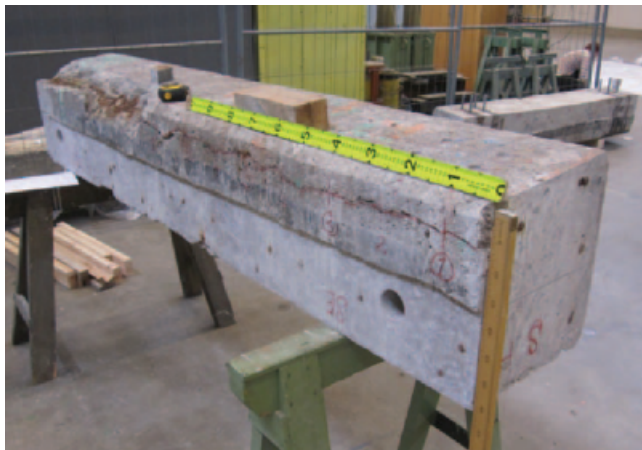
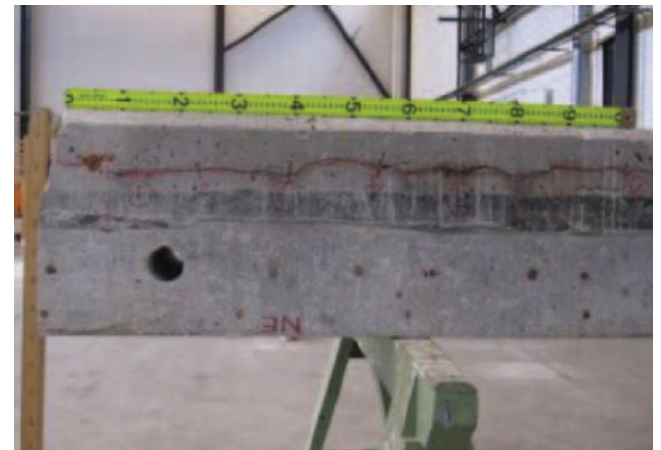
Figure 4. Examples of documentation of damage before testing: (a) M4; (b) M8 (concrete cover spalled in one corner during the preparation stage); (c) H5 with severe concrete cover spalling,

which failed on the side with only splitting cracks; (d) M12 with a continuous splitting crack along the failure side

The two R specimens showed rather different results. Photographs of some of the tested beams are shown in Figure 6. During the preparation stage, specimens M4 and M8 were slightly damaged and the concrete cover was spalled at one corner (Figure 4). Therefore, these specimens were regrouped into the H category. However, in M8, anchorage failure occurred on the side with no cover spalling. As mentioned earlier, in specimen M10, splitting cracks propagated on two sides. On the side where the splitting cracks first occurred, one of the bundled bars at one corner started to slip and, later, anchorage failure occurred on the other side. For the H specimens, beams H6 and H7 failed on the side with cover spalling, while failure occurred on the side with the splitting cracks in specimen H5. In specimen R4, rather large deflection was observed in the initial loading stage (Figure 7(a)). This behaviour could be partly related to existing damage due to freezing of the specimen. Zandi Hanjari *et al.* (2013) explained the phenomenon as the soft behaviour of damaged concrete in the compression zone, which might result in large mid-span deflections.

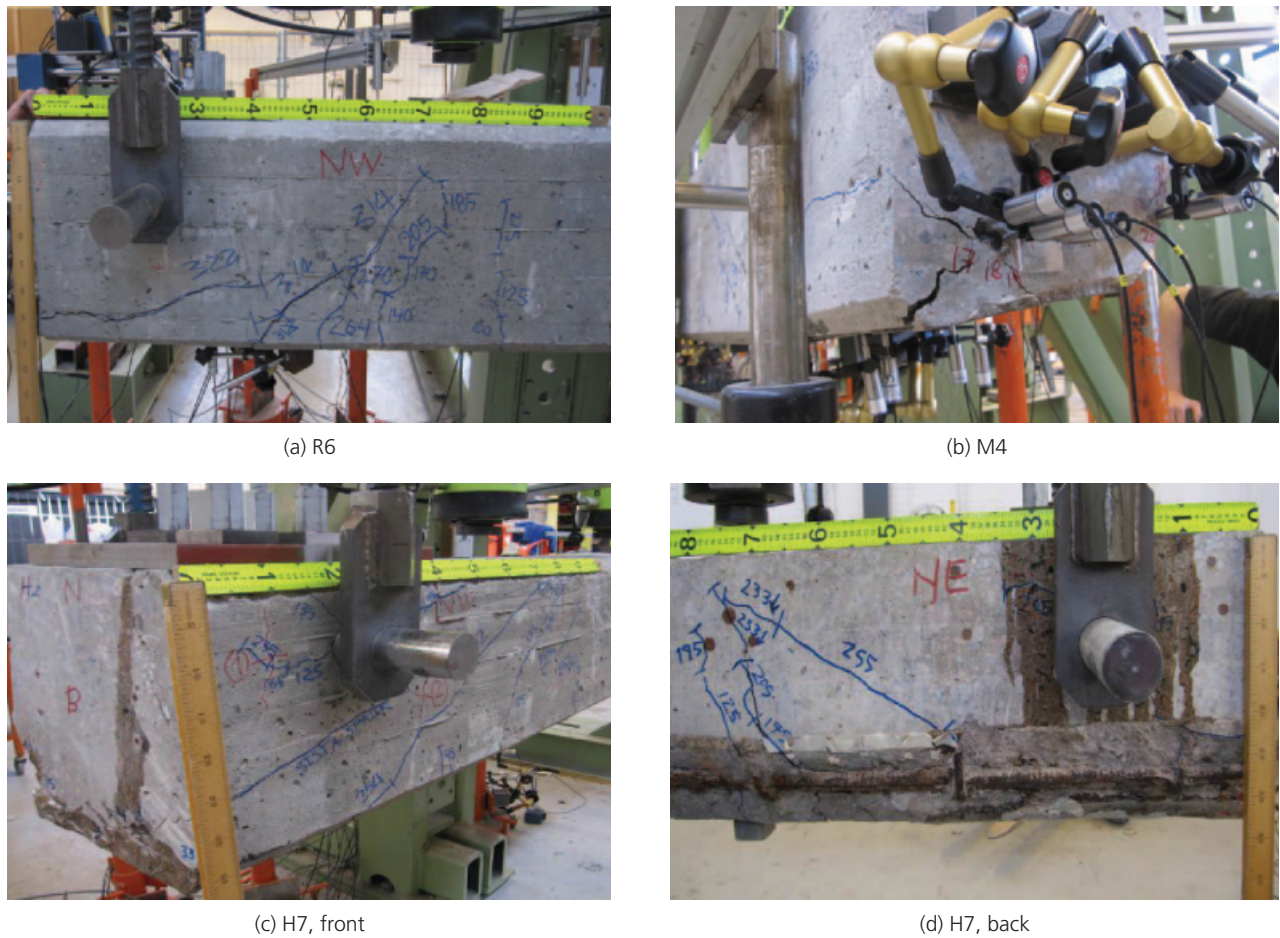
Figure 6. Failure and crack pattern of some of the beams after testing

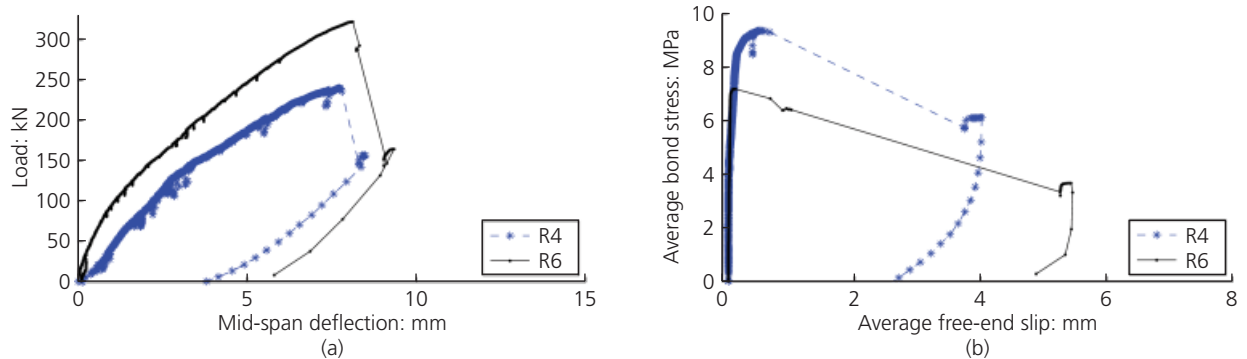
Figure 7. (a) Average load from hydraulic jacks versus measured deflection at mid span. (b) Average bond stress versus average measured free-end slip for R specimens

Figures 7, 10 and 11 show the calculated average bond stress versus measured average free-end slip for R, M and H specimens respectively (measurement noises were filtered out). It should be noted that the measured slips were all negative for the first test series (Lundgren *et al.*, 2014) and also for the first test in this series (M5) (see Figure 10). The problem was solved in the other tests of this series by measuring the deformation of the concrete

larger slips at post-peak behaviour. For example, in Figure 7, R4 showed larger deflections for the applied load compared with R6 and the main tensile reinforcements in R4 also showed more ductile bond behaviour. A residual bond capacity of around 50–70% of the maximum bond capacity was observed for large slip values in most of the tests.

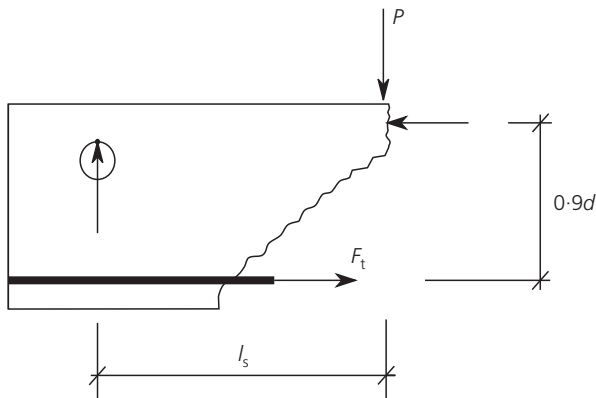
Figure 9. Notation used in estimation of the tensile force in the longitudinal reinforcement

The average bond stress along the bundled bars was estimated as follows. The axial force in the longitudinal reinforcement bars was calculated assuming that no tensile force was transferred over the main shear crack (see Figure 9). The inner lever arm was assumed to be $0.9d$, in which the effective height d was taken as the distance between the top of the cross-section to the average position of the tensile reinforcement bars. From equilibrium, the tensile force in the longitudinal reinforcement was thus calculated as

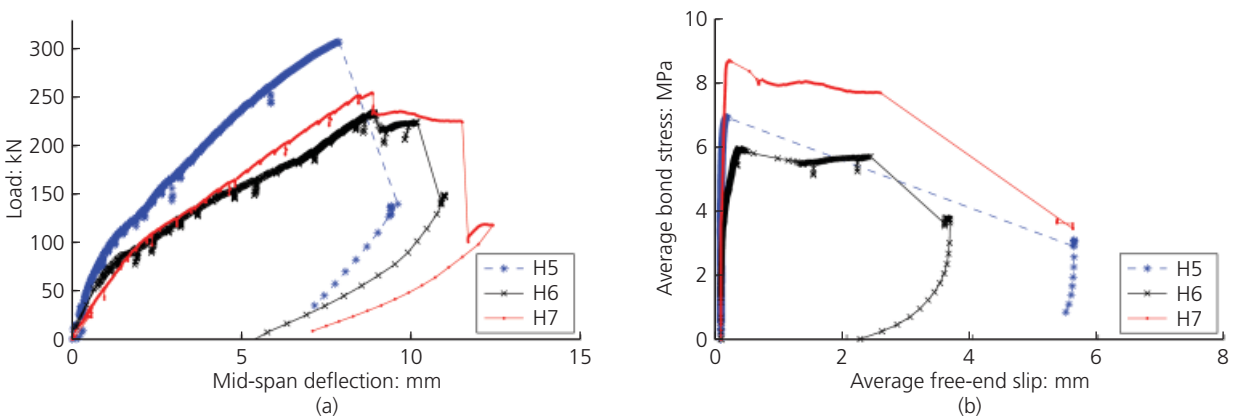
Figure 11. (a) Average load from hydraulic jacks versus measured deflection at mid-span. (b) Average bond stress versus average measured free-end slip for H specimens

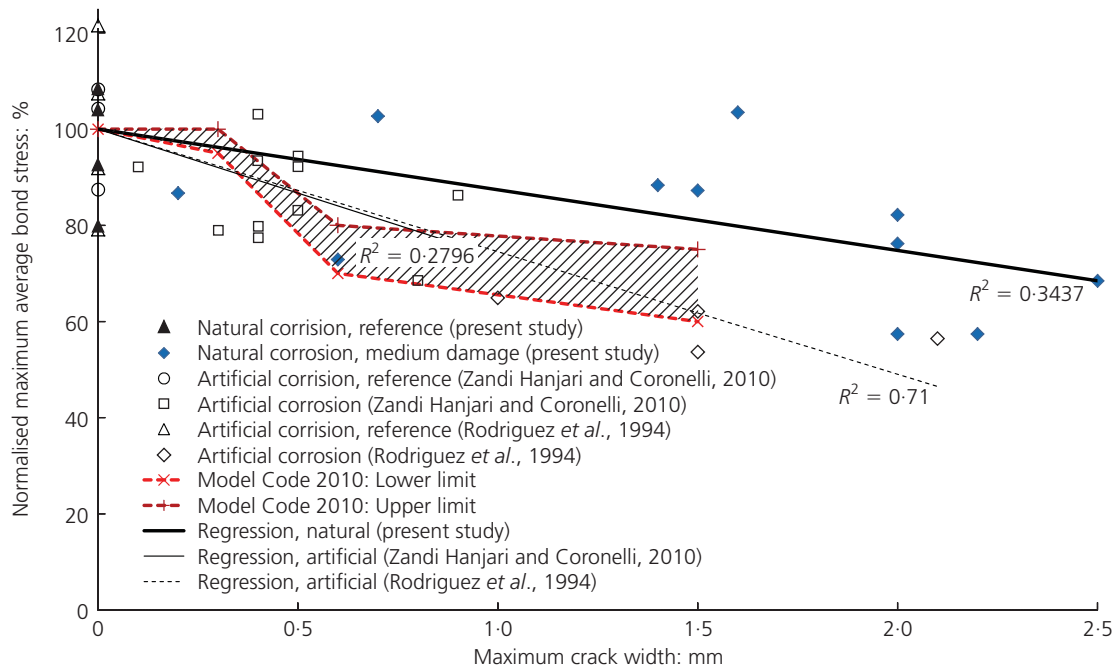
Figure 12. Comparison of test results from naturally corroded specimens with artificially corroded tests and with Model Code 2010 in terms of bond strength, normalised with respect to the

average maximum bond strength obtained from R samples, versus maximum crack width

The maximum observed crack widths before structural testing were measured in the shear and anchorage zones in each specimen (Table 10). These values are plotted against the maximum average bond stress normalised using the average value of the R specimen in Figure 12. The results indicate decreasing bond

capacity with increasing crack width. Model Code 2010 (fib, 2010) suggests a reduction in residual bond strength depending on the crack width and this is plotted for comparison in Figure 12. As Model Code 2010 gives a range for both bond strength and crack width, it was decided to plot the interval as the ranges in bond strength versus the average values of the relevant crack width ranges. As the figure shows, the upper and lower limits for

the residual bond strength also have a descending trend with respect to the increase in crack width. It can be observed that the residual bond capacities of the naturally corroded specimens were higher than the upper limit in Model Code 2010.

Furthermore, in Figure 12, the results of the present study are compared with two different test series of accelerated corroded

specimens carried out by Rodriguez *et al.* (1994) and Zandi Hanjari and Coronelli (2010). The results from the naturally corroded specimens in this study and the artificially corroded tests are different. The bond strength of the naturally corroded bars was considerably higher than that of the artificially corroded specimens. It is worth mentioning that the range of measured crack widths in the naturally corroded samples was wider than with the artificially corroded specimens in the previous studies. Andrade and Alonso (1993) found that crack width depended not only on the corrosion level (reduction of bar cross-sectional area) but also on the applied current density (corrosion rate). For the same corrosion level and with low corrosion rates, larger crack widths appeared on the concrete surface.

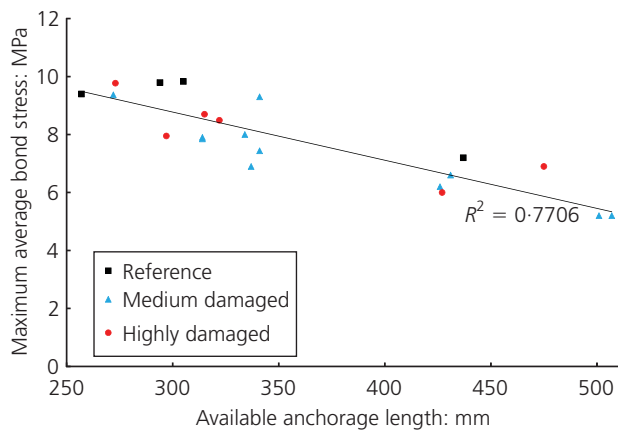
Figure 13. Maximum average bond stress in the anchorage zone versus the measured available anchorage length

As expected, the maximum average bond stress depends on the available anchorage length (Figure 13). The measured available anchorage length varied between 250 and 500 mm in the present study while it was fixed to a value of 210 mm in both the accelerated corrosion studies mentioned earlier. Furthermore, the artificially corroded specimens had a greater number of stirrups. It is therefore noteworthy that, for the same crack width, in spite of these differences, higher bond stresses were obtained in the naturally corroded tests than in the artificially corroded specimens.
