Assessment of the load-carrying capacity of existing structures with corroded smooth reinforcement bars

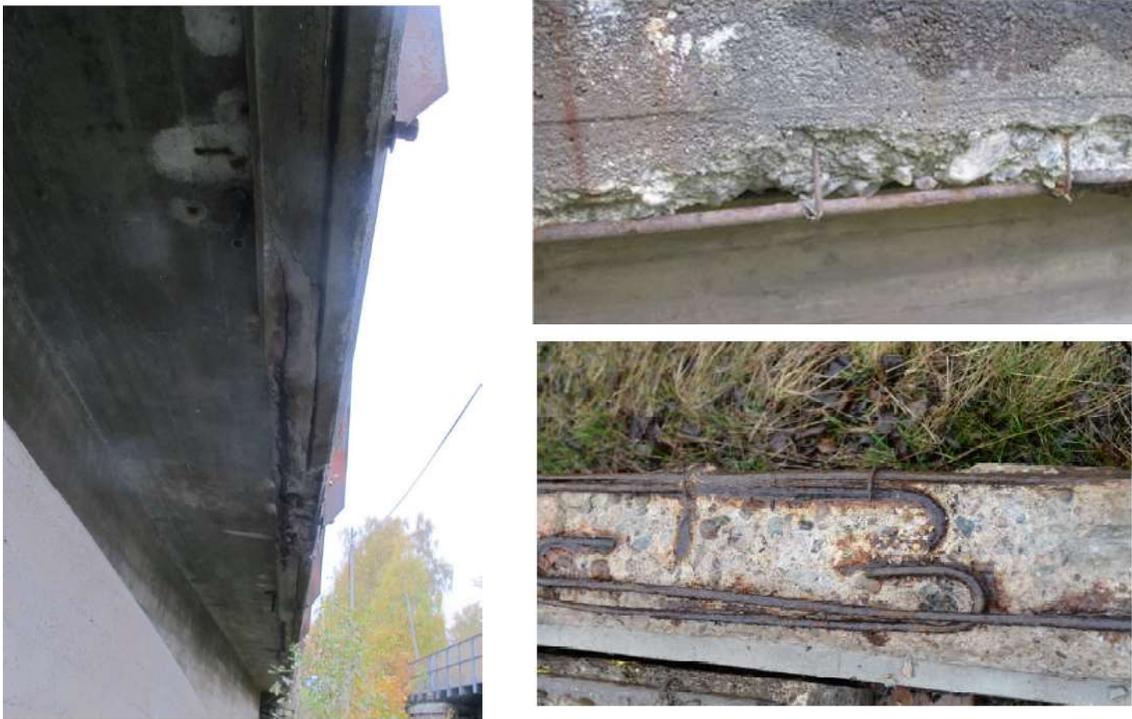
Figure 1 – On the left, the bridge in Gullspång before removal, photo from below showing the bottom side of the edge beam. On the right, a close-up of an edge beam and one of the edge beams after removal, note the hooks.

The bridge was built in 1935, and torn down in February 2016 due to heavy corrosion damages. The edge beams taken from the bridge were carefully inspected and documented before the bridge was demolished. The edge beams were then cut off, into 4-metre-long segments, and kept for research purposes, resulting in a total of 20 beams with varying amounts of corrosion damage (see

Fig.1). The specimens are naturally corroded and spalling, crack patterns, and crack widths of the surrounding concrete on the bridge were observed and documented.

confinement effects of the stirrups and the effect of top-cast and bottom-cast bars. Furthermore, the smooth bars have hooks at the ends, as was common to improve anchorage (as can be seen in Fig.1). For specimens with less corrosion damage, X-ray scanning will be used to locate the position of the hooks before cutting the specimens, to test specimens both with and without end hooks. Before testing, the edge beams will be grouped per similar damage pattern, in terms of cracking and cover spalling. During the tests, the applied load, deflection and end-slip will be measured and the crack pattern carefully documented. After structural testing of the beams, material tests will be performed on undamaged concrete, as well as on the corroded reinforcement bars. The aim is to investigate anchorage capacity of the corroded smooth bars, and, ultimately, to link bar properties, such as anchorage capacity, corrosion level, tensile capacity and ductility, to the documented visible damage, so as to provide guidance on how to obtain the load-carrying capacity of structures from visual inspection.
