INFLUENCE OF DESIGN AND MATERIALS WITH CONSIDERATION TO THE ANNUAL MAINTENANCE WORKS IN RECOVERY BOILERS

Diploma work No. 48/2011

at the Department of Materials and Manufacturing Technology CHALMERS UNIVERSITY OF TECHNOLOGY Gothenburg, Sweden

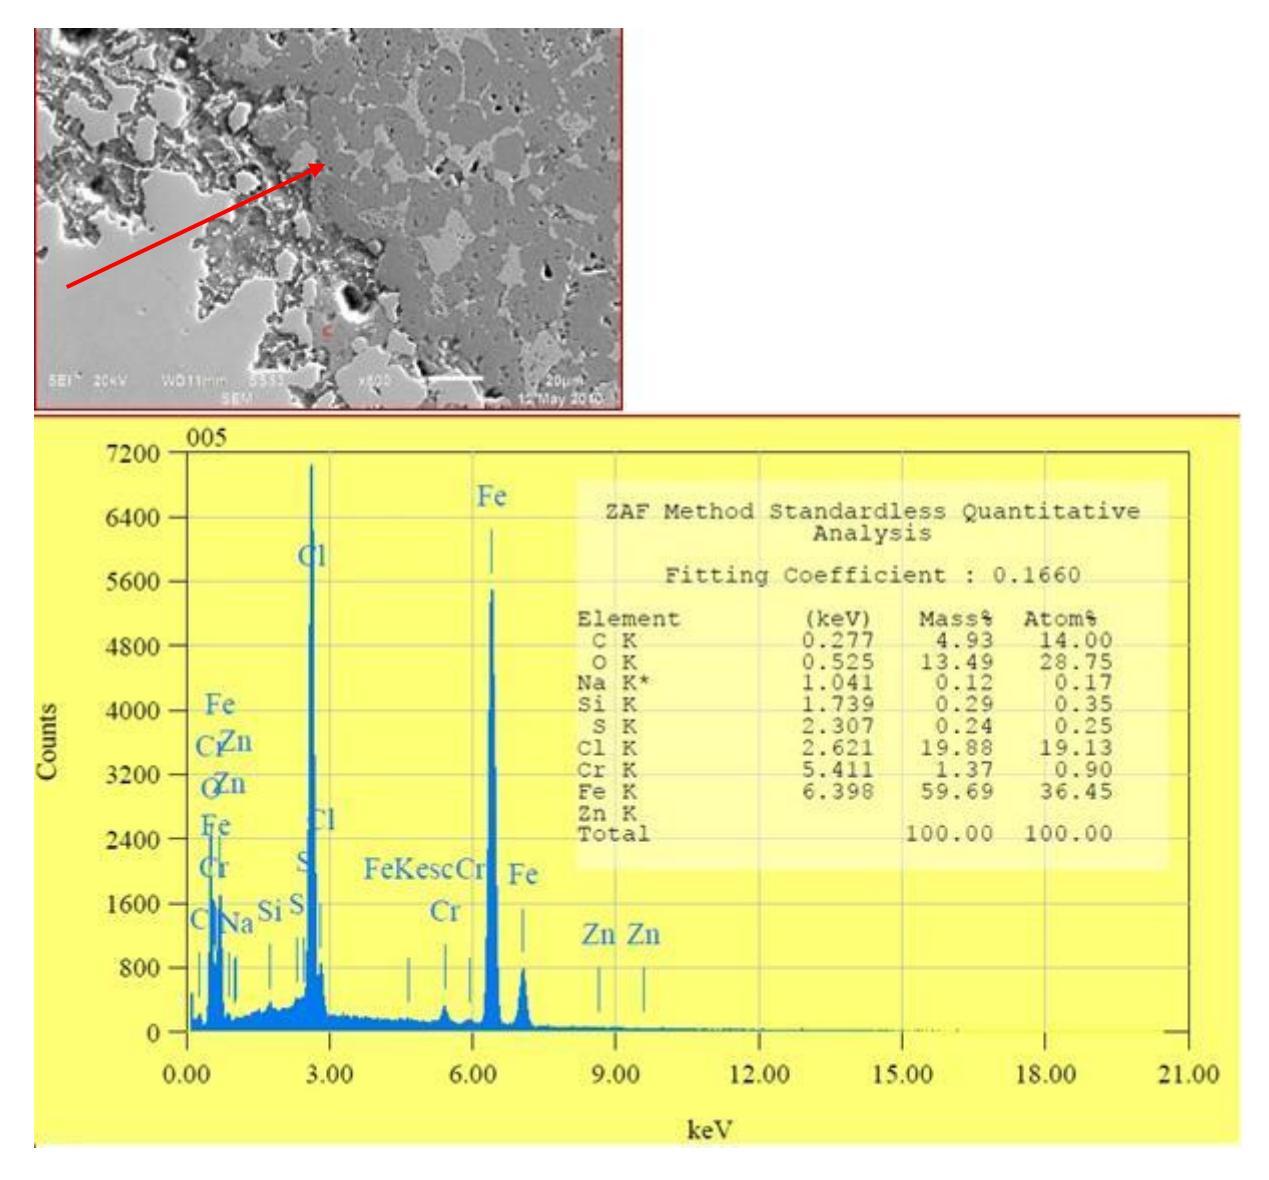
In the areas close to the base material and suffering from intergranular corrosion, energy-dispersive x-ray spectroscopy (EDS) revealed high content of chlorides, oxygen and carbon. The results are presented in Figure 18.

Figure 18 – Chemical composition by spot analysis at point shown by arrow

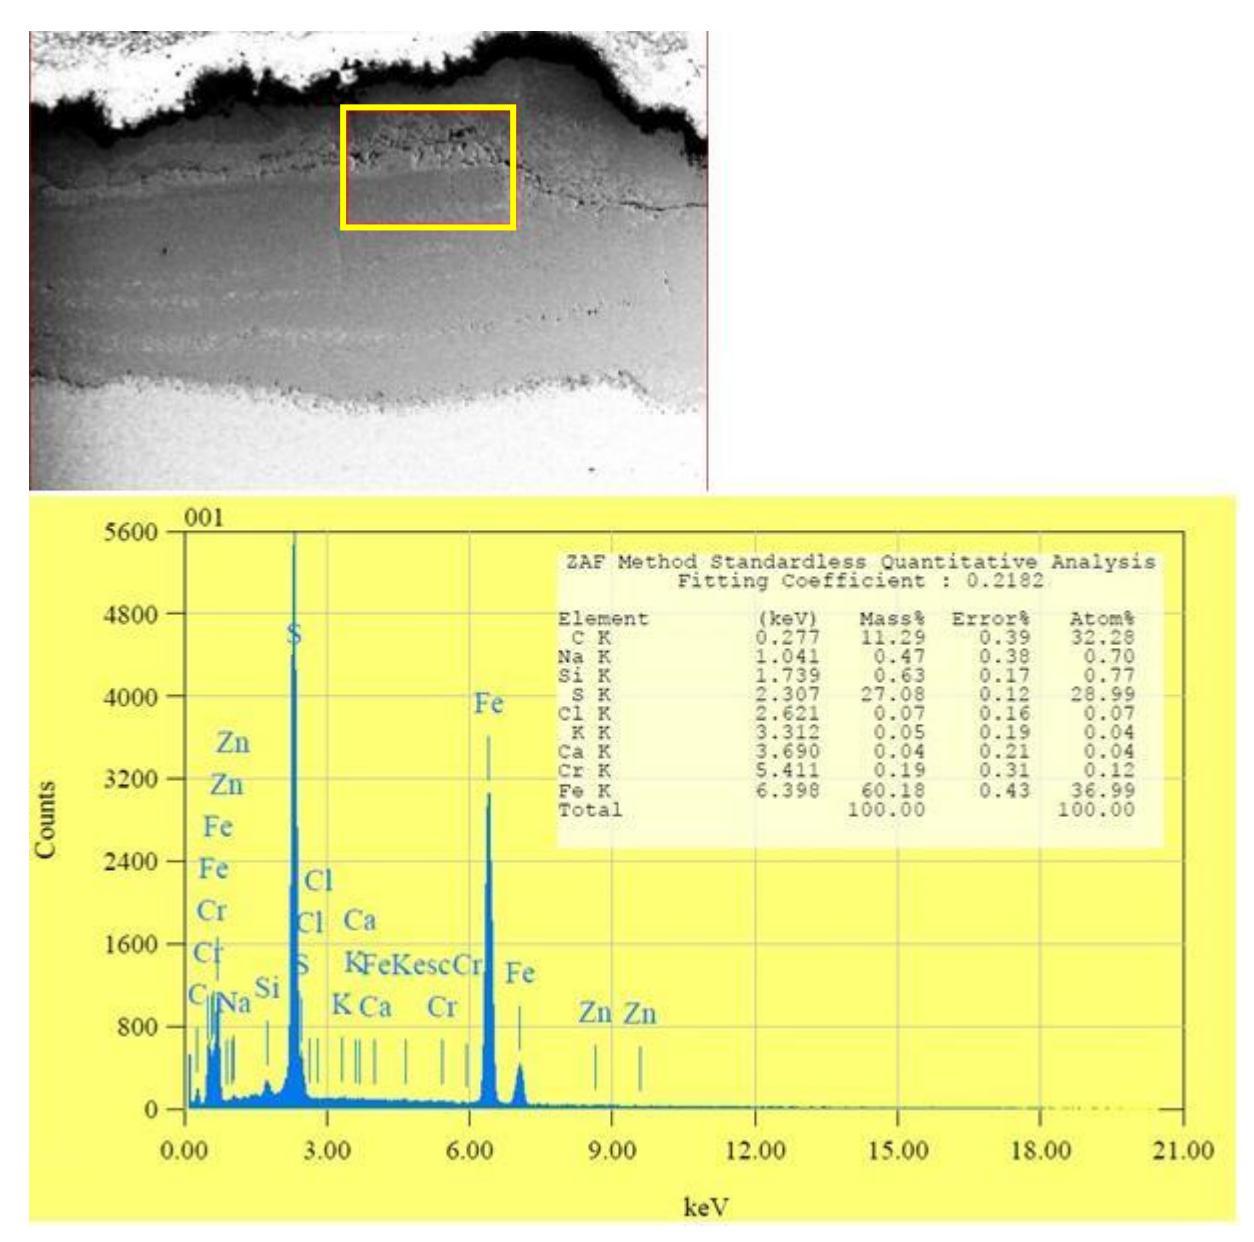
In the deposit about two thirds towards the gas-side EDS analysis of a light coloured part of the deposit revealed high content of sulphur and carbon. The results of the analysis are presented in Figure 19.

Figure 19 – Area analysis of deposit about 2/3 towards the gas side

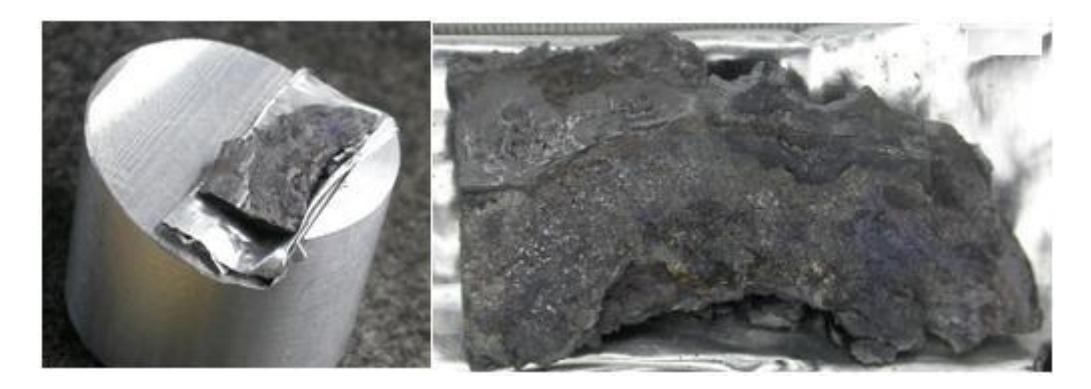
EDS was also performed on a chipped flake of the deposit from the tubes gas-side surface and the area analysis of the flake demonstrated high amounts of iron, sulphur and oxygen. Spot analysis in one part of the investigated area showed high amounts of potassium, chlorine and oxygen. A second spot was found to contain high amounts of iron and oxygen (iron oxide) but also elevated amounts of carbon. A fourth spot within the analysed area revealed high amounts of sodium and chlorides, but also quite large amounts of sulphur and carbon. The flake and the results from the area analysis are shown in Figures 20 and 21 respectively.

Figure 20 – The flake taken from the deposit

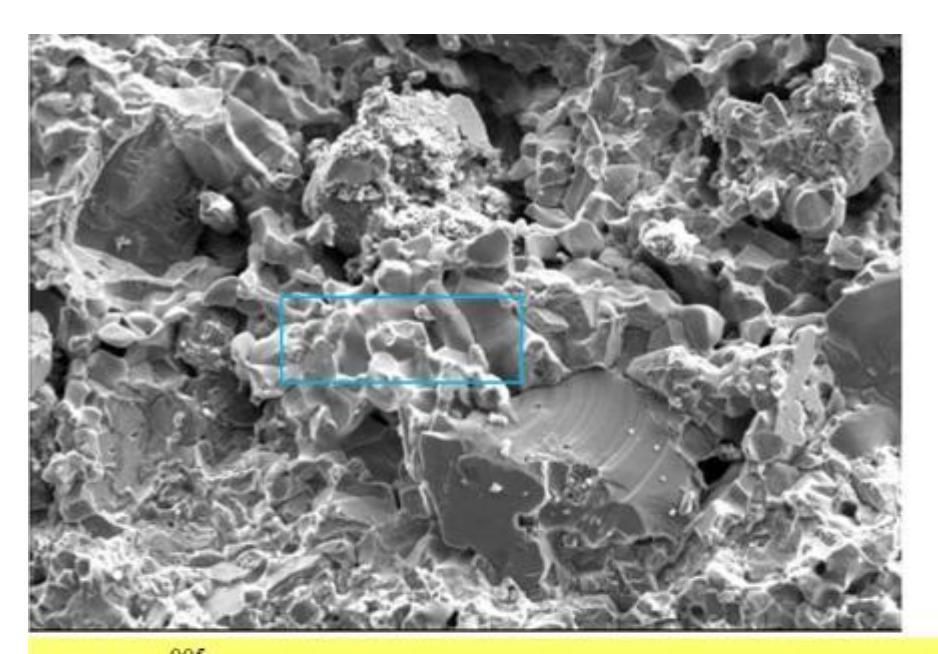
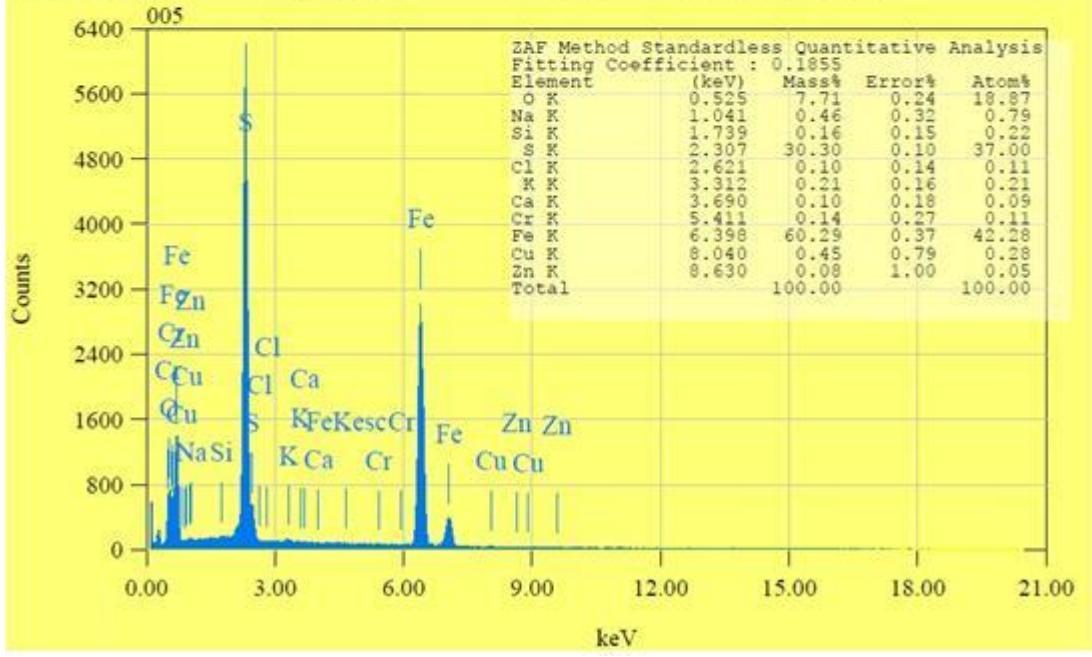
Figure 21 – Area analysis of the flake as shown in the Figure

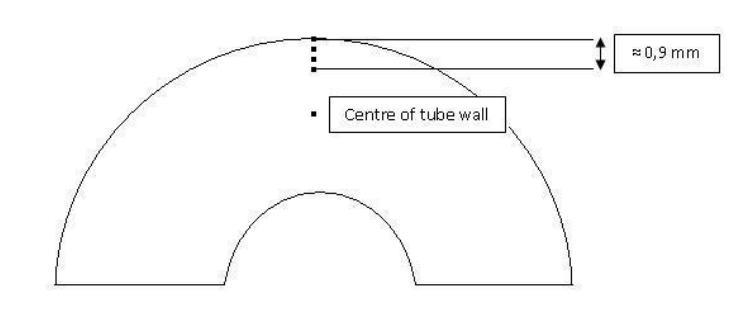
The hardness of the damaged tube from Nueva Aldea was tested with the Vickers method, using a load of 1 kg for the indentation. Measurements were first made in a line going from the outmost part of the tube wall (as close as possible to

the oxide) towards the centre of the tube wall as shown in Figure 22. The distance between each measurement was kept at 0,3 mm in order to ensure that they did not affect each other. All measurements were kept at the metal that is to say that no measurements were made in oxidized areas. The results of the measurements are presented in Tables 8 and 9.

Figure 22 – Hardness measurements method on the tube sample from Nueva Aldea

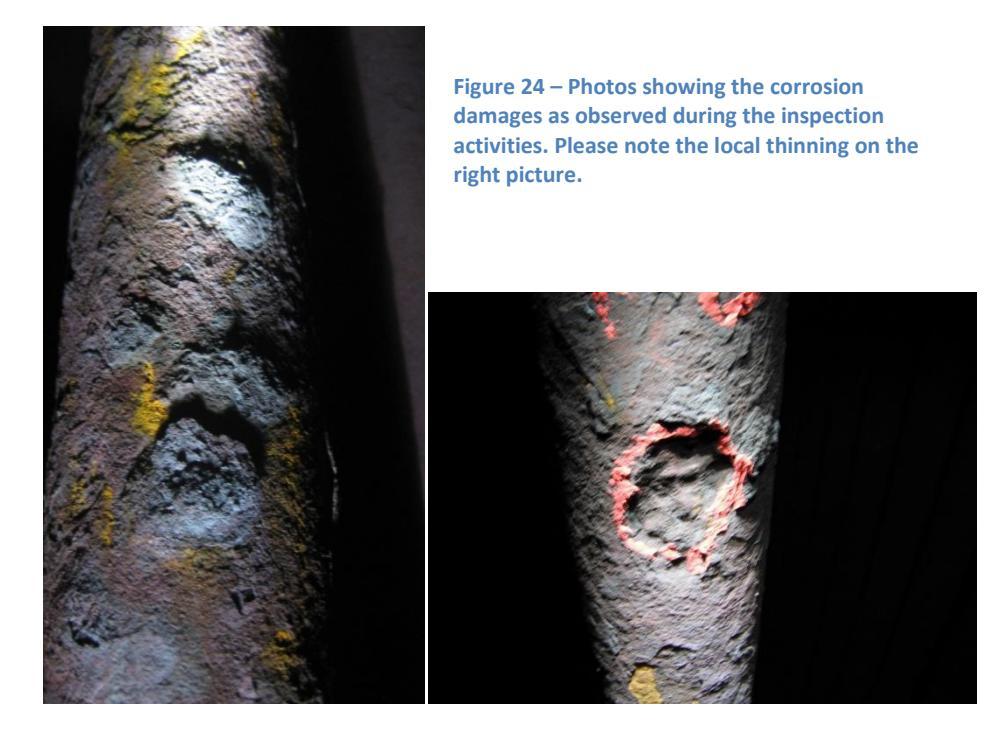
In the Burgo plant the damages were found in the tertiary superheater and not in the secondary superheater. Furthermore the damages appeared to be more severe than in Nueva Aldea. The damages typically began about one meter below the boiler roof and reached approximately three meters downwards. All tubes except for the tubes closest to the boiler sidewalls were affected and the tubes are all made in SA213T22 steel. The tubes, shown in Figure 24, had an appearance of a moon landscape with thick and poorly adhesive scales of corrosion products and deposits. The worst damages were found to be very local. Differences in thickness of up to 2 mm were found at a distance of only a few mm from the local damage.

What is interesting with the damages found in the Burgo plant is that the general steam temperatures are so low, that no serious damage to the superheater tubes should occur at all.

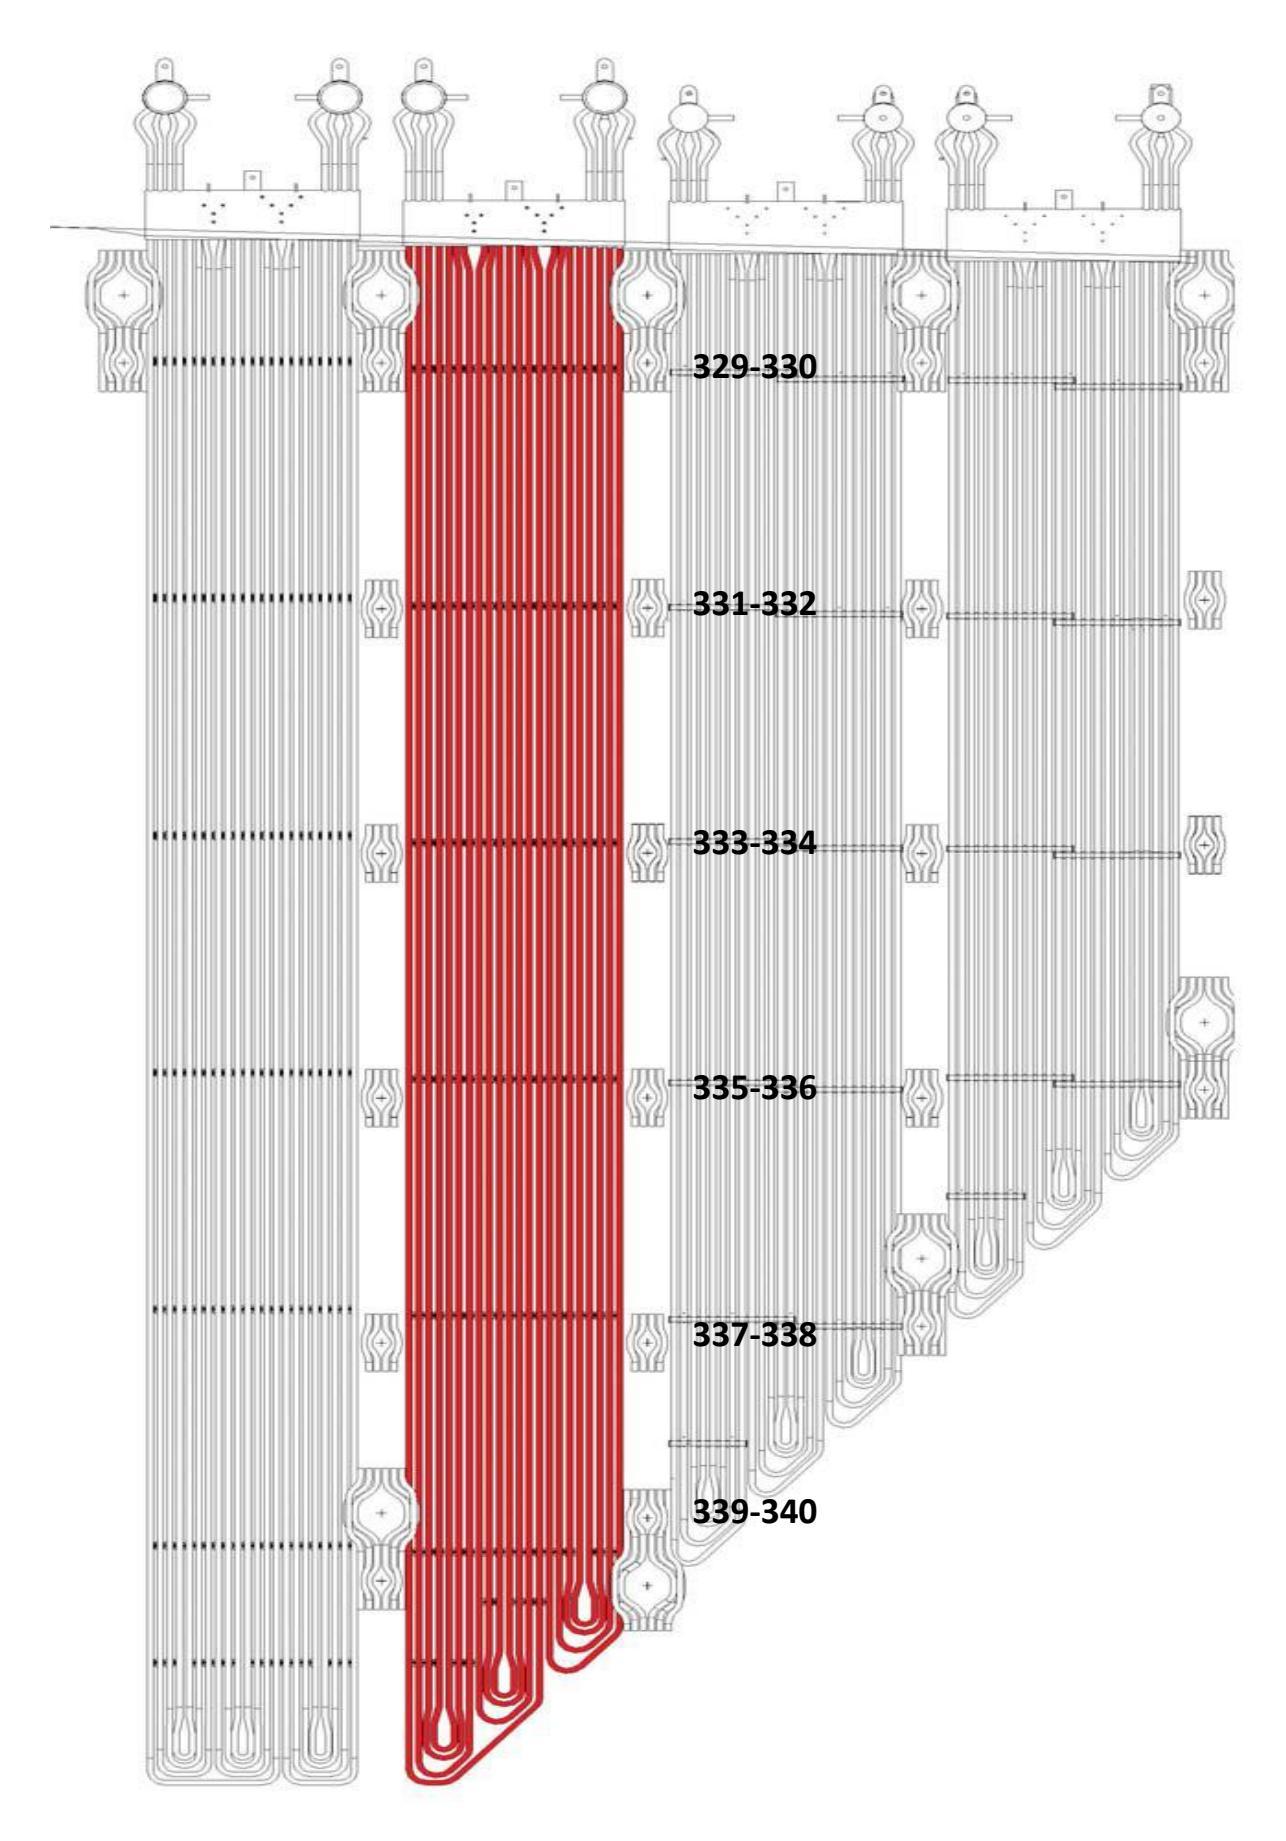
Figure 29– Superheater panels in the Valdivia plant. Tertiary panel in red with sootblower levels marked (Safe Control Boiler Service, 2009) (Courtesy of Metso Power)

From Table 15 it becomes clear that most corrosion damage has occurred high up on the tubes since the lowest measurement level (i.e. SB 333-334) has suffered a lot less damage than levels 331-332 and 329-330 (close to the roof). Please see Figure 29 on the next page for level references.

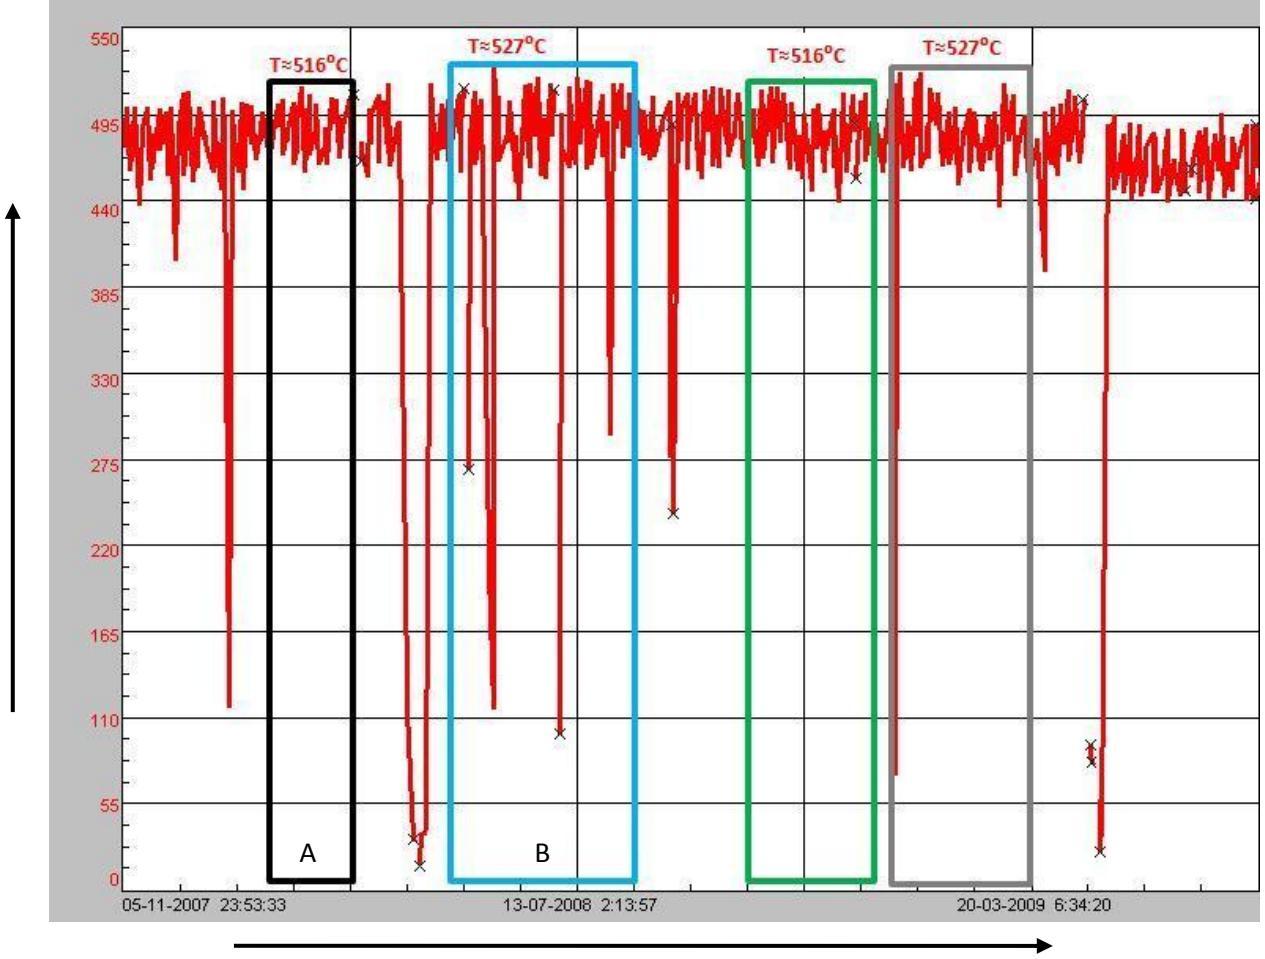
As seen in Figure 31 below, the steam temperature has continuously been close to and often above 495°C in the period of November 2007 to April 2009. Add to that the expected difference between steam and surface temperature (50°C) and we can draw the conclusion that metal surface temperature has been at least 545°C during a substantial part of the period. During the same period, the mean composition of the ash has been 1,08 % chlorine and 8,79 % potassium.

Figure 31 – Steam temperature and date in tertiary superheater in Valdivia with top interval notation above each box (Celulosa Arauco y Constitución S.A.)

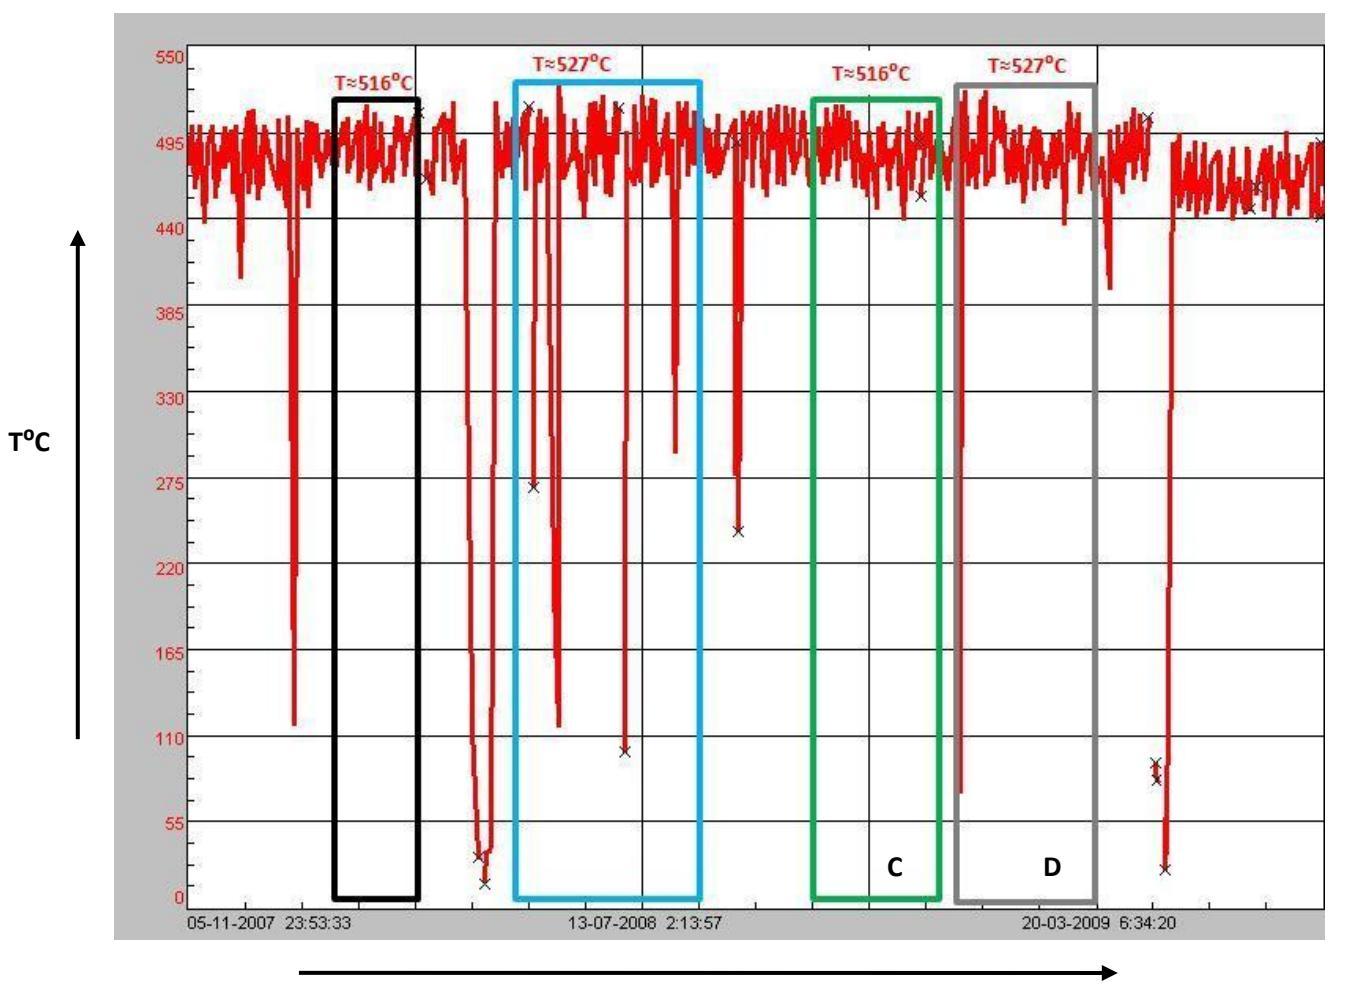
Figure 32 – Steam temperature and date in tertiary superheater in Valdivia (Celulosa Arauco y Constitución S.A.)

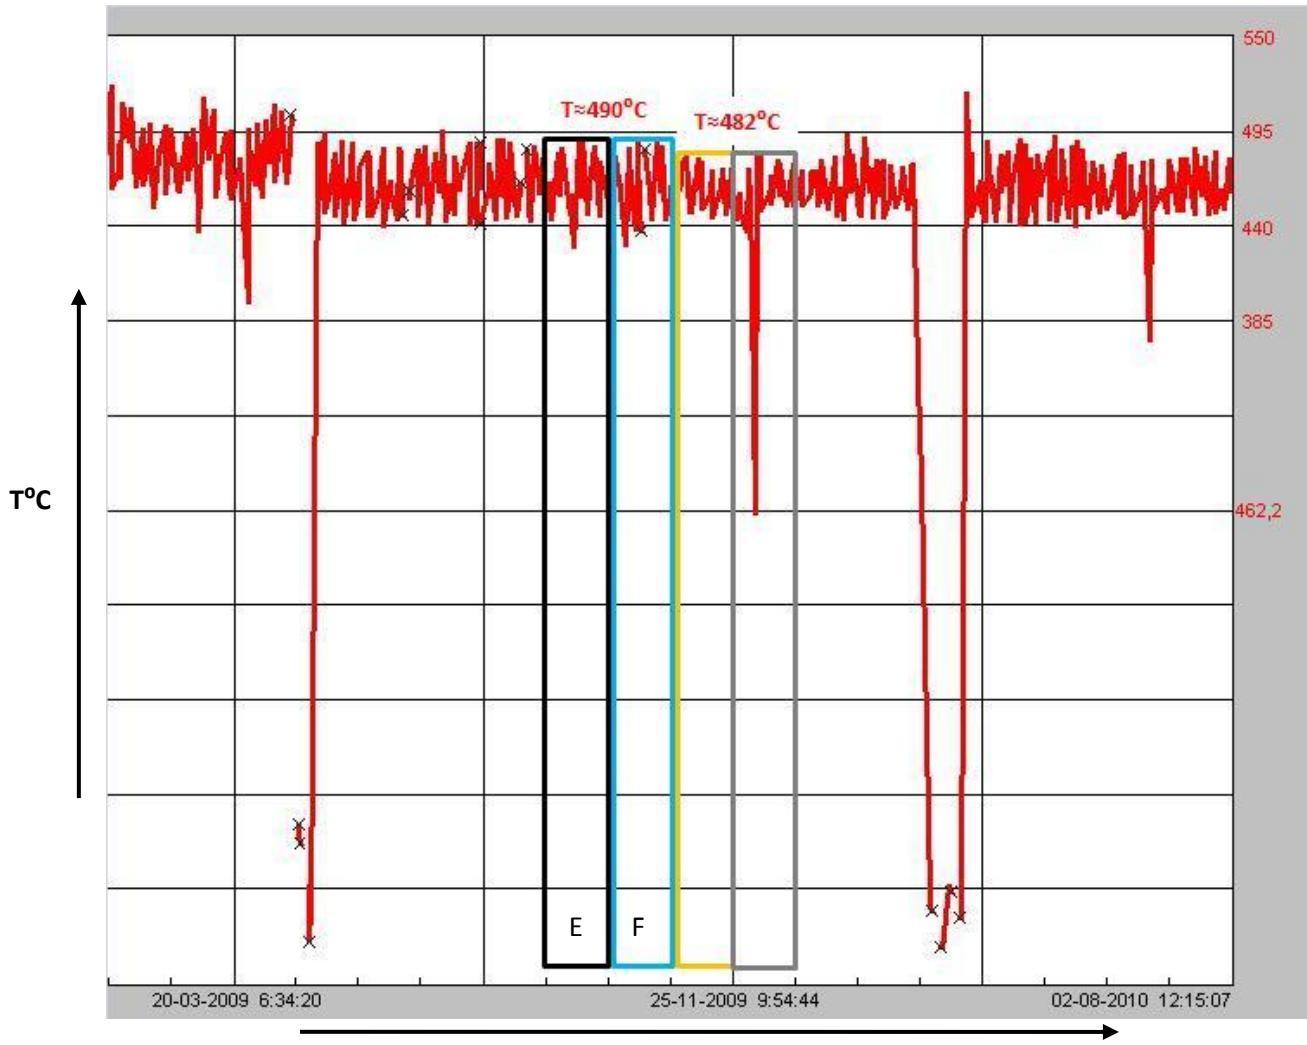
In October something happens and chlorine levels go up to very high amounts, passing 3 % for a period of about two weeks (late October/early November) with levels above 2,5 % for an even longer period. During this time the outlet steam temperature stays at about 480°C. The chlorine levels remain high until late December when they fall to a medium level below 2 %. NoTable for the period of high chlorine levels is a slight decrease in potassium.

Figure 33 – Steam temperature and date in tertiary superheater in Valdivia (Celulosa Arauco y Constitución S.A.)

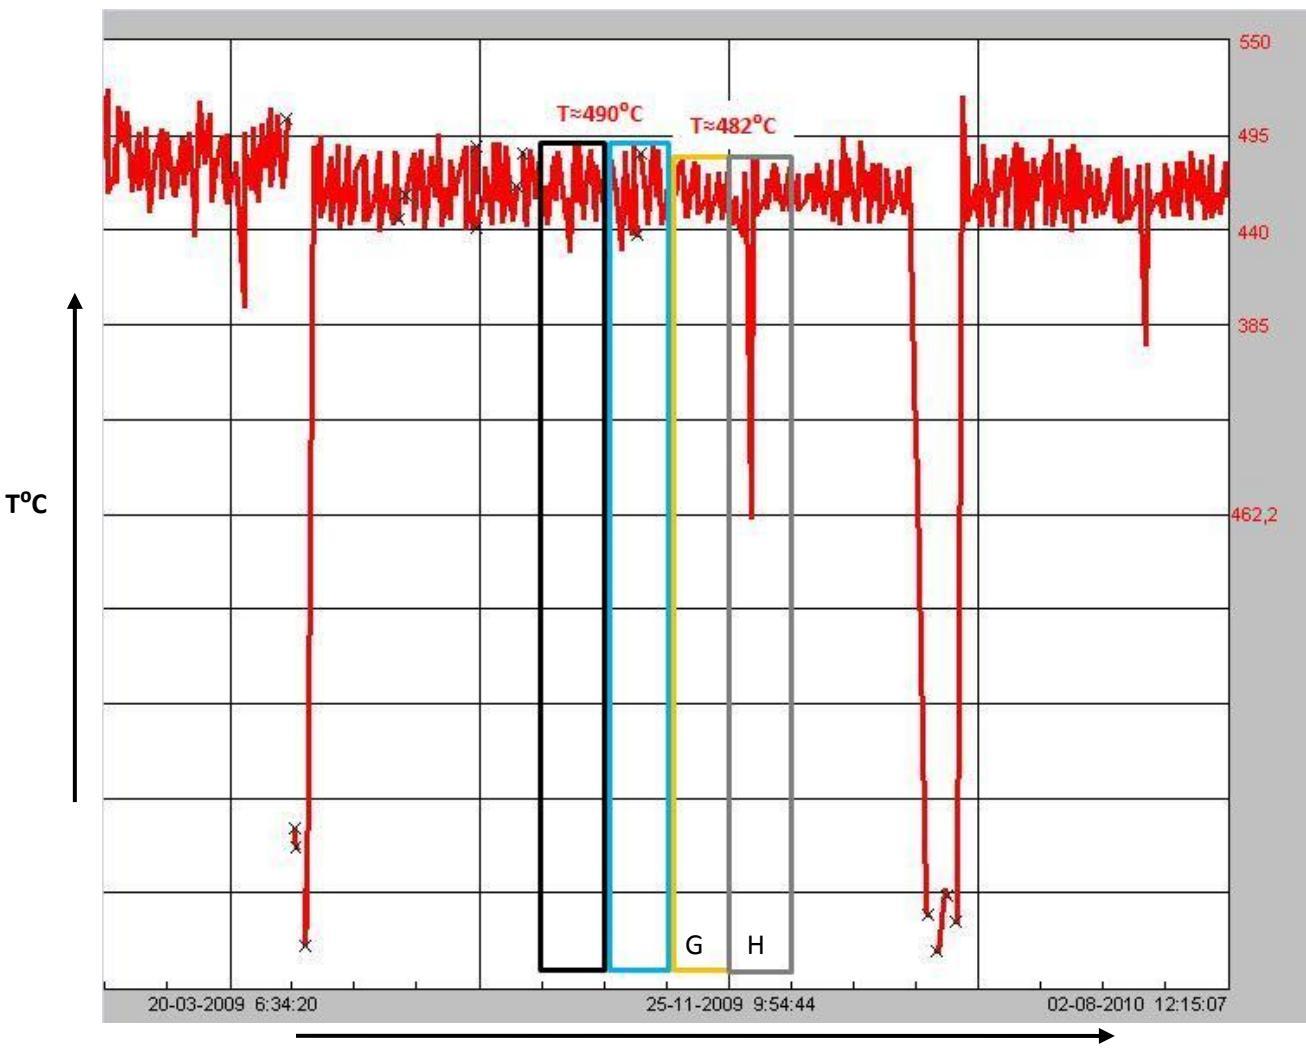
Figure 34 – Steam temperature and date in tertiary superheater in Valdivia (Celulosa Arauco y Constitución S.A.)

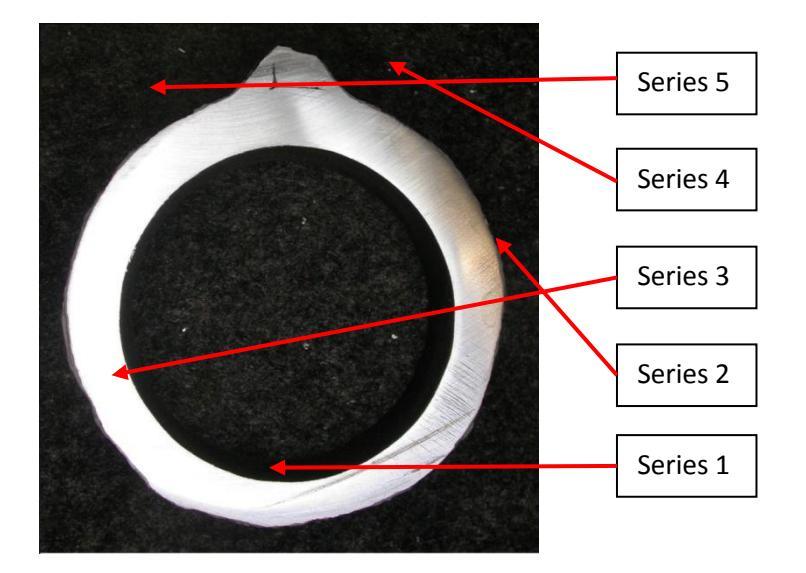
Figure 35 – Tube sample from sootblower level 329-330, showing where hardness measurement series were made

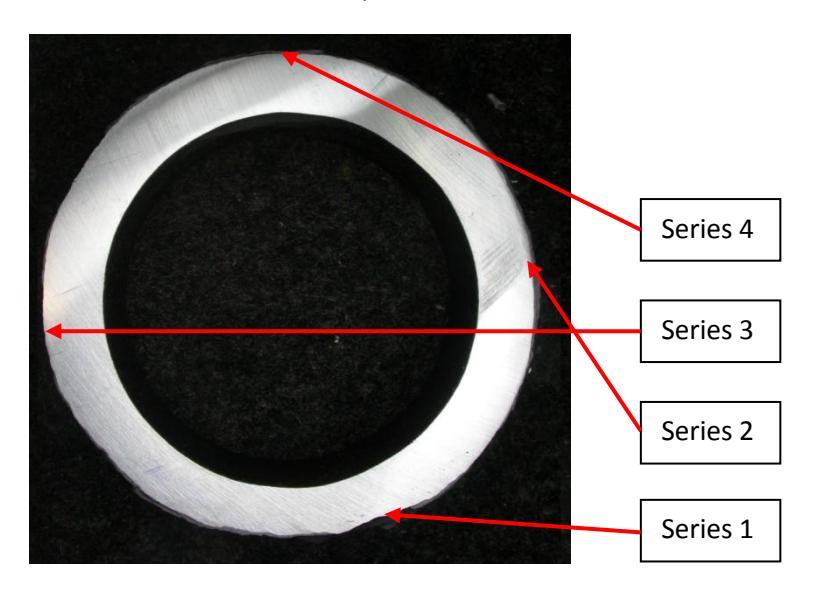
Figure 36 - Tube sample from 2 meters below sootblower level 329-330, showing where hardness measurement series were made

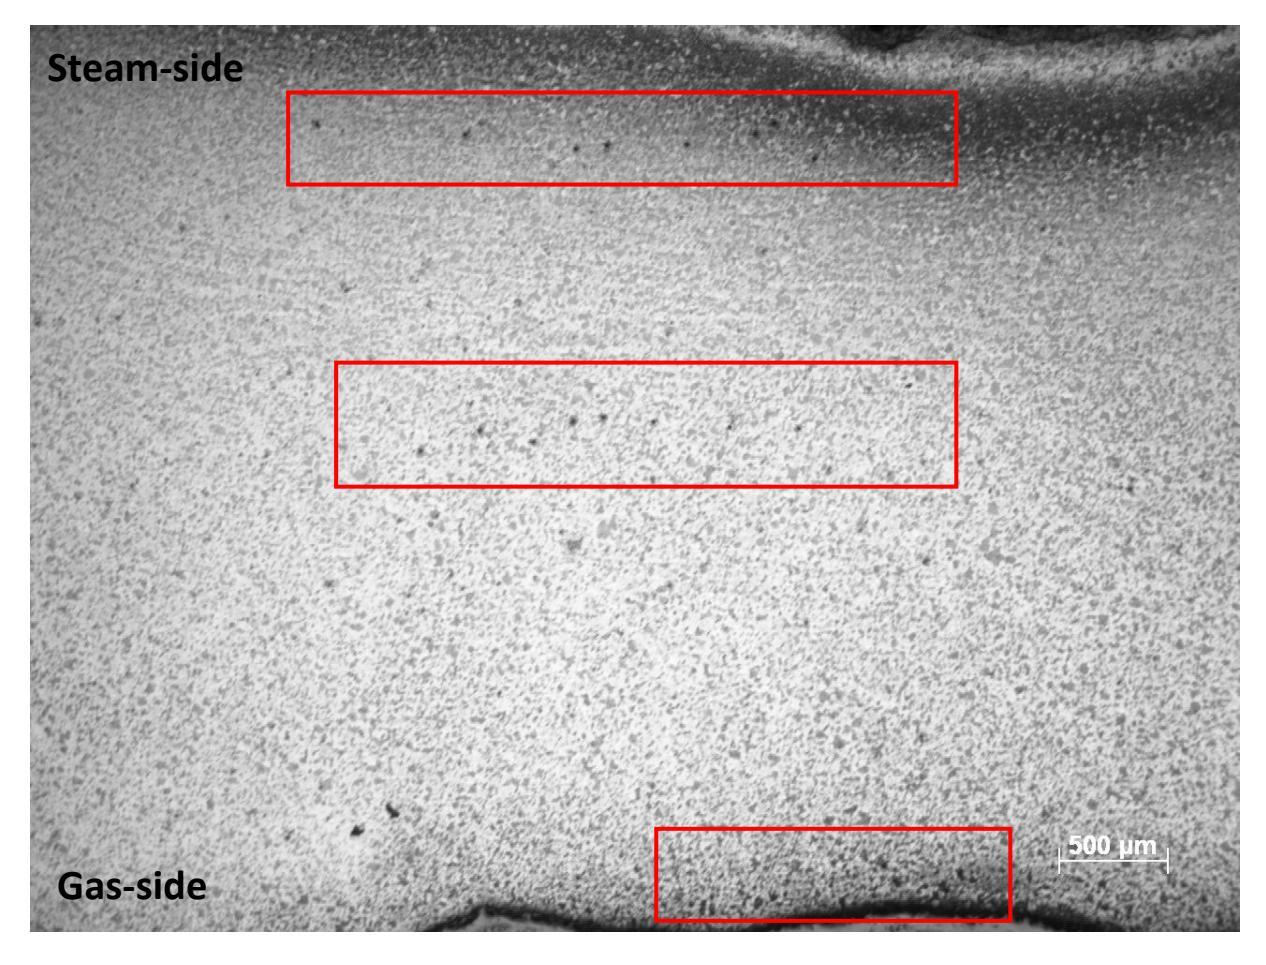
Figure 37 – Some of the measurement locations used for the micro hardness measurements. The measurement points can be seen as black dots within the marked rectangles.

Table 18 – Hardness of specific grains within the given zones given in Vickers. It can be seen that both the ferrite and pearlite closest to the gas-side is harder than their respective phases in the centre or towards the steam-side of the sample

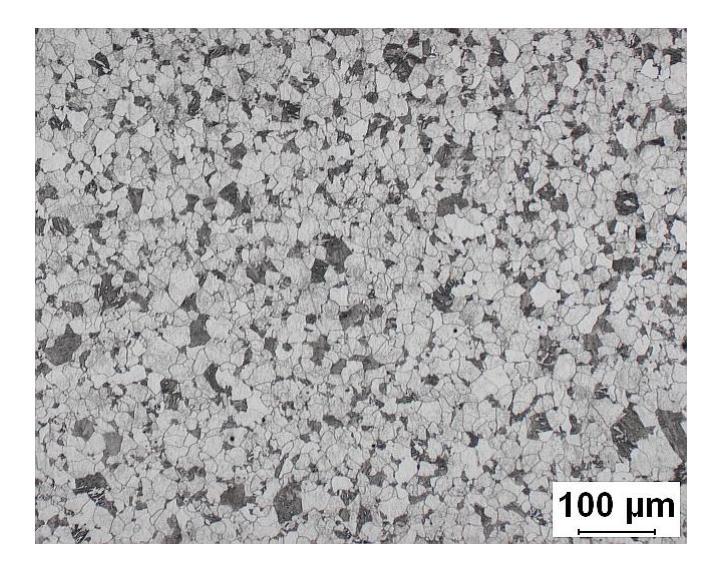
A micro structural analysis was done on the upper tube sample from sootblower level 329-330 and the microstructure is shown in Figure 39. The microstructure of the sample consisted of fine grained ferrite and pearlite with an average grain size of 8,5-9 using ASTM standard (\approx 10 µm). On the steam-side of the sample a decarburized zone consisting only of ferrite was encountered. The decarburized zone had a thickness of 150 µm and can be seen as an entirely white zone in Figure 40.

Figure 39 – The microstructure of the analyzed tube showing a fine grained structure consisting of ferrite (bright) and pearlite (dark)

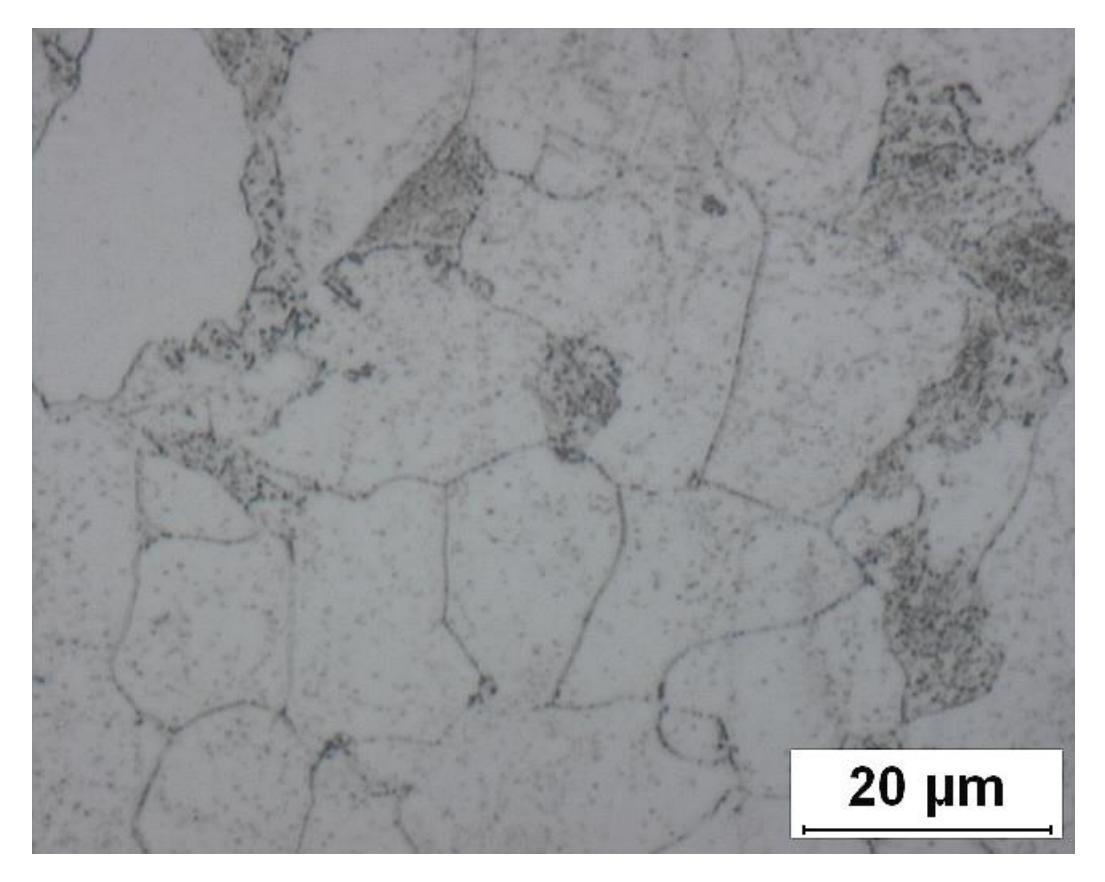
After etching the sample a closer examination of the microstructure was conducted. It was found that the pearlite in the entire sample had been spheroidized. In comparison with the microstructure in the centre of the sample (Figure 43), the pearlite appears to be a lot denser closer to the gas-side surface (Figure 42). This is consistent with carburization.

Figure 43 – A close up on the microstructure in the centre of the sample consisting of spheroidized pearlite and ferrite.

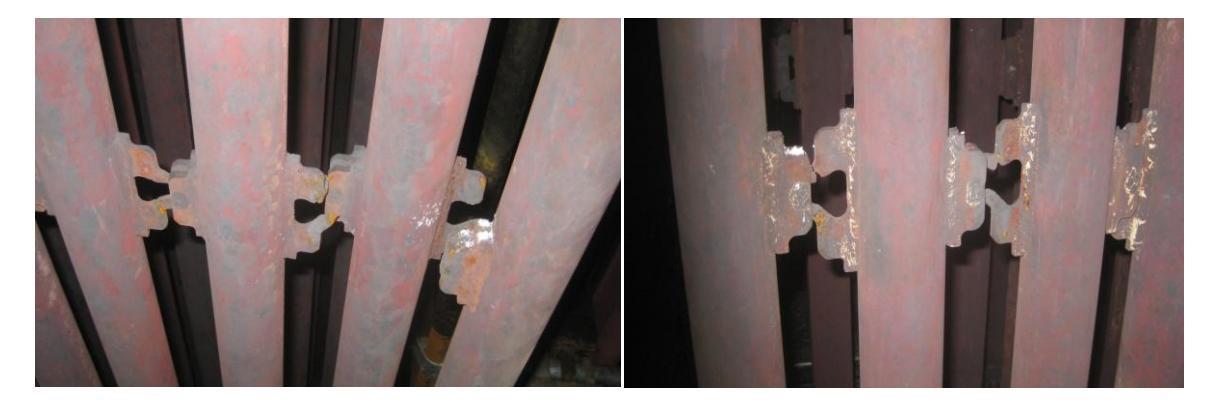
The production has been significantly increased, following increased gas flow and gas velocities through the superheaters. Increased fouling on the upper sections of the superheaters probably results in a further increase in gas velocities due to preferential gas flow channeling. Extreme wastage of ties began in 2007/2008 and in 2010 the failures created a situation where large production losses are foreseen due to the necessity of significant repairs.

The deterioration of these ties has been analyzed by the mill and by Safe Control Boiler Service AB.

The conclusion has been that the ties require significantly better cooling in order to survive in the present environment. Presently, the tie material temperatures simply become so high that the material loses much of its strength. This is why the ties deform plastically and open up or fail at the

slots as seen in Figure 51 above. The main failure is thus caused by overheating due to lack of sufficient cooling. For this particular case what would be desired is either colder cooling media (colder steam), lower heat input (lower heat load) or much shorter distance to the tube surface (lower tube spacing or other design of the tie). The path of the heat transfer is showed in Figure 52.

During 2010, approximately 400 ties were replaced and in 2011 around 500 ties will be replaced. As the problems do not have any permanent solution, it is predicted that about 500 ties need to be replaced annually.

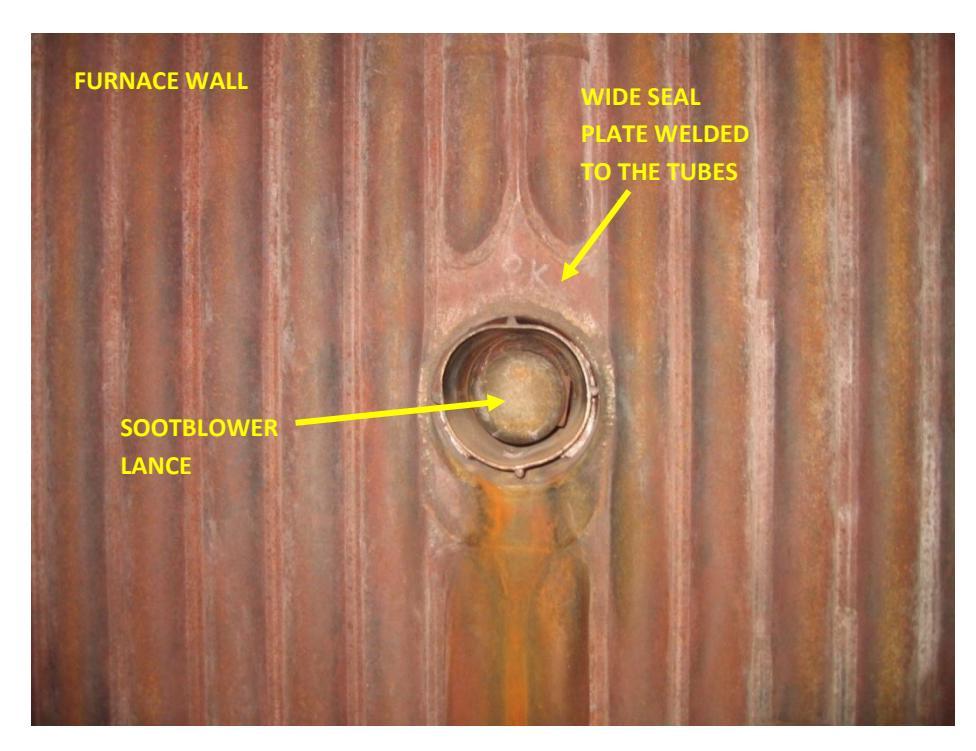
In one of the Andritz fabricated recovery boilers, in South America, the sootblower wall boxes were built as shown in Figure 53 below:

Figure 53 – Sootblower wall box with welded seal plate
