Surface analysis of polyethylene pipes and failure characterization of electrofusion joints

Master of Science Thesis in the Master Degree Programme, Materials and Nanotechnology

LUKAS BOGE
EMIL HJÄRTFORS

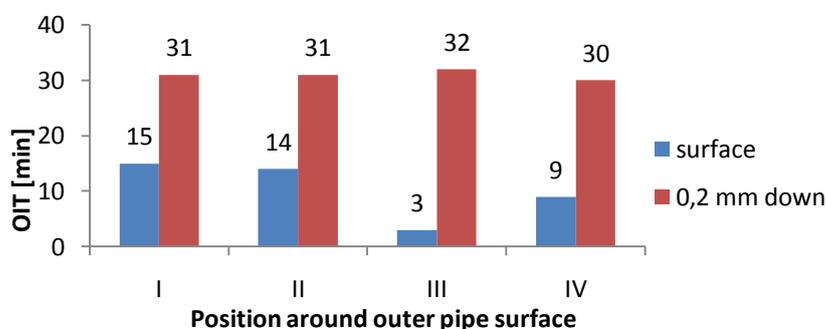
The old pipes circumference was divided into 4 sides named I, II, III and IV, oxidation induction time were measured at each of these sides. Differences can give an indication of the storage conditions e.g. material degradation due to sun exposure. The mean oxidation induction time at the surface was 10 minutes, with a small variation around the pipe surface as can be seen in Figure 21. For the new pipe and Profuse pipe the surface oxidation induction time were 4 to 5 times higher than for the old pipe.

Figure 21. Oxidation induction time around old pipe at outer surface and 0.2 mm down.

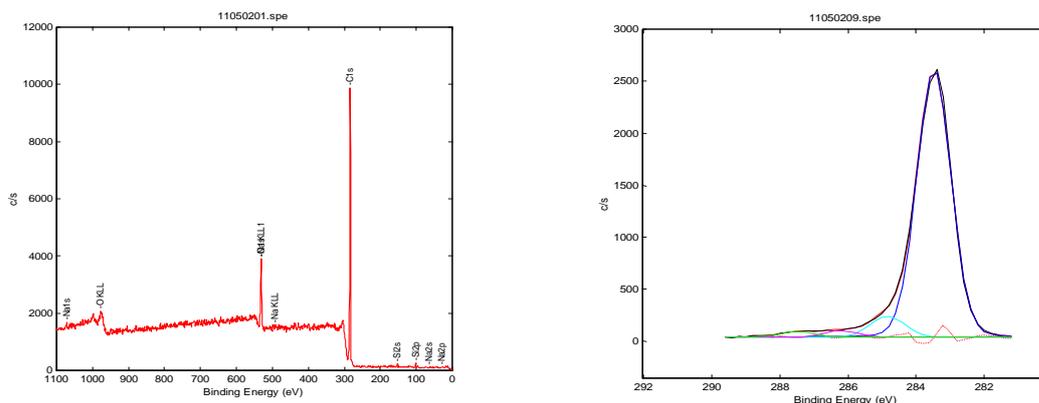
Mean values from the ESCA analyses can be seen in Table 4. The results from the two spots being analyzed on each sample were consistent in all cases. The analysis shows that the outer surface of old and new pipe are oxidized. On the other hand, the surface of the jacketed Profuse pipe contain close to 0 % oxygen. The oxygen concentration in the bulk samples were always zero or close to zero. The surface of the electrofusion coupler at the fusion zone was also oxidized, but not as much as the surface of new and old pipe. Some traces of other elements can be found on the surface samples, especially silicon on new and old pipe. These small fractions of other elements are probably due to contaminations of the samples or insufficient cleaning.

The C/1s peak was resolved into components peaks at different binding energies for all samples. For the Profuse and bulk samples the carbon peak is only due to the C-C band at 283.5 eV. Figure 22 shows a spectrum from a wide-scan (left) and the corresponding high-resolution spectra for the strong carbon peak at 283.5 eV, resolved into four component peaks around 283.5, 284.8, 286.4 and 287.5 eV.

Figure 22. ESCA spectrum for a wide-scan (left) and for a high-resolution scan over the C/1s region at the outer surface of old pipe.

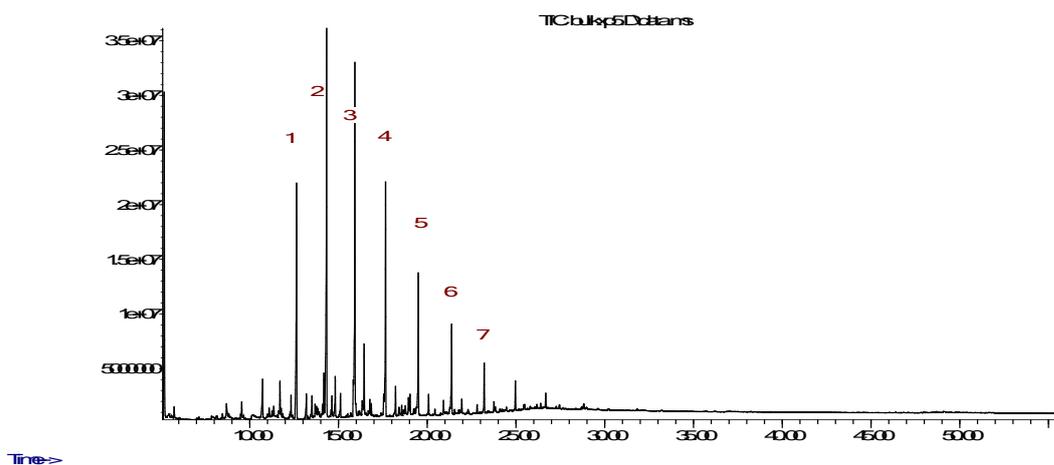
The GC-MS tests showed the presence of aliphatic hydrocarbons in all samples, ranging from tetradecane (C₁₄H₃₀) to hexacosane (C₂₆H₅₄). No oxidation products or other oxygen-containing compounds were found. At the untreated surface squalene was found, however it is very likely a contaminant from a fingerprint (Weyermann et al., 2011).

In Figure 23 the chromatogram of the bulk sample of the old pipe is shown, where the largest peaks were identified.

Figure 23. Chromatogram of the bulk sample of the old pipe. According to mass spectrometry the seven largest peaks corresponds to; 1: tetradecane, 2: hexadecane, 3: octadecane, 4: eicosane, 5: docosane, 6: tetracosane, 7: hexacosane.

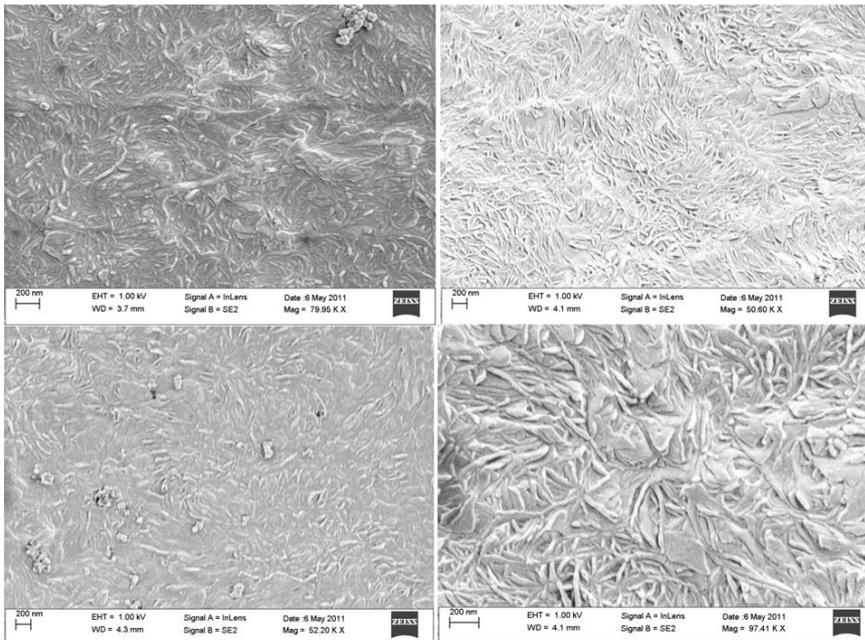
Images of the lamellar profile of outer surface for old pipe and Profuse pipe are shown in Figure 24. The lamellae structure is built up by randomly banded spherulites. The banded spherulites in Profuse seems to be more “thread-like” (upper right) and more elongated than those at surface (upper left) and bulk (down left) for old pipe. There is no difference in crystal morphology between the outer surface of old pipe and bulk, as can be seen in upper and down images to the left in Figure 24.

Figure 24. Crystal morphologies revealed after removal of amorphous regions by etchant. The lamellae structure consists of randomly oriented banded spherulites.

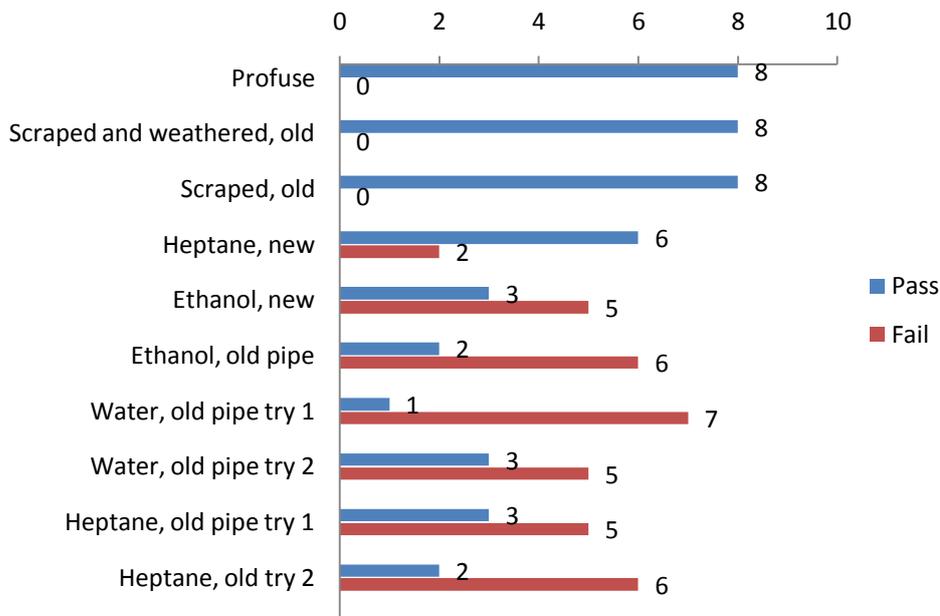
All samples were successfully tested according to ISO 13954. The number of passed and failed samples of every joint can be seen in Figure 26. In order for a joint to be approved all test samples have to pass, thus only three of the tested joints have passed. Two of these joints, scraped and Profuse, were made according to prescribed instructions while the joint scraped and weathered were not. Cleaning only, with water, ethanol or heptane, did not result in an approved joint.

Figure 26. Number of passed and failed samples per joint according to peel decohesion test ISO 13954.

Although the cleaning does not seem to have a substantial effect on welding of the old pipe, cleaning the new pipe with heptane was slightly better than cleaning with ethanol, but not enough to produce an approved joint.

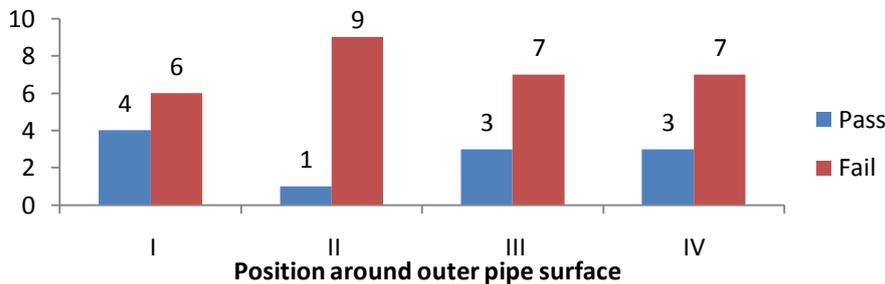
In Figure 27 the number of passed and failed test samples per side of the old pipe, for the not approved joints, is shown. Side II of the pipe seems to be slightly worse than the others.

Figure 27. Number of passed and failed peel-test samples per side for the old pipe.

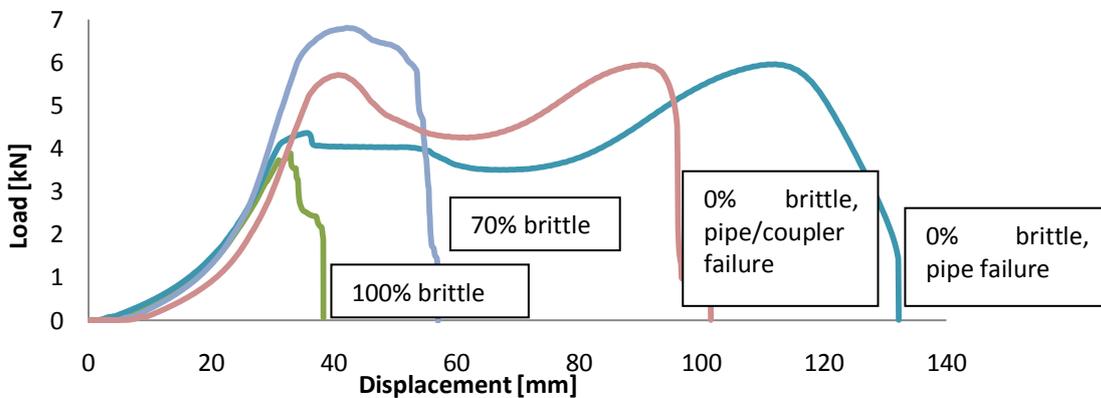
Figure 30 shows four typical graphs obtained during peel decohesion test. From the appearance of the graphs it is possible to get an indication of the failure mode. A typical brittle failure drops fast after reaching the peak load (found at 30-45 mm), thus brittle failures results in low positions. A typical ductile failure has a smoother and more extended curve. During the tests three different kinds of ductile failures could be observed; separation of pipe and couple or failure in either the pipe and/or the coupling. The ductile failures in pipe and/or coupling commonly lead to a second peak.

Figure 30. Example of load/position curves obtained from a peel test (ISO 13954). From the figure several types of failure mode can be seen

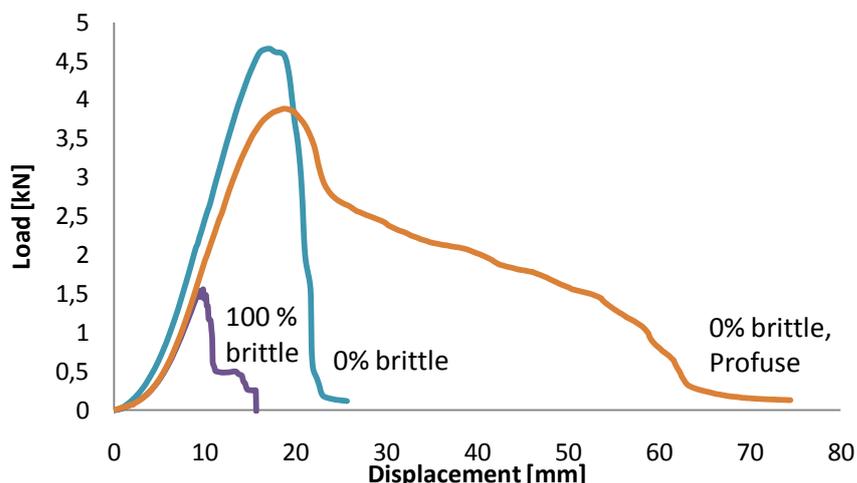
Figure 31 shows the load/displacement graphs obtained from double peel decohesion test. Compared to the load/displacement curves obtained from peel decohesion test, these curves show a more distinctive difference between the different kinds of failures. Apart from the peel decohesion test there is also a larger difference between the peak load of brittle and ductile samples.

Figure 31. Example of load/displacement curve obtained from a double peel test (EN 12814-4).

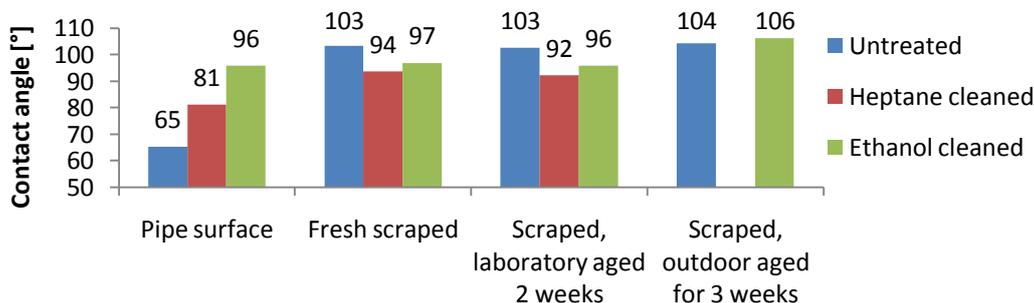
The contact angles for old pipe can be seen in Figure 32. The untreated pipe surface shows lowest contact angle indicating to be most hydrophilic. The contact angle increased after cleaning with heptane. Heptane cleaned surfaces showed higher contact angle than surfaces cleaned with ethanol. All three scraped surfaces have roughly the same contact angle and are thus more hydrophobic than the untreated pipe surface. Cleaning of a scraped pipe surface seems to decrease the contact angle, except when cleaning the outdoor aged sample with ethanol.

Figure 32. Results from the contact angle measurements on old pipe.

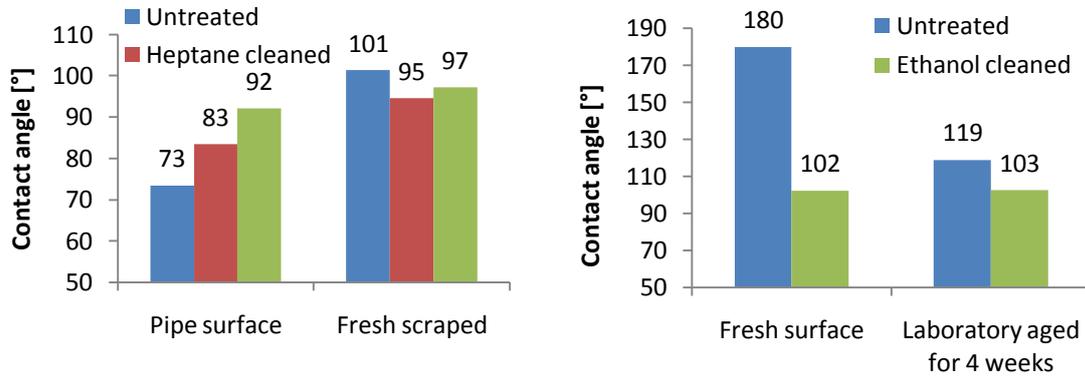
The results for new pipe show the same trend as the old pipe, with the difference that the untreated pipe surface is a bit more hydrophobic. The fresh Profuse outer surface (PP-jacket peeled away instantly) acts super hydrophobic i.e. water droplets do not wet the surface at all, and the contact angle was thereby set to 180°.

Figure 33. Contact angles for new pipe (left) and Profuse pipe (right).

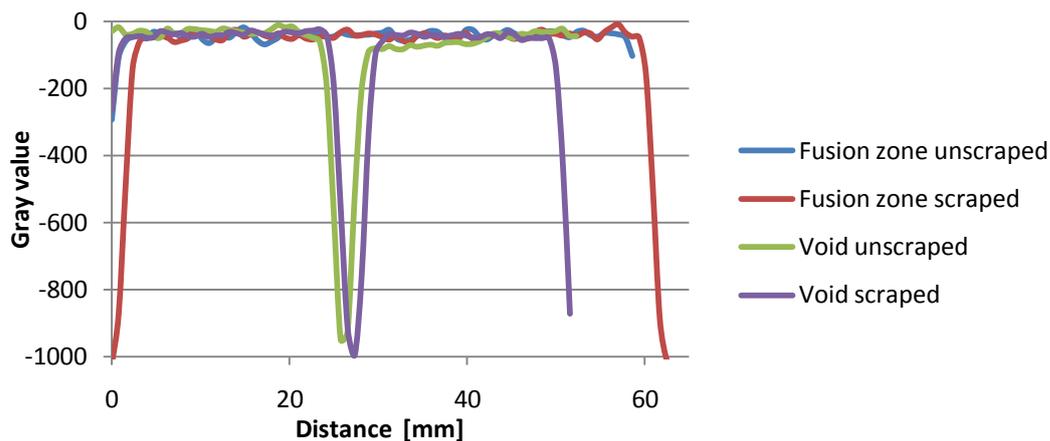
Density profiles, see Figure 36, were plotted at positions marked as white lines in Figure 35 above. The gray value (which is proportional to density) drops drastically close to the value for air (1000) in the profiles over a void. This drop was not present in profiles over a consistent fusion zone indicating fusion between pipe and coupler.

Figure 36. Density profiles over a cross-section at the fusion zone for scraped and unscraped side. The fusion interface is located around 26 mm.

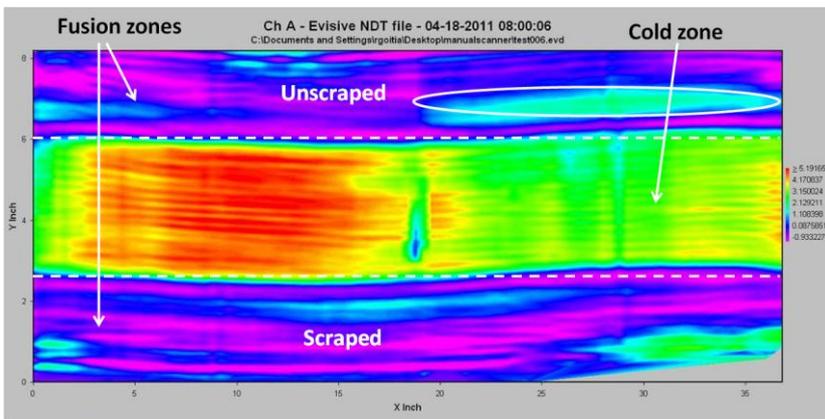
The image from the Evisive Inc. microwave scan can be seen in Figure 37. The image was analyzed by Ken Murphy, Exova. Murphy concludes that the signal from the fusion zones is mostly consistent except at the marked area at the unscrapped side of the joint. The fact that the cold zone in the middle is not straight could be an indication of melt flow, due to misalignment during production of the joint. Vertical lines can be found in the cold zone which are due to external features on the coupling. The final conclusion is that there may be a fault with this joint. Some degree of brittleness should be observed at the marked area at the unscrapped side in a peel test. (Murphy, 2011)

Figure 37. Microwave scan of the investigated electrofusion joint. The two fusion zones can easily be distinguished from the cold zone in the middle.
