## Fatigue-Prone Details in Steel Bridges

Reza Haghani \*, Mohammad Al-Emrani and Mohsen Heshmati

**Abstract:** This paper reviews the results of a comprehensive investigation including more than 100 fatigue damage cases, reported for steel and composite bridges. The damage cases are categorized according to types of detail. The mechanisms behind fatigue damage in each category are identified and studied. It was found that more than 90% of all reported damage cases are of deformation-induced type and generated by some kind of unintentional or otherwise overlooked interaction between different load-carrying members or systems in the bridge. Poor detailing, with unstiffened gaps and abrupt changes in stiffness at the connections between different members were also found to contribute to fatigue cracking in many details.

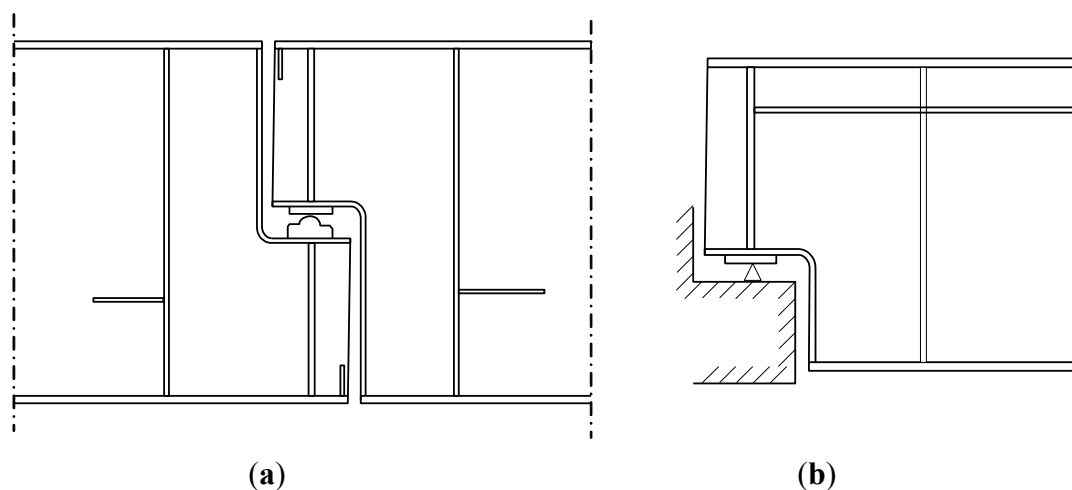
A detail in which numerous fatigue problems have been found in the United States and Japan [5,6] can be found in Gerber bridges and in bridge girders with reduced depth at the supports, Figure 3. According to beam theory, bending stresses in the girder near the support are negligible and the beam is designed at these locations with respect to shear force. Owing to the reduction in girder depth and the resulting change in cross-section, the deformation of the girder will induce additional tangential and radial stresses in the girder web and in the flange-to-web welds along the curvature of the out-cut, see Figure 4.

**Figure 3.** Bridge girders with reduced height are common in: (a) Gerber bridges; and (b) At bridge supports.

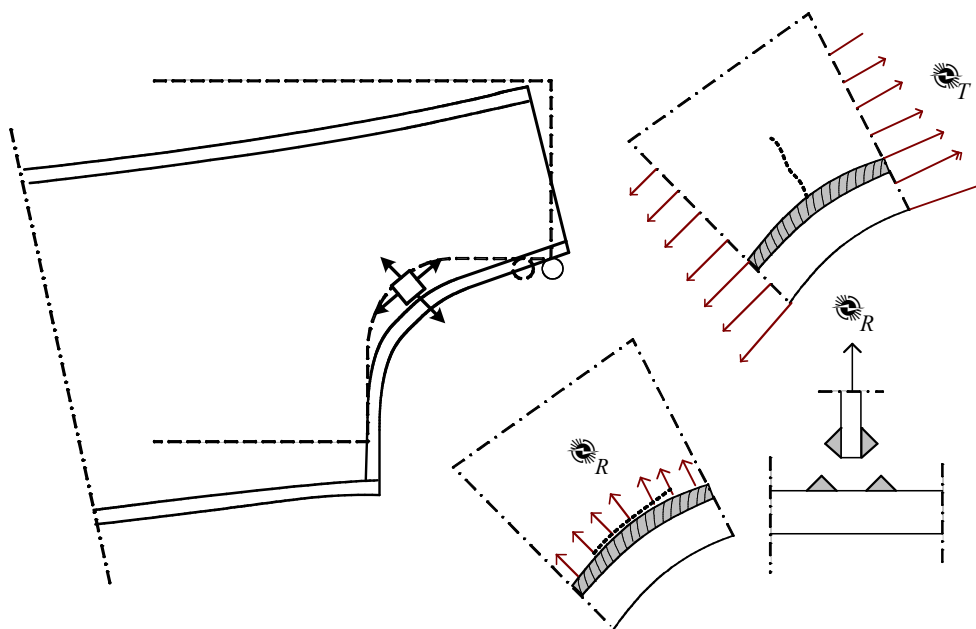
Damage cases involving fatigue cracking in the web of the girder, as well as in the flange-to-web welds, have been reported. In the latter case, the connection between the flange and web was made by means of fillet welds. The cracks in the girder web can grow either in a direction tangential to the flange curvature (caused by the radial stress component) or in a radial direction (generated by the tangential stress component), see Figure 5.

**Figure 4.** Tangential and radial stresses in beams with reduced depth and the three cracking modes that can occur in this detail.

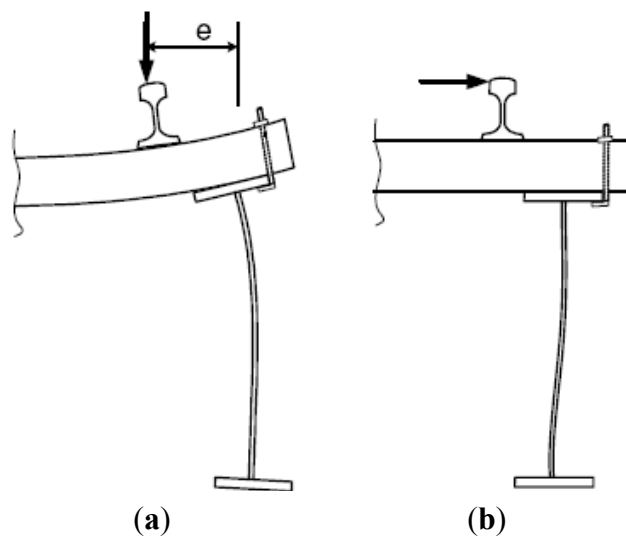
1. *Bending deformation of the timber ties under the action of vertical axle loads.* The corresponding rotation of the ends of the timber tie imposes local bending in the girder flange to which the tie is connected, along with an out-of-plane deformation of the girder web, see Figure 10a.
2. *Transverse forces on the bridge, causing the out-of-plane bending of the girder web.* This effect is more pronounced in curved bridges, but it can also be induced by different track irregularities in straight bridges, see Figure 10b.

**Figure 10.** Schematic figure showing the deformations induced in a bridge girder as a result of: (a) Bending deformation due to rail eccentricity; and (b) Transverse forces.

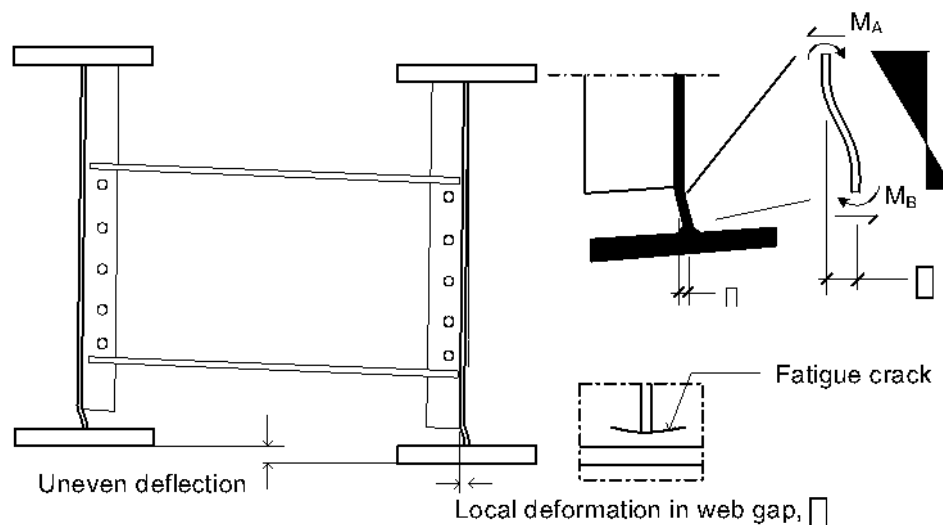
The detail near the termination of transverse plates (or vertical stiffeners) used to connect diaphragms or the cross-bracing is known to be one of the most critical in terms of fatigue in steel bridges. Fatigue cracking here is primarily found in the girder web, starting at the end of the stiffener and growing almost horizontally in a direction parallel to the normal bending stresses in the web, see Figure 12. This type of fatigue cracking has been reported in both railway and highway bridges and can be found in many bridge types, including two- and multi-girder bridges, box girder bridges and truss bridges. The mechanism behind fatigue cracking at diaphragm and cross-bracing connections is, however, the same, irrespective of bridge type. Loading cases, which result in secondary bending of the bridge girders (in the weak direction) and/or torsional deformation of the bridge cross-section, cause uneven deflection of the girders, which is resisted by the diaphragm or the cross-bracing elements. Consequently, tensile and compressive forces are generated in these elements, acting perpendicular to the plane of the girder web and causing secondary bending stresses which are localized in the unstiffened part of the web between the girder flange and the end of the connection plate, see Figure 12.

In railway bridges, these transverse and torsional loads are more obvious in curved and skewed bridges, but they may also be generated in straight bridges by possible track eccentricities or irregularities. The same effects are clear in highway bridges where the truck load can take any position in the transverse direction of the bridge, causing uneven deflection of the bridge girders.

**Figure 12.** The differential deflection of bridge girders results in high local bending stresses in unstiffened web gaps between the girder flange and the termination of cut-short connection plates.

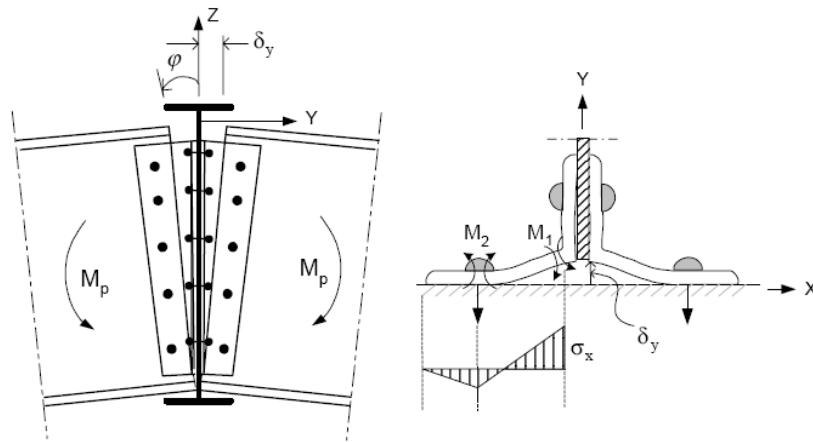
*The rotation of stringer ends associated with bending.* Even though double-angle connections were designed as simple shear connections, it is generally inevitable that these connections also acquire some rotational stiffness, thus partially restraining the rotation of stringer ends. Consequently, negative bending moment will develop at the ends of the stringers, subjecting the fasteners and the angles of the connections to load effects which are not taken into account during design, see Figure 15. This kind of action has a relatively short influence line, giving rise to a large number of loading cycles during the service life of the bridge.

**Figure 15.** Secondary bending at stringer ends due to restrained end rotation. Bending and axial stresses at the top of the stringer-to-floor-beam connection might be high enough eventually to result in fatigue cracking.

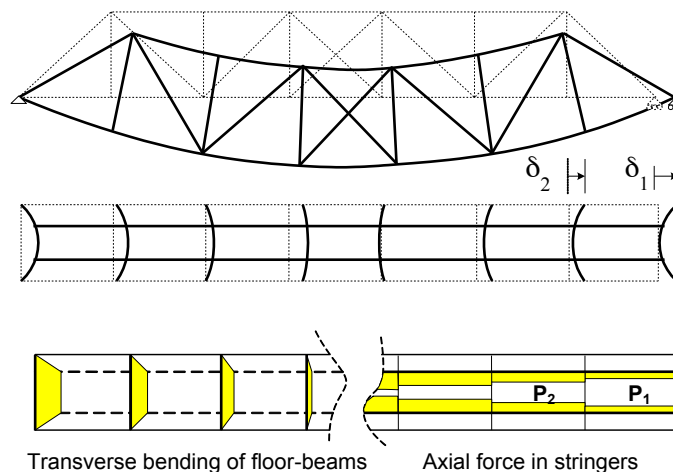
*An overlooked interaction between the floor system (stringers and floor beams) and the main load-carrying structure (main girders or main trusses, for example).* Bending deformation of the main truss bridge, for instance, involves the longitudinal displacement of the truss joints to which the floor beams are connected. The floor beams are, however, partially restrained from following this deformation due to the axial stiffness of the stringers and their connections to the floor beams. As a result, secondary axial forces will develop in the stringers and their connections to the floor beams, while the latter will be subjected to secondary bending (in the weak axis), see Figure 16. This kind of interaction has an influence line, which is equal to the span of the bridge and, in the case of railway bridges, there is essentially one loading cycle every time a train passes.

**Figure 16.** The interaction between the floor system (stringers and floor beams) and the main bridge trusses results in secondary axial forces and bending moment in the stringers and the floor beams, respectively.

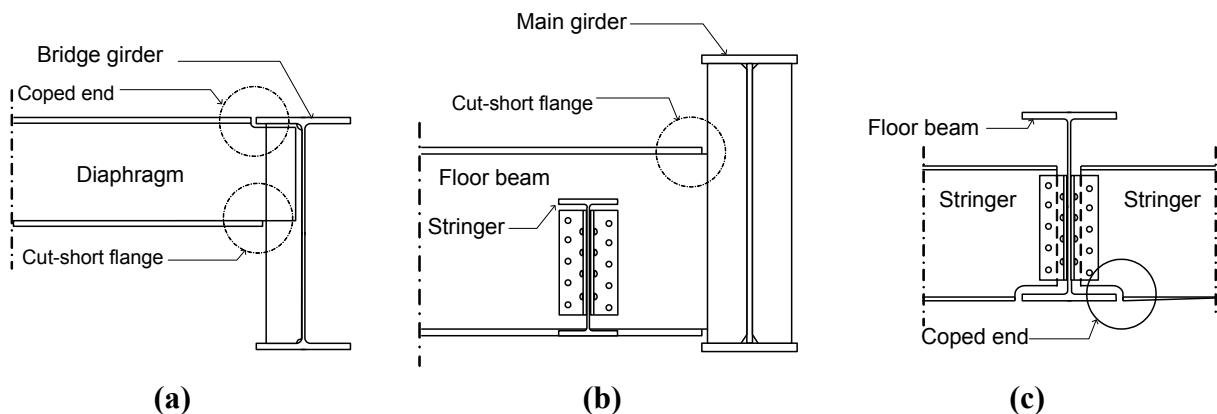
In order to facilitate their connection to other elements in the bridge, diaphragms, stringers and floor beams frequently have coped ends or cut-short flanges at their connections, see Figure 20. These elements have often been shown to be susceptible to fatigue cracking [4,5,15,16]. In general, the cracks start and grow in the web of the element in the areas that are weakened locally by coping or flange short-cutting.

**Figure 20.** Examples of bridge elements with coped ends or cut-short flanges: (a) diaphragm; (b) floor beam; and (c) stringer.

1. By removing parts of the beam flanges near the end, the section modulus of the beam is substantially reduced. Secondary bending due to restrained end rotation may therefore result in relatively high bending stresses in the web near the end connection.
2. The area near the coped end or the cut-short flange is also a location of stress concentration, which further reduces fatigue resistance.
3. Sometimes the ends are coped using flame cutting without post-treatment resulting in rough edges. The residual stresses generated by the cutting process may also contribute to early fatigue damage development in these elements.

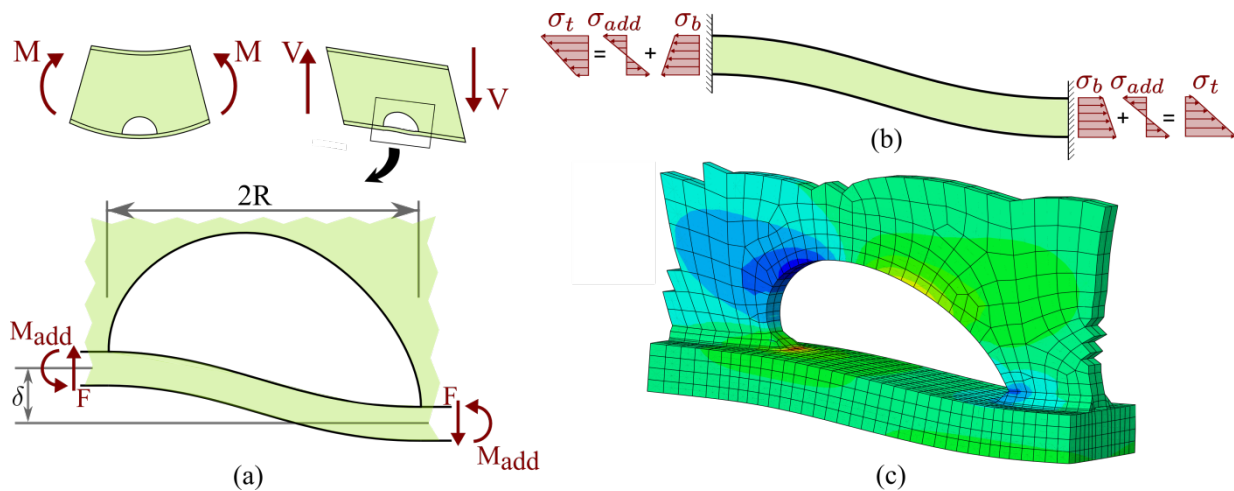
2. *Secondary stresses due to shear deformation of the girder.* Although the shear deformation of stiff long-span girders is generally neglected in design, the local effects of such deformations may be significant. As can be seen in Figure 23, as a result of existing shear, a relatively small displacement ( $\delta$ ) is induced between the sections before and after a cope-hole. However, as the lateral support of the flange provided by the web is no longer available in this section, the flange undergoes an additional deformation. In this instance, the flange is analogous to a beam with both ends fixed sustaining an additional moment ( $M_{add}$ ). This deformation gives rise to the stresses acting on the weld toe at one end and decreases them at the other end.

**Figure 23.** (a) Bending and shear deformation of a section with cope-hole; (b) Stress distribution through flange thickness at weld toe; (c) 3D finite element model.

The influence line of such mechanisms is limited to a small area and thus, a large number of loading cycles in each train passage are influenced. Furthermore, the effect of secondary stresses due to shear deformation becomes prominent in sections where the ratio of shear stress to normal stress increases [19]. Therefore, special attention should be given during the design phase to place the splices at less vulnerable locations.
