Proceedings of the 35th AIVC Conference, 24-25 September, 2014, Poznan, Poland

AIR LEAKAGES IN A RETROFITTED BUILDING FROM 1930: MEASUREMENTS AND NUMERICAL SIMULATIONS

Pär Johansson*¹, Angela Sasic Kalagasidis¹

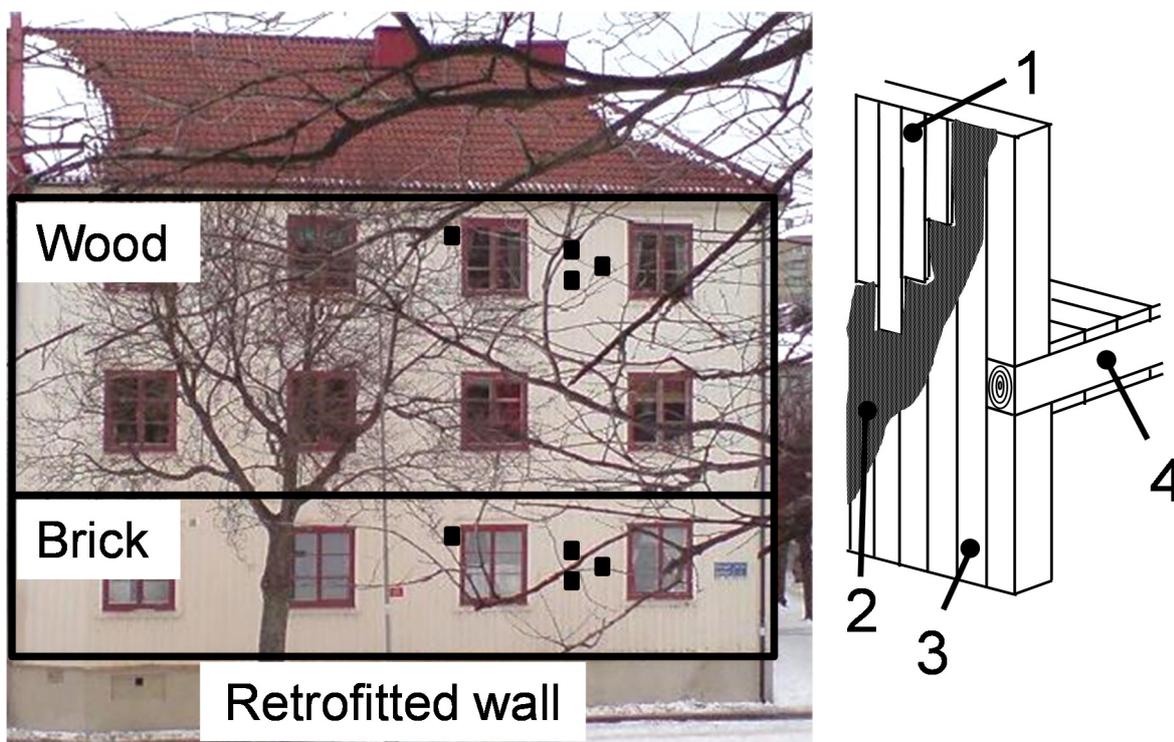
Figure 2: Left: The studied Landshövdingehus “County governor’s house” with approximate location of the hygrothermal sensors in the walls. Right: construction of the original wood wall. 1) Wooden cover boarding, 2) Tar paper, 3) Structural wood or brick, 4) Intermediate wooden floor

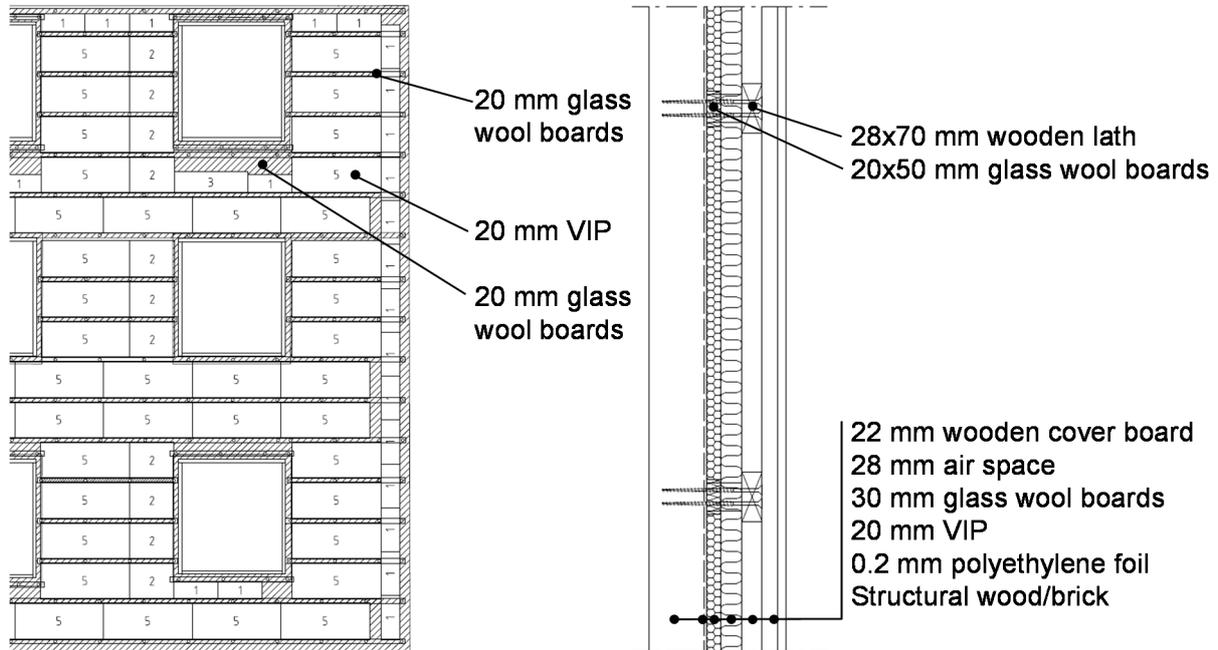
Due to the very limited space for additional insulation in the wall, the retrofitting, presented in Figure 3, was done with 20 mm thick vacuum insulation panels (VIPs) placed on the exterior side of the wall and protected by 30 mm of glass wool. Between the old wall and the VIPs, a polyethylene foil was applied as an air barrier to prevent indoor air entering the wall. An air space, 28 mm thick, was added to the façade which makes the total additional thickness of the wall to be 80 mm (Johansson, 2014).

Figure 3: Wall layout after retrofitting with 20 mm VIPs and 30 mm glass wool boards.
