# Influence of running-in on surface characteristics of efficiency tested ground gears

D. Mallipeddi<sup>a,\*</sup>, M. Norell<sup>a</sup>, M. Sosa<sup>b</sup>, L. Nyborg<sup>a</sup>

## ABSTRACT

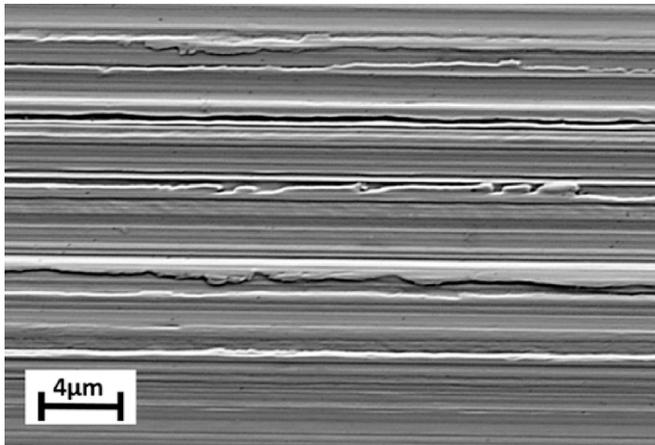
The grinding lay of an as-ground gear flank is shown in Fig. 3. It consist of adjacent peaks and valleys with irregular surface asperities along the axial direction. These surface micro-features are considered to play a prominent role in contact fatigue.

Fig. 3. Surface topography of an as-ground gear tooth, higher magnification SEM imaging.

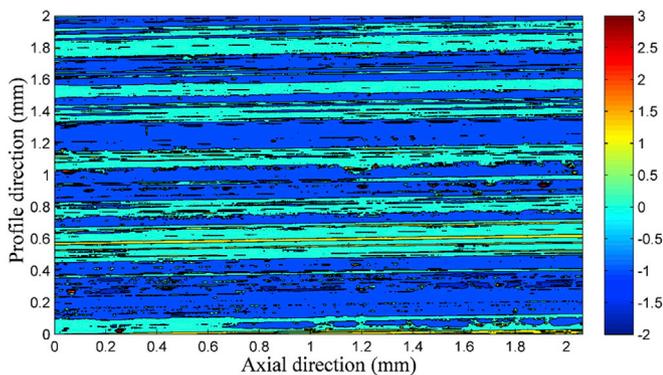
The 3D surface topography measured with the profilometer can be seen in Fig. 4. The same distinct ridges from grinding as found in the SEM images is seen in these measurements.

Fig. 4. Surface topography (3D) of an as-ground gear tooth as measured with profilometer.

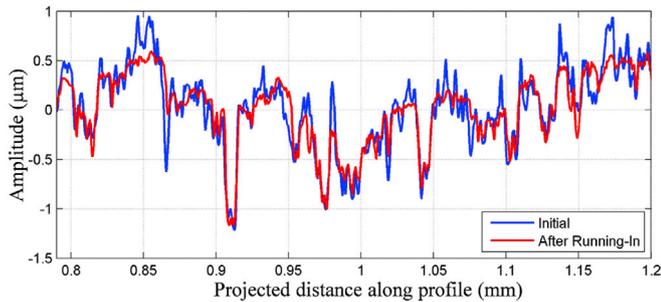
**Fig. 10.** Example of profile measurements comparing as-ground (initial) with after running-in.

The smoothening of the asperities can consistently be seen from both the profilometer measurements and the SEM micrographs. The main advantage of the profilometry is the quantification of the results, and that it can be done in situ to follow a test. Detailed observation as in Fig. 10

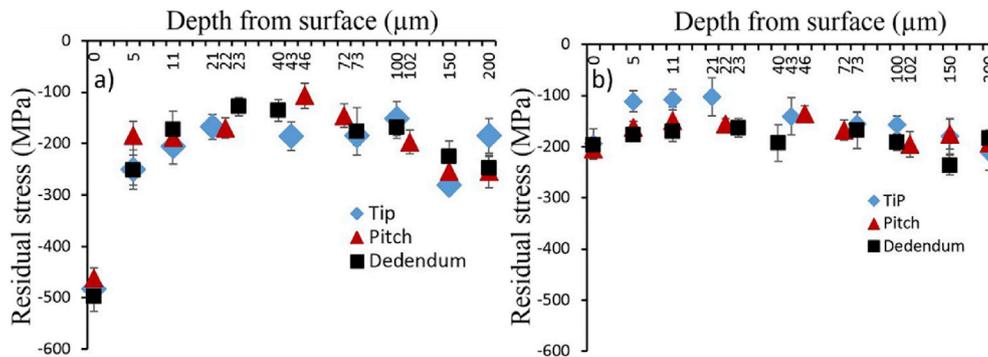
The residual stress profiles measured in both profile and axial direction of an as-ground tooth are shown in Fig. 11. It is evident from the graph that the stresses in both directions were compressive. However, the surface stresses induced by grinding in profile direction were more than twice those in axial direction. Below the surface, i.e. from about 5 µm, the stress levels are quite similar in both directions. After running-in, the compressive residual stresses had increased in both directions but only in a layer very close to the surface. Fig. 12 shows that RI5 gave higher surface stresses in profile direction than RI9, while the opposite occurred in axial direction. Notably, the dedendum surface had higher stresses in both directions compared to tip and pitch. The residual stresses changed also after efficiency testing but again the change was confined to the outermost 5 µm (not shown).

**Fig. 11.** Residual stress profiles of an as-ground tooth in a) profile and b) axial direction.

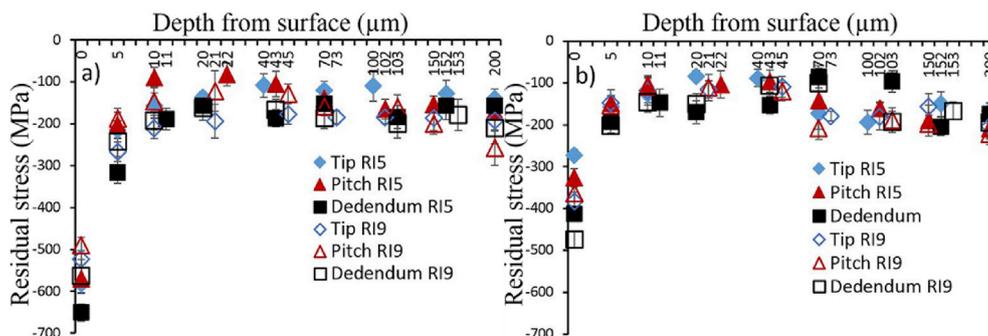
**Fig. 12.** Residual stress profiles after running-in in a) profile and b) axial direction.

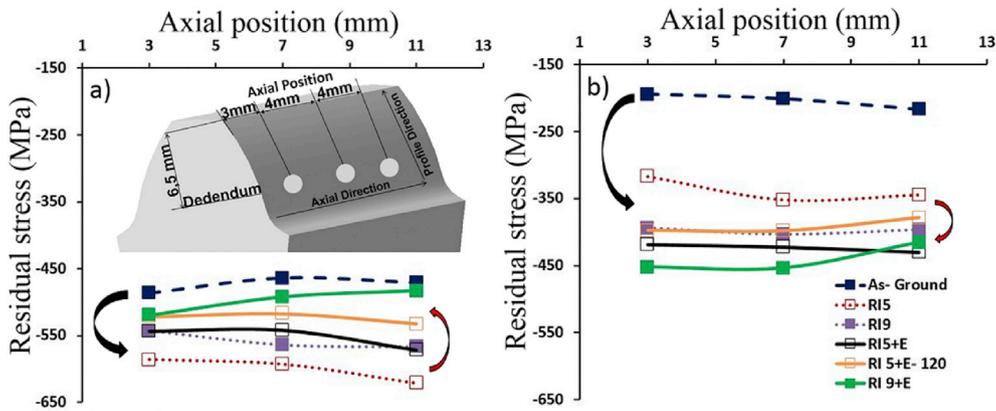
Actually, the distribution of the residual stresses at the surface have been mapped over the gear flank on these gears, see Ref. [29]. Fig. 13 summarizes the stresses at dedendum in three points in axial direction. It illustrates how the stresses increased in both axial and profile direction after running-in (arrows on left side). After efficiency testing, for both RI5 and RI9, the stresses decreased in profile direction and increased in axial direction towards a rather uniform stress level of about 450 MPa.

Fig. 13. Surface residual stresses for three points in axial position at dedendum for different test conditions in a) profile and b) axial direction.

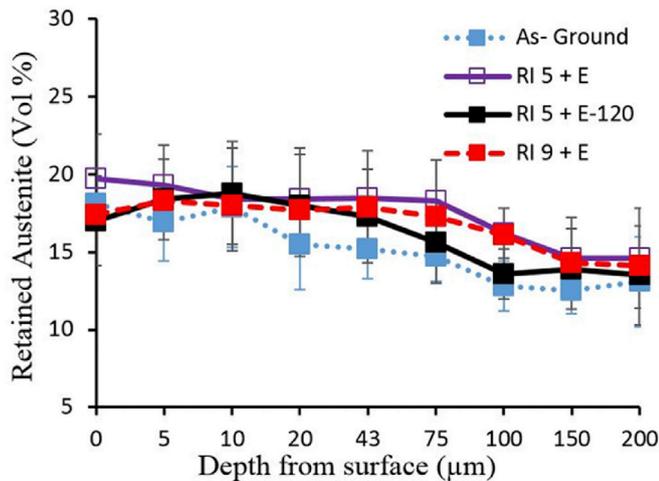
The microstructure of the case hardened layer consists of plate martensite and about 20% retained austenite. The depth profiles of retained austenite measurements at dedendum surface for as-ground and efficiency test conditions are shown in Fig. 14. It is evident from the graph that no transformation of retained austenite can be quantified by means of XRD even after efficiency testing.

Fig. 14. Retained austenite profiles after efficiency tests compared to as-ground condition.

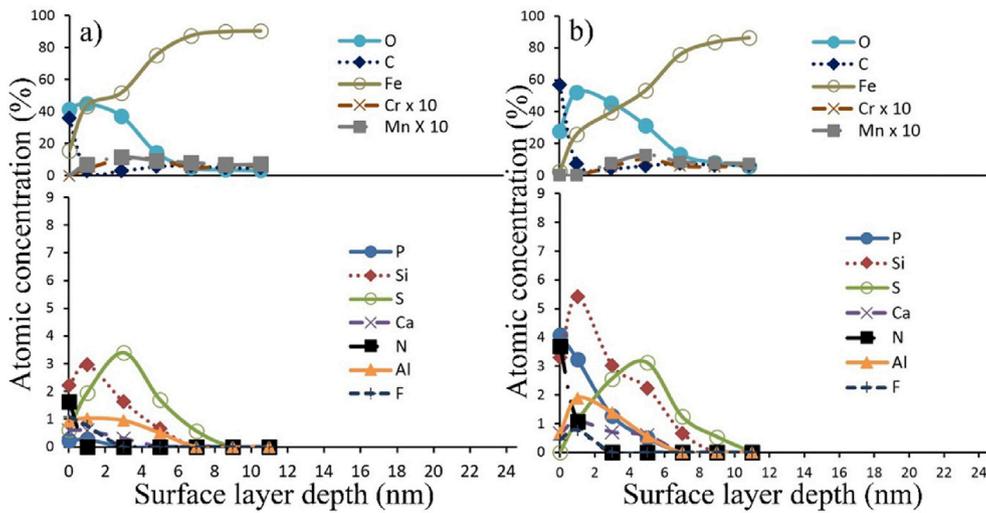
A depth profile for as-ground tooth are shown in Fig. 21a. The surface was rich in C, O and Fe but the supposed Fe-oxide was limited to a few outermost nm for all conditions. Carbon was removed after the first etch cycle. This is typical for contamination, but it cannot be excluded that some C from the lubricant remain after cleaning of the sample. The alloying elements Cr and Mn were also detected. These elements are presented in the upper part of all Figs. 21–23. However, the focus here will be on other elements, in particular those from lubrication additives, presented in the lower part. The most characteristic elements for the as-ground tooth was S and Si. Still, N, Al, P, Ca, and F were also recorded in

low amounts i.e.  $\leq 1$  atomic percent. Sulphur, Si and Al were present down to about 5 nm below the original surface. Fig. 21b shows depth profiles after static immersion test (SIT). Again, the highest amounts in the lower profile were recorded for S and Si, but the most significant difference compared to the as-ground tooth was the presence of P within the outermost 2 nm. Furthermore, higher N content was observed at the surface. For the other elements, the profiles were similar to the as-ground condition.

Fig. 21. XPS depth profiles of a) an as-ground tooth and b) after static immersion test.

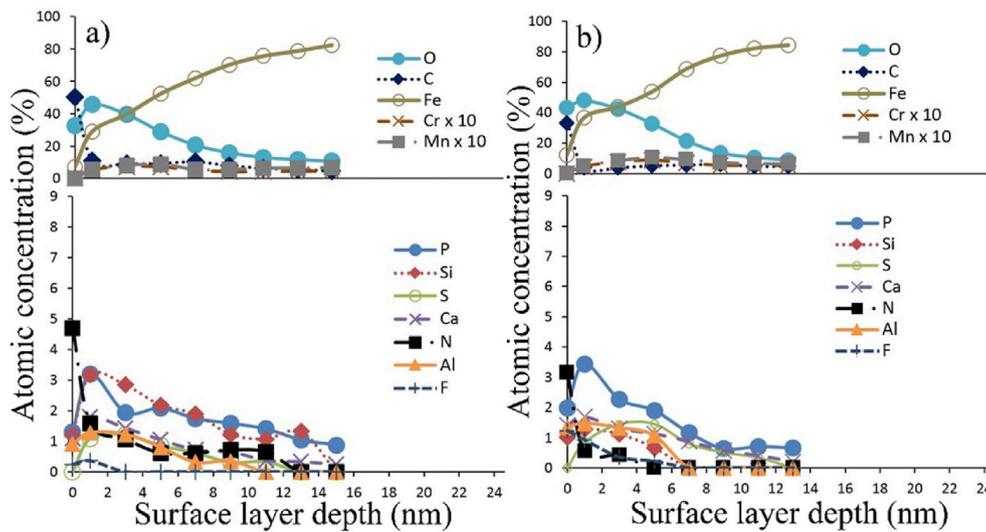
More P from EP additive was observed after running-in, see Fig. 22.

Fig. 22. XPS depth profiles after running-in a) RI5 b) RI9.

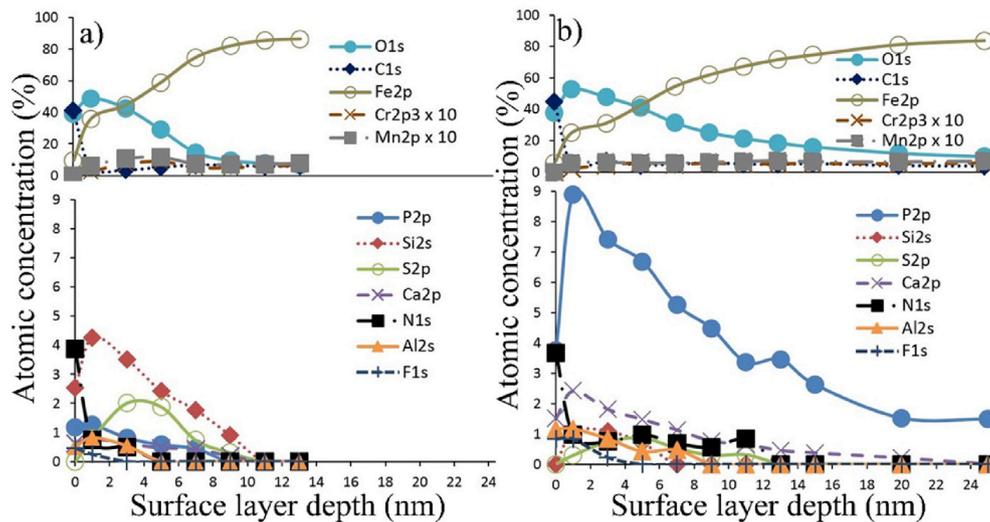
The most interesting result from the surface analyses is possibly the P profiles after efficiency testing (Fig. 23). After RI9+E, P is present much deeper into the surface and at higher concentrations than for other conditions. In contrary, after RI5+E less P was present than even after RI5. Significant amounts of Ca were also recorded after RI9+E. Regarding Si a similar trend was found as after running-in; significant amounts after RI5+E and less after RI9+E. The profile for RI5+E-120 (not shown) was similar to that for RI5.

Fig. 23. XPS depth profiles after efficiency testing a) RI5+E b) RI9+E.
