## Corrosion Mechanisms under Organic Coatings A study in relation to Next Generation´s Pretreatments

**Master of Science Thesis in the International Master´s program  
Chemical Engineering**

Department of Chemical and Biological Engineering  
*Division of Environmental Inorganic Chemistry*  
*Corrosion Science*  
CHALMERS UNIVERSITY OF TECHNOLOGY  
Göteborg, Sweden, 2011

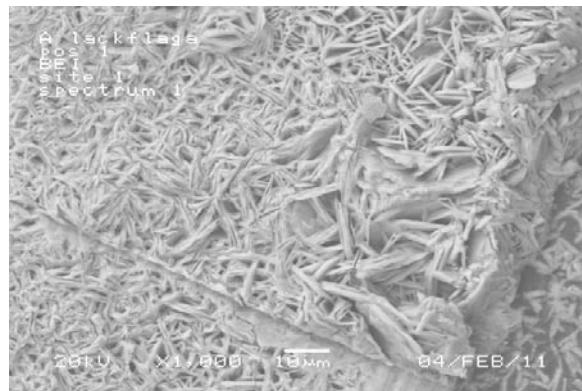
All samples were analyzed with SEM/EDS analysis. Figure 4.3 is a SEM picture from backside of paint from position A (marked in Fig. 4.2). In the picture thin needle like crystals are seen. EDS analysis (Tab. 4.1) shows highly chlorine containing corrosion products.

Figure 4.3. *SEM picture from backside of paint position A. Needle like crystals are seen.*

Position	Crystal shape	C	O	Al	Si	P	Cl	Ti	Mn	Fe	Ni	Zn
A	Needles (Fig. 4.3)	21,32	38,42	0,31			9,24	1,25		4,11		25
B	Phosphate crystal backside (Fig. 4.4)	33,94	46,9	0,87	1,14	3,08	1,65	3,03	0,28	0,09	0,1	8,84
C	Hexagonal plates (Fig. 4.5)	22,11	54,71	0,19			6,25	0,2				16,6

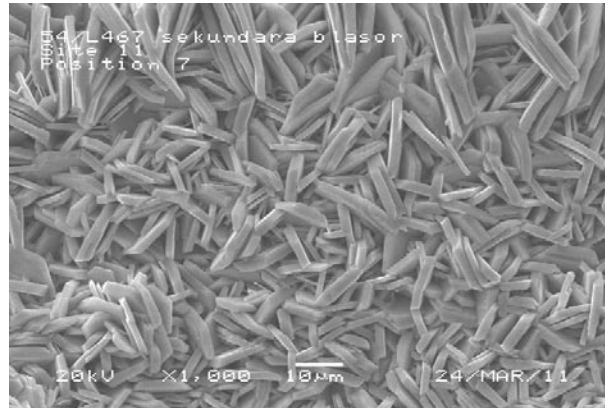
Figure 4.5 is from position C (marked in Fig. 4.2) backside of paint flake. The SEM picture shows thicker and bigger crystals if compared to the needle shaped crystals in figure 4.3. The crystals in SEM picture (Fig. 4.5) are more shaped like hexagonal plates. The EDS analysis (Tab. 4.1) shows in conformity with EDS analysis from position A highly chloride containing corrosion products.

Figure 4.5. SEM picture from backside of paint position C. The crystals are formed as hexagonal plates.

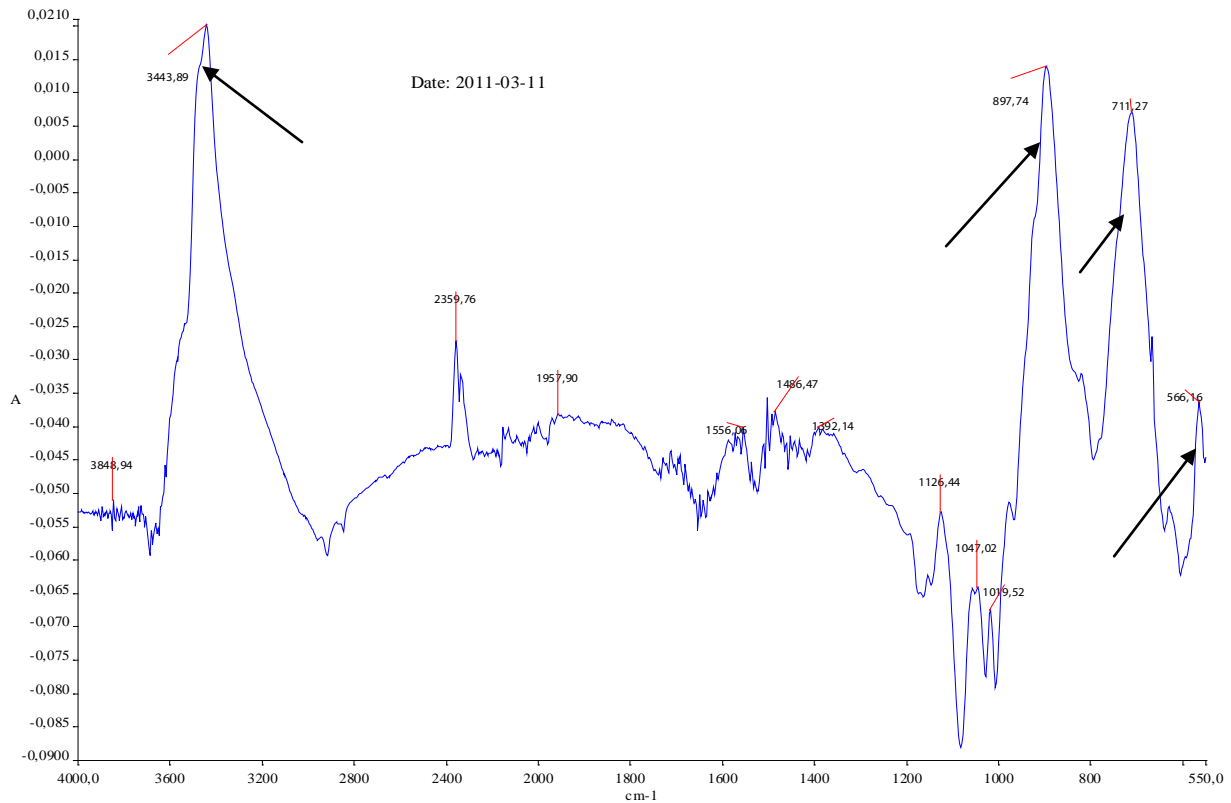
FTIR analysis was performed on the backside of the coating and the result corresponds well with the SEM/EDS analysis. A piece of the backside of the coating from material A, sample A2, was mounted on the FTIR sample holder and analyzed. Figure 4.7 shows a difference spectrum of the sample. To obtain the difference spectrum the signals from ED coating and phosphate have been subtracted, by using reference spectrum for ED coating and phosphate. The remaining spectrum is in good agreement with simonkolleite. (A reference spectrum of simonkolleite is attached in appendix).

Figure 4.7. *Difference IR spectrum of material A from backside of paint.*

The most important peaks that are characteristic for simonkolleite are pointed out in figure 4.7.

The most important peaks that are characteristic for simonkolleite are pointed out in figure 4.19. The difference IR spectrum is well in accordance with figure 4.7 (IR- spectrum from the silane based pretreated panel).

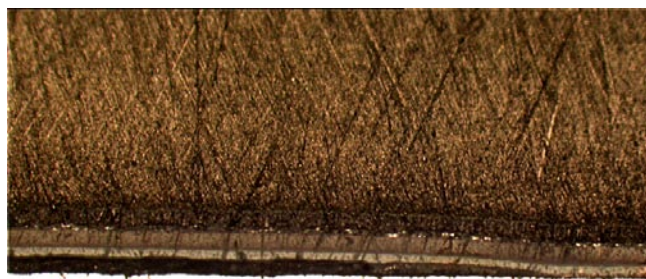
A cross section of a corrosion blister on material A is shown in figure 4.8. The cross section of material A, sample A2, shows that the entire zinc layer,  $\sim 10\mu\text{m}$ , has completely corroded and there are no signs of any metallic zinc in the area under the blister (Fig.4.8).

Figure 4.8. *AX70 Microscope picture of the cross section of a corrosion blister on sample A2.*

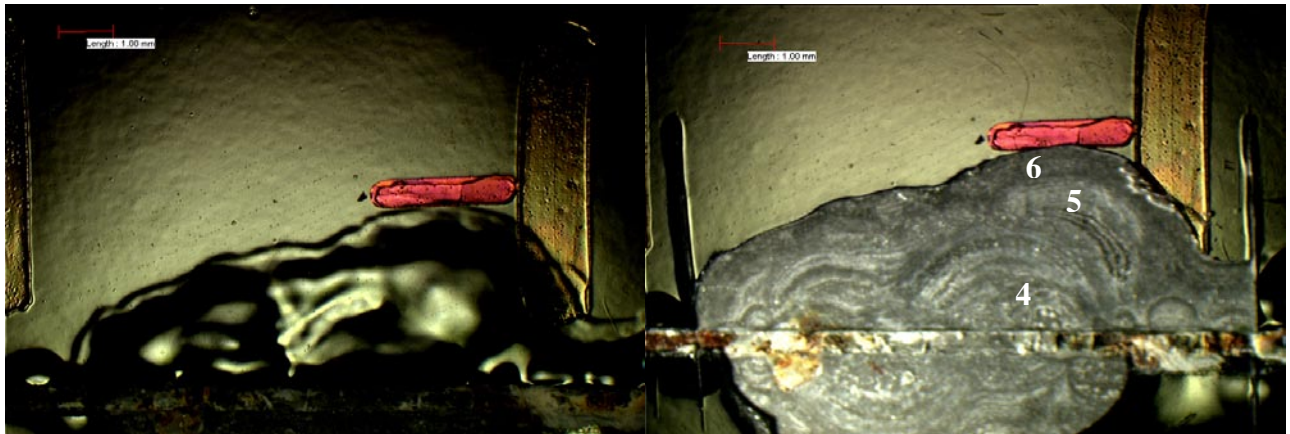
Figure 4.15 shows the corrosion spreading from the scribe on a painted panel with the silane based pretreatment, material B. The panel was exposed 6 weeks in ACT II. The shape of the blister in the figure below is different if compared to the blister on the phosphated panel. The blister in the picture below does not show any signs of secondary blisters and the shape of the blister is not as distinct as on the phosphated panel (Fig. 4.1). Figure 4.15 shows a less topographic corrosion blister compared to the phosphated sample. In the right part of the picture the paint film has been removed. A semi circular pattern, growth rings, is clearly seen. The growth ring pattern is more distinct than on the phosphated sample. The markings, number 4-6, in the right picture represent different analyzing spots, which is used in table 4.9.

Figure 4.15. Corrosion spreading on material B. The scribe is in both pictures at the bottom of the picture. The left picture is with coating and in the right picture the coating has been peeled off. The markings 4-6 represent analyzing spots.

Table 4.9 shows the result from the EDS analysis, 20kV, from the substrate side on material B, position 4-6 in figure 4.15. The analysis was performed in low vacuum mode in order to get a zirconium signal (otherwise, on gold sputtered samples, the Au signal interferes with the Zr signal). In the corrected zinc value (corr Zn) the zinc bounded in the pretreatment layer has been subtracted. The corrected oxygen (corr O) value represents what is present in the corrosion products. The bounded oxygen in coating is thus removed. The table shows highly chloride containing compounds in all positions. Table 4.3 shows highly chloride containing corrosion products with a Zn/Cl ratio 3,08-3,88. This indicates that the corrosion product found is a higher order of zinc hydroxy chloride.

The backside of the paint peeled off from material B and corresponding to figure 4.15 was analyzed. The analysis was in conformity with the analysis above (Tab. 4.9) made in low vacuum mode. Table 4.10 shows the result from the EDS analysis. Significant amounts of zirconium are present on the backside of paint (highlighted in table 4.10). In table 4.9 on the other hand no zirconium was detected.

Figure 4.17 shows the corrosion spreading from the scribe on a panel with the zirconium based pretreatment, material C. The shape of the blister is in accordance with the blisters on the silane based pretreated panels (Fig. 4.15) less topographic compared to the phosphated sample (Fig. 4.1). The blisters on the zirconium based sample (Fig. 4.17) are even more flat than the silane based (Fig. 4.15). No secondary blisters are seen.

The number of growth rings seen in fig. 4.15 is approximately 20. The number of drying cycles in ACT II is 30. An initiation period must be taken in consideration and it is therefore suggested that the growth rings correspond with the drying cycles in ACT II.

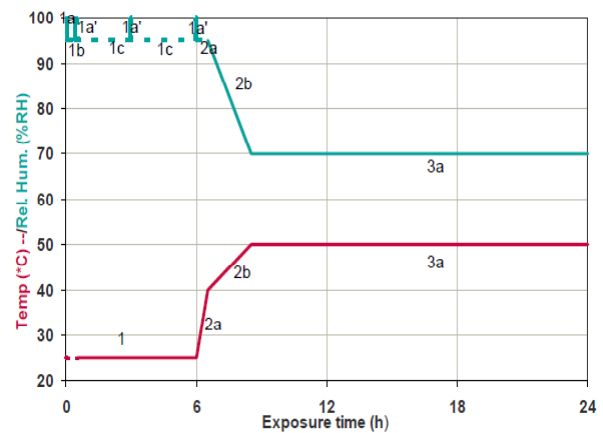
Figure A.4 *Workday (mon-fri) test cycle (left) and complete weekly program (right).*
