## D5.3

### Needs for maintenance and refurbishment of bridges in urban environments

### Management of bridges for strengthening and repair

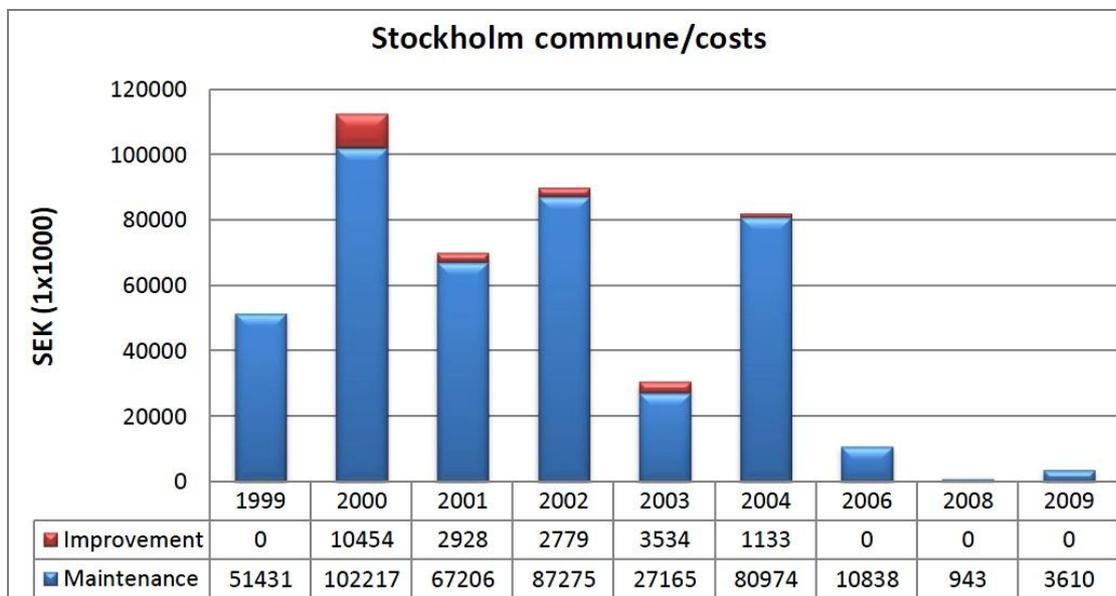
Figure 11 Investment distribution made by Stockholm commune for road and railway bridges [3].

Figures A2.11 and A2.12 present the investment made by Stockholm and Gothenburg communes for both railway and roadway bridges, respectively.

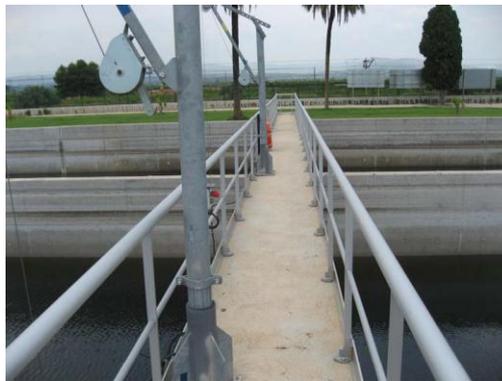
*Figure 4.1 Footbridge over the biological digester*

The two reinforced concrete footbridges were built in 2005 and the inspection was made in 2008. The final report recommended to increase the safety factors of the structures using carbon fiber laminates at the bottom of the spans where it was required. In these cases hand-lay-up process was used. The strengthening of the footbridge over the biological digester of the purifying plant in L'Alcudia in Spain was performed.

The Figures 4.1, 4.2, 4.3 show the footbridges, pathologies and the Figure 4.4, 4.5 and 4.6 show strengthening process.

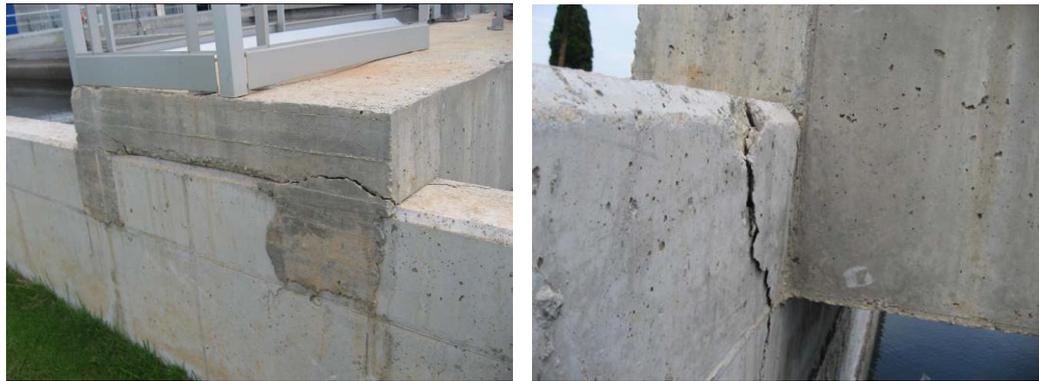
*Figure 4.2 Cracks in the abutments*

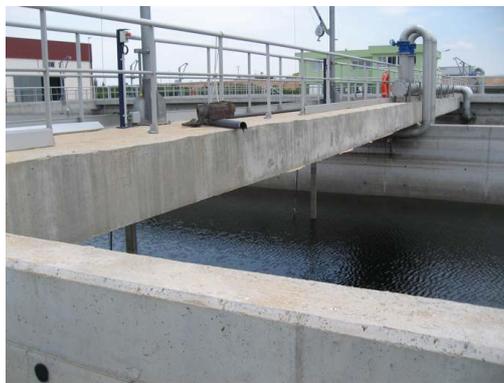
*Figure 4.3 Deformations up to 4cm in the first span of one of the footbridges*

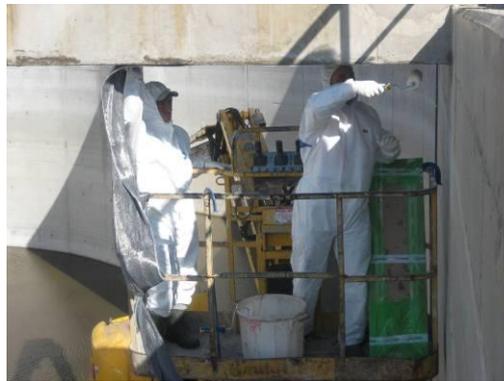
*Figure 4.4 Hand-lay-up process, impregnation of fibres*

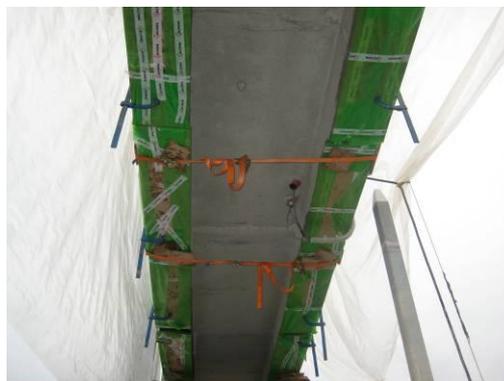
*Figure 4.5 Curing of the CFRP reinforcement*

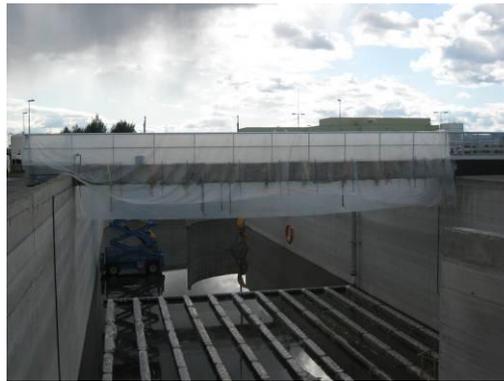
Figure 4.6 *Protection of the CFRP reinforcement during curing period*

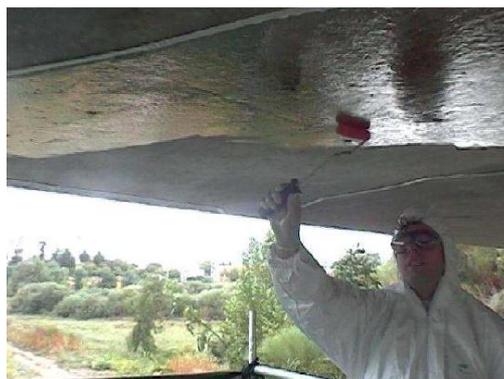
Figure 4.7 *Resin impregnation of the surface*

The reinforcement of the bridge was needed due to an accident in which a truck hit the soffit of the bridge beams. The strengthening was done on a bridge along the motorway A-5 in Extremadura in Spain in 2005. Figures 4.7 to 4.10 show how the process looked like.

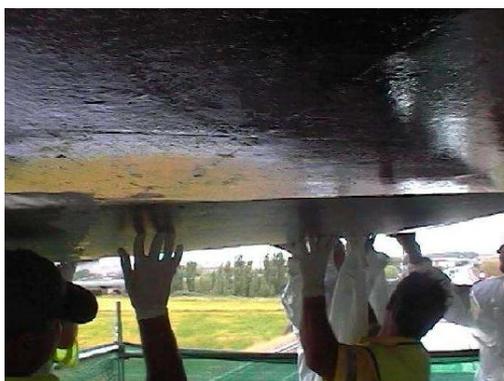
Figure 4.8 *Fiber placement*

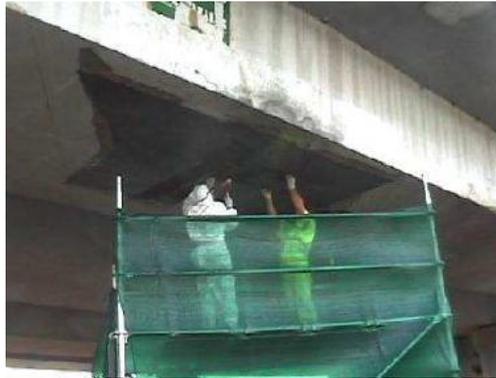
Figure 4.9 Fiber placement

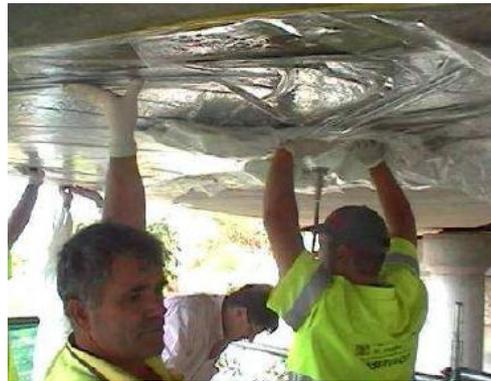
Figure 4.10 Installation of vacuum system

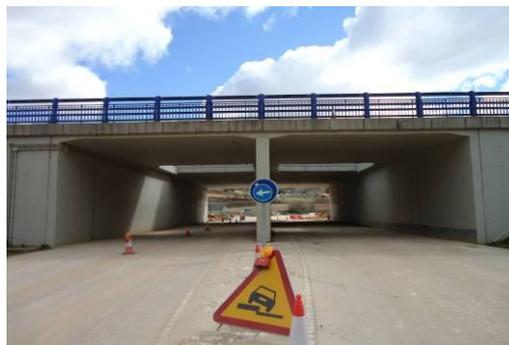
Figure 4.11 Initial situation of the project site (Motorway A-2 in Spain)

The structure consists of a buried box of two cells with a width of 19.4m and a height of 6.8m (see Figure 4.11). The strengthening is needed due to a load increase coming from the increase in the ground level over the lintel.

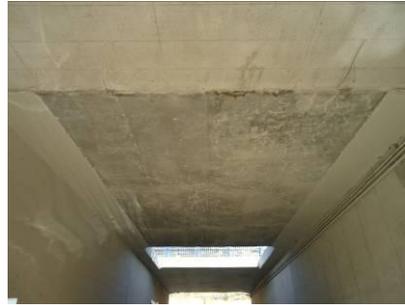
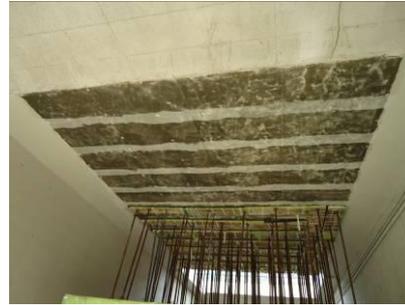
*Figure 4.12*

*Surface preparation and impregnation*

The strengthening process used was the hand-lay-up. The process started with the treatment of the surface with sand-blasting in order to get better cohesion and roughness that guarantees good adherence of the product to be glued. The next step was the surface and laminate impregnation with resin. After that, the fabrics are placed on the surface and the hand lay-up

process is carried out. The resin cured for a minimum period of 24 hours at ambient temperature. Figures 4.12 to 4.16 show how the process looked like.

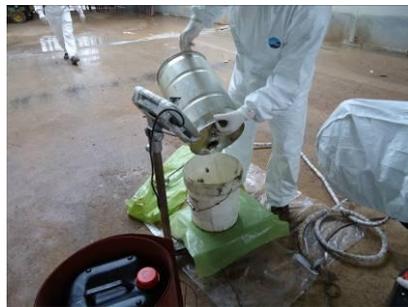
*Figure 4.13*

*Preparation of resin for laminate impregnation*

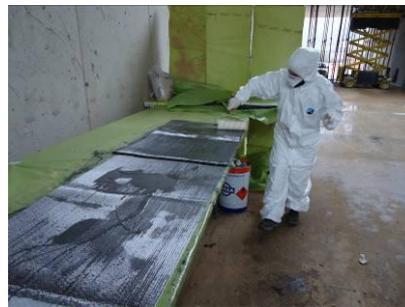
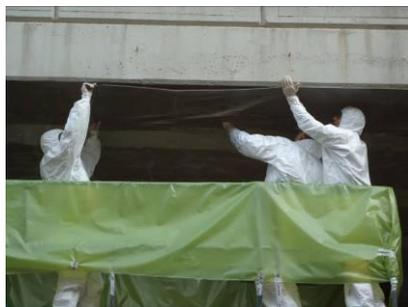
*Figure 4.14*

*Preparation and placement of laminate and formwork*

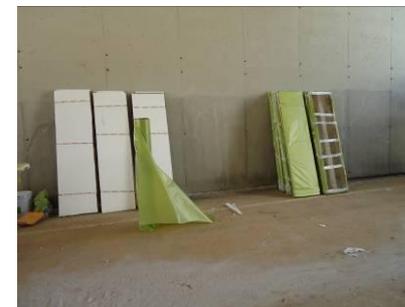
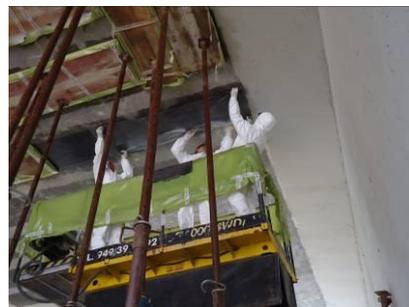
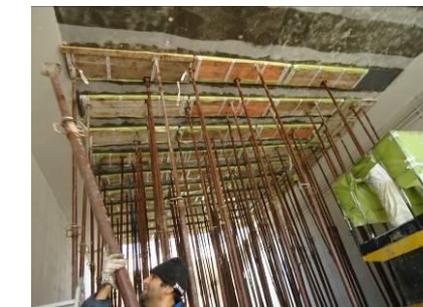
*Figure 4.15*

*Laminate and props placement*

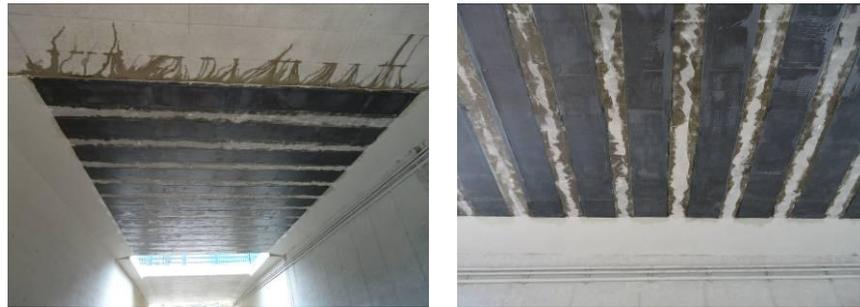
Figure 4.16 Final FRP reinforcement with carbon fiber and epoxy resin

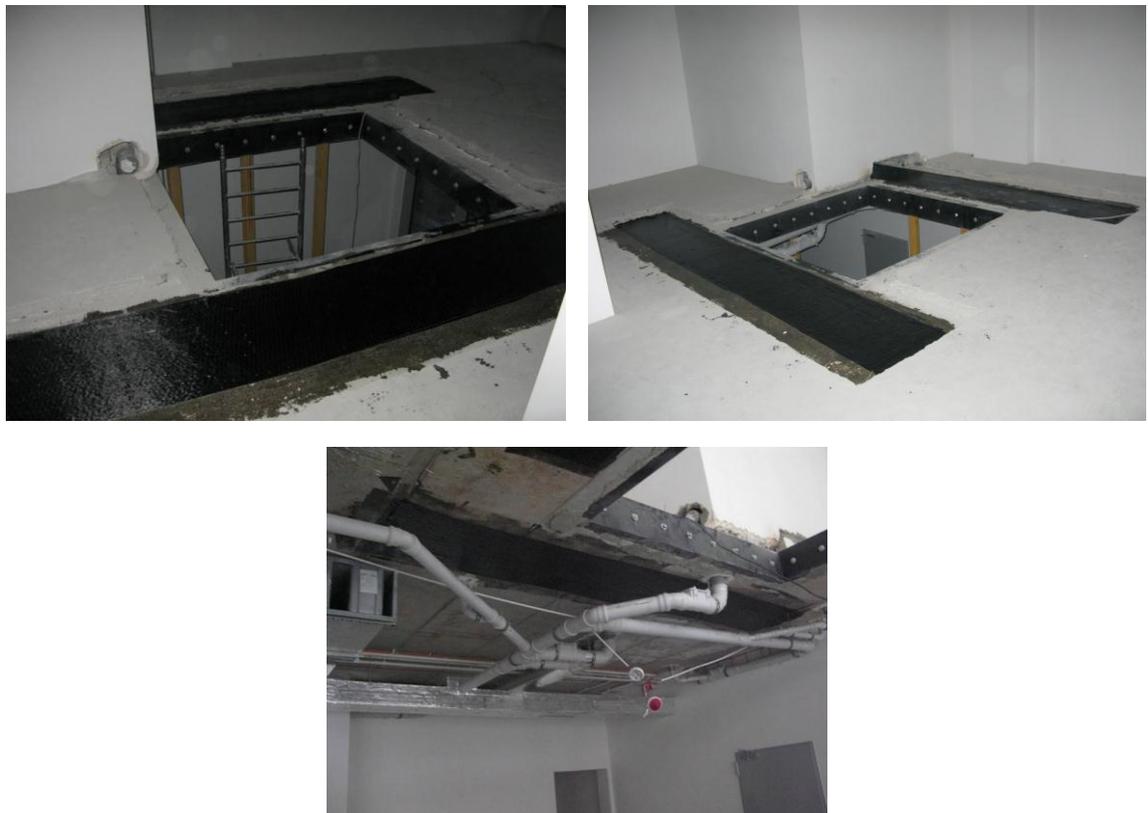
Figure 4.17 FRP reinforcement with carbon fiber and epoxy resin on the floor and opening in residential building.

The strengthening was performed in newly constructed residential building on Pańska street in Warsaw in Poland. The problem was the opening for the stairs (in order to connect two flats) that was not designed primary. However change of the static scheme provokes additional bending moments and it was necessary to reinforce/strengthen the floor. For the reinforcement carbon woven 600g/cm<sup>2</sup> and epoxy resin were used. The strengthening was done in technology way-lay up. Firstly the surface was prepared, dust, dirt, oil, existing coatings and cement layer, and any other matter that could interfere with the bond of the FRP system to the concrete were removed. Then the primer was applied and the saturated woven with epoxy resin was placed.

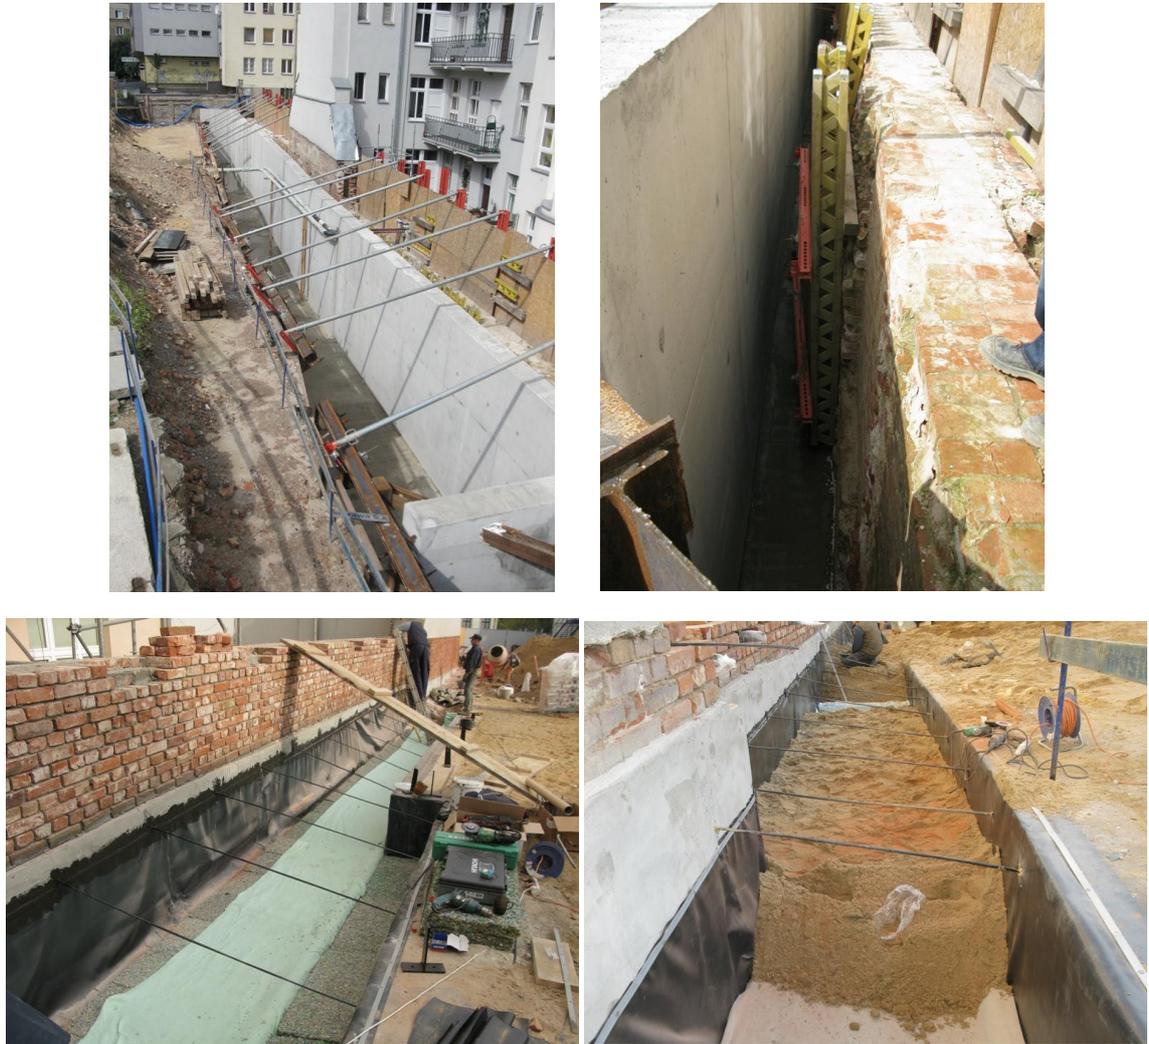
Figure 4.18 Strengthening of historical brick-wall with FRP carbon bars in Warsaw.

Case study describes strengthening of historic brick-wall situated on Ordynacka street in Warsaw (Poland). The wall was linked with reinforced concrete retaining wall with carbon FRP bars with diameter  $\Phi 10\text{mm}$ , Figure 4.18. Bars were glued within two structures with epoxy adhesive Hilti HIT-HY 70 330/2.

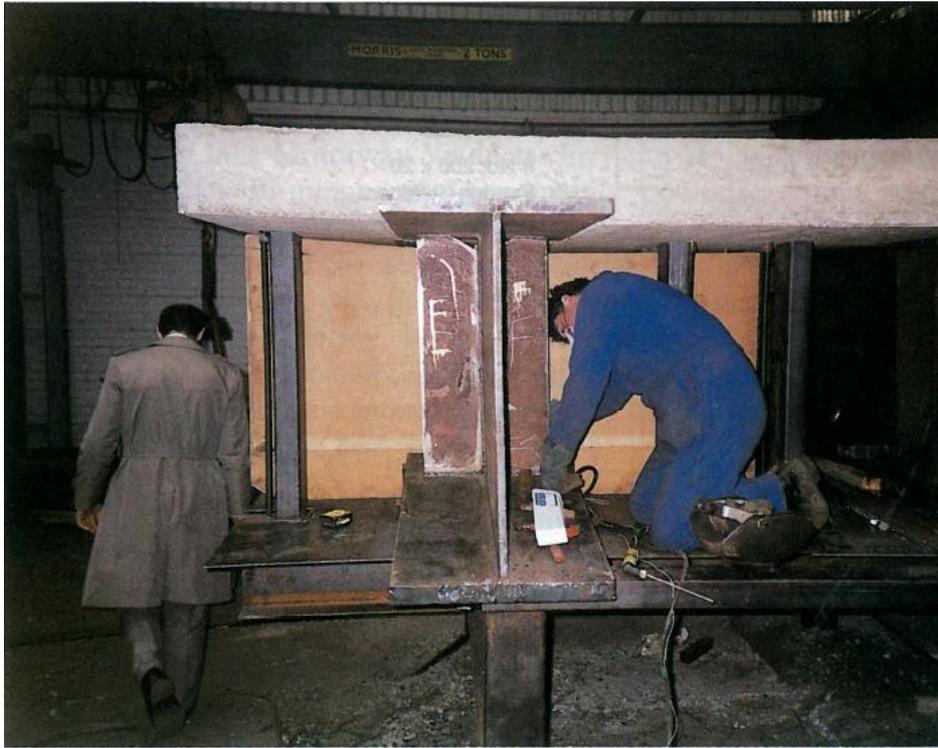
Figure 1.2 Bearing stiffener welding trial

<b>Prior inspection</b>	The height, inclination and bow of webs were measured before works.
<b>Prior testing</b>	Ultrasonic examination of webs was carried out to detect laminations to avoid lamellar tearing on welding. Chemical analysis was carried out to determine a welding procedure. A mock-up of the restricted access was built for the welding trial in advance of the contract (see Figures 1.2 and 1.3). A mock-up was built at the start of the contract to check that welding procedures would not result in unacceptable strains on the shear connectors. A sample at each geographical location was taken and tested to ensure that the carbon content was not excessive for the welding procedure adopted.
<b>How fasten?</b>	By fillet welding. Buttering (coating with weld metal) over laminations.
<b>How fit?</b>	By grinding to close tolerances to permit fillet welding to the webs and fitting to the bottom flanges. The stiffeners were held by G-clamps during welding.

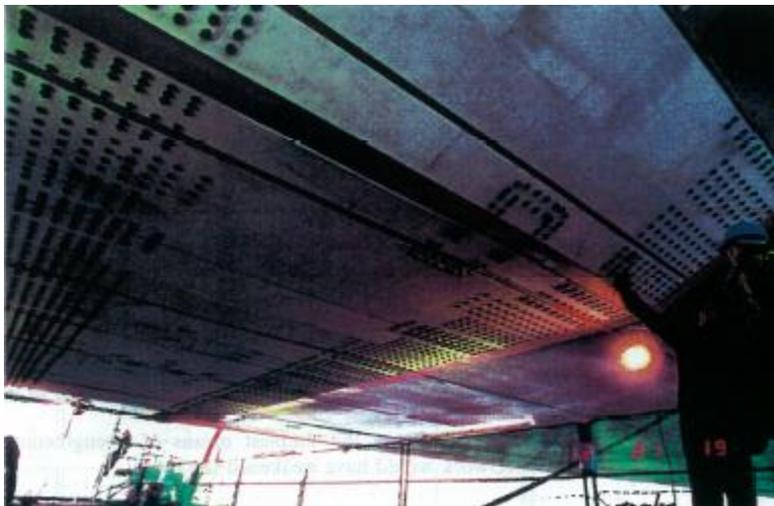
Figure 11.4 External permanent repair

<b>Prior inspection</b>	A detailed internal and external survey was carried out to determine the extent of damage and the size of distortions. The external survey was carried out initially by abseilers and later in more detail using a suspended gantry.
<b>Prior testing</b>	MPI around damaged areas.
<b>How fasten?</b>	High friction grip bolts were generally used to minimise further distortion.
<b>How fit?</b>	All internal components were made small enough to be man-handled and for transport through access holes. Outer doubler plates were lifted from inside the box via strands through holes in the bottom flange. Templating was used for all steelwork.
<b>Traffic management</b>	One carriageway of the bridge was kept open to 3 t vehicles once the temporary strengthening had been installed. The carriageway that was kept open depended on which portion of the diaphragm was undergoing repair.
<b>Testing afterwards?</b>	Draw-wire displacement sensors and strain gauges were installed at critical points around the damaged areas to warn of unexpected movement. These sensors were left in place after the bridge was reopened to heavy vehicles to monitor behaviour. MPI testing of the weld reinforcement to existing diaphragm starter plate welds was

carried out.
<b>Within programme?</b>	Yes. Work completed within 30 weeks.
<b>Problems revealed?</b>	Grit blasting could not be used to remove the lead-based paint due to the likelihood of damaging the prestressed bars in the vicinity of the repair zone. Solvents were used to remove the paint.
<b>Anything went badly?</b>	Nothing significant.
<b>What changes if do again?</b>	No major changes.
