### **Renovation of buildings from before 1945: status assessment and energy efficiency measures**

**Energy Procedia: 11th Nordic Symposium on Building Physics, NSB2017, 11-14 June 2017, Trondheim, Norway (ISSN: 1876-6102)**

Pär Johansson<sup>a\*</sup>, Paula Wahlgren<sup>a</sup>

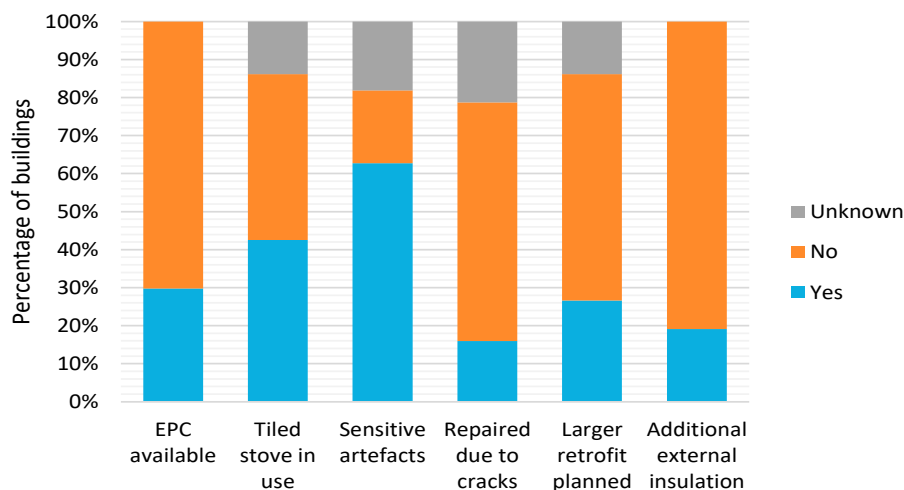
Fig. 1. Information on the 94 properties in the inventories presented in [5] and by Trafikverket.

The total project inventory has currently covered 640 buildings, on 602 properties, of which all were built 1945 or earlier. This data set has been compared to the inventory and status assessment by Trafikverket (Swedish transport administration), previously mentioned, resulting in 94 properties that were included in both data sets. The results of the inventory for a number of parameters are presented in Fig. 1.

The sensitive and vulnerable artefacts can for example be tiled stoves, stucco, ornamentation, windows, paintings, ceramic tiles and sculptures in the building. It is also interesting to note how many of the buildings that have a tiled stove in use. As a consequence, the measured energy use in the EPC might be difficult to interpret since the extent of the use of the stove is not always known. The degree of renovation in the buildings has been evaluated in [5] using EPCs and value year (as a measure of the degree of renovation). The share of buildings with additional insulation was determined by site visits. A small share of the buildings have been repaired due to cracks on the interior or exterior surfaces. Larger retrofit was planned for 25 of the buildings and common measures were; converting attic space into apartments, converting common or commercial premises to apartments, change of ventilation system and change of windows.
