## River erosion, landslides and slope development in Göta River

A study based on bathymetric data and general limit equilibrium slope stability analysis

*Master of Science Thesis in the Master's Programme Geo and Water Engineering*

**DANIEL MILLET**

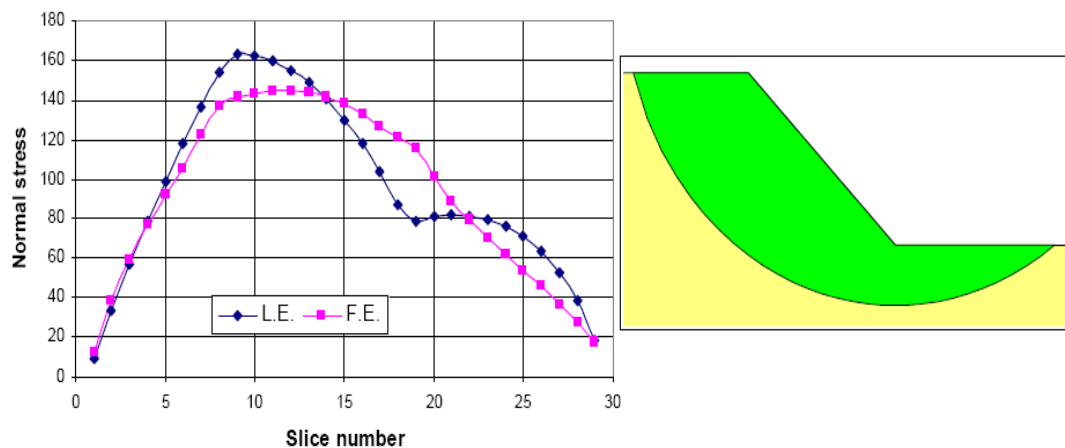
Figure 6 Difference in stress distribution between limit equilibrium (L.E.) and finite element (F.E) analysis along the base of each slice for the slip surface to the right in the picture (GEO-SLOPE International Ltd, 2008).

Another important note on the GLE method is that the normal stresses calculated at the base of each slice might not represent a fully realistic stress situation in the soil. This is because of the fact that the GLE method is based purely on statics without any constitutive strain-displacement equations. An example of the difference between the stresses calculated by a finite element-analysis and a limit equilibrium analysis are shown in Figure 6. The overall distribution is however similar, and even though the local slice forces might be slightly unrealistic the global factor of safety is still realistic (GEO-SLOPE International Ltd, 2008).

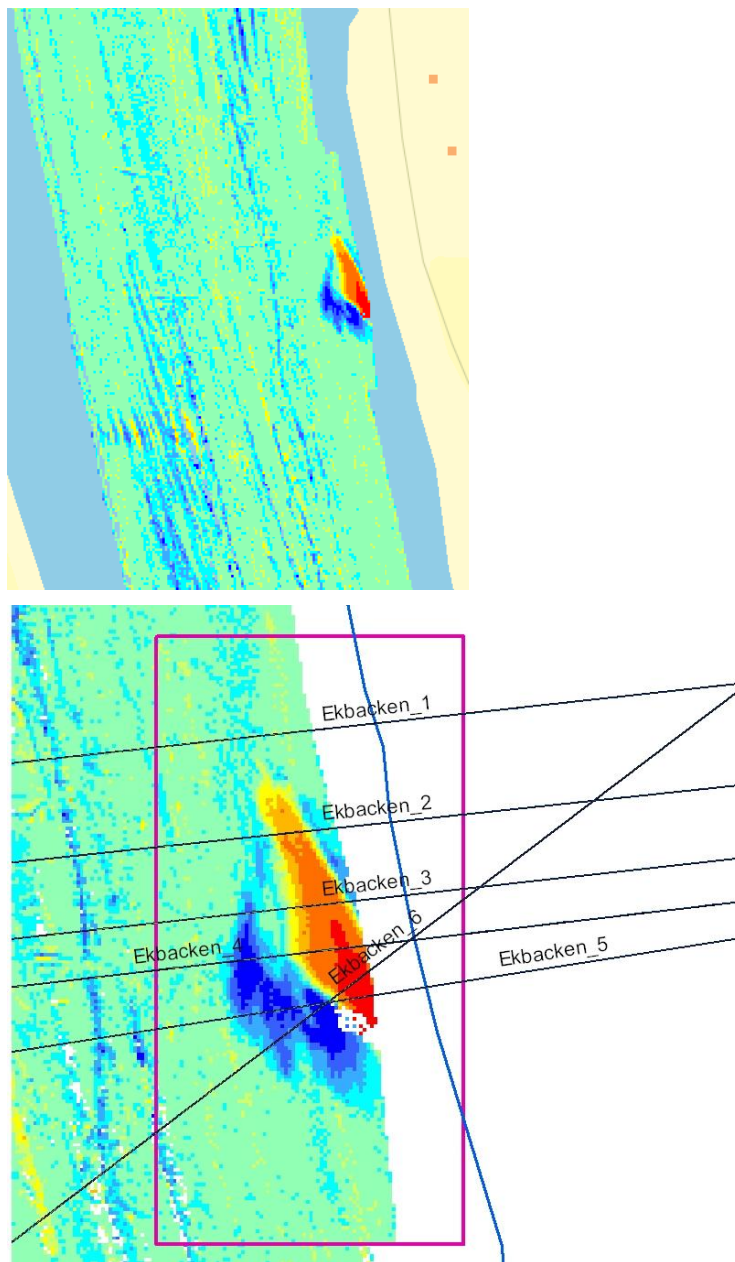
*Figure 14 2003-2009 dataset at Ekbacken, showing possible subaquatic landslide (ArcGIS, 2011).*

Figure 14 below shows the 2003-2009 dataset from a section of Göta River close to Ekbacken. There is an abrupt discontinuity in the overall patterns visible on the right slope of the deep river channel. The coloring pattern indicates that soil has been removed and possibly deposited directly below further down the slope, which would be expected for a typical landslide.

The bottom image in Figure 14 shows a close up of the area, as well as profiles that were drawn through the possible landslide. Profiles 1 and 3-6 are presented on the next page.

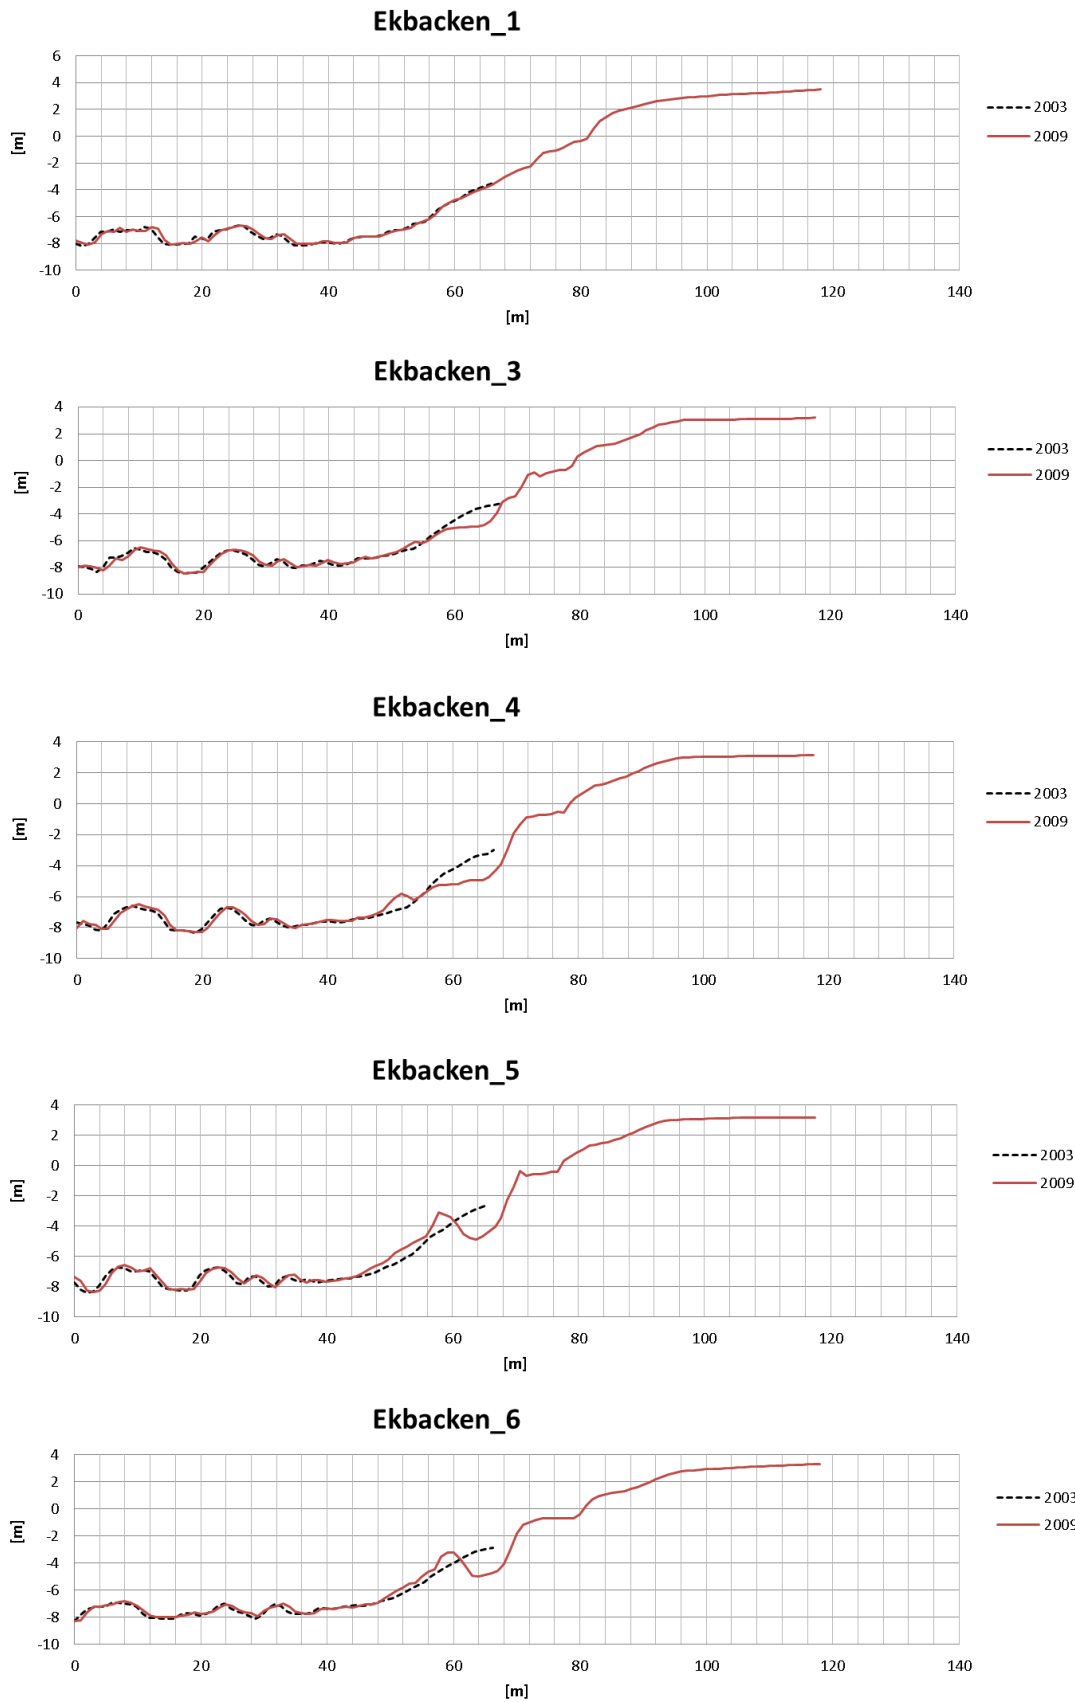
Figure 15 Slope profiles drawn through the possible subaquatic landslide at Ekbacken, showing bathymetric values from 2003 and 2009.

In the profiles in Figure 15 the underlying bathymetry changes that have given rise to the color pattern in the previous figures are clearly visible. In particular the profiles in *Ekbacken\_3* and *Ekbacken\_4* show characteristics of a typical landslide slip surface and signs that deposits of the land slide soil mass is lying below the slip surface. *Ekbacken\_1* is a slope profile just to the north of the possible landslide, and it can be assumed to represent a typical pre-landslide slope of that area. It also shows very little signs of any type of significant erosion between 2003 and 2009. The profiles in Figure 15 also show what appears to be distinct erosion trenches along the deep section of the river,  $0\text{ m} < x < 40\text{ m}$ , in particular the larger trench at  $12\text{ m} < x < 24\text{ m}$ .

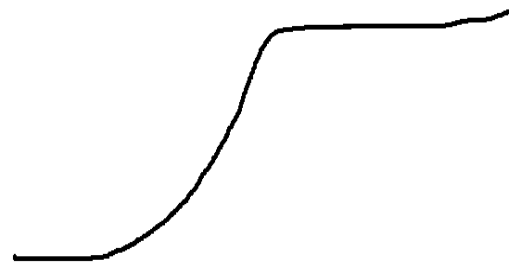
#### 1. High terrace- steep slope

Distinct subaquatic terrace with a rather steep slope, approximately more than  $25^\circ$ . The steepest slope measured among the samples in the case study was about  $45^\circ$ . The height of the terrace is approximately more than 5 m. For most samples in the case study the heights were around 10 m. The water depth above the actual terrace is small, in general a maximum of about 1-3 m decreasing towards the shore line. Notice the concave shape of the steep slope

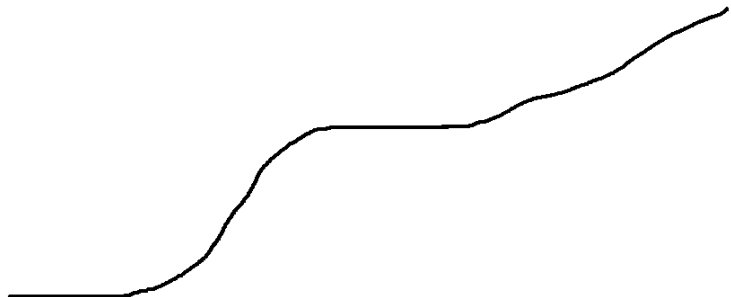
### 6. Deep terrace

This type of profile also refers to any of the terrace profiles 1-6 but with the difference that the actual terrace lies very deep beneath the water surface compared to the usual rather shallow terraces.

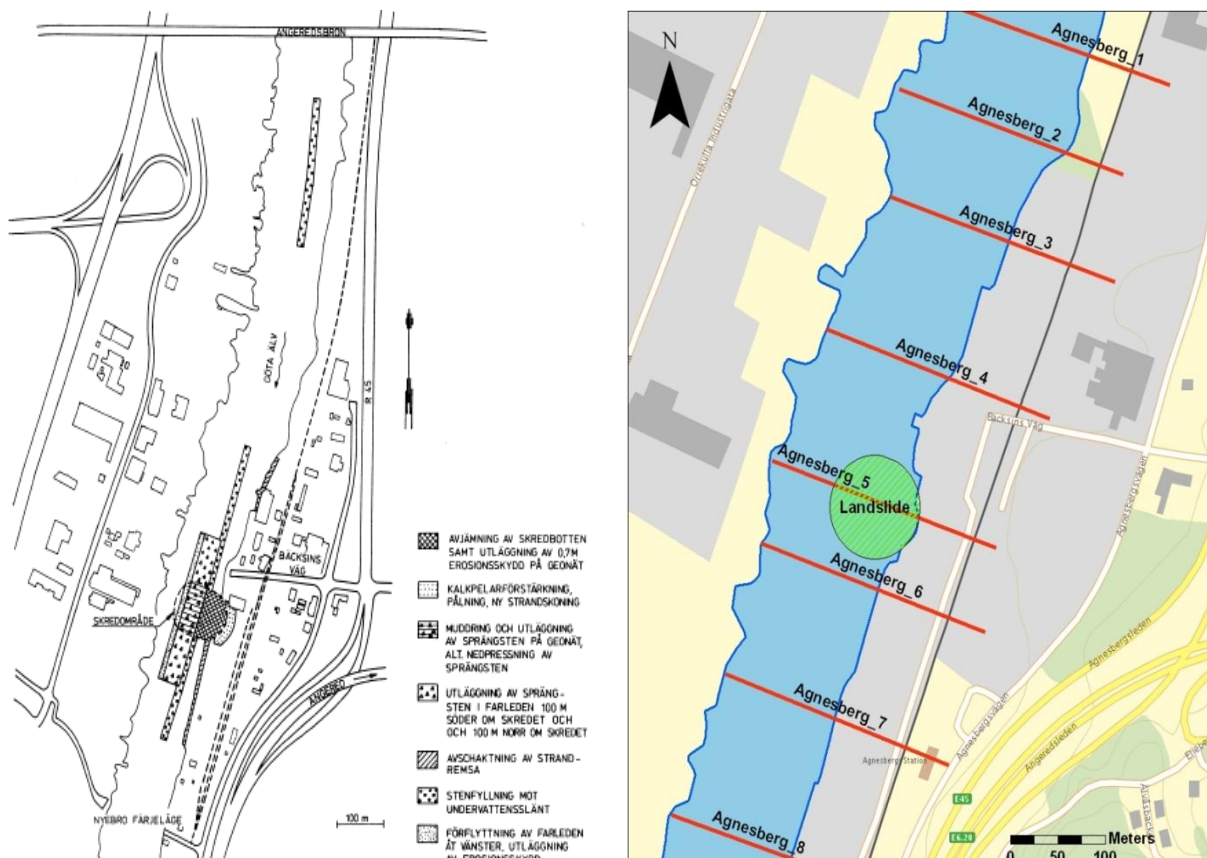
Figure 17 To the left: map of the measures taken in the aftermath of the Agnesberg landslide to reinforce and stabilize the river bottom (Sandebring, 1994). To the right: map of the same area showing profile lines (ArcGIS, 2011).

In the aftermath of the landslide many measures were taken to reinforce, stabilize and prevent any further landslides from occurring in the area. These measures included dredging and placement of blasted rock rubble and small rock on the river bottom, excavation of soil on land to minimize the load on the slope, as well as lime cement columns and geosynthetics (geonets), see Figure 17. These measures obviously affect the geometries of the slopes in the area, and therefore slope profiles have been extracted both from within the area where measures has been taken and outside of it, see Figure 17.

The profiles cover the entire length of the lines as they are drawn in Figure 17 and the smaller boxes to right show the eastern bank of the profile in a much different scale where the topographic variations are more easily observed. The features that would be expected to be seen in the profiles because of the landslide itself and the stabilizing measures taken afterwards are visible in the profiles in the figures. For example Agnesberg\_1 and Agnesberg\_2 don't show any signs of a berm at the foot of the steepest slope leading down to the deep shipping lane. Whereas Agnesberg\_3 and Agnesberg\_6 have a clear showing of what resembles such a thing, also to some extent Agnesberg\_7. This would be because of the rock fill that has been placed in accordance to Figure 17. The profile Agnesberg\_4 doesn't show this so clearly, but that profile is very close to the land slide and that area has been subjected to additional measures which might have given it a different appearance. The fact that the sub aquatic slope of Agnesberg\_4 has the lowest height of them all could be an indication that the blast rock that was put in that section has filled up the entire width of the bottom thus not leaving a berm.

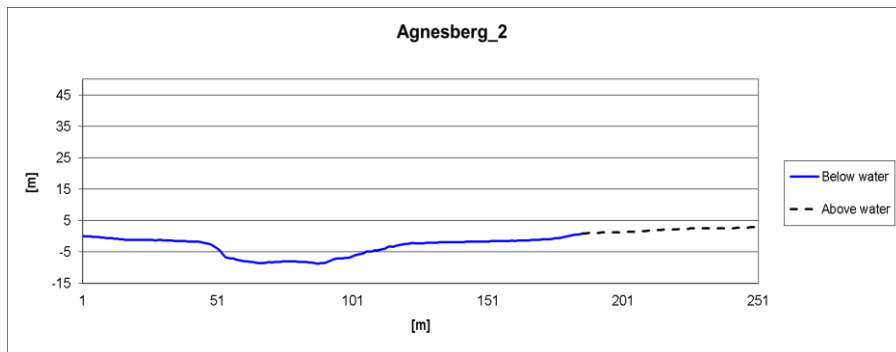
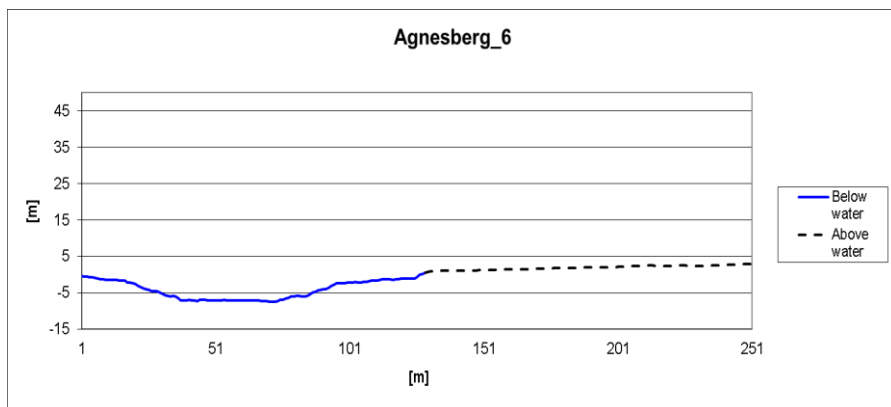
Agnesberg\_5 which is the section that cuts right through the landslide shows the very distinct geometry of a bank terrace that has collapsed. Agnesberg\_8 however which would be expected to look similar to Agnesberg\_1, Agnesberg\_2 or Agnesberg\_7 looks very different. Studying a satellite photo of the area it however becomes very clear that the reason for this is most likely the pier where large ships or barges seem to dock for on and off loading of scrap goods, see Figure 18.

The two profiles Agnesberg\_5 and Agnesberg\_8 will be disregarded for further analyses because they are considered not to represent natural slopes in the area. In Agnesberg\_2 and Agnesberg\_6 the sub aquatic slopes towards the river bottom have a rather constant angle, as has the bank terrace. The profiles Agnesberg\_1, Agnesberg\_3, Agnesberg\_4 and Agnesberg\_6 instead have a geometry that consists of an intermediate plane between the sub aquatic slope and bank terrace, see Figure 19. These two geometries, from now on simply referred to as profile Type 1 and 2 respectively, form the base of further erosion analyses in this chapter and slope stability calculations in Chapter 8.
