## Fracture mechanisms during intergranular hold time fatigue crack growth in Inconel 718 superalloy.

**Abstract** Ni-base superalloy IN718 is known to display time-dependent intergranular crack growth under dwell time mechanical loading at high temperature under atmospheric conditions. Oxygen has been pointed out as a cause of the intergranular damage causing embrittled crack growth during both cyclic and hold time loading. Investigation of the mechanisms responsible for the embrittlement should not only focus on the effect of environment but also on the combined action of fatigue, creep, temperature and time. In this work material from experiments with fatigue crack growth in combination with hold times of different length at different temperatures has been investigated. Fractographic studies and metallographic cross sections of fatigued specimens has been subjected to careful analysis using ECCI- imaging in order to shed light on the fracture mechanisms. The results show that the damage is caused by the influence of a combination of environment and severe local damage manifested as a transformation of the microstructure into sub cells, micro twins and recrystallised areas close

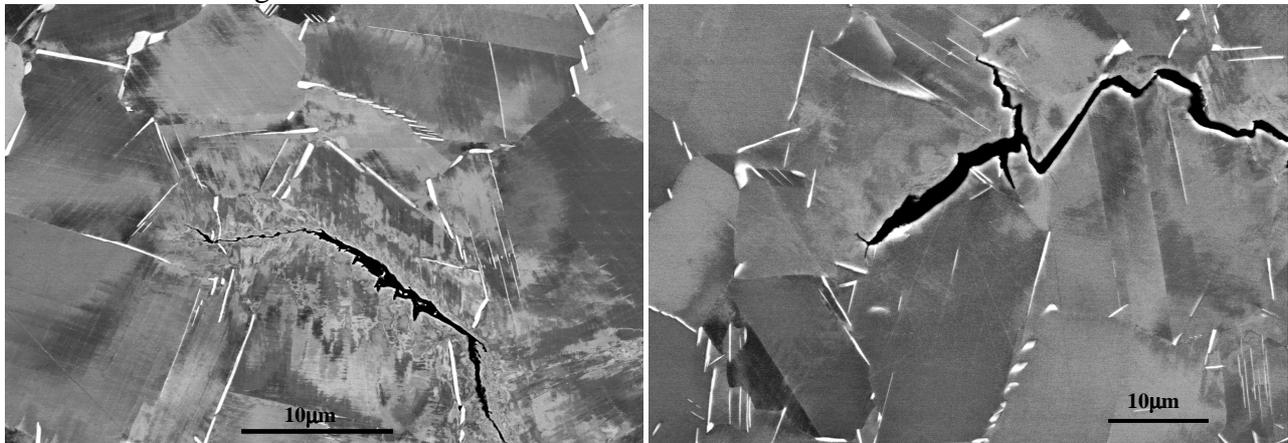
Figure 1. SEM-ECCI micrograph showing cross section of the crack tip region of IN718 subjected to base line fatigue at a) 450°C showing high slip activity and 650°C with lower slip activity.

In order to be able to distinguish between crack growth at different temperatures with and without dwell the results from crack growth without dwell will be presented first. In figure 1 the crack zone for baseline cracking at 450°C and 650°C is shown.

The lower temperature shows clear channeling contrast from plastic deformation caused by homogeneous slip on primary slip systems and in a narrow zone close to the crack localized more concentrated multiple slip. The crack path is transcrystalline with slight crack branching. The crack growth mechanism seems to be based on a weakening of interface at the crack tip by plastic deformation. For the higher temperature the crack path is more intergranular with more crack branching and the slip intensity is less pronounced.

The first one is the growth along grain boundaries where the mating grains are subjected to planar slip on one or two slip systems Figure 1a. The second growth mode is along grains with heavier homogeneous slip and a narrow zone close to the fracture surface with heavy non planar dislocation structure and sometimes twins and recrystallisation structure nicely shown in ECCI mode in the SEM Figure 3.

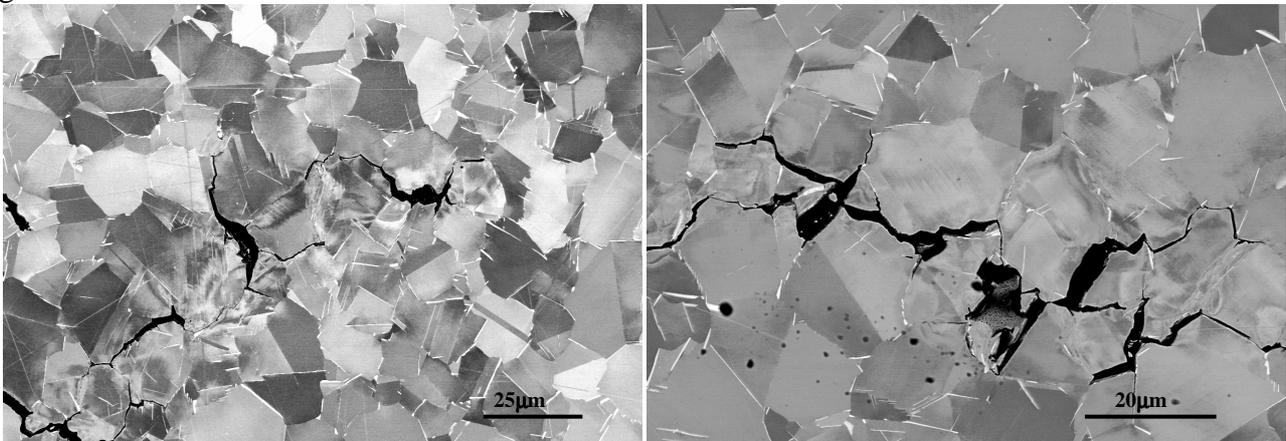
a b  
Figure 2. SEM-ECCI micrographs showing cross sections of specimens with hold time at a) 550°C with intergranular branched cracks and clear signs of slip and b) 650°C with intergranular cracking and less pronounced plasticity.

The specimens subjected to dwell show more intergranular fracture and branching Figure 2 and the plastic deformation is more pronounced at 550°C but the fracture mode is varying along the crack

events caused by unloading between each hold time are difficult to distinguish along the crack front. The crack front seems to have the character of a spherical discontinuous process zone (fig.2) with branched intergranular cracks rather than a single crack moving through the microstructure. Crack growth could then consist of environmental oxygen induced intercrystalline growth of cracks along sensitized paths in different directions and an interlinking between embrittled areas showing ligaments with more severe slip. The ligaments are severely plastically deformed to a level that is very close to dynamic recrystallization with characteristic pores shown as black dots in Fig. 4b, Fig. 5 indicating a future crack path. The growth of the main crack is also influenced by interaction with  $\delta$ -plates acting either as a crack path or as a crack stopper (fig 4a) depending on orientation. The fact that the  $\delta$ -phase is ductile makes it less probable as a crack path but the interface between  $\delta$  and matrix is often acting as a crack [10] path through severely oxidized pores in the interface as observed in this work. Non propagating branched cracks are stopped due to blunting and/or geometrical reasons like going into mode II. Residual stress built up during growth manifested by a closure of the crack along the front also plays a role for the path taken by the crack.

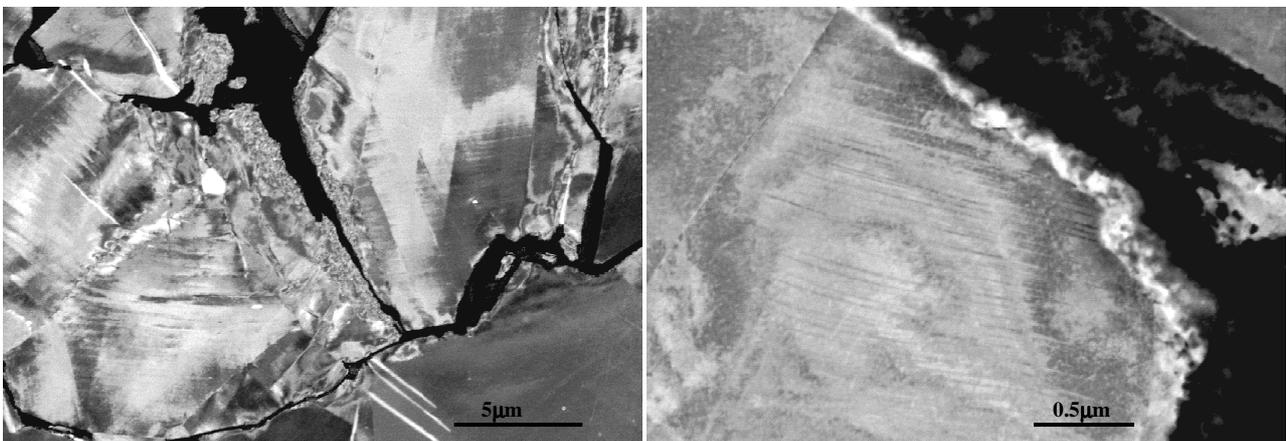
a) b)  
Figure 3. SEM-ECCI micrographs showing a) the plastically damaged zone with sub grains and beginning recrystallisation close to the crack surface and b) deformation twins.

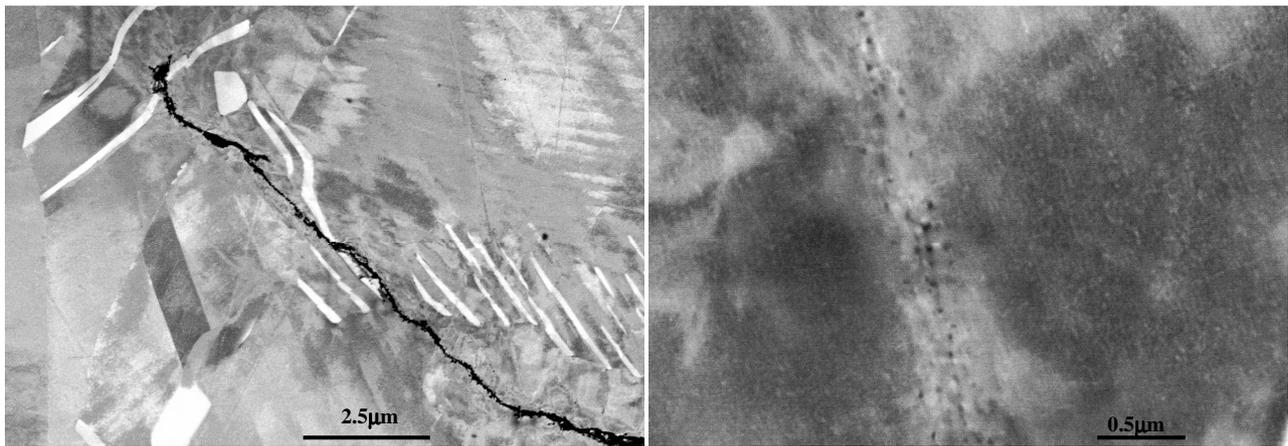
Figure 4. SEM-ECCI micrograph showing a) the crack tip region and b) the damage zone in front of the crack tip at higher magnification with stringers of pores.

The third growth mode is cracking along  $\delta$ -phase often oxidized into a sponge like structure in the interface between a  $\delta$ -plate and the crack. It is thus difficult to say anything about the time-sequence of these events but the nanometric oxidized pores present at crack tips with a smallest size in the order of the hardening precipitates could trigger the onset of intercrystalline failure and the stress state and dislocation structure contributing factors Figure 4, 5, 6. The separate dwell time cracking

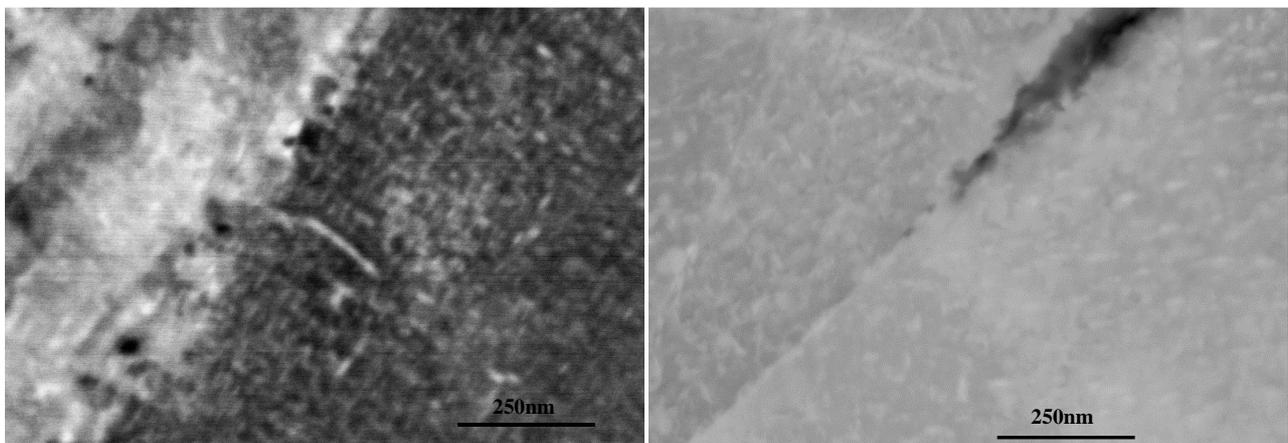
Figure 5. SEM-ECCI picture of the damaged zone in IN718 at 550°C temperature close to the crack showing a) the hardening precipitates along with nano sized pores in an area with high plastic deformation and b) pores in a grain boundary with no plastic deformation.

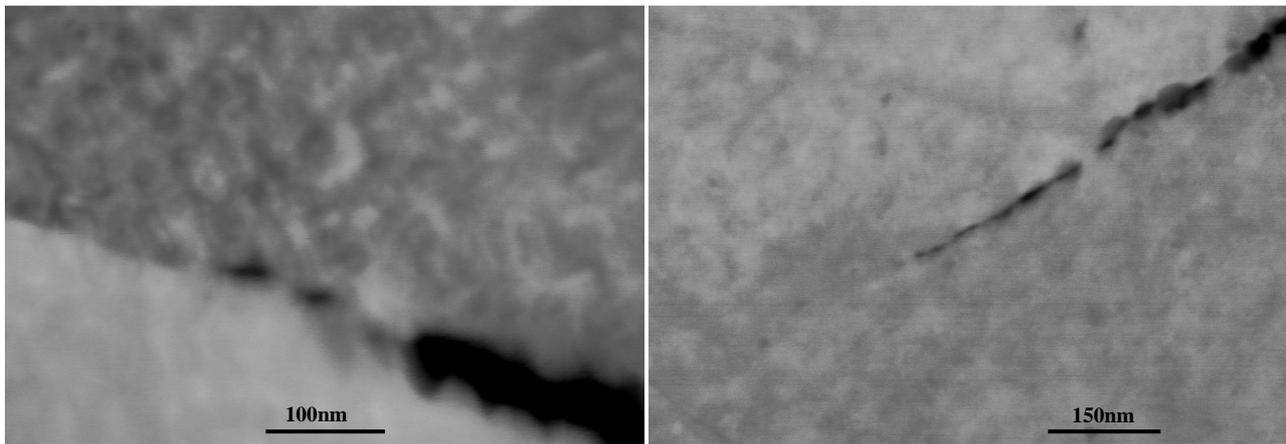
a b  
Figure 6. SEM-ECCI micrographs of a) IN718 650°C during hold and b) ALVAC718plus 700°C during hold. Both alloys show voids in front of the crack tip. The smallest voids are in the same range of size as the hardening precipitates that are clearly visible in a).

The macroscopic crack path often shows a mismatch orthogonally indicating shear or grainboundary sliding along the crack growth direction. SEM ECCI pictures taken at a very high magnification of non propagating secondary cracks is shown in Fig. 6 where nanometric voids in the same size range as the clearly visible hardening precipitates Fig 6a are seen along the grain boundary. This type of voids is often seen along the crack front for longer cracks being coarser and more oxidized.

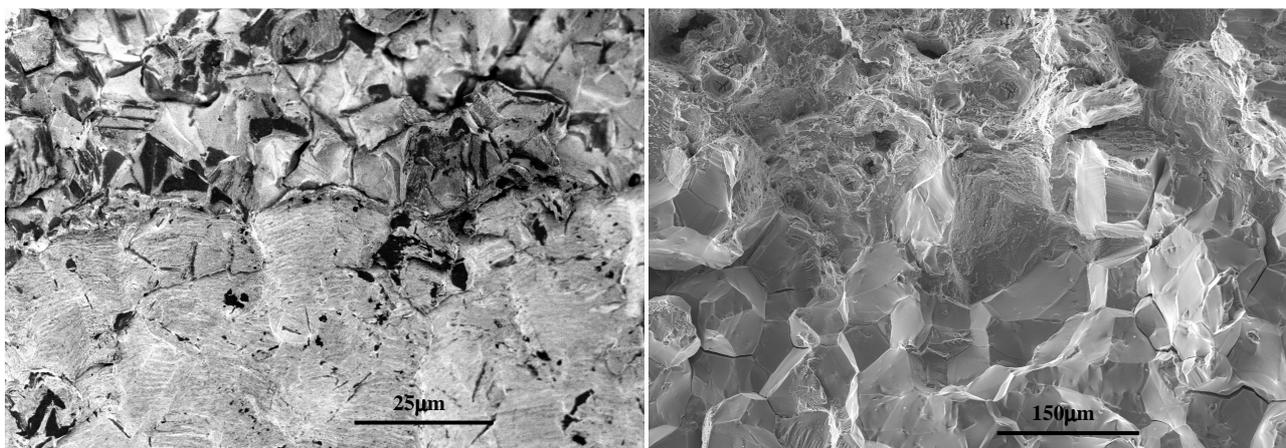
a b  
Figure 7. SEM fractographs showing a) boundary between pre cracking at room temperature (lower) and dwell time growth at 550°C (upper), black contrast is  $\delta$ -phase b) boundary between dwell cracking (lower) and final fracture (upper)in Allvac718plus at 700°C in pure oxygen atmosphere.

The dwell time cracking of Alvac718Plus in pure oxygen atmosphere shows (Fig. 7b) more clearly the intercrystalline character of the crack growth due to the absence of  $\delta$ -plates (black in Fig. 7a) in this condition. The observable environmental action manifested by growth of oxidized pores in the grain boundaries seems to be the same as for IN718. The completely flat grain boundary surface has still slip bands and microscopic pores. The fatigue cycling in oxygen atmosphere at 700°C before the start of the dwell time cycle show clear striation like arrest markings indicating a continuous crack growth mode. Studying the fracture surfaces in higher magnification show signs of nano sized voids at the tip of branched cracks. The intergranular facets giving a smooth appearance at lower mag. (Fig 7b) show signs of voids at higher magnification (Figure 8, 9).

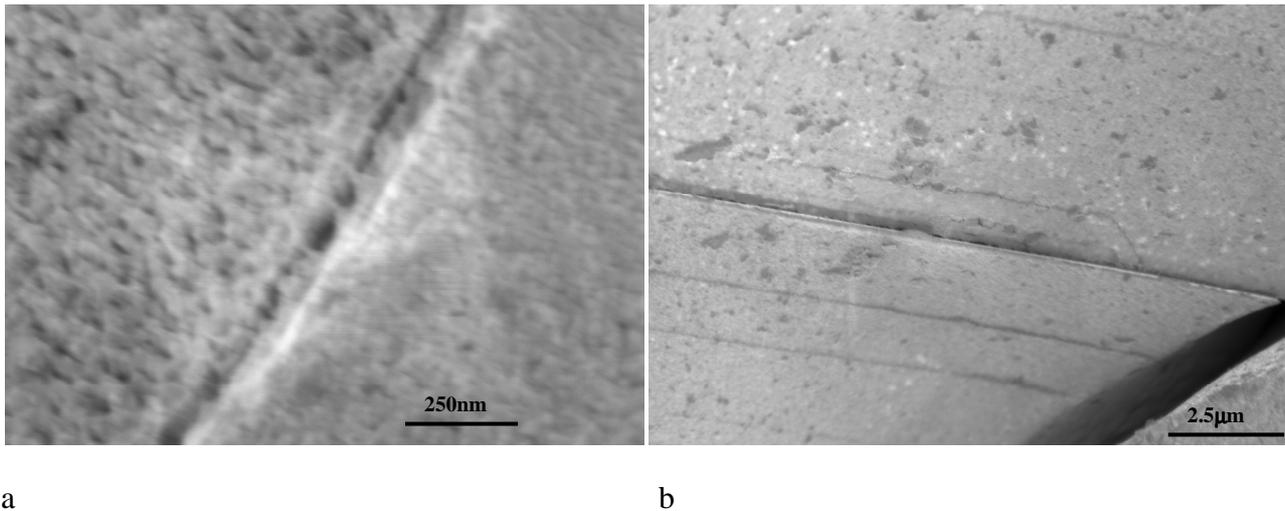
a b  
Figure 8. SEM fractographs of grain facets in Allvac718plus (700°C dwell) a) oxidized surface with voids b) surface at lower magnification with one open and one closed secondary crack with voids.

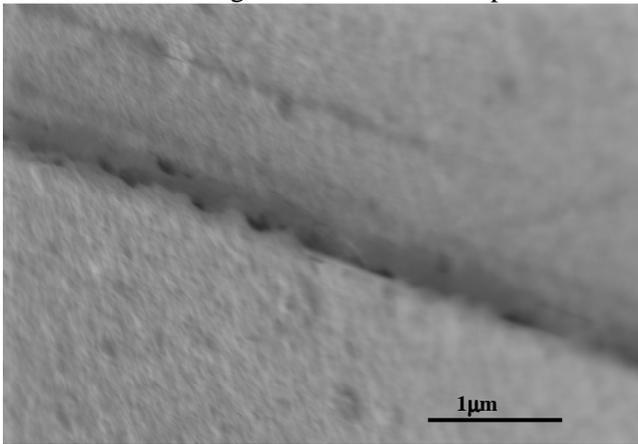
Figure 9. SEM fractograph showing the voids in the grain boundary shown in fig. 8b at higher magnification.
