Strategy for developing a future support system for the Vasa warship and evaluating its mechanical properties

Lechner, T. ; Bjurhager, I. ; Kliger, R. (2013) "Strategy for developing a future support system for the Vasa warship and evaluating its mechanical properties". Heritage Science (Chemistry Central), vol. 1(35),

Strategy for developing a future support system for the *Vasa* warship and evaluating its mechanical properties

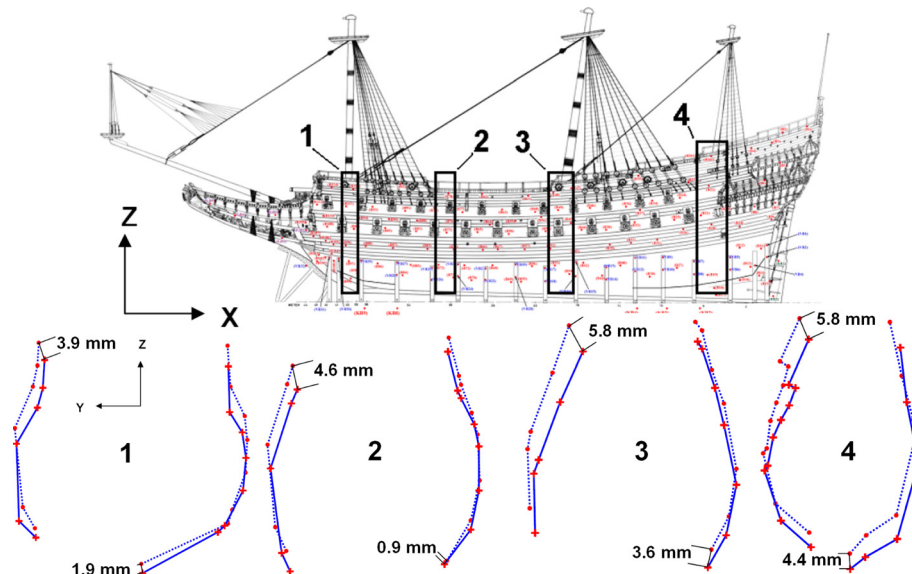
Figure 1 This figure shows the deformation pattern of the *Vasa* warship between 2000 and 2003, on both the starboard and the port side in four different sections. Figure adapted from [9].

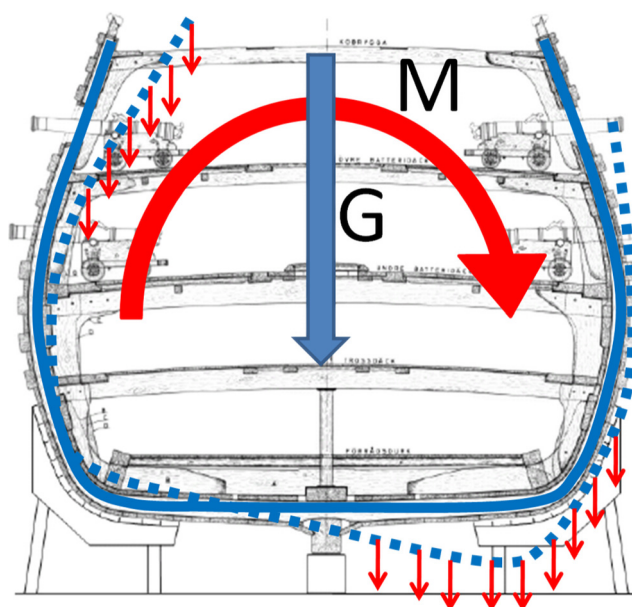
Figure 2 Cross-section of the *Vasa* warship. The deformation and translation are expected to be caused by deck structures that are not sufficiently stiff, weak connections between decks and the hull and asymmetrically distributed weight, e.g. the warship's inclined mast.

beams [10] and also deformation of the bilge, see Figure 2. The model and the material parameters were subsequently updated by Ljungdahl [9]. The updated model suggested that improved support, especially the strengthening of the main frames supporting the gun decks, would increase the stiffness of the ship's structure and probably reduce the speed of the time-dependent deformation. This FE model used material parameters from only a few *Vasa* oak samples as input. So, in order

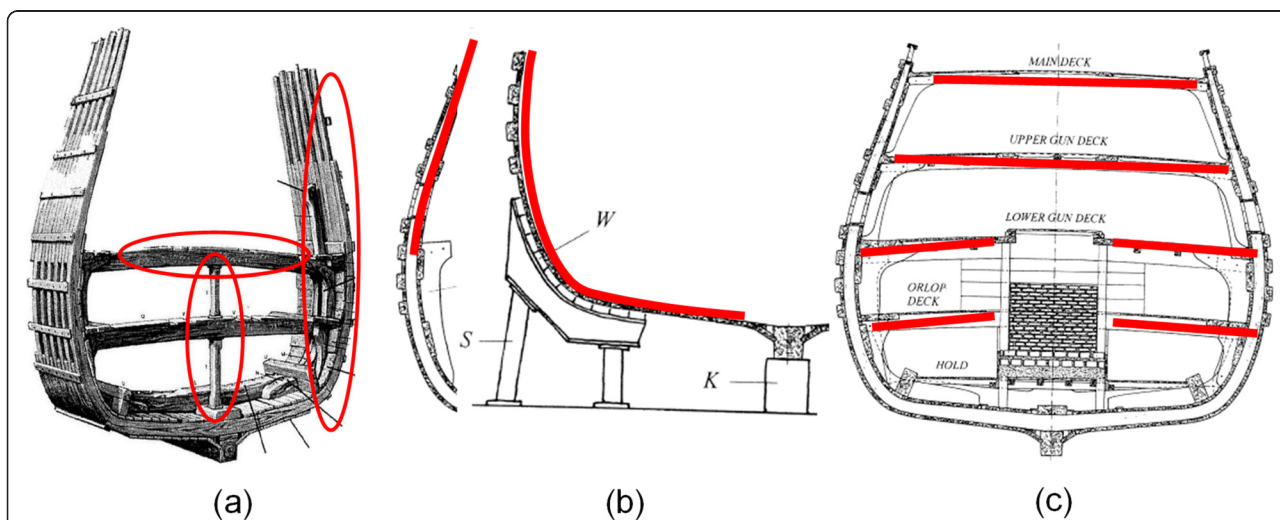
Figure 3 Possible future intervention strategies for the *Vasa* warship suggested by Ljungdahl [9]. (a) Strengthening centre columns using fibre composites, for example, (b) increasing the stiffness of the side and bottom structure of the hull and (c) increasing the stiffness of both the deck beams and their connections.

Both the on-site assessment and the analysis of the bearing capacity (Steps 1 and 2) provide the basis for the choice of support (Step 3), where a decision will be made about how to support the ship in the best possible way. This implies a new and improved support system, preferably including load cells at each supporting position. An analysis of this kind could be very useful for decisions relating to strengthening and/or stiffening actions of the ship's structure and the second step may lead to the need to strengthen some parts of the hull, cf. Figure 3.

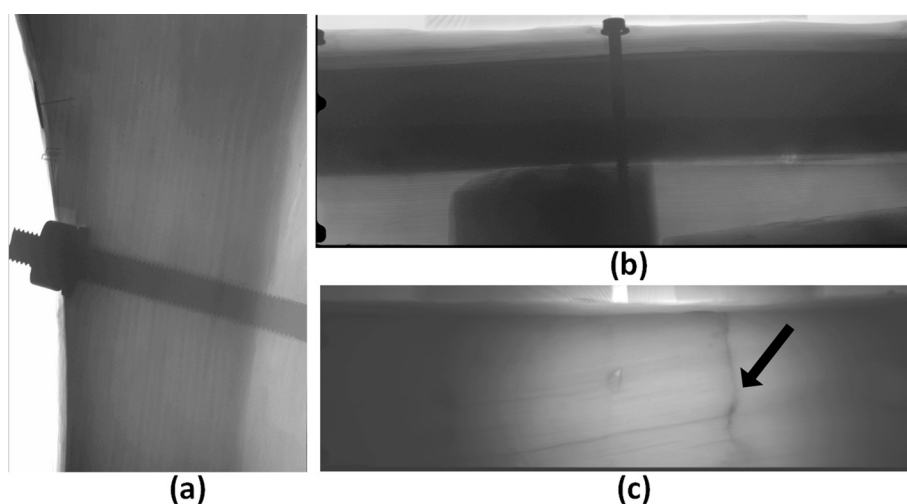
Figure 5 X-ray examination to evaluate the structural integrity of connections (a, b), components (b) and the internal condition (c). (a) Bolt connection of knee to the hull structure on upper gun deck (beam 5). (b) Integrity of structural components from upper gun deck, porthole 6. (c) Plank with internal fracture from stern, portside, 3rd gangway. The images were enhanced in Photoshop®.

In addition to the determination of density, the X-ray technique is well established as a powerful tool for investigating the internal condition of the structure [14], especially the examination of connections and the integrity and condition of the structural components, such as those in the *Vasa* warship, see Figure 5. The investigation of connections in the *Vasa* warship is decisive for the load transfer within the hull and the load transfer from the hull to the existing support cradle and needs to be made in detail. This will also make it possible to measure and make visible geometry and joint configurations, as well as contact between hidden elements. Information of this kind is crucial for the accuracy of the FE model and supports the decision-making when it comes to ways of transferring the forces between the elements in the model.
