# **Retrofitting of a listed brick and wood building using vacuum insulation panels on the exterior of the facade: measurements and simulations**

listed building; retrofit; brick; wood; vacuum insulation panel; measurement; simulation; hygrothermal performance; thermal transmittance; thermal comfort

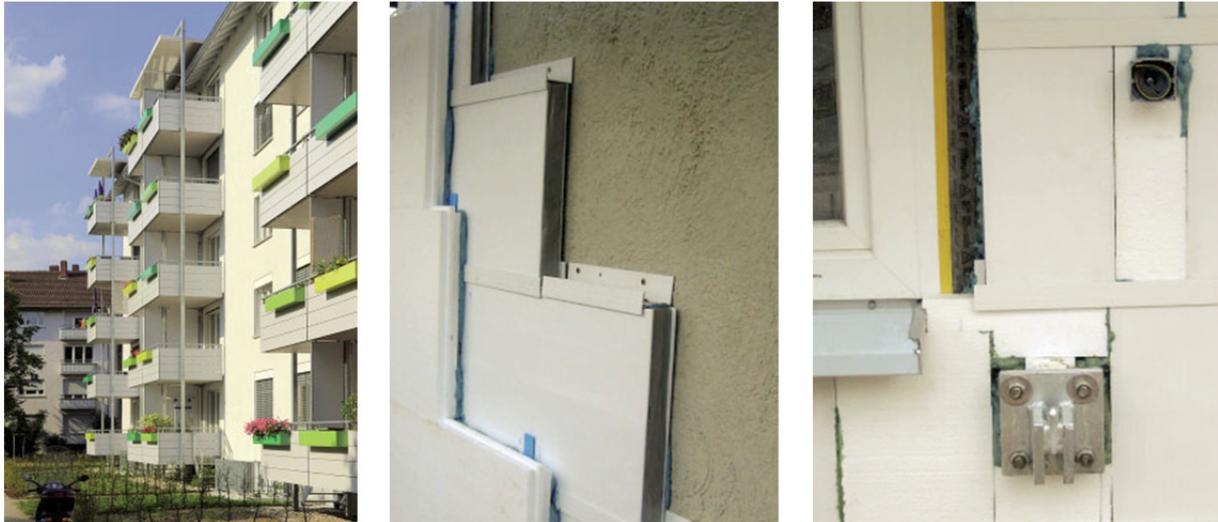
Figure 1. VIP used in the retrofitting of a multi-family building in Karlsruhe, Germany. The 40 mm thick VIP was attached to the façade in a rail system and covered on the exterior by 50 mm EPS. The aim of the design was to maximize the surface covered by VIP (Photo: Schöck Balkonsysteme GmbH, Brillux GmbH & Co. KG).

Examples of a number of different constructions where VIP has been used in retrofitted building envelopes have been reported in the literature. During 2002-2005 the international efforts in VIP research were assembled in the IEA/ECBCS Annex 39 High Performance Thermal Insulation (HiPTI). The project included monitoring and evaluation of 20 buildings with VIP in floors, roofs, walls, dormer windows and other constructions [10]. The number of case studies where VIP was used in façades is limited, but there exists studies of VIP used both on the interior [11, 12] and exterior [13-15] of existing external walls. Some practical issues when retrofitting with VIP on the exterior were discussed by Zwerger and Klein [15] who investigated the use of VIP in an ETIC system such as the one presented in Figure 1.

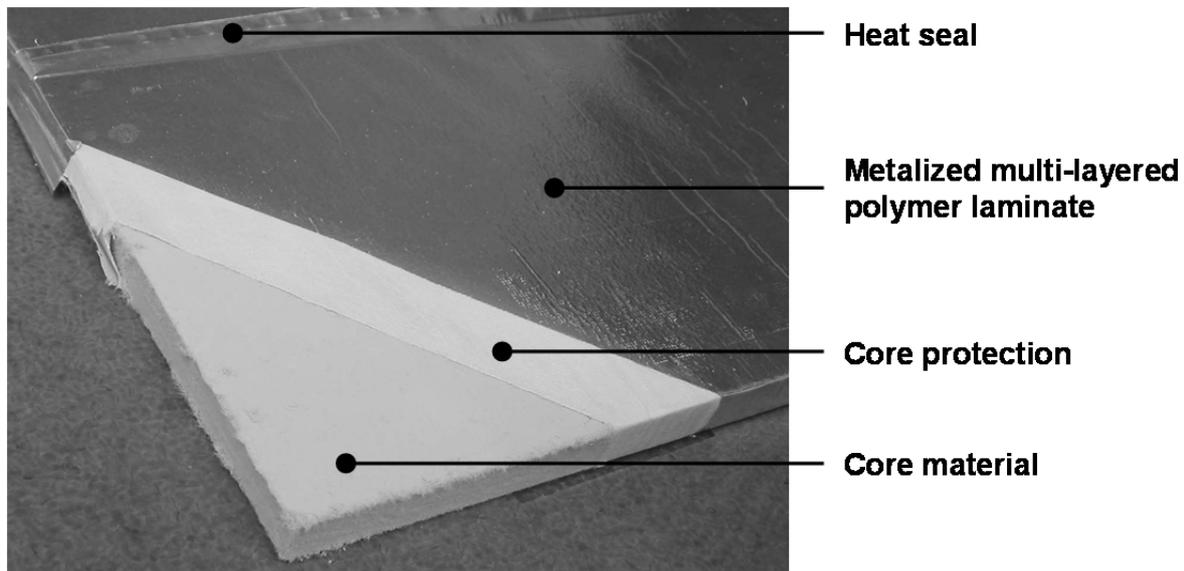
Figure 2. VIP is a composite with a fine powder core or fiber wrapped in a heat sealed metalized multi-layered polymer laminate (Photo: va-Q-tec AG).

VIP is a composite which can be divided in two parts; the core material and the laminate, as shown in Figure 2. The core material is a fine powder or fiber which is evacuated to pressures of 0.2-3 mbar and therefore should be able to resist the atmospheric pressure on the laminate, i.e. 0.1 MPa or 10 metric tons/m<sup>2</sup>, without changing dimensions over time. The most common core material for VIP used in buildings in Europe is fumed silica while also glass wool and open cell polyurethane are common for other applications areas where the service life is shorter. Fumed silica is a material used in semiconductor industry and in the production of photovoltaic cells. It is produced by pyrolysis of silicon tetrachloride, SiCl<sub>4</sub>, which is vaporized and reacts with oxygen to form silicon dioxide, SiO<sub>2</sub> [23]. To reduce the heat transfer by radiation inside the pores of the fumed silica silicon carbide, SiC, is added to the

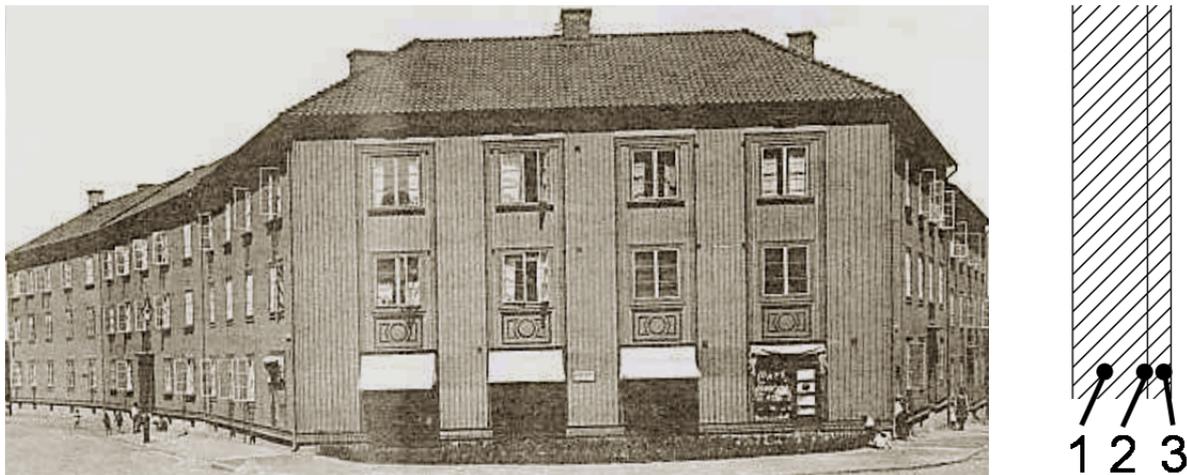
Figure 3. Landshövdingehuset “County governor’s house” in Gothenburg, Sweden. A façade in 1930 (left) and the construction of the original wood wall (right). 1) Structural wood or brick, 2) Tar paper, 3) Wooden cover boarding. (Photo from Sören Nilsson’s collection of postcards; Pär Johansson).

The building chosen for the study is a landshövdingehus “County governor’s house” built in 1930 in Gothenburg, Sweden, see Figure 3. This is a typical historical building for the city of Gothenburg, located on the Swedish west coast. Most of these buildings were constructed during 1876-1936 when fire regulations limited the height of wood buildings to two floors. After the county administrative board approved buildings with two wood floors on top of a brick or stone masonry ground floor, the building type became very popular. Today there are over 1 400 similar buildings in the Gothenburg region although many were demolished in the 1960-1970s. Today, the exterior aesthetics of the buildings are protected by Swedish legislation as a cultural environment of national interest. The buildings are inhabited with

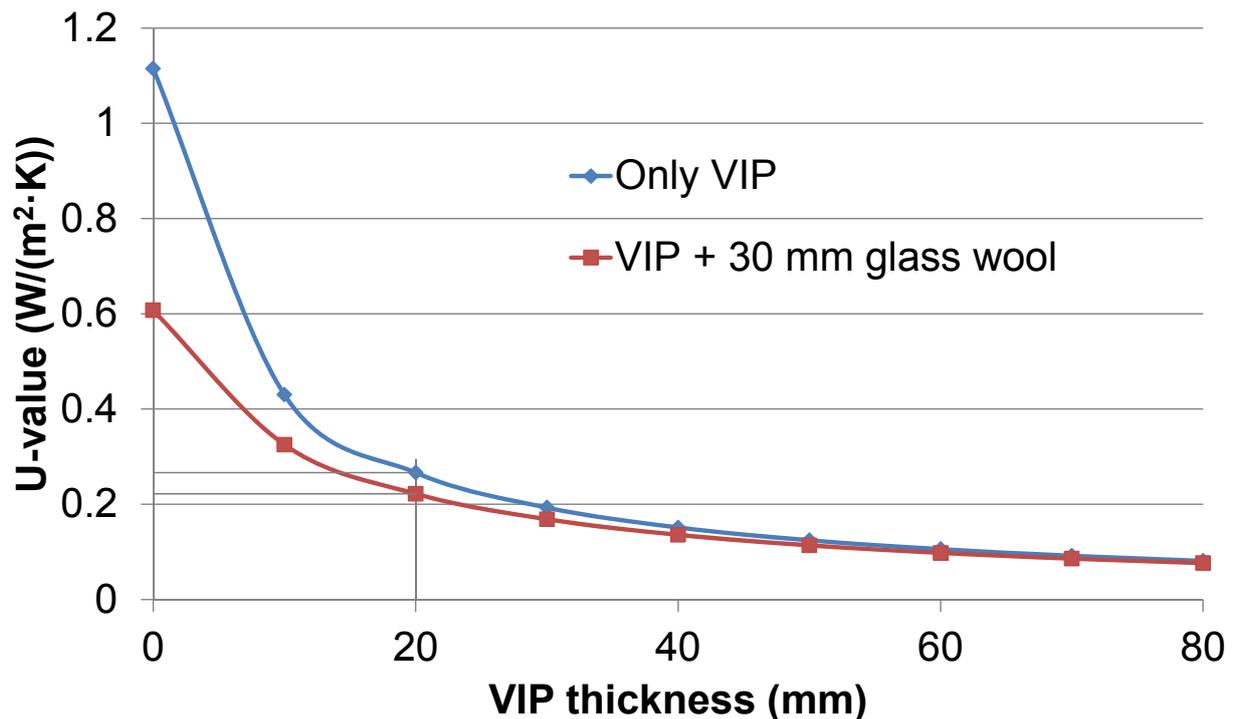
Figure 4. U-value as a function of the thickness of the VIP in the exterior brick wall, with and without 30 mm glass wool to protect the VIP. The chosen VIP thickness 20 mm is marked with the line. The thermal conductivity of the VIP was 0.007 W/(m·K) and 0.04 W/(m·K) for the glass wool.

The resulting U-value for different VIP thicknesses is presented in Figure 4. A protection layer of 30 mm glass wool boards was proposed to be installed over the entire VIP surface. The influence by the protection layer on the U-value is also shown in Figure 4. Discussions in

If the wall had been insulated with a continuous layer of 20 mm VIP, the theoretical U-value was 0.22 W/(m²·K), as shown in Figure 4. However, the gaps filled with glass wool create

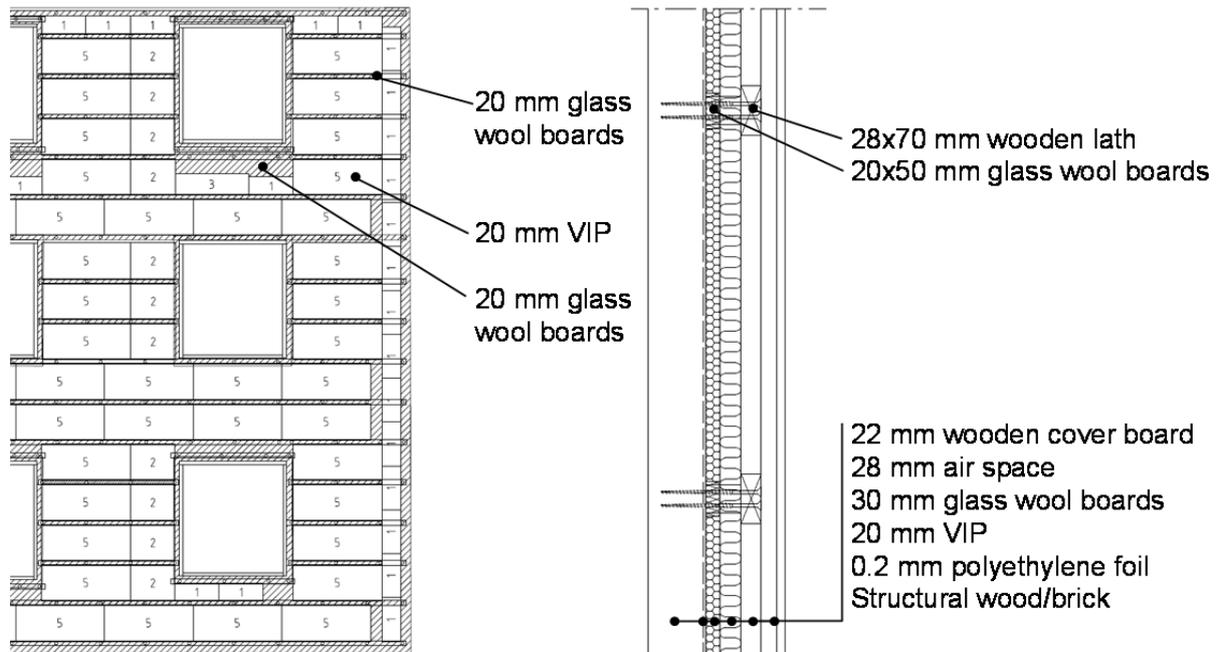
Figure 5. Wall layout after retrofitting with 20 mm VIP and 30 mm glass wool boards.

the design team and with the building owner Familjebostäder i Göteborg AB resulted in an allowed additional thickness of 80 mm without risking the original features of the façade. This solution demanded that the old windows were moved 80 mm outwards, to be in line with the new façade. The thickness of the VIP was decided to be 20 mm. With the 30 mm thick layer of glass wool on the exterior of the VIP, 30 mm remained. An air space, 28 mm thick, was added to the façade, see Figure 5, to allow for drying of possible moisture entering through the wooden cover board.

One difficult detail of the design was the attachment of the wooden cover board on the façade. The chosen solution presented in Figure 5 shows distances of glass wool boards, 50 mm wide and 20 mm thick, between the VIP that allows for the wooden cover board to be attached without damaging the VIP. Another difficult detail was the insulation around the windows. The irregularities of the old wall made it impossible to use VIP here. Therefore glass wool was used to fill the space between the VIP and windows.

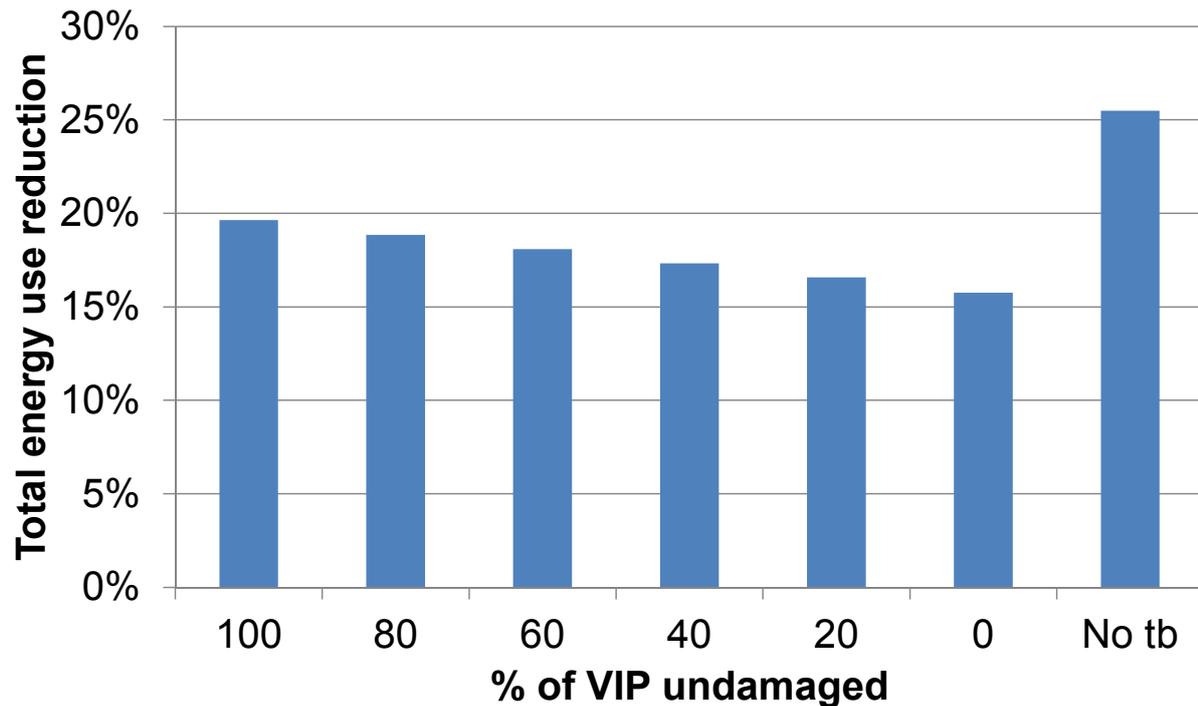
Figure 6. Reduction in total energy use for different scenarios of the percentage of undamaged VIP compared to the case without any thermal bridges (No tb) between the VIP.

Based on the technical drawings it was estimated that 21% of the façade was covered by windows with a U-value of  $3 \text{ W/m}^2\text{K}$  which were kept after the retrofitting. The U-value of the roof and floor were estimated to be  $0.5 \text{ W/m}^2\text{K}$  and  $0.9 \text{ W/m}^2\text{K}$  respectively. The U-value of the wall was calculated with regard to the thermal bridges created by the glass wool between the VIP and around windows, and the laminate around the VIP. The total average U-value was increased by 5% to include the additional thermal bridges between building elements. Figure 6 shows the reduction in the total energy use dependent on the percentage of undamaged VIP compared to the case before retrofitting.

The calculated energy use before retrofitting was  $158.7 \text{ kWh/m}^2$  for heating and domestic hot water. The total energy use was reduced with more than 25% for the case with an unbroken VIP layer and without any thermal bridges. With regard to the thermal bridges in the façade, the reduction became 20% with all the VIP undamaged which was further reduced to 16% if all the VIP were punctured. As a comparison, changing the windows to windows with a U-value of  $1 \text{ W/m}^2\text{K}$  gave an energy use reduction of 15%. The combination of changing windows and installing VIP gave an energy use reduction of 34%.

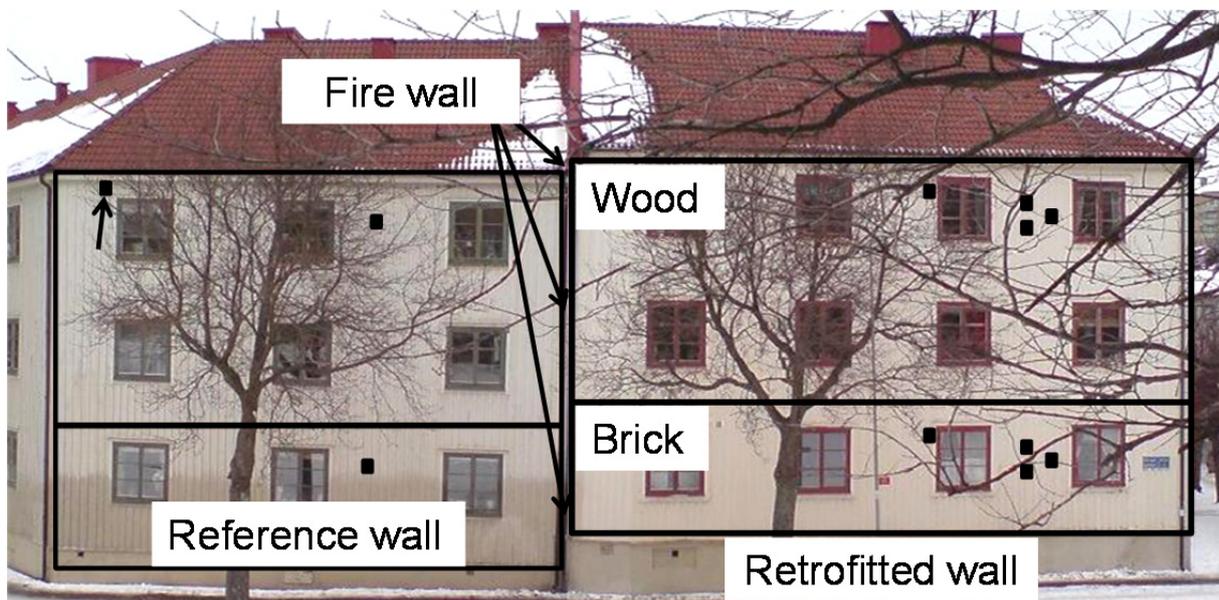
Figure 7. Reference and retrofitted wall with the approximate location of the sensors in the walls. Between the walls there is a thick brick fire wall separating the two buildings. The arrow in the upper left corner indicates the sensor monitoring the outdoor climate.

Depending on which U-value that is targeted for the wall after retrofitting, the thickness of the VIP can be varied. The appearance of the building cannot be changed, which limits the overall thickness of the wall and thereby the U-value of the wall. The wall thickness is limited by the connection between the wall and the roof, and it should remain as it was before. Also the connection between the wall and a fire wall which separates the building from the wall of the next building, see Figure 7, should be kept.

location behind the VIP-VIP connection was missed and the sensor was located too low which meant two sensors monitored the glass wool strip. In the reference façade, two sensors were located behind the wooden cover board, as shown in Figure 7, one in the brick and wood wall respectively. Furthermore, one sensor was located in the kitchen of each of the four apartments closest to the monitored part of the wall to obtain the indoor conditions. The final sensor monitors the outdoor temperature and relative humidity at the building site. It was located in a perforated plastic box placed underneath the roof eave facing southwest, as shown in Figure 7. Solar radiation influences the measurements and therefore it was not the air temperature that was measured, but an effective (solar-air) temperature of the wall. The sensor was protected from rain and the whole box was ventilated through a number of holes drilled in its bottom.

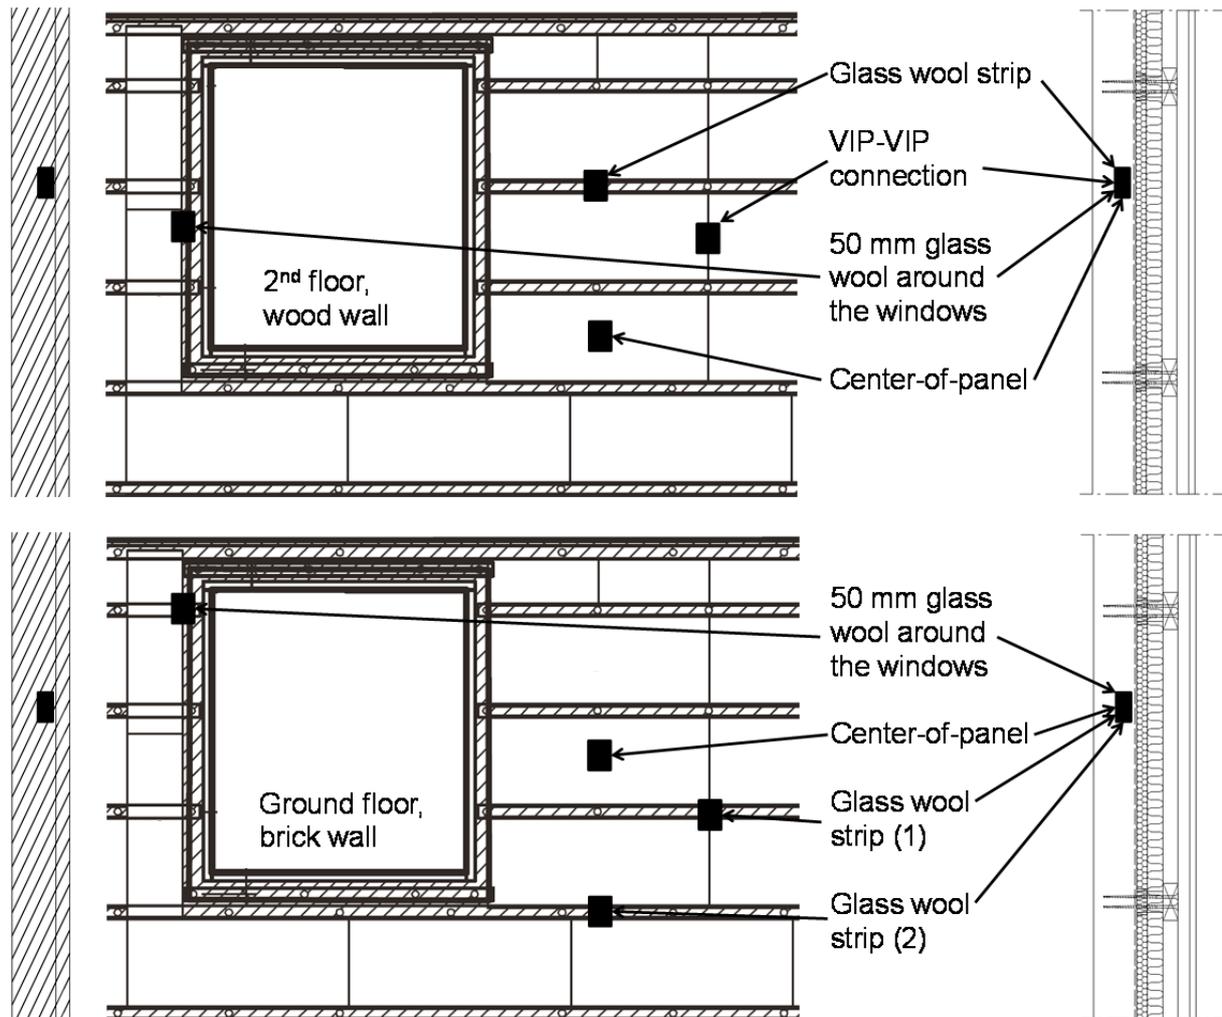
Figure 8. Location of sensors in the reference (left) and retrofitted wall (right). Upper: wood wall, lower: brick wall. The sensors in the reference wall were located behind the wooden cover boarding while all the sensors in the retrofitted wall were located in the existing wood on the interior of the polyethylene foil and VIP.

As discussed in Section 3.4 and shown in Figure 8, the measurement locations are not entirely the same for the two walls. This explains some of the differences between the ground floor and the 2<sup>nd</sup> floor measurement results. As can be expected, the temperature was highest behind the center-of-panel in most cases. There was one exception where the temperature in January, 2013 behind the VIP-VIP on the 2<sup>nd</sup> floor was higher than behind the center-of-panel location. The temperature was lower behind the glass wool laths, than at the VIP-VIP, where the thermal bridge was smaller. The lowest temperature in the retrofitted wall was found at the window frame where there was less insulation.

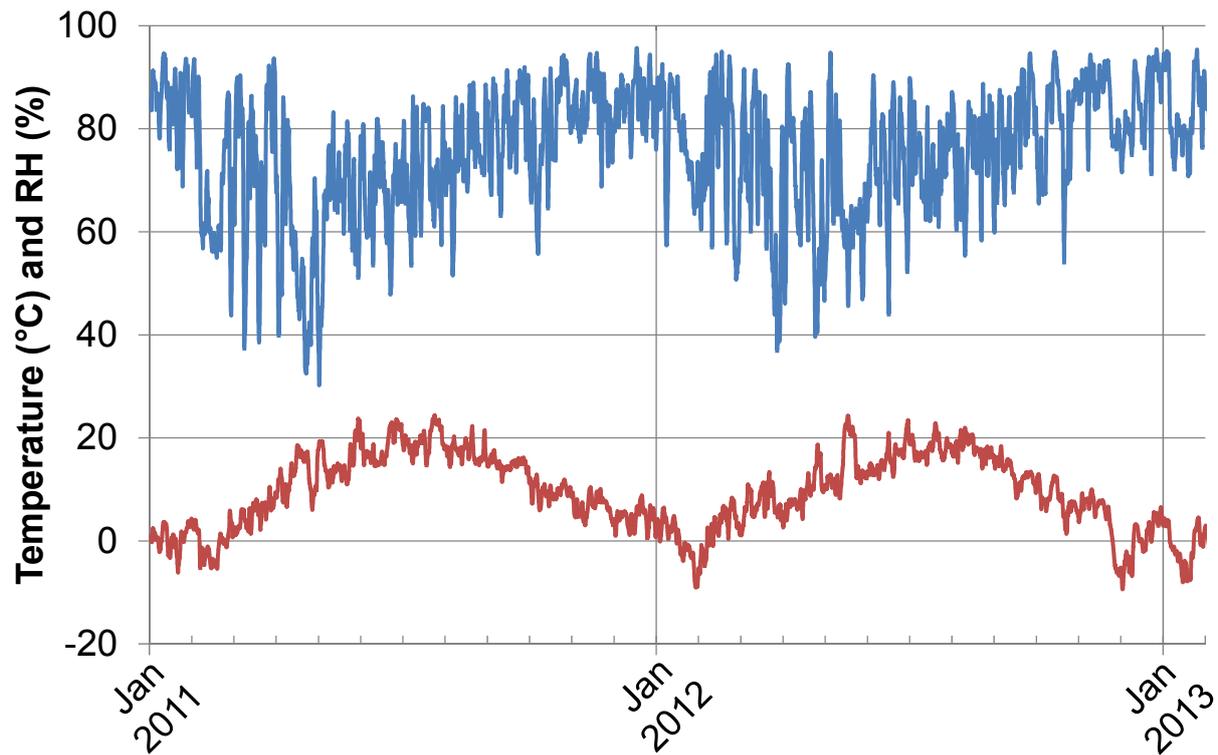
Figure 9. Daily averaged measured effective outdoor wall temperature and relative humidity during 2011, 2012 and January, 2013. The sensor is located in a perforated plastic box, exposed to solar radiation and some wind but protected from rain.

The measurements were started in October 2010, but as discussed earlier some data are missing because of problems with the sensors. There were some hours with missing data also later during the measurement period. These short gaps were filled by linear interpolation. Figure 9 presents the daily averaged measured effective outdoor wall temperature and relative humidity from January, 2011 to February, 2013.

The annual average effective outdoor wall temperature was 10.3°C in 2011 and 9.3°C in 2012, varying between -10.4°C and 32.1°C in 2011 and -12.7°C and 32.9°C in 2012. The relative humidity was on average 74.4% in 2011 and 75.7% in 2012, with the lowest relative humidity in 2011 of 16.9% and 16.4% in 2012. The maximum relative humidity was 96.1% in 2011 and 96.5% in 2012. The two years were quite similar in regard of relative humidity while the annual average effective outdoor wall temperature was on average 1°C higher in 2011 than in 2012. This deviation has to be taken into account in the analysis.

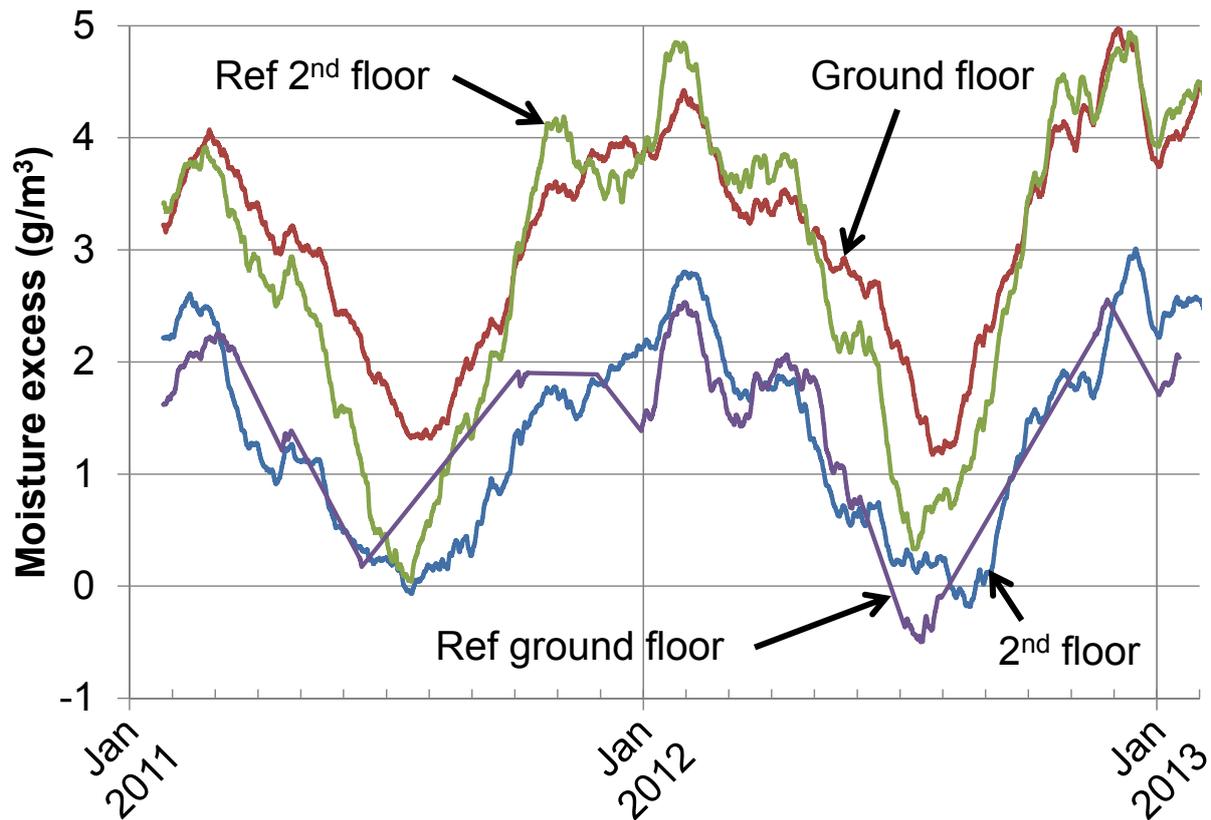
Figure 10. Monthly average moisture excess in the four apartments during 2011, 2012 and January, 2013. For the reference ground floor data for 131 hours (1.5%) are missing during 2011 and 209 hours (2.4%) during 2012 which explains the straight lines in the figure.

The average indoor temperature in the apartments was higher in 2011 than in 2012 which could be explained by the higher effective outdoor wall temperature in 2011. The average difference between the indoor temperature and the effective outdoor wall temperature in the four apartments was 0.3°C higher in 2012 than in 2011 which is less than the sensor accuracy of  $\pm 0.5^\circ\text{C}$ . The relative humidity was similar for the two years, but differs with 10 percent points between the apartment with the highest and lowest relative humidity. The moisture excess was varying with more than 100% between the apartments: one apartment, each in the reference building and the retrofitted building, was represented in the highest and lowest moisture excess range. In Figure 10, the moisture excess during 2011, 2012 and January, 2013 are presented as monthly averaged values.

It is clear that the moisture excess varies during the year, with the highest values in the winter and lowest in the summer. This is probably caused by an increased airing by the occupants and less time spent indoors during summer time. The difference between the maximum and minimum moisture excess during the year was  $4.9 \text{ g/m}^3$  in the reference apartment on the 2<sup>nd</sup> floor during the year while it was  $3.2 \text{ g/m}^3$  in the apartment on the 2<sup>nd</sup> floor in the retrofitted building. Therefore, the retrofitting did not change the indoor climate more than what can be expected from the influence of the occupants' behavior.

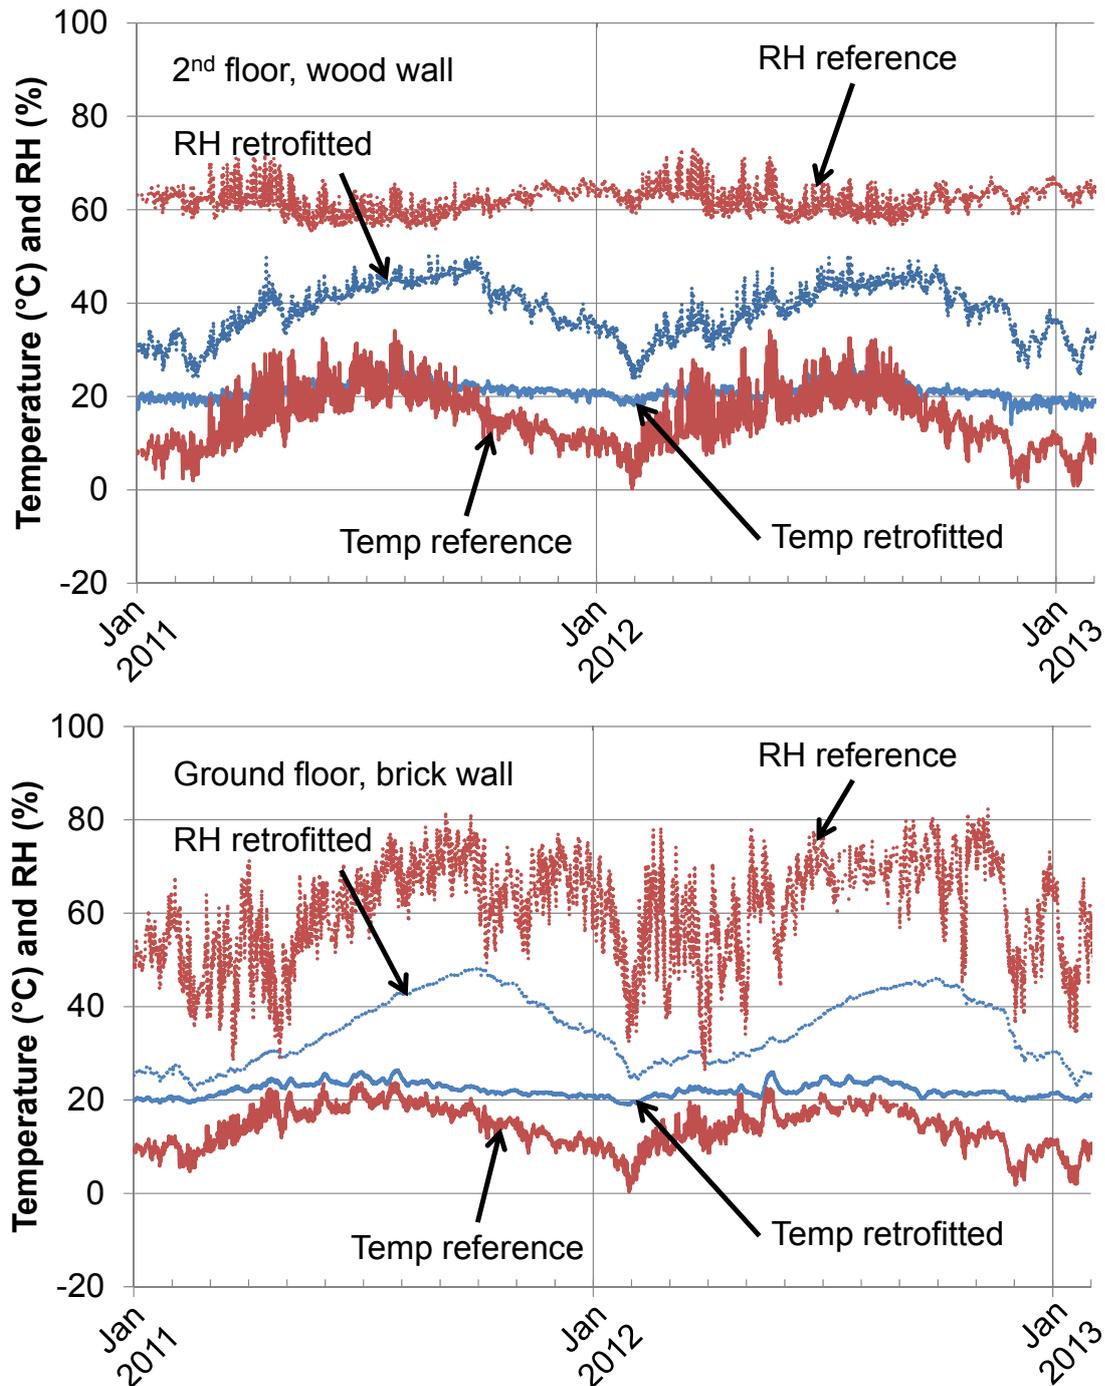
Figure 11. Temperature and relative humidity in the 2<sup>nd</sup> floor wall (top) and in the ground floor wall (bottom). The reference wall (center-of-panel) is compared to the retrofitted wall during 2011, 2012 and January, 2013.

The relative humidity in the wall was already in a safe hygrothermal range before the retrofitting, i.e. around 70% measured in June, 2010. This is also confirmed by measurements in the reference wall, as shown in Figure 11, where the temperature and relative humidity in the retrofitted wall (center-of-panel) are compared to the reference wall during 2011, 2012 and January, 2013.

The temperature in the reference and retrofitted walls differed substantially during 2012. In the ground floor reference wall the temperature varied between 0.4°C and 22.5°C with an average of 12.9°C. In the retrofitted wall it varied between 19.0°C and 26.0°C with an average of 21.9°C. As for the 2<sup>nd</sup> floor, the temperature in the reference wall varied between 0.3°C and 34.1°C with an average of 14.8°C, and it varied between 14.0°C and 28.3°C with

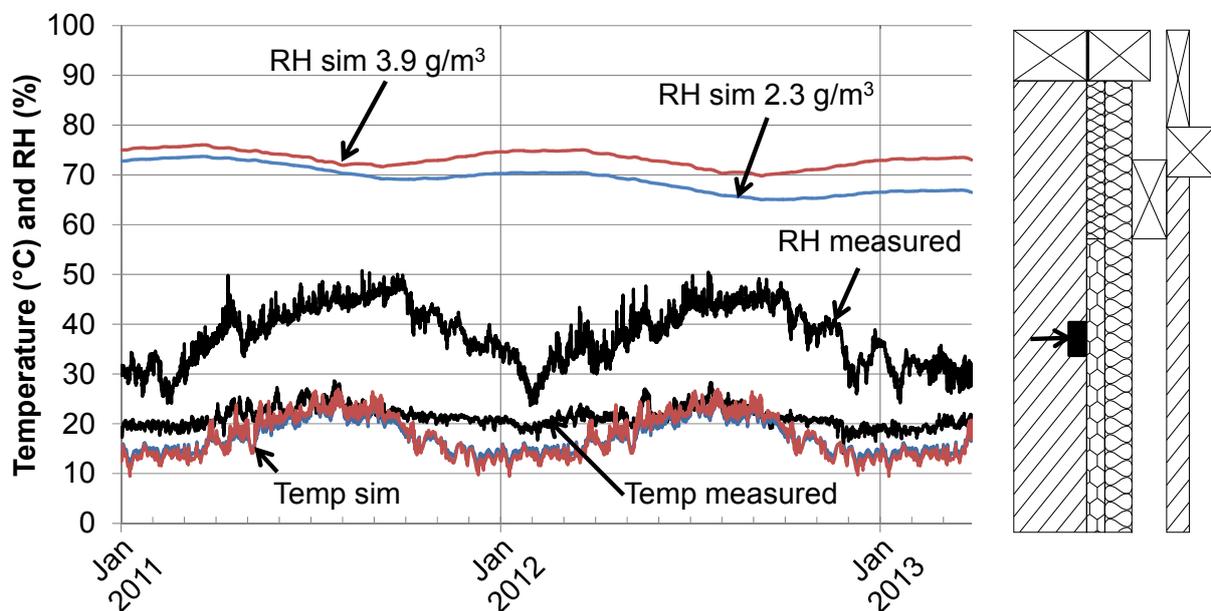
Figure 12. Comparison of the hygrothermal simulations with the measurements of the temperature and relative humidity behind the VIP in the wood wall. Two different indoor climates were simulated where the difference was in the level of indoor moisture excess. The location of the sensor is marked by the black box with a black arrow pointing from the left.

8.8°C. The outdoor relative humidity is on average 74.5% and ranges between 19% and 100%. Two levels of the average indoor moisture excess were estimated based on the measurements in two apartments in June to August, 2010. The average moisture excess was  $2.3 \text{ g/m}^3$  in one apartment and  $3.9 \text{ g/m}^3$  in the second. These values were used as input data in the simulation to create two scenarios of the indoor moisture excess. The lower moisture excess scenario had an average indoor temperature of  $21.1^\circ\text{C}$  and 48.8% relative humidity while the higher moisture excess scenario had an average indoor temperature of  $22.2^\circ\text{C}$  and 53.3% relative humidity. The simulation results presented in [20] for the two levels of moisture excess are compared in Figure 12 to the measurements in the wall during the period 7 January, 2011 to 3 April, 2013.

The simulations differed significantly from the measurements during the period 7 January, 2011 to 3 April, 2013 where the measured temperature was higher and the measured relative humidity was lower than in the simulations. The simulated temperature and relative humidity in the wall was on average  $17.3^\circ\text{C}$  and 73.2% for the high moisture excess and  $17.4^\circ\text{C}$  and 69.2% for the low moisture excess while the measured temperature and relative humidity was  $21.3^\circ\text{C}$  and 37.8% on average. The measured indoor temperature was  $24.4^\circ\text{C}$  which is 2.3-3.4°C higher than what was used in the two simulated scenarios while the measured relative

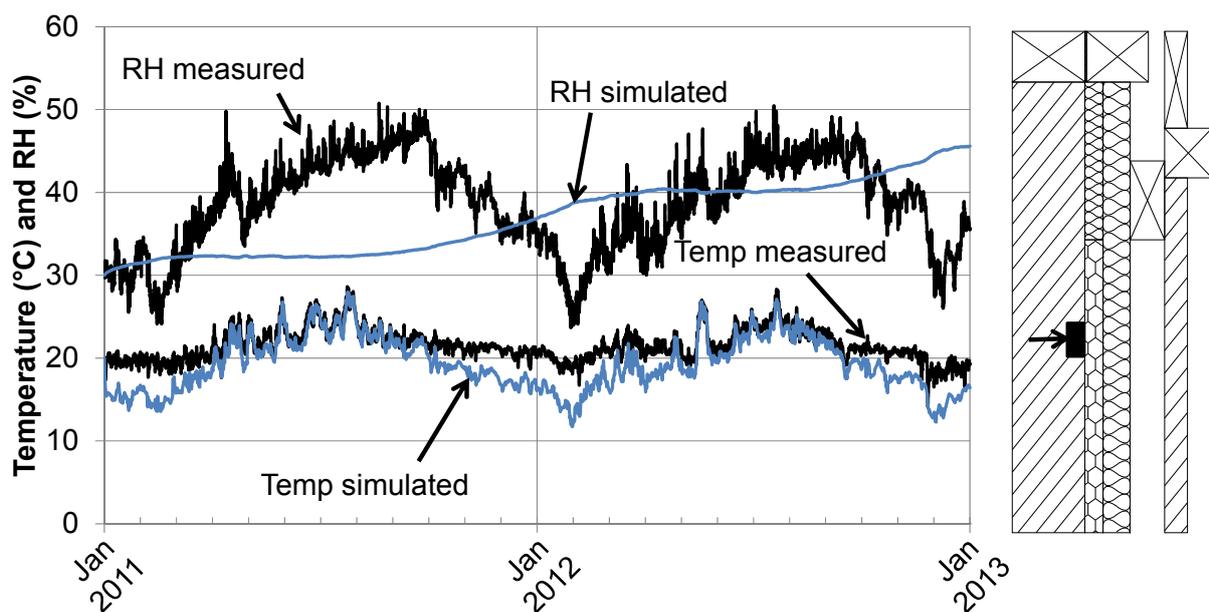
Figure 13. Comparison of the hygrothermal simulations with the measurements of the temperature and relative humidity behind the VIP in the wood wall. The simulation was based on the measured indoor and outdoor climate in 2011 and 2012. The location of the sensor is marked by the black box with a black arrow pointing from the left.

The accuracy of the simulation was, as expected, improved when simulating with the measured climate data and changed initial conditions. However, the measured temperature was still higher than what was simulated and the relative humidity increased over the two

years simulation with less variation than what the measurements showed. The average simulated temperature and relative humidity in the wall was 19.3°C and 36.9% while the measurements gave 21.5°C and 38.6%. Therefore, there are other sources, except for the indoor and outdoor climates, causing the deviations. The vapor content was on average 1.2 g/m<sup>3</sup> higher in the simulations than from the measurements so there is an additional drying process in the wall which could be from air exchange with the dryer outdoor air. As described earlier, the sensor is located in an air filled void in the wood, measuring the temperature and relative humidity of the air closest to the sensor. The high fluctuation in the measured relative humidity indicates a leaky construction with air leakage from the interior or exterior side of the vapor barrier into the wood construction. In the real wall, air could enter e.g. through details around windows and be transported along the interior of the vapor barrier to the location of the sensor. The wall was designed to be as air tight as possible, but it is hard to make every connection and detail perfectly air tight. To match the simulated temperature and relative humidity with the measurements, an air exchange with the outdoor air was added to the model between the vapor barrier and wood, see Figure 14.

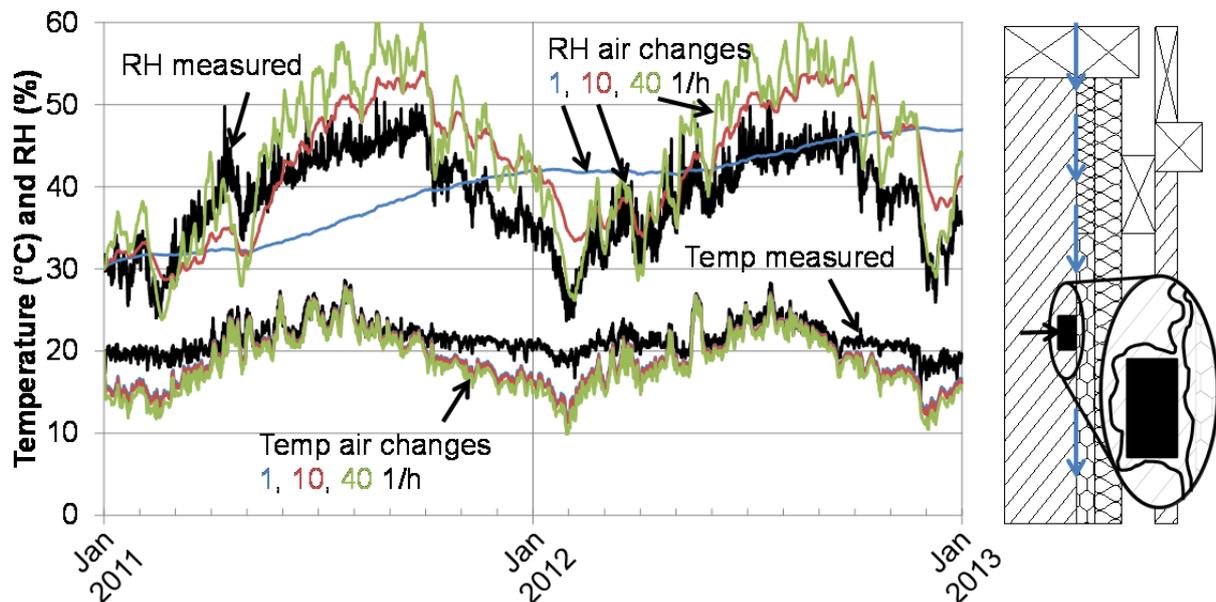
Figure 14. Comparison of the hygrothermal simulations with the measurements of the temperature and relative humidity behind the VIP in the wood wall. The air changes per hour with the outdoor air were varied from 1 1/h to 40 1/h. The location of the sensor is marked by the black box with a black arrow pointing from the left. The material surfaces in the wall are not perfectly smooth which makes air flow through the small voids between them possible.

It is clear that the relative humidity in the wall fluctuates more with increasing air changes. For 1 air changes per hour, the average relative humidity was 39.8%, for 10 1/h it was 42.7% and for 40 1/h it was 43.9%. The simulated average relative humidity is not increasing with time since the drying out capacity of the wall was increased with the air exchange. However, the temperature in the wall still differs from the measurements. The average simulated temperature was 19.3°C for 1 air changes per hour, 19.2°C for 10 1/h and 18.5°C for 40 1/h while the measured average temperature was 21.5°C.

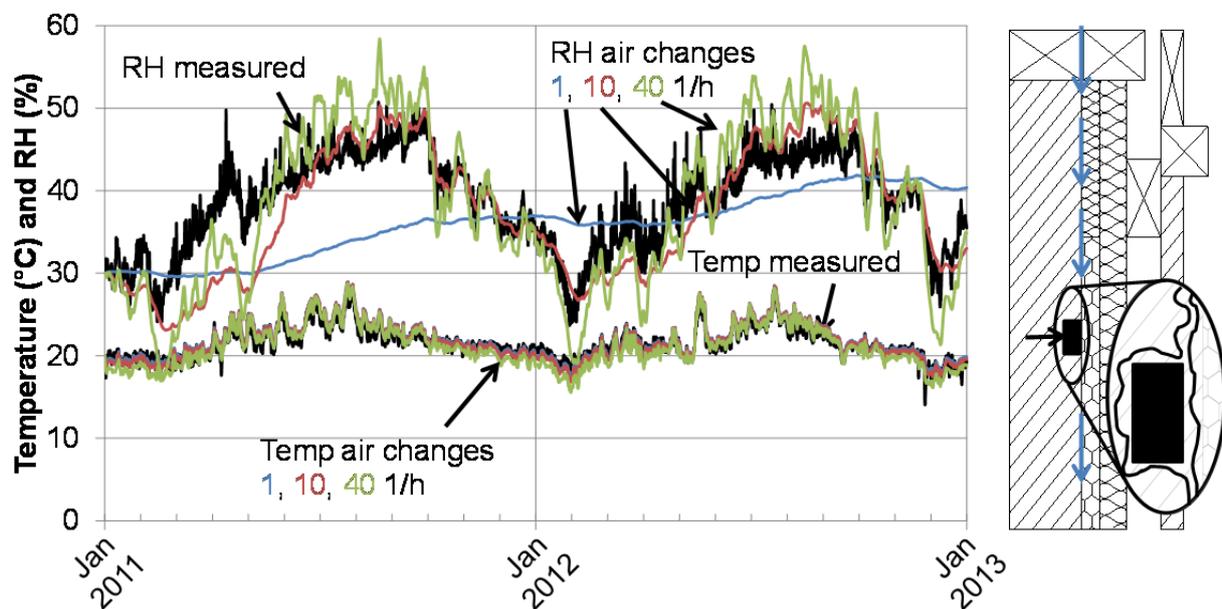
Figure 15. Comparison of the hygrothermal simulations with the measurements of the temperature and relative humidity behind the VIP in the wood wall. Simulations with a higher thermal conductivity of the air layer and glass wool and a lower thermal conductivity of the wood compared to the previous simulations. The air changes per hour with the outdoor air

were varied from 1 1/h to 40 1/h. The location of the sensor is marked by the black box with a black arrow pointing from the left. The material surfaces in the wall are not perfectly smooth which makes air flow through the small voids between them possible.

With the additional changes to the model, the simulated temperature in the wall shows a substantially better agreement with the measurements. For 10 air changes per hour, the average temperature was 21.7°C, for 20 1/h it was 21.5°C, for 40 1/h and 100 1/h it was 21.2°C. Also the average simulated relative humidity was in line with the measurements. For 10 air changes per hour, the average relative humidity was 37.4%, for 20 1/h it was 37.6%, for 40 1/h it was 38.3% and for 100 1/h it was 40.2%. The measured relative humidity was 38.6% which corresponds well with the results of an air exchange rate of 40 1/h. These results show the importance of knowing the correct material parameters and the air permeability of the construction. It is especially important when calculating the relative humidity in the construction which can be heavily influenced by the air exchange with the indoor or outdoor air.
